# A STUDY OF A LANDSLIDE IN BIRMINGHAM, ALABAMA

Caitlin L. Bukovitz  
*Michigan Technological University*

A REPORT

In Civil Engineering

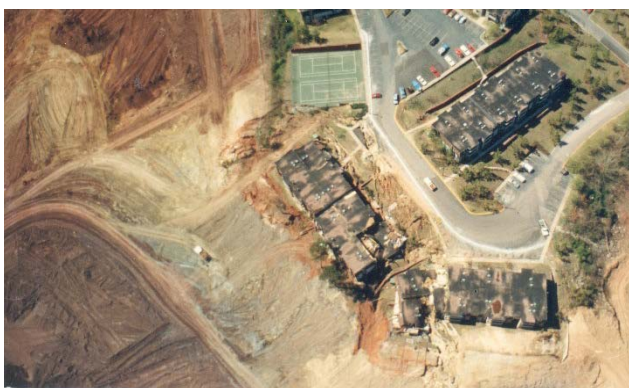
FIGURE 1: THE MOUNTAIN TOP APARTMENTS AND THE CONSTRUCTION SITE DIRECTLY AFTER THE TWO GROUND MOVEMENTS.

On March 14<sup>th</sup>, 1988, during construction of the cut slope, slope failed along the claystone layer. At the time of failure, the slope had been excavated to about 65 feet. The first failure caused one of the apartment buildings to slide downslope. The day after the first

failure, a second landslide broke one of the other buildings in half and brought part of the building downslope. Fortunately, the accident only resulted in one minor injury to a resident of the apartments and no construction workers were injured. After the landslides, the construction site was shut down and a failure investigation was conducted.

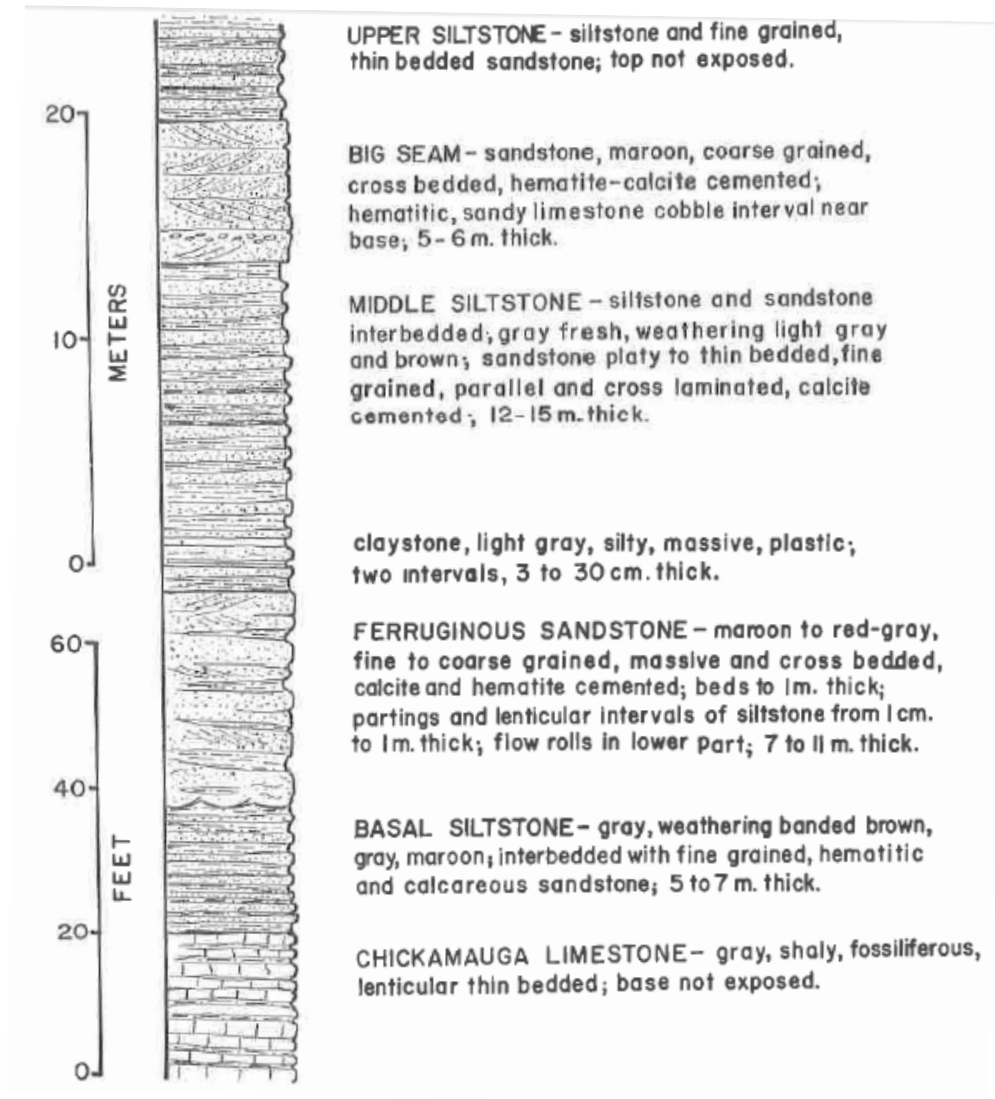
FIGURE 5: ASSUMED STRATIGRAPHY FROM BORING 1.<sup>[2]</sup> SEE APPENDIX FOR PERMISSIONS.

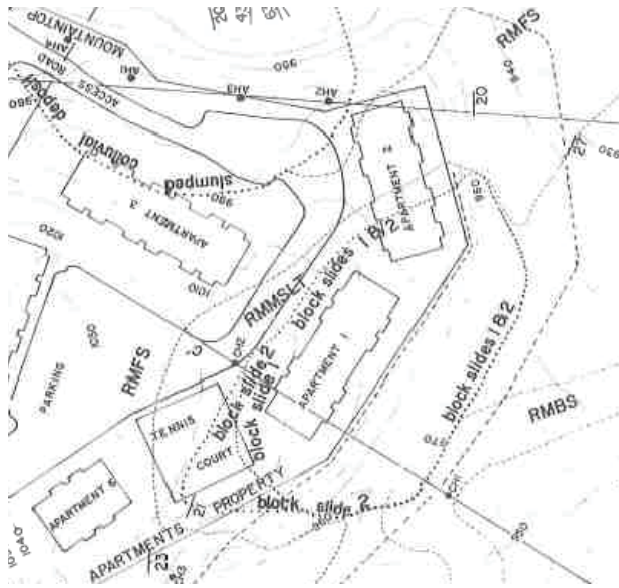
FIGURE 6: MOUNTAIN TOP APARTMENTS AND THE BLOCK SLIDES OUTLINED.<sup>[2]</sup> SEE APPENDIX FOR PERMISSIONS.

The design company drilled five exploration borings within the construction site, which are shown on Figure 6. Boring 1 was the only hole within the perimeter of either ground movements, though Boring 2 was close to the edge of the second ground movement (Figure 6). The designing company then tested the strength of several of the rock layers. The soil groupings were classified into three groups: a clay/siltstone layer, a silt/sandstone layer, and limestone

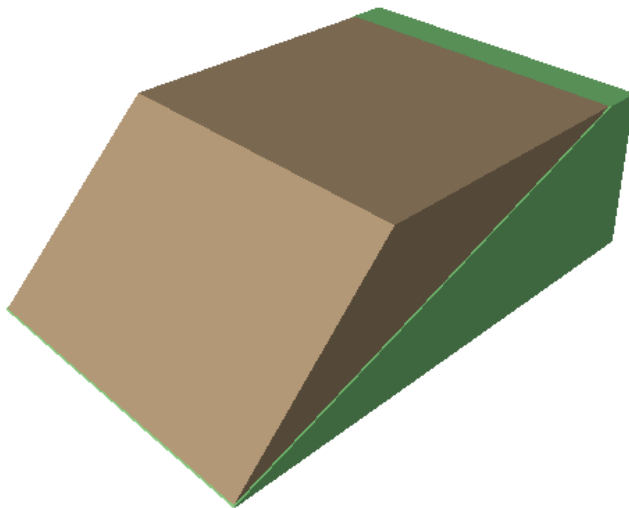
RocPlane can only utilize one set of soil or rock input parameters, so the strength values of the rock that failed were used. A baseline analysis was conducted that represents the analysis of the designing company. The model utilizes a cohesion of 1152 psf, a friction angle of 10 degrees, and no pore water pressure. The report stated that the factor of safety that the designing company calculated was 1.48. The RocPlane factor of safety came to 1.54. This analysis is provided in the Appendix.

FIGURE 9: BASELINE MODEL THAT REPRESENTS AS DESIGNED FACTORS FROM THE DESIGNING COMPANY.

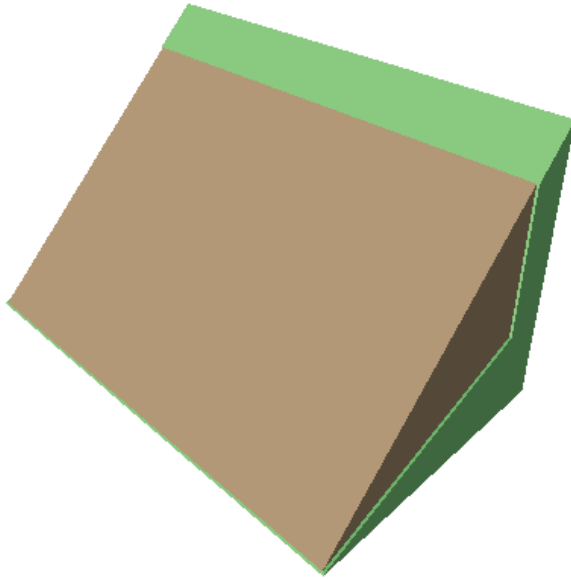
**FIGURE 11: THE MODEL SHOWING A FACTOR OF SAFETY OF 1.0 AT 50 FEET WITH FRACTURES AND WATER PRESSURE AT THE BASE OF THE FRACTURES.**

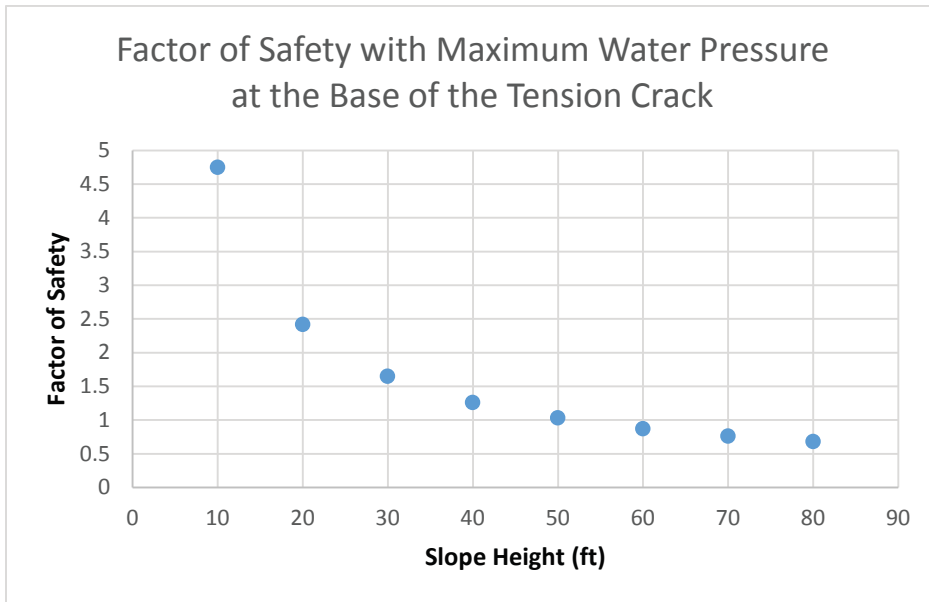
**FIGURE 12: GRAPH OF THE FACTOR OF SAFETY VERSUS SLOPE HEIGHT WITH FRACTURES AND WATER PRESSURE AT THE BASE OF THE FRACTURE.**

As seen on the graph, the slope had a factor of safety of 1.0 at a slope height of about 50 feet with the maximum pore water pressure at the base of the fractures and the given soil strength parameters. This analysis is also provided in the Appendix.

infiltration, it was assumed the greatest pressure would be at the base of the fractures. In comparison to the actual failure, the analysis of the fractures with maximum pore water pressure at the fractures' base matches the failure relatively well. The slope was excavated to a maximum of 65 feet and a block failure occurred along the claystone layer.<sup>[8]</sup> The fractures would allow for a block failure and the model showed that the slope would have failed above approximately 50 feet, well within the 65 foot excavation.

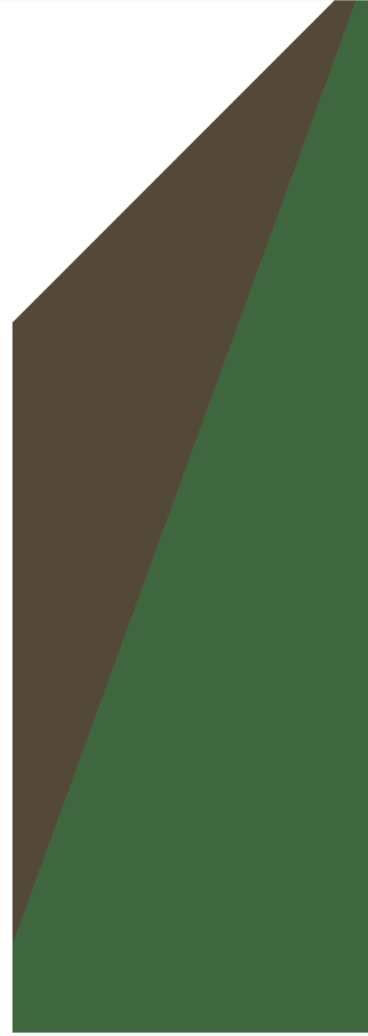
Wedge Information:	
<b>Deterministic Analysis</b>	
Factor of Safety:	1.54377
Normal Force:	698874 lbs/ft
Normal Stress:	2987.86 psf
Shear Strength:	1678.84 psf
Driving Force:	254369 lbs/ft
Resisting Force:	392688 lbs/ft
<b>Geometry</b>	
Slope Height:	80 ft
Wedge Weight:	743726 lbs/ft
Wedge Volume:	5591.93 ft <sup>3</sup> /ft
Wedge Height:	80 ft
Unit Weight:	133 lbs/ft <sup>3</sup>
Slope Angle:	45 deg
Failure Plane Angle:	20 deg
Upper Face Angle:	0 deg
Bench Width:	Not Present
Waviness:	0 deg
Failure plane length:	233.904 ft
Slope length:	113.015 ft
<b>Strength</b>	
Shear Strength Model:	Mohr-Coulomb
Friction Angle:	10 deg
Cohesion:	1152 psf
Shear Strength:	1678.84 psf
Shear Resistance:	392688 lbs/ft

FIGURE 13: RocPLANE RESULTS FOR THE BASELINE MODEL.

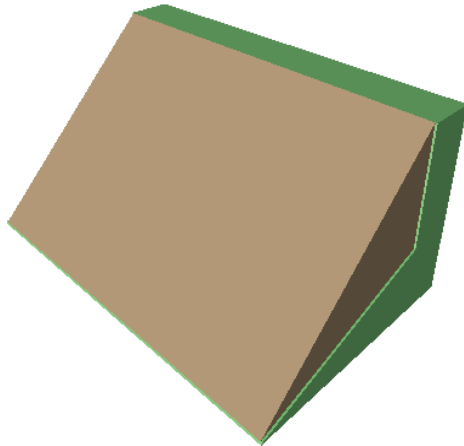
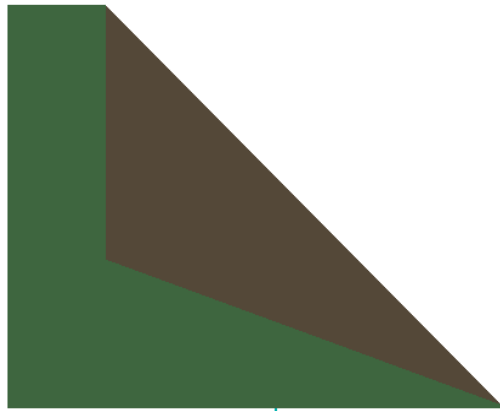
**Deterministic Analysis**  
Factor of Safety: 1.00245  
Normal Force: 28979.3 lbs/ft  
Normal Stress: 605.147 psf  
Shear Strength: 1084.26 psf  
Driving Force: 53310.9 lbs/ft  
Resisting Force: 53441.6 lbs/ft

FIGURE 14: RocPLANE RESULTS FOR THE AS FAILED MODEL.
