Retrofitting boreholes contaminated with iron in rural Uganda

RETROFITTING BOREHOLES CONTAMINATED WITH IRON IN RURAL UGANDA

A REPORT

Civil Engineering

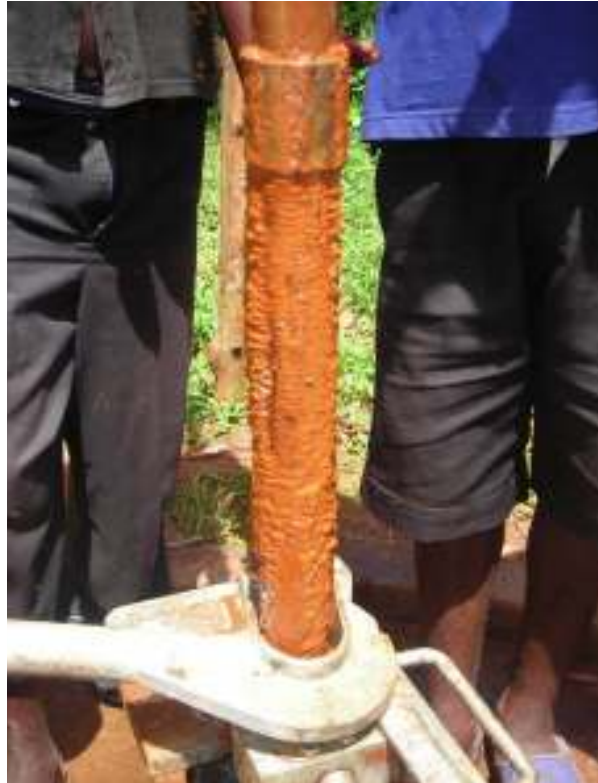
Visual observation of these wells gave a few clues as to potential factors that might be contributing to the problem. After the water was pumped and allowed to sit for a short while, an oily sheen appeared on the surface, almost as if there were a petroleum product in the water. The pipes of these wells also had some unique characteristics. Some of the pipes were covered in a black slime and smelled of rotten eggs. Other wells had pipes that were covered in a thick orange slime. Most of the pipes and rods suffered from a pitting form of corrosion.

Figure 1.2 Orange slime found on galvanized iron riser pipes extracted from the well in Bulegete (photograph by author)

The community of Bulegete is unique compared to other villages in the area. Strong community leadership and attention to maintenance had kept their well functioning since its construction in 2003. The iron level in the water was diluted enough, as a result of serving many people, that it was used for all purposes, even drinking. However, the community had grown weary of repairing their well. The pipes ruptured repeatedly, and the rods frequently failed due to extremely high rates of corrosion. We did not chlorinate the well since it was being used at the time of the 6-pipe conversion. The pipes extracted were covered in a thick orange slime (Figure 1.2). This work was completed on May 6, 2010.

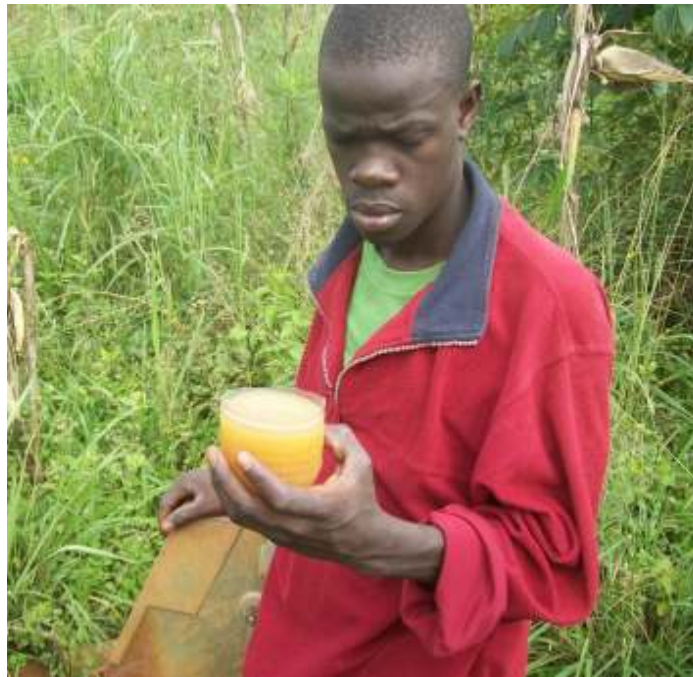
Figure 2.3 Bujune Aloysius reflects on the iron-rich water he just drew from the Kigoli borehole (photograph by author)

The well in the community of Kigoli was constructed on June 21, 2003. It produced good water for one month before starting to produce reddish/yellow-colored, iron-rich water (Figure 2.3). It was then completely abandoned. We converted the 10 pipes and chlorinated the well on March 30, 2010. The galvanized iron riser pipes removed from the well were covered in a black slime and smelled of hydrogen sulfide. The driller's log for this well and the following wells can be found in Appendix D.

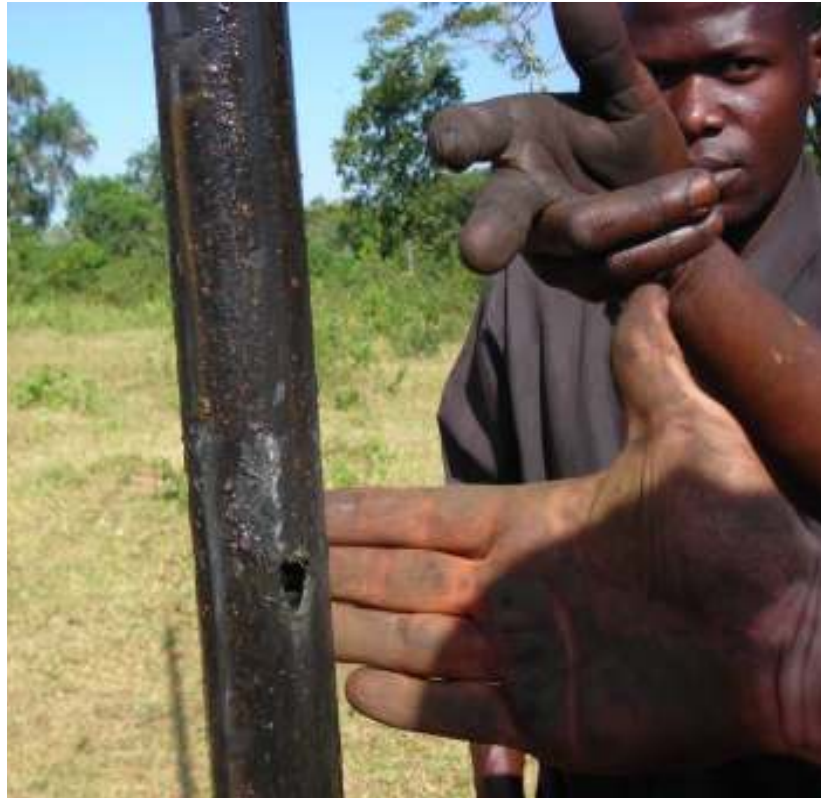
gas), tubercles and corrosion, and black slimes (Cullimore 1993). The presence of H_2S gas is of concern because it triggers a series of complex electrolytic corrosion processes on the surface of metal components (Cullimore 1993). The black slime covering the pipes is a metallic sulfide which is a product of hydrogen sulfide reacting to large amounts of metallic materials in the water such as iron or manganese (Cullimore 1993). SRB are controlled in the same way as IRB. As they cannot be completely and permanently eradicated, periodic dosing of the well with a strong oxidant is necessary.

Figure 2.6 A hole eaten into an iron riser pipe from the Kyabasaija well (photograph by author)

The well at Kyabasaija church was drilled on June 19, 2003. It functioned for about 5 years until it started producing 'yellowish' water. The pump failed shortly thereafter. The community put forth no effort to fix it because of the unpalatable water it had started to produce. The pipes pulled from this well were black and had obvious instances of localized corrosion as seen in Figure 2.6. Disinfection and a 13-pipe conversion were completed on June 23, 2010.

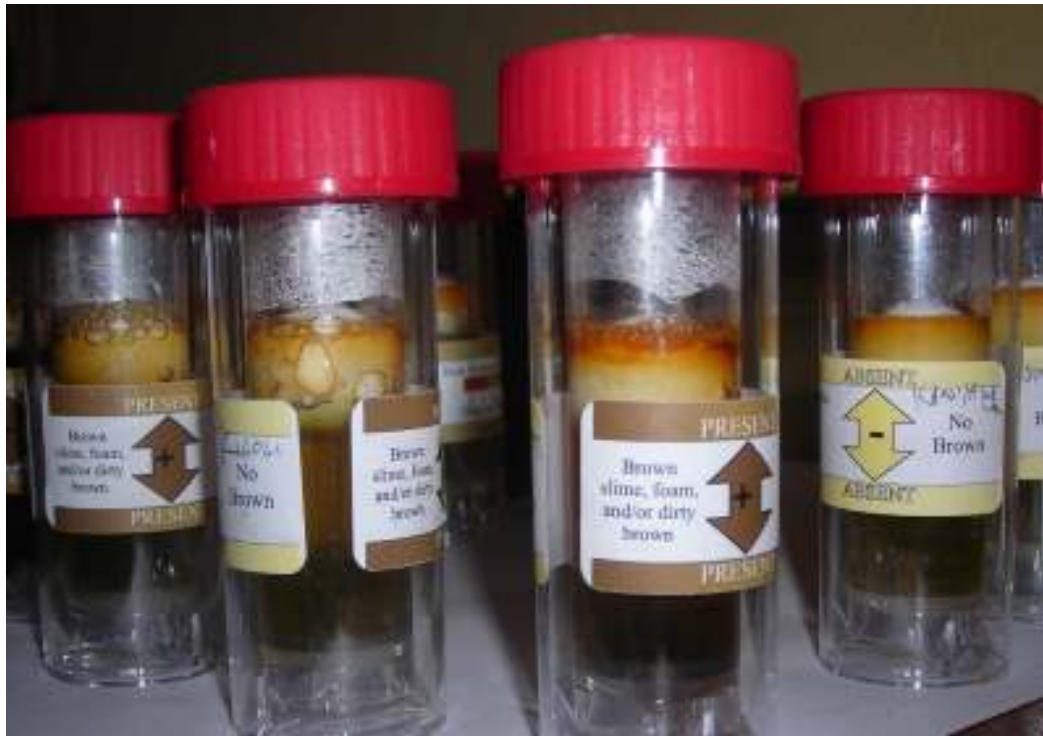
Eleven of twelve wells tested showed a positive reaction for anaerobic bacterial activity. This is referred to as Reaction 5 and is indicated by bubbles or foam appearing under and around the floating ball of the IRB-BART™ kit as shown in Figure 4.2. The literature states that a correlation potentially exists between Reaction 5 and the presence of sulphate reducing bacteria (Cullimore 1993).

Figure 4.2 From left to right: bubbles appearing in IRB-BART™ samples taken from Bukumi, Kigoli, and Bulegete. No bubbles in Kanyawawa’s sample. (photograph by author)

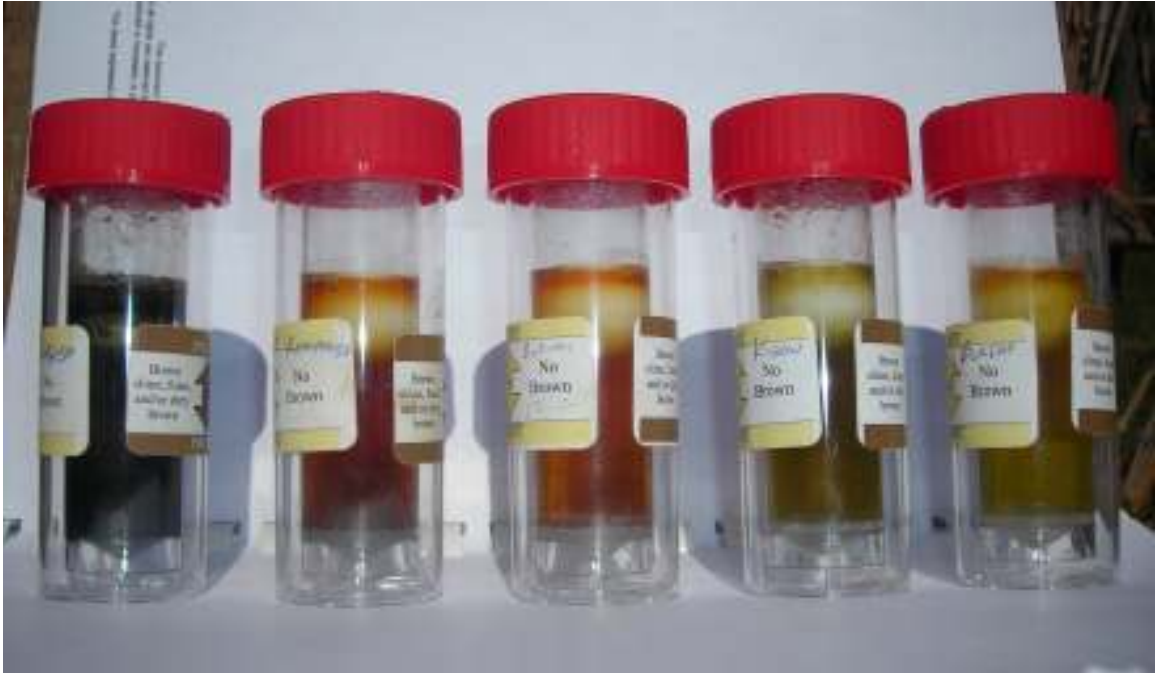
All of the samples that showed the signs of enteric bacteria did so as a secondary reaction following Reaction 5. The bacteria of a secondary reaction are not as dominant as those of the primary reaction. Enteric bacteria can be indicated by a scarlet red hue, seen in Figure 4.3, which is characterized as Reaction 7. The two major genera of bacteria causing this reaction are klebsiella and enterobacter (Cullimore 1993). Enteric bacteria can also be indicated by a blackening of the sample as shown by Kasojo in Figure 4.3. This is characterized as Reaction 10, which can also indicate the presence of sulphate reducing bacteria.

Figure 4.3 From left to right: black reaction from Kasojo, scarlet samples from Kihurumba and Bukumi, and clear green reaction from Kigoli and Bulegete. (photograph by author)
