A STUDY OF A LANDSLIDE IN BIRMINGHAM, ALABAMA

A REPORT

In Civil Engineering

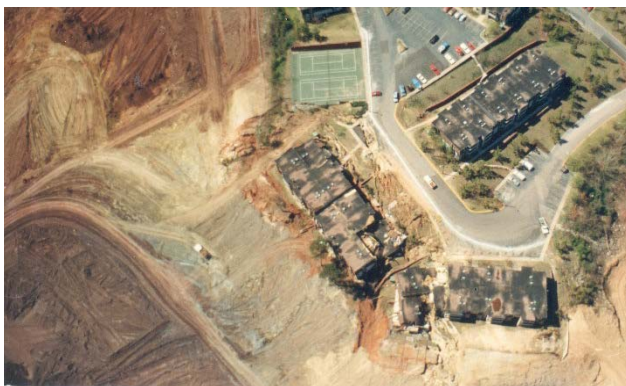
FIGURE 1: THE MOUNTAIN TOP APARTMENTS AND THE CONSTRUCTION SITE DIRECTLY AFTER THE TWO GROUND MOVEMENTS.

On March 14th, 1988, during construction of the cut slope, slope failed along the claystone layer. At the time of failure, the slope had been excavated to about 65 feet. The first failure caused one of the apartment buildings to slide downslope. The day after the first

failure, a second landslide broke one of the other buildings in half and brought part of the building downslope. Fortunately, the accident only resulted in one minor injury to a resident of the apartments and no construction workers were injured. After the landslides, the construction site was shut down and a failure investigation was conducted.
