## A STUDY OF A LANDSLIDE IN BIRMINGHAM, ALABAMA

Caitlin L. Bukovitz  
*Michigan Technological University*

A REPORT

In Civil Engineering

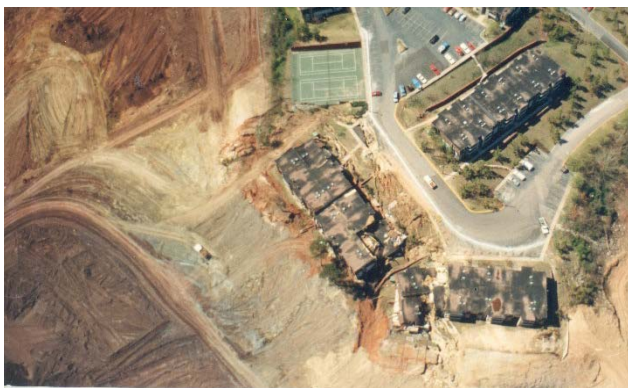
FIGURE 1: THE MOUNTAIN TOP APARTMENTS AND THE CONSTRUCTION SITE DIRECTLY AFTER THE TWO GROUND MOVEMENTS.

On March 14<sup>th</sup>, 1988, during construction of the cut slope, slope failed along the claystone layer. At the time of failure, the slope had been excavated to about 65 feet. The first failure caused one of the apartment buildings to slide downslope. The day after the first

failure, a second landslide broke one of the other buildings in half and brought part of the building downslope. Fortunately, the accident only resulted in one minor injury to a resident of the apartments and no construction workers were injured. After the landslides, the construction site was shut down and a failure investigation was conducted.

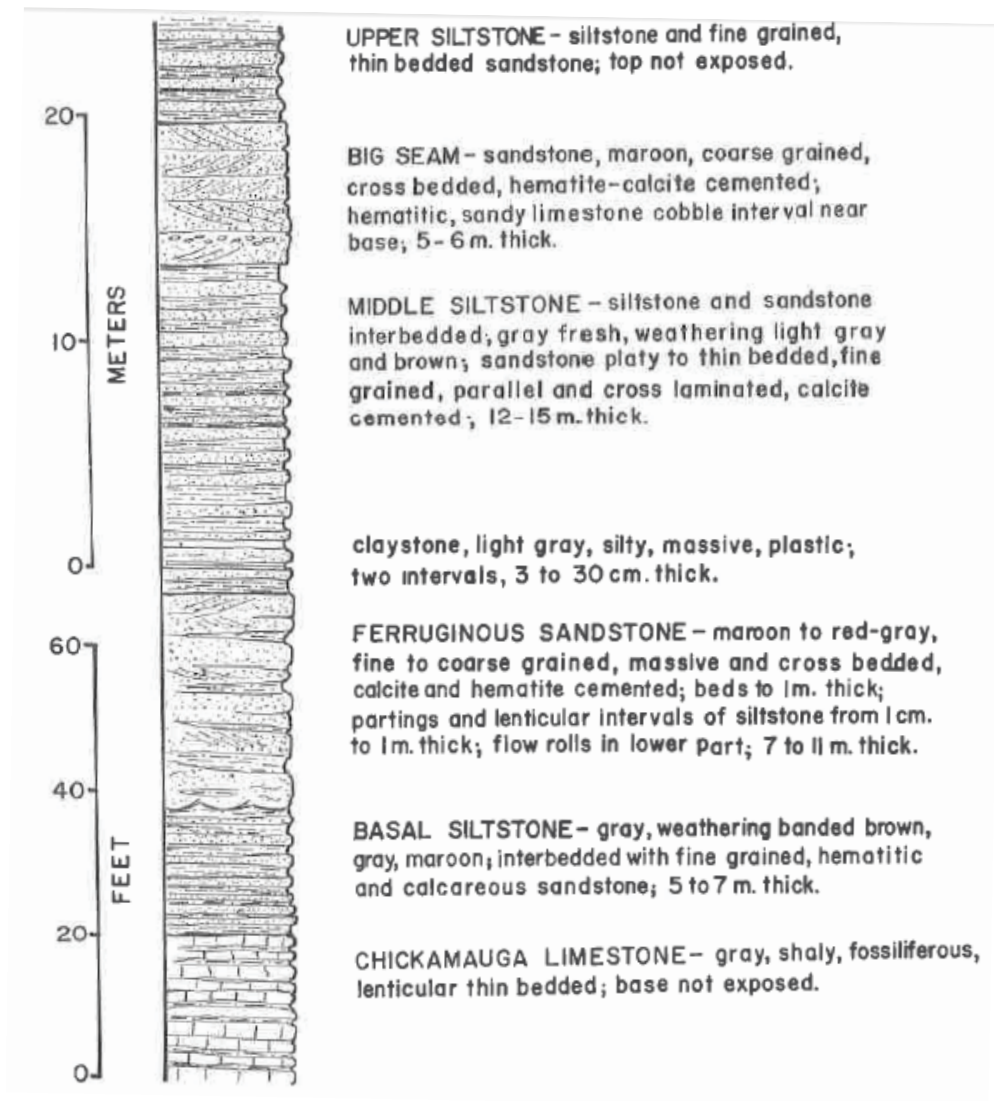
FIGURE 5: ASSUMED STRATIGRAPHY FROM BORING 1.<sup>[2]</sup> SEE APPENDIX FOR PERMISSIONS.

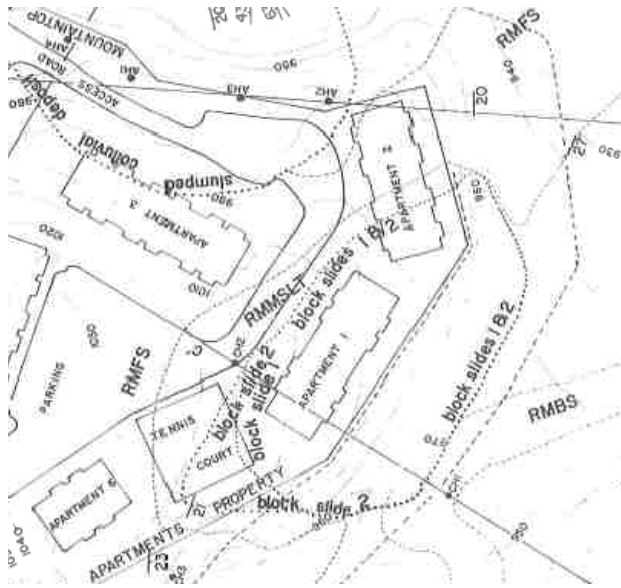
FIGURE 6: MOUNTAIN TOP APARTMENTS AND THE BLOCK SLIDES OUTLINED.<sup>[2]</sup> SEE APPENDIX FOR PERMISSIONS.

The design company drilled five exploration borings within the construction site, which are shown on Figure 6. Boring 1 was the only hole within the perimeter of either ground movements, though Boring 2 was close to the edge of the second ground movement (Figure 6). The designing company then tested the strength of several of the rock layers. The soil groupings were classified into three groups: a clay/siltstone layer, a silt/sandstone layer, and limestone

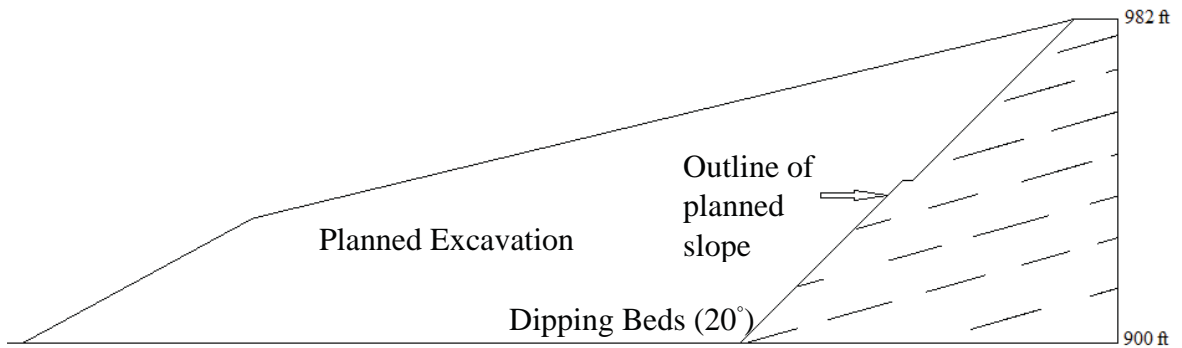
FIGURE 7: DESIGN OF CUT SLOPE DRAWN FROM INFORMATION IN THE DESIGNING COMPANY REPORT.<sup>[1]</sup>

The designing company designed two different slopes for the project. The first slope was designed to have a slope of 4 to 1 and contained two drainage outlets. The company deemed that the design was infeasible due to the cost of slope support needed. A second slope was designed to have an average slope of 1 to 1 and have a concrete drainage ditch. The cut was designed to vary according to the natural slope in order to increase stability. The cut was specifically designed to reduce the cost of support for the slope.

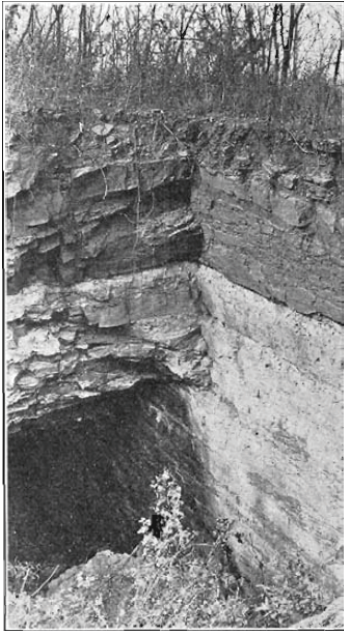
FIGURE 8: FROM CRANE'S PAPER SHOWING THE FRACTURE SYSTEMS. SEE APPENDIX FOR PERMISSIONS.

In 1927, Walter R. Crane, working for the U.S. Bureau of Mines, described the issues of subsidence and drainage in the iron ore mines in the Birmingham, Alabama. Crane's main focus was the extensive fracture system that resulted in significant amounts of water entering into the underground mines. Crane identified two major joint sets, both relatively vertical and nearly perpendicular to each other (an example is seen in Figure 8).<sup>[4]</sup> According to

Crane's paper<sup>[4]</sup>, the vertical fractures contributed to mine collapses due to slipping along the fractures in the mine ceilings and the introduction of significant amounts of water. Crane also observes that the dual fracture system could also cause slope failure

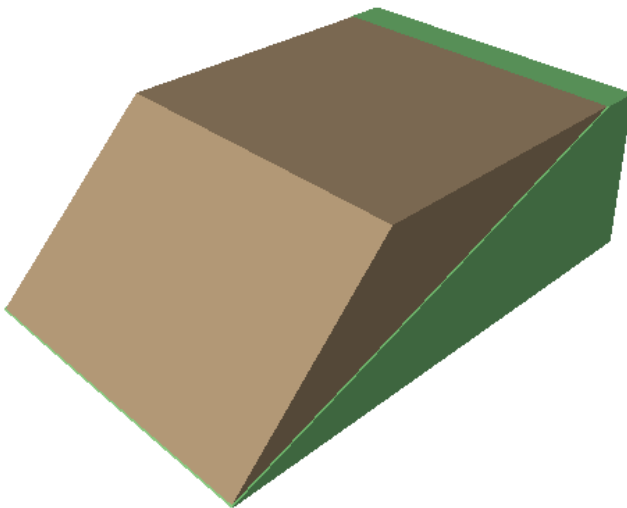
RocPlane can only utilize one set of soil or rock input parameters, so the strength values of the rock that failed were used. A baseline analysis was conducted that represents the analysis of the designing company. The model utilizes a cohesion of 1152 psf, a friction angle of 10 degrees, and no pore water pressure. The report stated that the factor of safety that the designing company calculated was 1.48. The RocPlane factor of safety came to 1.54. This analysis is provided in the Appendix.

FIGURE 9: BASELINE MODEL THAT REPRESENTS AS DESIGNED FACTORS FROM THE DESIGNING COMPANY.

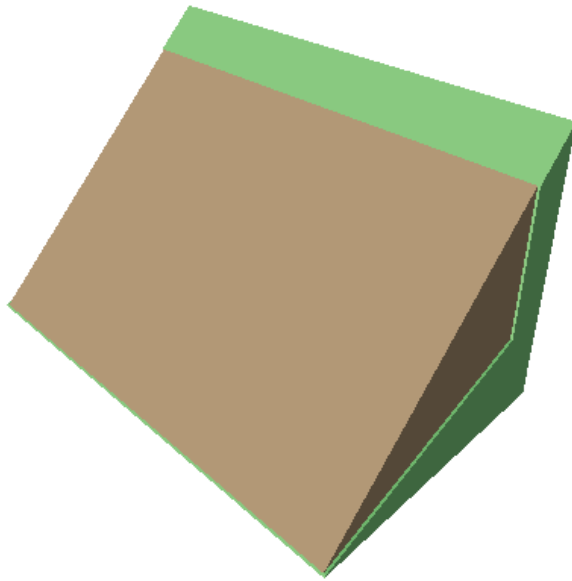
**FIGURE 11: THE MODEL SHOWING A FACTOR OF SAFETY OF 1.0 AT 50 FEET WITH FRACTURES AND WATER PRESSURE AT THE BASE OF THE FRACTURES.**

infiltration, it was assumed the greatest pressure would be at the base of the fractures. In comparison to the actual failure, the analysis of the fractures with maximum pore water pressure at the fractures' base matches the failure relatively well. The slope was excavated to a maximum of 65 feet and a block failure occurred along the claystone layer.<sup>[8]</sup> The fractures would allow for a block failure and the model showed that the slope would have failed above approximately 50 feet, well within the 65 foot excavation.

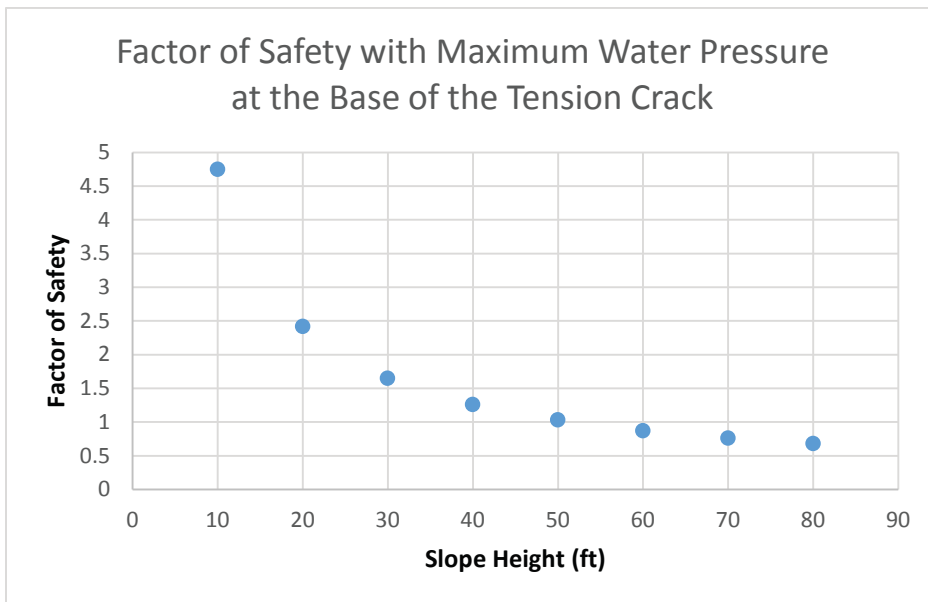
**FIGURE 12: GRAPH OF THE FACTOR OF SAFETY VERSUS SLOPE HEIGHT WITH FRACTURES AND WATER PRESSURE AT THE BASE OF THE FRACTURE.**

As seen on the graph, the slope had a factor of safety of 1.0 at a slope height of about 50 feet with the maximum pore water pressure at the base of the fractures and the given soil strength parameters. This analysis is also provided in the Appendix.

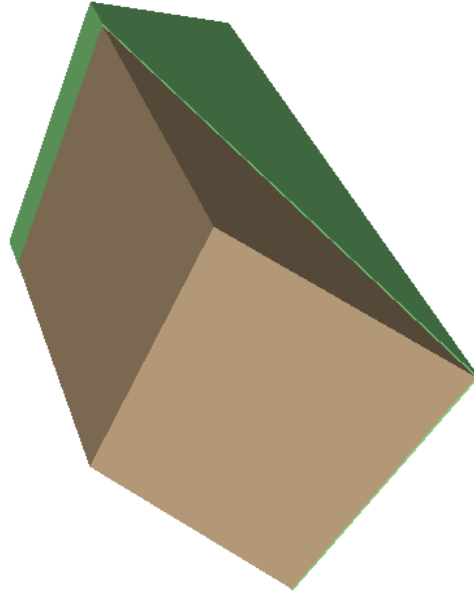
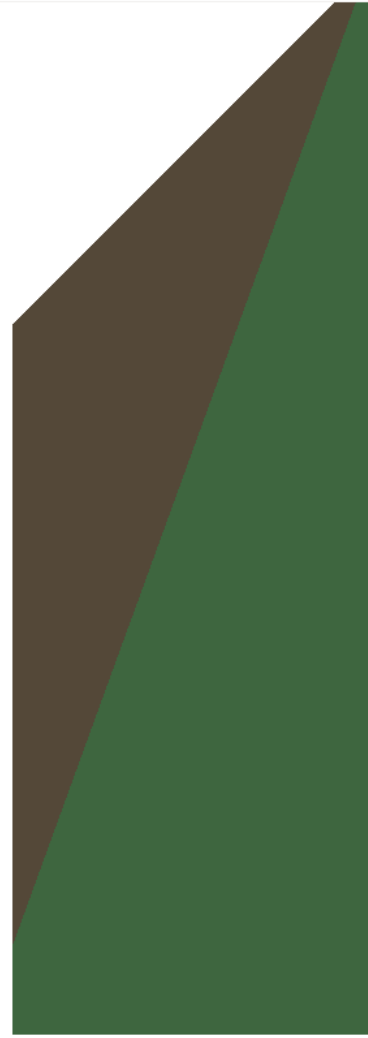
Factor of Safety: 1.54377

FIGURE 13: RocPLANE RESULTS FOR THE BASELINE MODEL.

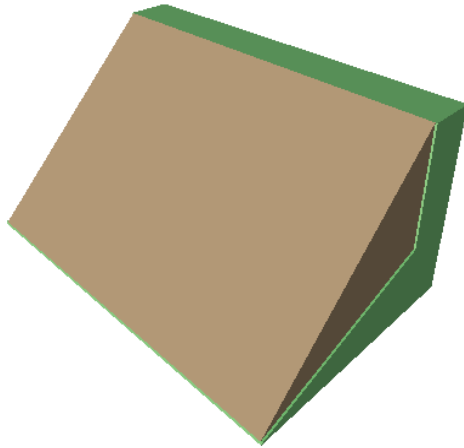
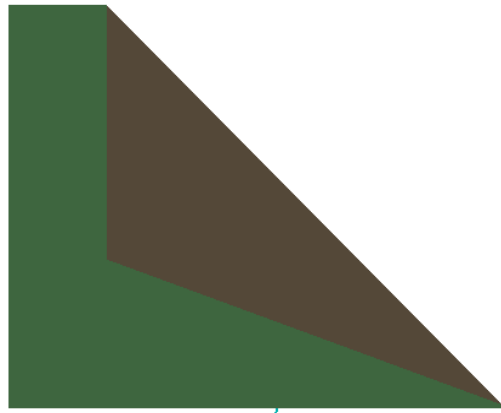
Factor of Safety: 1.00245

FIGURE 14: RocPLANE RESULTS FOR THE AS FAILED MODEL.
