## Characterization of edge damage induced on REBCO superconducting tape by mechanical slitting

William N Hartnett<sup>1</sup>, Javier Ramirez<sup>1,2</sup>, Tanner E R Olson<sup>1,3</sup>, Christopher T Hopp<sup>1</sup>, Matthew C Jewell<sup>1</sup> , Allan R Knoll<sup>4</sup>, Drew W Hazelton<sup>4</sup> and Yifei Zhang<sup>4</sup> <sup>1</sup> University of Wisconsin-Eau Claire, Eau Claire, WI, United States of America<sup>2</sup> University of Wisconsin-Madison, Madison, WI, United States of America<sup>3</sup> Michigan Technological University, Houghton, MI, United States of America<sup>4</sup> SuperPower, Inc., Glenville, NY, United States of AmericaE-mail: [jewellmc@uwec.edu](mailto:jewellmc@uwec.edu)**Keywords:** REBCO, coated conductor, superconductor, tape slitting

## Abstract

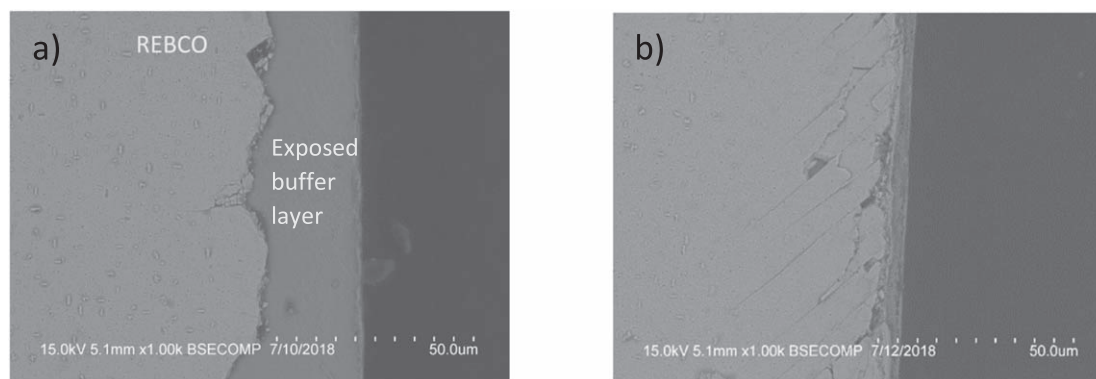
Specimens for investigation were sectioned from samples 1–6 and were imaged on the SEM. Two clear damage patterns emerged from the SEM image analysis. In exactly half of the samples, an approximately  $20\ \mu\text{m}$  layer of completely removed REBCO resulted in the exposure of the buffer stack near the slit edge (figure 4(a)). In the other half of the samples, the REBCO was nearly fully retained, however  $20\text{--}30\ \mu\text{m}$  cracks in the REBCO were visible with a periodicity of  $\sim 5\ \mu\text{m}$  (figure 4(b)). There was a clear pattern dictating which samples showed which behaviour. In the UP orientation samples, the odd-numbered samples (1, 3, 5) exhibited the complete fracturing, and the even-numbered samples (2, 4, 6) exhibited the retained cracks. In the DOWN orientation samples, the behaviour was identical, except that it was the even-numbered samples that exhibited the complete fracturing, and odd-numbered samples exhibited the retained cracks. A likely mechanism for this effect is discussed in section 4 of this paper. Through the remainder of this paper, the vocabulary complete fracturing and retained cracks will be used to identify samples of the type shown in figures 4(a) and (b), respectively.

**Figure 4.** SEM micrograph of (a) complete fracturing and (b) retained cracks exhibited in the REBCO layer.

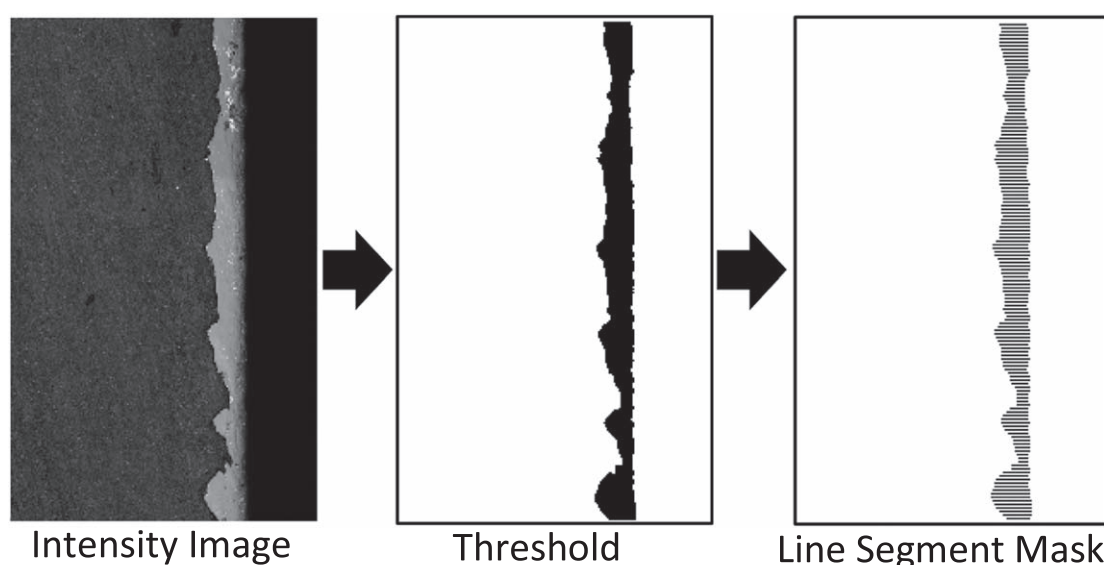
For samples exhibiting complete fracturing, confocal laser microscopy was used to acquire additional images of the fractured surface. Samples were imaged at  $200\times$  magnification utilizing both white light colour and a  $406\ \text{nm}$  laser. Contrast between the REBCO and exposed buffer layer was used to perform a greyscale threshold in the image processing software ImageJ. A line segment mask was applied to the threshold to measure the length of the REBCO that had fractured (see figure 5).

**Figure 5.** The image analysis process for determining width of exposed buffer stack region.

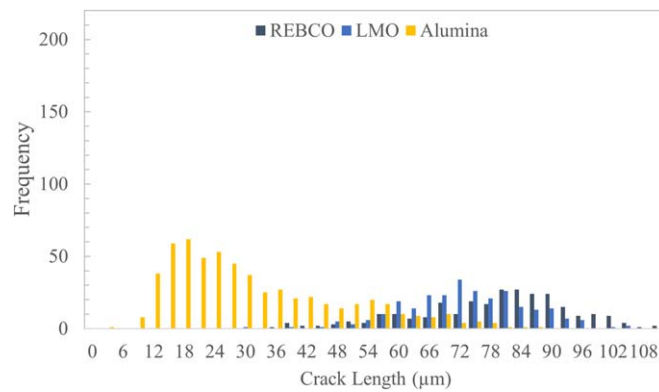
**Figure 15.** Crack distribution of all three analyzed layers in sample 4 (UP).

In the crack length distribution results section, we investigated cracks in narrow damage samples that were a result of slitting. A general trend observed across all samples was that the LMO layer showed more total cracks than the REBCO layer, with the REBCO cracks averaging 21% longer. Another trend that was observed was that the alumina layer showed 74% more cracks than the other two layers, with cracks averaging 50% shorter than those in the other two layers. Spatially, there is excellent matching between the location of cracks in the REBCO layer and those in the LMO layer, indicating that the cracks initiate in one layer and propagate to the adjacent layer. Since the REBCO layer is thicker than LMO by an order of magnitude and located at the maximum bend radius as it goes through the slitter (see figure 17), we can infer that the cracks most likely begin in the REBCO layer and propagate to the LMO layer.

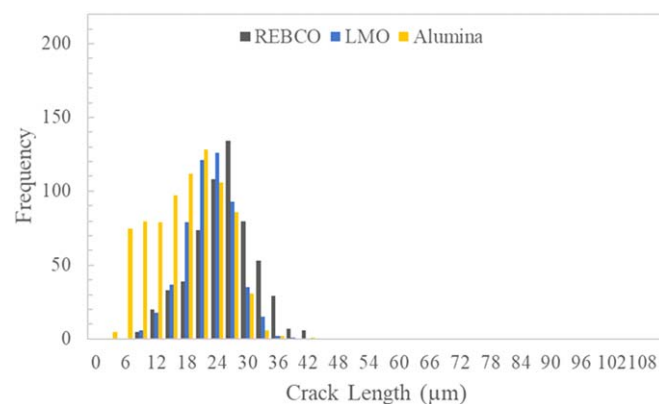
**Figure 16.** Crack distribution of all three analyzed layers in sample 5 (DOWN).

The cracks in the alumina layer, by contrast, are much shorter and more numerous than those in the REBCO or LMO layers. As a result, it is not clear that the alumina cracks propagate to the REBCO/LMO layers or vice versa. Rather, it is more likely that there is a separate crack initiation mechanism governing the damage seen in the  $\text{Al}_2\text{O}_3$ . For example, the mechanically weak  $\text{Y}_2\text{O}_3$  layer may be heavily cracked and initiating the cracking in the  $\text{Al}_2\text{O}_3$  (keep in mind that the  $\text{Y}_2\text{O}_3$  layer was too thin to isolate via etching and observe in this section of the experiment). Alternatively, the strong and very thick (50  $\mu\text{m}$ ) Hastelloy layer adjacent to the  $\text{Al}_2\text{O}_3$  may determine its mechanical behaviour. The nature of the crack initiation mechanism in the  $\text{Al}_2\text{O}_3$  layer requires further investigation.

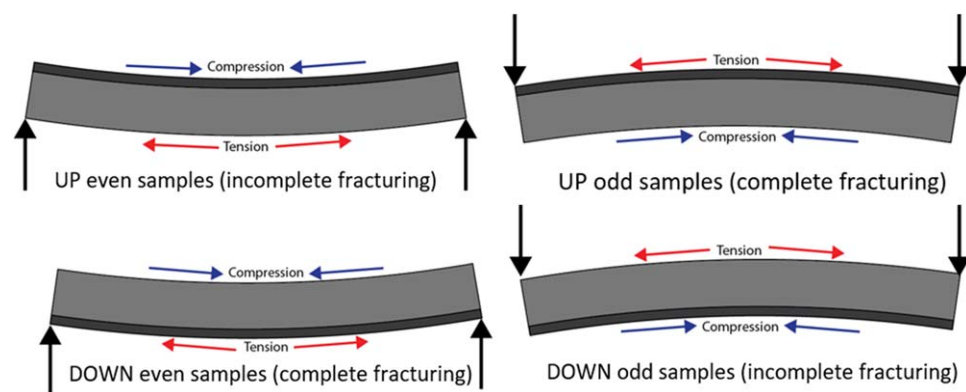
The mechanical slitting in this work produces two distinct fracture morphologies. The odd-numbered UP samples (1, 3, 5) show complete removal of the REBCO layer to a width of about  $20\ \mu\text{m}$ , and the even-numbered DOWN samples (2, 4, 6) show an identical pattern. This clear periodicity correlates with the direction of the bending moment experienced by the REBCO layer of the tape as it passes through the slit. As shown in figure 17, the forces applied by the mechanical slitter will result in a tensile bending moment on the odd-numbered UP samples, but a compressive bending moment on the even-numbered UP samples. The

**Figure 17.** Visual representation of the bending moments due to slitting relative to the REBCO layer.

configuration is exactly the opposite for the DOWN samples. As a result, the cracks that nucleate as a result of the shear strain provided by the slit can propagate more easily when the REBCO layer is under tensile bending rather than compressive bending. This in turn has a clear and marked effect on the damage pattern observed, and we expect similar damage on the two edges of any individual sample after slitting. This matches the results of other studies in different mechanical configurations such as [21] and [22], where tensile fatigue testing caused REBCO cracks to grow and compressive fatigue testing did not result in crack growth. This crack growth can cause significant degradation in  $I_c$  under fatigue conditions which are common in superconducting magnets.

For example, in [21] 100,000 cycles to a tensile strain of  $\varepsilon = 0.50\%$  were shown to result in a 70%  $I_c$  degradation. Transverse compressive stresses in [22], by contrast, are shown to reduce  $I_c$  by less than 1%. Another study compared the lateral distribution of critical current density for different slitting methods and found that when the superconducting layer was under compression during slitting, the equivalent length was less than when the superconducting layer was under tension during slitting [17]. A clear implication is that damage propagation can be minimized by minimizing the extent of tensile bending as the tape passes through the slitter, e.g. by redesigning the device to better support the tape as it passes through.
