SLOPE STABILITY ANALYSIS OF MOUNT MEAGER, SOUTH- WESTERN BRITISH COLUMBIA, CANADA

A THESIS

In Geology

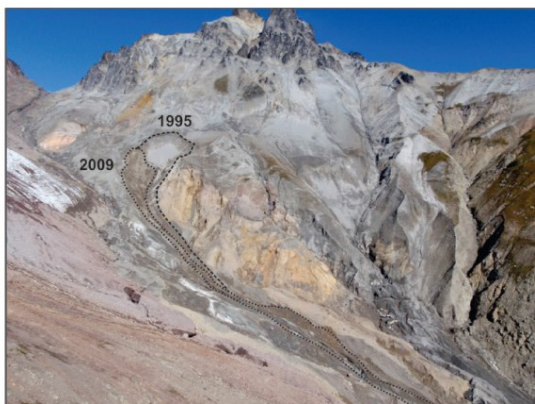
During historic time there have been ten recorded debris flows and rock avalanches, most occurring at Capricorn Creek in the south-east of the complex (Guthrie *et al.*, 2012). A section of Mount Meager failed in July 1998 in Capricorn Creek (Fig. 5). An estimated $1.2 \times 10^6 \text{ m}^3$ of material was displaced after record breaking high temperatures were recorded that same month (Bovis and Jakob, 2000). A glacially de- buttressed slope collapsed leading to a debris flow in Devastation Creek in July 1975 (Holm *et al.*, 2004) after a similar pattern of high temperatures which probably caused extensive snow melt (Bovis and Jakob, 2000). This was another large volume event with $1.2 \times 10^7 \text{ m}^3$ of material released (Friele *et al.*, 2008; Guthrie *et al.*, 2012) which killed four people in Meager Creek (Mokievsky-Zubok, 1977). Guthrie *et al.*, (2012) also documented a smaller failure of $0.5 \times 10^6 \text{ m}^3$ from 2009 to the left of the 1998 failure site (Fig. 5).

Fig. 5. Detachment zones of the 1998 and 2009 failures on the southern side of Mount Meager (from Guthrie *et al.*, 2012).

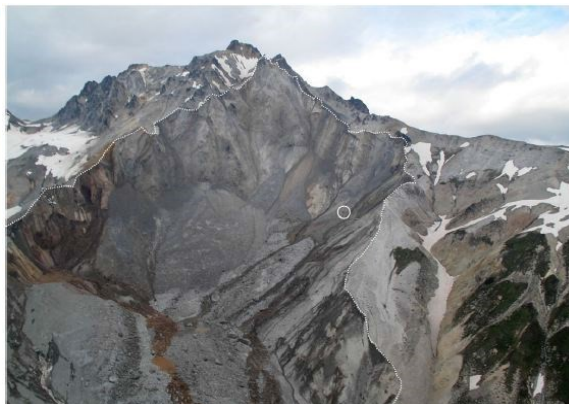
The 2010 debris avalanche occurred on the 6th August and was the tenth mass flow with a volume greater than $0.5 \times 10^6 \text{ m}^3$ at the MMVC since 1850, and the sixth largest over the Holocene (Fig. 6) (Guthrie *et al.*, 2012). The 2010 event occurred at Capricorn Creek with the failure of the southern side of Mount Meager, which flowed into Meager Creek and Lillooet River, temporarily damming both rivers (Fig. 7). The volume of material which failed during this event was estimated at $48.5 \times 10^6 \text{ m}^3$ (Guthrie *et al.*, 2012). This was the most recent event.

Fig. 6. Detachment zone of the 2010 failure on the southern face of Mount Meager. A helicopter is circled for scale (from Guthrie *et al.*, 2012).

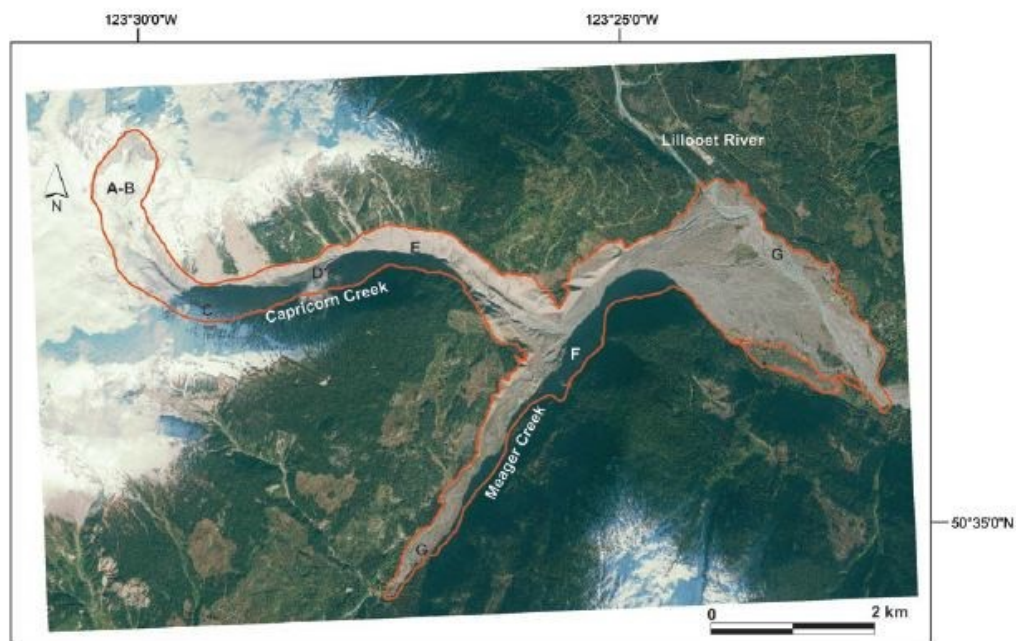
Fig. 7. The 2010 debris flow deposit from Capricorn Creek entering Meager Creek and Lillooet River, damming both rivers (from Guthrie *et al.*, 2012).

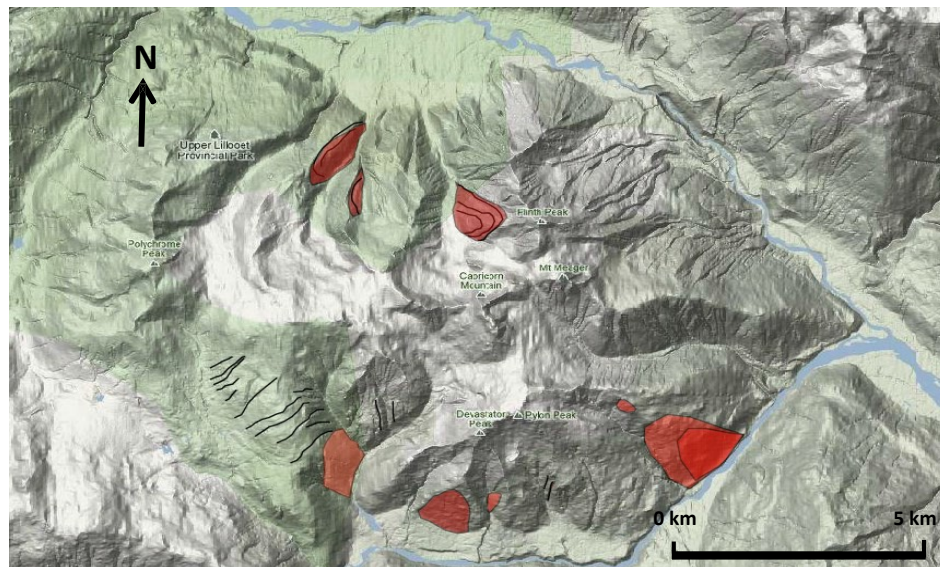
Preliminary mapping of the entire complex using Google Earth shows there are many more sites of possible instability, and areas which appear to be already failing (Fig. 10). Images show there are bulges, fractures and slumping, terrace-like features around the complex which is supported by literature describing sackungs at various locations

Fig. 10. Preliminary map of the MMVC. Areas in red show sections of possible instability as seen using Google Earth and areas that are already failing as found in literature. The literature describes most of the same areas as found when mapping, validating the use of Google Earth as a useful tool for detecting areas which appear unstable. Black lines show fractures and terracing (Image from Google Earth, 2010).

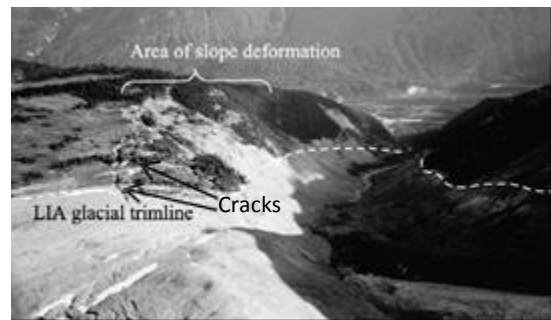
Affliction Creek, in the north-west of the MMVC, is split into two tributaries within the Complex, which join and flow as one into Lillooet River. On the western side of each tributary there is an area where slope sagging appears to be taking place (Fig. 12). The sloping scarps can clearly be seen using Google Earth. This would indicate slow movement such as rotational creep.

Fig. 12. Slope sagging (sackungs) at Affliction Creek in relation to the LIA glacial trimline. View to the north (from Holm *et al.*, 2004).

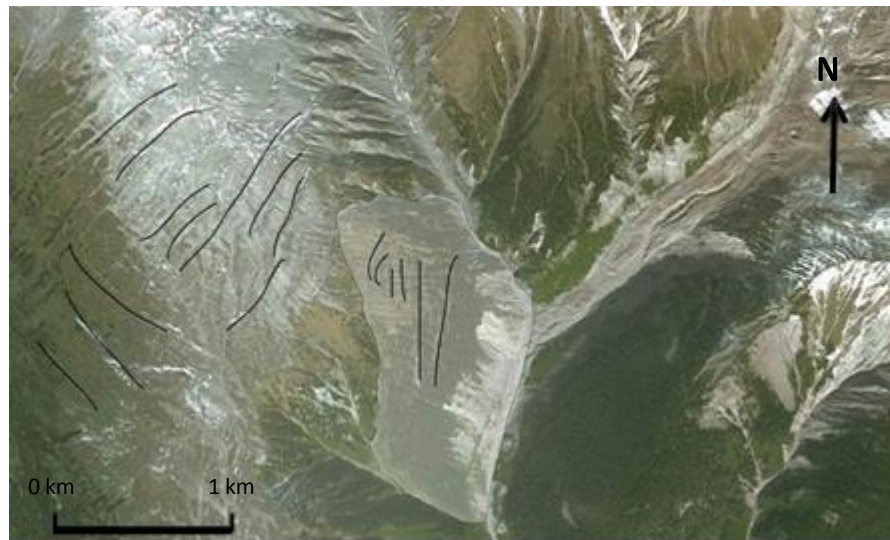
Terraces can be seen within the material in East Devastation Creek. The ridge to the west of Devastation Creek displays numerous linear fractures, many of which are perpendicular to the majority. The fractures follow weaker planes in the rock down to the valley. Images show snow collected in these fractures, so may be expanded as a result of freeze-thaw processes. The block at the end of the ridge, directly above the valley, displays what appear to be a series of anti-scarps (Fig. 13). If this end block failed, the rock fall would likely dam Meager Creek.

Fig. 13. West Devastation Creek showing the block at the end of the ridge which appears to be a site of instability. The black lines within the block section show prominent anti-slope scarps suggesting slope sagging and progressive movement. The other black lines show the main fractures at higher elevation of the ridge (Image adapted from Google Earth 2010).

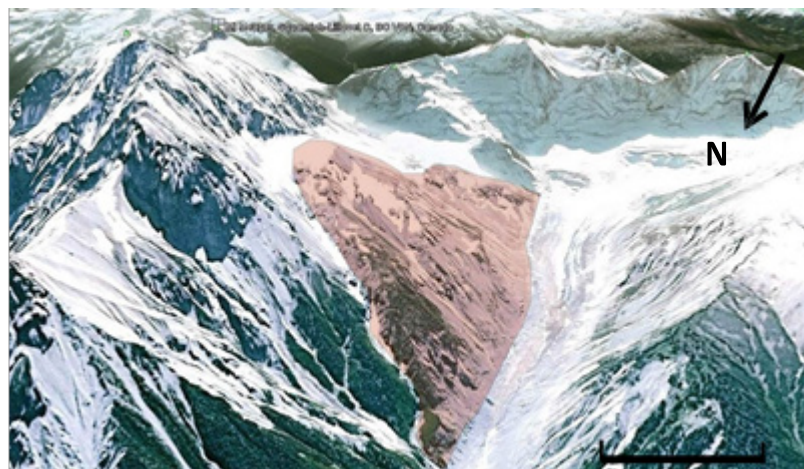
Job Creek is composed of hydrothermally altered rocks and is one of the sources for major prehistoric failures and edifice collapses (Friele *et al.*, 2008). This is thought to be the origin for one of the three major debris flow deposits in Lillooet River Valley, identified by Simpson *et al.* (2006). There are many large unstable masses within the MMVC capable of generating future edifice collapse, one of the most likely of these sites to fail being the eastern side of Job Creek (Friele *et al.*, 2008).

Fig. 14. Deformation in Job Creek, on the western flank of Plinth Peak. Mount Meager can be seen in the background behind Plinth (Image adapted from Google Earth 2010).

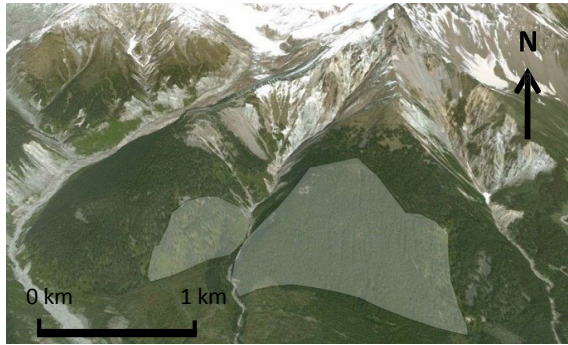
Fig. 15. Devastation Creek (left), Boundary Creek (center) and No Good Creek (right) below the Devastator Peak. Shaded sections are areas of possible future failure, where slumping appears to be occurring. (Image adapted from Google Earth 2010).

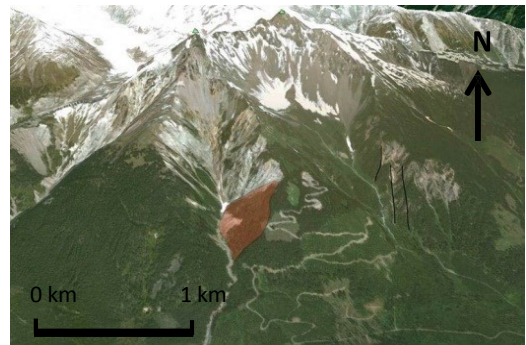
Fig. 16. Slumping indicating possible future failure (shaded area) on the eastern side of No Good Creek, below the Devastator and terracing (black lines) on the eastern side of Angel Creek, below Pylon Peak (Image adapted from Google Earth 2010).

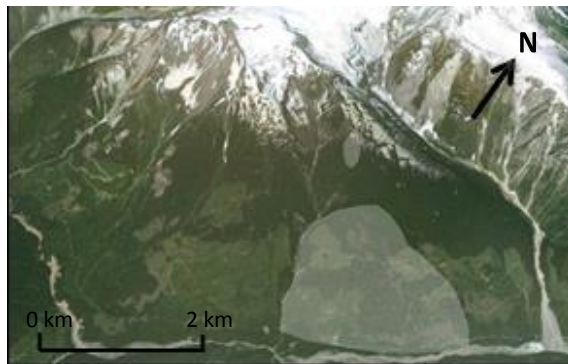
Fig. 17. The shaded areas are possible future failures based on slumping of the eastern side of Canyon Creek, below Pylon Peak (Image adapted from Google Earth 2010).

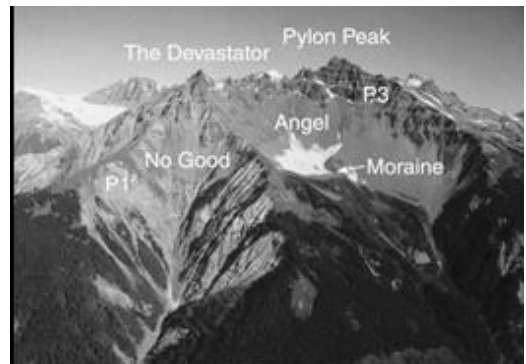
According to Holm *et al.* (2004), Angel Creek will likely experience a future increase in debris flow activity as the basin reaches its storage capacity (Fig. 18). Friele *et al.* (2008) state that Angel Creek is a major source of edifice collapse and due to its composition of hydrothermally altered material the flanks of Pylon are likely sites for future failures.

Fig. 18. Angel Creek is expected to have an increase in debris flow activity as the basin reaches its storage capacity (from Friele & Clague, 2004).

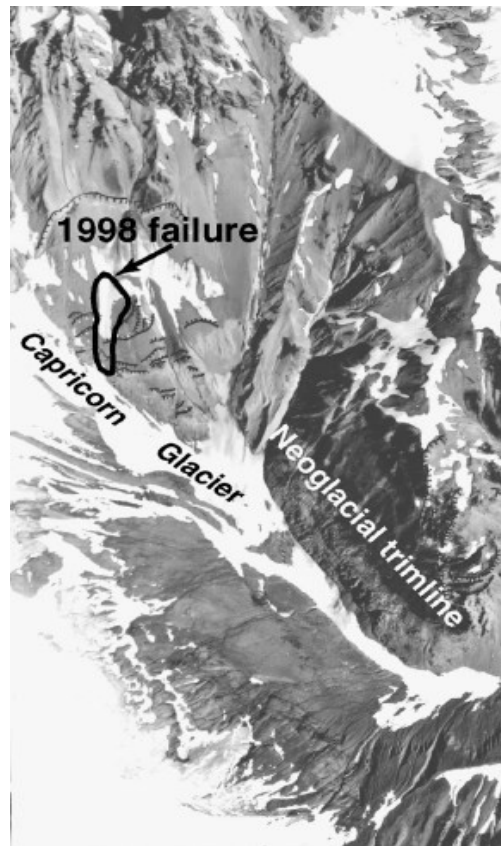
Tension cracks and scarps were observed around the detachment zone of the 1998 failure, as previously mentioned, (Fig. 19) in photographs dating back to 1948. This indicates there was a period of 50 year of progressive slope movement prior to failure (Bovis & Jakob, 2000). Bovis & Evans (1996) stated that there were on-going gravitational slope movements at Capricorn Creek which, like at Devastation Creek, implies a potential for future rock failures in the area surrounding slopes traversed by linears. Failures have occurred in Capricorn Creek three times since then, in 1998, 2009 and 2010.

Fig. 19. Black toothed lines show anti-slope scarps and tension cracks around the detachment zone of the 1998 failure of Mount Meager (from Bovis & Jakob, 2000).

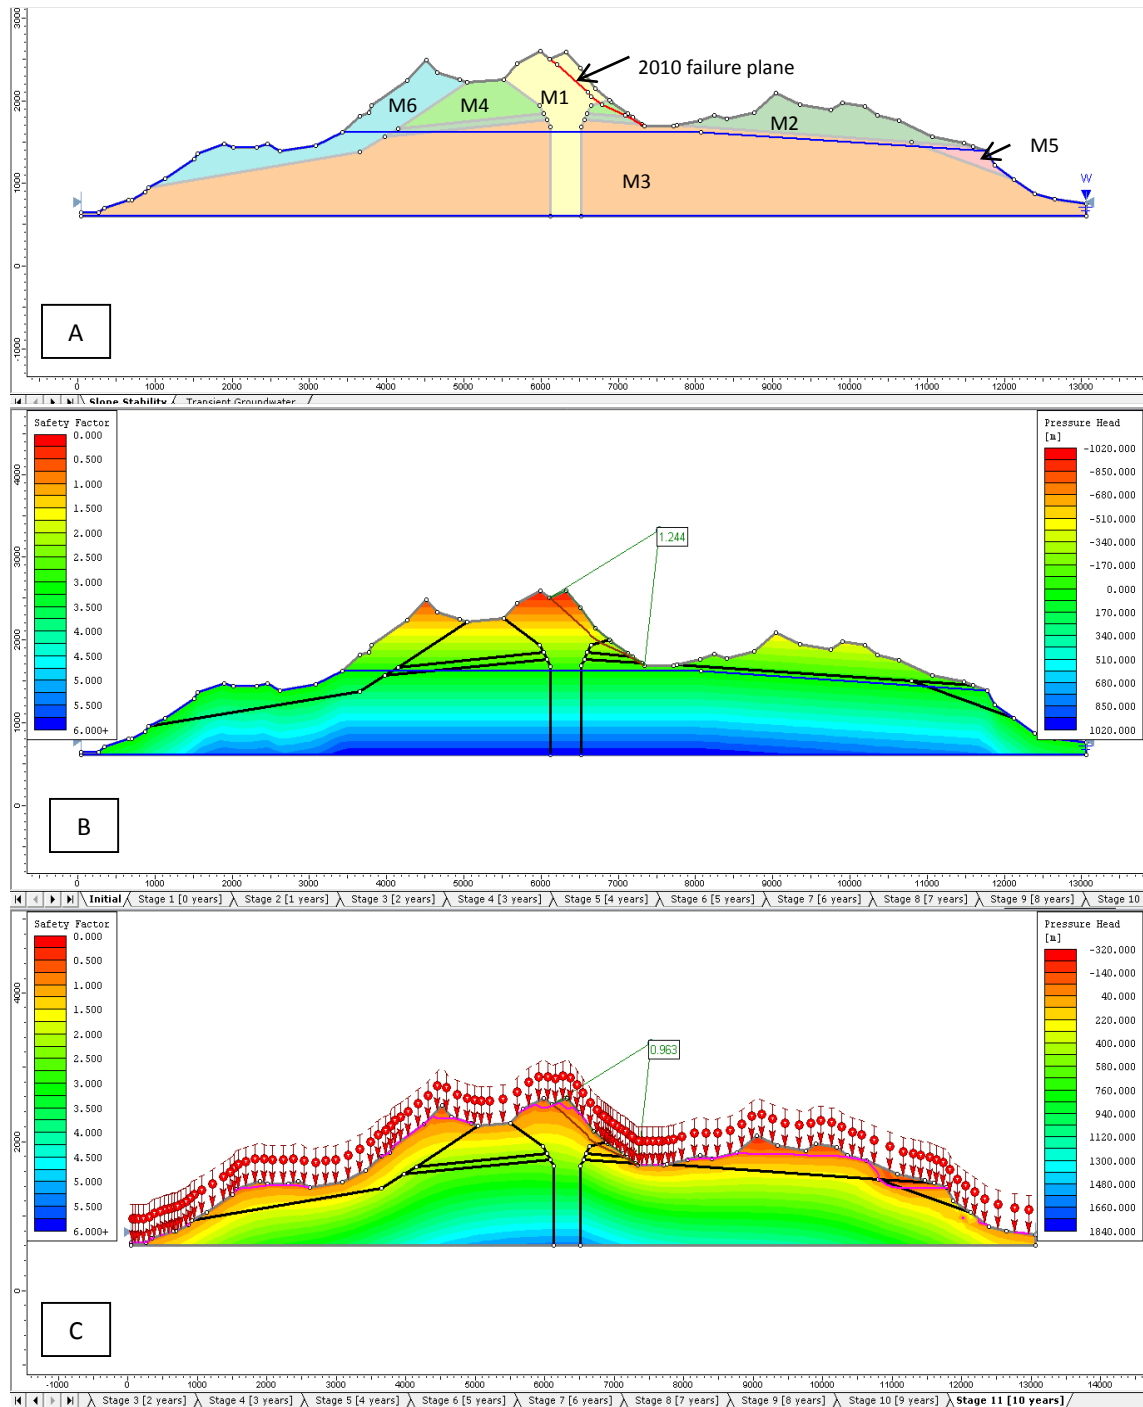
In all models for the N-S profile of Mount Meager, the water table reached the surface at stage 1 (first stage of infiltration added). The 'before failure' model, which determines failure along the 2010 failure plane, shows that at the initial stage (before infiltration began) the FOS was at 1.2. When annual infiltration begins, the FOS drops to just above 1 and gradually decreases over the stages down to 0.963 at the final stage (representing 2010) (Fig. 22).

Fig. 22. N-S profile. Slide model and back analysis up to the 2010 failure. A) Model before analysis showing profile and assumed internal structure. Materials and the 2010 failure plane are labelled. B) Initial stage showing FOS of the specified plane before infiltration. This shows that the southern side of Mount Meager was already inherently unstable without water. C) Final stage of analysis representing 2010. Water table is at the surface (pink line) and the FOS has decreased to 0.963

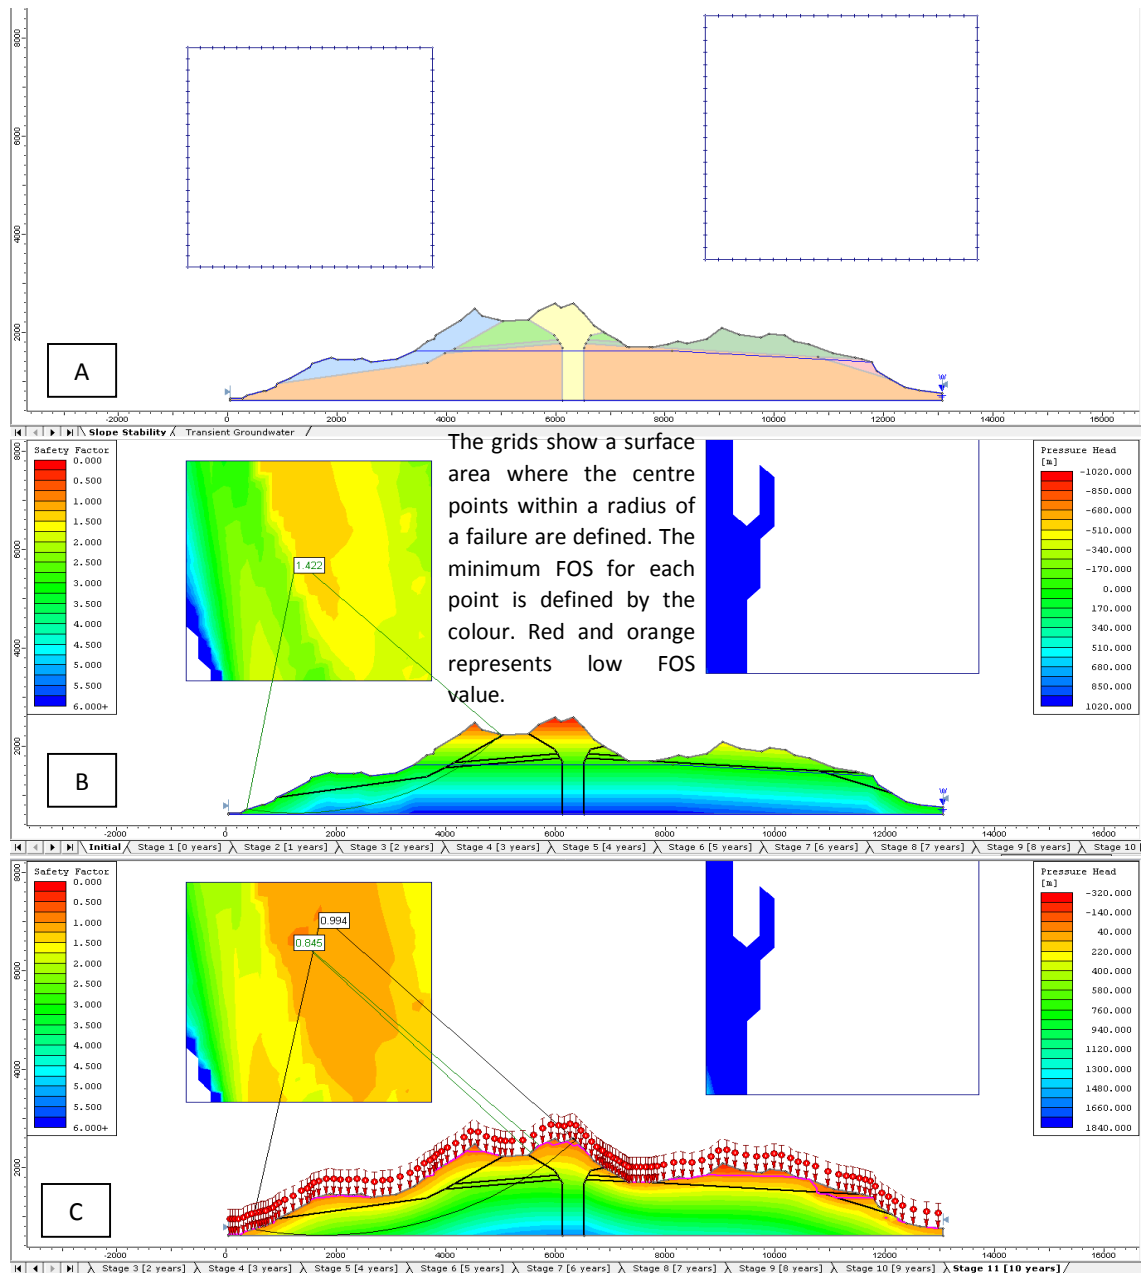
Fig. 23. N-S profile. Slide model and back analysis showing all failure planes below FOS of 1 for the northern side of the section. A) Model before analysis. Grids are for analysis using grid search in each direction. B) Initial stage showing FOS of the weakest plane before infiltration. This shows that the northern side of Mount Meager was moderately stable without water. C) Final stage of analysis representing 2010. Water table is at the surface (pink line) and the lowest FOS has decreased to 0.845. The deep failure plane shows a FOS of 0.994. The failure plane indicated at Mount Meager (FOS of 0.845) may have resulted in a relatively small rock fall onto Capricorn Glacier which would likely have gone unnoticed. The deep failure below Plinth (FOS of 0.994) shows it is at the point of failure. The speed of failure however cannot be determined using Slide. This therefore may indicate slow, progressive movement as seen at various locations around the MMVC.

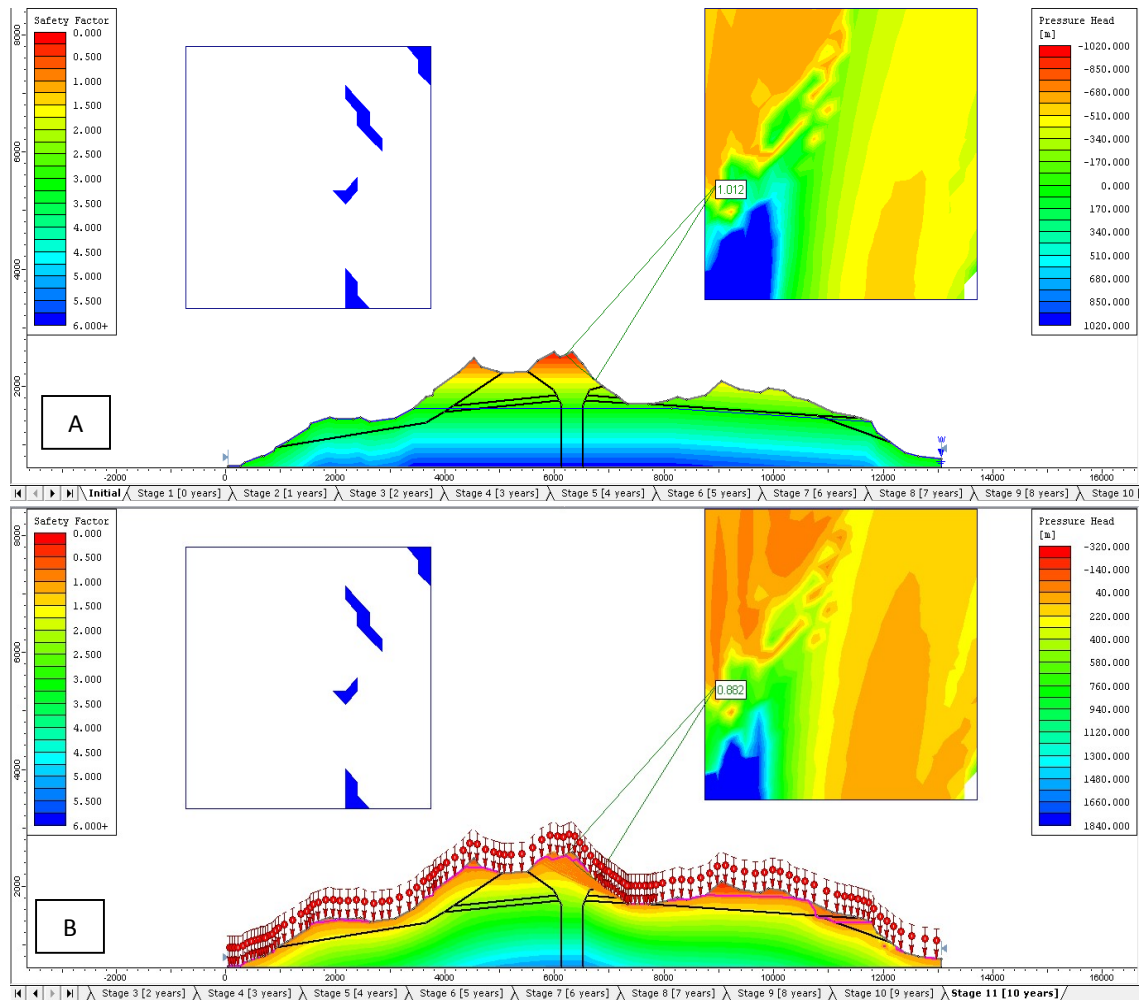
Conditions were applied to all areas along the N-S profile to verify the lowest FOS was at the 2010 failure site. The northern section of the Complex displayed a higher FOS, suggesting the values used were realistic. If the FOS was lower than at the 2010 site, it would suggest this area should have failed instead. At the initial stage, the northern half appears stable with a FOS of 1.4. Again, when infiltration is added the FOS decreases significantly, but remains at 0.994 throughout. This area displays a deep failure surface, which includes a large portion of Plinth and section of Meager Peak. Some stages show a lower FOS of 0.845 for a small area on the northern side of Mount Meager (Fig. 23). The southern section of the profile had an initial FOS of 1.012 and decreased to a minimum of 0.882 with infiltration. All failure planes with a FOS below 1.04 occurred at Mount Meager Peak. Failure planes with a FOS above this also occurred in the southern section of the model, towards Pylon Peak (Fig. 24).

Fig. 24. N-S profile. Slide model and back analysis showing all failure planes below FOS of 1 for the southern side of the section. A) Initial stage showing FOS of the weakest plane before infiltration. This shows that the southern side of Mount Meager was already at the point of failure. B) Final stage of analysis representing 2010. Water table is at the surface (pink line) and the lowest FOS has decreased to 0.882. All failure planes with a FOS below 1 are located at the peak of Mount Meager where the 2010 failure actually occurred. The grids show a surface area where the centre points within a radius of a failure are defined. The minimum FOS for each point is defined by the colour. Red and orange represents low FOS values

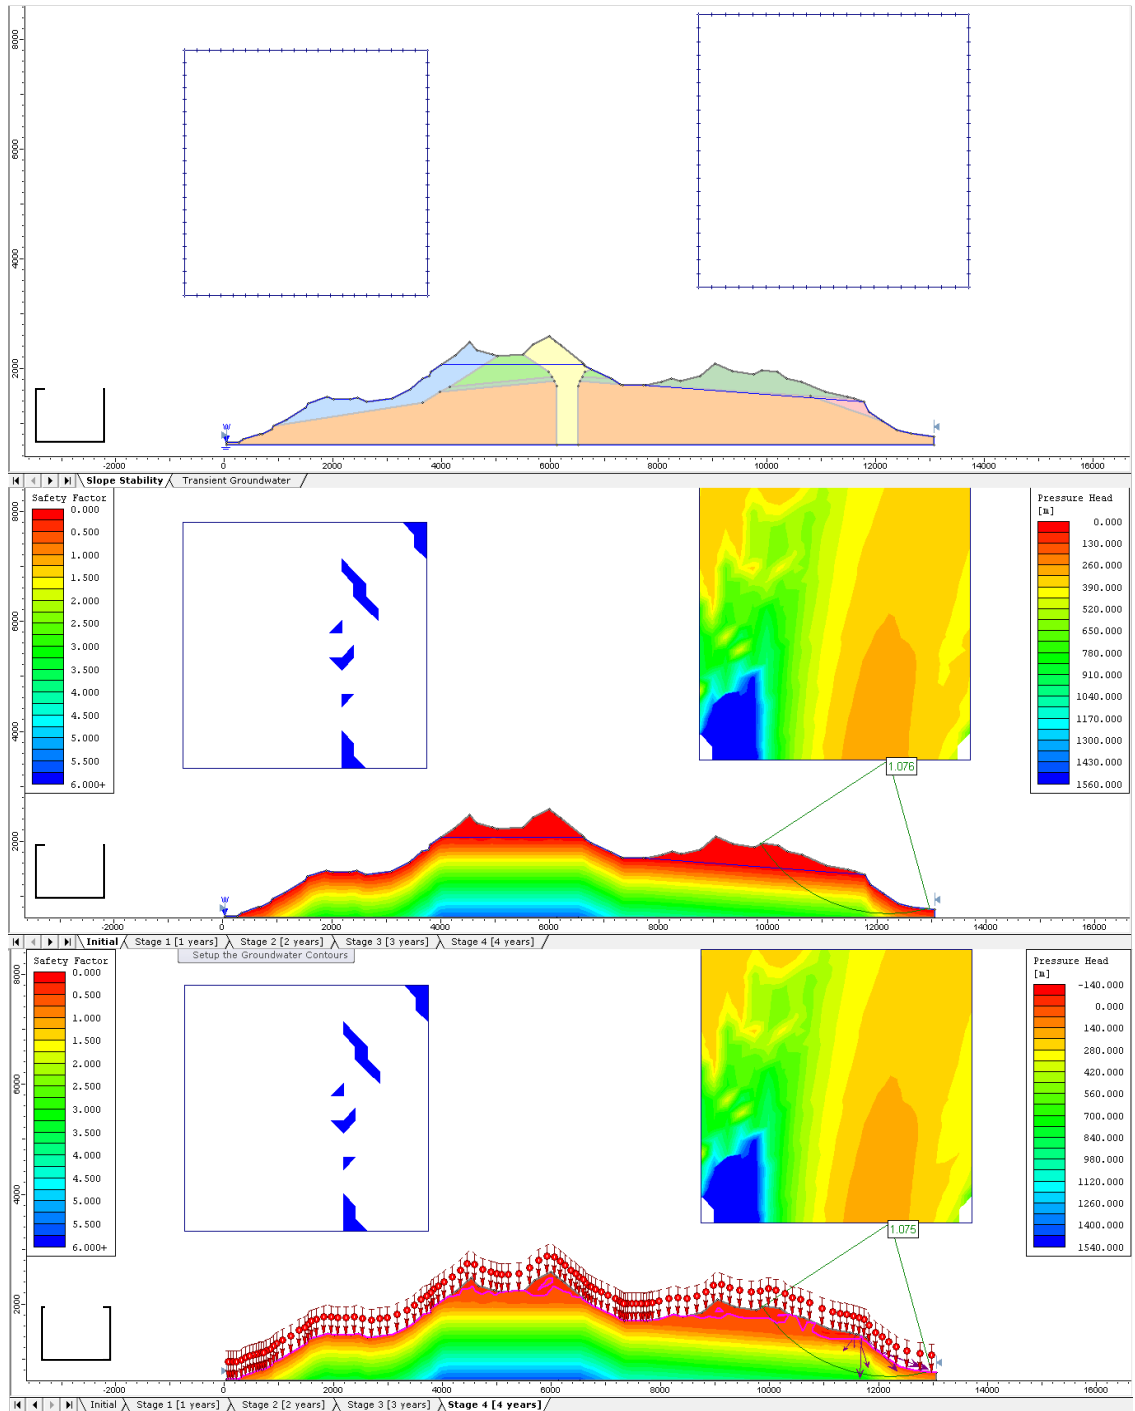
Fig. 25. N-S profile. Slide model for after failure in the southern section. Actual infiltration values were used for stages 1 and 2 (2011 and 2012) and extremes were used for stages 3 and 4 (2013 and 2014). A) Initial model with after failure topography. B) Initial stage showing the lowest FOS before infiltration. C) Final stage after infiltration displaying the lowest FOS. The weakest areas of the southern section are located on the flanks of Pylon. The grids show a surface area where the centre points within a radius of a failure are defined. The minimum FOS for each point is defined by the colour. Red and orange represents low FOS values.

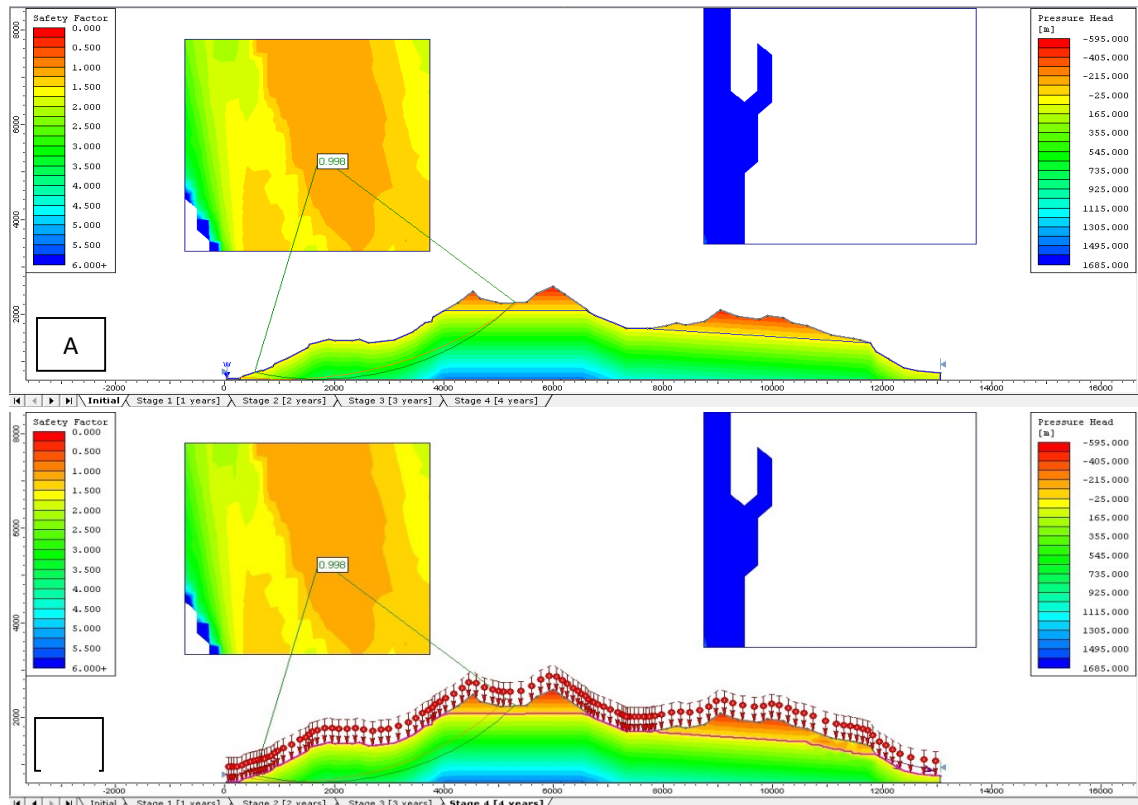
Fig. 26. N-S profile. Slide model for after failure in the northern section. Actual infiltration values were used for stages 1 and 2 (2011 and 2012) and extremes were used for stages 3 and 4 (2013 and 2014). A) Initial stage showing the lowest FOS before infiltration. B) Final stage after infiltration displaying the lowest FOS. The FOS in the northern part of the profile is non-changing, but appears to be at failure. The grids show a surface area where the centre points within a radius of a failure are defined. The minimum FOS for each point is defined by the colour. Red and orange represents low FOS values.

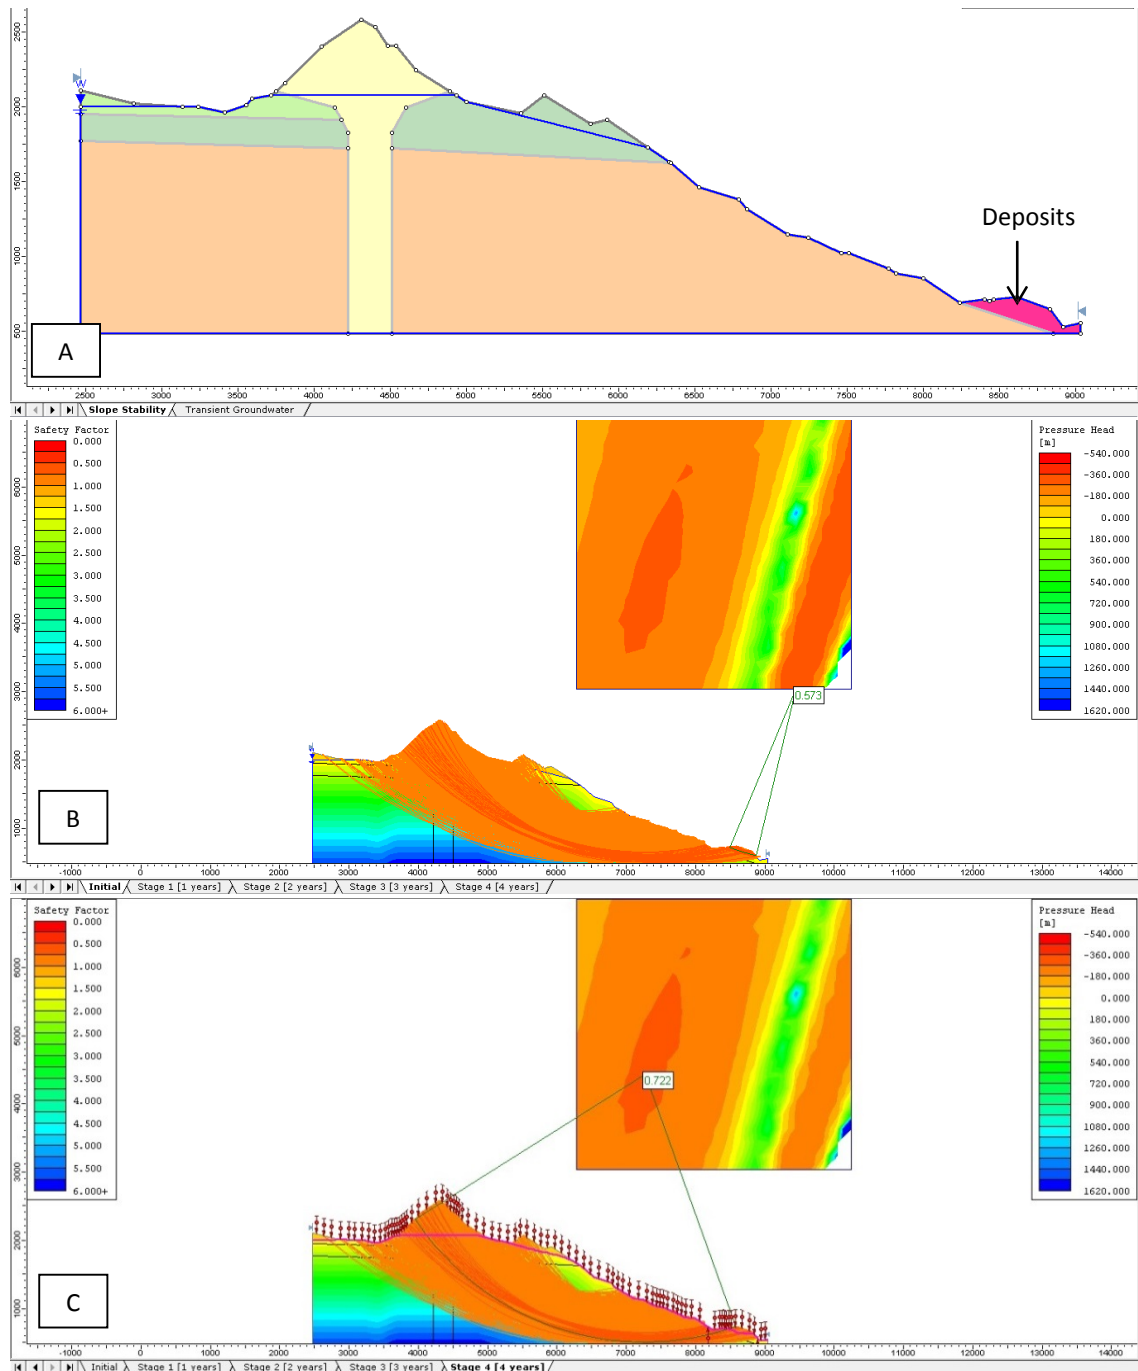
A SW-NE profile through Mount Meager was also modelled testing stability of the eastern flank of Plinth Peak. With failure in the NE direction (Fig. 27), the weakest area at the initial stage (before infiltration) is in the deposits at the bottom of the profile, entering the valley with a FOS of 0.573. Once infiltration was added, the lowest FOS was 0.722. The FOS was higher after infiltration than in the initial stage, which is contradictory to the normal assumption, and to that shown in the other models. This is because the location of the weakest plane changes from a shallow failure plane to a deep failure plane, showing that infiltration has an effect at depth, reducing the FOS of deep planes. The FOS value, however, is very low suggesting failure. This may indicate that either there is slow, on-going, progressive failure, or no failure is occurring here and the material is stronger than assumed in the models.

Fig. 27. SW-NE profile. Slide model for after failure infiltration through Mount Meager and the eastern flank of Plinth. Actual infiltration values were used for stages 1 and 2 (2011 and 2012) and extremes were used for stages 3 and 4 (2013 and 2014). A) Initial profile with assumed internal structure. B) Initial stage showing the lowest FOS before infiltration. C) Final stage after infiltration displaying the lowest FOS. The eastern flank of Plinth appears to be at failure along many possible planes. The grids show a surface area where the center points within a radius of a failure are defined. The minimum FOS for each point is defined by the colour. Red and orange represents low FOS values.

There were many failure planes with a FOS below 1, most being deep failures and including the peak of Mount Meager (Fig. 27). The extreme infiltration values at stages 3 and 4 appear to have no impact on slope stability in this profile. Slope failure of the eastern flank of Plinth would have significant effects on communities downstream as it is situated directly above Lillooet River Valley. Damming and future breach of the dam could cause extensive flooding downstream.

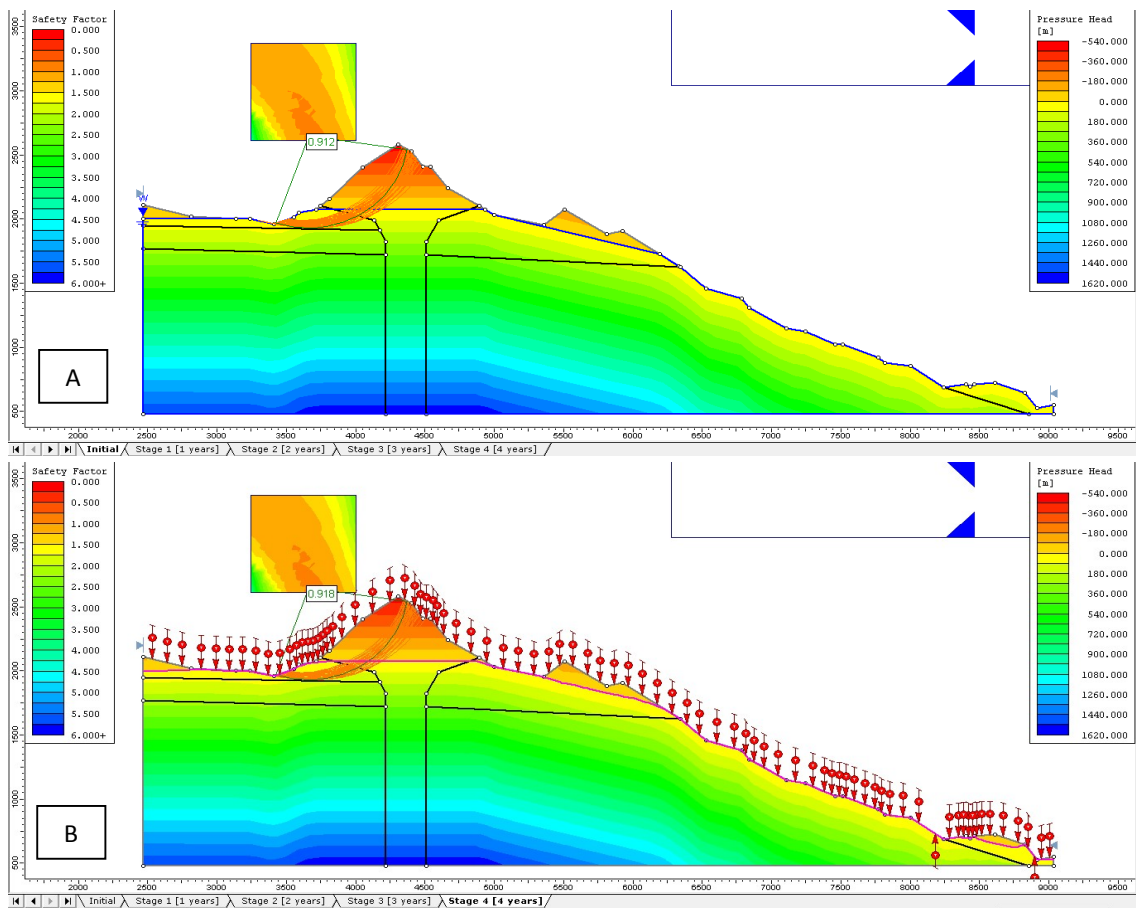
Failure to the SW shows an initial minimum for FOS is 0.912. The FOS increases slightly with each stage, the final stage having a lowest FOS of 0.918. This failure would remove the bulk of Meager Peak (Fig. 28). Failure here would travel down Capricorn Creek and likely dam Meager Creek and possibly Lillooet River.

Fig. 28. SW-NE profile. Slide model for after failure infiltration through Mount Meager and the eastern flank of Plinth. Actual infiltration values were used for stages 1 and 2 (2011 and 2012) and extremes were used for stages 3 and 4 (2013 and 2014). A) Initial stage showing the lowest FOS for the south-western face of Mount Meager Peak before infiltration. B) Final stage after infiltration displaying the lowest FOS. The south-west face of Mount Meager appears to be at failure. Material removed here would flow down Capricorn Creek into Meager Creek, likely damming the river. The grids show a surface area where the centre points within a radius of a failure are defined. The minimum FOS for each point is defined by the colour. Red and orange represents low FOS values.

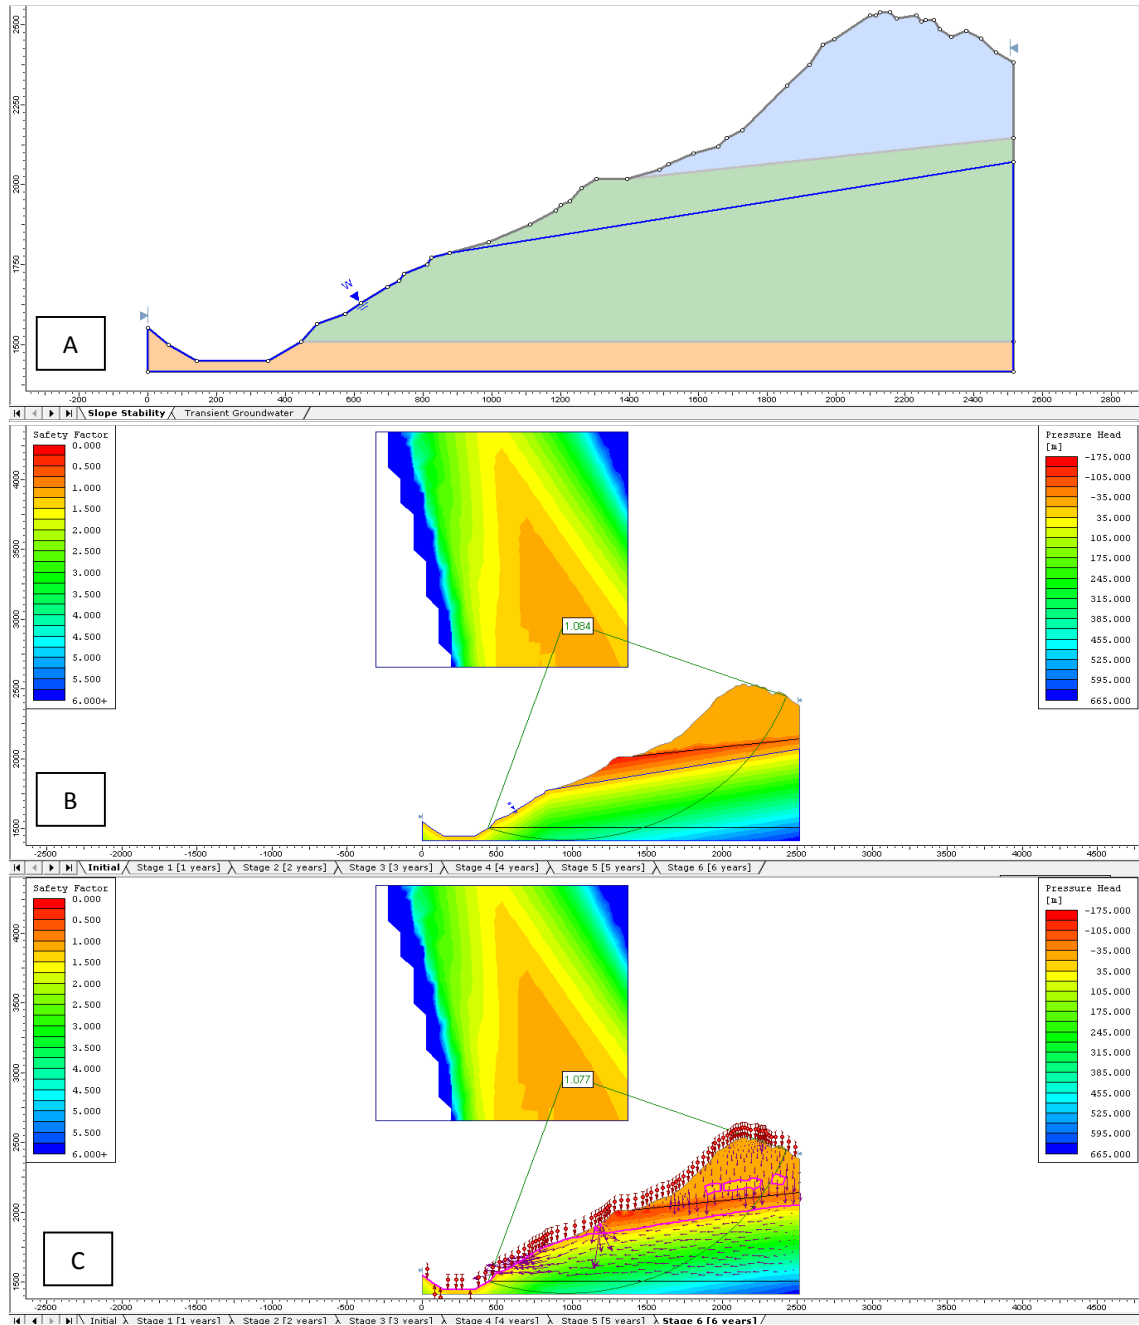
Fig. 29. Job Creek/Plinth profile. Slide model for after failure infiltration for the western flank of Plinth into Job Creek. Actual infiltration values were used for stages 1 and 2 (2011 and 2012), two random, but similar values chosen for the following two stages and extremes for the last two stages. A) Initial profile with assumed internal structure. B) Initial stage showing the lowest FOS before infiltration. C) Final stage after infiltration displaying the lowest FOS. The western flank of Plinth has a FOS indicating instability along a deep failure plane. The grids show a surface area where the centre points within a radius of a failure are defined. The minimum FOS for each point is defined by the colour. Red and orange represents low FOS values.

Preliminary mapping showed there to be an area of possible instability in Job Creek on the western flank of Plinth. The initial stage shows that this area is already unstable before infiltration is added, having a FOS of 1.084. When infiltration is included the FOS drops to 1.077. At each stage the failure plane is deep, having implications for Lillooet River. The upper boundary of M2 appears slightly impermeable, causing a concentration of water within the upper material (M6). The model shows a large amount of internal flow (Fig. 29).

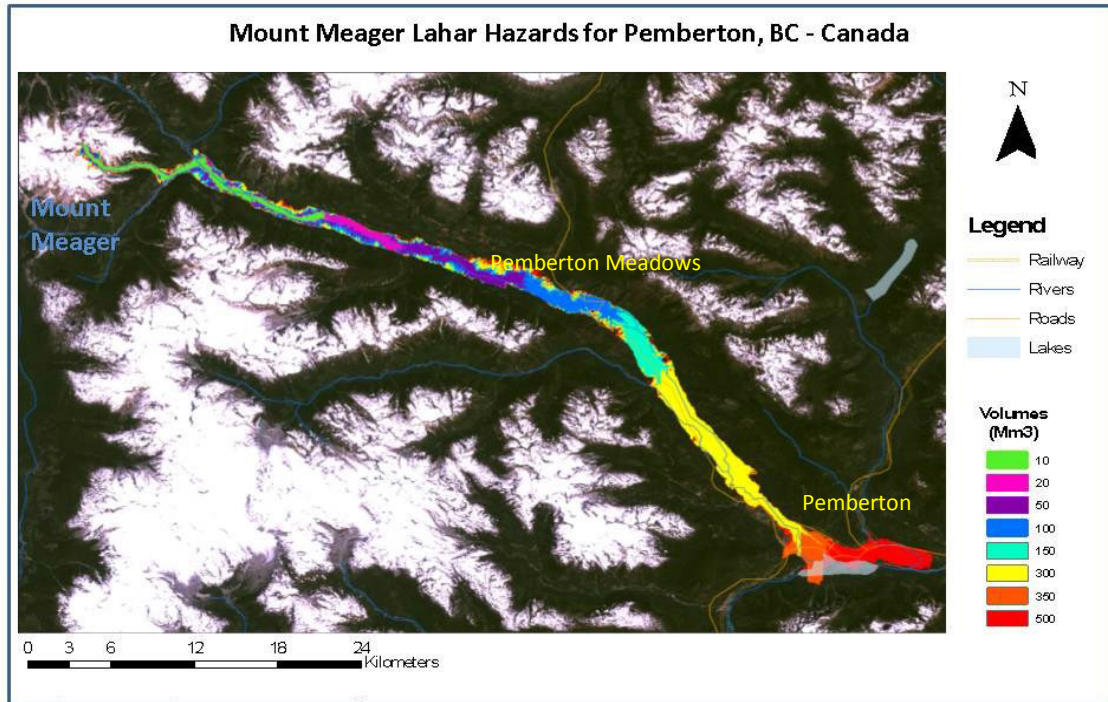
Fig. 30. Hazard inundation map, using LAHARZ and ArcGIS, showing volumes and extent of various debris flow simulations originating from Mount Meager in Capricorn Creek. Flows overlain on a Natural Colour Landsat TM image (25/07/2010) (www.earthexplorer.usgs.gov). Infrastructure data from www.geocomm.com.
