## STABILITY ANALYSIS OF THE SLOPE ALONG US-2 BETWEEN EPOUFETTE BAY AND THE CUT RIVER BRIDGE

**STABILITY ANALYSIS OF THE SLOPE ALONG US-2  
BETWEEN EPOUFETTE BAY AND THE CUT RIVER  
BRIDGE**

A REPORT

*In Civil Engineering*

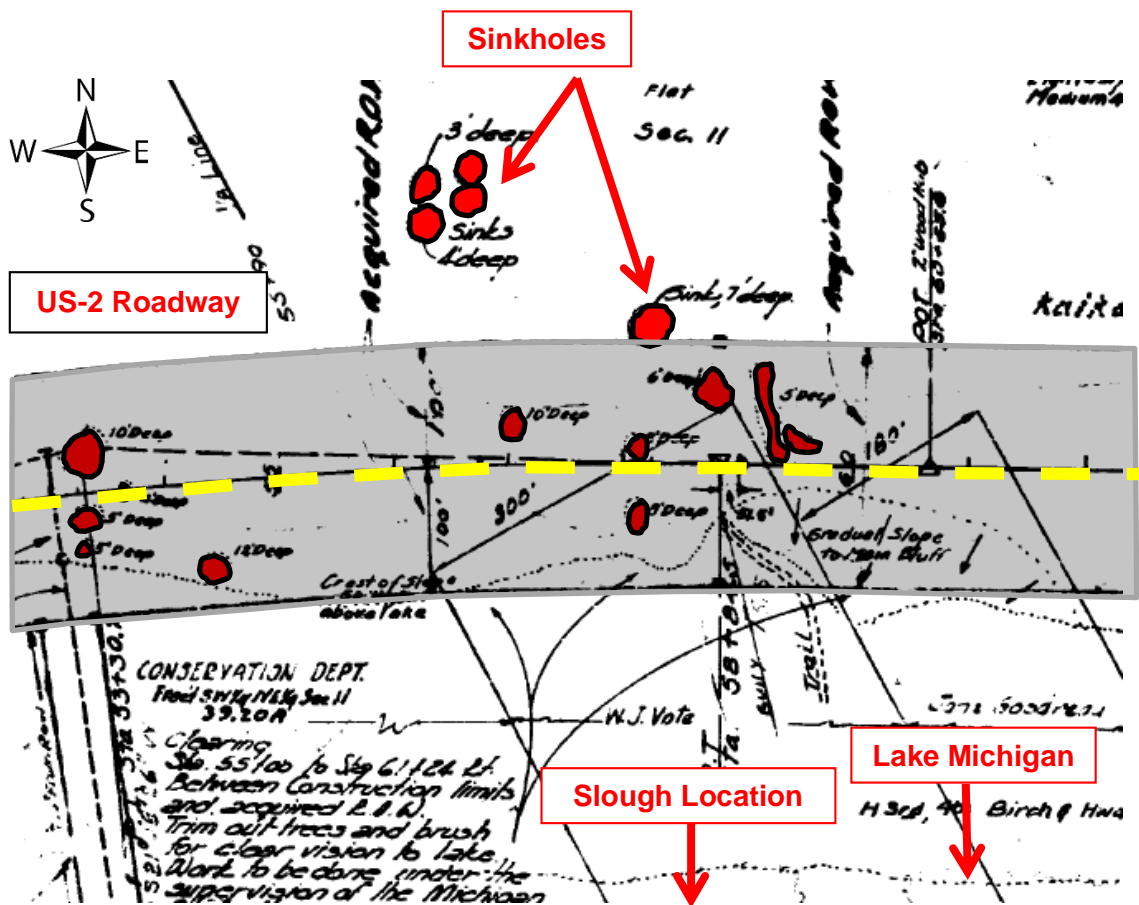
The highway was constructed in 1948 and consists of a concrete pavement with asphalt overlays. A review of the construction drawing for this section of highway above the slough also indicated the presence of sinkholes. A section of the 1948 construction drawing is shown in Figure 2. A total of 13 sinkholes can be seen on this section of highway just about the area where the water was observed coming out of the slough area. During the summer of 2012 MDOT conducted field operations that included site drilling, falling weight deflectometer, ground penetrating radar and surveying to investigate the area.

Figure 2 Construction drawing for the section of US-2 above the slough; sinkholes are indicated in red.

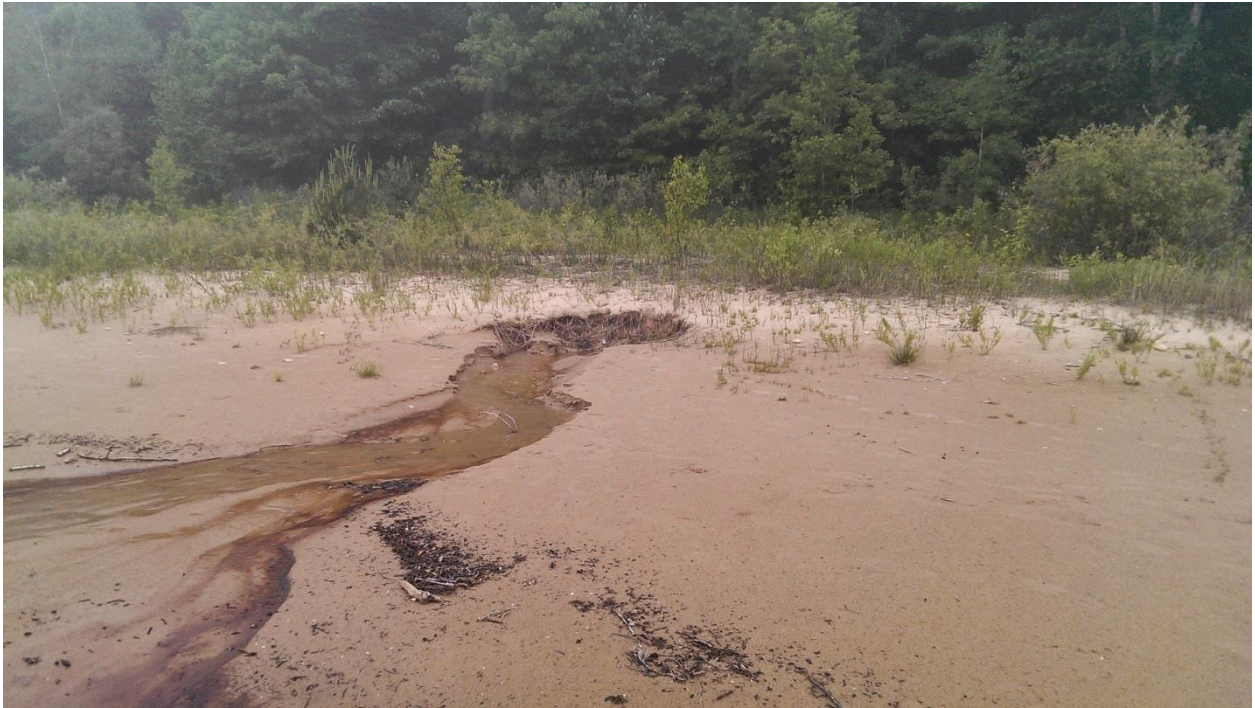
As previously mentioned, over a year ago a concern (regarding roadway stability) occurred upon spotting water flowing out of the south slope along US-2. Later site inspections noticed water flowing from the slope. However, it is possible that artesian conditions could occur at this point in the slope, during the spring time. Artesian Conditions are common along the base of the slope between Epoufette Bay to the west and the Cut River Bridge one mile to the east of the AOI. Two examples were noted, on the following page. The first example occurs at the Cut River Bridge where an artesian well is located on the west side of the Cut River between the base of the slope and Lake Michigan. This artesian well is shown in

Figure 3: Artesian well at the Cut River Bridge

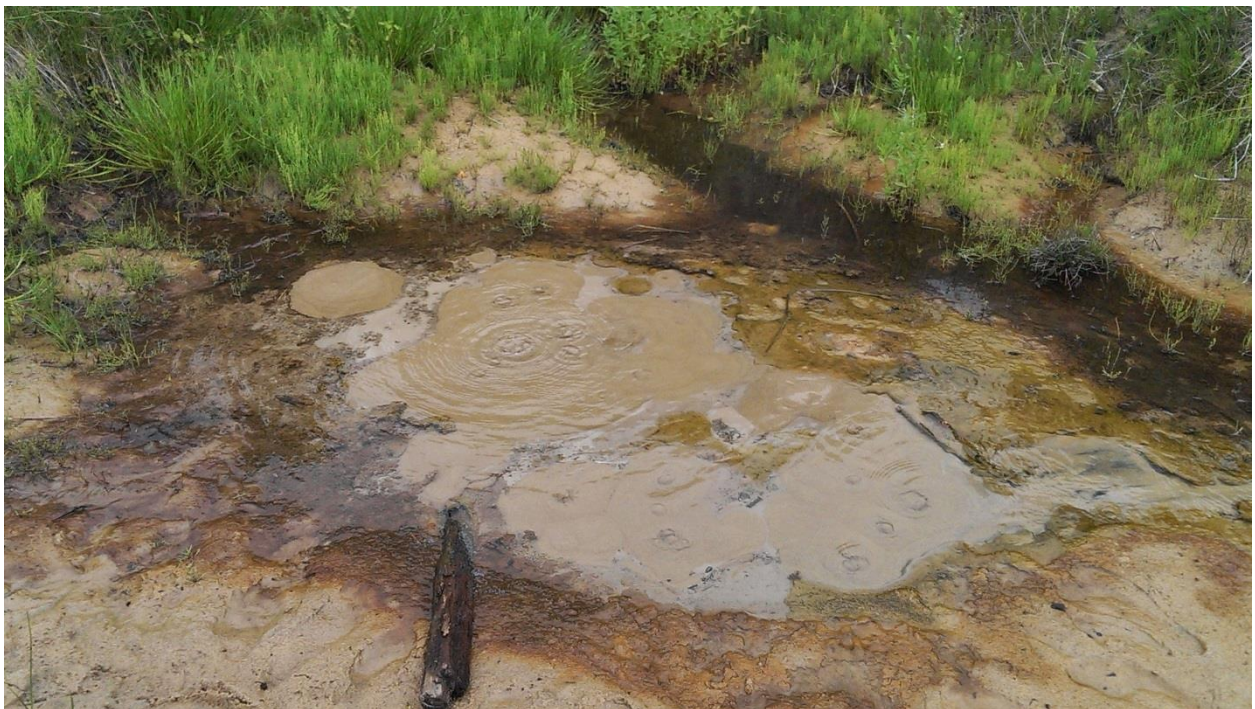
Figure 4: Artesian well and creek at the base of the AOI

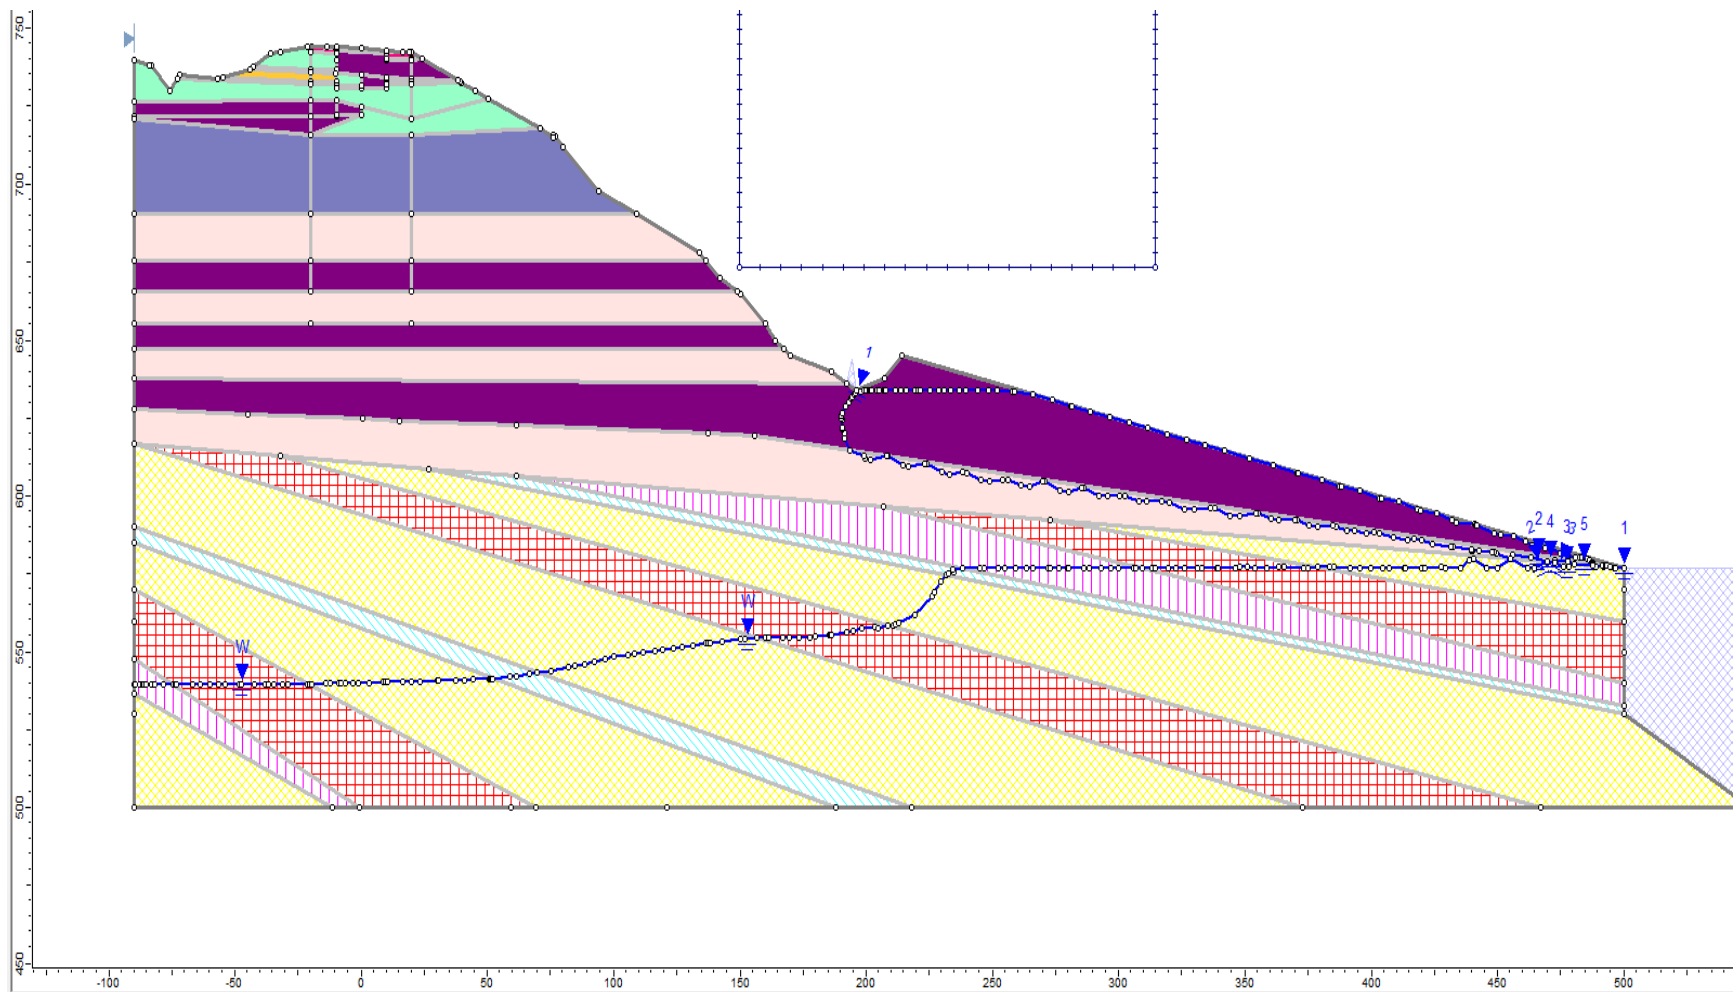
Shown below, Figure 16 is a cross-sectional view of the land slope. The y-axis is set to feet above sea level and the x-axis zero-point is the center line of the roadway. In this model there are about 16 different programmed materials, most of which are slight variations of sand: loose (coarse) at the top and medium dense to dense (medium coarse to some fine) further below the surface. Finally, the bottom (not solid) shaded areas represent bedrock: limestone, dolostone, sandstone and shale (most to least). A complete list of materials are provided in Appendix E: Material Properties. The [Original LEM Modeler](#) and [Original FEA Modeler](#) can also be found in Appendix F: Stability Analysis Models.

Figure 16: Multiple Water Tables

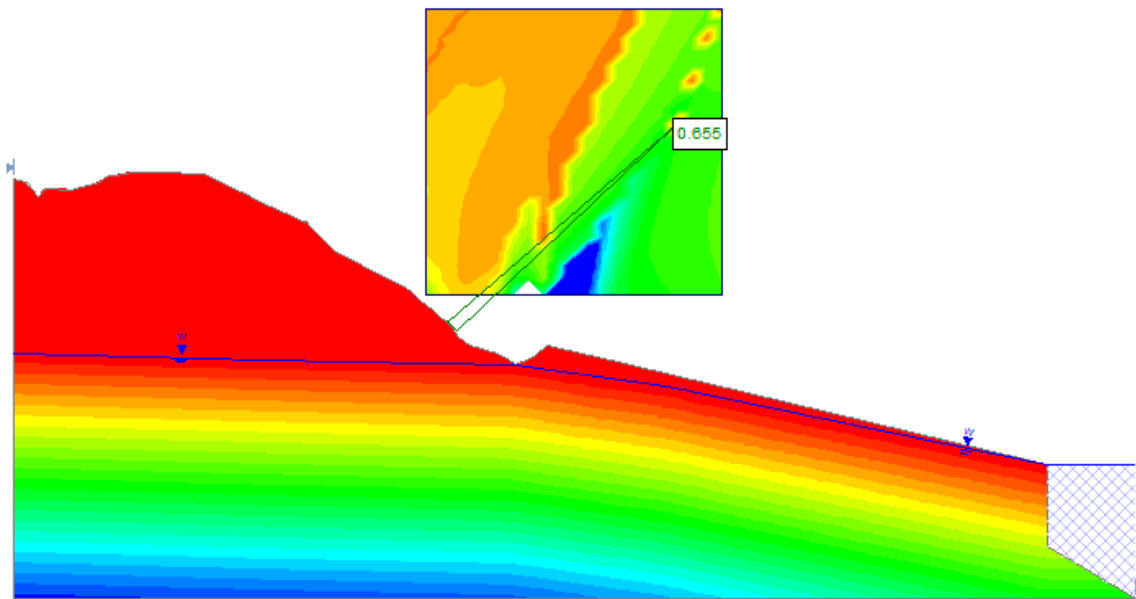
Subsequently, most of the tests that were performed used a single GWT that simply travel along an angle and barely touched the artesian well and continued downward to make contact with the lake. Shown below, Figure 17 is the LEM global minimum (Bishop simplified) analysis with a singular GWT resulted in a FS of 0.655 [[Original LEM](#)]. For clarification, global minimum implies that out of all failure surfaces, the one with the lowest value is the global minimum.

Figure 17: Bishop Simplified LEM FS

Although the SRF was determined to be slightly greater than the FS, they were more or less the same value, which was less than 1; implying that it is failing. While it is not the best news to see that every test run for this slope confirmed the slope is failing, it is encouraging to know that both very different methods give similar results, ensuring the quality of the analysis.

For future work and recommendations, it is recommended to continue observing the slope as well as conducting further soil testing, deeper borings and a determination of the groundwater conditions to observe changes or irregularities. Since sinkholes are actually present in the area it cannot be ruled out that something is happening in the subsurface that is related to a change in the groundwater table—possibly in relation to karst. Unfortunately, since time did not allow for karst testing, a major future recommendation would be to use geophysics such as electrical resistivity (ERM) in order to test for karst topography.

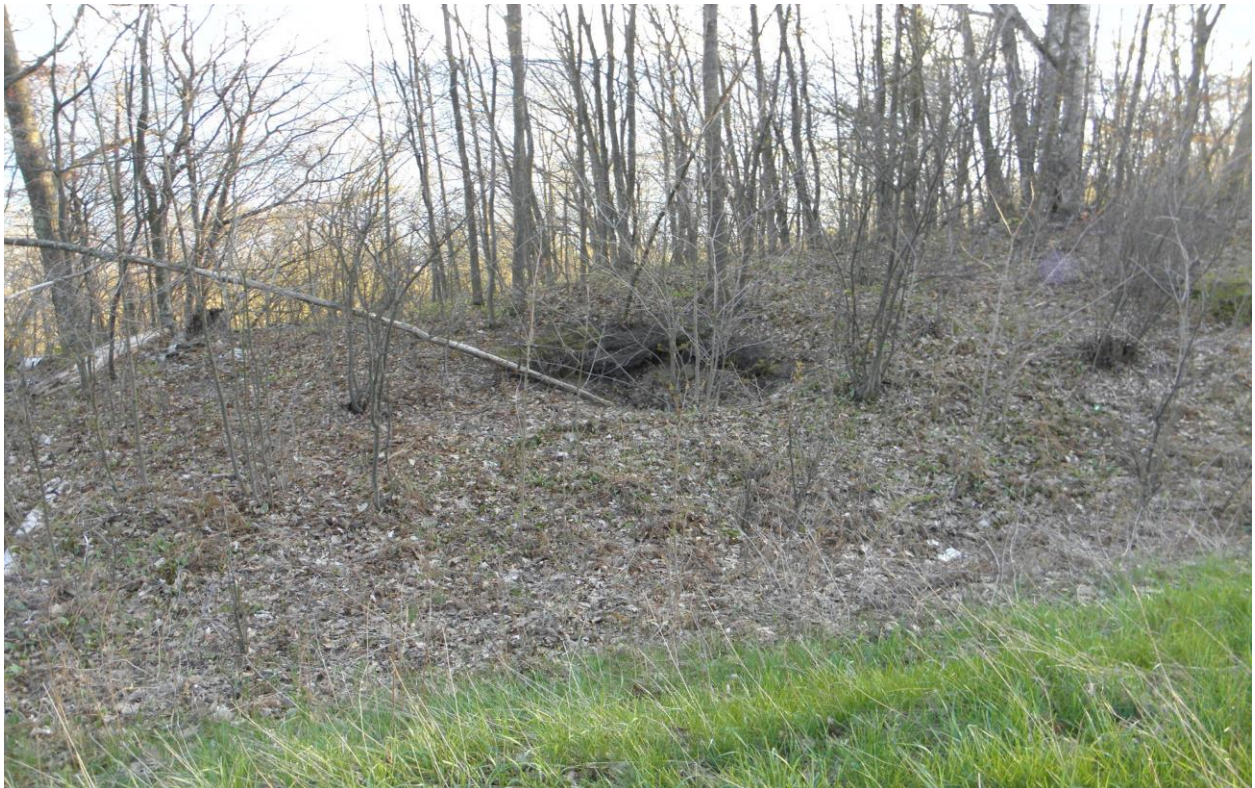
*Sinkhole*

Upon the site to the AOI, more sinkholes were discovered. A sinkhole approximately 5' in diameter and 1.5'-2' deep has formed on both the North and South side of the roadway [Sinkhole]. Although sinkholes are much more numerous south of the road, it is possible that the sinkhole on the north side was initiated through similar means. As previously implied, the sinkholes off both sides of the roadway are relatively circular. This could mean one of two things: either it is a subsidence sinkhole or it is a sinkhole formed from the process called "rat-holing". Both of these types of sinkholes have somewhat similar mechanisms of development, which will be clarified in section 2.4 Sinkhole Formation.

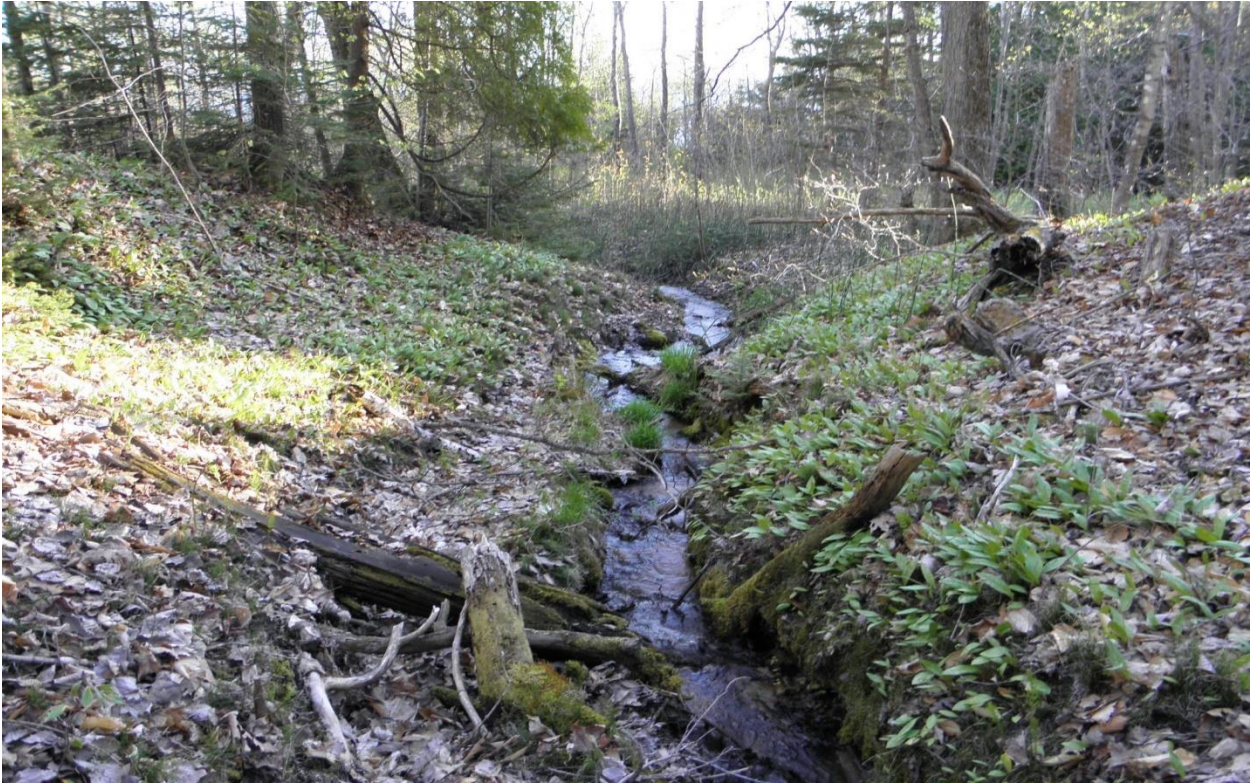
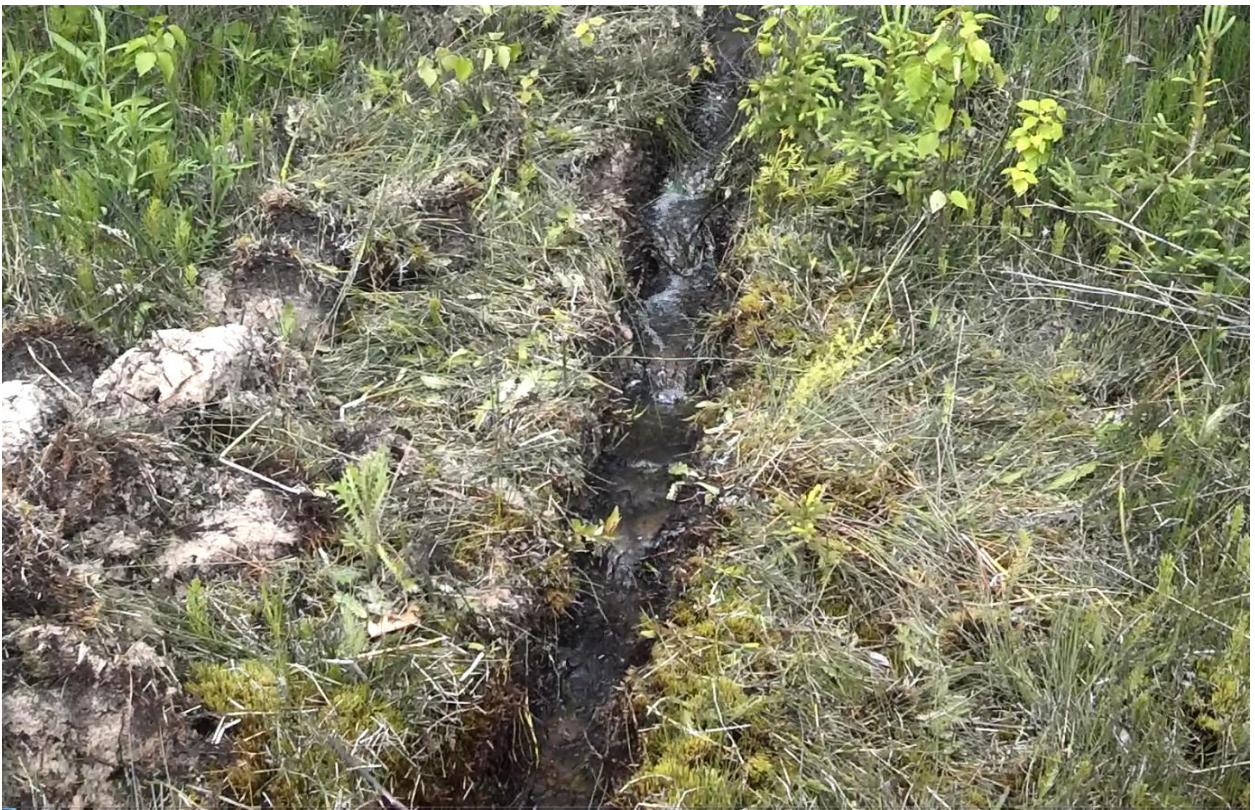
*Small Stream 2012, 2013 respectively (Looking South)*

A small water flow was observed coming out of the slough. The water flow was about 6 inches wide by about 3-4 inches deep and can be seen in Appendix D: Visual Walkthrough, [Small Stream 2012, 2013 respectively (Looking South), Stream April 2014].
