Geotechnical Data and Numerical Analysis of Edifice Collapse and Related Hazards at Pacaya Volcano, Guatemala

GEOTECHNICAL DATA AND NUMERICAL ANALYSIS OF EDIFICE
COLLAPSE AND RELATED HAZARDS AT PACAYA VOLCANO, GUATEMALA

A THESIS
Submitted in partial fulfillment of the requirements for the degree of
MASTER OF SCIENCE
In Geology

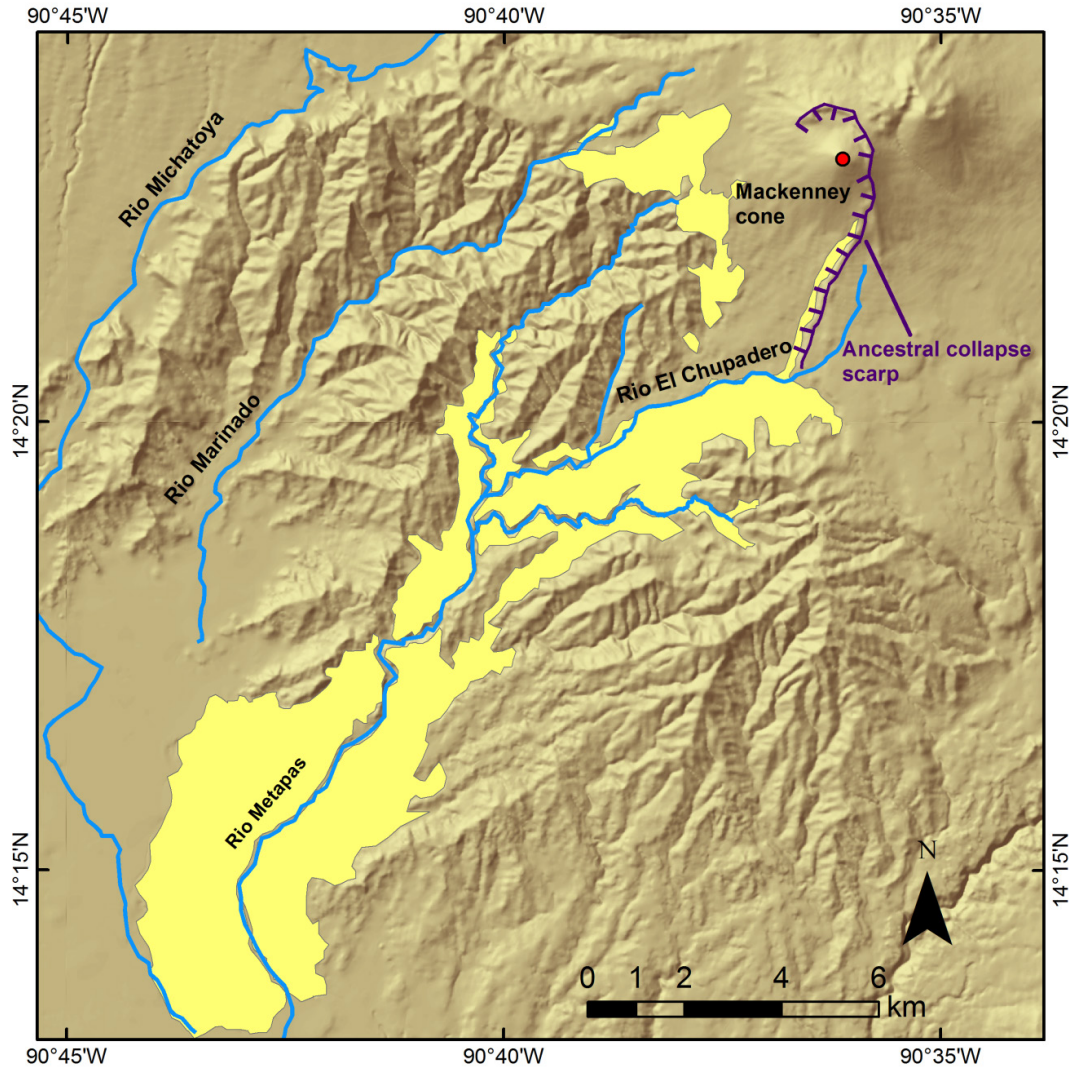
Figure 1-1 Extent of the debris avalanche deposit (in yellow) from the ancestral collapse, which traveled 25 km to the SW. Modified from Vallance et al. (1995).

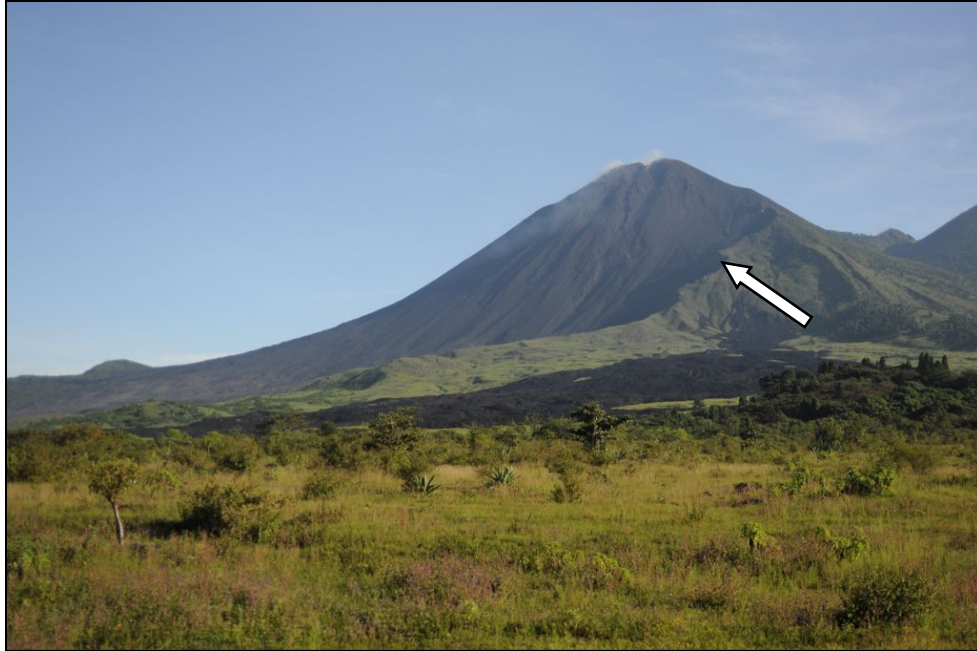
Figure 1-2 Pacaya volcano looking to the NW, with arrow pointing to the ancestral collapse scarp.

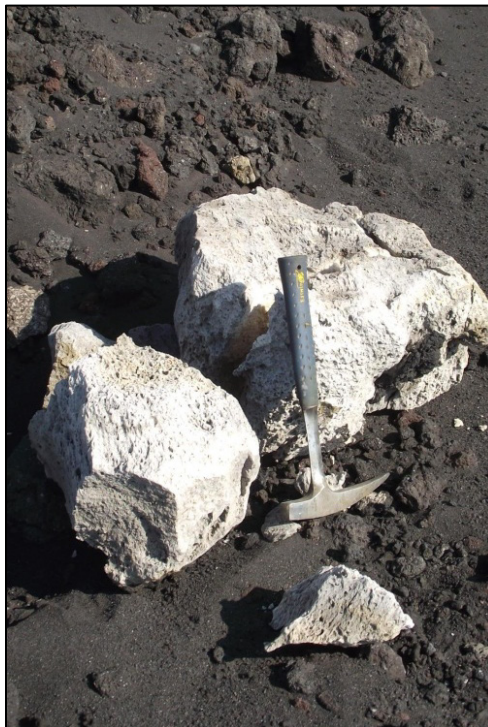
Figure 1-3 Pieces of the tephra and ignimbrite pyroclastics erupted from the nearby Amatitlán caldera are brought up in current eruptions.

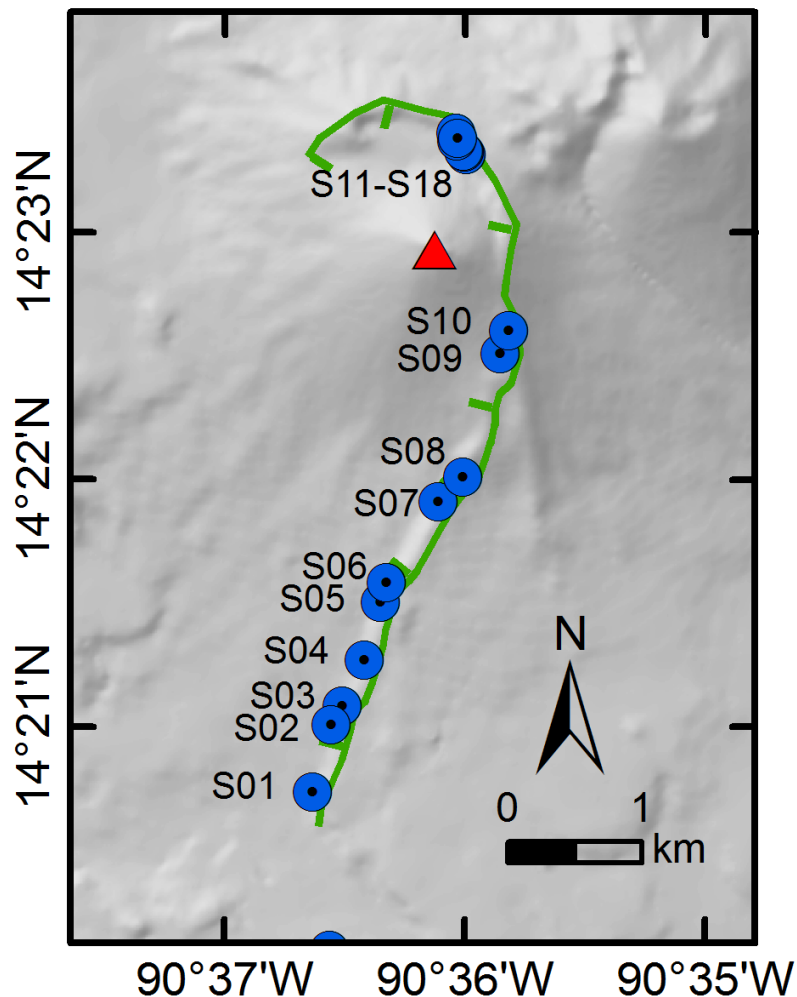
Figure 2-1 Location of geotechnical surveys along Pacaya’s scarp marked with dotted circles. The main volcanic vent (Mackenney cone) is noted with a triangle.

Classification and characterization of the rock mass and discontinuities were conducted at 10 field sites (sites S1-S10, Fig. 2-1) based on International Society for Rock Mechanics (ISRM) procedures (ISRM 1981). The properties of discontinuities are used as an initial review of stability conditions of a site, as they can act as potential failure planes and generally weaken the rock mass. Surveys at each site included identifying the number of joint sets and their representative orientations, geometry of the joints (strike, dip, and inclination), spacing of the joints, type of movement, amount of dilation, degree of alteration, roughness coefficient, and presence and nature of infill as described in Wyllie and Mah (2004). These parameters were only found for lava rock, as it is often impossible to identify and describe discontinuities in disintegrated or highly weathered rocks.

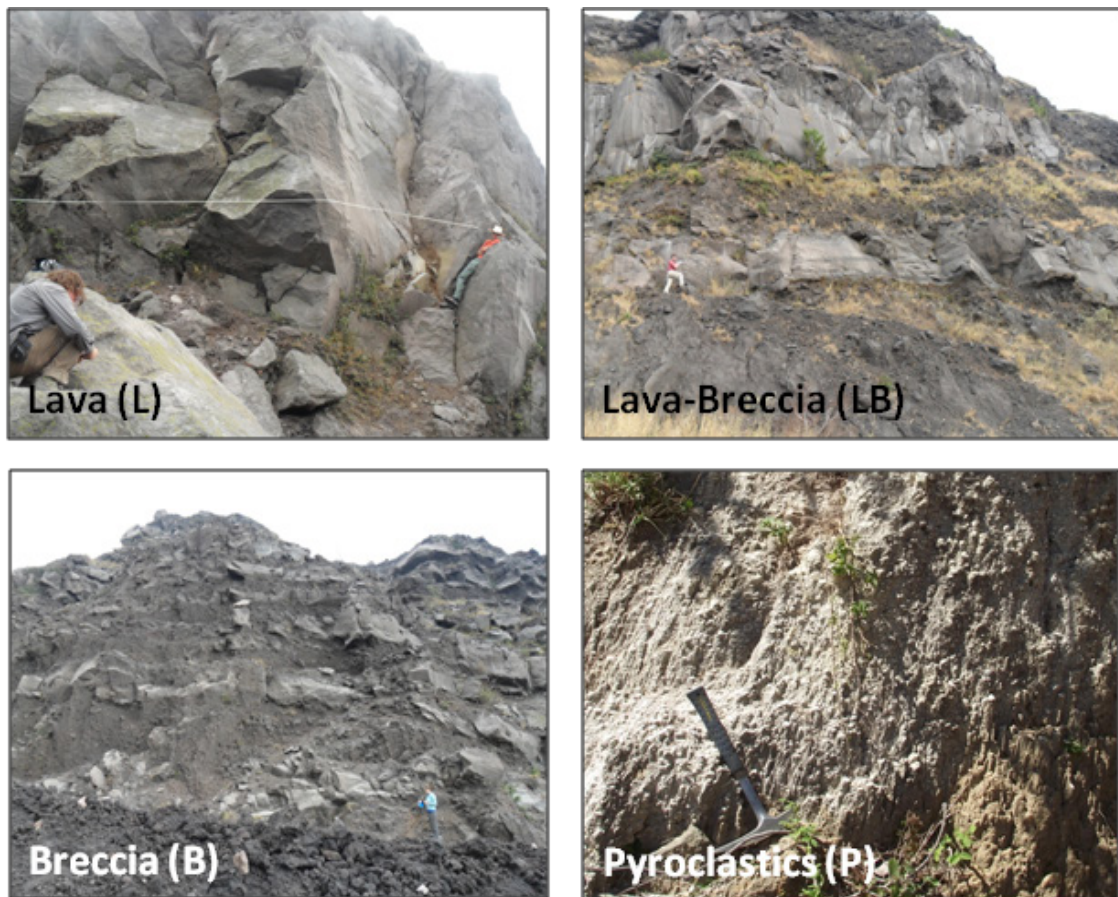
Figure 2-2 Lithotechnical units at Pacaya. For modeling, the major rock mass of the edifice was represented by an alternating lava (40-70%) and breccia sequence (LB).

as shown in Fig. 2-2. Along the scarp, an alternating pattern of lava and breccia rocks can be projected and used as a good indication of the interior stratigraphy of the volcano. As described above, Pacaya has been characterized by other authors as having more or less the same geochemical and petrologic properties throughout its growth (Eggers 1972; Walker 1989; Bardinezteff and Deniel 1992; Vallance et al. 1995). To simplify the edifice for modeling purposes, the rock mass can be represented by the most prevalent percentage of lava to breccia in

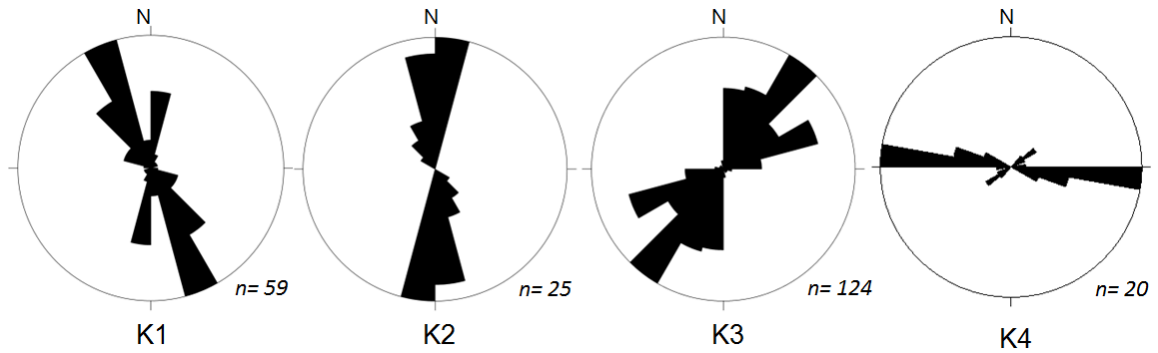
Figure 2-3 Joints from all the outcrops were grouped into four sets to recognize patterns in the join systems.

To recognize patterns in the joint systems, joints from all of the outcrops were grouped into four sets based on dip/dip direction (Fig. 2-3). The spacing of the joints was determined using a scan-line approach in which the number of joints and distance between each joint is determined in a chosen vertical and horizontal orientation (Fig. 2-4). The strike directions of the main discontinuities at each site are shown in Appendix A.

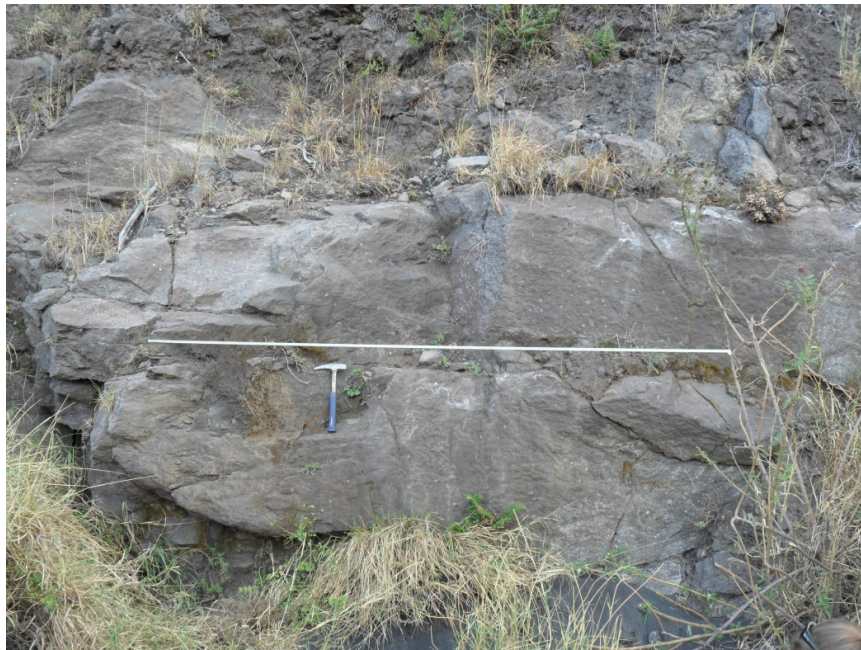
Figure 2-4 A horizontal segment using the scan-line approach.

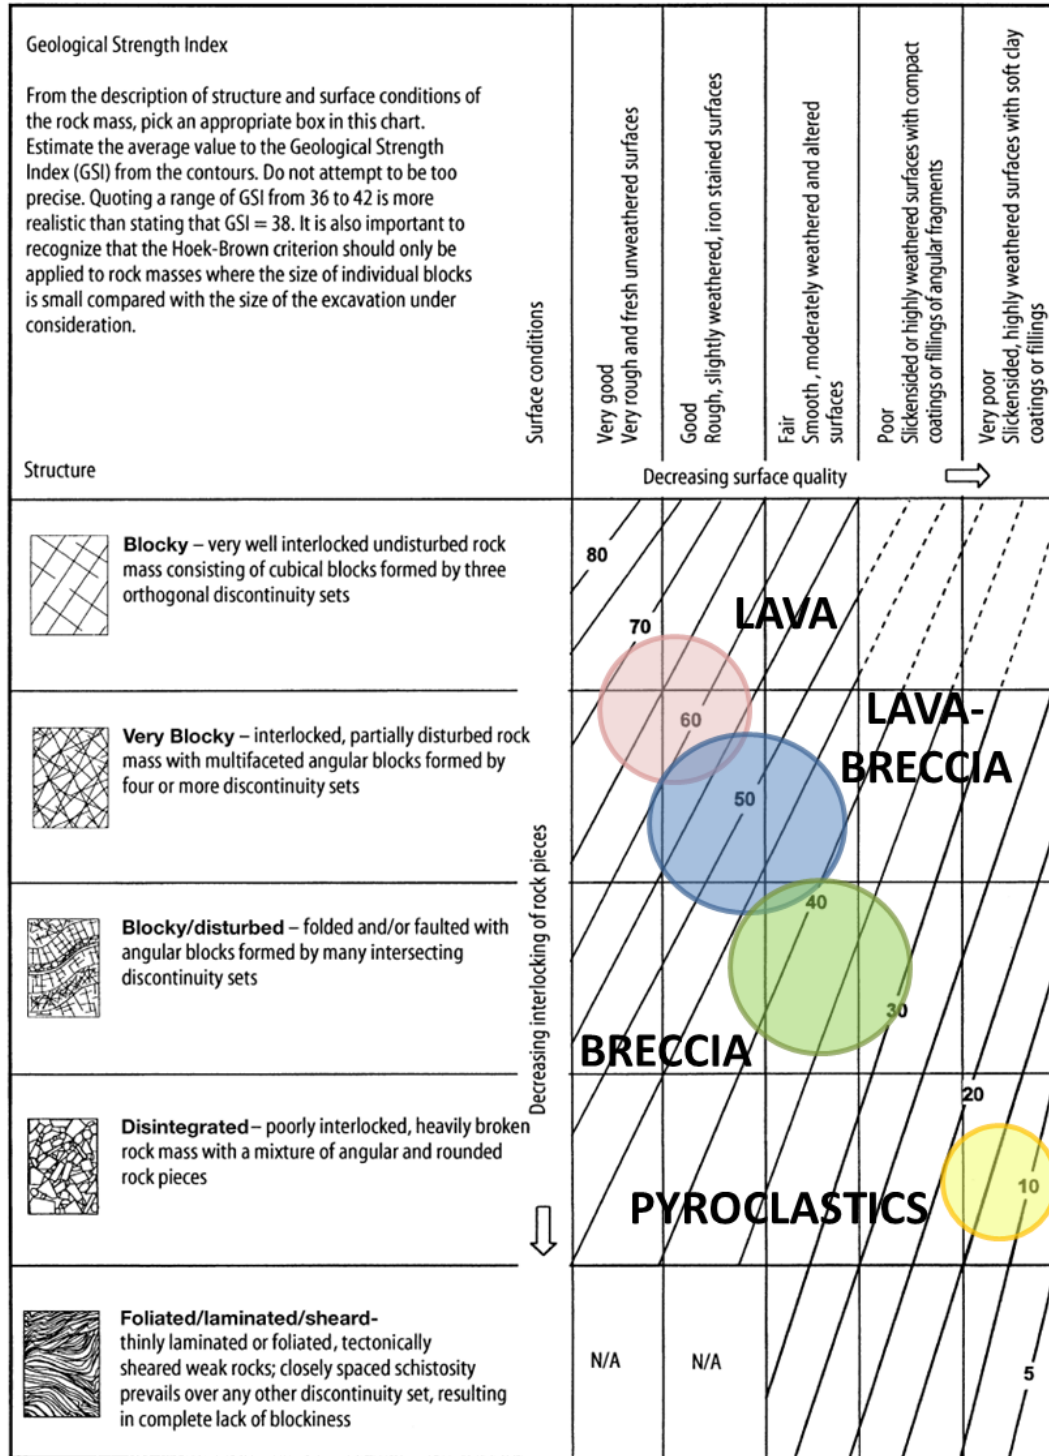
Figure 2-5 Geological Strength Index (GSI) classification of the different lithotechnical units. Classification table modified from Marinos and Hoek (2000).

The GSI uses visual characterizations of the rock mass structure and discontinuity surface condition and, when combined with intact rock properties, can be used to extrapolate the rock mass strength and deformability parameters by applying the Hoek-Brown failure criterion. Using GSI, the LB unit was characterized as having good to fair surface quality and slightly disturbed structural integrity (GSI value of 40-60). The other lithotechnical units are shown for comparison, with L having the highest GSI range of 55-70, and B (30-45) and P (8-20) degrading in surface quality and structural integrity (Fig. 2-5).

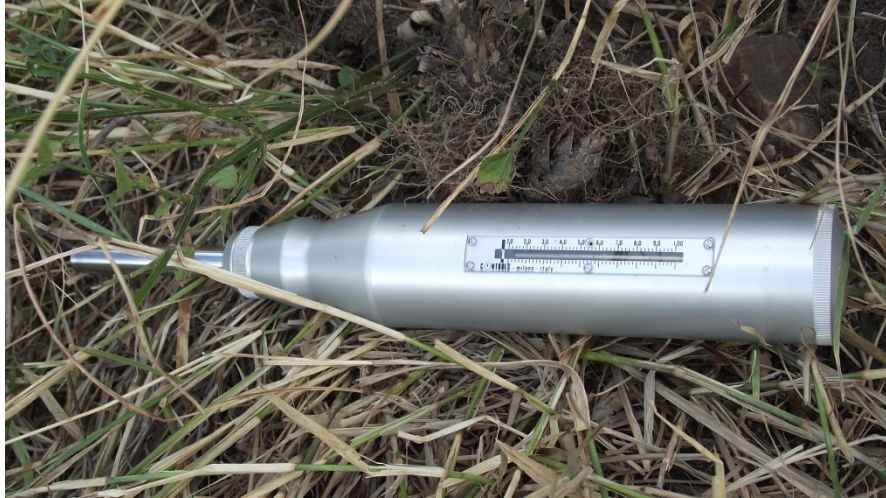
Figure 2-6 The Schmidt hammer measures intact rock strength in the field.

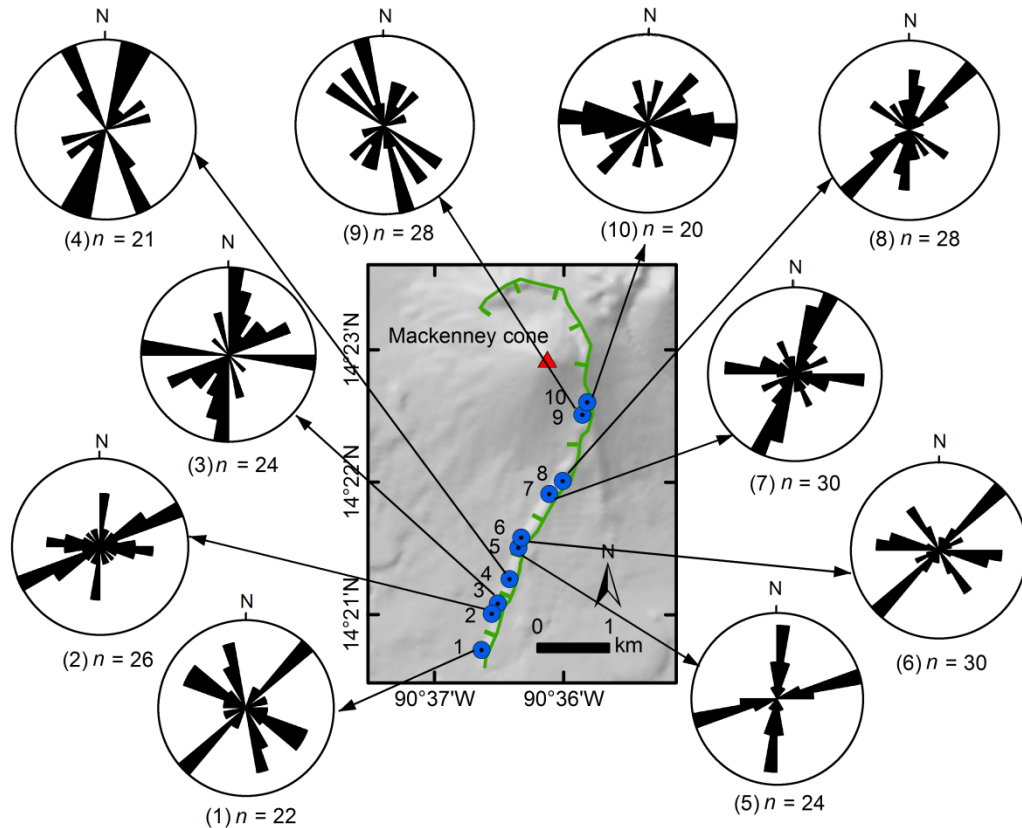
Figure 3-3 Rose diagrams show the geometry of the joints and fractures at survey sites along Pacaya's scarp, with n being the number of joints and fractures measured.

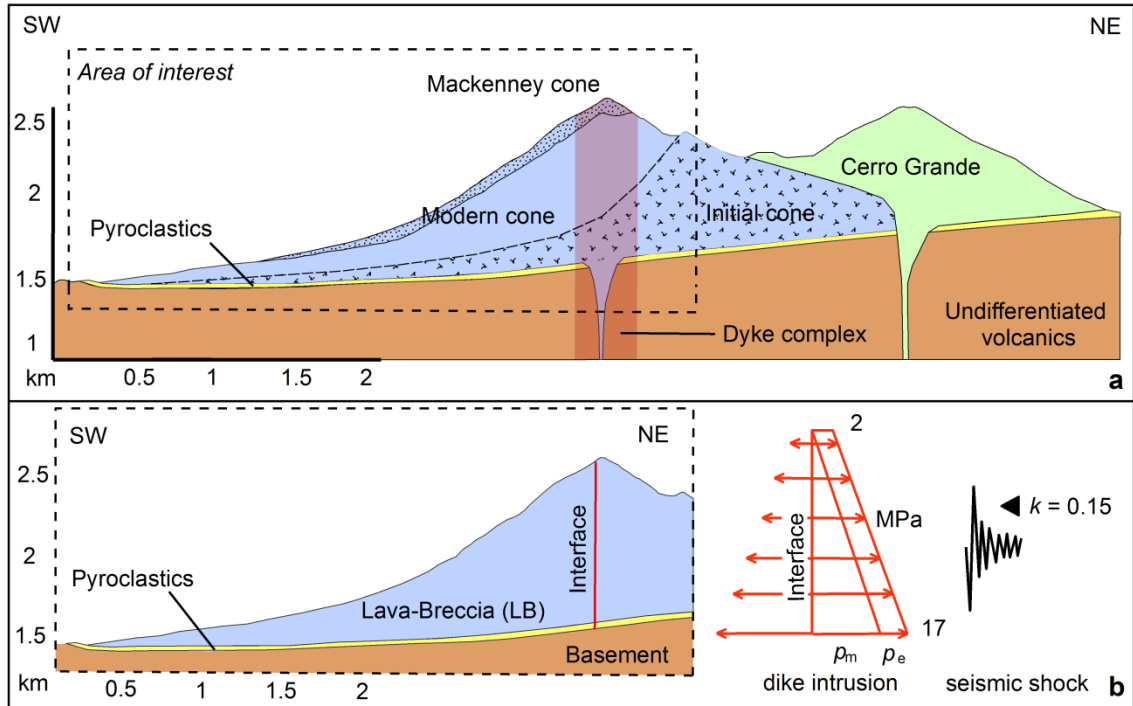
Figure 3-4 a) Geological cross section of Pacaya volcano with major geologic-structural features (trace A-A' in Figure1b). **b)** Cross section showing lithotechnical units (lava-breccia, pyroclastics and basement) and location of the physical interface representing the dyke. In the inset, representation of external forces seismicity and magma pressure. Magma pressure components include the magmastatic pressure (p_m) due to magma weight with a triangular distribution, and magma overpressure (p_e) due to excess-pressure added as a constant along the interface height.

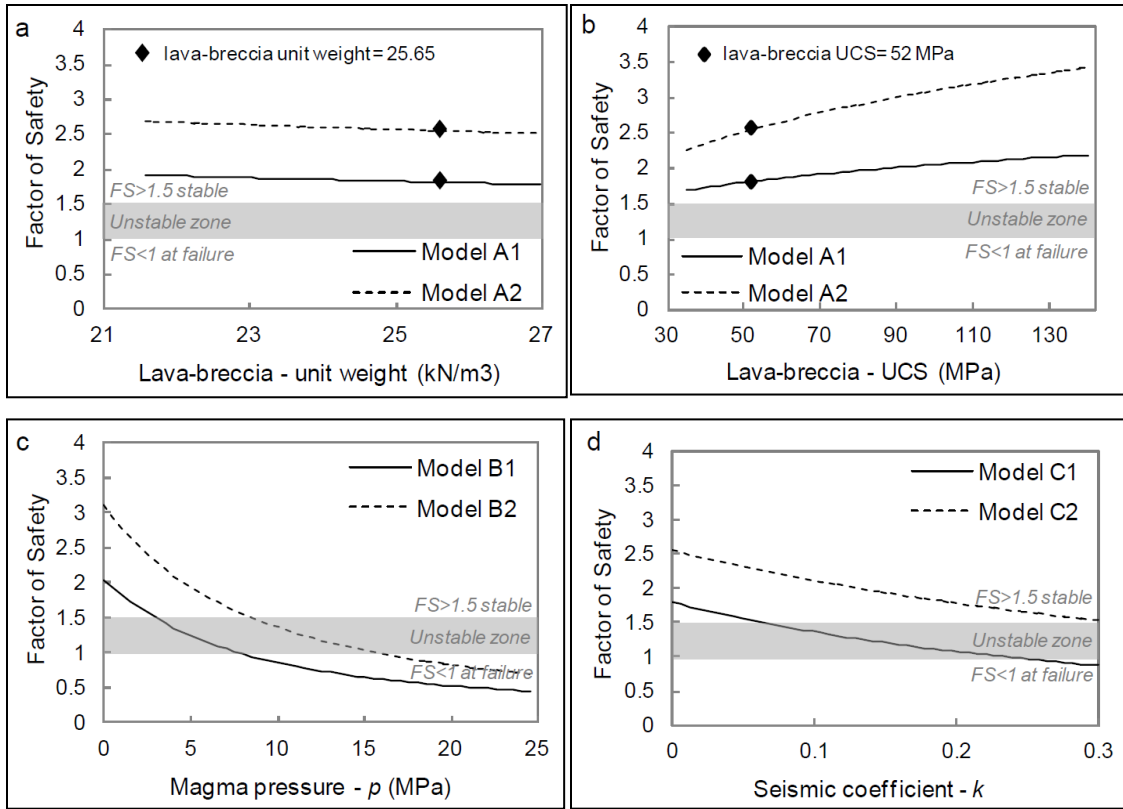
Figure 3-5 Sensitivity analysis of unit weight (5a), UCS (5b), magma pressure (5c), and seismic coefficient (5d) in model conditions A-C. The UCS of the lava-breccia unit would have to be reduced to unrealistic values to induce failure, however magma pressure in a dyke and seismic acceleration can result in instability ($FS < 1.5$) within expected ranges.

However, magma pressure in a dyke can act as a destabilizing factor: if kept constant along the dyke, the slope reaches an unstable range ($FS < 1.5$) when magma pressure reaches 2.9 MPa, and failure ($FS < 1$) at 7.7 MPa in model B-1 (Fig. 3-5c). In model B-2, these pressures are 8.4 and 15.6 MPa, respectively. These values are well under the expected maximum of 17 MPa. The inclusion of

Seismic acceleration can also cause the slope to reach the unstable zone. For model C-1, $FS < 1.5$ when the seismic coefficient reaches 0.06, and $FS < 1$ at 0.23 (Fig. 3-5d). Again, these values are well under the expected range of 0.25-0.3 for the maximum seismic coefficient. The seismic loading required to destabilize

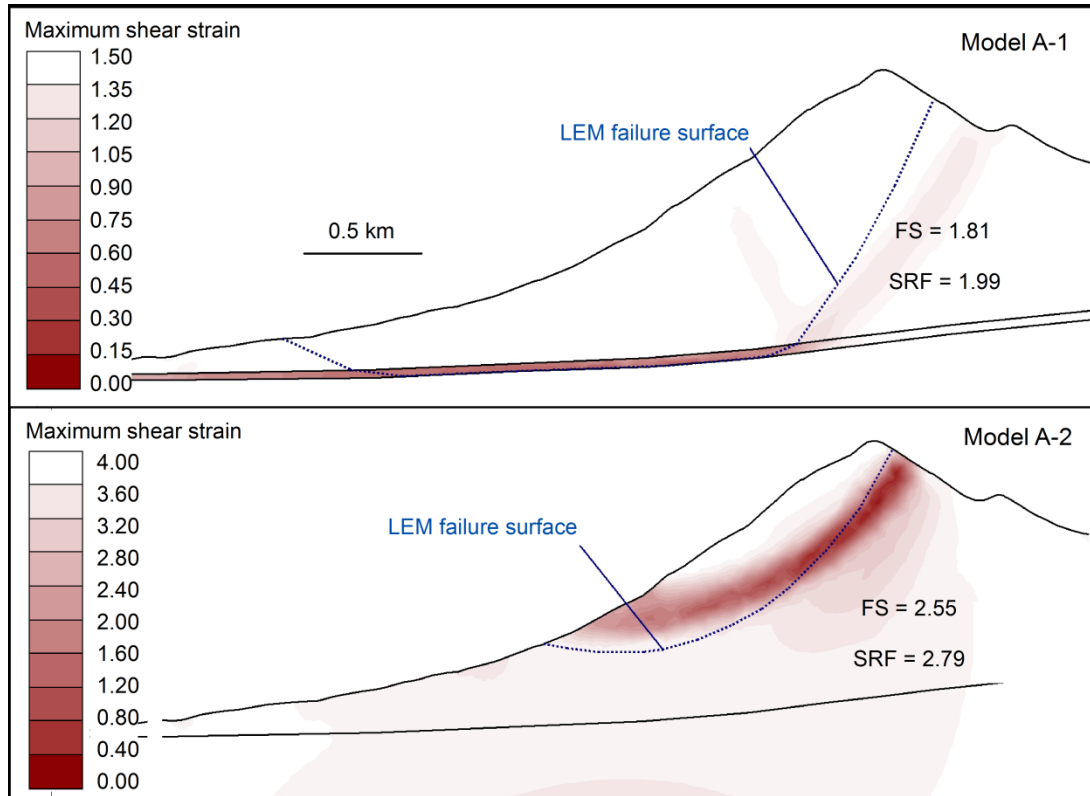
Figure 3-6 LEM critical slip surface superimposed on the contours of FEM maximum shear strain for model A-1 (top) and model A-2 (bottom). This change in geometry was also true in models B and C. The unstable mass geometry outlined in the models with pyroclastics resembles the magnitude of the ancestral collapse, suggesting that pyroclastic deposits beneath the edifice could have been a feature that controlled that collapse.

pyroclastics beneath the edifice (model A-1) greatly increases the depth of the slip surface and the amount of material predicted to fail (Fig. 3-6). This change in geometry was also true in models B-1 and C-1. In all cases, the probability of the mass reaching instability is considerably higher in models with pyroclastics as seen in probabilistic analyses (Fig. 3-7), emphasizing the effect that weak units can have on edifice stability.

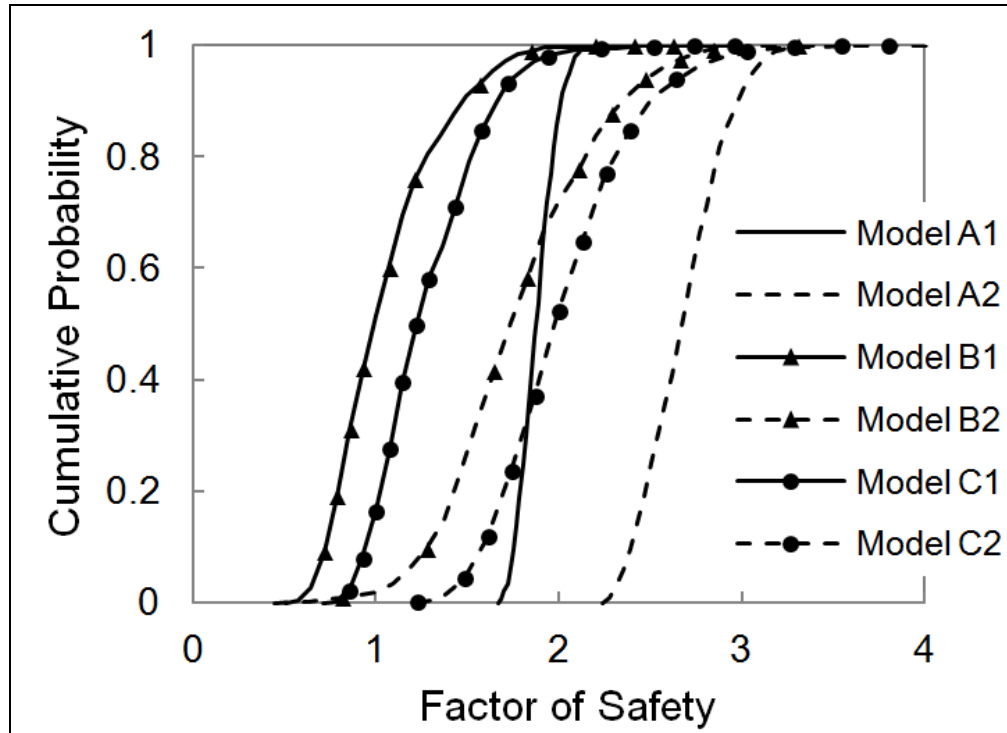
Figure 3-7 Cumulative probability of failure for each model condition. FS = 1 and 1.5 marked by grey dotted lines.

Cumulative probability analysis shows that the probability of the slope reaching instability (FS<1.5) is 90% for model B-1 and 30% for model B-2 (Fig. 3-7), the first being a considerably high probability. In models where seismic force is applied, the mass reaches instability (FS<1.5) at 78% for model C-1, for only 4%

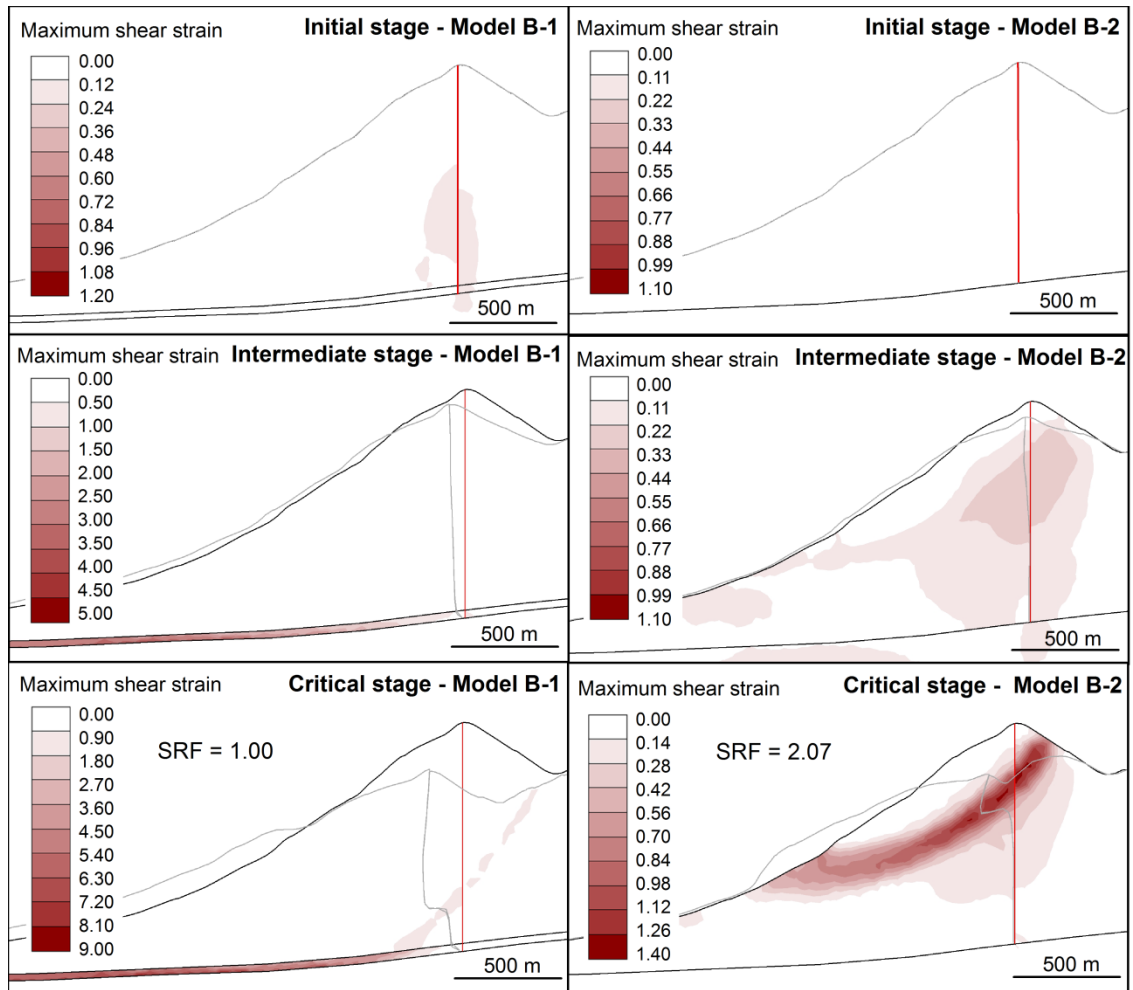
Figure 3-8 FEM shear strain and displacement vectors of magma application (B-1, B-2) and seismic force (C-1, C-2). Results are for the critical SRF stage.

When magma pressure is applied, deformation develops as a bulge in the middle of the cone (Fig. 3-9), and continues to develop this bulge through slope failure. The application of seismic acceleration produces areas of maximum shear strain in similar patterns in models A and B. However, the models with seismic force have lower SSR values (see Table 3-3) and higher shear strain (Fig. 3-8).

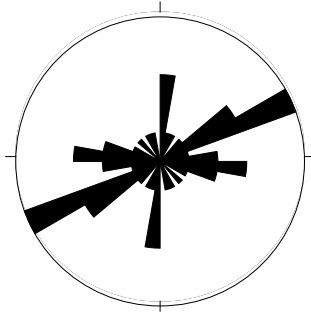
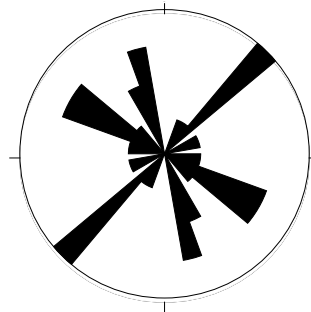
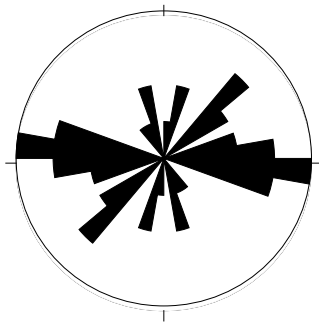
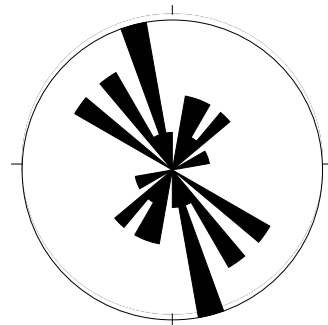
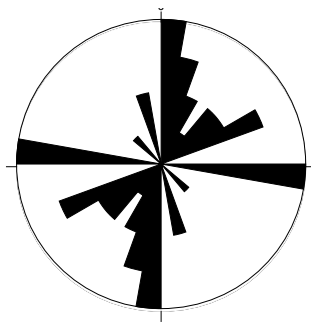
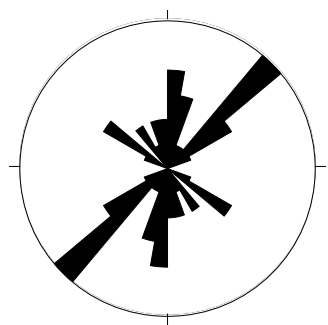
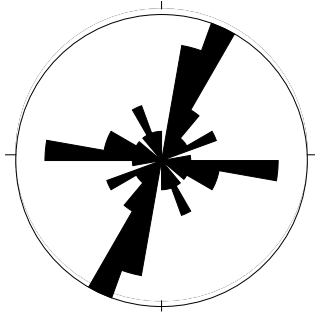
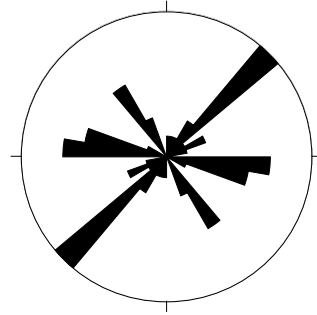
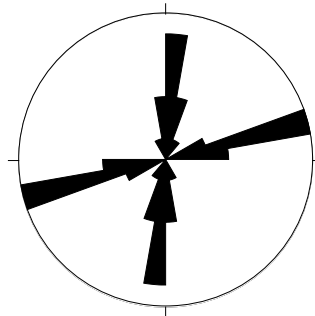
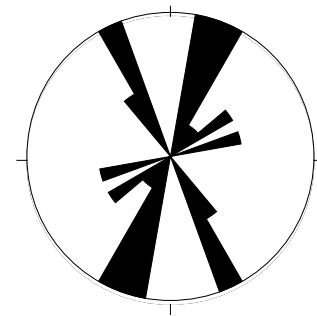
APPENDIX A: Rose diagrams (strike direction) of principal discontinuities at each survey site
