## APPLICATION OF A HAZARD RATING SYSTEM FOR ROCK SLOPES ALONG A TRANSPORTATION CORRIDOR USING REMOTE SENSING

APPLICATION OF A HAZARD RATING SYSTEM FOR ROCK SLOPES ALONG A  
TRANSPORTATION CORRIDOR USING REMOTE SENSING

A REPORT

In Geological Engineering

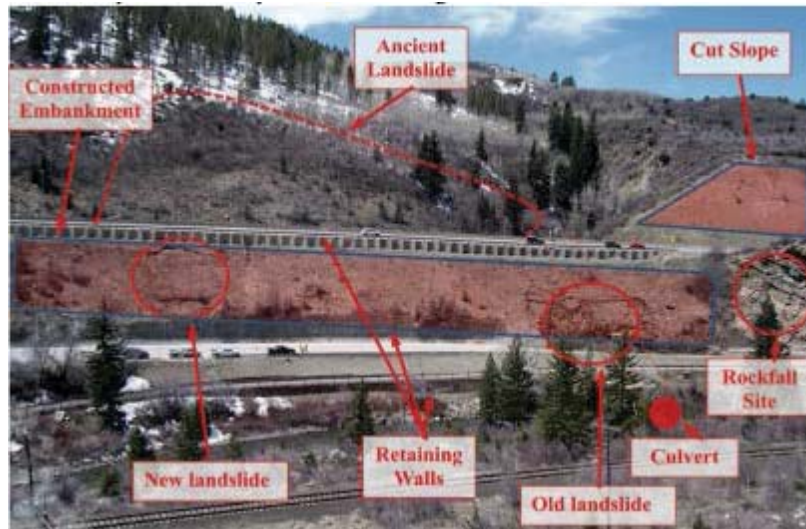
**FIGURE 2-1: SCHEMATIC OF GEOTECHNICAL ASSETS AS DEFINED BY THE FEDERAL HIGHWAY ADMINISTRATION (10). THERE ARE MANY GEOTECHNICAL ASSETS PRESENT ALONG TRANSPORTATION AREAS. THIS DIAGRAM SHOWS THE INFRASTRUCTURE ASSETS ARE INSEPARABLE FROM THE GEOTECHNICAL ASSETS THEY ARE BUILT UPON.**

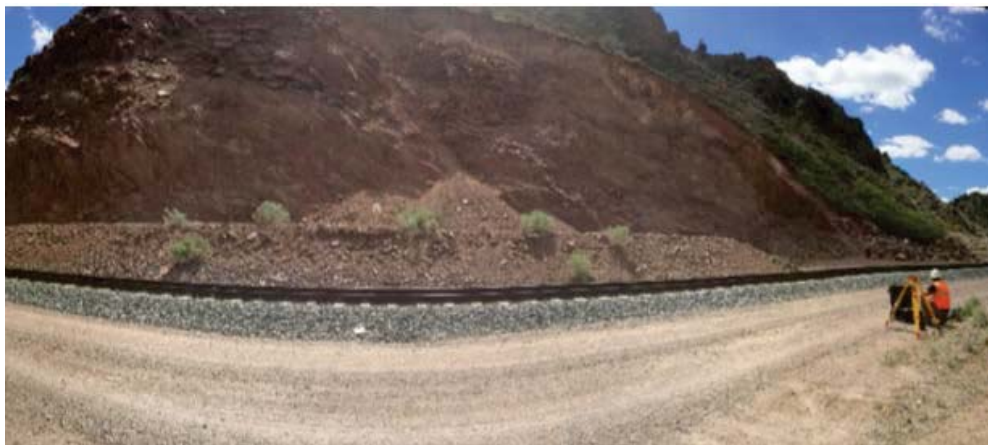
**FIGURE 2-6: TERRESTRIAL LiDAR SCANNER USED AT THE STUDY LOCATION IN SOUTHERN NEVADA. THIS IS A STATIC SCANNER, AND WAS SET UP TO SCAN THE ENTIRE SLOPE HEIGHT. LOCATION MUST BE ADJUSTED TO SCAN THE ENTIRE LENGTH OF THE**

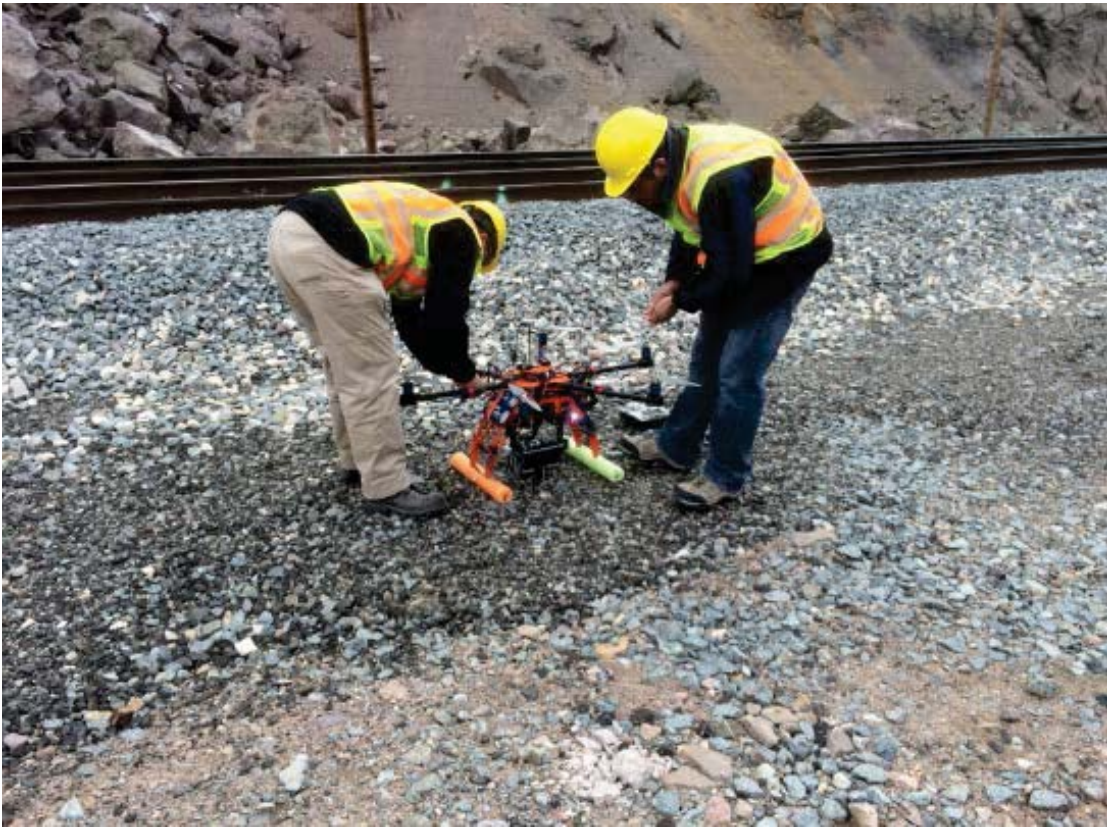
**FIGURE 2-7: OPTICAL PHOTOGRAMMETRY SET-UP USE AT THE STUDY SITE LOCATION IN SOUTHERN NEVADA. THE CAMERA WAS ATTACHED TO AN UNMANNED AERIAL VEHICLE, TO CAPTURE THE SLOPE FROM ABOVE.**

Optical photogrammetry can be performed with non-specialized equipment, but is heavily influenced by shadows and changing light conditions. Photogrammetry is able to capture more of the site, and is able to access multiple angles, which LiDAR might not be able to scan. Photogrammetry requires ground control points at the site for reference and scaling objects. A noteworthy benefit for using photogrammetry is that the point clouds are already rendered in true-color RGB (red, green, blue) color space. This distinction allows for easier identification of geological and structural features. Photogrammetry also offers advantages in cost and ease-of-use over LiDAR, with commercial equipment and software available, and light, more portable equipment than laser scanners (41). Photogrammetry can be captured either from the ground, or from the air using manned (helicopter) or unmanned flight vehicles, such as the unmanned aerial vehicle in Figure 2-7.

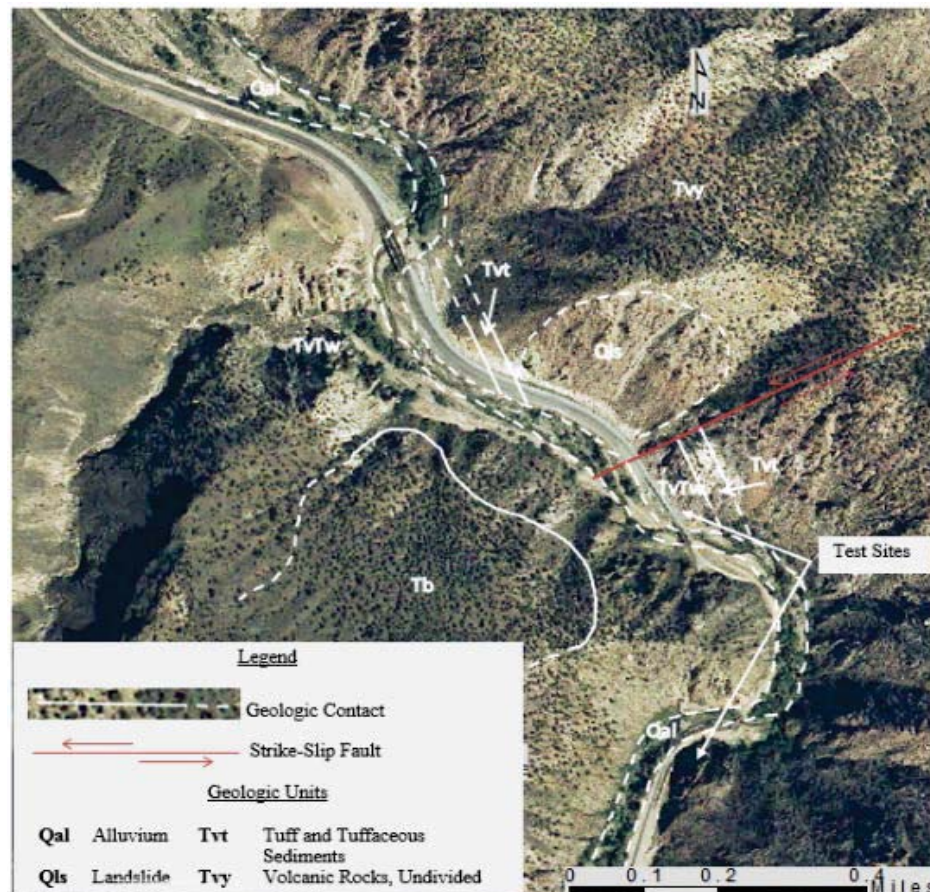
FIGURE 3-3: RELEVANT GEOLOGY MAP OF THE STUDY SITES SLIDE 1 AND SLIDE 2.

welded tuff breccia. The contact between the two units creates the head scarp for Slide 1. The geology is the same for Slide 2, as seen in Figure 3-3. The rock varies from low to moderate strength for the rhyolite tuff to moderate to high strength for the crystalline welded tuff. The crystalline tuff is found in a 100-foot thick band across the top of the head scarp. The units Tvt and Tvtw are bounded between the alluvial sediments at the center of the valley, and the geologic unit Tvy, undivided volcanic rocks. This is a relatively high strength rhyolite mixed with a low strength yellow tuff. This unit is much more prevalent than the Tvt or Tvtw, and is significantly less weathered than the other two units. An older landslide can be seen in this unit, suggesting that all the volcanic units in this area are prone to some rock failures. The 2011 landslide at Slide 1 is seen in figure 3-3, and occurred in the Qls rock formation. It is immediately north of a fault also seen in Figure 3-3.

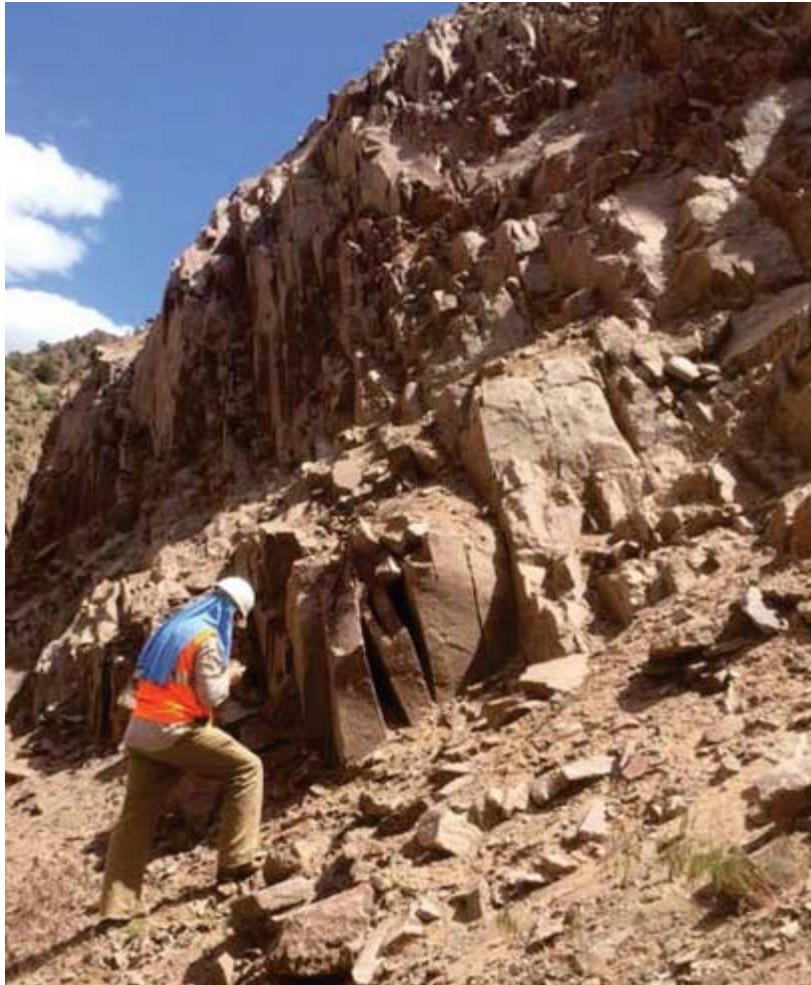
**FIGURE 3-7: ROCK STRUCTURES AT SLIDE 2 CAN BE SEEN IN THIS PHOTOGRAPH. ONE OF THE MAJOR STRUCTURES IN THE ALMOST VERTICAL PLANE. ROCK BLOCKS APPEAR TO MOSTLY BE FAILING ALONG THIS PLANE.**

Slide 2, shown in Figure 3-7 has less rock structures then Slide 1 and has generally more favorably oriented structure with the slope face. The slope face runs nearly parallel to the railroad tracks at this location, and has two faults that strike parallel to the slope face. Their dips are very similar to each other, diverging slightly. Both faults are rough and undulating, with very little infilling. Fault 1 is slightly more weathered than fault 2, likely due to the gulley running from the top of the slope, which intermittently fills with water during the wet season.

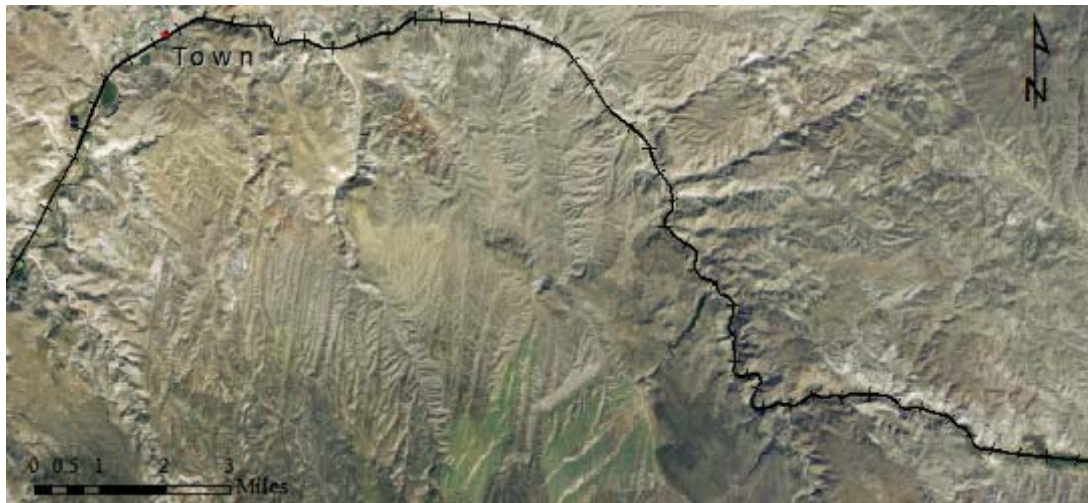
**FIGURE 4-3: A 1 METER RESOLUTION ORTHO-PHOTO OF THE STUDY CORRIDOR IN SOUTHERN NEVADA. THE PHOTOS COME FROM THE NATIONAL MAP VIEWER WEBSITE, WHICH IS HOSTED BY US GEOLOGICAL SOCIETY (USGS).**

Viewer, were used to determine an RHRS score. The resolution of the ortho-photos was estimated to be at 1 meter, which is on the same scale as required by the RHRS.

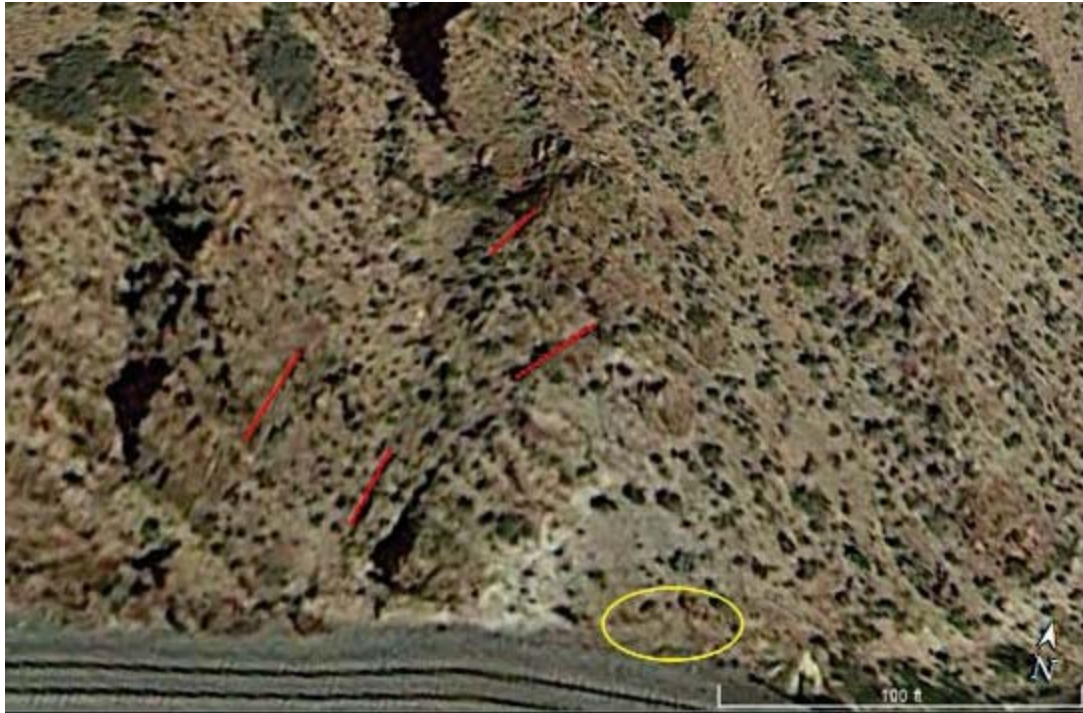
**FIGURE 4-5: ZOOMED IN ORTHO-PHOTO OF SLIDE 3 FOR GEOLOGICAL CONDITION. THE RED LINES ARE FRACTURES IDENTIFIED IN THE SLOPE. THEY CAN BE MEASURED FOR LENGTH AND ASSESSED FOR WEATHERING. THE YELLOW OVAL IDENTIFIES FALLEN ROCK BLOCKS. THESE CAN BE MEASURED AND ASSESSED FOR THE "ROCKFALL EVENT" CATEGORY.**

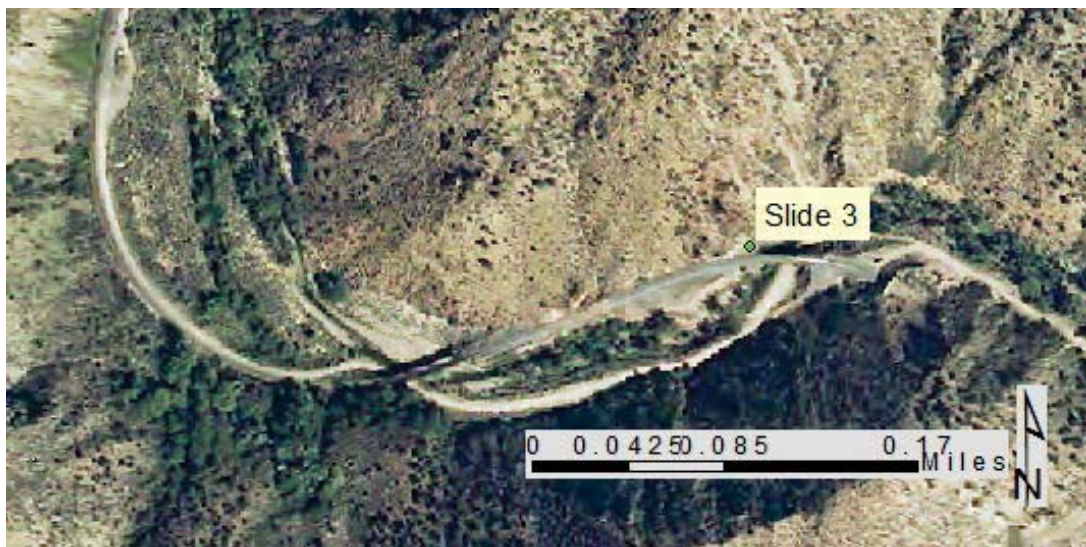
**FIGURE 4-4: ZOOMED IN ORTHO-PHOTO OF SLIDE 3. FROM THIS PHOTO, MEASUREMENTS OF "SITE DISTANCE" AND "ROAD WIDTH" CAN BE DETERMINED FOR THE RHRS CATEGORIES.**

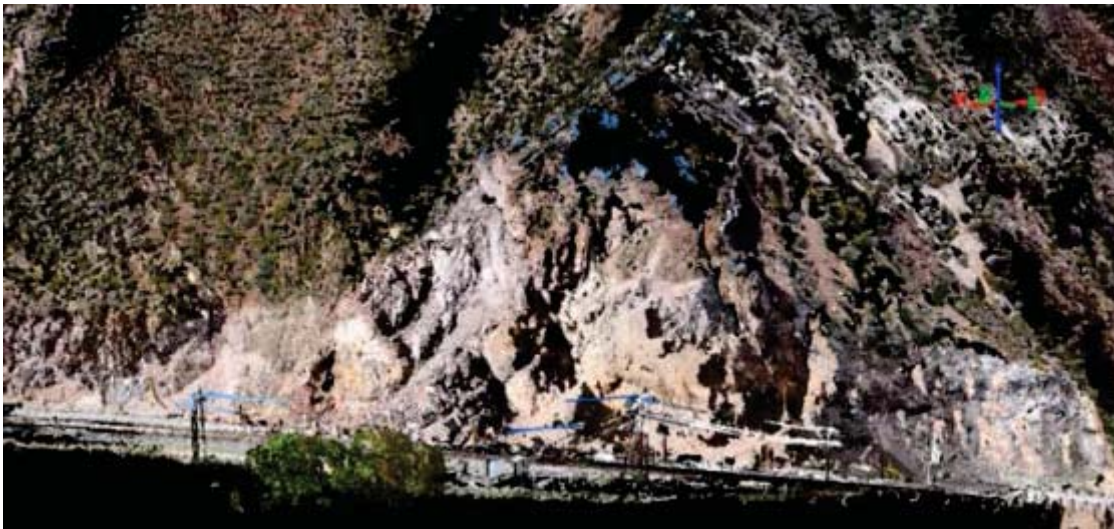
**FIGURE 4-6: TERRESTRIAL LiDAR POINT CLOUD OF STUDY SITE SLIDE 1. THE RAILROAD CAN BE SEEN AT THE TOE OF THE SLOPE. THERE IS A HOLE IN THE IMAGE INDICATED WHERE THE LiDAR SCANNER COULD NOT SEE, BECAUSE OF A CHANGE IN THE ANGLE OF THE SLOPE.**

In addition to identifying the structures and discontinuities in the rock mass, the remote sensing point clouds were valuable in determining factors of safety for rock slopes. This was done by first converting the LiDAR, shown in Figure 4-6 for Slide 1, or photogrammetry, shown in Figure 4-7, also for Slide 1, into a HRDEM.

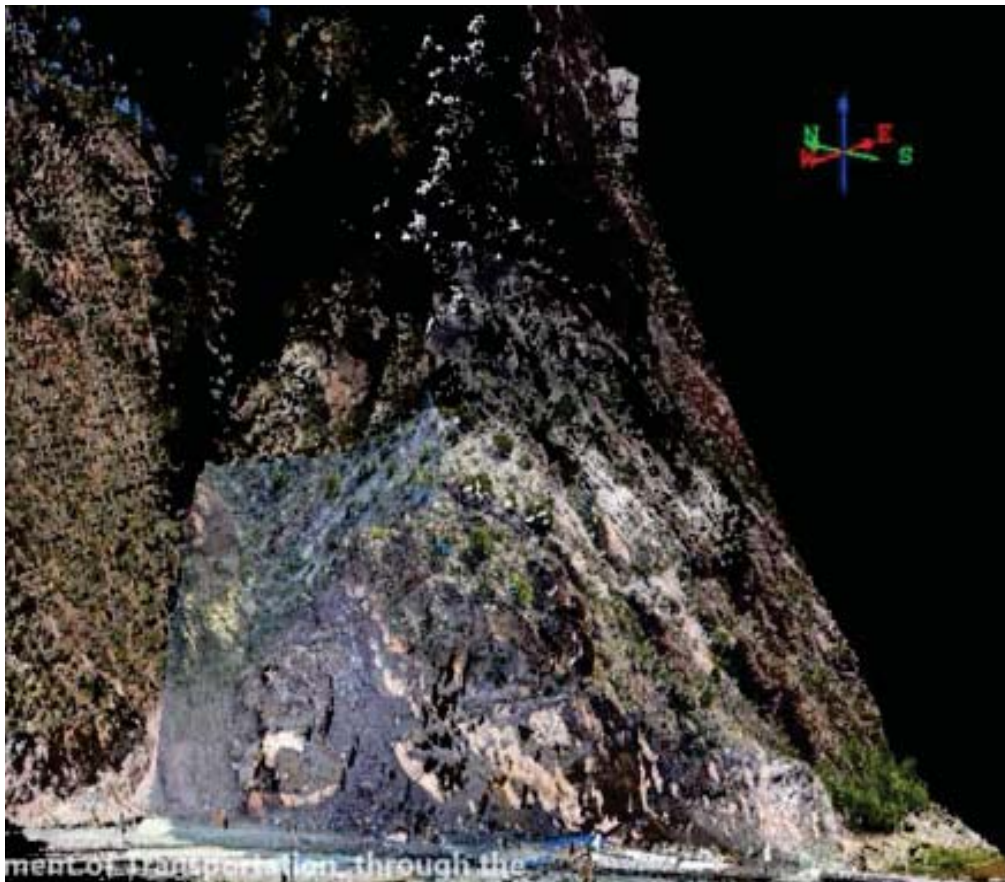
**FIGURE 6-6: LIDAR AND OPTICAL PHOTOGRAMMETRY POINT CLOUDS FOR SLIDE 1 ARE COMBINED INTO A SINGLE IMAGE. THE INTEGRATED DATA SETS PROVIDES THE BEST POINT CLOUD FOR USE IN HAZARD ANALYSIS.**

The structural information for the slide was extracted from the point cloud data (Figure 6-6), and verified with the field measurements.

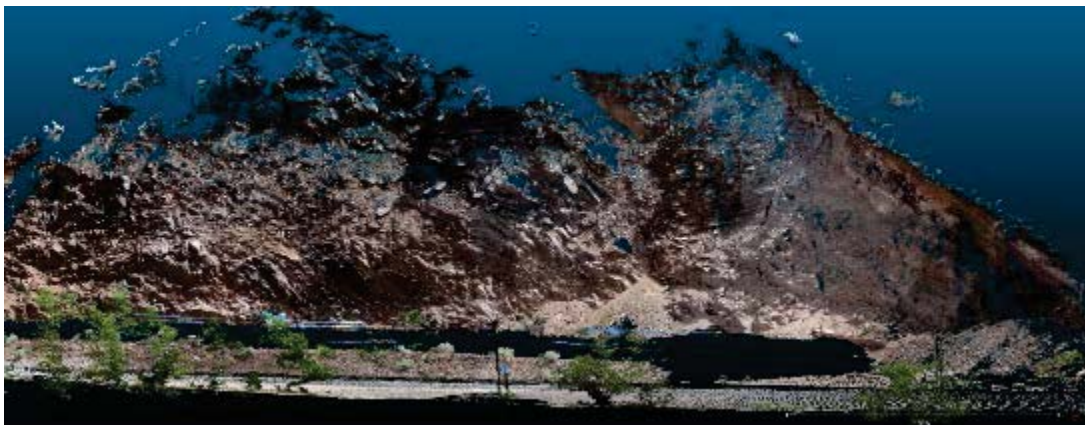
**FIGURE 6-10: LiDAR POINT CLOUD GENERATED FOR SLIDE 2. THE ROCK STRUCTURES CAN BE EXTRACTED FROM THIS AND USED FOR ANALYSIS. THE HOLE AT THE TOE OF THE SLOPE IS DUE TO SLOPE ANGLE CHANGES THAT THE LiDAR SCANNER COULD NOT CAPTURE. THIS AREA IS NOT SIGNIFICANT TO THE OVERALL STRUCTURE OF THE SLOPE.**
