Research article

Utilizing Vegetation Indices as a Proxy to Characterize the Stability of a Railway Embankment in a Permafrost Region

This study focused on the Hudson Bay Railway (HBR), a 510-mile track constructed within the permafrost region of northern Manitoba, Canada. The HBR, owned by OmniTRAX Inc. at the time of this study, serves as a critical linkage for passengers and freight from The Pas (milepost 0) to Churchill (milepost 510), connecting locations in North America to international destinations through the Port of Churchill. All three permafrost types occur along the HBR route. From The Pas to Churchill, there is a gradual northward transition from no permafrost zone, to sporadic discontinuous, to extensive discontinuous, and finally to continuous permafrost (Figure 1).

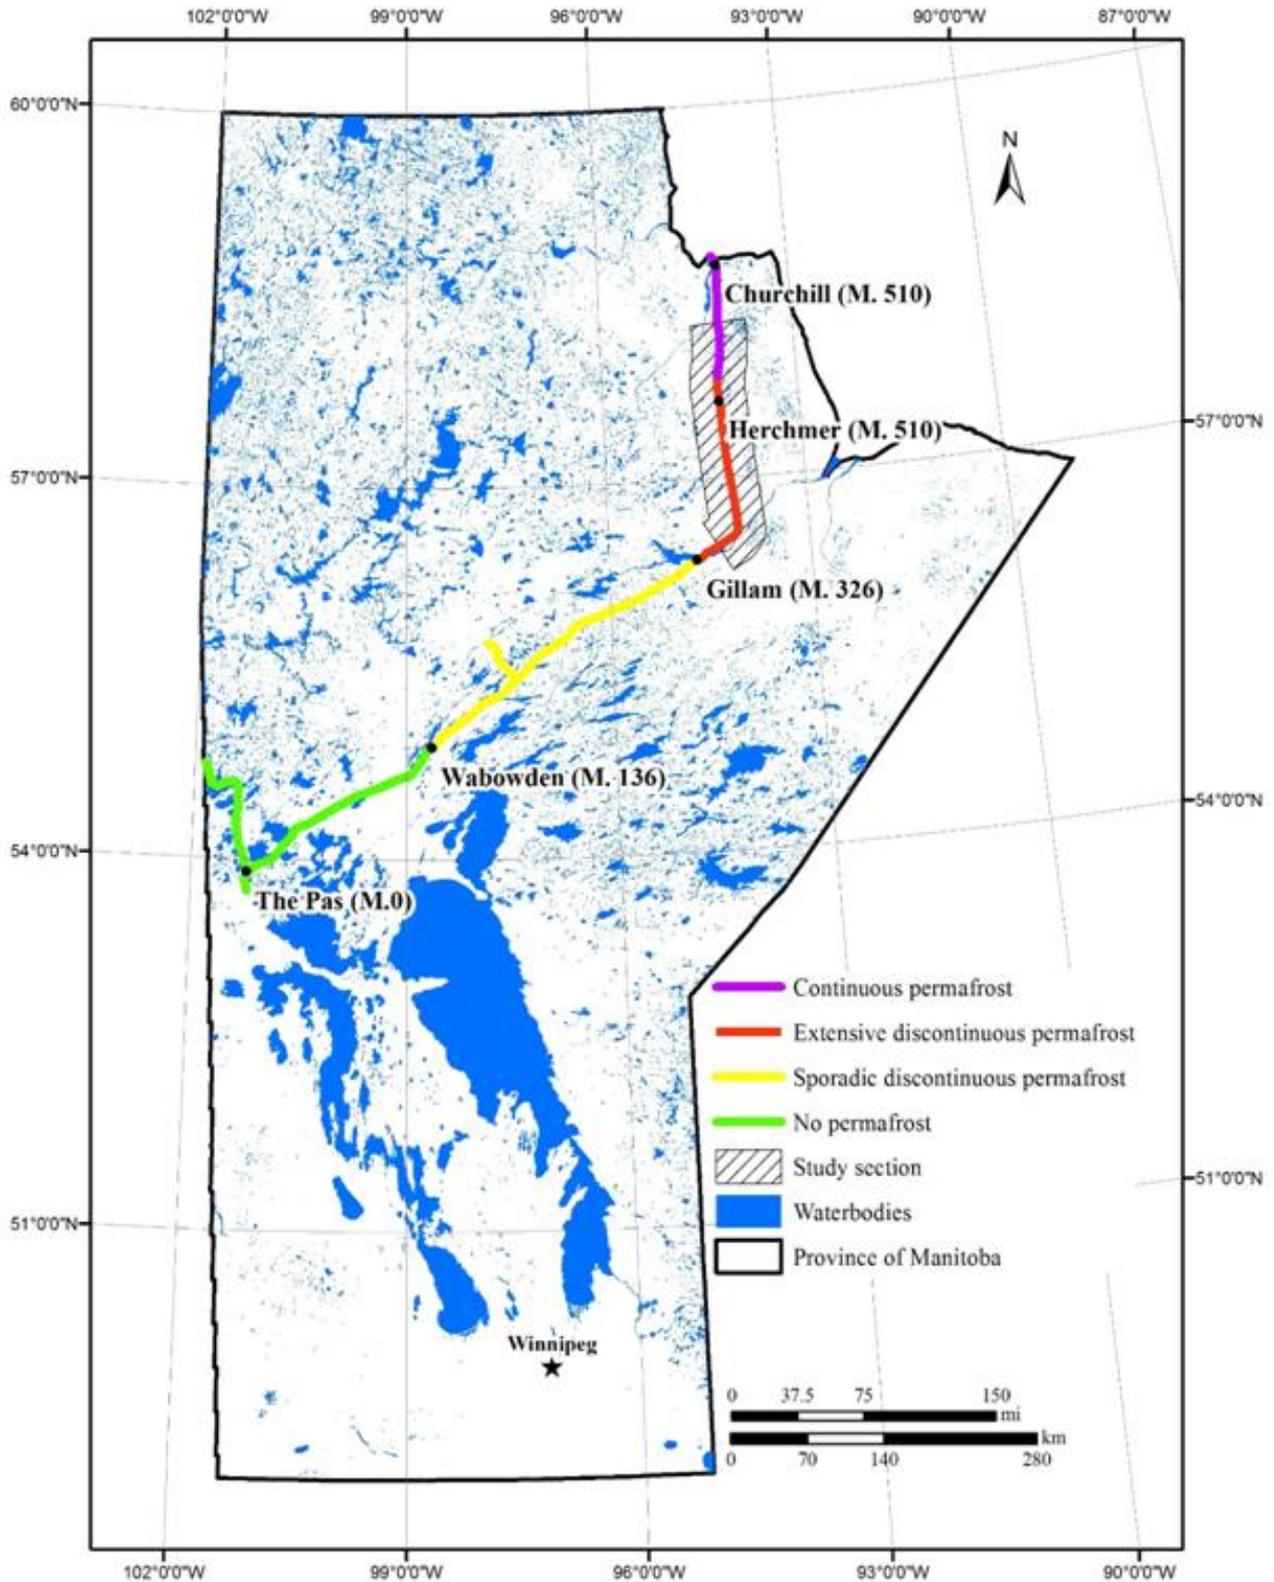
Figure 1. Location of the HBR from The Pas to Churchill showing the varying permafrost conditions.

Since the completion of the HBR in 1929, sinkhole formation has been an increasingly recurrent phenomenon during the summer thawing season. From 1976–1991, an engineering consulting company, EBA Engineering Consultants Limited (from here onwards referred to as EBA), was tasked to undertake extensive research along the rail corridor to understand the geothermal regime of the subsurface and to uncover the mechanism of sinkholes formation [9]. The reports produced by EBA indicate that the extensive discontinuous permafrost region between mileposts 330 and 430 is the most problematic segment of the HBR [12,13]. Recent track surfacing records, increases in slow orders (speed restrictions placed on a section of track to limit train speeds below regular limits due to unfavourable track conditions) [14], and interviews with OmniTRAX personnel confirmed that this section remains the most problematic, depicting increasing structural instability. Hence this section of the HBR, as well as an overlap in the continuous permafrost region to milepost 473, was chosen as the focus of the study (Figure 1).

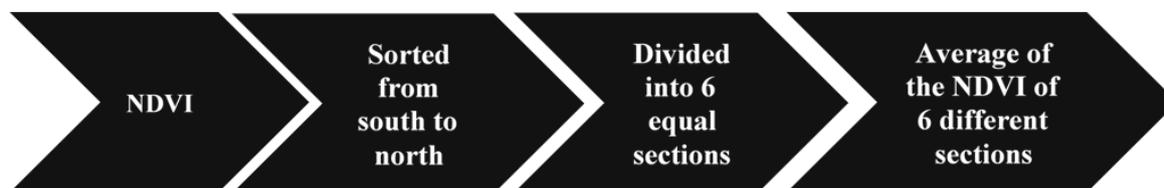
Figure 2. Process for determining relation between NDVI and track geometry exceptions.

Results from the ERT surveys at the 10 sites were compared against the track exception data to identify trends between these datasets. The objective was to infer subsurface conditions delineated by the ERT from the surficial data of the track exceptions. After establishing this relationship, the NDVI from the remote sensing analyses was compared against their corresponding average number of track exceptions recorded. This analysis was modelled after Roghani et al.’s approach [31] by dividing the study section into 22-mile sections, resulting in six subsections from milepost 341 (southern end) to milepost 473 (northern end). The process is summarized in Figure 2. The corresponding track exceptions per mile of track were calculated by combining the recorded yearly average exceptions per section and dividing them by the segment length (22-miles).

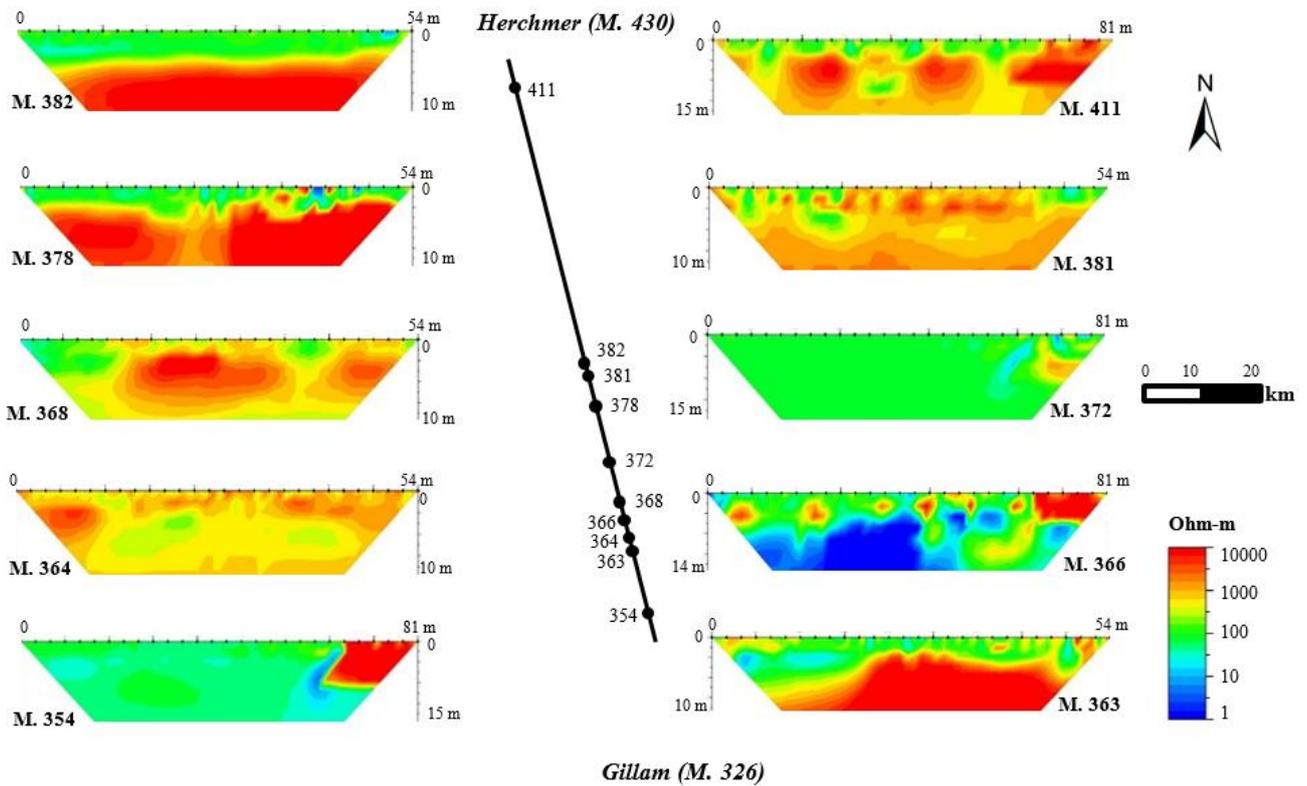
Figure 4. Subsurface profiles from the ERT investigation displayed along the track route of the study section, showing ground resistivities from low resistive thawed soils in blue to highly resistive permafrost layers in red color.

Results of the subsurface profiles from the ERT investigation are displayed along a plot of the study section in Figure 4. The legend at the bottom right of the figure provides an explanation of the color scheme from blue to red, representing low to high resistivities. Palacky and West [32] found that the average resistivity for permafrost materials is 10,000 ohm. Figure 4 shows that several

locations recorded a resistivity of 10,000 ohm indicating the presence of permafrost (indicated by the red color).

From Figure 4, it can be seen that the only site underlain by well-defined continuous permafrost is milepost 382. For all other sites, various degrees of permafrost degradation were observed. Particularly noteworthy is that excluding the subsurface profile of milepost 363, the southern sections of the study area were found to be almost devoid of permafrost. The lack of permafrost in the southern sections correlate with lower records of track exceptions in the south as observed in Figure 3. The northern sections, which recorded higher track exceptions, have permafrost present but they seem to be actively thawing, as indicated by the profusion of thawing transition zones. These subsurface profiles suggest that permafrost zones classification by EBA (shown in Figure 1) is changing, as permafrost degradation appears to be moving northward. It is likely that the southern boundary of the extensive discontinuous permafrost zone is transitioning into a sporadic discontinuous zone, whereas the southern boundary of the continuous permafrost zone may also be converting into extensive discontinuous zone. The results also confirm EBA's hypothesis that sinkholes develop at the permafrost transition zones, as thawing northern sections with the most transition zones also recorded the high occurrences of track exceptions.

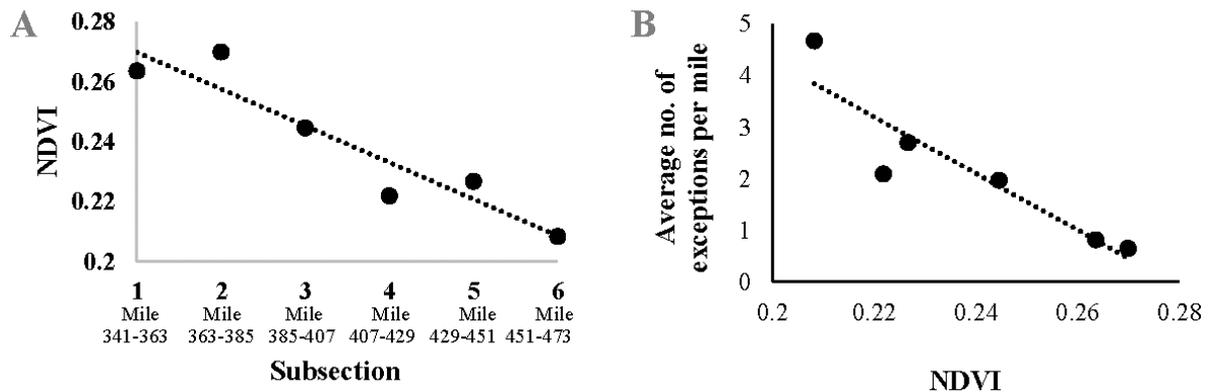
Figure 5. A plot of track sections versus NDVI showing the tendency to find less vegetation as you move northwards (left); and NDVI versus track exceptions showing that it is more likely to find track exceptions in locations with little vegetation and vice versa (right).

NDVI was compared against the corresponding average number of track exceptions recorded for each of the six subsections. A plot of the NDVI against subsection shows a general negative correlation from section 1 to 6 (Figure 5A), which indicates a decrease in the vegetation density as one moves northward. A plot of the NDVI versus the track exception also shows a negative correlation indicating that as vegetation decreases, the number of track exceptions increases and vice versa (Figure 5B).

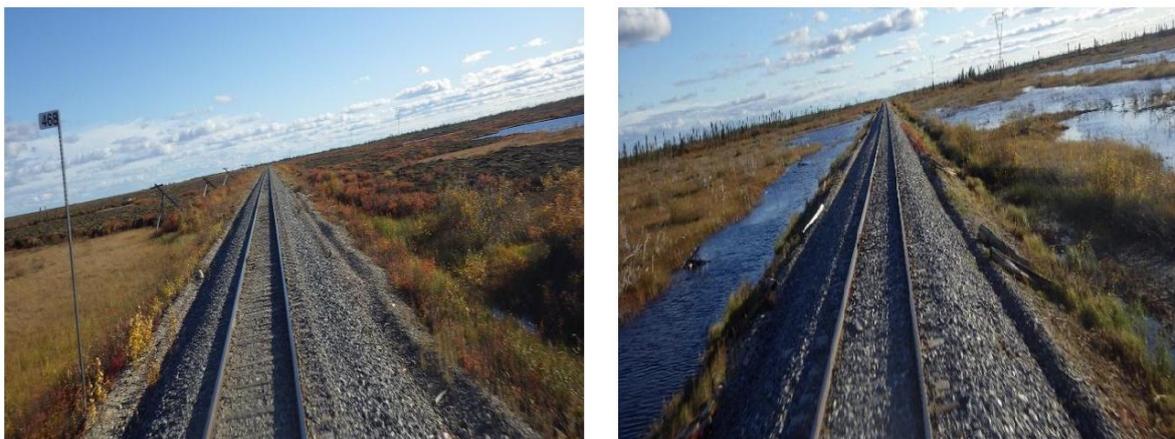
Figure 6. Photos of milepost 468 (left) and milepost 448 (right) showing no tree cover and ponded water close to embankment shoulders.

Photo images were taken in 10-second intervals while traversing the entire study area by a hi-rail truck. A comparison between the photos and research findings revealed that the northernmost sections with the lowest NDVIs (Subsections 5 and 6) are generally devoid of tree cover. This is intuitive; however, a more noteworthy finding was that these sections had substantial amounts of ponded surface water close to the embankment shoulders. Figure 6 shows two such typical images for milepost 468 (Subsection 5) and milepost 448 (Subsection 6). Conversely, the southernmost sections, which recorded the highest NDVIs, had denser vegetation with no surface water close to the embankment shoulders (Figure 7). From these photos, it was realized that the low NDVIs obtained for this particular study site translate not only to low vegetation densities but also to high percentage of ponded surface water.

These photos also reinforced the perceived relationship between the NDVI and track exceptions, as past literature have shown collected waterbodies in the form of ponds and lakes have deleterious effects on underlying permafrost. Ponded water absorbs the sun's heat and transfers it to the permafrost table [33], which explains why the northernmost sections recorded higher frequencies of track exceptions, indicative of permafrost degradation.

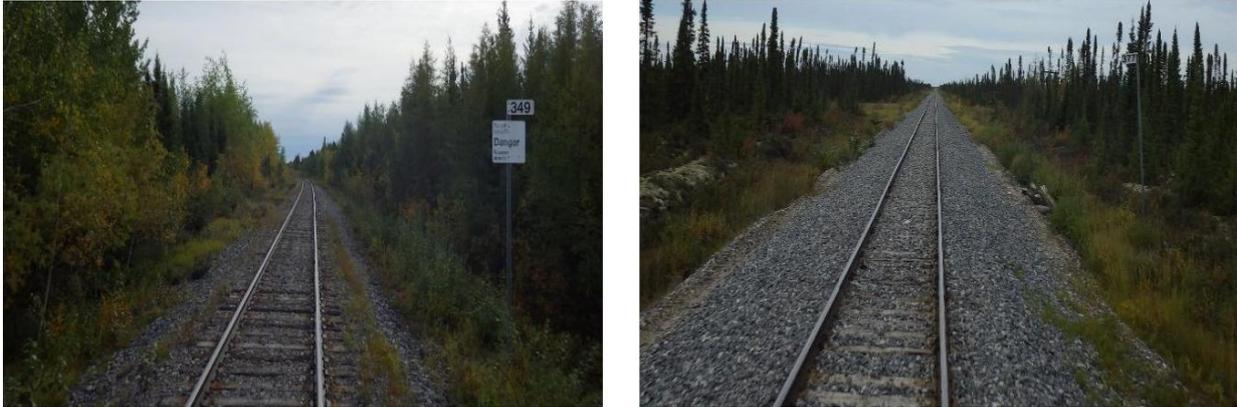
Figure 7. Photos of milepost 349 (left) and milepost 377 (right) showing population of trees and no surface water ponded close to the embankment shoulders.

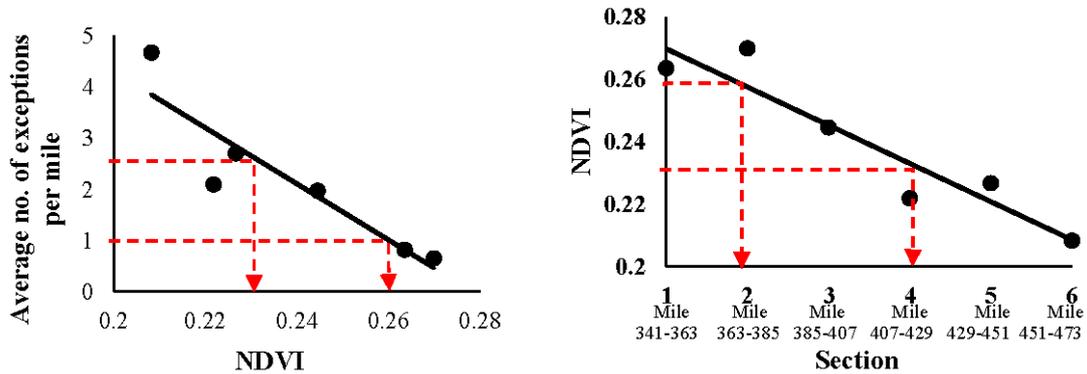
Figure 8. Defining percentiles for developing severity chart.

The average number of exceptions recorded was used as the basis of the chart. Locations that developed a maximum of one exception per year were generally considered stable and within acceptable performance levels, whereas locations that developed more than 2.5 exceptions are of concern and need to be mitigated [31]. Using these two track exception limits, a three-level severity chart was developed. The results are summarized in Figure 8 and Table 1.
