## **Exploring Rapid Solidification and Equal Channel Angular Pressing in the Fabrication of Mg-Based Alloys for Medical Applications**

EXPLORING RAPID SOLIDIFICATION AND EQUAL CHANNEL ANGULAR  
PRESSING IN THE FABRICATION OF MG-BASED ALLOYS FOR  
MEDICAL APPLICATIONS

A THESIS

In Materials Science and Engineering

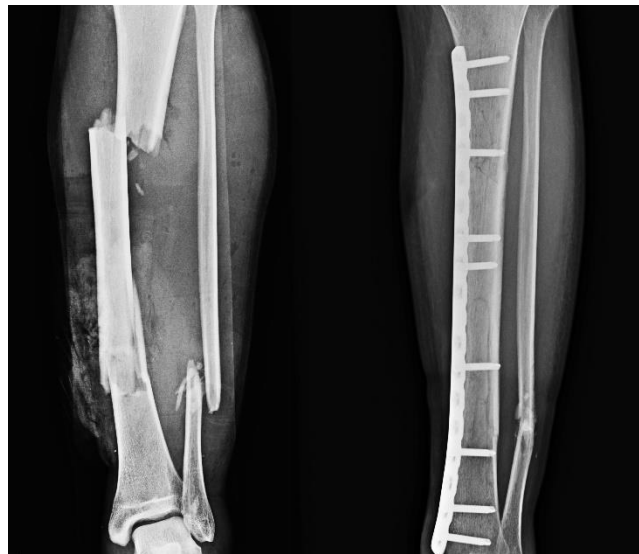
Figure 1.1. An ORIF implant used on a fractured humerus. From IStock, Tonpor Kasa [5].

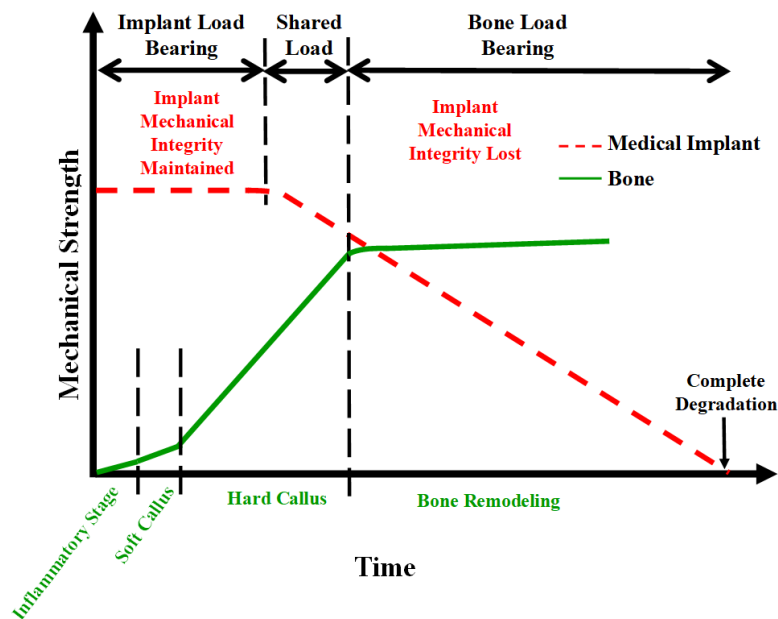
Figure 1.2. Example timeline of bioresorbable implant degradation. Adapted from Zhao et al. [14].

mechanical strength of the implant until the bone is able to carry load again (Figure 1.2) [8]. Alloying magnesium with other elements has been a popular route to increase its strength and reduce the corrosion rate. Rare earth elements (REEs) including Nb, Gd, Y, Dy, La, Ce are the most extensively explored alloying elements in formulation of bioresorbable Mg alloys [9]. This is because REEs can improve mechanical strength, creep resistance and corrosion resistance of Mg [9]. However, their presence in bioresorbable implants and associated potential long-term toxicity effects on the human body is highly debated [10–12]. Alloying elements which are naturally found or essential in the body such as zinc, calcium, manganese, and strontium have become increasingly popular to avoid the use of REEs [6,12]. The only downside in using these alloying elements is that these alloying additions do not have as drastic effects on the improvement of the corrosion rate and mechanical strength of magnesium compared to REEs, in low concentrations [13].

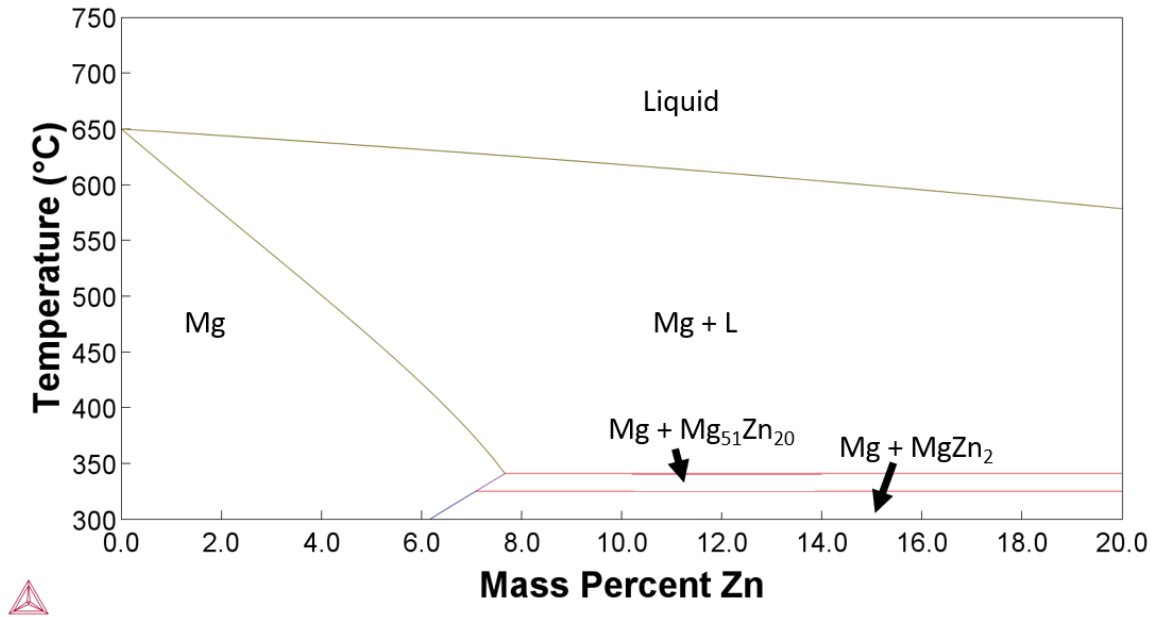
Figure 1.3. Magnesium-zinc phase diagram generated in Thermo-Calc 2021a using the TCMG6 database.

Zinc is an essential element in the human body and participates in numerous enzymatic processes [18]. It is also one of the most popular alloying elements in structural magnesium alloys due to its strengthening mainly through solid solution strengthening [1]. With small (1-4 wt%) additions of zinc, magnesium's strength and ductility increases without a large decrease in corrosion resistance (Table 1.3) [18]. Small additions of zinc are most effective because the corrosion resistance of magnesium is maintained by preventing zinc-rich intermetallic precipitates from forming which are detrimental to the galvanic corrosion (Figure 1.3) [18].

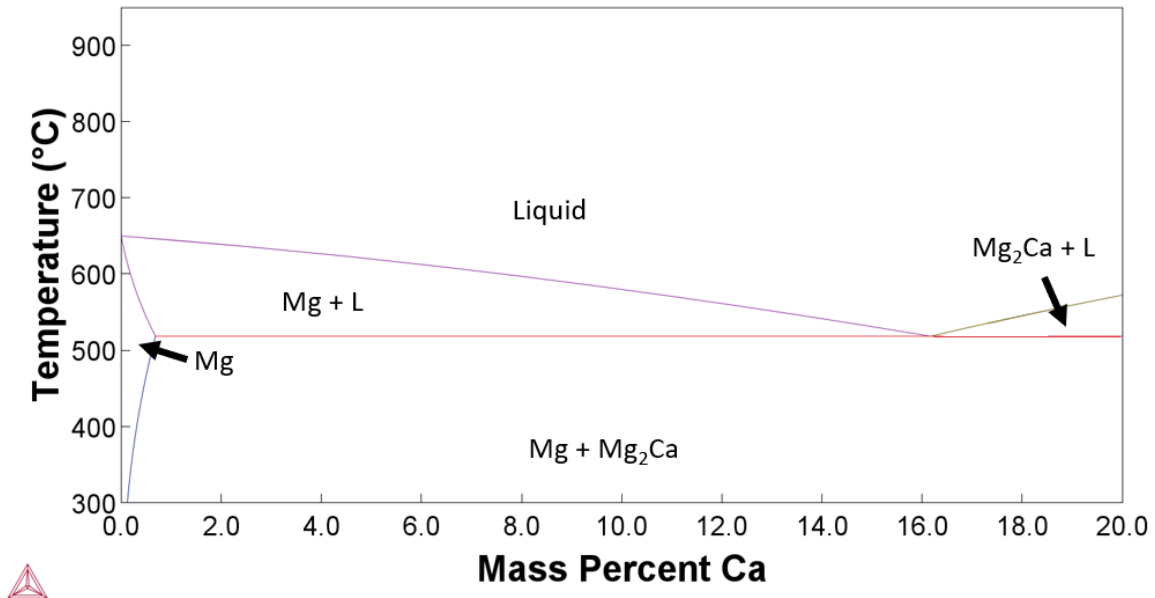
Figure 1.4. Magnesium-calcium binary phase diagram generated in Thermo-Calc 2021a using the TCMG6 database.

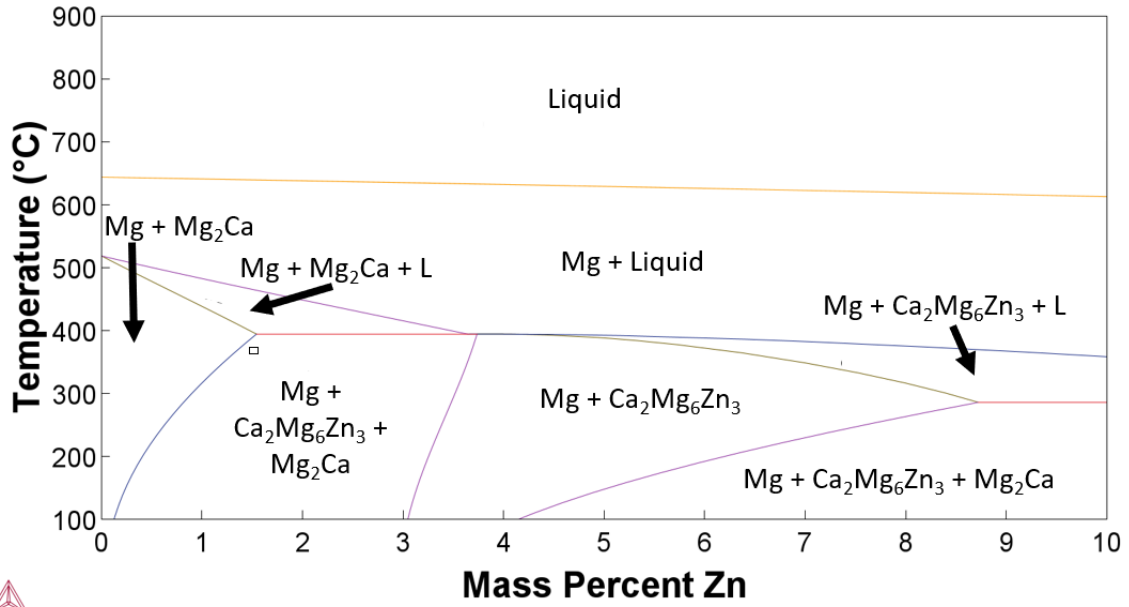
Figure 1.5. Phase diagram of Mg-Zn-Ca alloys for Mg-1.2Ca vs zinc, generated through Thermo-Calc 2021b using the TCMG6 database.

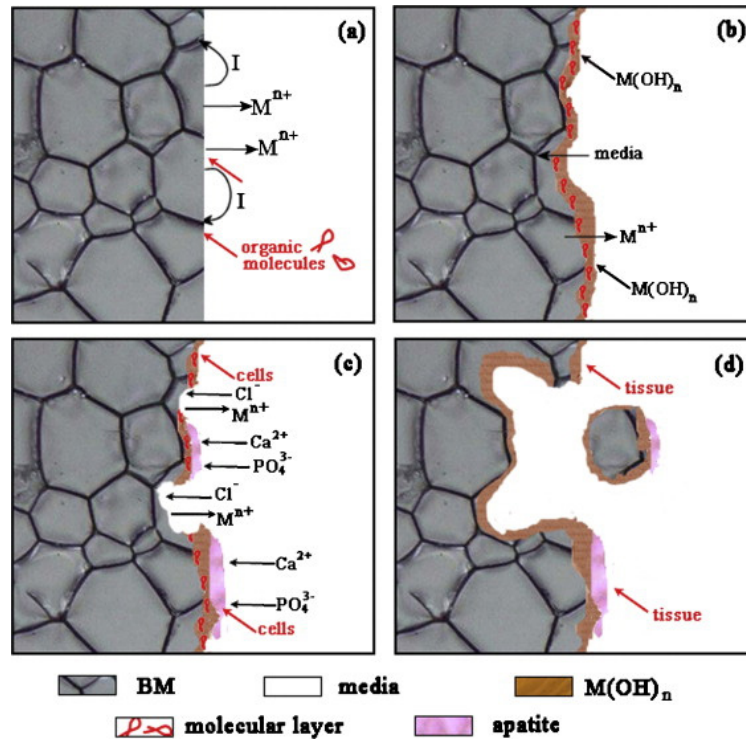
Figure 1.6. Schematic of biocorrosion of magnesium. Reproduced with permission from [18], 2014, Elsevier.

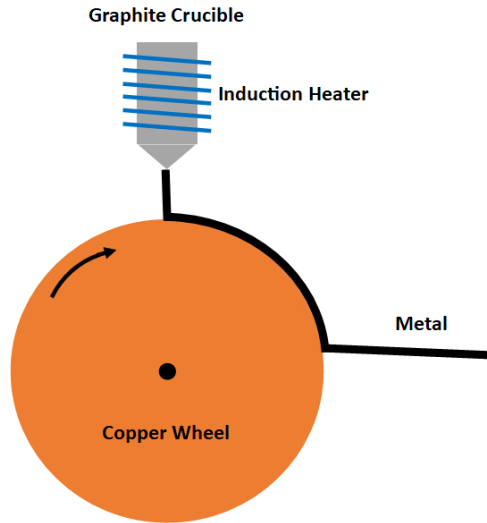
Figure 1.7. Schematic of a melt spinning process from a front view.

One technique to achieve rapid solidification of an alloy, is melt spinning. Melt spinning is a process that uses a rotating copper wheel to rapidly cool metal that is ejected from a crucible on to it (Figure 1.7). The high heat transfer of copper allows the metal to cool rapidly when ejected which forms thin ribbons of metal that feature a nonequilibrium, supersaturated microstructure [34]. As discussed, this microstructure consists of fine grains and smaller precipitate size compared to that of a conventionally cast microstructure which produces Mg-Zn-Ca alloys with an increased corrosion resistance.

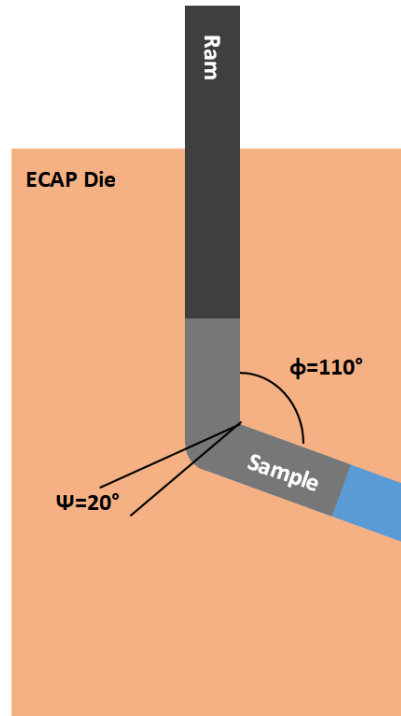
Figure 1.8. Schematic of an ECAP die viewed through the cross section.

The most popular SPD technique is equal channel angular pressing (ECAP). ECAP consists of pushing a billet through two channels of identical cross-sectional areas that intersect at an angle (Figure 1.8). This change in direction introduces a large simple shear to the billet without changing the geometry of the billet allowing for multiple ECAP passes. The massive grain refinement that occurs during ECAP affects the corrosion and mechanical properties in magnesium alloys [8,33].

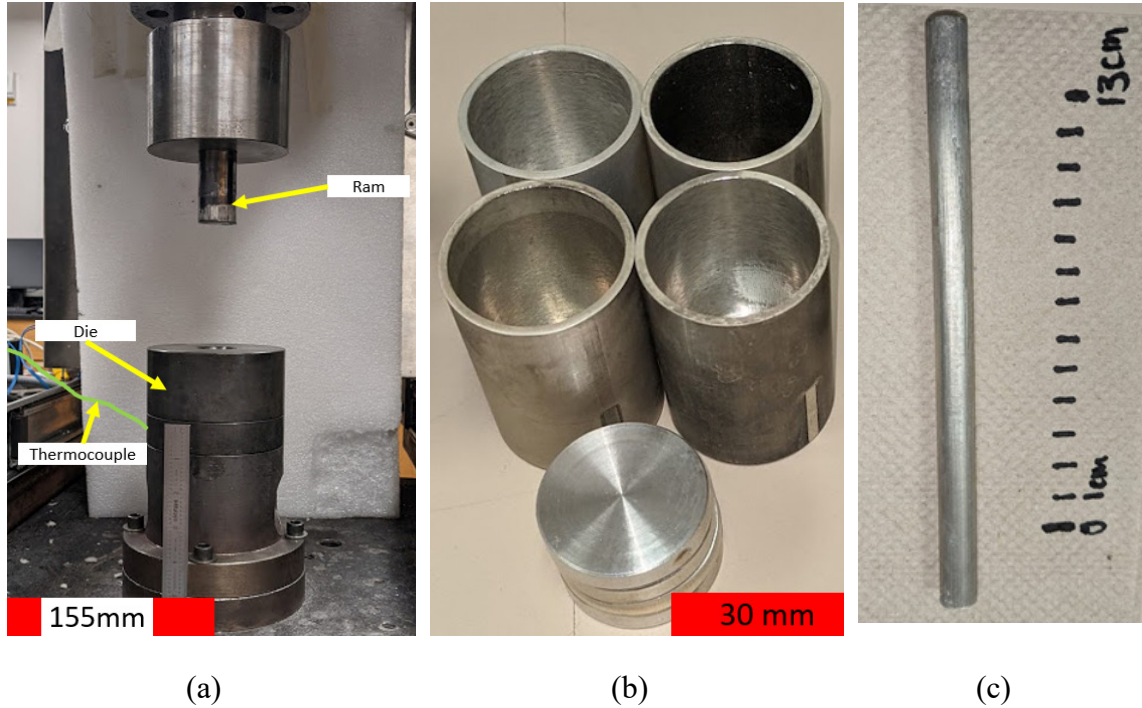
Figure 2.2. (a) Extrusion die set up which the induction coil wraps around for heating, (b) magnesium cans which are packed with ribbons for consolidation through extrusion, and (c) produced extruded rod of consolidated ribbons.

To consolidate the melt spun ribbons, hot extrusion was performed with an extrusion ratio of 8:1. The ribbons were compacted into pure Mg cans with an outer diameter of 31 mm, inner diameter of 28 mm, and walls 45 mm tall (Figure 2.2b). These cans were then extruded at 390°C with a ram speed of 5 mm/min using boron nitride spray as a lubricant. The die was heated using an induction heating coil and temperature was monitored through an inserted thermocouple within the die (Figure 2.2a). The first 3 cm of the extruded rod (Figure 2.2c) were then cut off before processing for ECAP since this material was

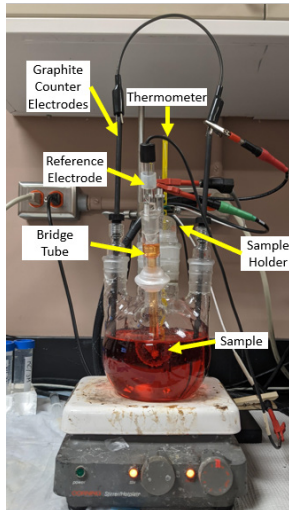
Figure 2.4. Conventional 3-electrode corrosion cell set up.

Potentiodynamic polarization and electrochemical inductance spectroscopy (EIS) tests were performed using a Princeton Applied Research PARSTAT 4000 with the VersaStudio® software. All tests used a conventional three-electrode corrosion cell with a saturated calomel electrode (SCE) reference electrode with graphite counter electrodes (Figure 2.4). The exposed surface area of the samples was about  $0.6 \text{ cm}^2$ . For each test, the open circuit potential (OCP) was measured for 1 hour before potentiodynamic or EIS tests were performed. Potentiodynamic tests were carried out over a range of  $-0.25 \text{ V}$  vs OCP to  $0.75 \text{ V}$  vs OCP with a scan rate of  $0.166 \text{ mV/s}$ . For EIS testing, a frequency range of  $100 \text{ kHz}$  to  $0.01 \text{ Hz}$  with an oscillation amplitude of  $10 \text{ mV}$  was used. The corrosion rate was estimated following ASTM G102 following the Tafel extrapolation method using the potentiodynamic curves [39]. Three repetitions of each test were completed for the two alloys and the two different processing conditions.

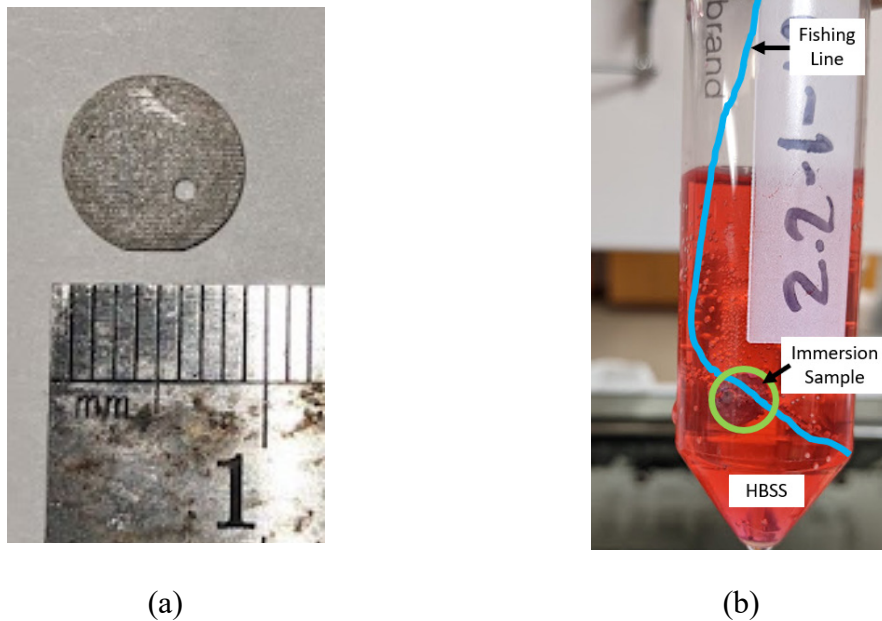
Figure 2.5. (a) Immersion test samples and (b) immersion samples inserted into HBSS.

For immersion testing, ASTM guide G31 was followed [40]. Round samples 8.3 mm in diameter and 1 mm thick were immersed for durations of 2, 5, 10, and 15 days (Figure 2.5a). Samples were cut from a turned down billet using wire electrical discharge machining (wire-EDM). Three samples in each of the four conditions were suspended in HBSS by fishing line in a 50 mL test tube. The volume of HBSS to surface area ratio was  $0.2 \text{ mL/mm}^2$  and the solution was changed every 2 days to keep the pH of the solution consistent (Figure 2.5b). The mass of samples pre- and post-immersion was measured using a scale accurate to 0.0001 g. Corrosion products were removed using a chromic acid aqueous solution of 200 g/L  $\text{CrO}_3$  and 10 g/L  $\text{AgNO}_3$  and then sonicated for 5 minutes in ethanol followed by 5 minutes in acetone. Cross sections of pre-cleaned immersion samples were examined using backscatter SEM to observe corrosion uniformity and corrosion product morphology. Secondary SEM was used to examine the surface morphology of the magnesium alloys once the corrosion products were removed.

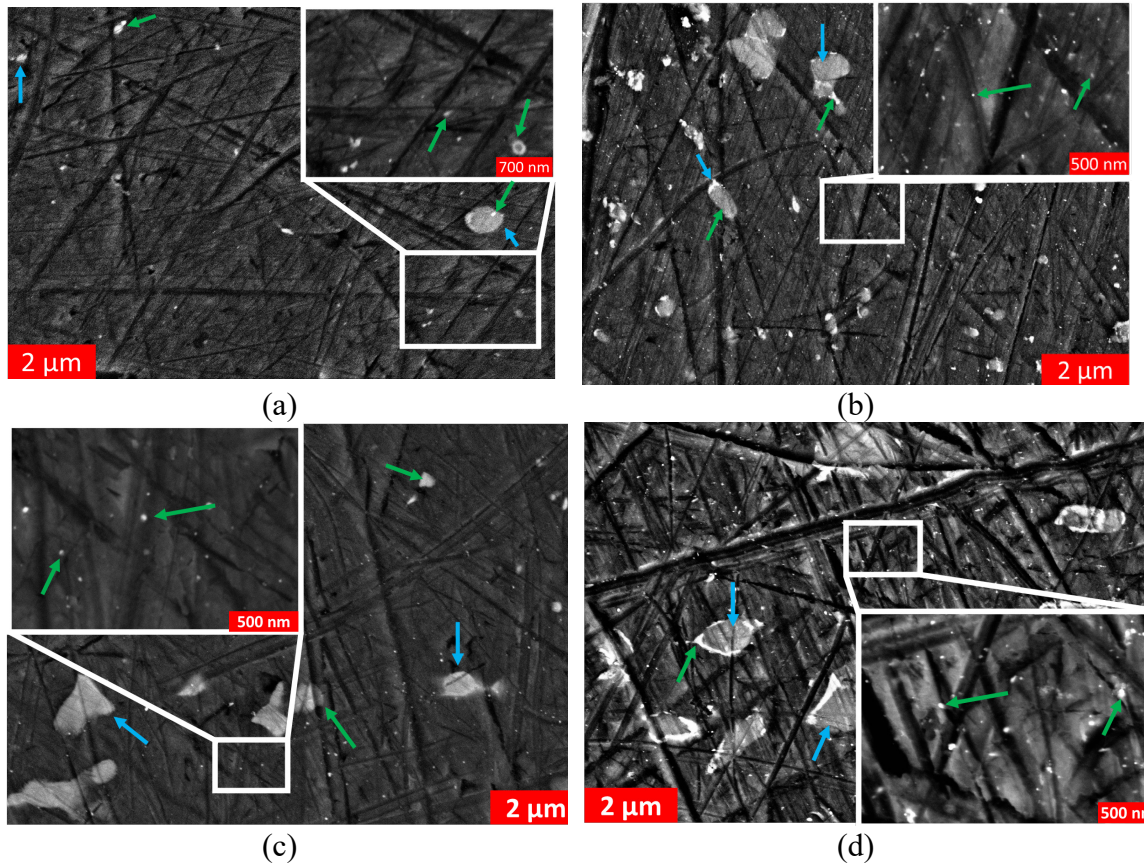
Figure 3.1. BSE SEM images of Mg-1.2Zn-0.8Ca-0.2Mn (a) RS and (b) ECAP alloys, and Mg-1.8Zn-0.8Ca-0.2Mn (c) RS and (d) ECAP alloys along the extrusion and ECAP direction. Green arrows indicate  $\text{Ca}_2\text{Mg}_6\text{Zn}_3$  intermetallics and blue arrows indicate  $\text{Mg}_2\text{Ca}$  intermetallics and the extrusion and ECAP direction runs from left to right.

arrows (Figure 3.1)) contained Mg, Zn and Ca whereas the dark precipitates (blue arrows (Figure 3.1)) only contained Mg and Ca (Figure 3.2). In the magnesium matrix, manganese was not detected because the additions of Mn were below the detection limit of SEM-EDS. The identification of these two precipitates was attempted using x-ray diffraction (XRD) but the volume fraction of these two precipitates was too low to be detected among the background of the diffraction pattern (Figure 3.3a). There were a few low intensity peaks (circles) that did show up in the pattern that could not be matched to the diffraction patterns of Mg (diamonds), any expected precipitate ( $\text{Mg}_2\text{Ca}$ ,  $\text{Ca}_2\text{Mg}_6\text{Zn}_3$ ), nor any other compound that could form between the present alloying elements (Figure 3.3b). These peaks were suspected to be from  $\text{Ca}_2\text{Mg}_6\text{Zn}_3$  and  $\text{Mg}_2\text{Ca}$  phases and the lack in matching peaks is caused by the low concentration of alloying elements and non-equilibrium processing these alloys underwent. After ECAP processing, the  $\text{Ca}_2\text{Mg}_6\text{Zn}_3$  precipitates are more abundant and formed on the edges of larger  $\text{Mg}_2\text{Ca}$  precipitates (Figure 3.1).

concentration of zinc added to the alloy. This difference is especially evident between the RS processed alloys. The ECAP processed alloys (Figure 3.1b, d) exhibited a higher volume density of these nano-precipitates than the RS processed alloys (Figure 3.1a, c) demonstrating the dynamic recrystallization occurring during ECAP processing.

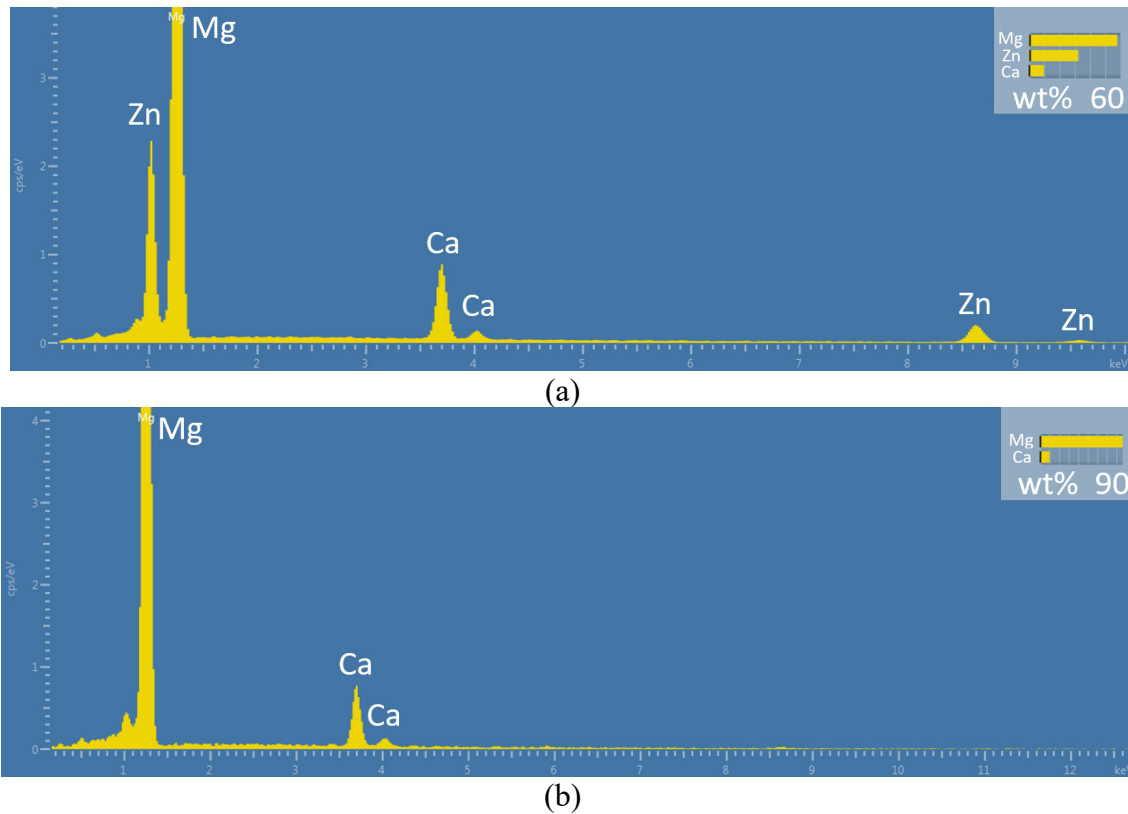
Figure 3.2. SEM-EDS spectra for the precipitates pointed out by (a) the green arrows and (b) the blue arrows.

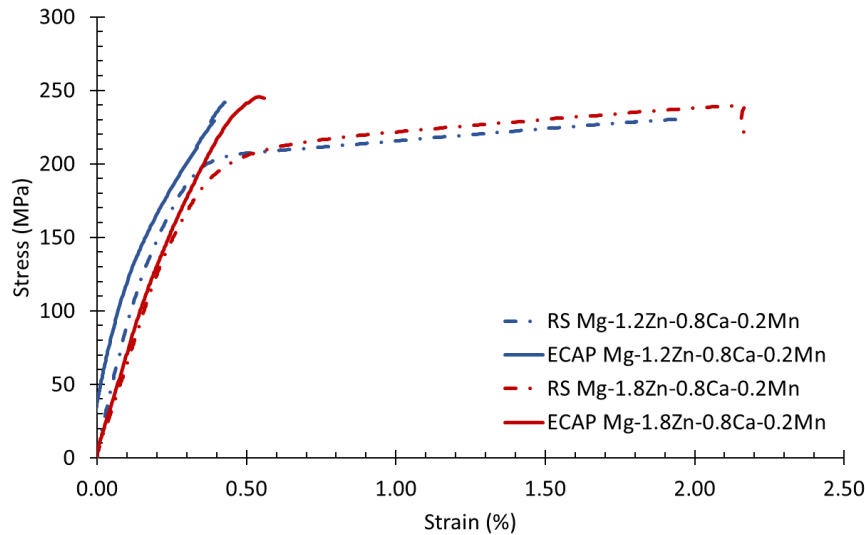
Figure 3.5. Tensile stress-strain curves for RS and ECAP Mg-1.2Zn-0.8Ca-0.2Mn and Mg-1.8Zn-0.8Ca-0.2Mn alloys.

The elastic modulus, yield strength (YS), ultimate tensile strength (UTS), and elongation at break (% EL) were determined (Table 3.2) from tensile stress-strain curves of the RS and ECAP processed Mg-1.2Zn-0.8Ca-0.2Mn and Mg-1.8Zn-0.8Ca-0.2Mn alloys (Figure 3.5). The tensile mechanical behavior of the RS processed samples exhibited a more ductile behavior (~3% EL) than the ECAP processed samples. The ECAP samples exhibited an almost brittle fracture behavior with elongations only of ~0.4% EL (Figure 3.5). Comparing the YS and UTS between the two processing techniques, the YS and UTS of the ECAP Mg-1.8Zn-0.8Ca-0.2Mn alloy was about 40 MPa higher than the RS processed alloy. The ECAP Mg-1.2Zn-0.8Ca-0.2Mn alloy fractured before yielding occurred, so a YS was not determined. The UTS of the Mg-1.2Zn-0.8Ca-0.2Mn alloy appears higher in the stress-strain curve in Figure 3.5 but in Table 3.2 the UTS average is lower than the RS processed alloy. The variation in UTS of the processed alloy is much larger in the ECAP processed alloys because some samples did experience stresses higher than the RS alloys whereas other samples fractured at lower stresses than the RS alloys. All four alloys had relatively close elastic moduli at about ~45 GPa. The ECAP Mg-1.8Zn-0.8Ca-0.2Mn alloy exhibited the lowest modulus at  $37 \pm 5$  GPa while the RS Mg-1.2Zn-0.8Ca-0.2Mn had the highest modulus at  $48 \pm 8$  GPa.

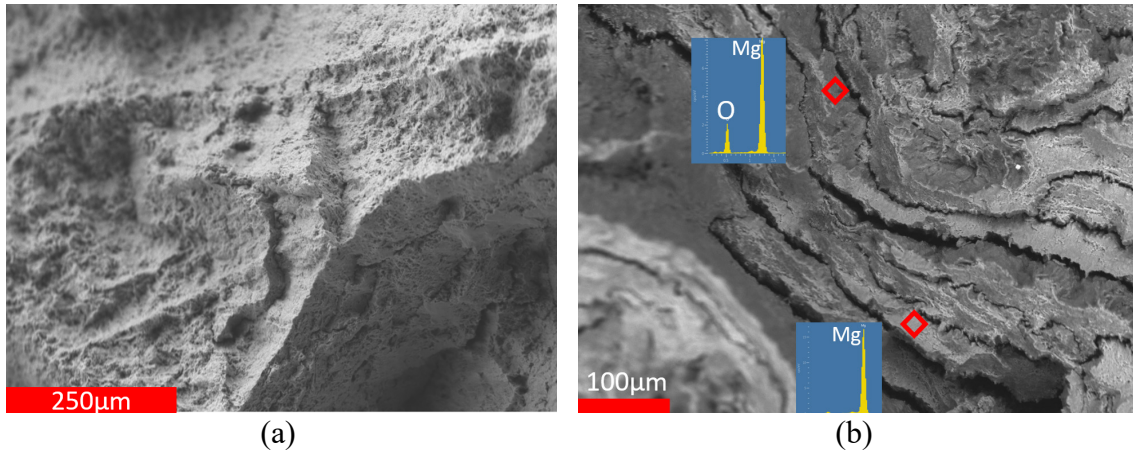
Figure 3.6. Fracture surfaces of (a) RS (SE SEM image) and (b) ECAP (BSE SEM image with EDS spectra) Mg-1.8Zn-0.8Ca-0.2Mn tensile samples.

The fracture surfaces of the RS processed alloys exhibited a more ductile failure mode; the surfaces were dimpled and did not reveal large flaws on the surface compared to the ECAP processed alloys (Figure 3.6a). The ECAP processed alloys possessed longitudinal fissures on the fracture surface in a “ribbon” like nature (Figure 3.6b). The layers between these fissures were smooth and did not exhibit the small dimpling that the RS processed alloys had. SEM-EDS of the fracture surfaces revealed an oxide layer was present in the ECAP processed alloys surfaces but not in the RS processed alloys.

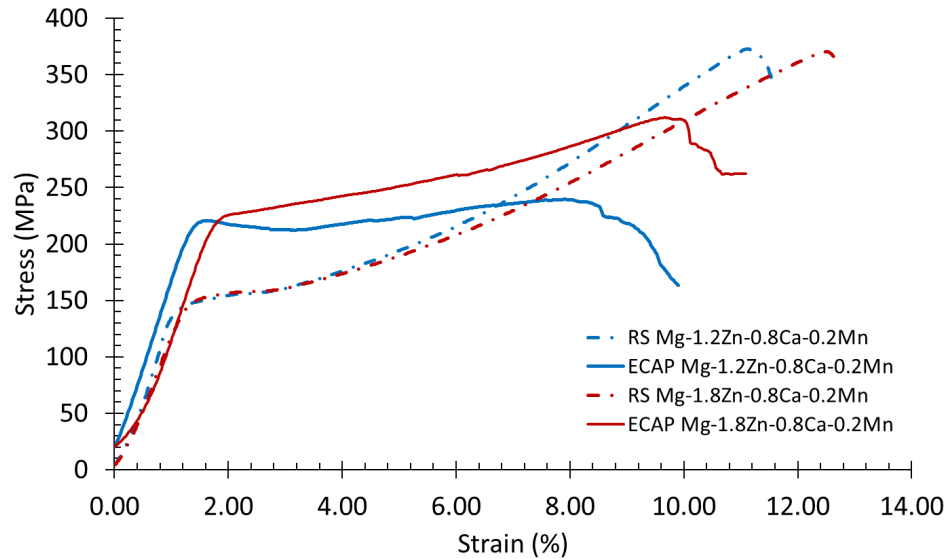
Figure 3.7. Compressive stress-strain curves for RS and ECAP Mg-1.2Zn-0.8Ca-0.2Mn and Mg-1.8Zn-0.8Ca-0.2Mn alloys.

The RS and ECAP processed alloys exhibited two different compressive mechanical behaviors. The RS processed alloys had a lower CYS (~160 MPa) compared to the ECAP processed alloys (~210 MPa) but then the stress increased for the RS processed alloys at a faster rate as strain increased compared to the ECAP processed alloys. While the ECAP processed alloys had a higher CYS, the RS processed alloys had a higher UCS (~365 MPa) compared to the ECAP alloys.

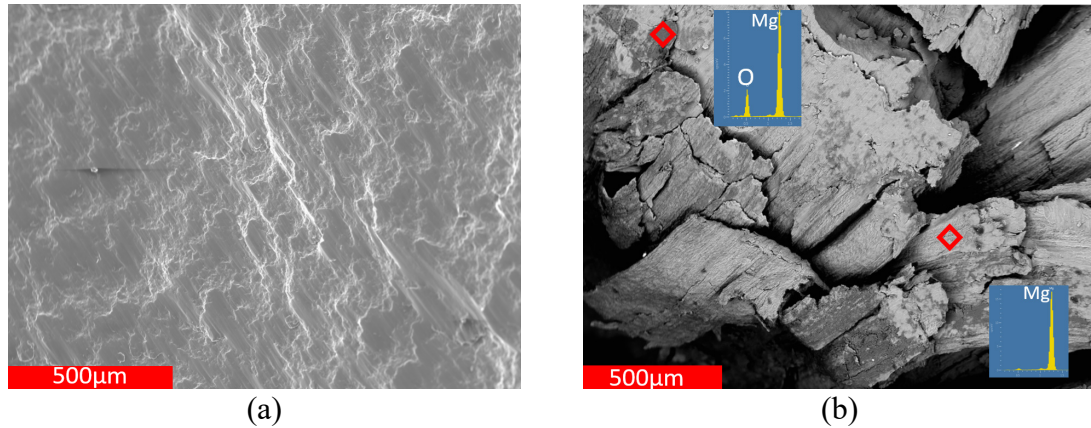
Figure 3.8. Fracture surfaces of (a) RS (SE SEM image) and (b) ECAP (BSE SEM image) Mg-1.8Zn-0.8Ca-0.2Mn compression samples.

structure observed in the tensile samples but the layers “shattered” apart under the compressive load along the cracks running through the sample ( Figure 3.8b). From SEM-EDS of the fracture surface, an oxide was also found on the surfaces between the layers in the same manner that was found on fracture surfaces of the ECAP tensile samples. The shattering of these samples could account for the stress leveling off at higher strains.

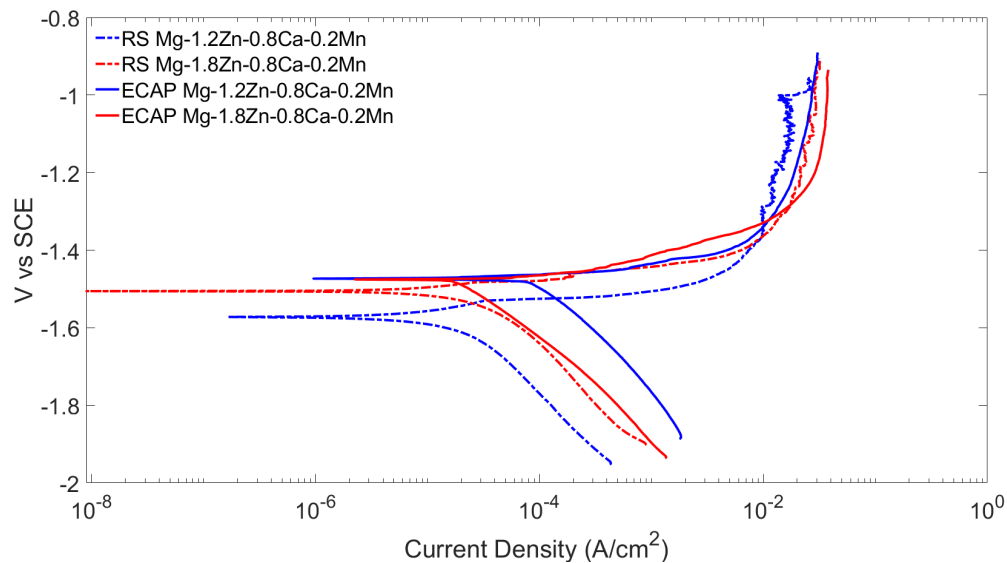
Figure 3.9. Potentiodynamic curves for RS and ECAP Mg-1.2Zn-0.8Ca-0.2Mn and Mg-1.8Zn-0.8Ca-0.2Mn alloys.

Electrochemical tests were performed to evaluate the corrosion rates and underlying mechanisms of corrosion of the Mg-Zn-Ca alloys. Corrosion rates were calculated from potentiodynamic curves using the Tafel extrapolation method (Figure 3.9). The electrochemical potential ( $E_v$ ) of the ECAP processed Mg-1.2Zn-0.8Ca-0.2Mn alloy indicates that it is more noble than the RS processed alloy. However, the calculated corrosion rate of the ECAP processed alloy was almost double the calculated corrosion rate of the RS processed alloy (Table 3.5). The  $E_v$  of the ECAP processed Mg-1.8Zn-0.8Ca-0.2Mn alloys did not change after ECAP but the corrosion rate of the ECAP processed alloy was significantly larger (Table 3.5).

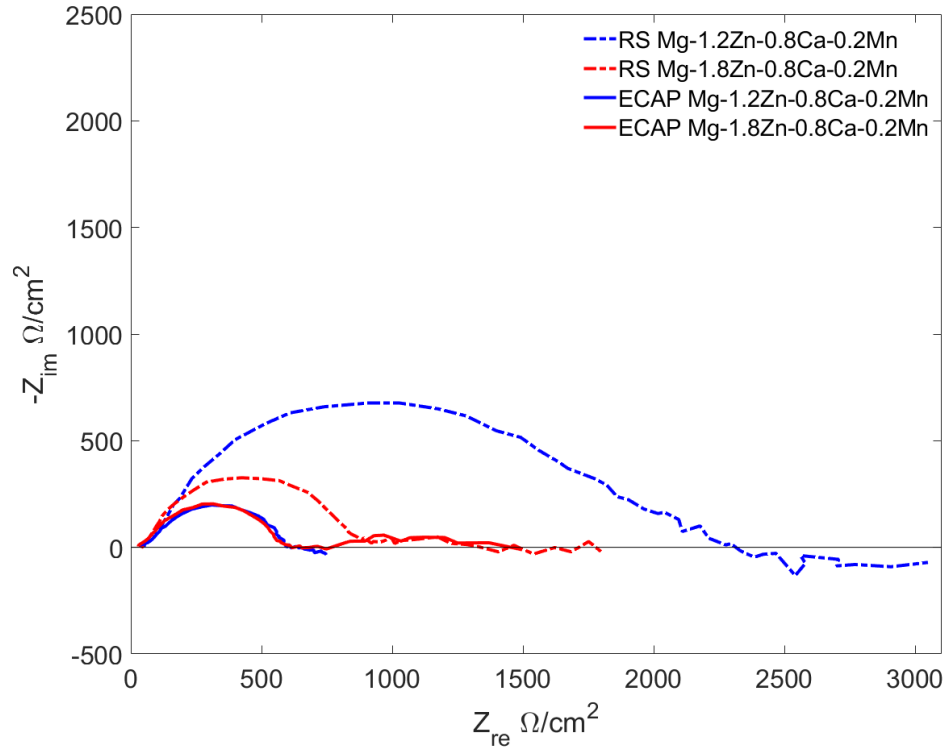
Figure 3.10. Nyquist plot from EIS testing of Mg-1.2Zn-0.8Ca-0.2Mn and Mg-1.8Zn-0.8Ca-0.2Mn RS and ECAP alloys.

The Nyquist plots from EIS testing show larger high frequency (HF) capacitive loops for the RS processed alloys compared to the ECAP processed alloys. Larger diameter HF capacitive loops indicate slower dissolution kinetics during corrosion meaning lower corrosion rates [15]. The ECAP processed alloys exhibited almost identical HF capacitive loops but the RS processed Mg-1.2Zn-0.8Ca-0.2Mn capacitive loop was more than double the size of the RS processed Mg-1.8Zn-0.8Ca-0.2Mn. The larger diameter loops for the RS processed alloys indicate that these alloys experienced slower corrosion kinetics than the ECAP alloys. The curves for the RS and ECAP processed Mg-1.8Zn-0.8Ca-0.2Mn alloys exhibit a slight inductive tail in the low frequency region of the curve on the right end. The slight inductive tails for the Mg-1.8Zn-0.8Ca-0.2Mn alloys suggest the alloy experienced pitting during corrosion or that intermediate phases were adsorbed on the alloy [43].

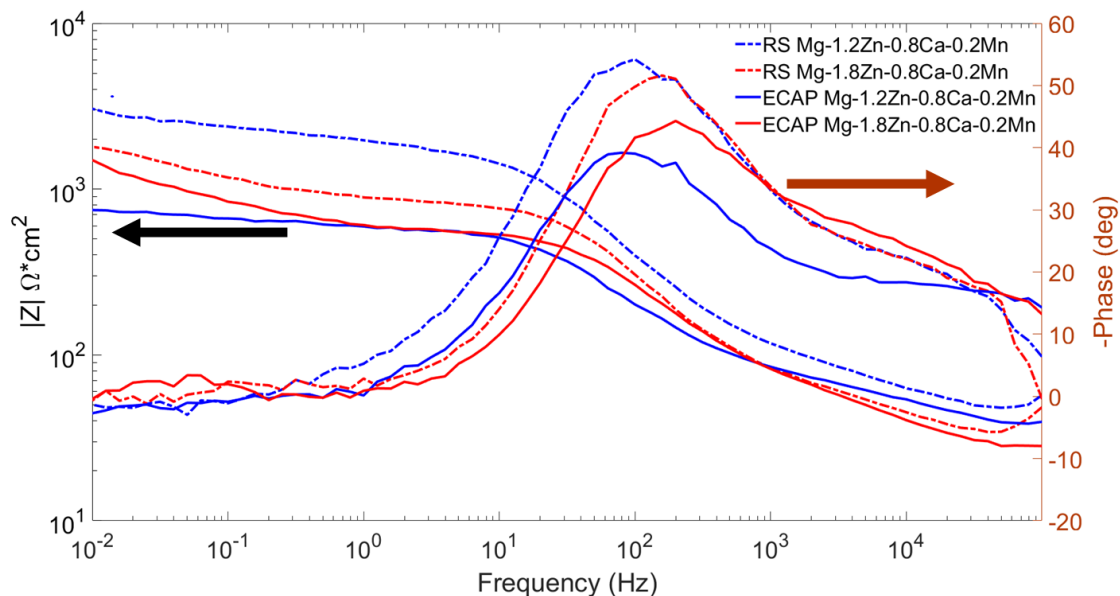
Figure 3.11. Bode plot from EIS testing of Mg-1.2Zn-0.8Ca-0.2Mn and Mg-1.8Zn-0.8Ca-0.2Mn RS and ECAP alloys.

Examining the Bode plots, the RS processed Mg-1.2Zn-0.8Ca-0.2Mn alloy had the highest impedance,  $|Z|$ , ( $\sim 2200 \Omega/\text{cm}^2$ ) of the four samples tested over all frequencies. The ECAP processed Mg-1.2Zn-0.8Ca-0.2Mn alloy had the lowest impedance ( $\sim 800 \Omega/\text{cm}^2$ ) of the four alloys at low frequencies and then at high frequencies it possessed an impedance higher than the Mg-1.8Zn-0.8Ca-0.2Mn processed alloys. The Mg-1.8Zn-0.8Ca-0.2Mn alloys had an impedance of about  $1500 \Omega/\text{cm}^2$  at low frequencies and then the impedance dropped farther than the ECAP Mg-1.2Zn-0.8Ca-0.2Mn alloy at high frequencies. Examining the phase shift curves, the peaks of the RS processed alloys peaked higher ( $\sim 55^\circ$ ) than the ECAP processed alloys ( $40^\circ$ ). The phase shift between the Mg-1.2Zn-0.8Ca-0.2Mn and Mg-1.8Zn-0.8Ca-0.2Mn alloys demonstrates a lower susceptibility to corrosion.

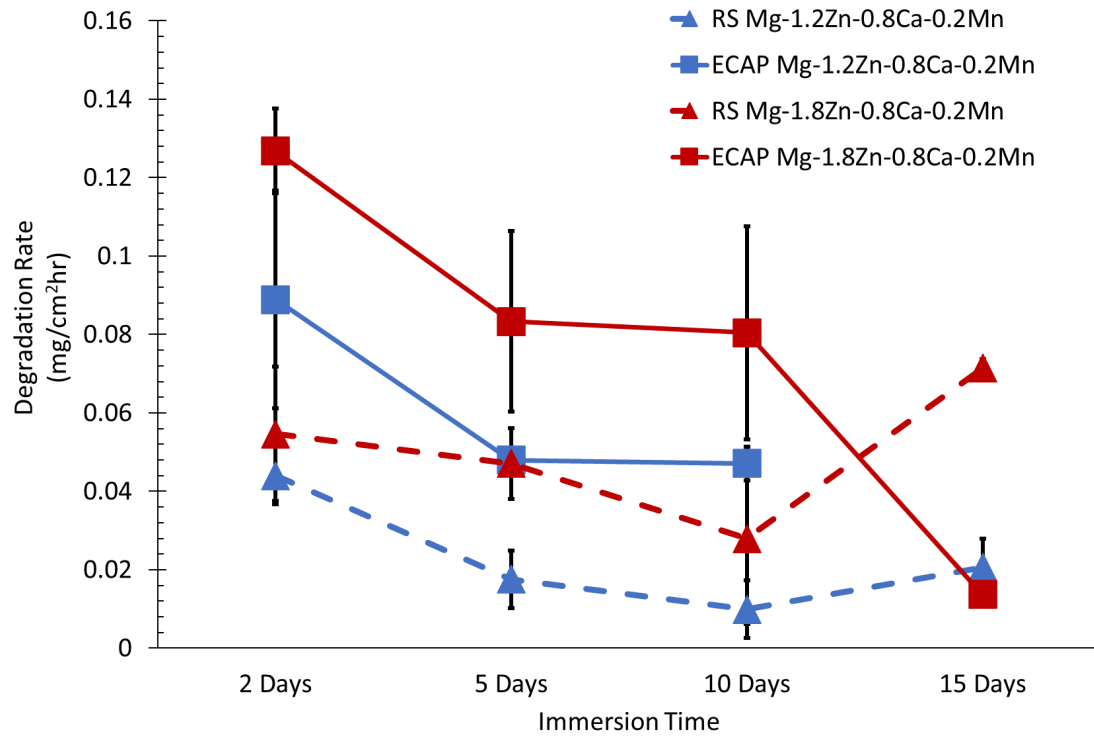
Figure 3.12. Weight loss of Mg-1.2Zn-0.8Ca-0.2Mn (blue) and Mg-1.8Zn-0.8Ca-0.2Mn (red) RS (triangles) and RS+ECAP (squares) alloys.

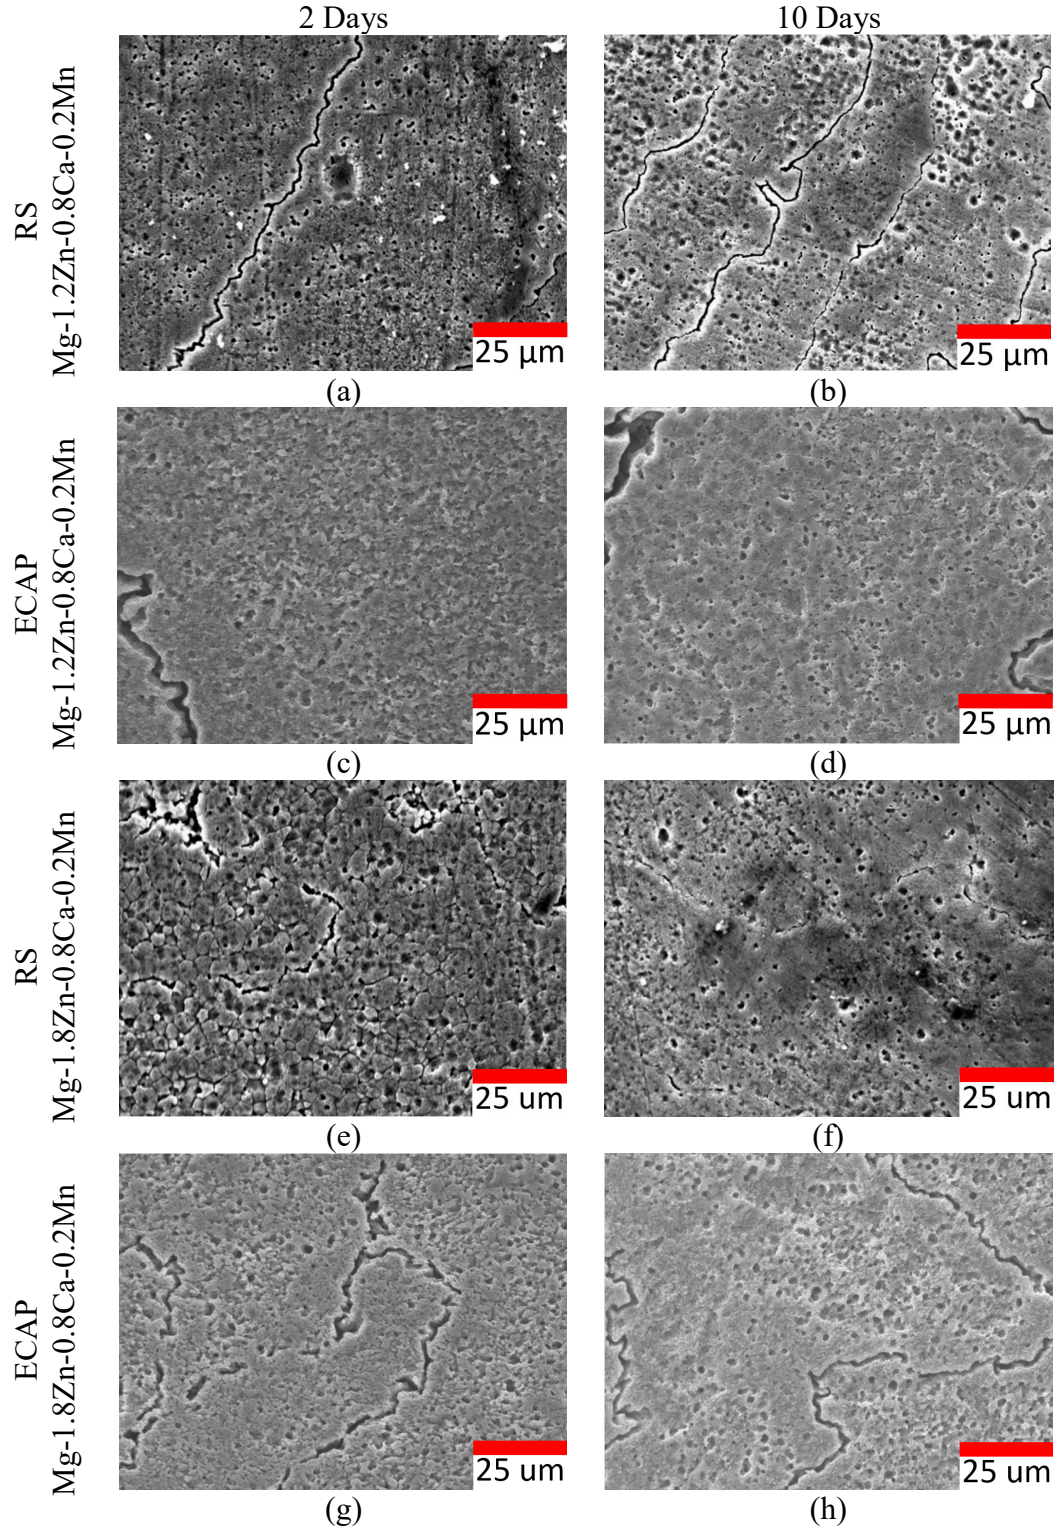
Figure 3.13. Surface morphology of cleaned samples immersed for 2 and 10 days of RS and ECAP Mg-1.5Zn-1.2Ca-0.4Mn and Mg-2.2Zn-1.2Ca-0.4Mn alloys.

The size and amount of pits were larger on the surface of the ECAP processed alloys for 2 days and 10 days compared to the RS processed alloys immersed for the same duration (Figure 3.13). This trend in the condition of the corrosion surfaces between the ECAP and RS processed alloys correlates to the higher degradation rates calculated from the mass loss experiments. The surfaces of the RS and ECAP processed Mg-1.8Zn-0.8Ca-0.2Mn alloys exhibit larger pits and more severely corroded features compared to the Mg-1.2Zn-0.8Ca-0.2Mn alloys of the same processing route. In the RS processed alloy images, there appears to be deep crevices along the surface that look like the cracks in the ECAP alloys.

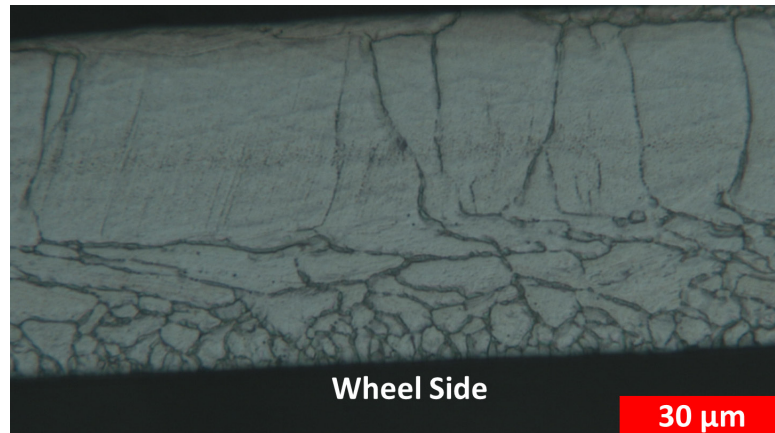
Figure 4.1. Melt spun ribbon of Mg-1.8Zn-0.8Ca-0.2Mn showing columnar grain structure forming above the small grains formed along the wheel surface.

Grain size analysis through optical microscopy provided an understanding of the grain size and morphology in the RS and ECAP processed alloys. The equiaxed, fine grains present after the hot extrusion consolidated the melt spun ribbons indicates that dynamic recrystallization (DRX) took place. DRX in the RS processed alloys was promoted by the high number of solute atoms and fine precipitates within the magnesium matrix acting as heterogeneous nucleation sites for grain recrystallization [15]. The DRX'ed grain structure is markedly different from the initial melt spun ribbon grain structure. The ribbon grain structure has fine grains forming along the surface in contact with the copper wheel and then columnar-like grains formed normal to the surface of the copper wheel (Figure 4.1).

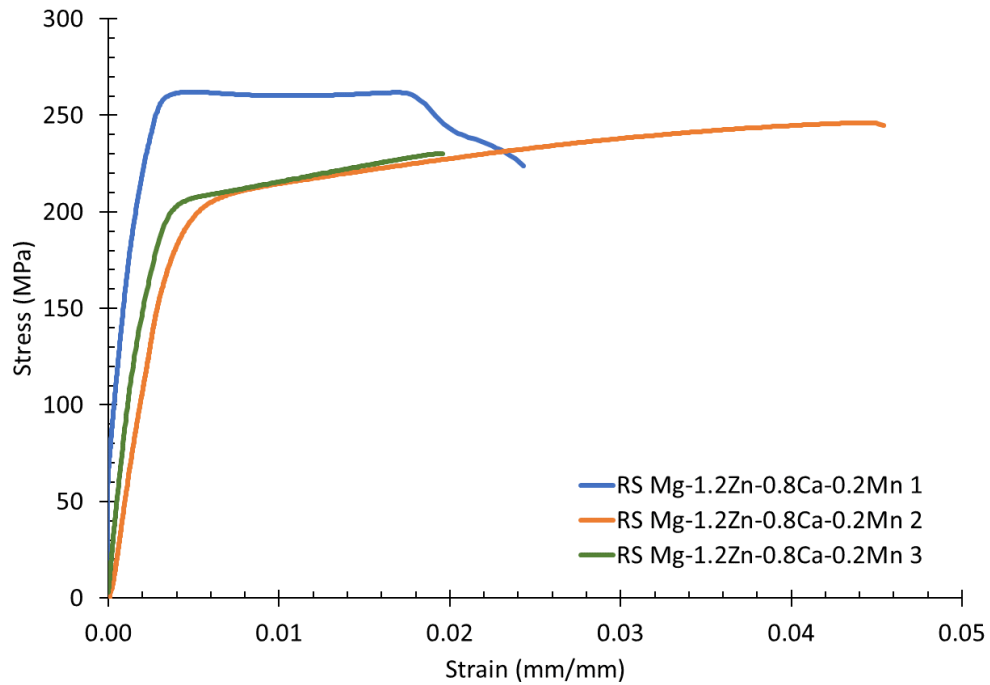
Figure 8.1. Tensile curves of the three RS Mg-1.2Zn-0.8Ca-0.2Mn samples.

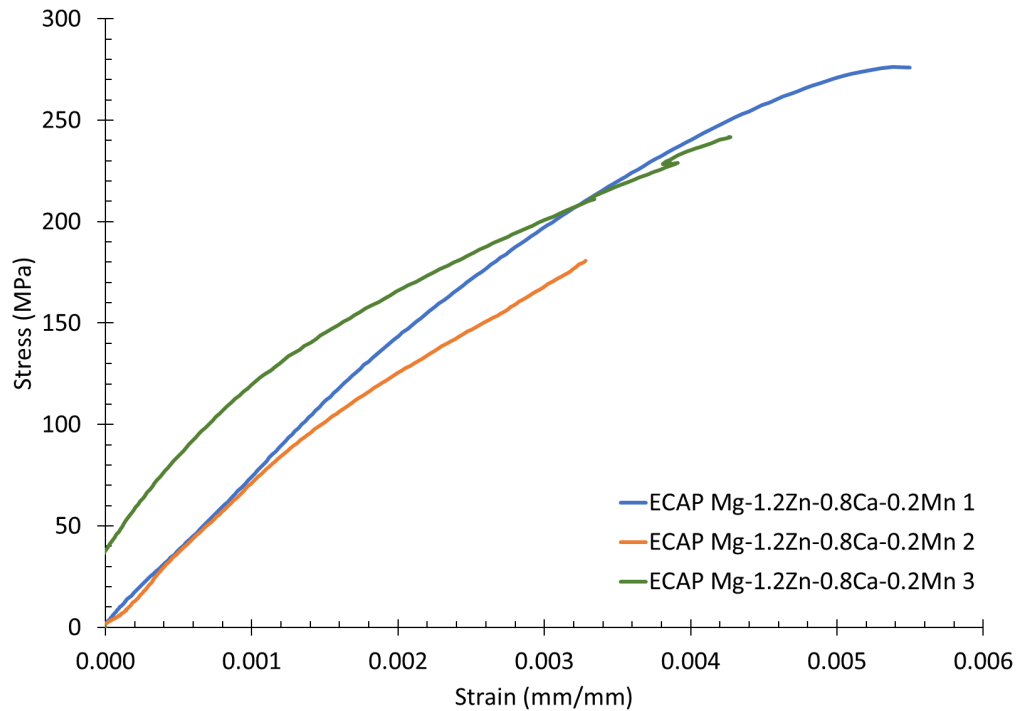
Figure 8.2. Tensile curves of the three ECAP Mg-1.2Zn-0.8Ca-0.2Mn samples.

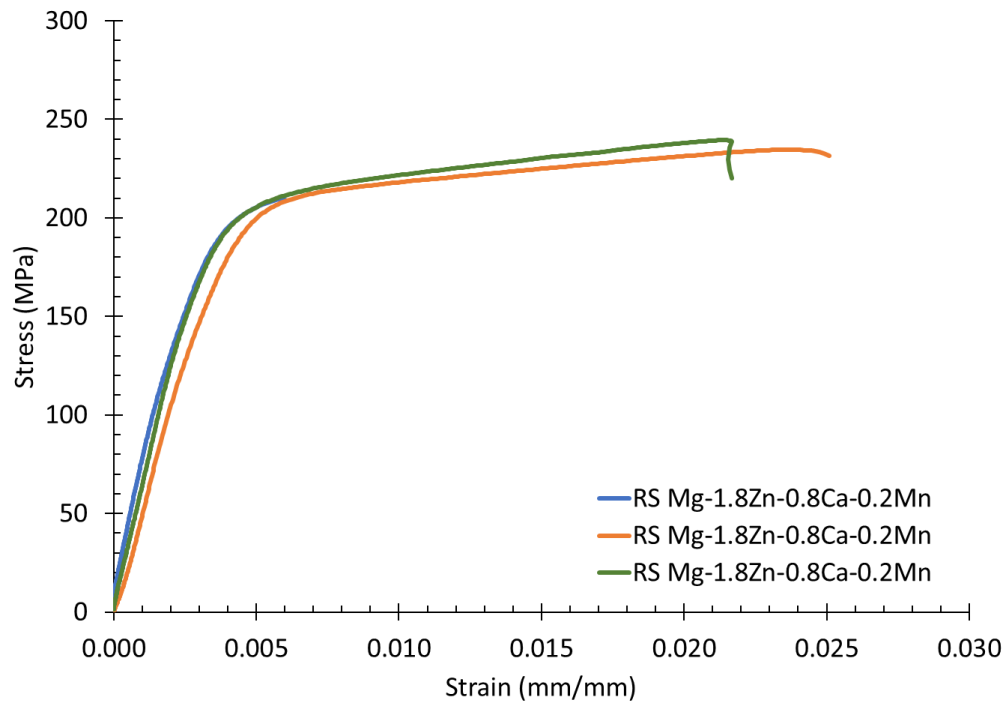
Figure 8.3. Tensile curves for the three RS Mg-1.8Zn-0.8Ca-0.2Mn samples tested.

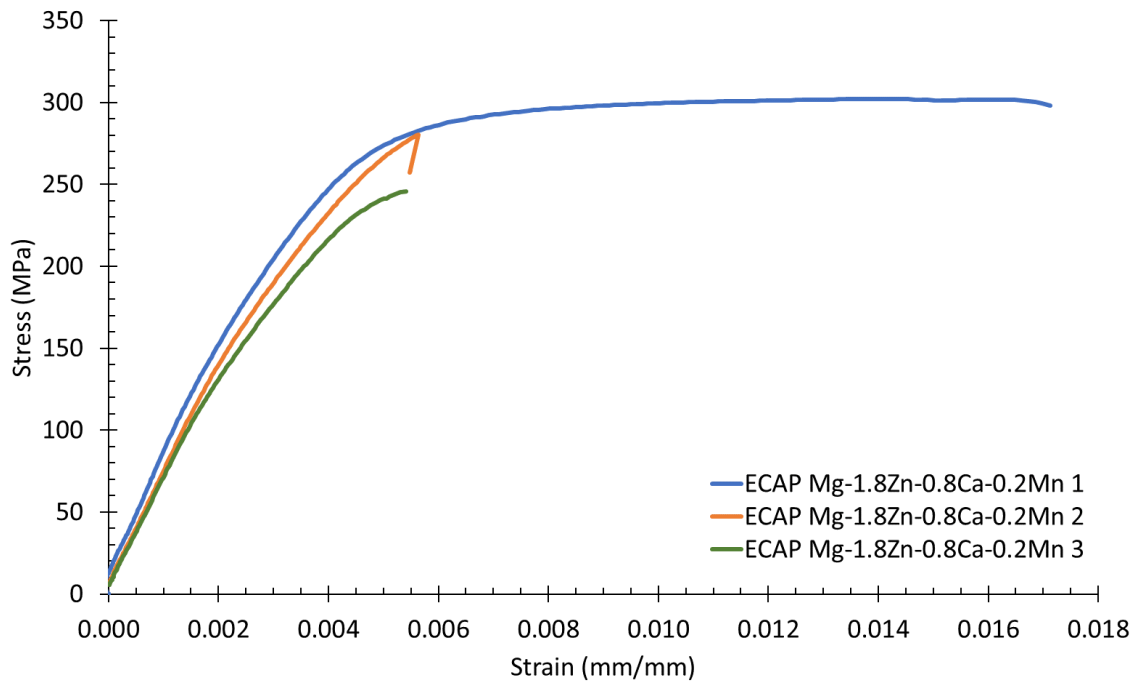
Figure 8.4. Tensile curves for the three ECAP Mg-1.8Zn-0.8Ca-0.2Mn samples tested.

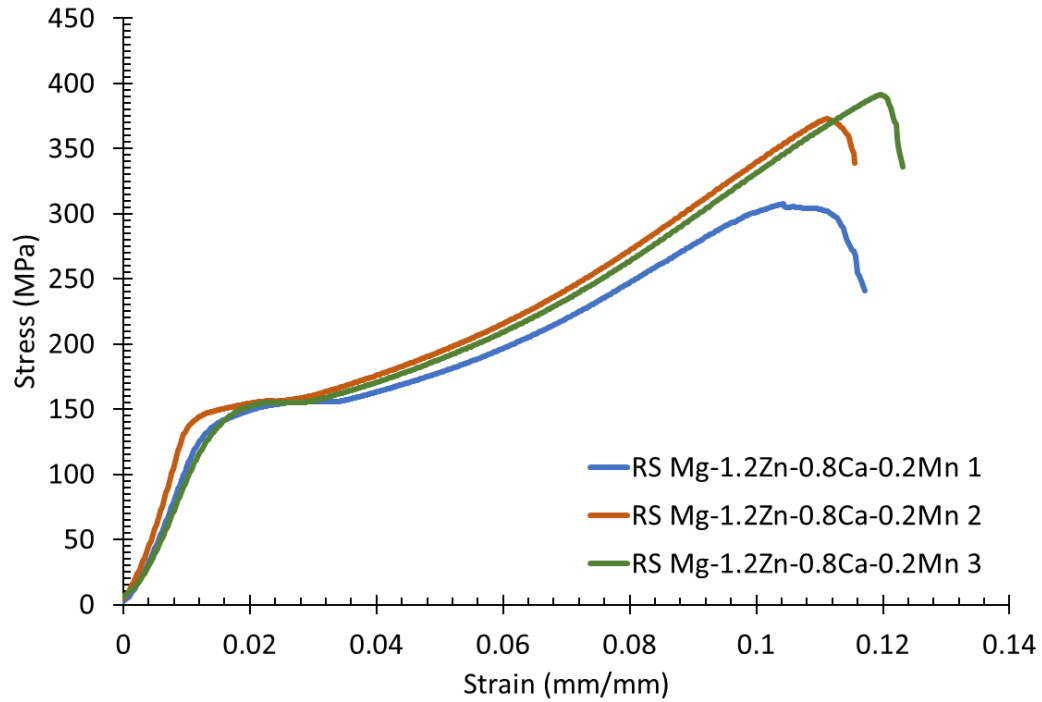
Figure 8.5. Compression stress-strain curves of the three RS Mg-1.2Zn-0.8Ca-0.2Mn samples tested.
