## **Exploring Rapid Solidification and Equal Channel Angular Pressing in the Fabrication of Mg-Based Alloys for Medical Applications**

EXPLORING RAPID SOLIDIFICATION AND EQUAL CHANNEL ANGULAR  
PRESSING IN THE FABRICATION OF MG-BASED ALLOYS FOR  
MEDICAL APPLICATIONS

A THESIS

In Materials Science and Engineering

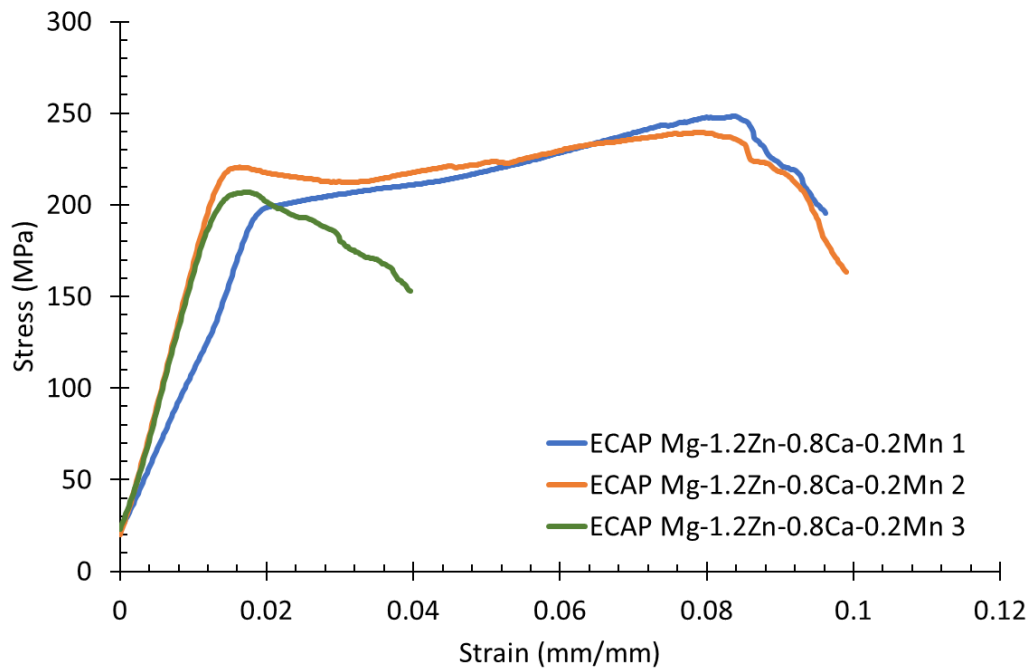
Figure 8.6. Compression stress-strain curves of the three ECAP Mg-1.2Zn-0.8Ca-0.2Mn samples tested.

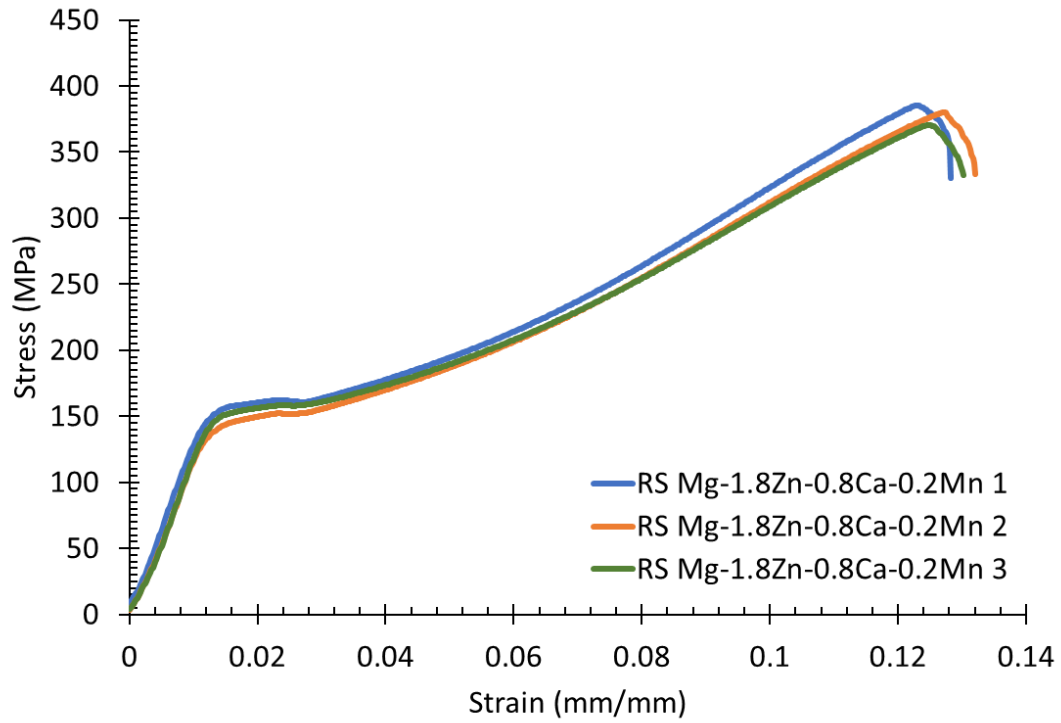
Figure 8.7. Compression stress-strain curves of the three RS Mg-1.8Zn-0.8Ca-0.2Mn samples tested.

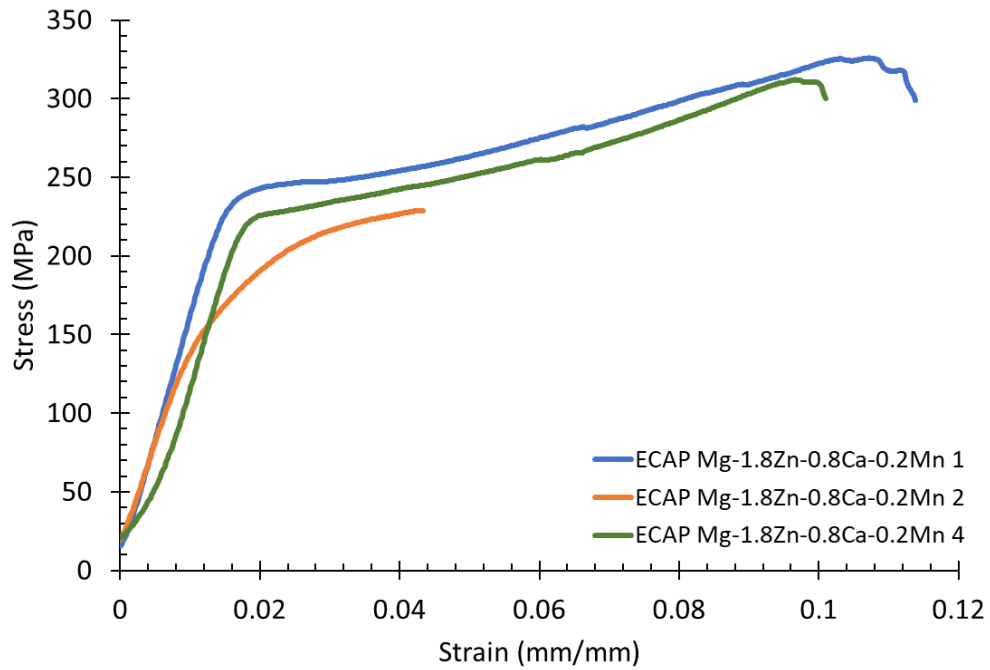
Figure 8.8. Compression stress-strain curves of the three ECAP Mg-1.8Zn-0.8Ca-0.2Mn samples tested.

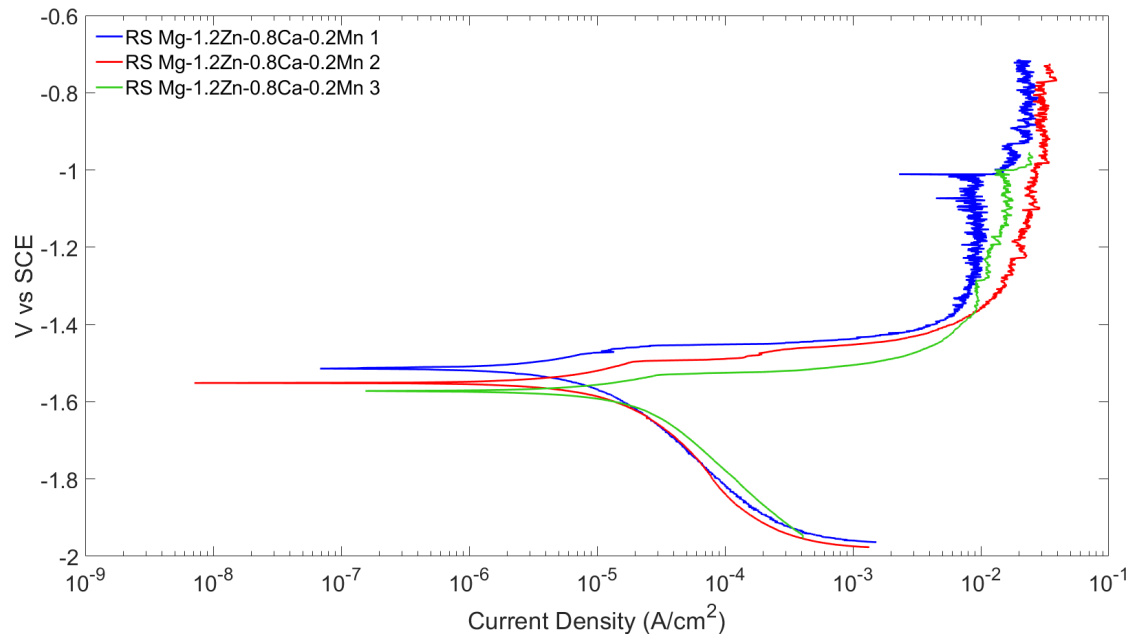
Figure 9.1. Potentiodynamic curves for three RS Mg-1.2Zn-0.8Ca-0.2Mn.

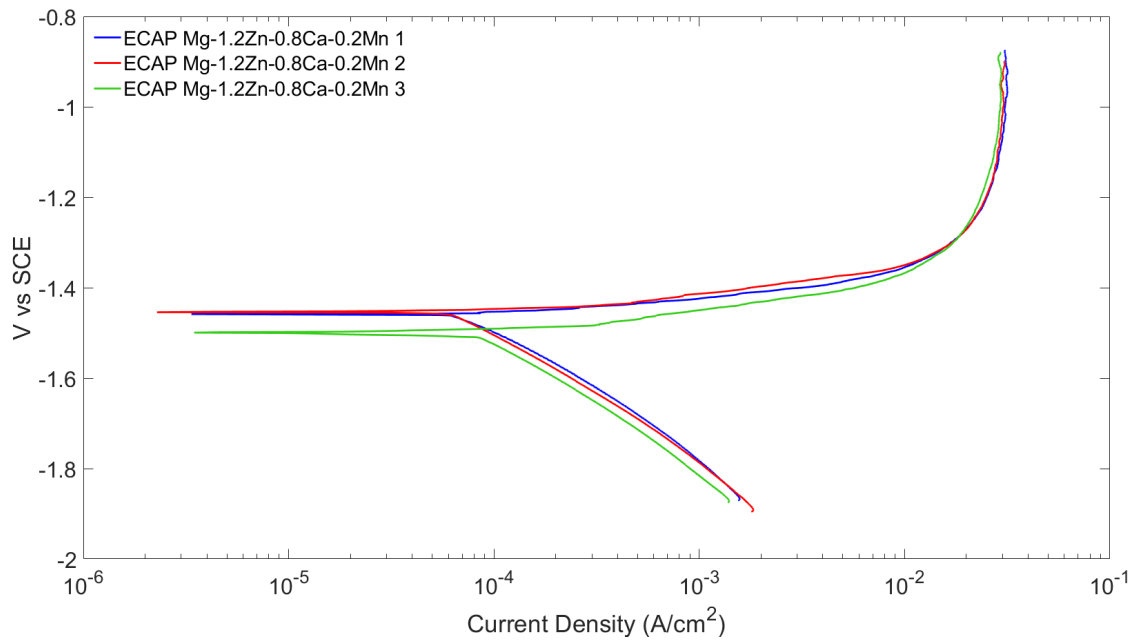
Figure 9.2. Potentiodynamic curves for three ECAP Mg-1.2Zn-0.8Ca-0.2Mn.

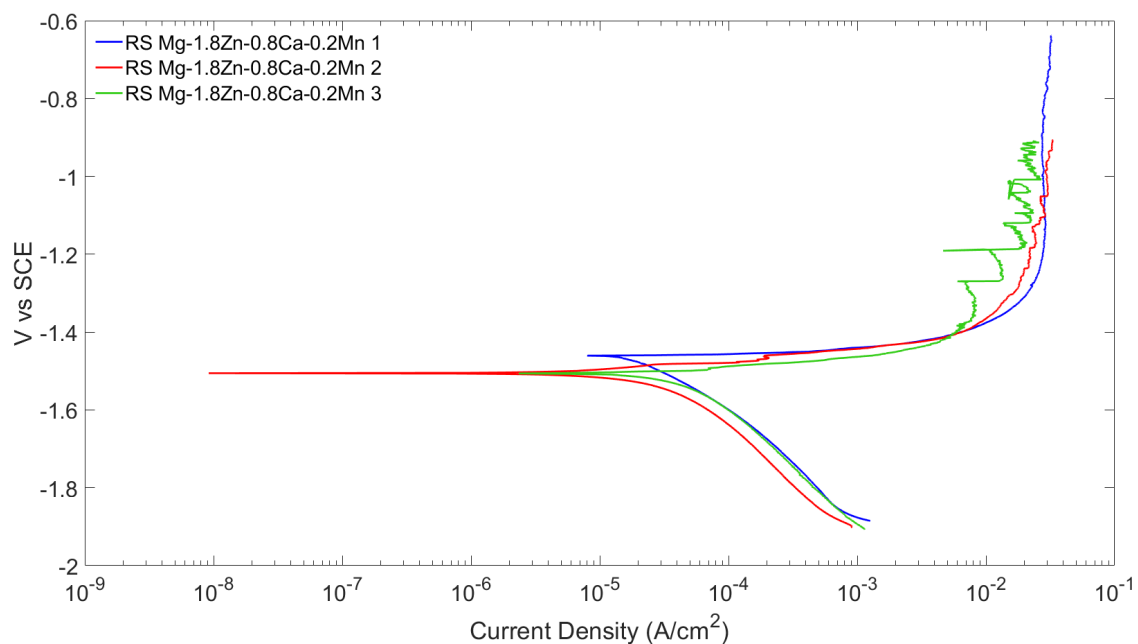
Figure 9.3. Potentiodynamic curves of the three RS Mg-1.8Zn-0.8Ca-0.2Mn alloys tested.

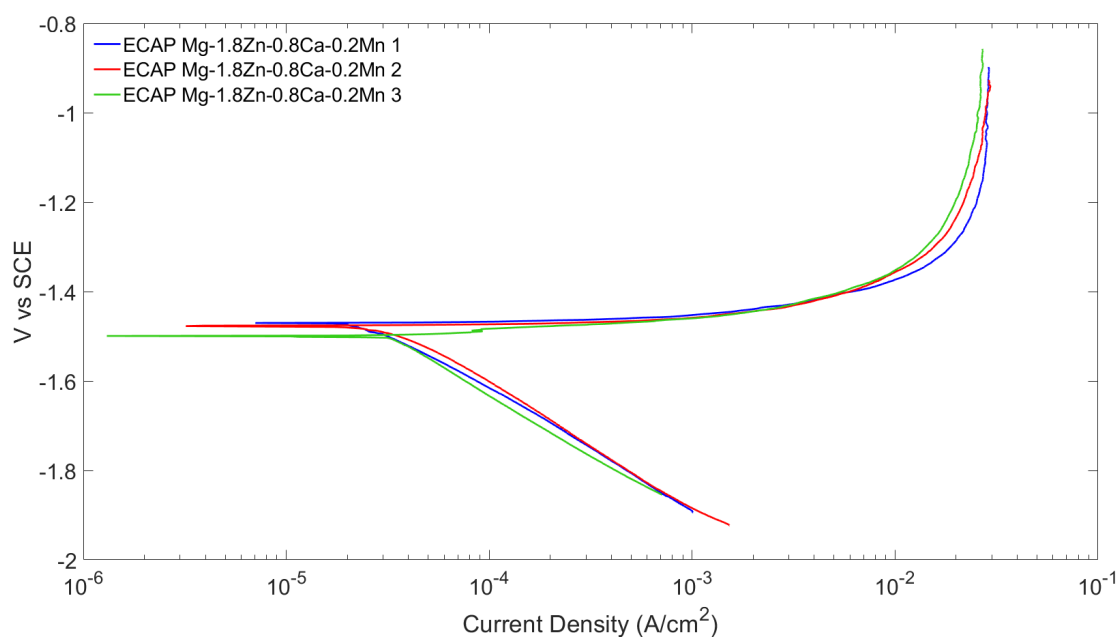
Figure 9.4. Potentiodynamic curves of the three ECAP Mg-1.8Zn-0.8Ca-0.2Mn alloys tested.

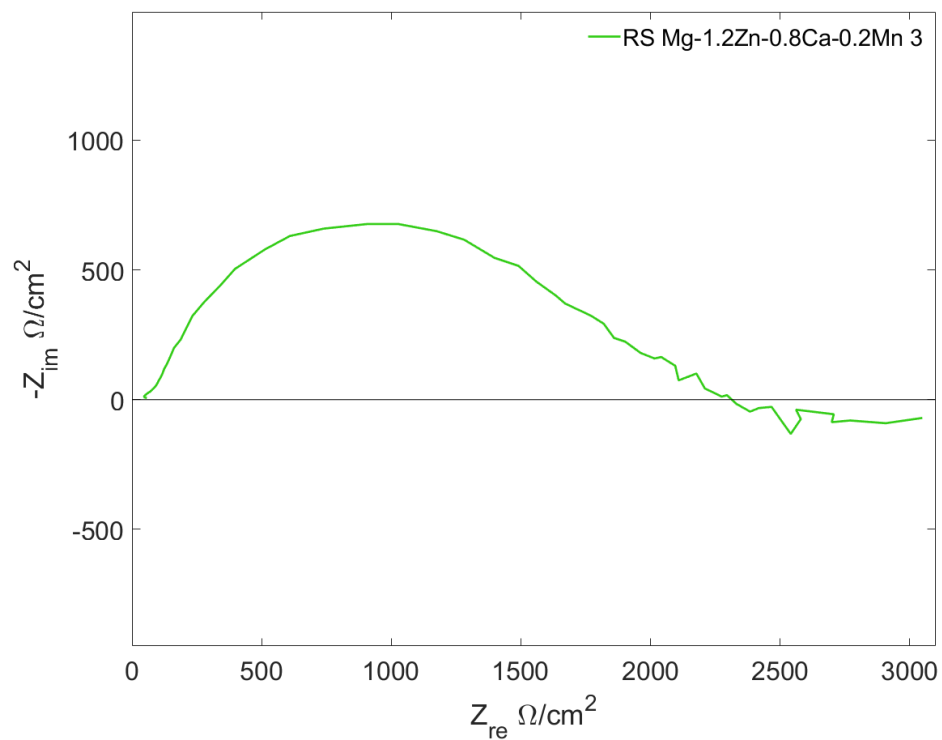
Figure 9.5. Nyquist Plot for RS Mg-1.2Zn-0.8Ca-0.2Mn.

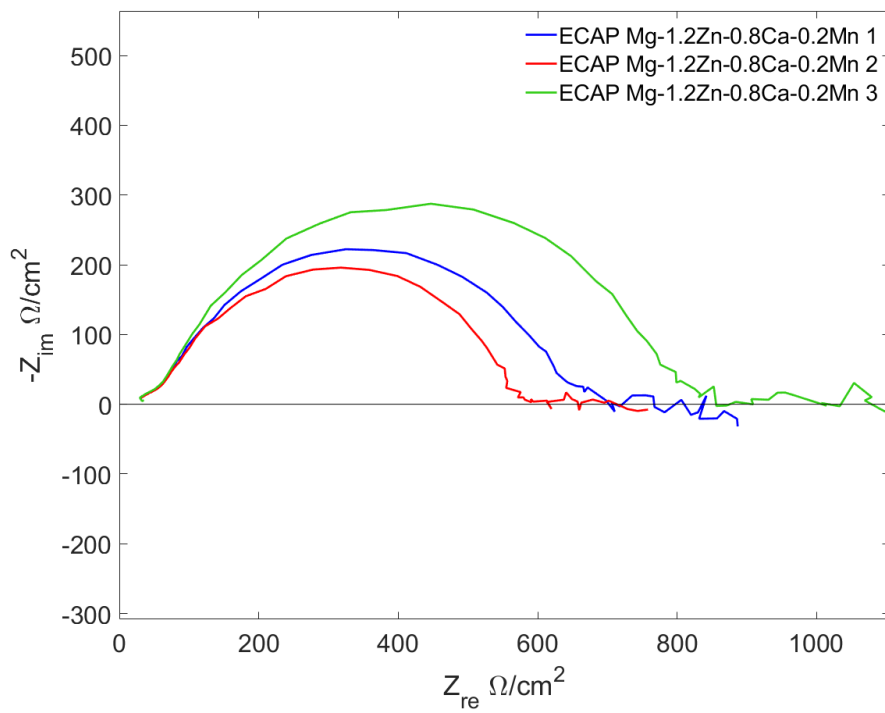
Figure 9.6. Nyquist plots for ECAP Mg-1.2Zn-0.8Ca-0.2Mn.

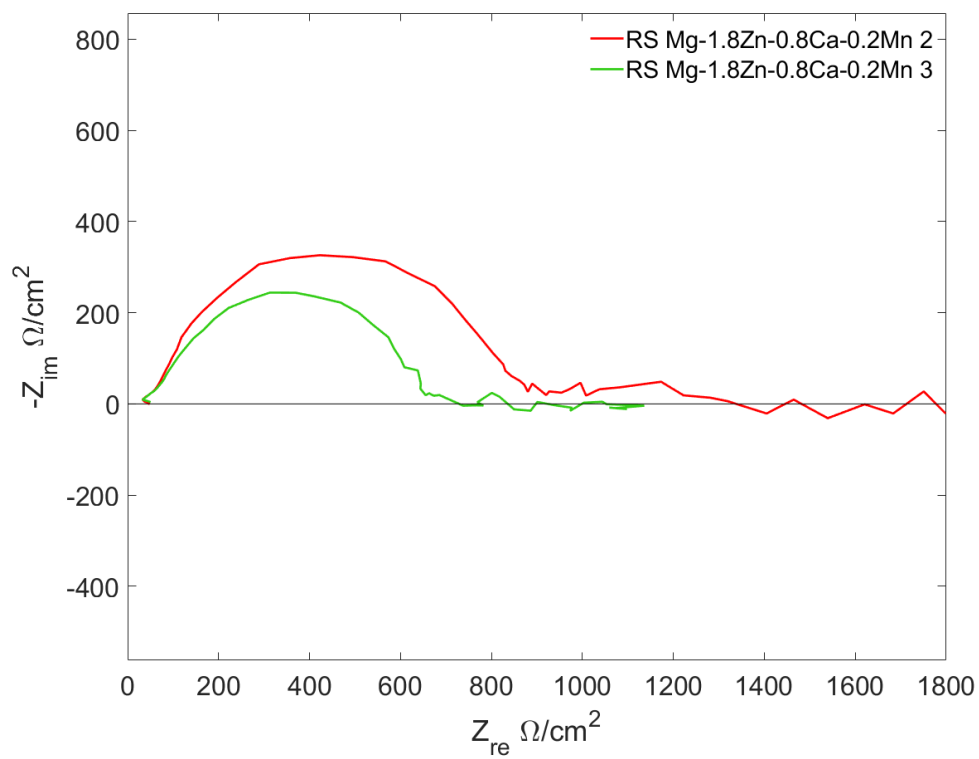
Figure 9.7. Nyquist plots for RS Mg-1.8Zn-0.8Ca-0.2Mn.

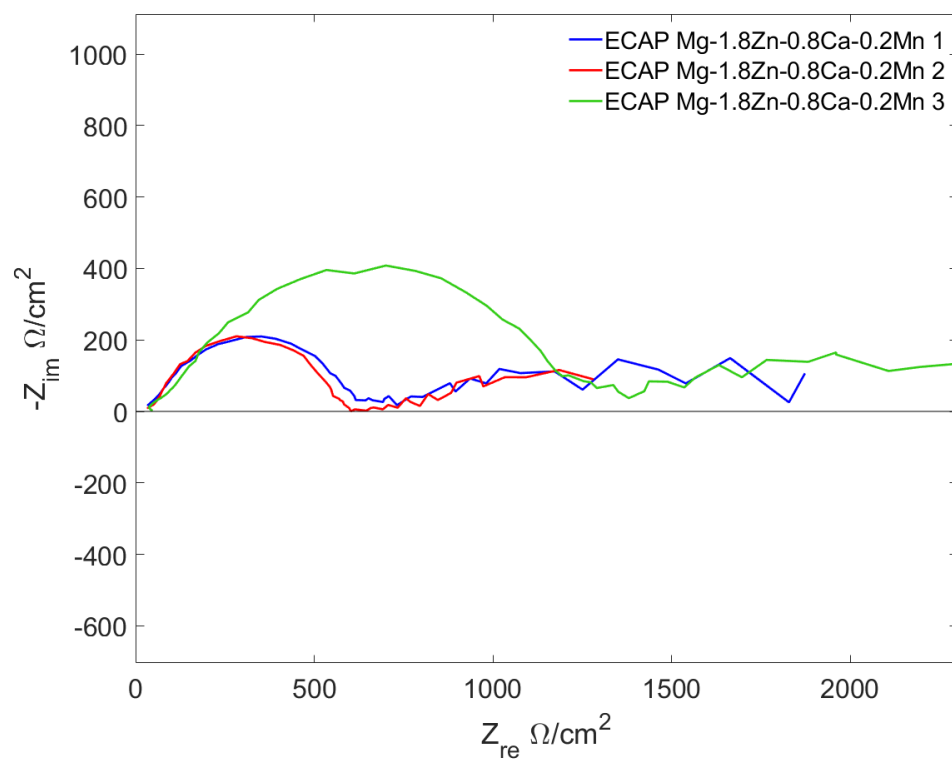
Figure 9.8. Nyquist plots for ECAP Mg-1.8Zn-0.8Ca-0.2Mn.

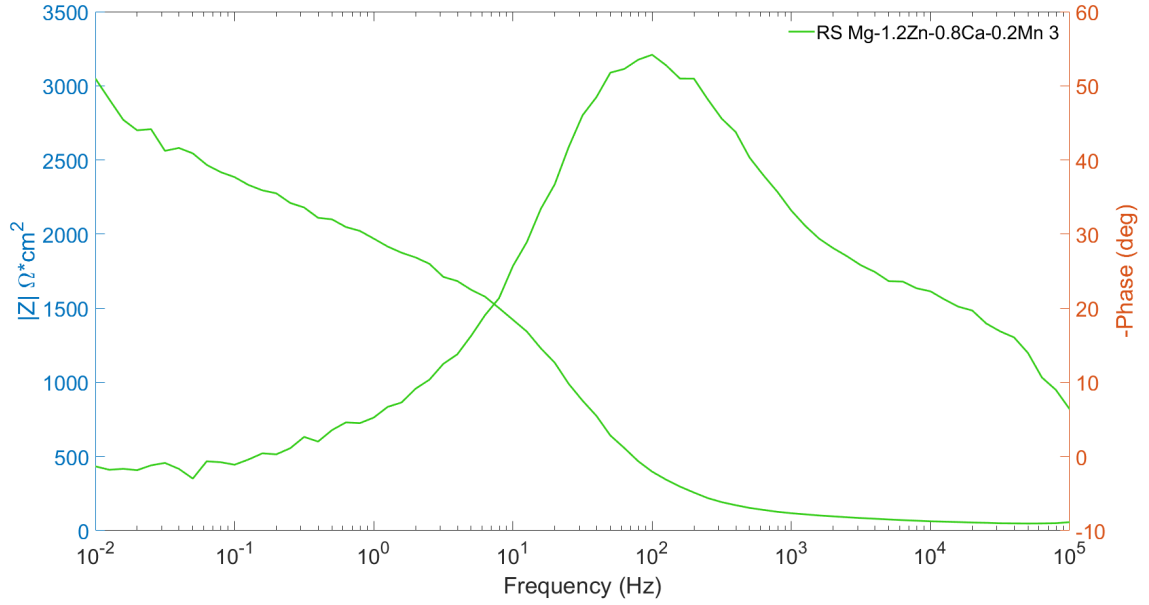
Figure 9.9. Bode plot of RS Mg-1.2Zn-0.8Ca-0.2Mn.

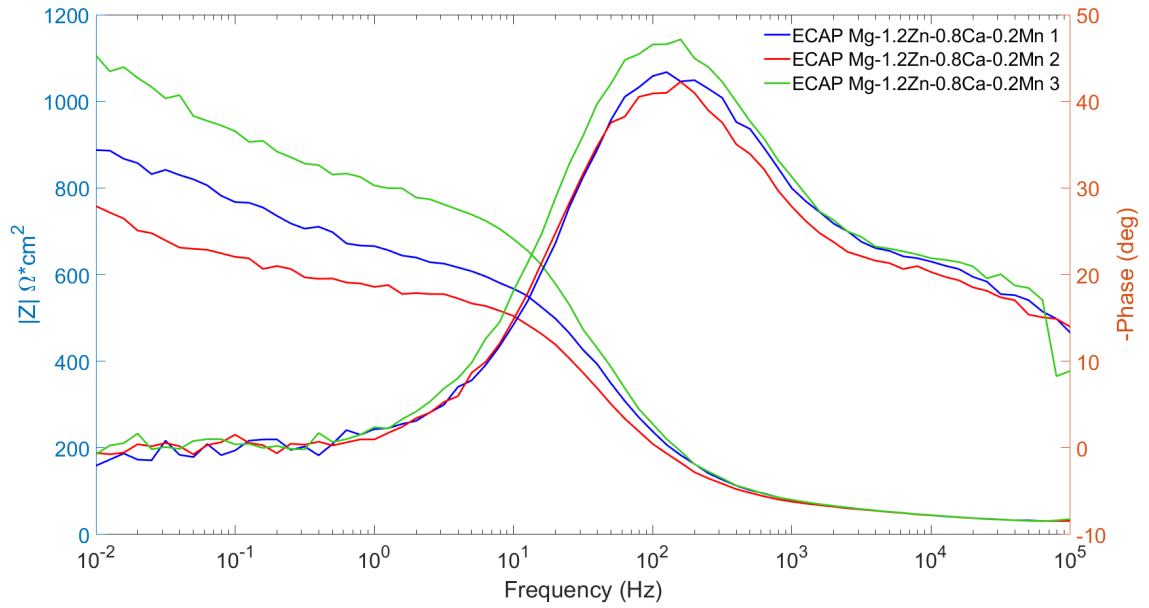
Figure 9.10. Bode plot of ECAP Mg-1.2Zn-0.8Ca-0.2Mn

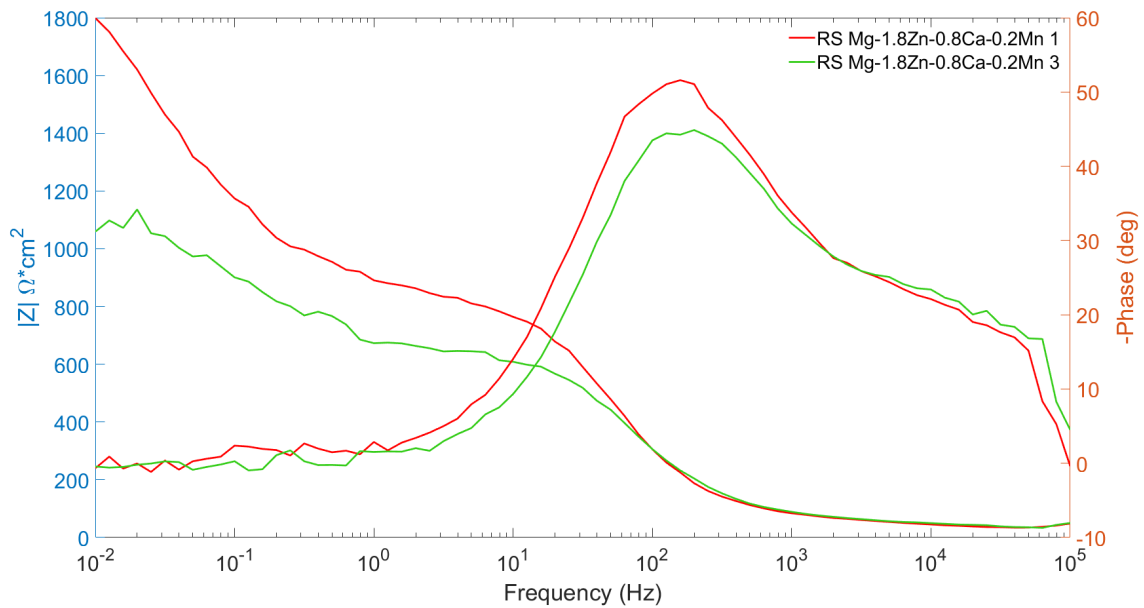
Figure 9.11. Bode plots of RS Mg-1.8Zn-0.8Ca-0.2Mn.

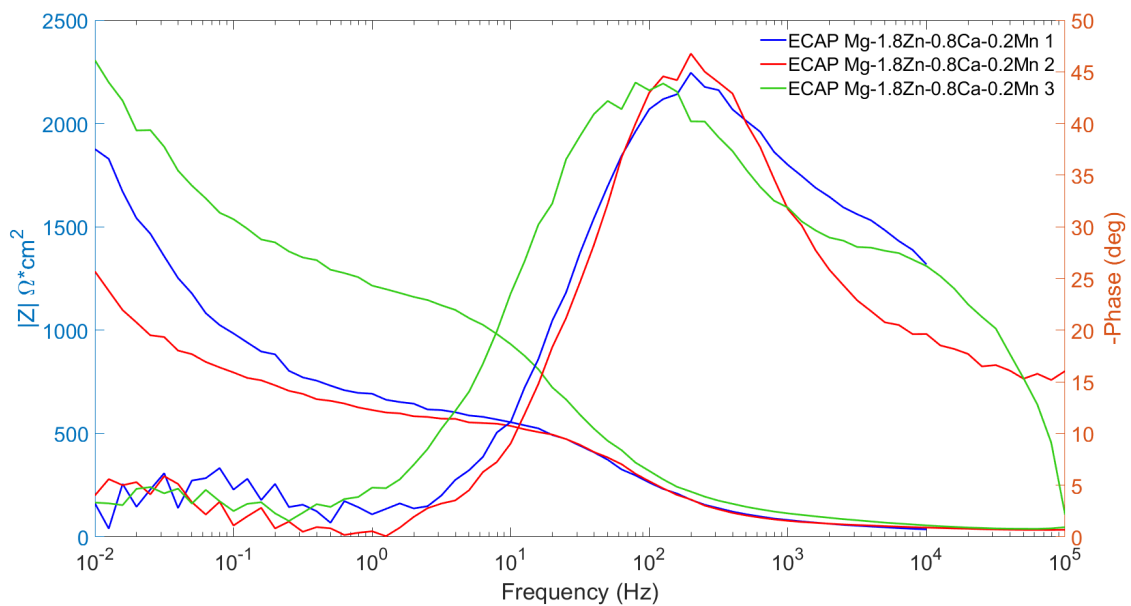
Figure 9.12. Bode plots of ECAP Mg-1.8Zn-0.8Ca-0.2Mn.
