HYDROLOGIC INVESTIGATION OF THE CHIWAUKEE PRAIRIE (WISCONSIN) RESTORATION

A REPORT

In Geology

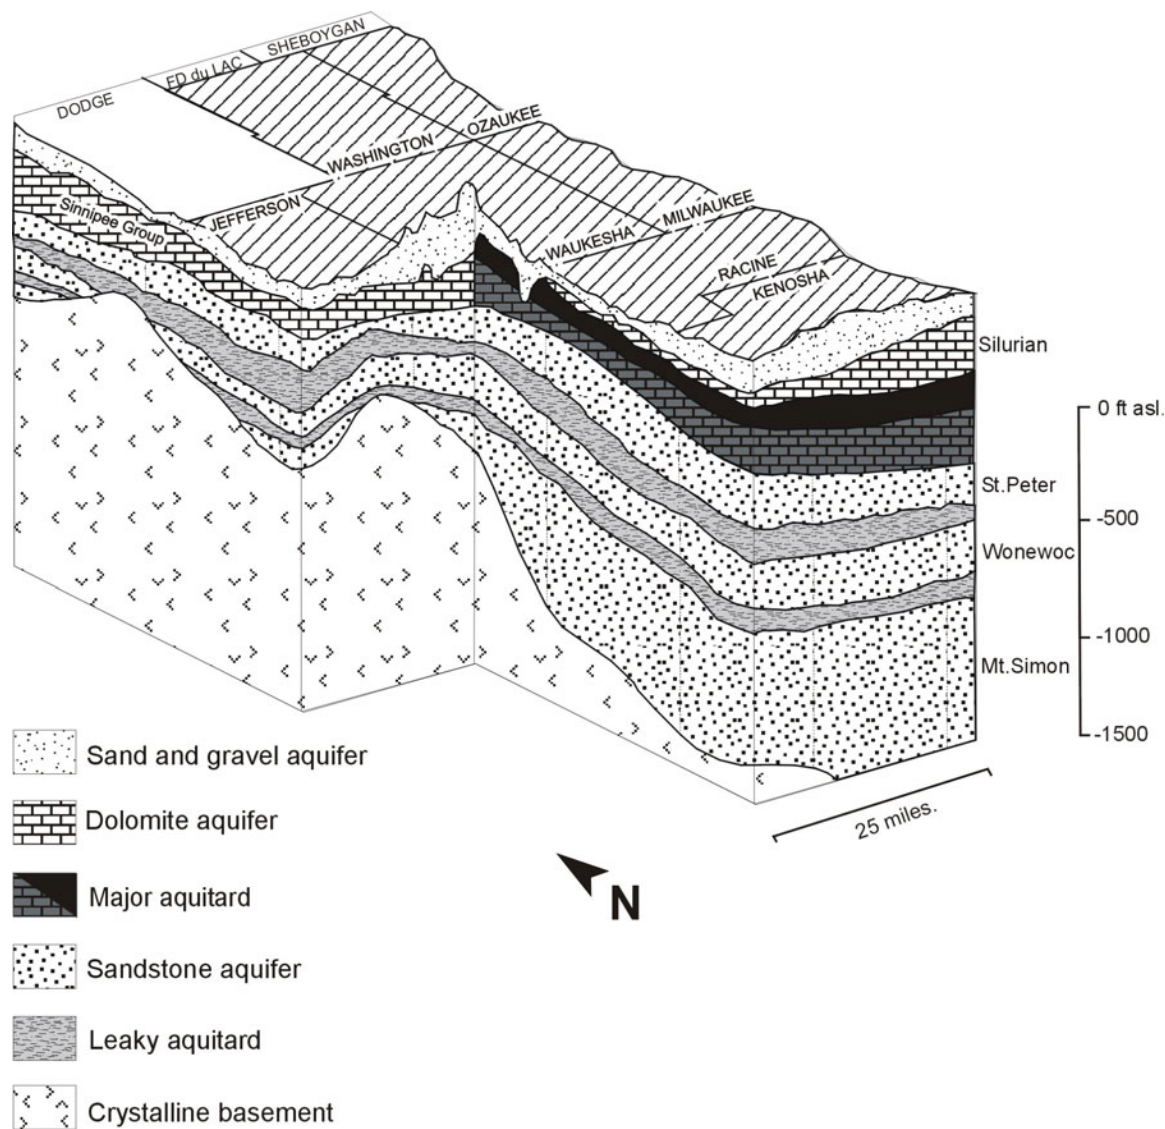
Figure 2.3 The major stratigraphy of the southeastern from Wisconsin from Feinstein (2004).

The very base of the geologic column is Precambrian igneous and metamorphic bedrock (Feinstein, Eaton, Hart, Krohelski, & Bradbury, 2004). This bedrock is overlain by layers of several successions of sandstones, siltstones and carbonates (Figure 2.3) (Feinstein et al., 2004). This is all topped by Silurian dolomite. At the study site the top of this dolomite is found 70 to 150 feet below the ground surface according to the more than 200 well logs within and surrounding the study area (Wisconsin Department of Natural Resources). Above this bedrock there are layers of quaternary gravels, sands, clays, and of course glacial till also known as “hardpan”. The following is an example from one of the drill logs: sand, gravel, stony clay, gray clay, hard pan, gray clay, gravel, limestone. While interesting, deeper layers beyond the first few layers are beyond the scope of this research.

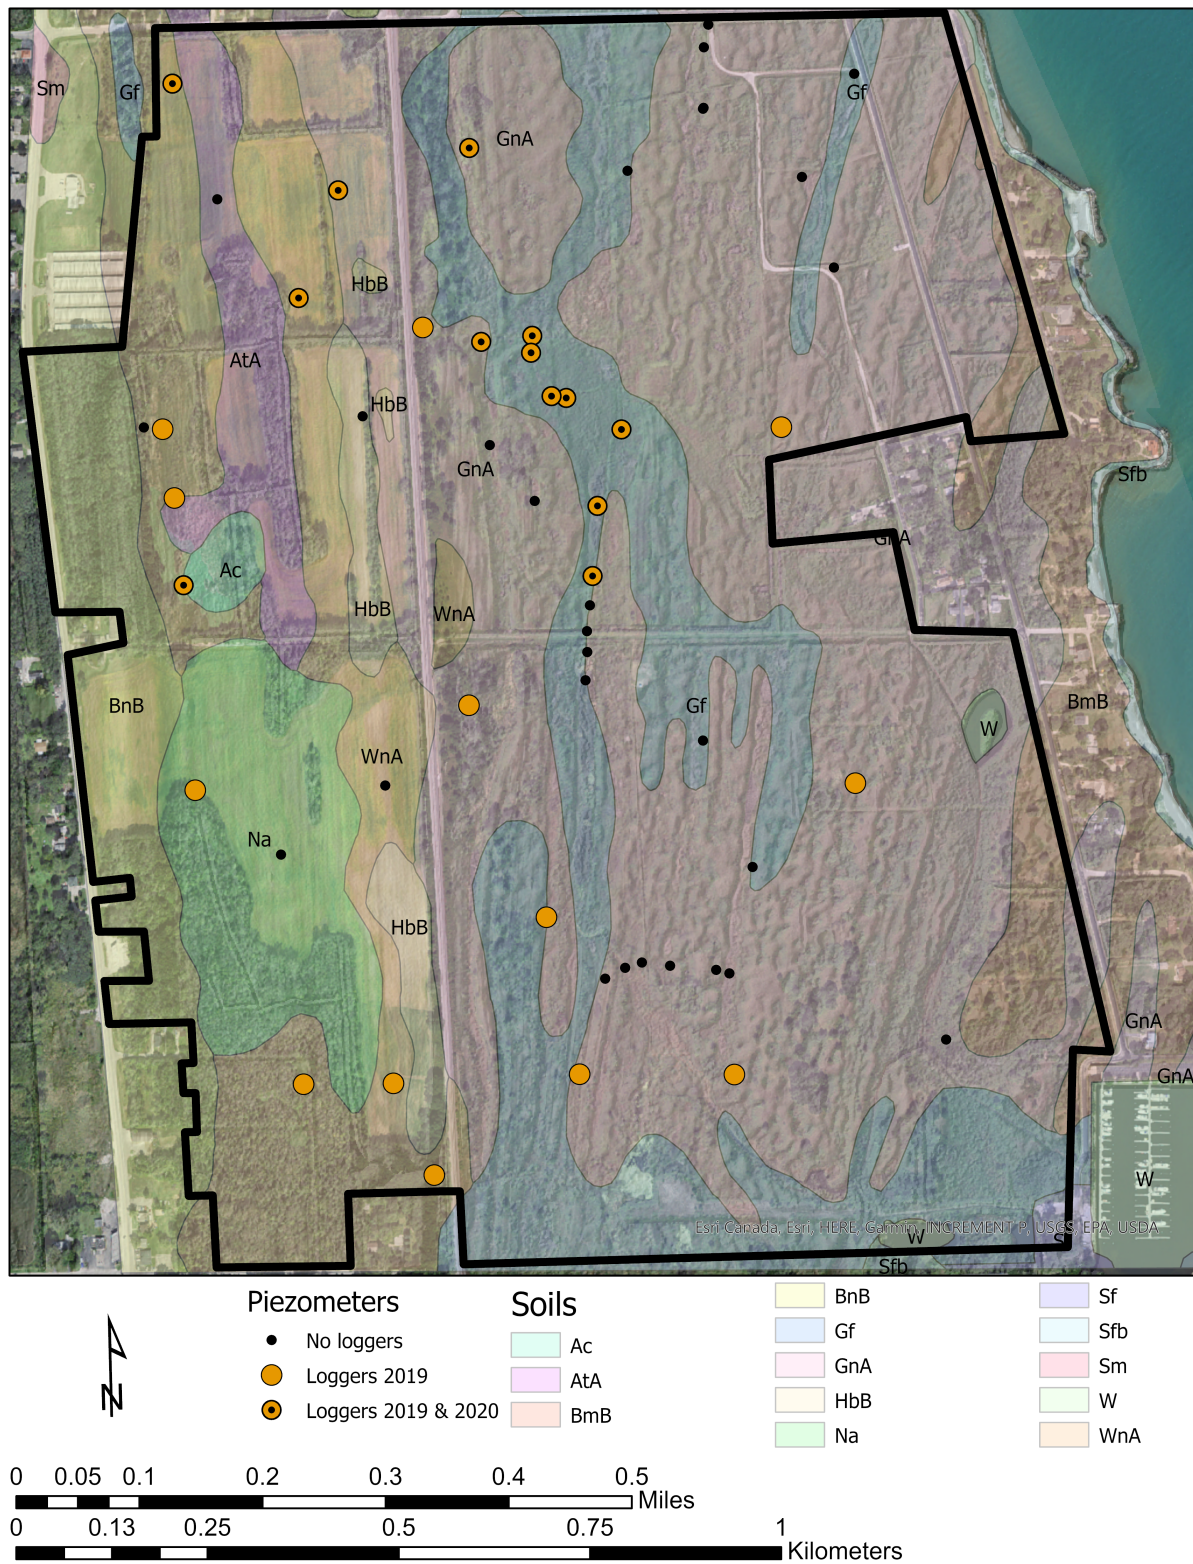
Figure 2.4 Map of the study site showing the piezometer locations and the soils according to the United States Department of Agriculture Soil Survey Geographic Database

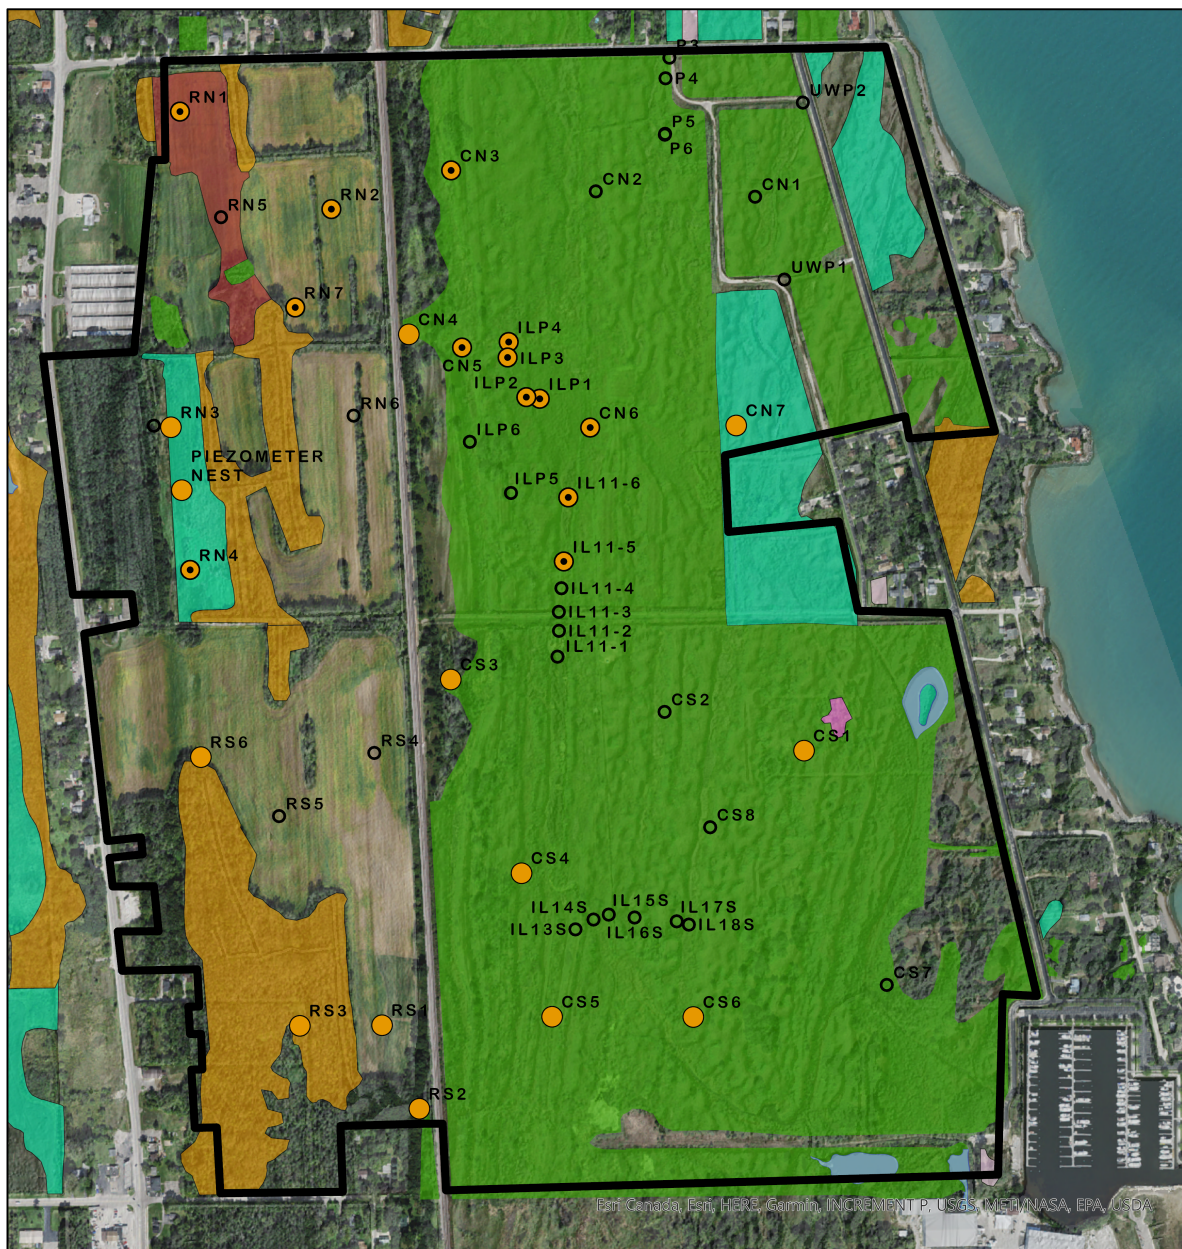
Figure 2.5 Map of the study site showing the piezometer locations and the wetlands types according to the South Eastern Wisconsin Regional Planning Commission (SEWRPC).

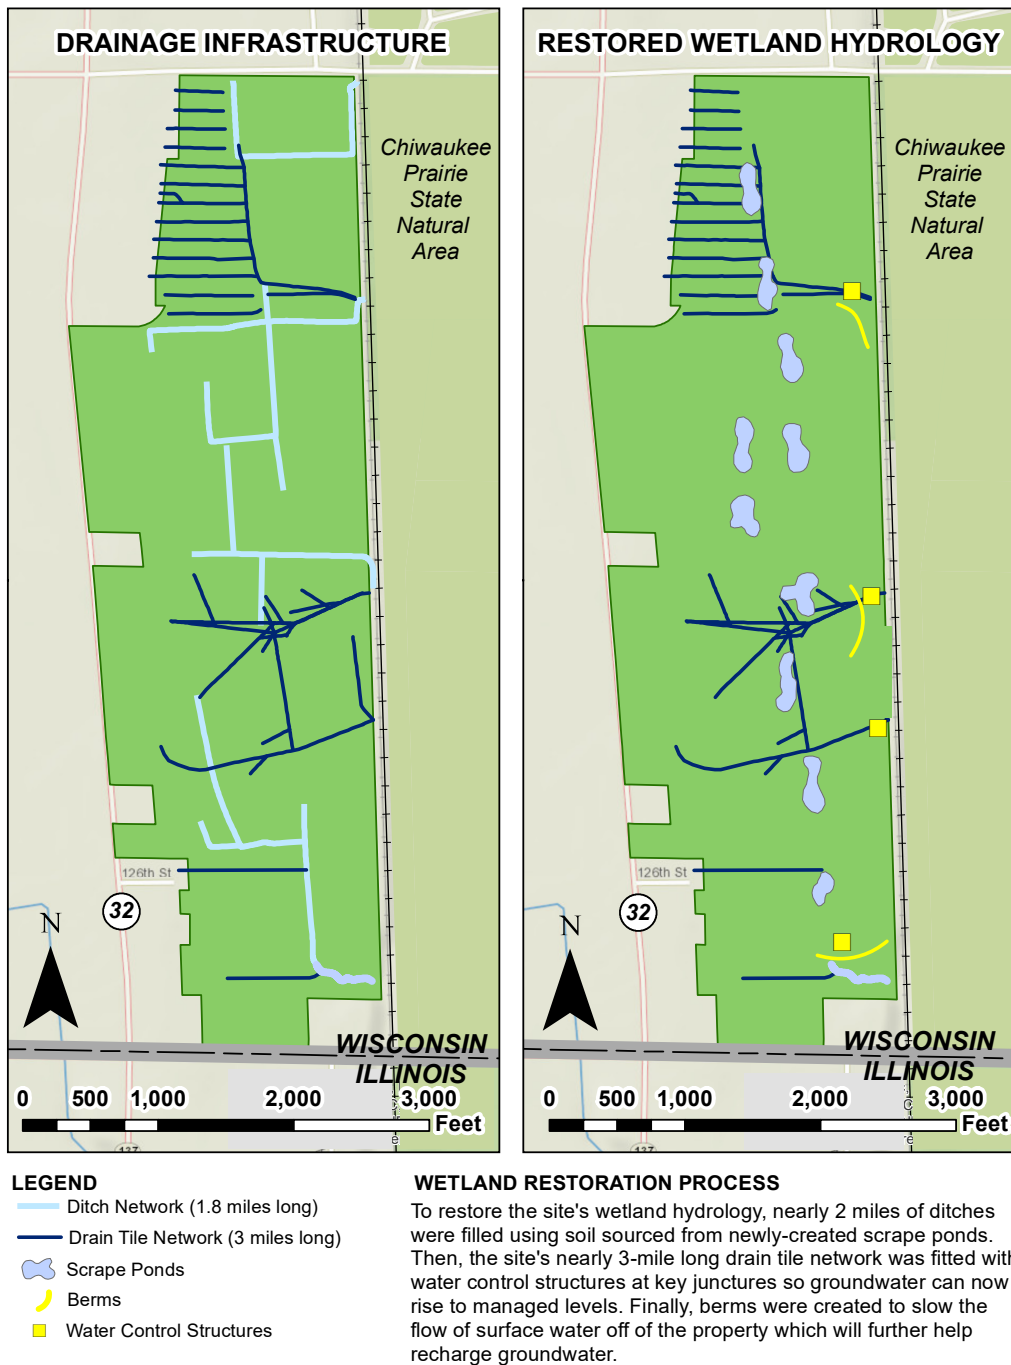
Figure 2.7 Map of the TNC on the left showing location of pre-restoration ditches and drain tile and the right post-restoration plans.

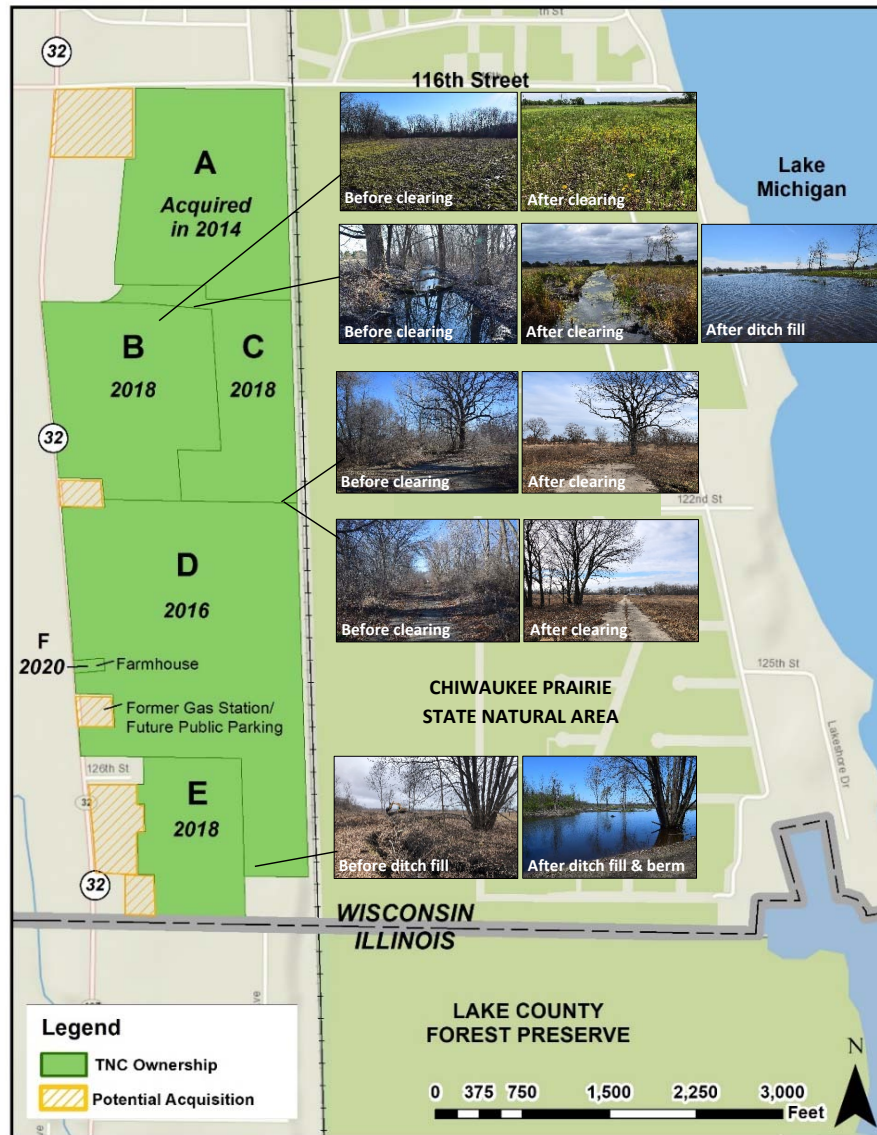
Figure 2.8 Map from The Nature Conservancy showing the acquisition times for different portions of the restoration site and images before and after recontouring and the addition of water control structures of the restoration site.

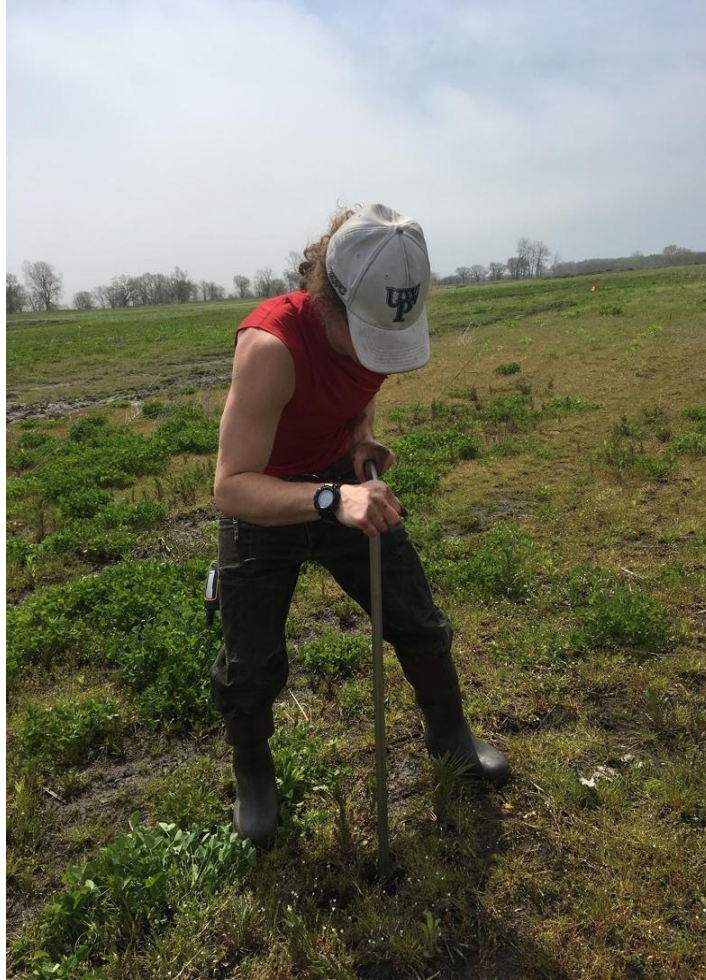
Figure 3.2 Author using a soil auger to dig a hole for piezometer RN1.

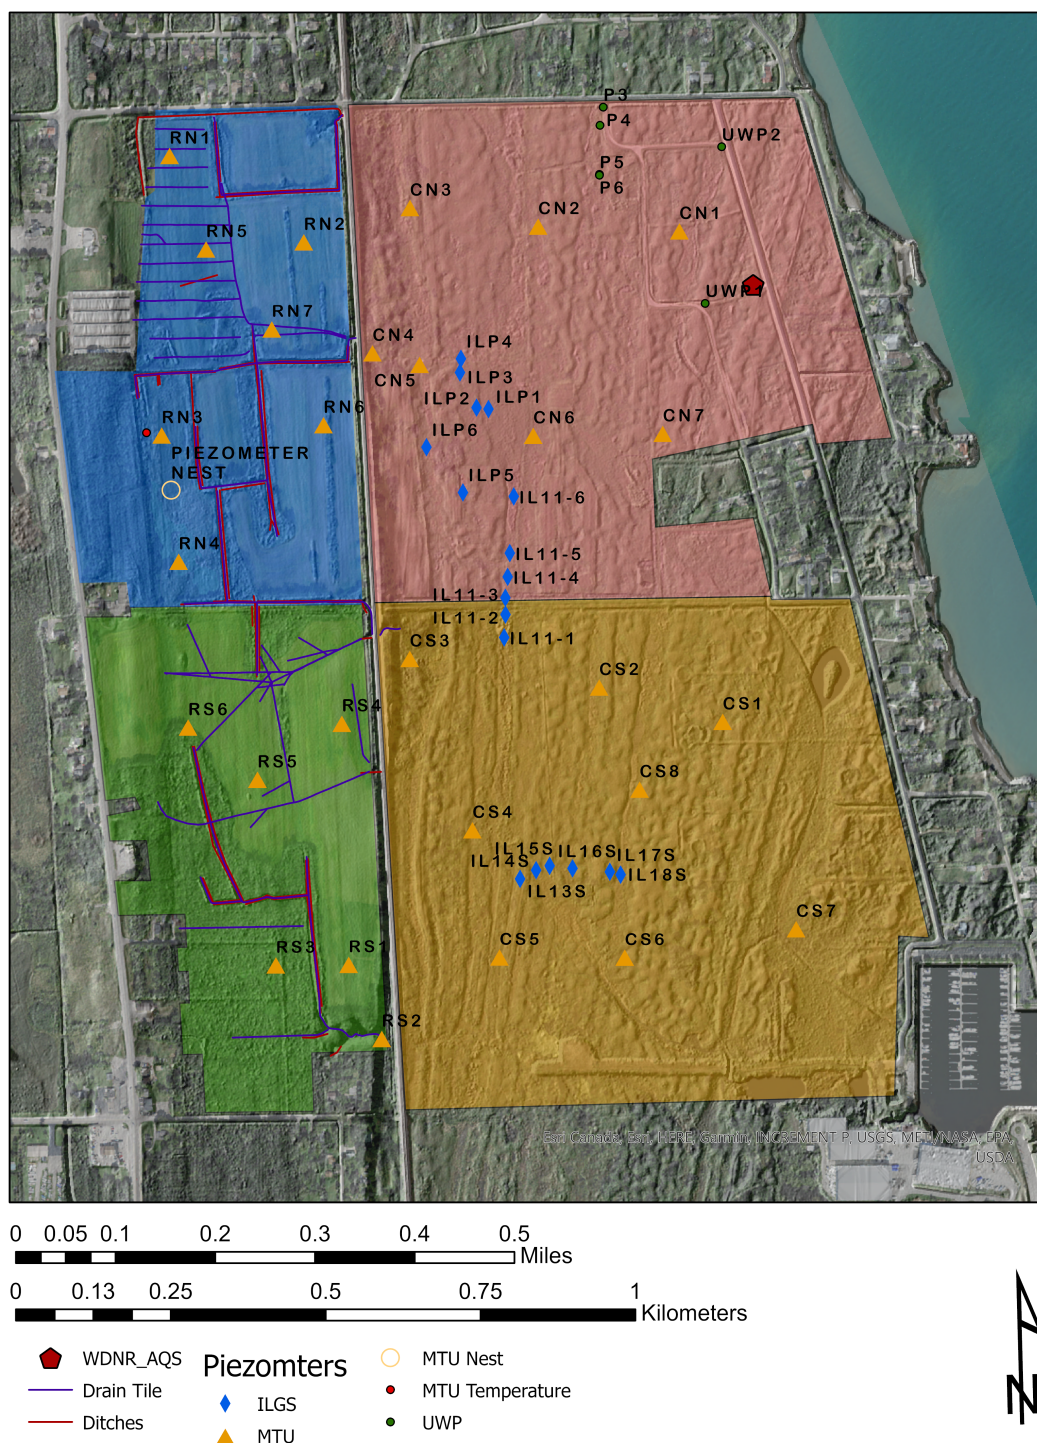
Figure 3.3 Map of the Chiwaukee Prairie showing all piezometers and their installers.

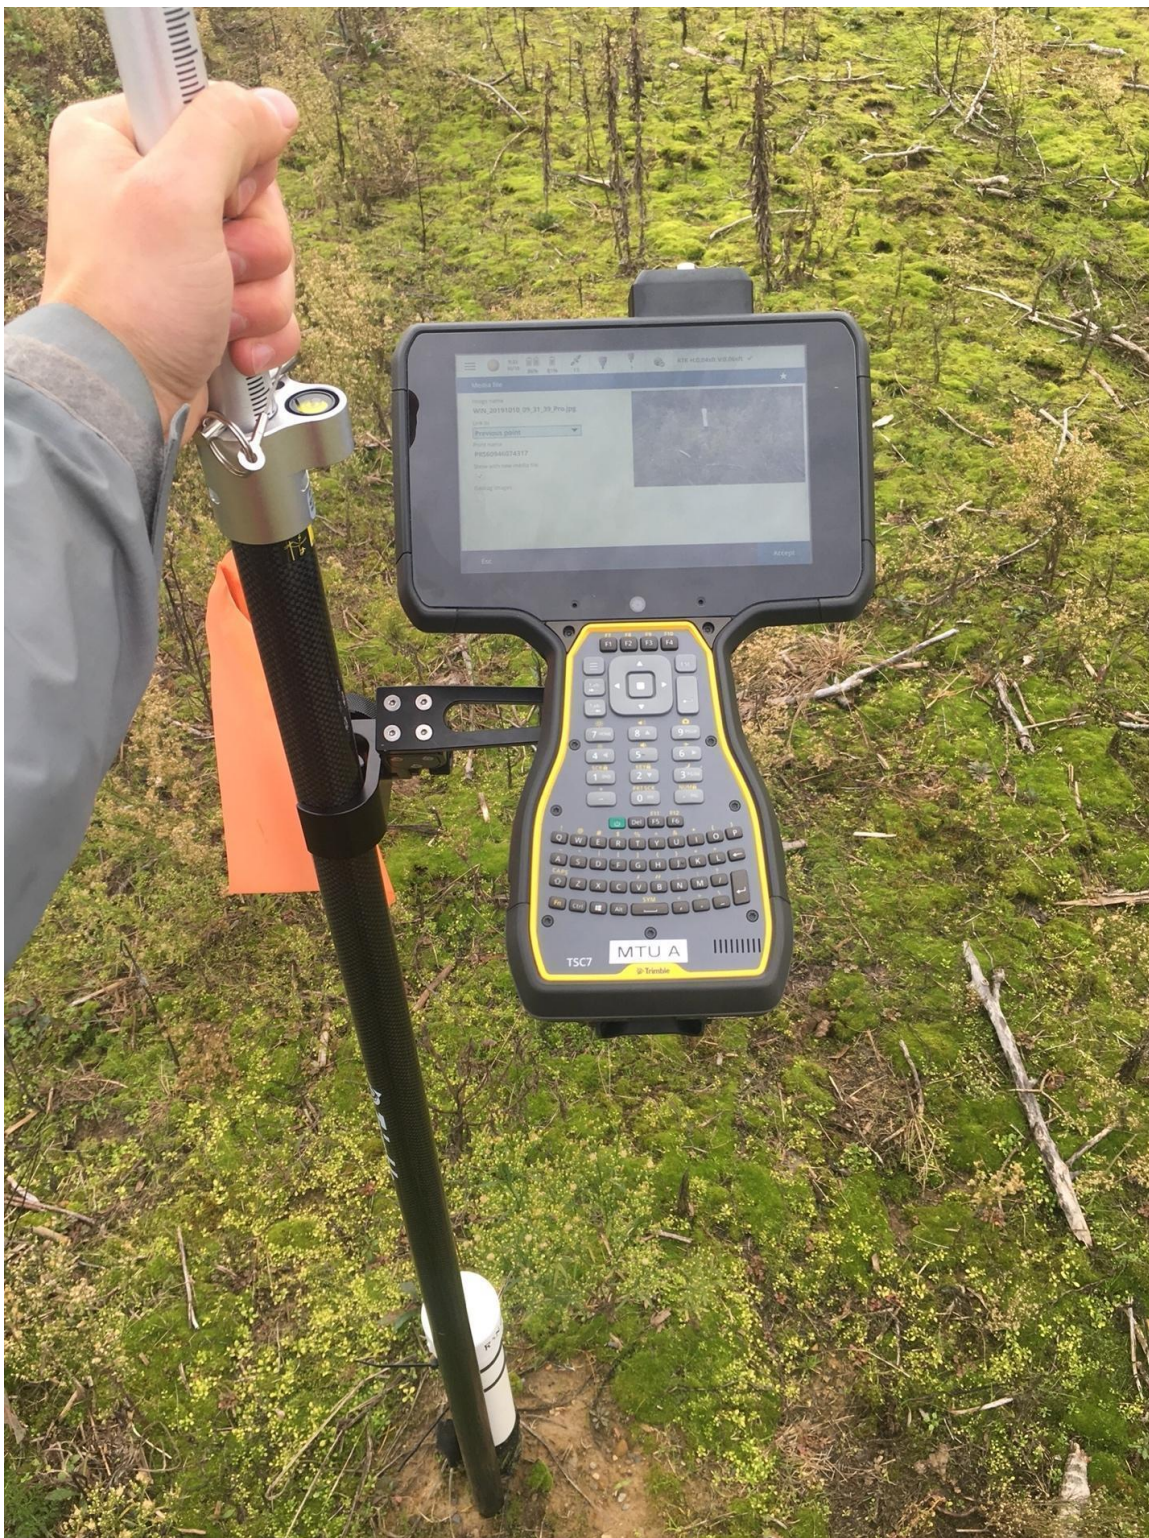
Figure 3.5 Author GPS survey of RN6 location using Trimble TSC7 RTK GPS.

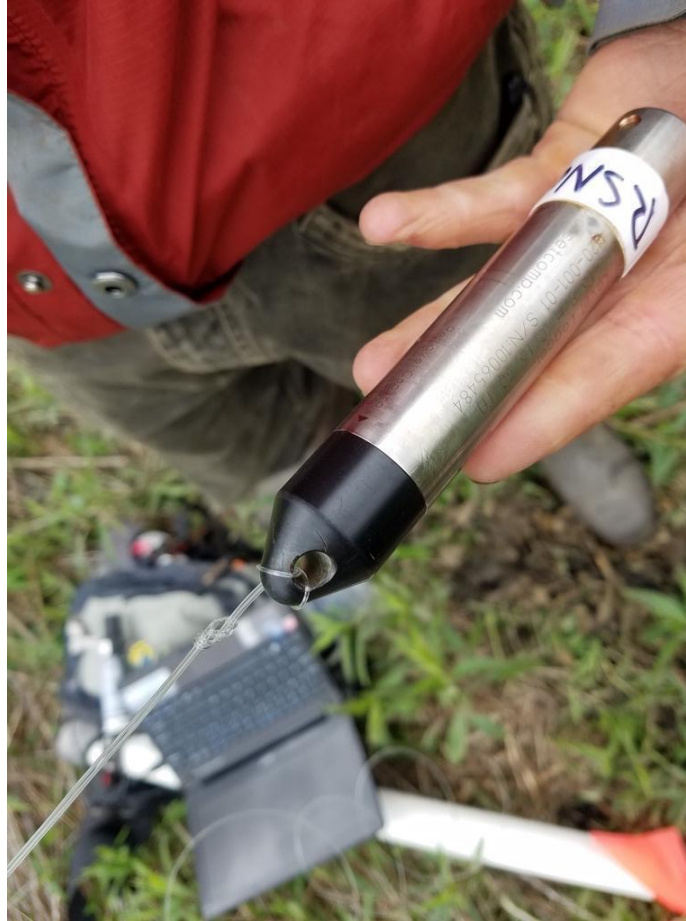
Figure 3.6 Author holding HOBO Logger tied with monofilament line.

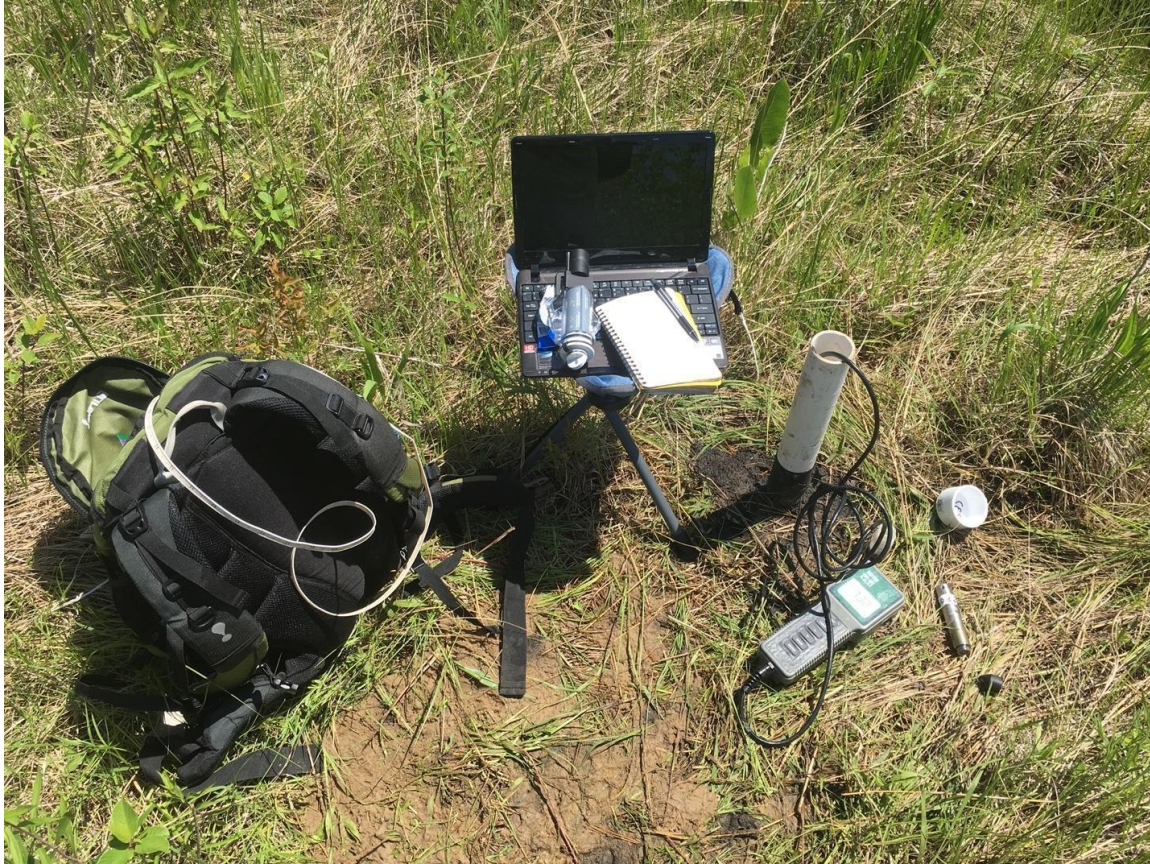
Figure 3.7 Typical sampling trip equipment. From left to right are sounding tape, computer with HOBOT adaptor, notebook, piezometer, multimeter, HOBOT logger.

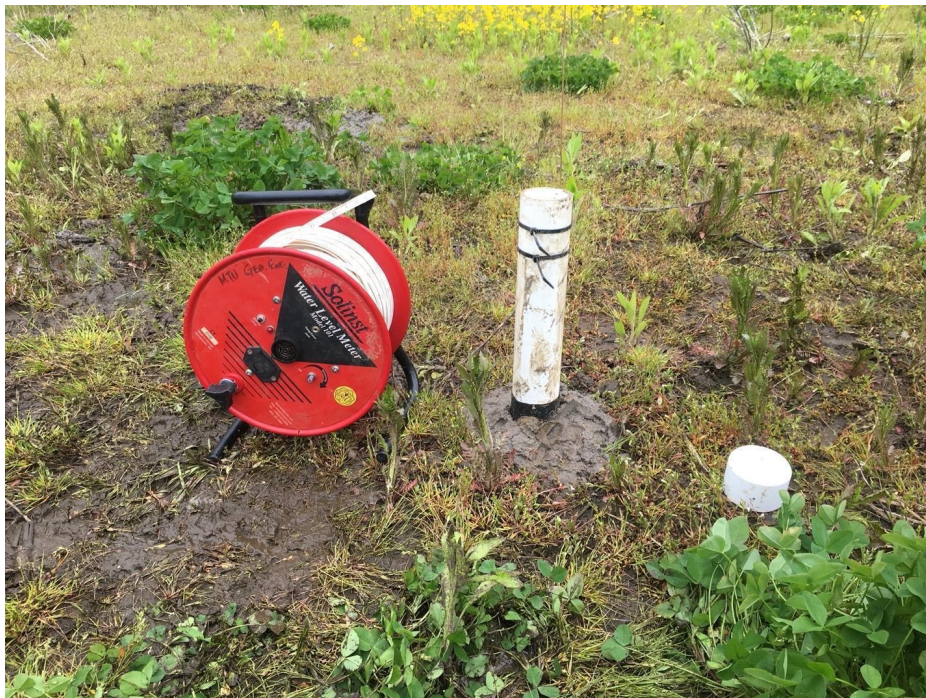
Figure 3.8 Solinst water-level meter next to piezometer RN1.

Sampling with an electric sounding tape (Model 101 Water Level Meter, Solinst Canada Ltd., Georgetown, Ontario) (Figure 3.8), referred to as hand measurements, was conducted approximately every two weeks. A total of 45 piezometers were used in this study. Ten sampling trips were conducted during the 2019 season and 3 trips during the 2020 season. Each of these sampling trips provides a snapshot of the conditions. Figure 4.7 shows the equipment used for a typical trip. Piezometers near the restoration site were prioritized when time was limited. Water-level hand measurements were collected by using the water level meter. Measurements were measured from the north side of the piezometer. Each measurement was repeated a minimum of three times to obtain consistent measurements. The distance between the top of the pipe and the ground (stick-up) was measured and the water depth from the top of the casing to the depth below ground surface.

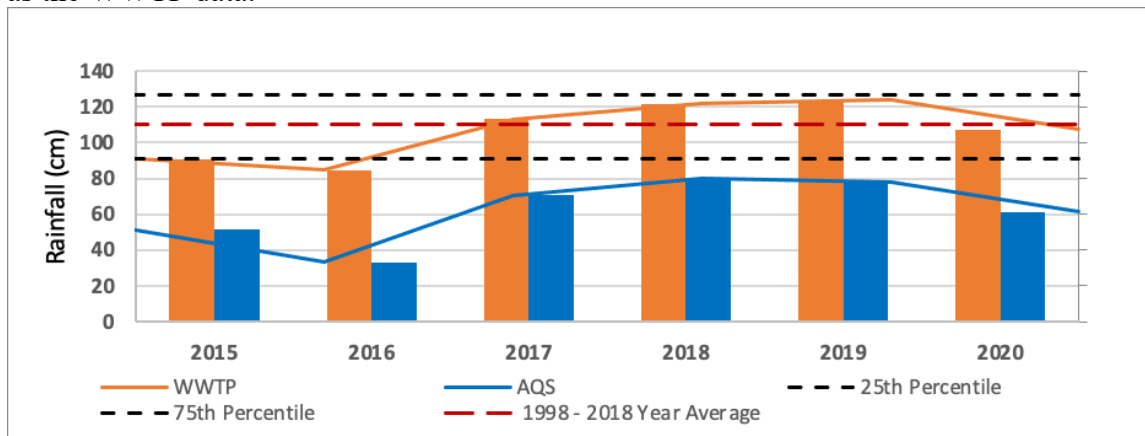
Figure 4.1 Bar graph showing the the annual sumations presipitaion of the Wiscinsin Departmnt of natiral resources air quality monitoirtin sataion (AQS) and the Kenosha waste water traement plant (WWTP).

It was observed that the two stations show the same trends but the AQS shows lower precipitation. When comparing the monthly summations we can see that the WWTP almost always has higher values (Figure 4.2). This may be due to different methods of collection, errors in calibration or collection, or the fact that it consistently rains less at the AQS compared to the WWTP. When comparing 2019 and 2020, average water levels in 2020 are lower. The precipitation record by the AQS shows lower results compared to the WWTP. This can be partly because the AQS excludes snow and does not operate all year, but when comparing the annual data month to month, they are much closer. The AQS results are lower but follow the same trend as the WWTP data.

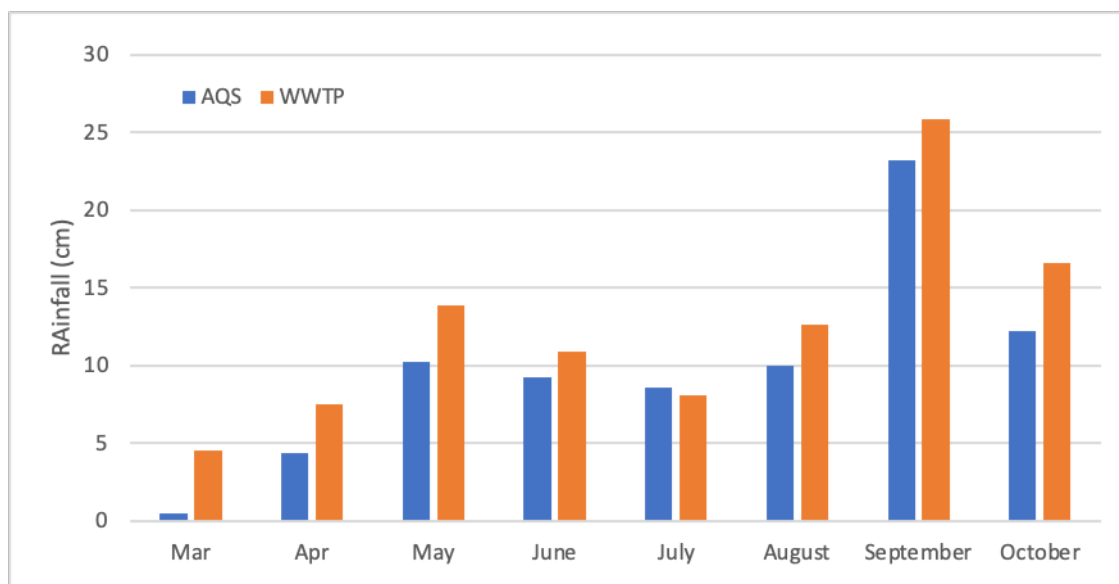
Figure 4.2 Monthly precipitation for 2019. The blue represents the WDNR AQS data, and the orange represents WWTP data.

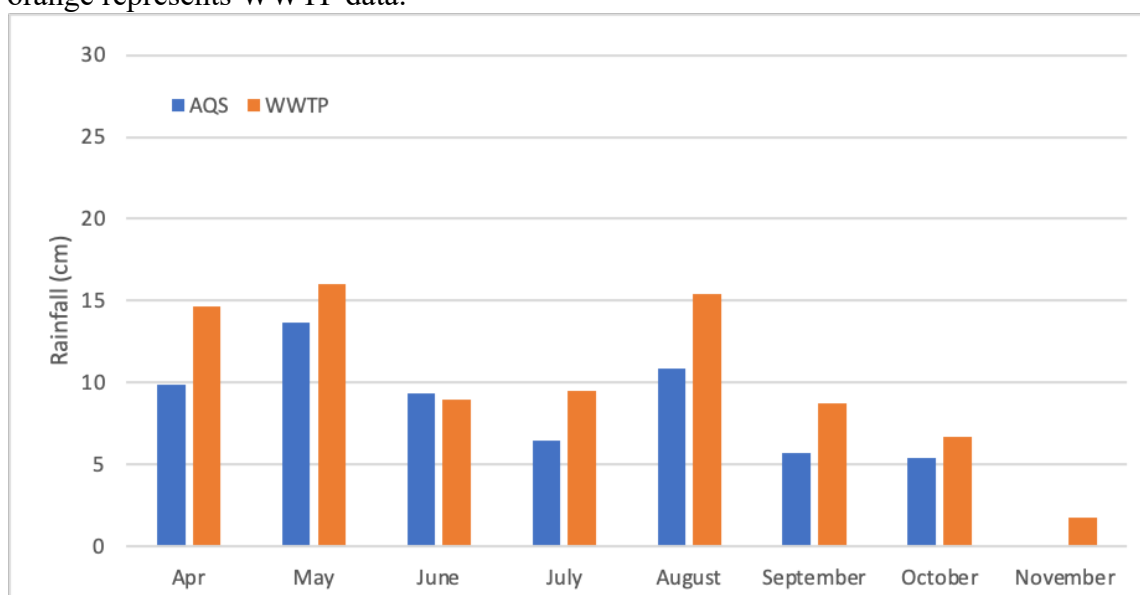
Figure 4.3 The monthly precipitation for 2020. The blue represents the WDNR AQS data, and the orange represents WWTP data.

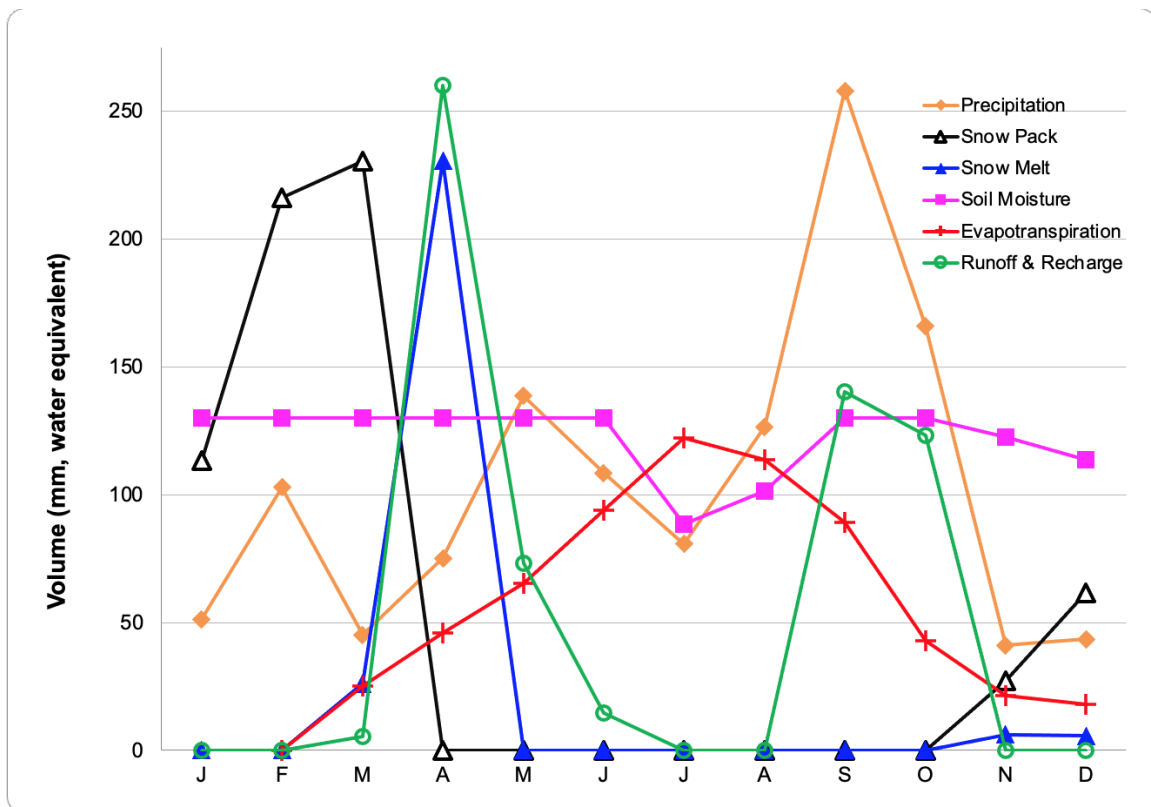
Figure 4.4 Results of the Thornthwaite-type monthly water budget using 2019 monthly averages (runoff and recharge could not be separated, so they were left as a combined variable, which is primarily recharge because of the low topographic relief).

liquid-water equivalent), based on observed precipitation and adjusted for monthly average temperature. The yellow line with diamonds is precipitation (snowfall is represented as precipitation in liquid-water depth equivalent). Blue lines with triangles represent snowmelt. Magenta lines with squares represent soil moisture as depth-equivalent liquid water (Note: “depth equivalent” is a representation of the amount of water present in an equal depth as liquid rather than distributed as moisture throughout the soil profile to facilitate water-balance calculations using all depth equivalents as liquid water.). The x-axis represents time in months and the y-axis represents water volume in mm equivalent. Snowpack was higher in 2019 than 2020, which experienced the lowest snowpack and earliest melt compared to the 2019 and long-term results.

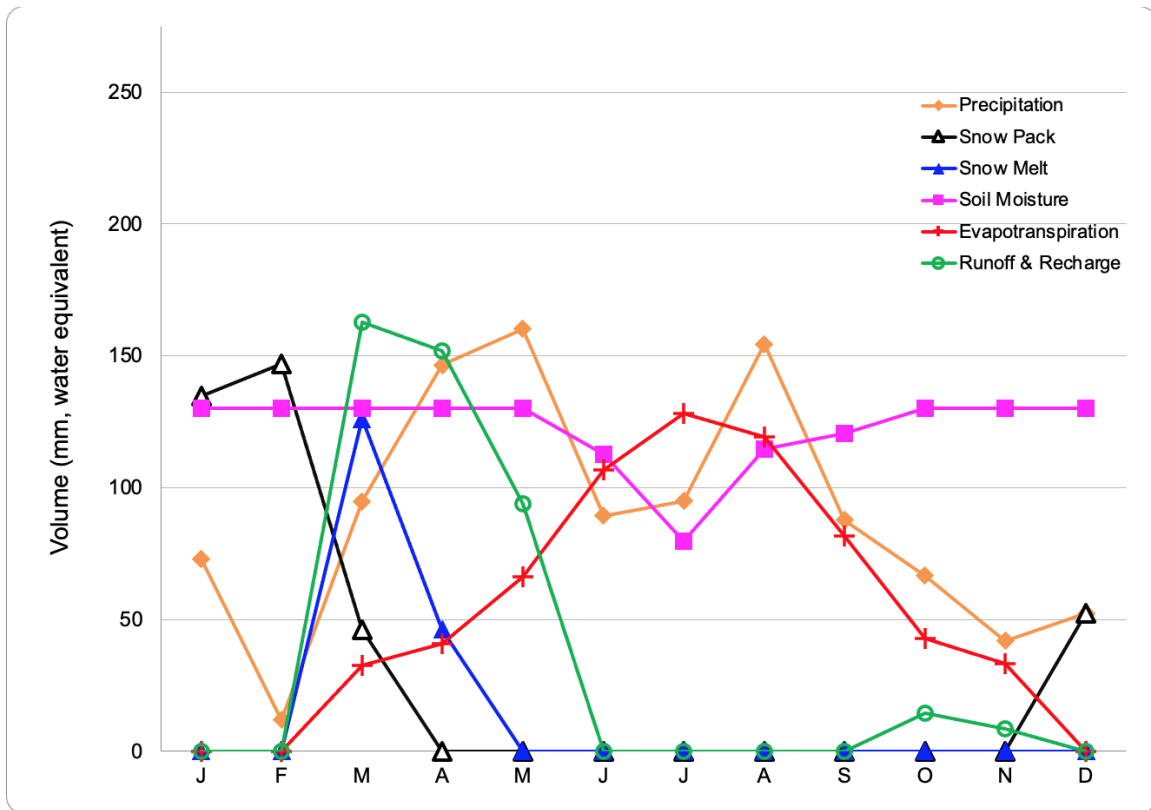
Figure 4.5 Results of the Thornthwaite-type monthly water budget using 2020 monthly averages (runoff and recharge could not be separated, so they were left as a combined variable, which is primarily recharge because of the low topographic relief).

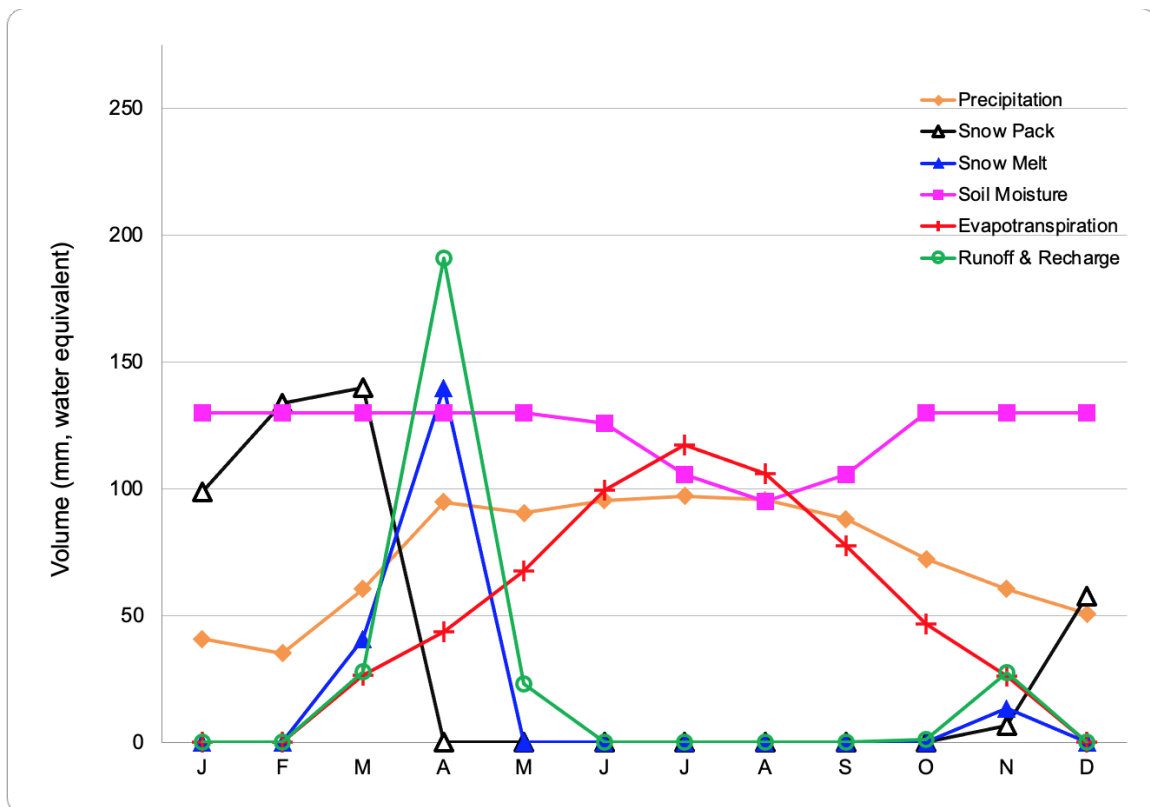
Figure 4.6 Results of the Thornthwaite-type monthly water budget using long-term monthly averages (runoff and recharge could not be separated, so they were left as a combined variable, which is primarily recharge because of the low topographic relief).

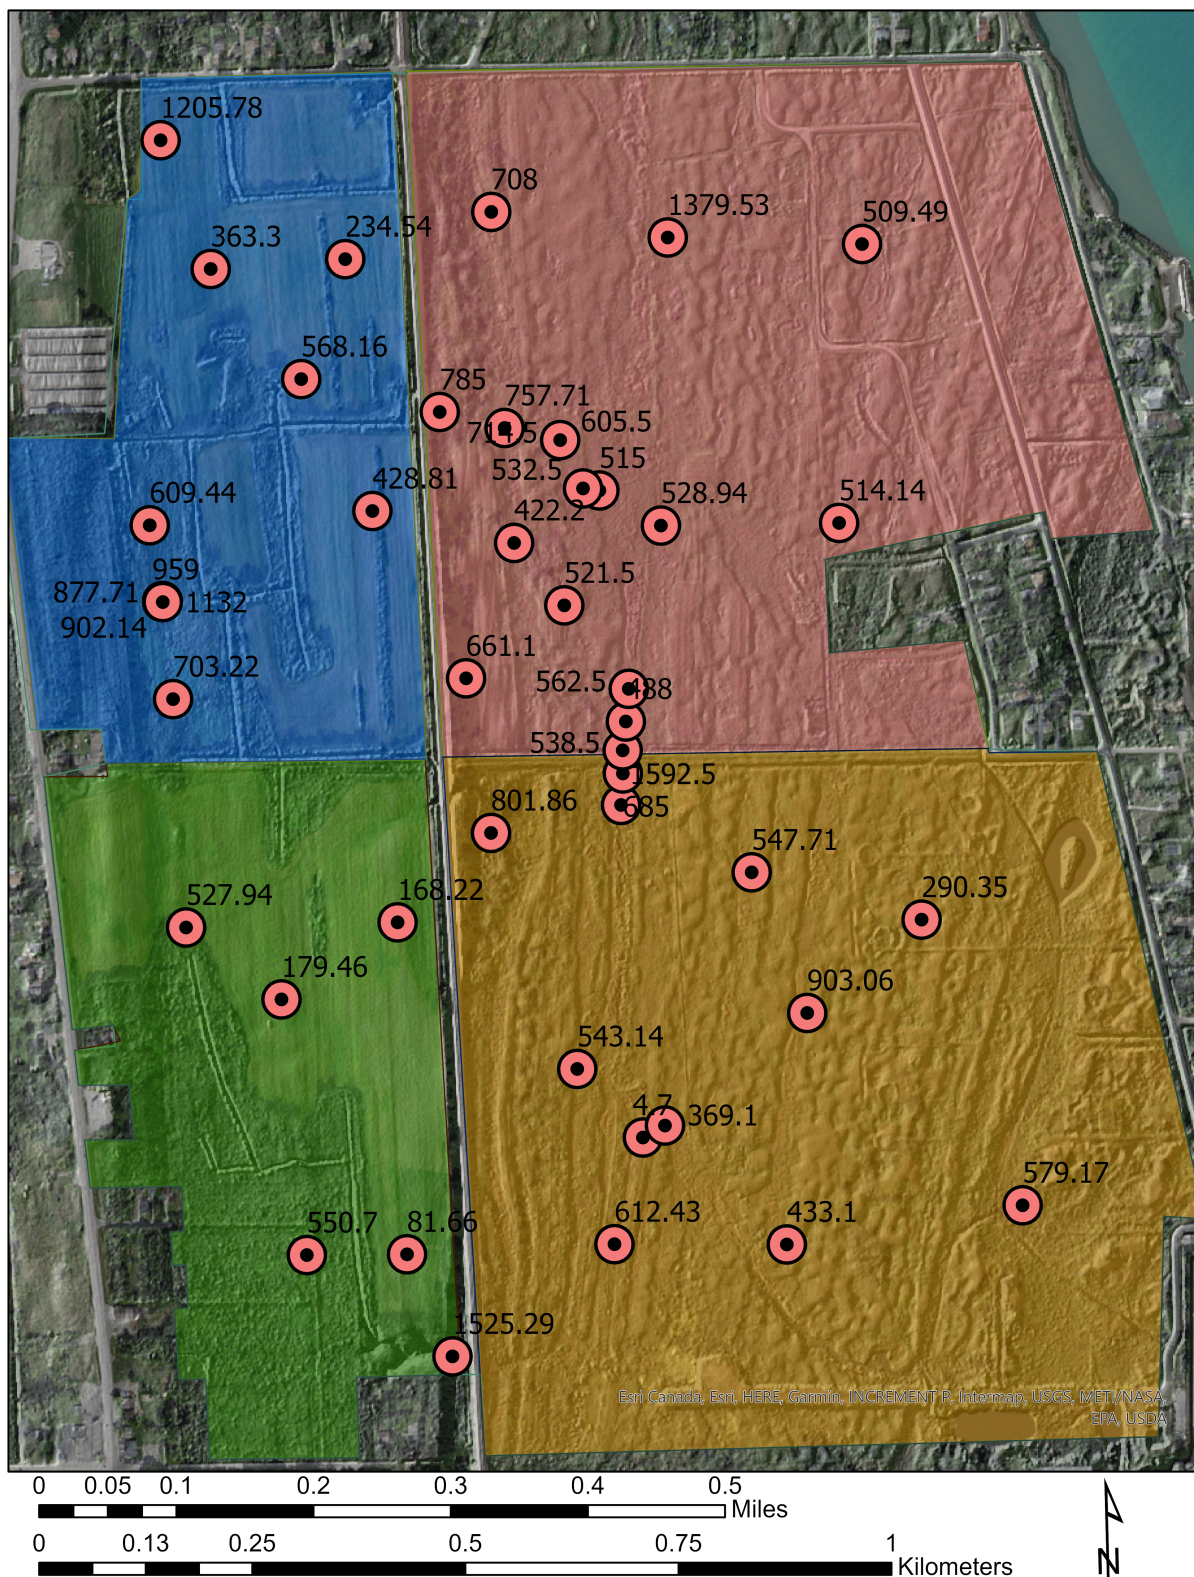
Figure 4.7 Map showing the average conductivity for each piezometer in microsiemens for the 2019 field season.
