HYDROLOGIC INVESTIGATION OF THE CHIWAUKEE PRAIRIE (WISCONSIN) RESTORATION

A REPORT

In Geology

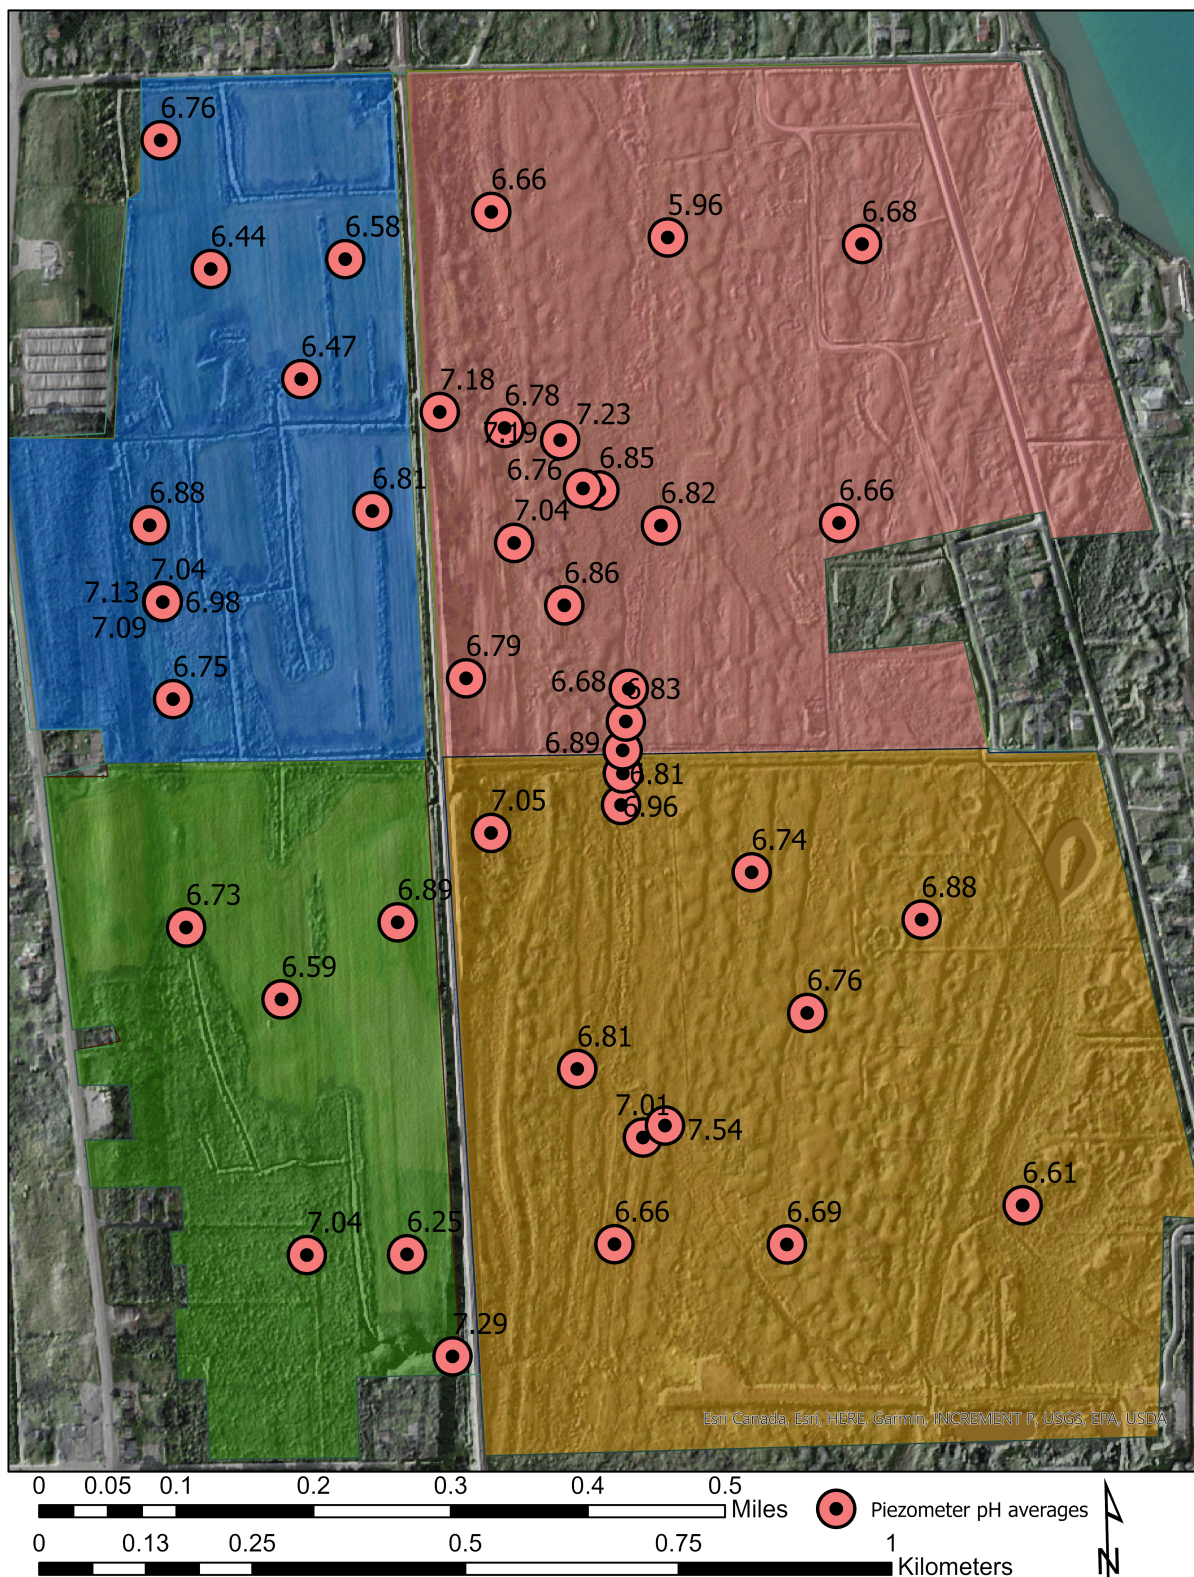
Figure 4.10 Map showing the average conductivity for each piezometer for the 2019 field season.

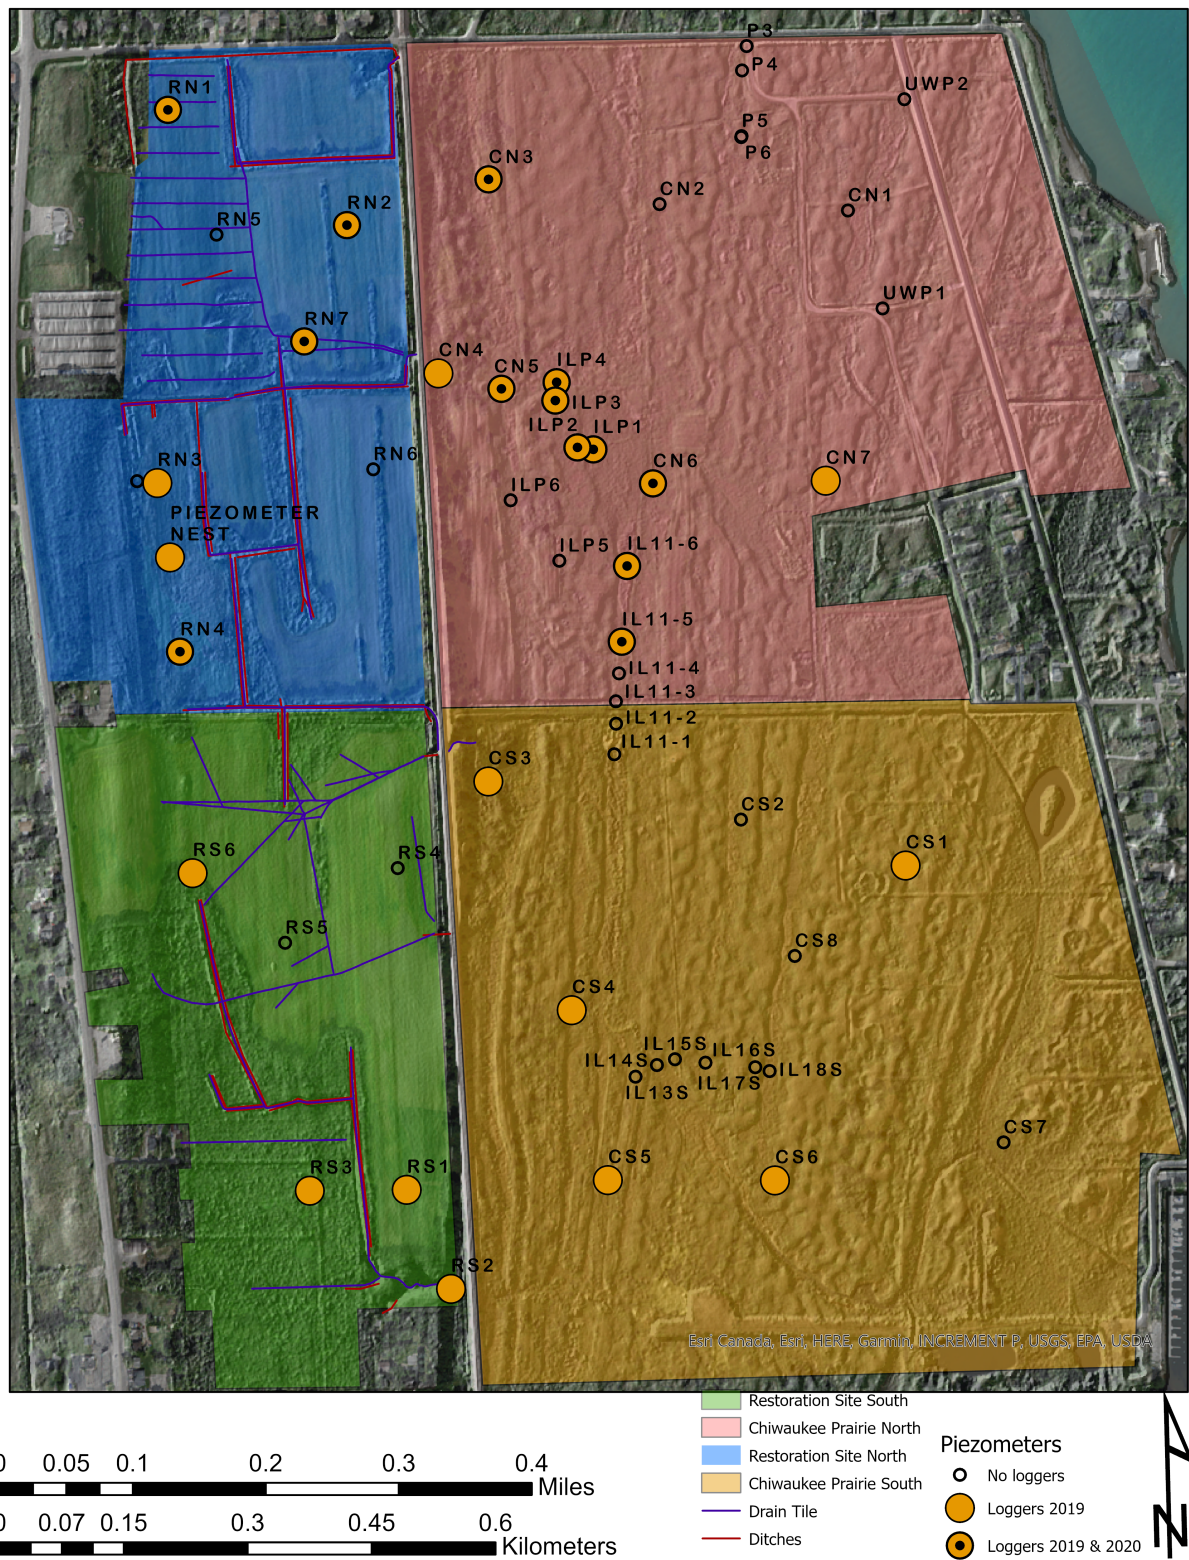
Figure 4.11 A map of the study site showing the piezometer and pressure-transducer locations for 2019 and 2020.

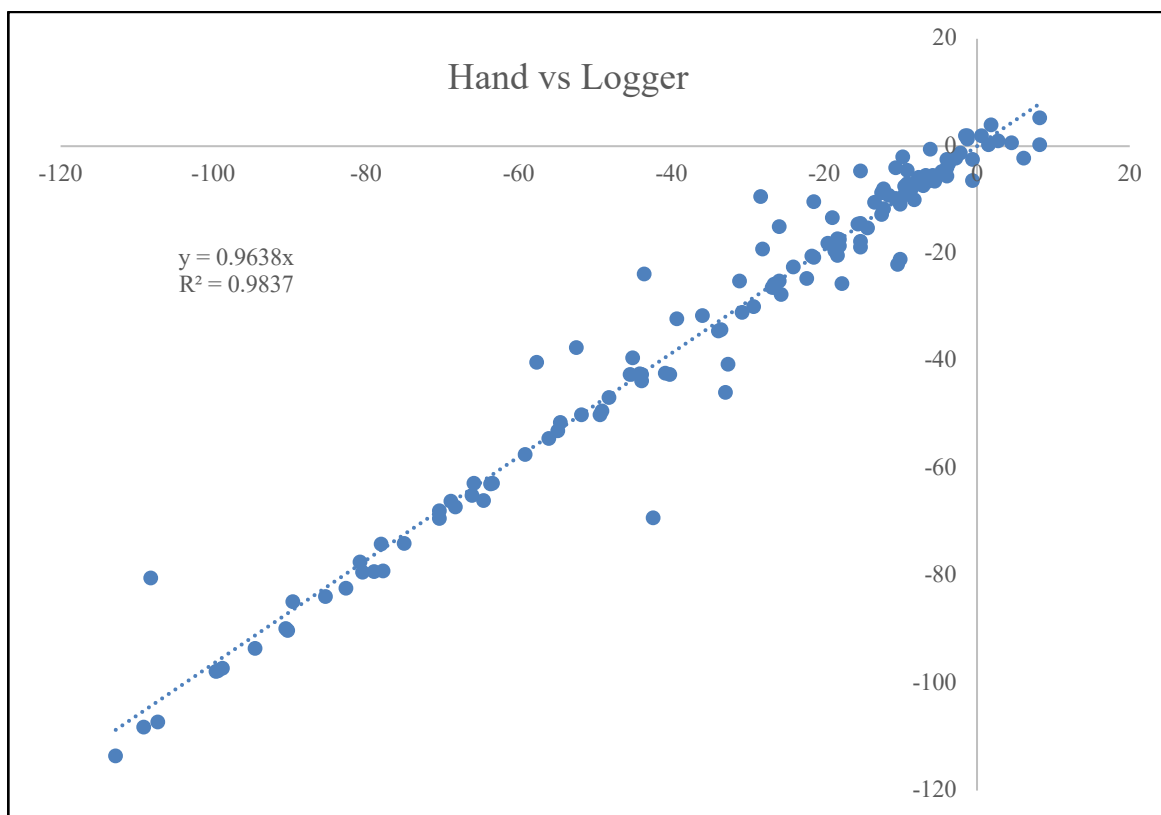
Figure 4.12 Comparison of calculated distance from ground surface (cm) hand measurements to logger results.

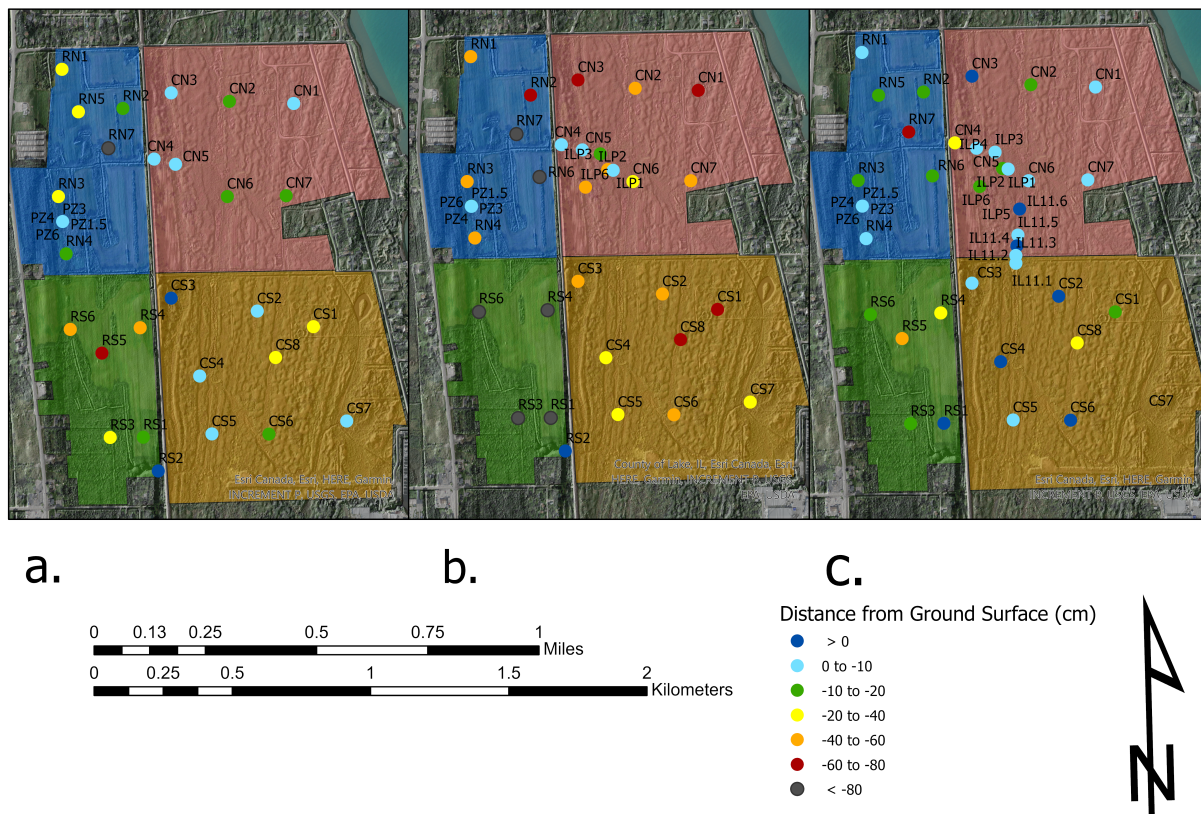
Figure 4.13 Maps showing the results of hand measurements throughout the year. a. Shows measurements from June; b. Shows measurements from August; and c. Shows measurements from October.

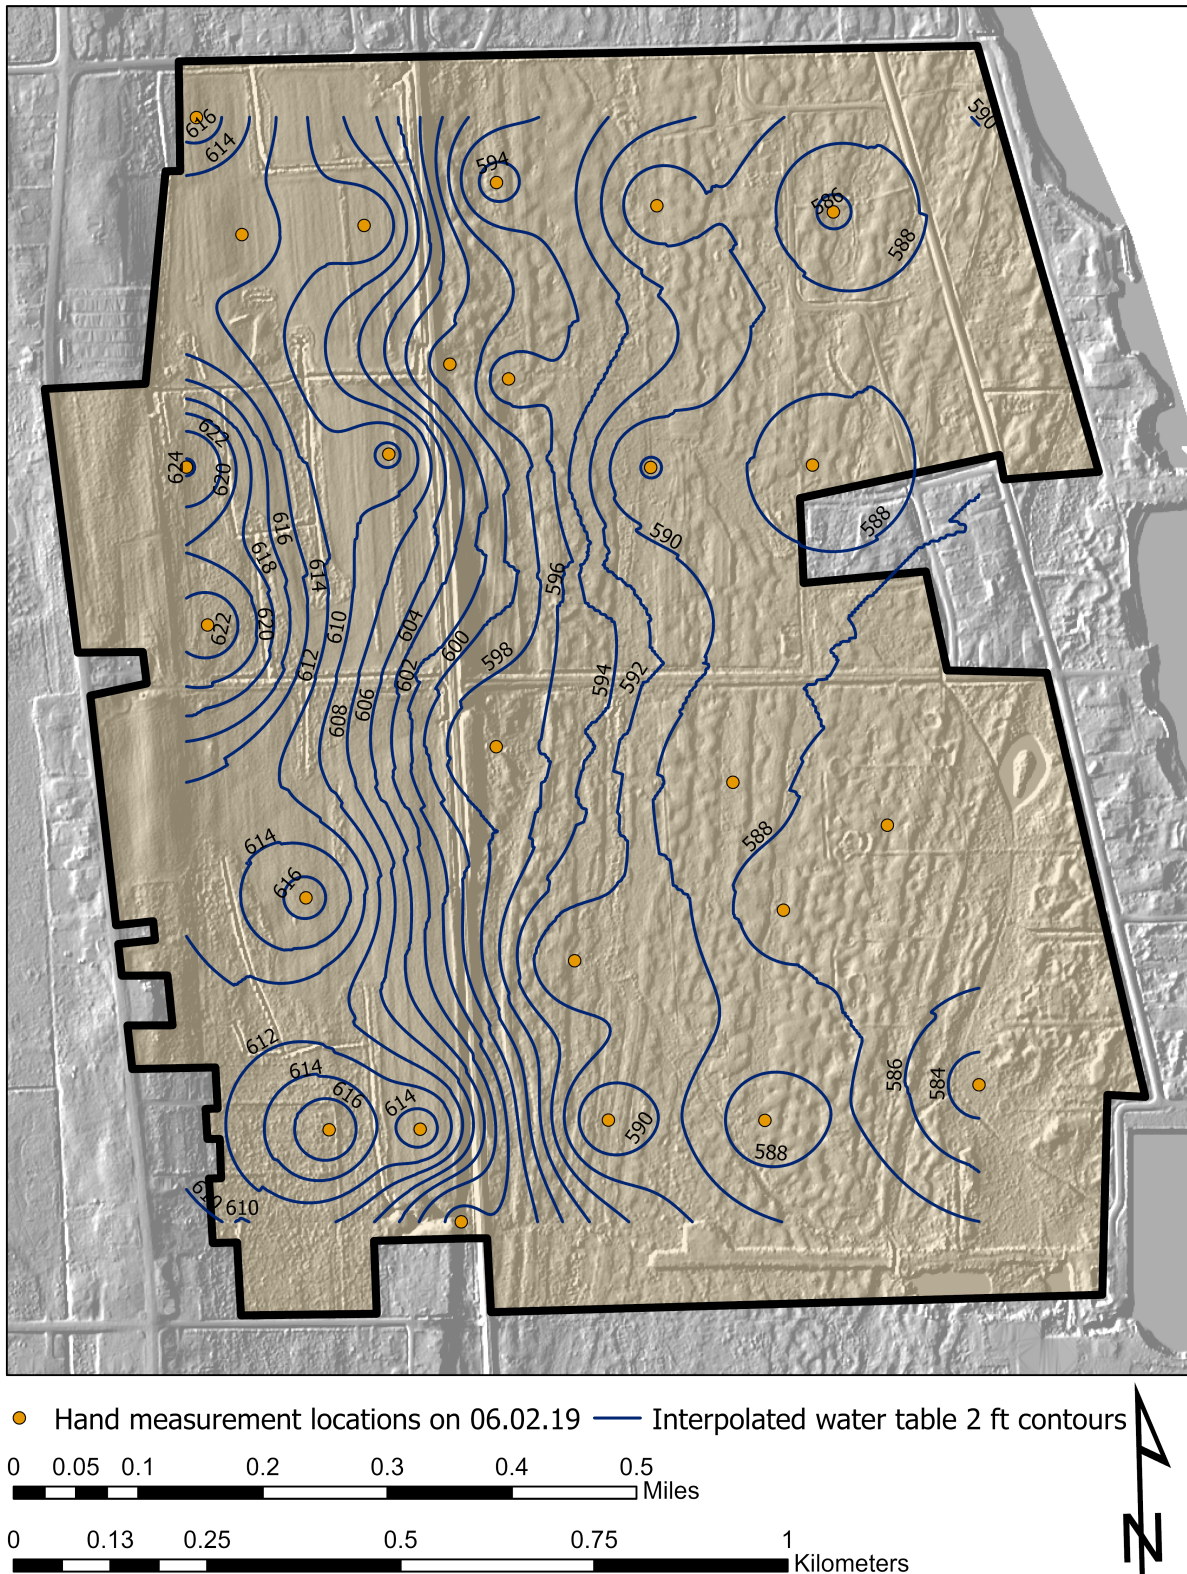
Figure 4.14 Water table elevation map showing the interpolated water table for 06/02/19 sampling trip. orange filled circles represent the points at where the water table was measured for interpolation. Dark blue lines represent 2-ft contours interpolated water table.

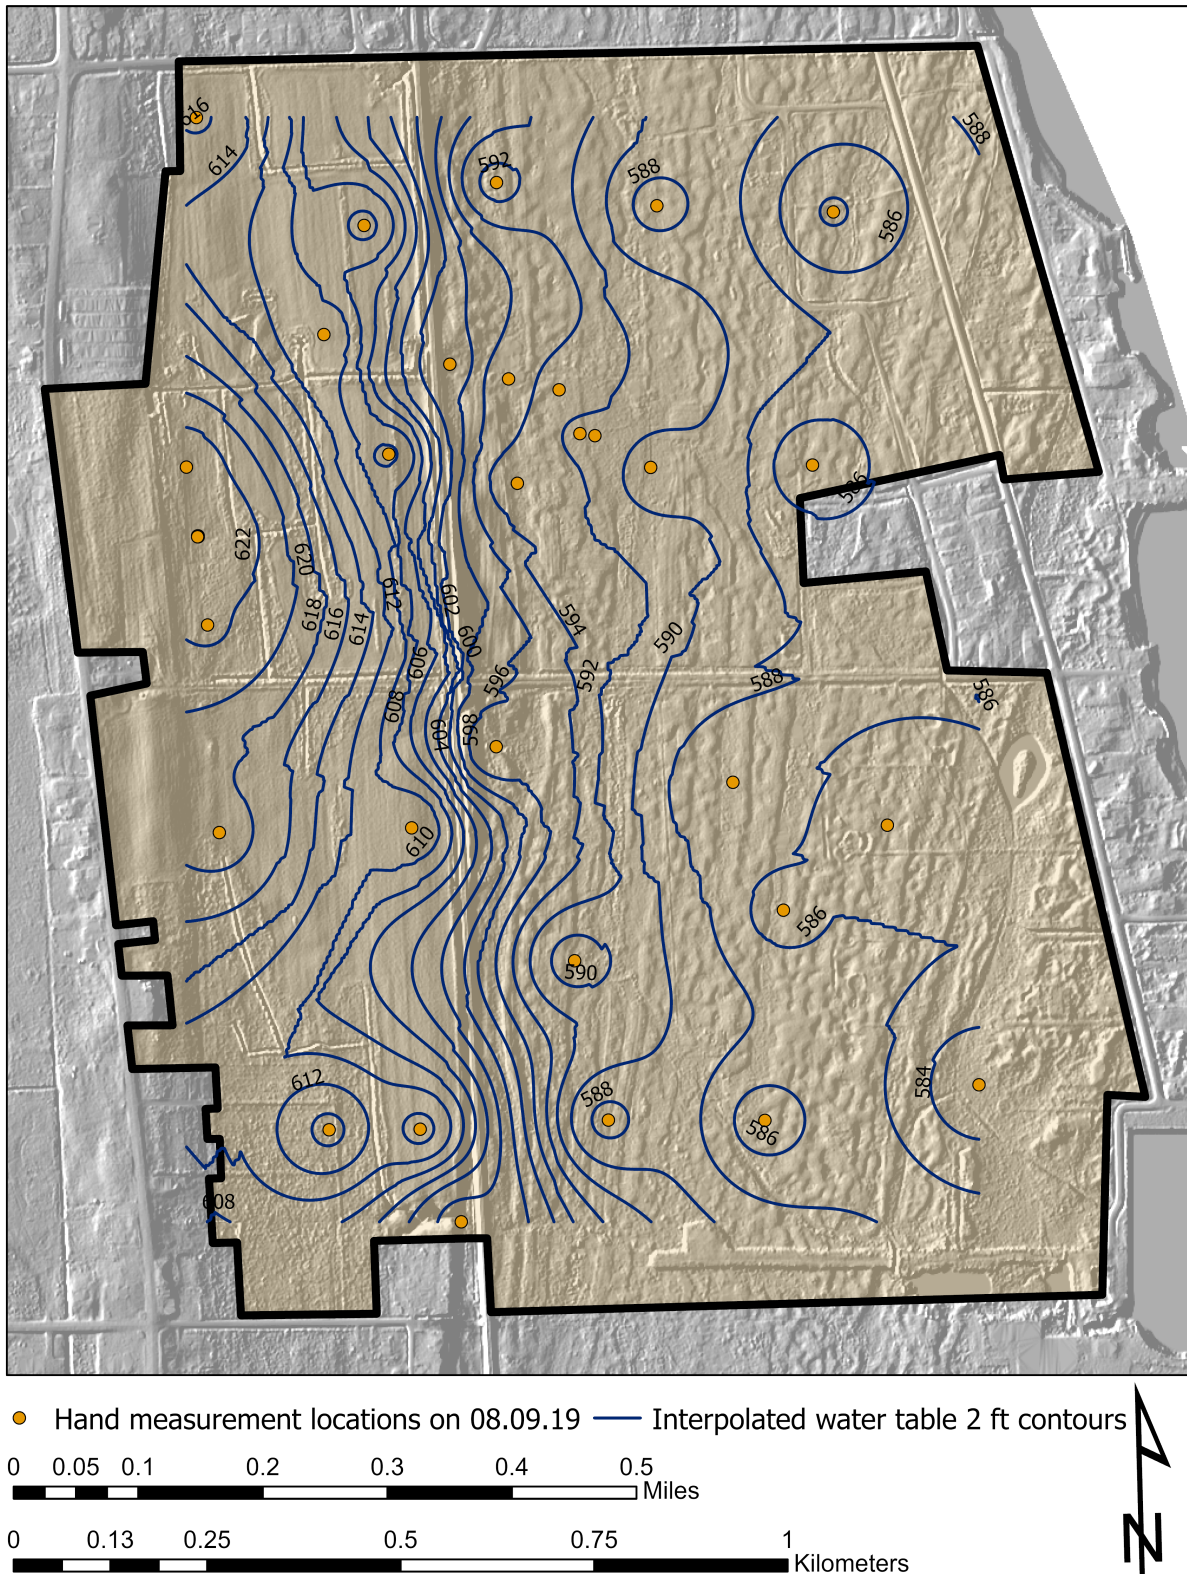
Figure 4.15 Water table elevation map showing the interpolated water table for 08/09/19 sampling trip. orange filled circles represent the points at where the water table was measured for interpolation. Dark blue lines represent 2-ft contours interpolated water table.

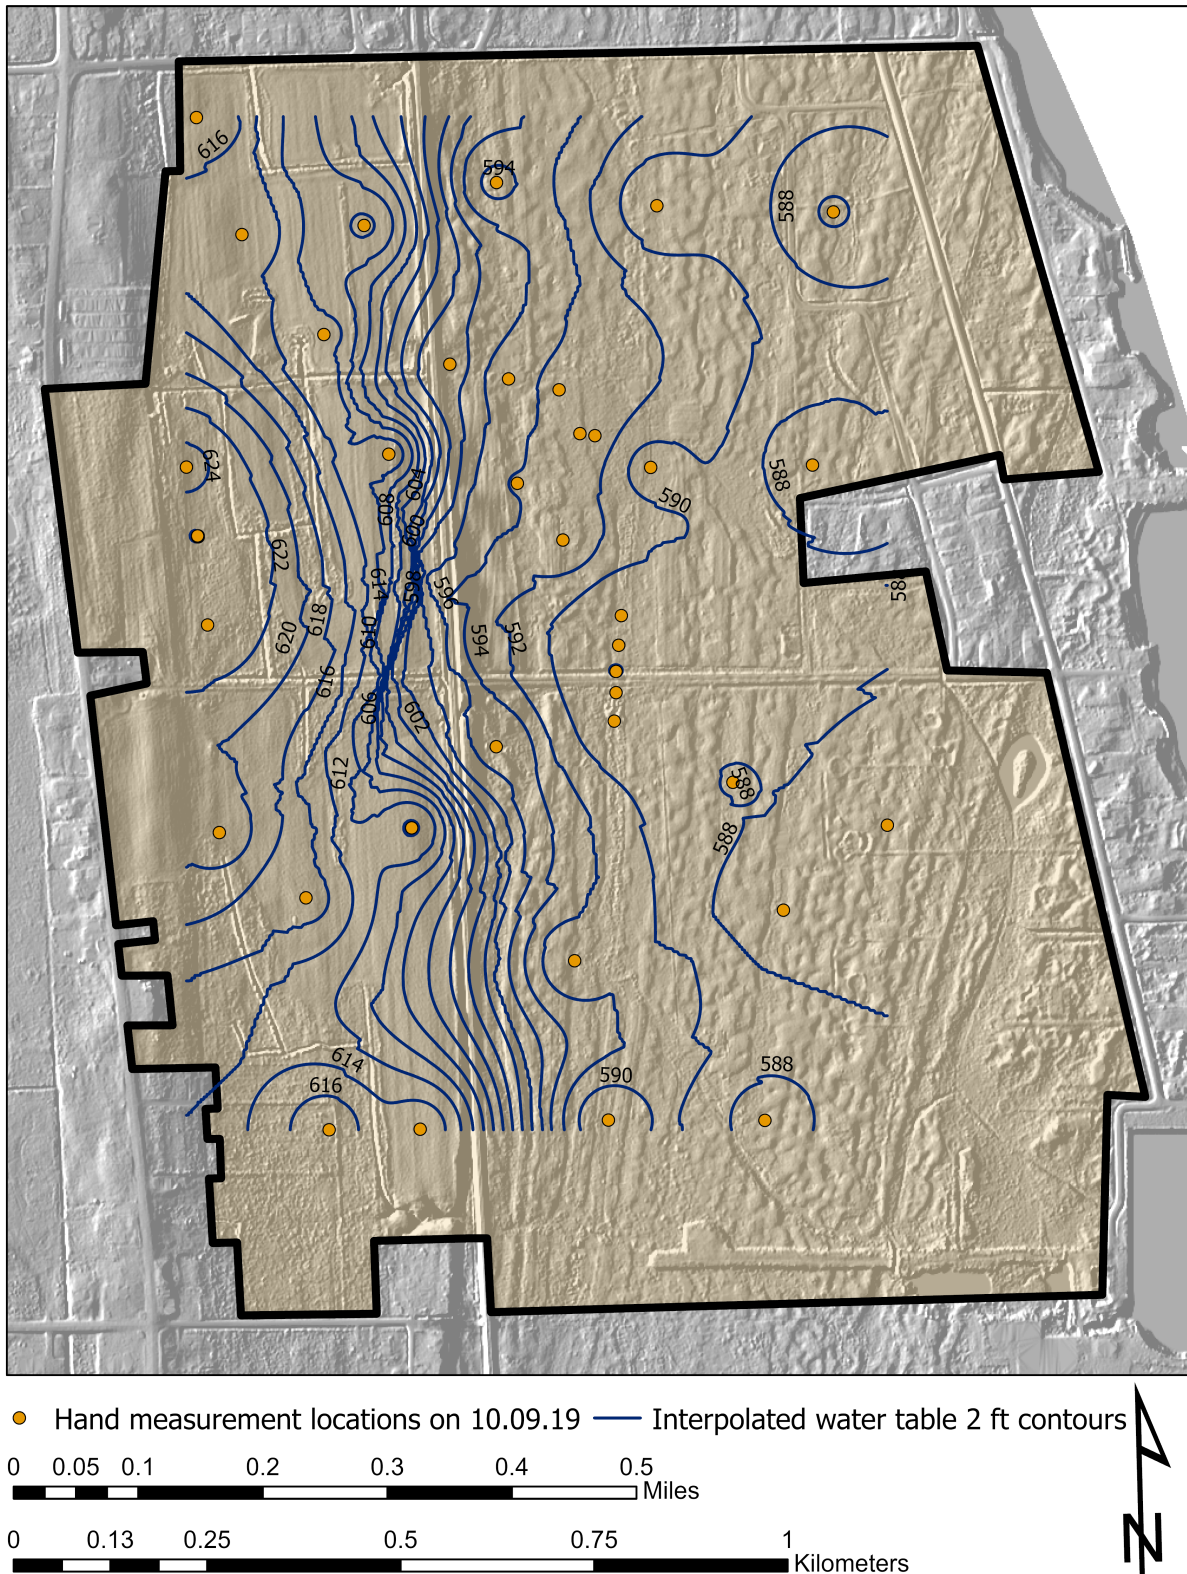
Figure 4.16 Water table elevation map showing the interpolated water table for 10/09/19 sampling trip. orange filled circles represent the points at where the water table was measured for interpolation. Dark blue lines represent 2ft contours interpolated water table.

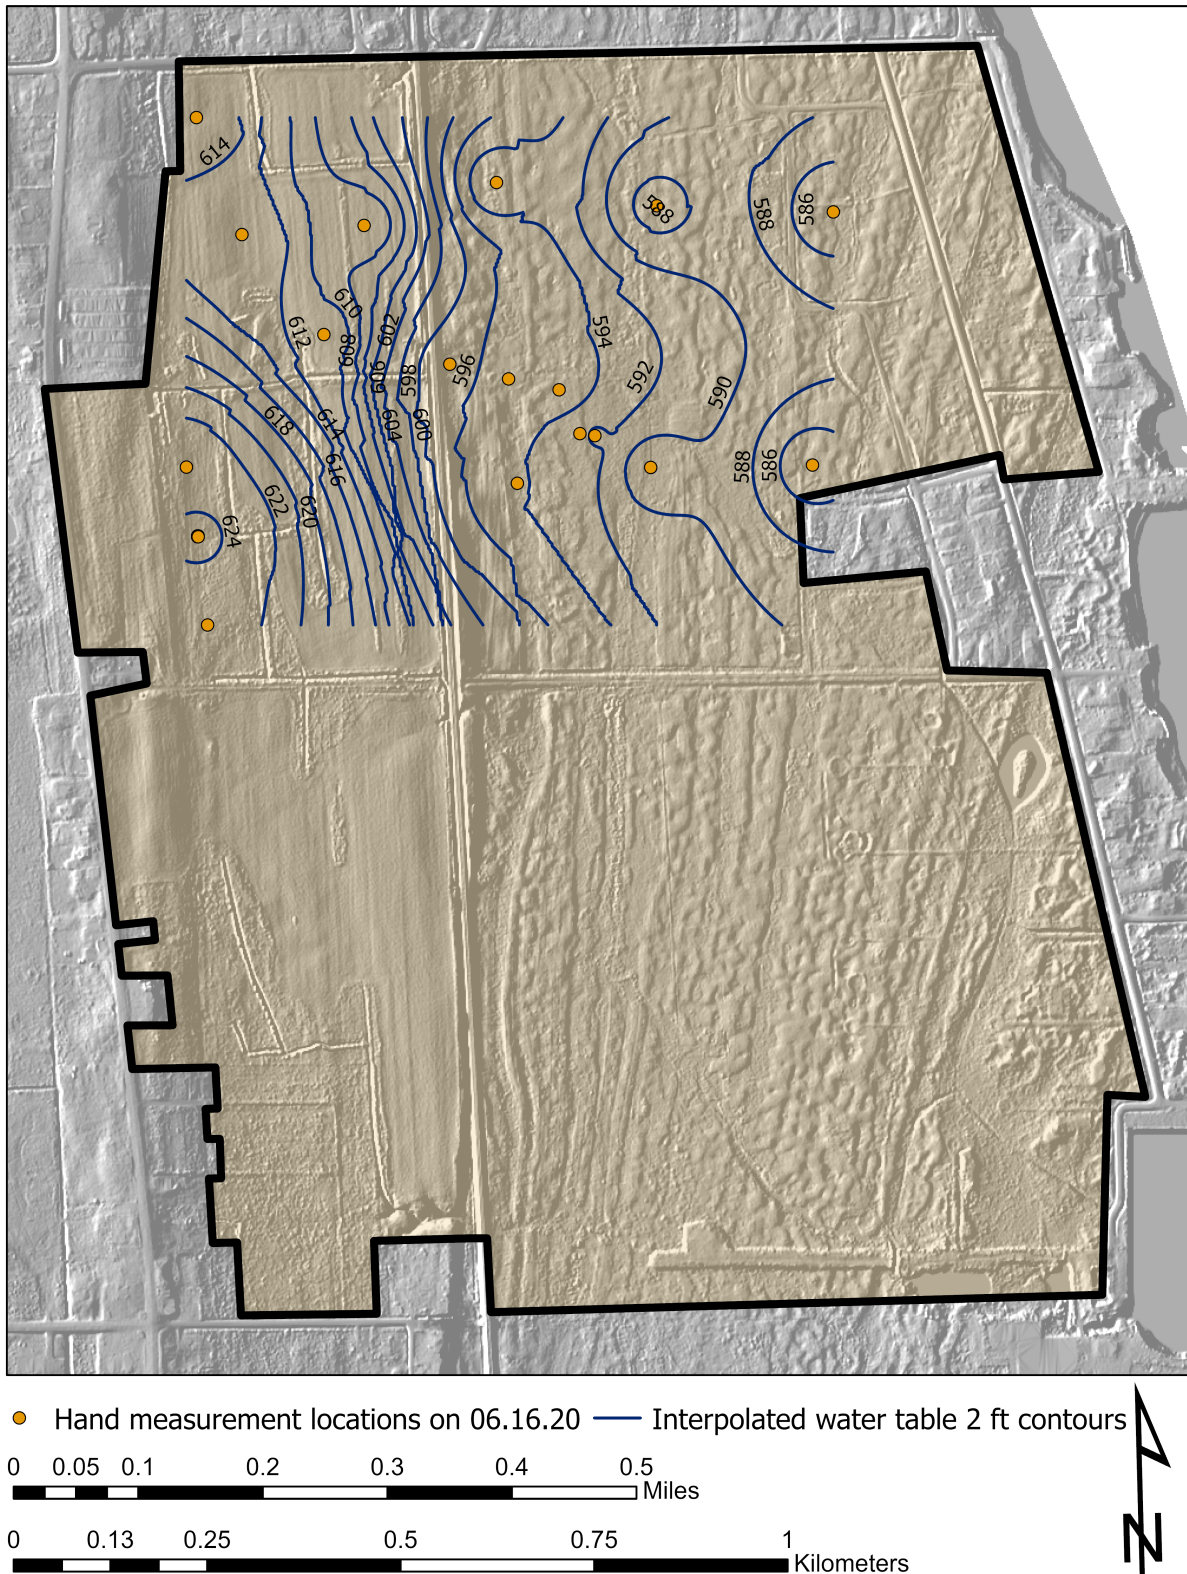
Figure 4.17 Water table elevation map showing the interpolated water table for 06/16/20 sampling trip. orange filled circles represent the points at where the water table was measured for interpolation. Dark blue lines represent 2-ft contours interpolated water table.

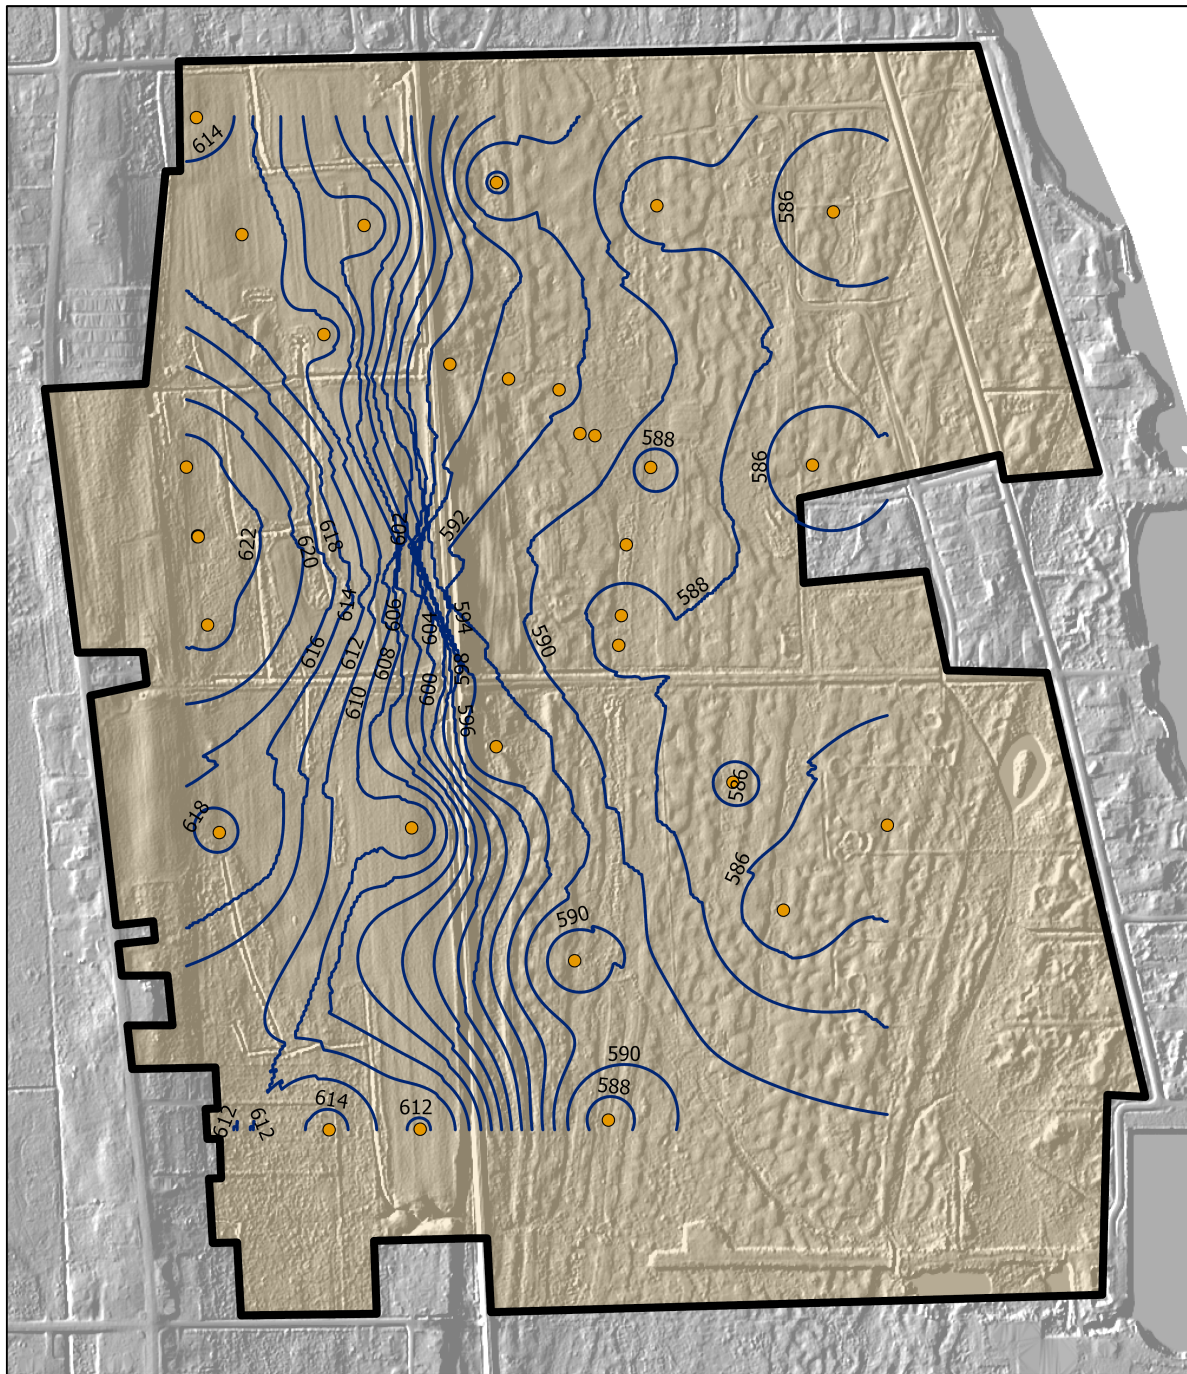
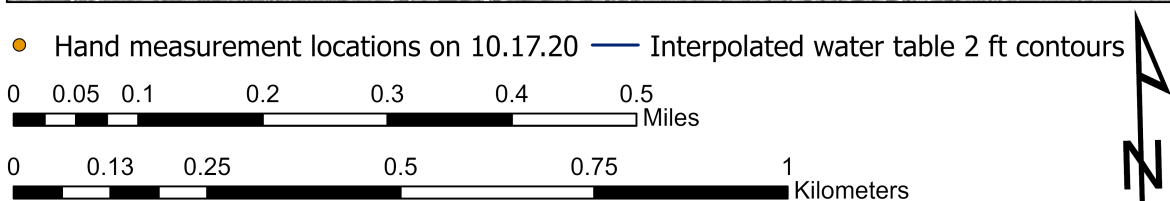
Figure 4.18 Water table elevation map showing the interpolated water table for 10/17/20 sampling trip. orange filled circles represent the points at where the water table was measured for interpolation. Dark blue lines represent 2-ft contours interpolated water table elevation.

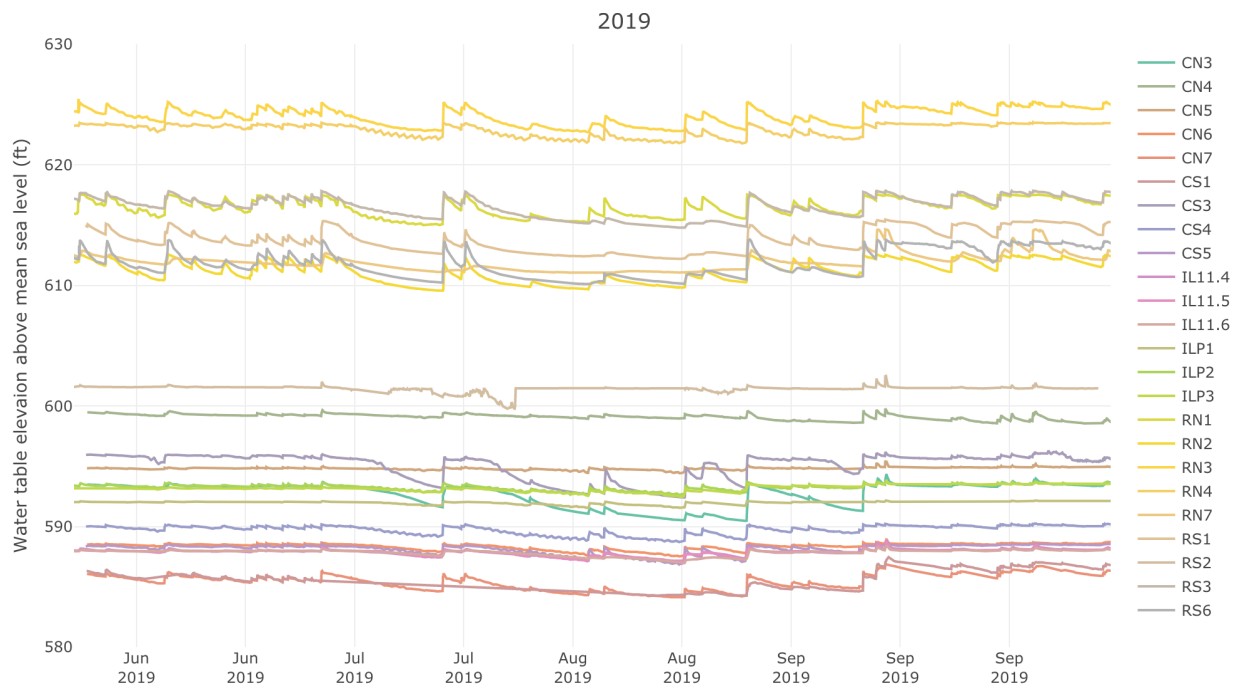
Figure 4.19 Graph showing water table elevation of piezometers in 2020.

The water table elevations were observed in several piezometers over the two seasons (figures 4.19-20). Both 2019 and 2020 showed wetter springs that dried during the summer and then experienced a wetter fall season, which is typical in the Great Lakes region. The hydrographs are shown herein as depth to the water table from ground surface. Water table trends can be looked at in many ways and this report presents the data both in water table elevation (Figures 4.21-24) and relative to ground surface (Figures 4.25-28). When looking at water table elevation across all the sites in figure 4.18-19 we can see that the water table elevation drops from the restoration site to Chiwaukee Prairie. The interpolated potentiometric maps have also been made and are represented in Figures 4.13-17. Time-series plots of water table depths (Figures 10.17-10.25) show how different the shallow groundwater system responds in periods between rain events and at the start of the snow melt. The hydrographs are organized by subsite, which roughly corresponds with water table level and ground surface elevation, the northwest (RN) being the highest in elevation and the southeast (CS) being the lowest in elevation. A control piezometer, RN4, was installed in the small undeveloped area within the restoration site. This area is a remnant of the original wetland landscape and shows similar hydrographs to those in the northwest Chiwaukee Prairie subsite, CN. Because of the shallow depths to the water table, all the piezometers showed flashy responses to precipitation events; piezometers in the restoration site were flashier than those in the Chiwaukee Prairie.

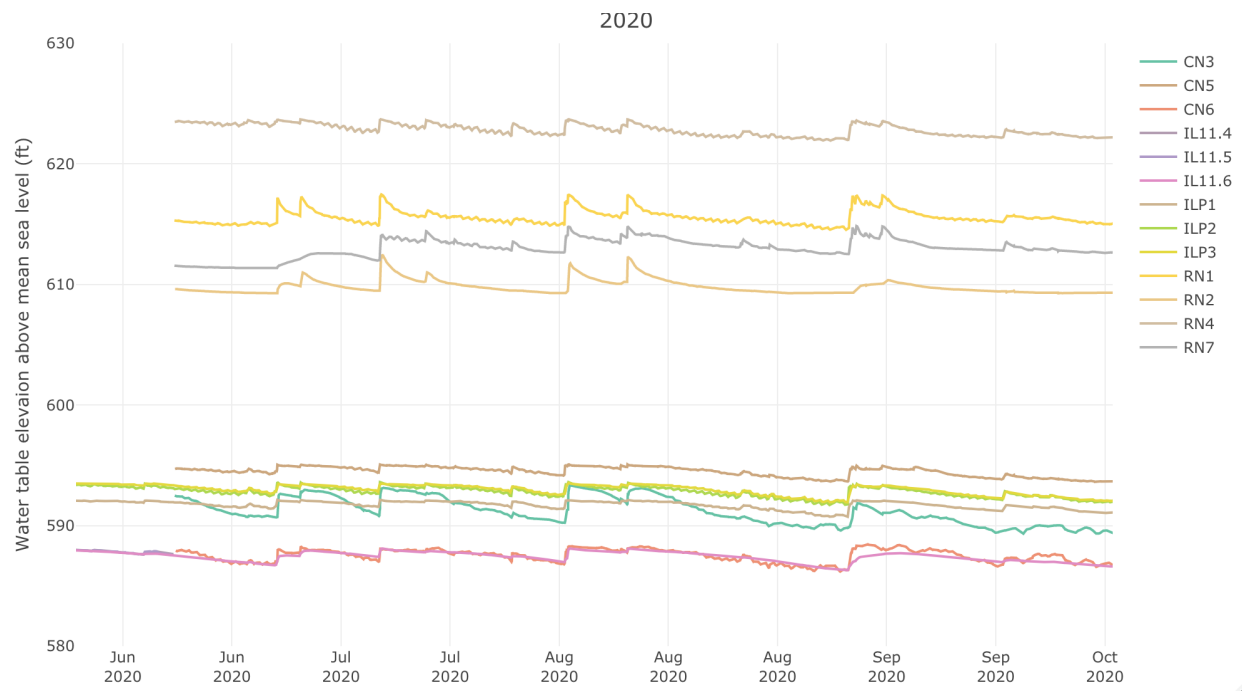
Figure 4.20 Graph showing water table elevation of piezometers in 2019.

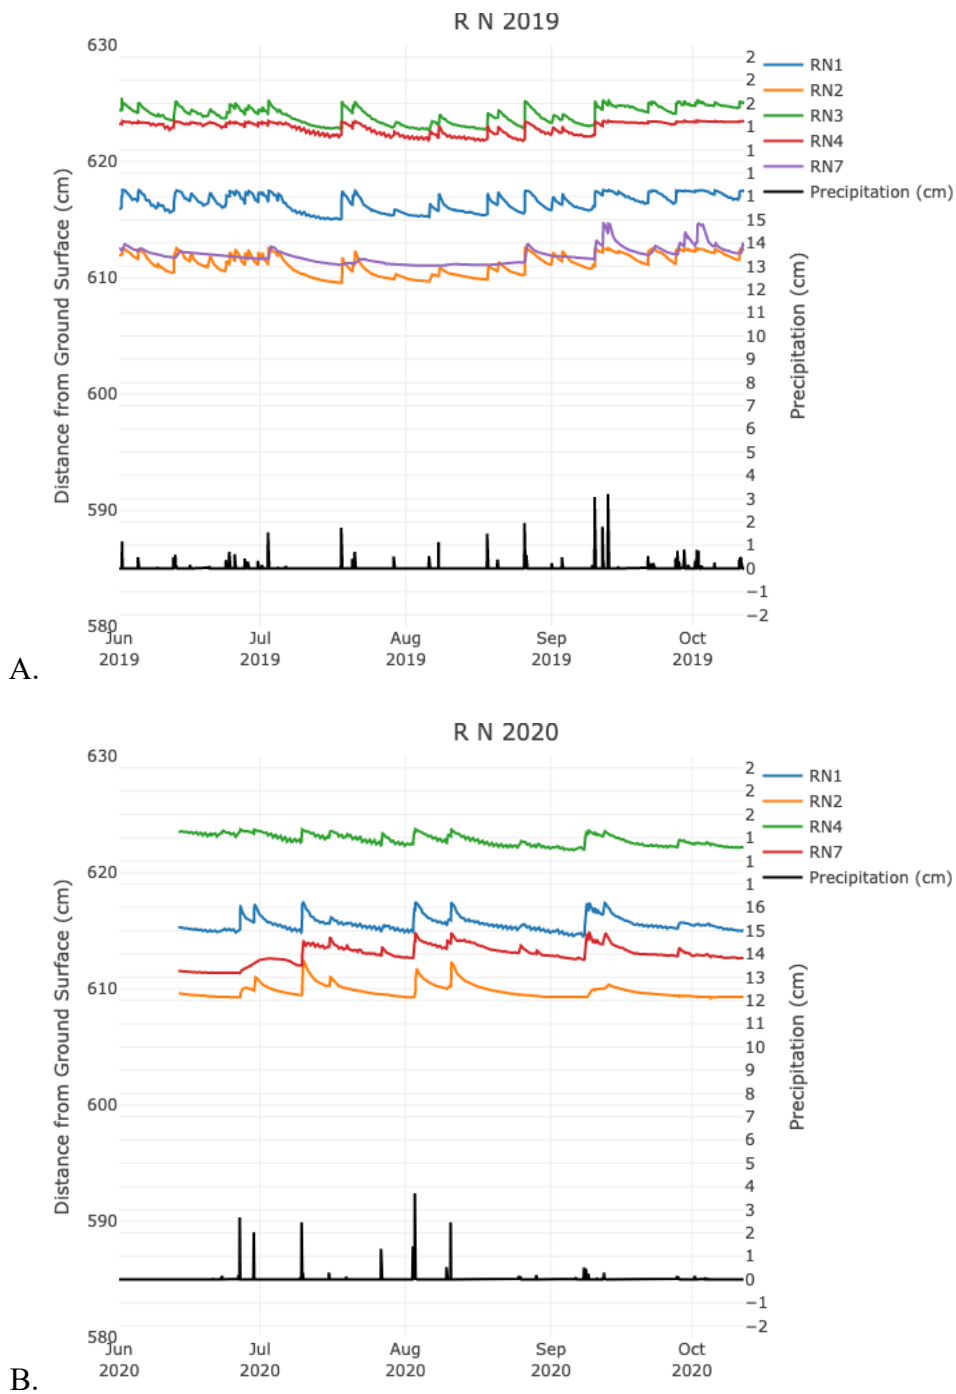
Figure 4.21 Water table elevation in piezometers in the northern section of the restoration site. a. 2019 field season RN1, RN2, RN3, RN4, and RN7. b. 2020 field season RN1, RN2, RN4, and RN7.

- In 2019 the RN piezometers wettest to driest were RN4, RN1, RN3, RN2 and then RN7.
- In 2020 the piezometers wettest to driest were RN4, RN7, RN1, and RN7. On a note, RN7 had a drain leaking for part of the year between July 1 and August 9.
- In 2019 the piezometers wettest to driest were CN5, CN4, CN6, CN3, and CN7. In 2020 the piezometers wettest to driest were CN5, CN6, and CN3.

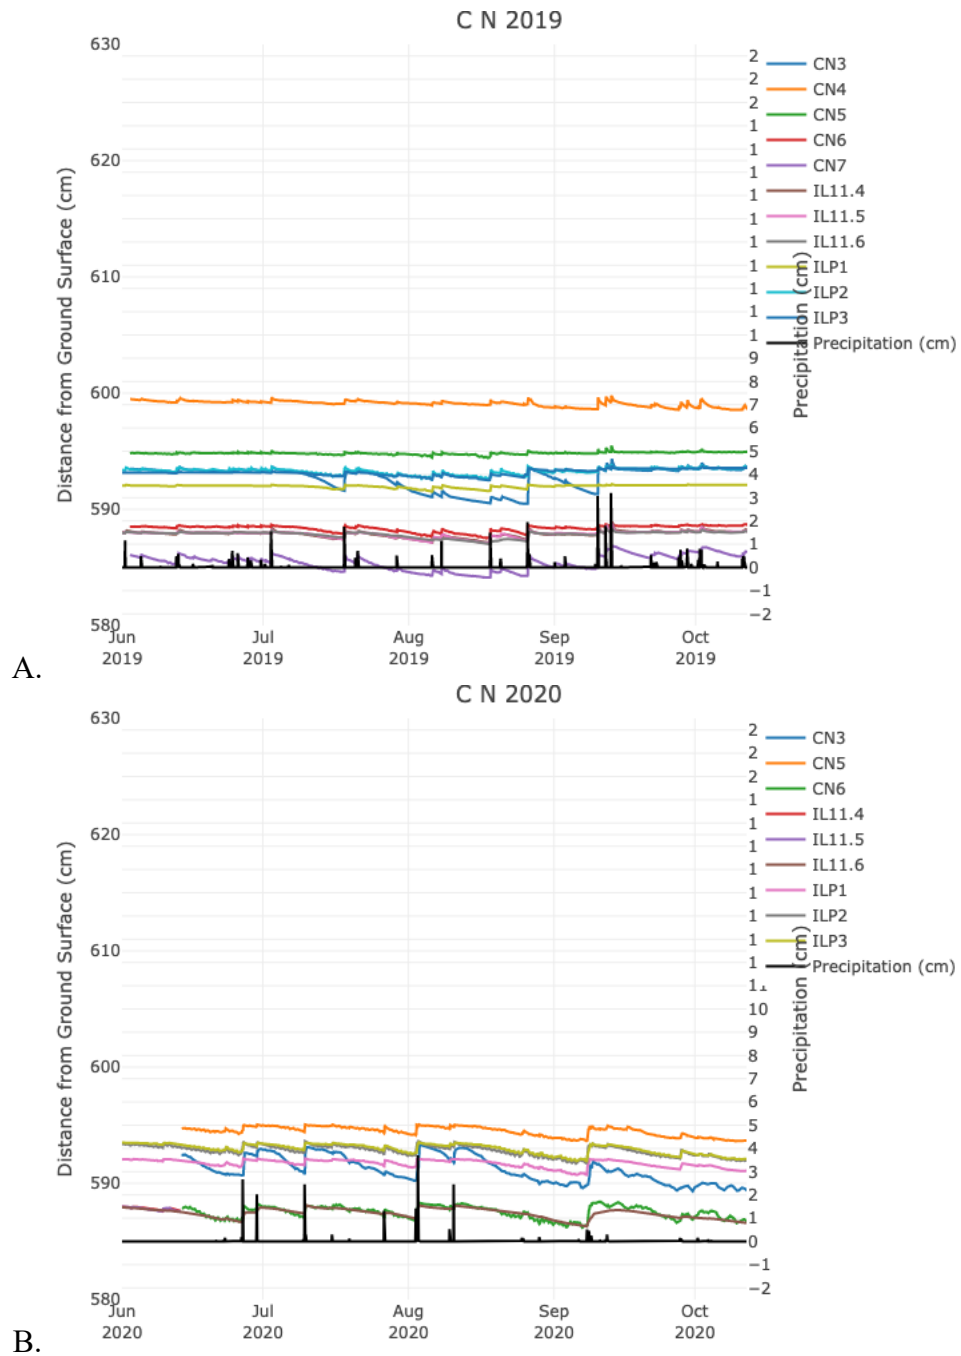
Figure 4.22 Water table elevation for the northern section of Chiwaukee Prairie: a. 2019 field season water depths in piezometers CN3, CN4, CN5, CN6, CN7, ILGS11.4, ILGS11.5 ILGS11.6 ILP1, ILP2, and ILP3; and b. 2020 field season water depths in piezometers CN3, CN5, CN6, ILGS11.4, ILGS11.5 ILGS11.6 ILP1, ILP2, and ILP3.

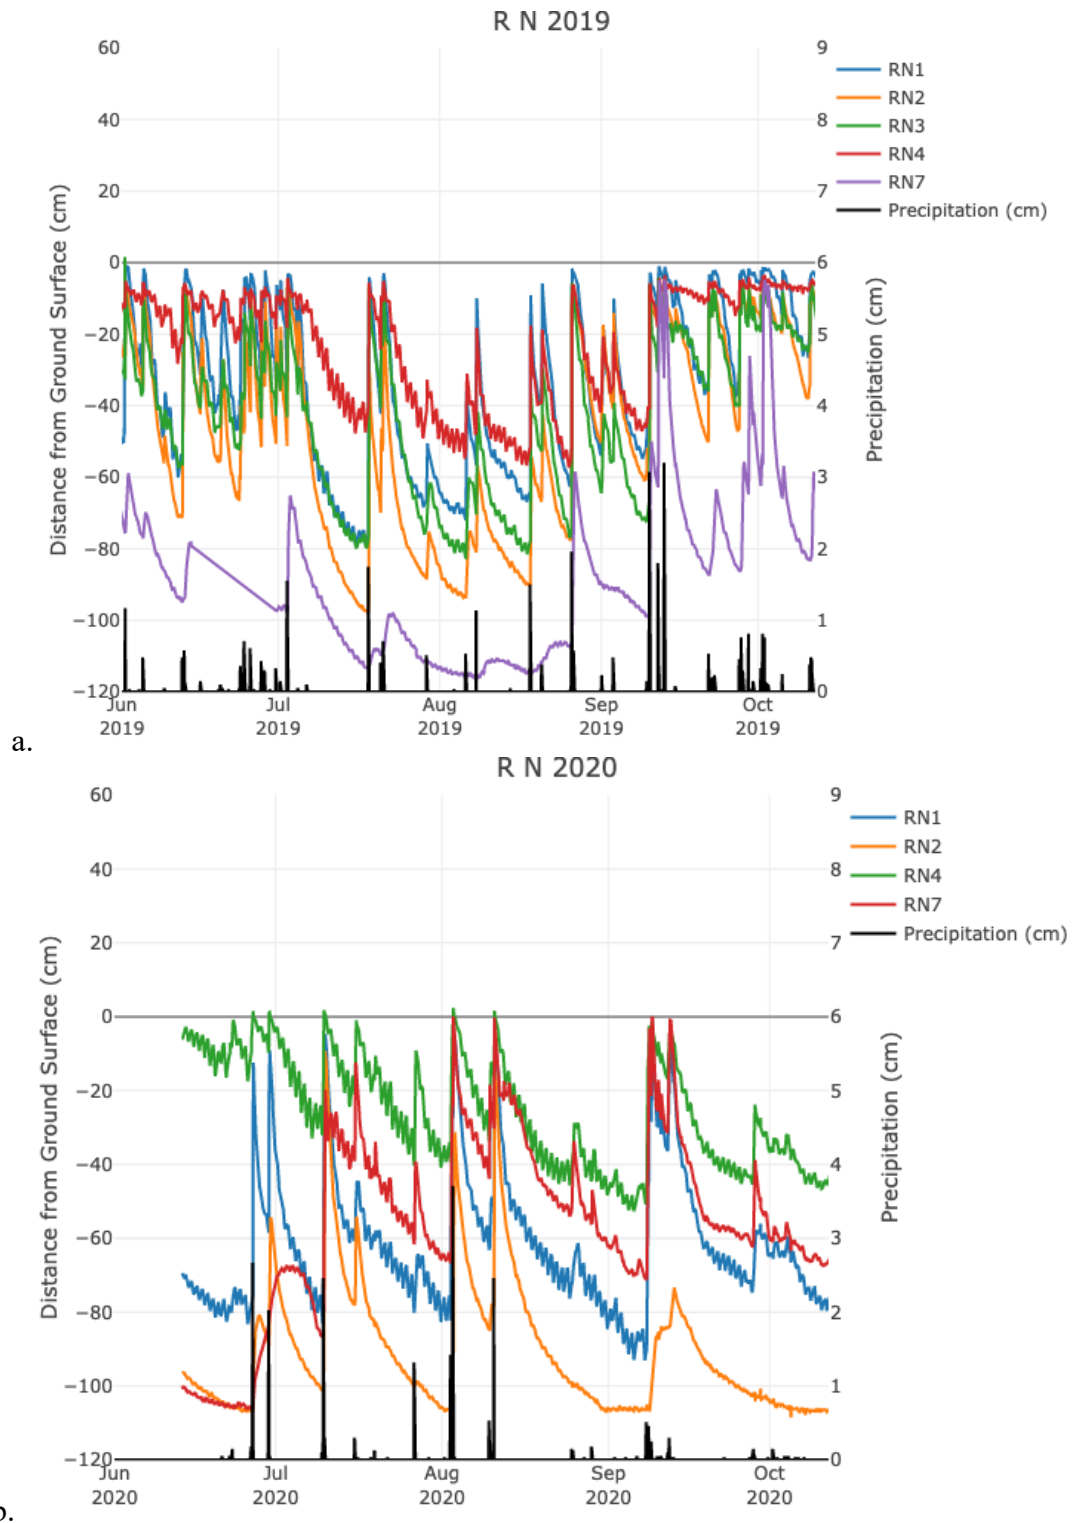
Figure 4.25 Water depths in piezometers in the northern section of the restoration site.
a. 2019 field season RN1, RN2, RN3, RN4, and RN7. b. 2020 field season RN1, RN2, RN4, and RN7.
