HYDROLOGIC INVESTIGATION OF THE CHIWAUKEE PRAIRIE (WISCONSIN) RESTORATION

A REPORT

In Geology

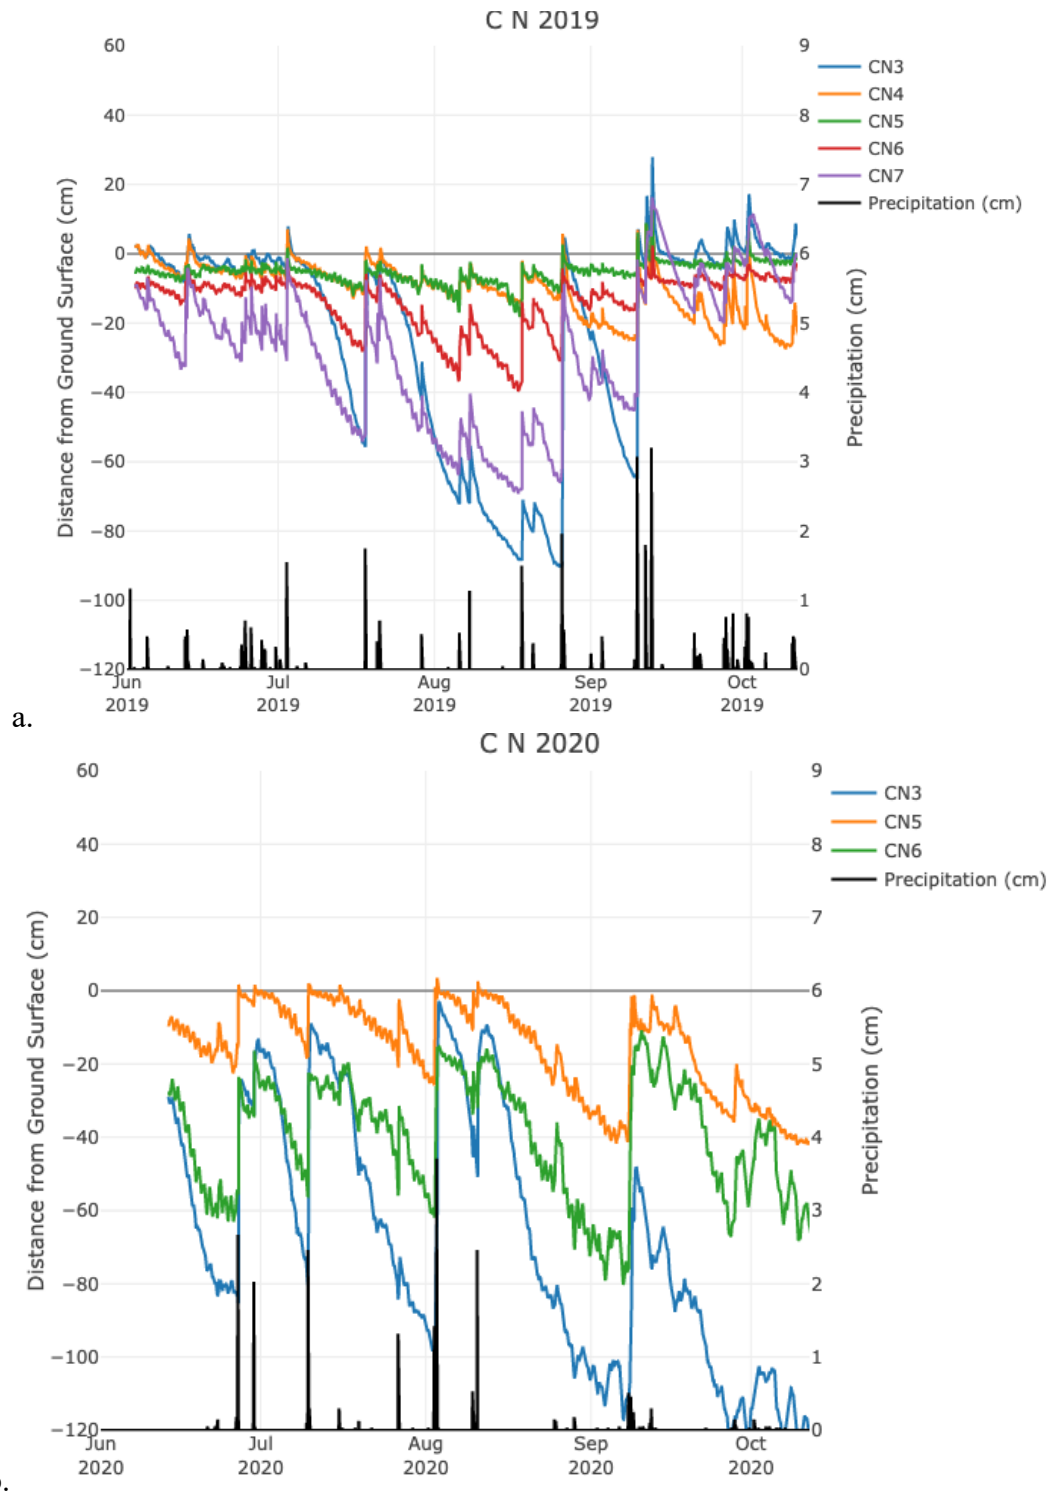
Figure 4.26 Water depths for the northern section of Chiwaukee Prairie: a. 2019 field season water depths in piezometers CN3, CN4, CN5, CN6, and CN7; and b. 2020 field season water depths in piezometers CN3, CN5, and CN6.

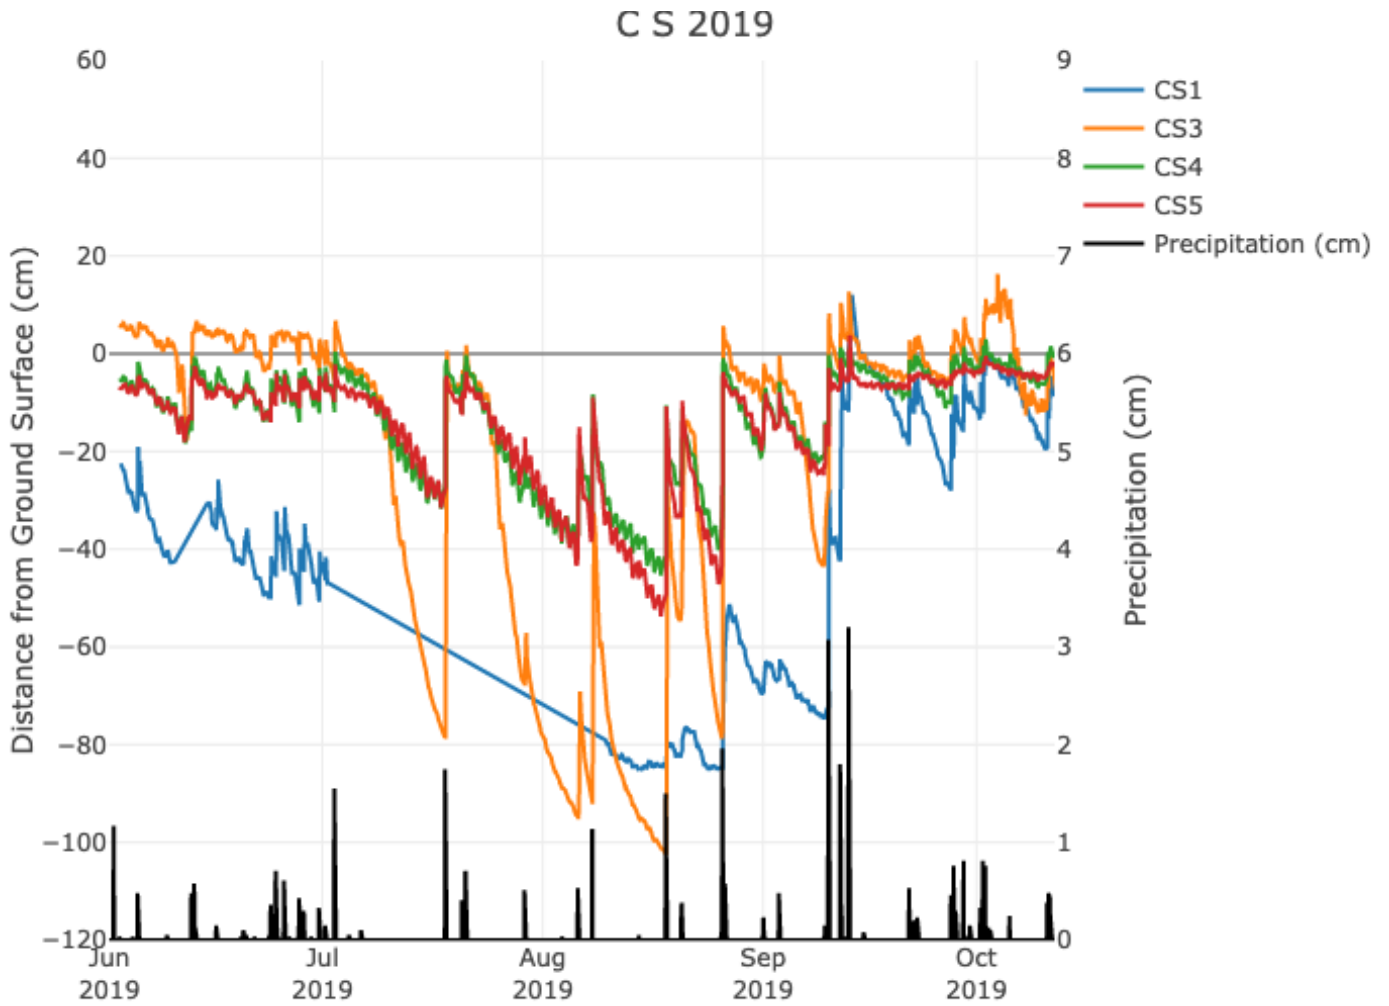
Figure 4.27 Water depths in piezometers CS3, CS4, and CS5 in the 2019 field season. CS1 experienced a 6-week span of no data between the July 1 and August 9.

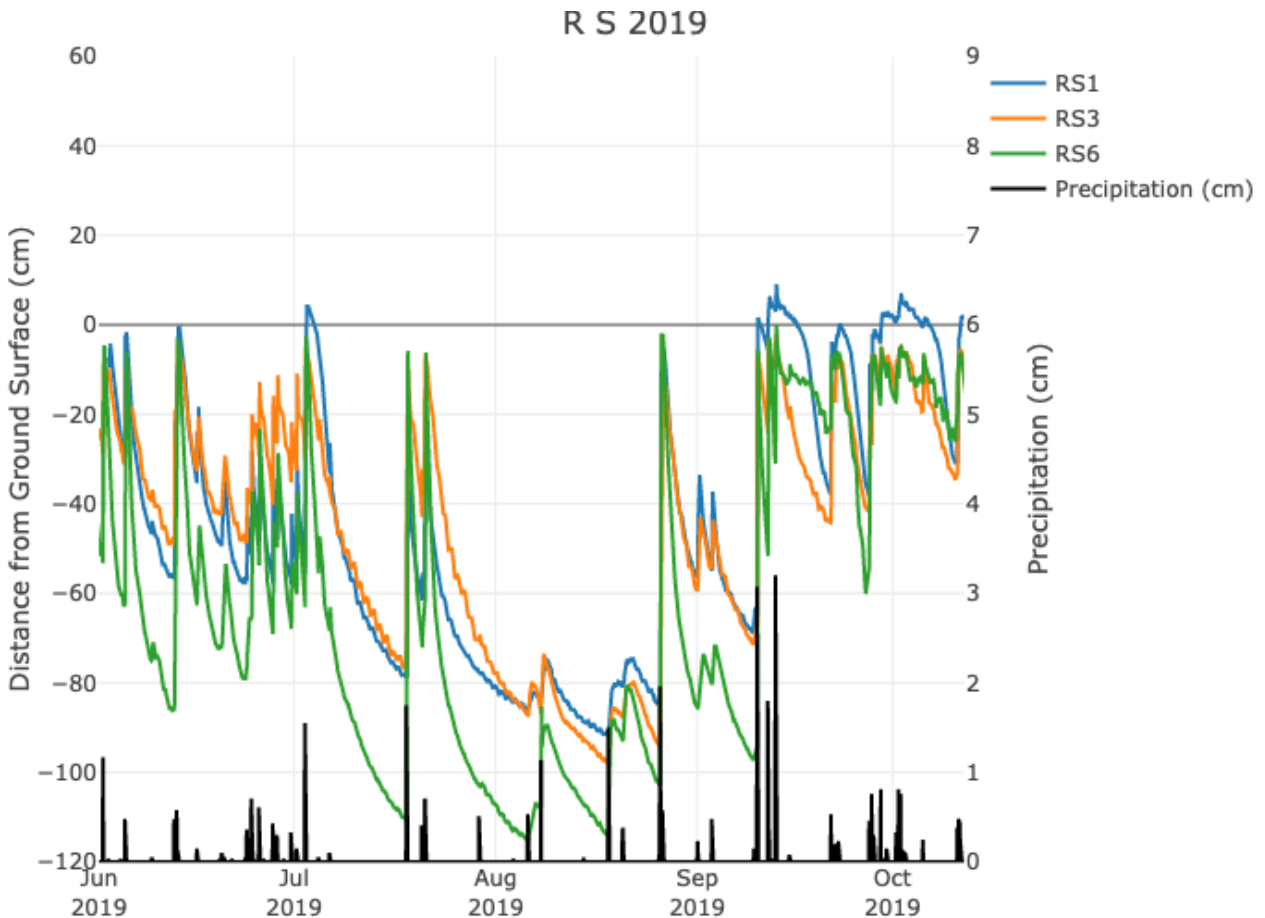
Figure 4.28 Water depths in piezometers RS1, RS3, and RS6 in the 2019 field season.

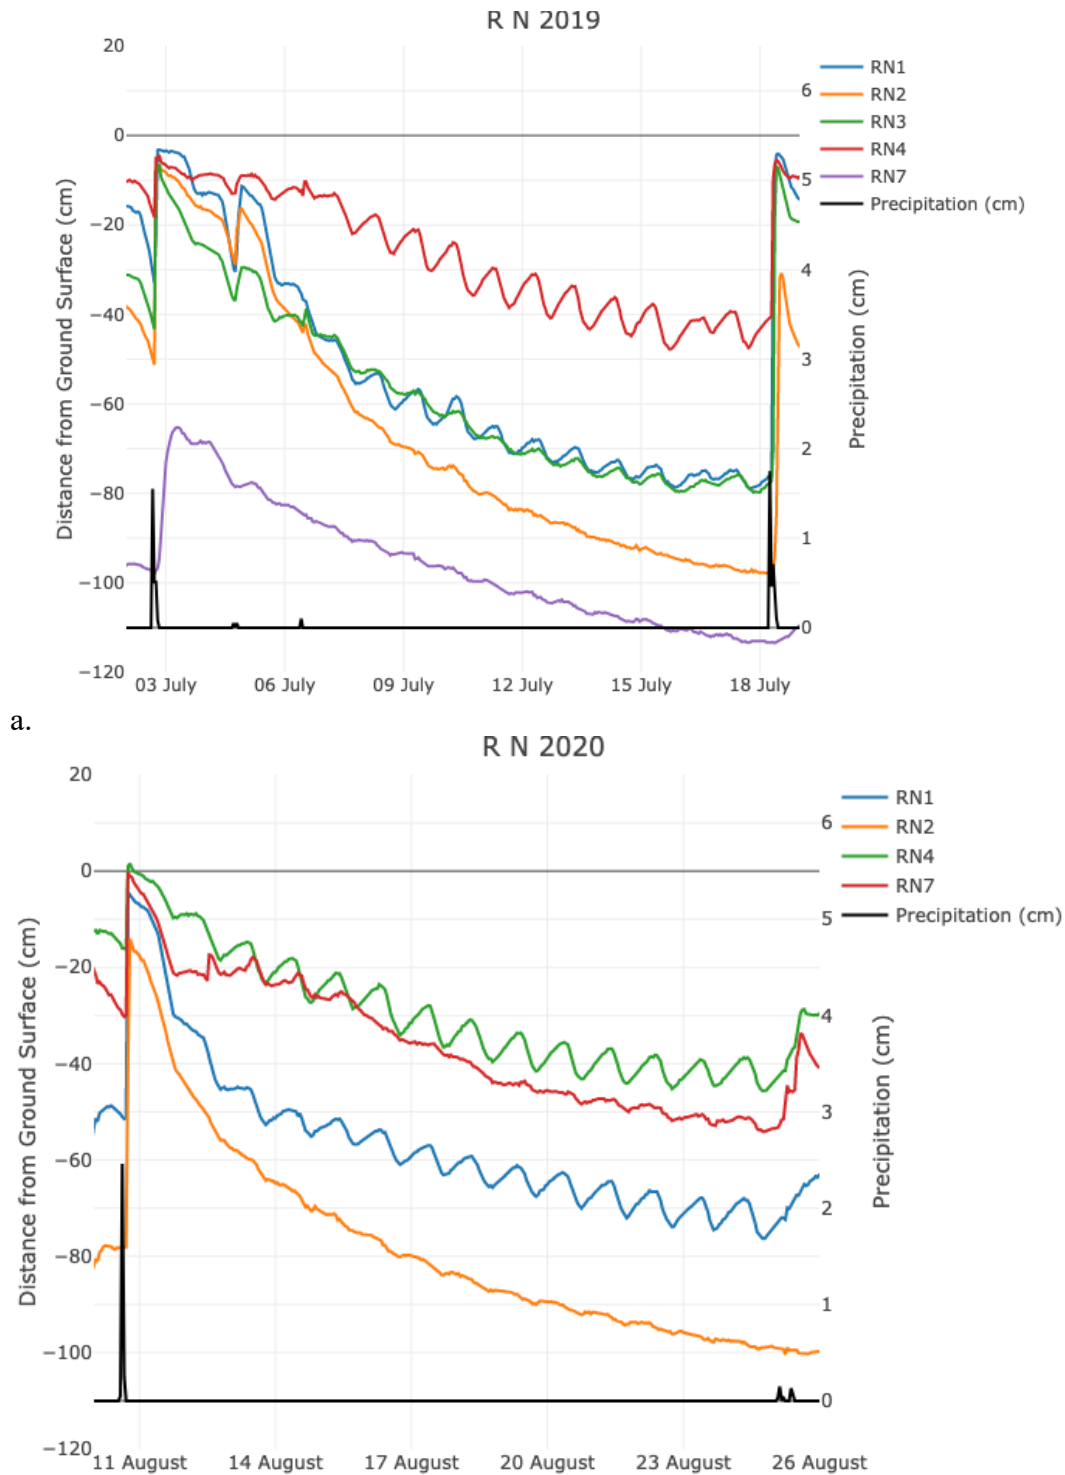
Figure 4.29 Dry-period recession curves from the northern section of the restoration site from 2019 and 2020. a. Water depths in piezometers RN1, RN2, RN3, RN4, and RN7 in the 2019 field season during one 2-week recession period between rain on 3 July 2019 and then on 18 July. b. Water depths in piezometers RN1, RN2, RN4, and RN7 in the 2020 field season during one 2-week recession period between rain on 11 August 2019 and then on 26 August.

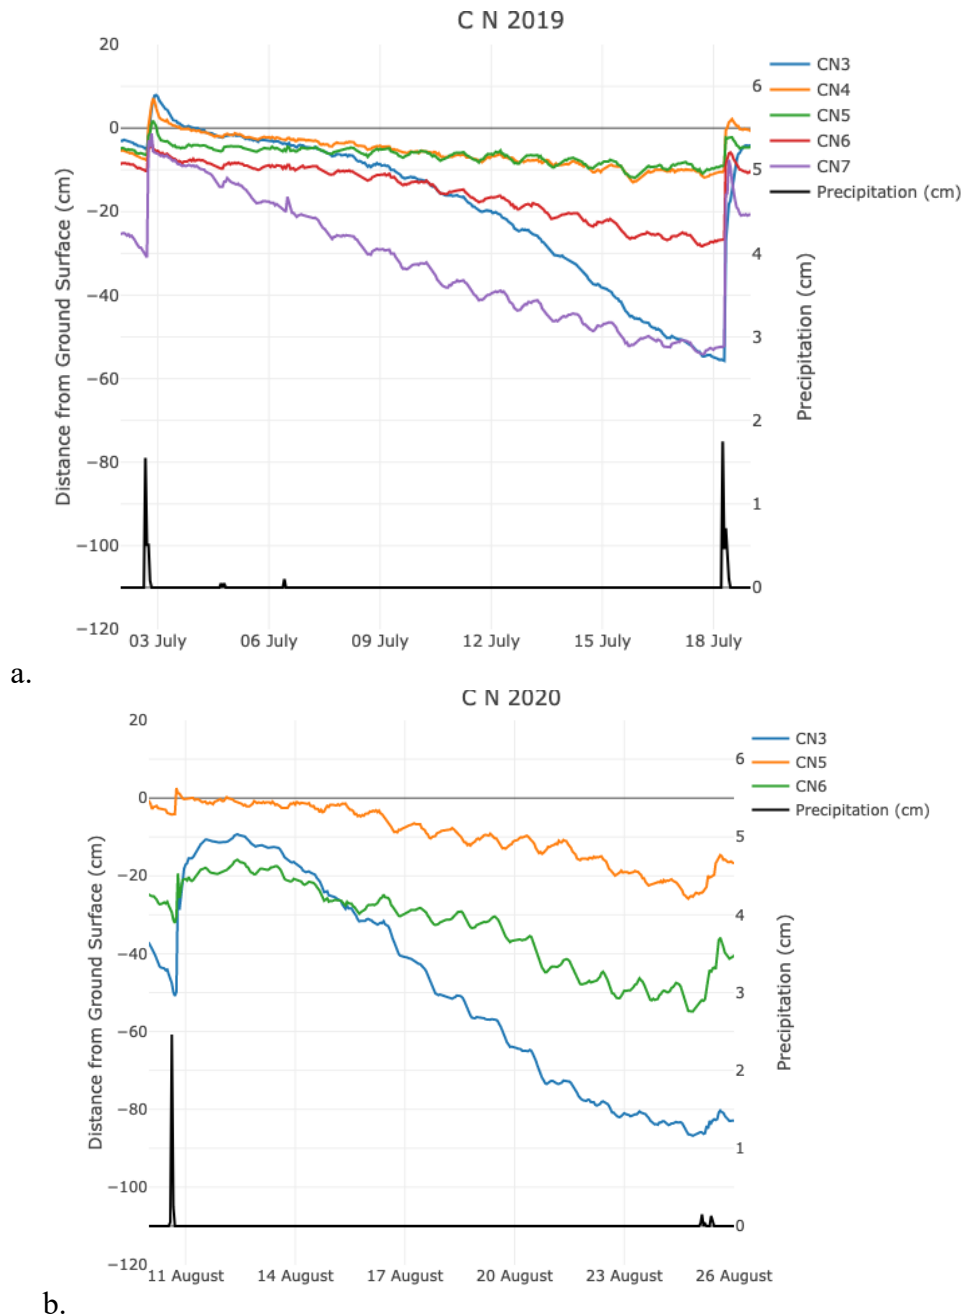
Figure 4.30 Dry-period recession curves from the northern section of Chiwaukee Prairie from 2019 and 2020. a. Water depths in piezometers CN3, CN4, CN5, CN6, and CN7 in the 2019 field season during one 2-week recession period between rain on 3 July 2019 and then on 18 July. b. Water depths in piezometers CN3, CN5, and CN6 in the 2020 field season during one 2-week recession period between rain on 11 August 2019 and then on 26 August.

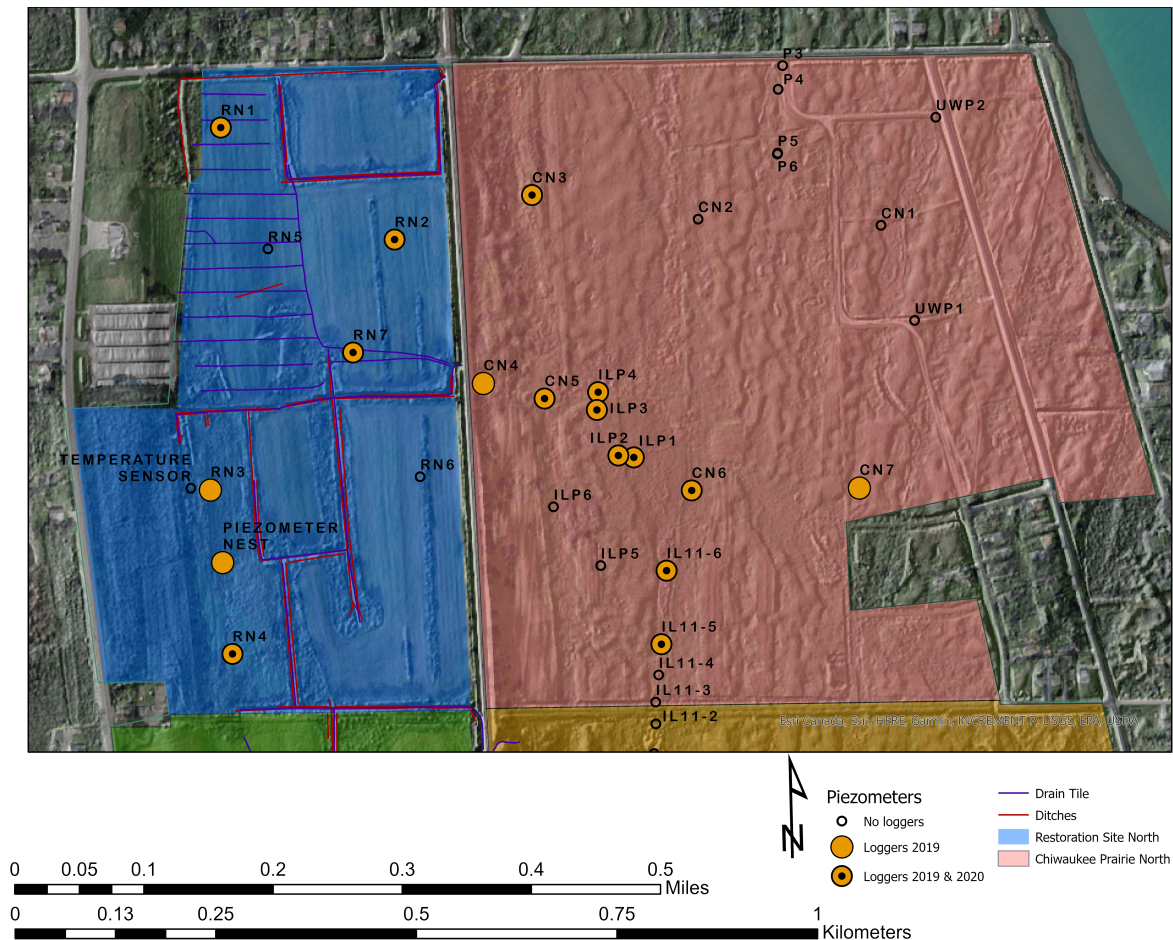
Figure 4.33 Map of the northern sections of the restoration site and Chiwaukee Prairie and the piezometer and pressure-transducer locations for 2019 and 2020.

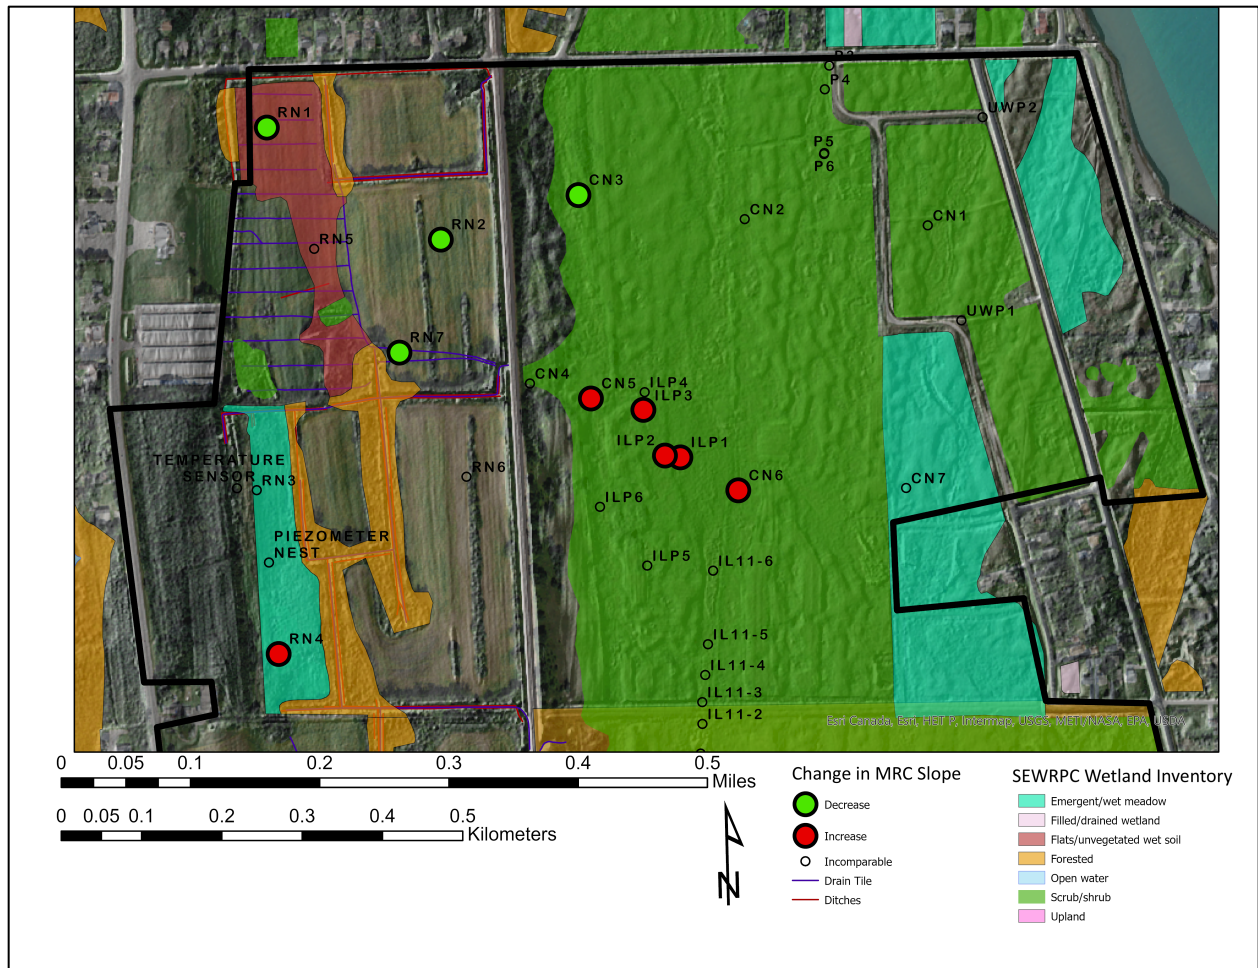
Figure 5.1 Map of the study area showing the piezometers that showed a decrease in master recession curve (MRC) slope in green (slower drying rate), an increase in red, and empty circles where piezometers that were not comparable because the piezometers did not have loggers both years.

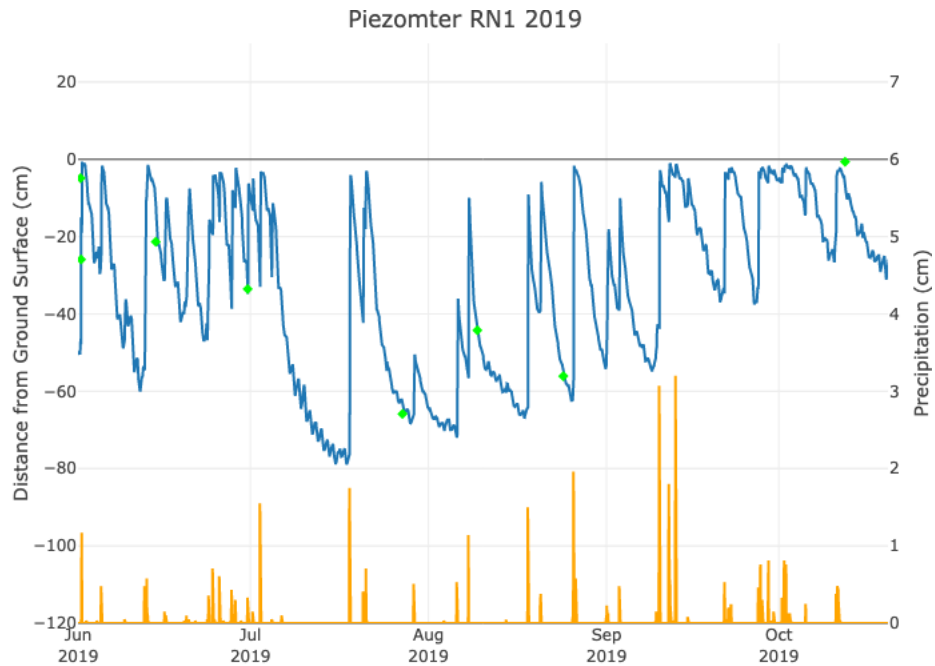
Additional Figure B.12 Water depth in piezometer RN1 during the 2019 field season. The blue line represents the pressure transducer measurements, green diamonds are hand measurements, and orange bars are precipitation.

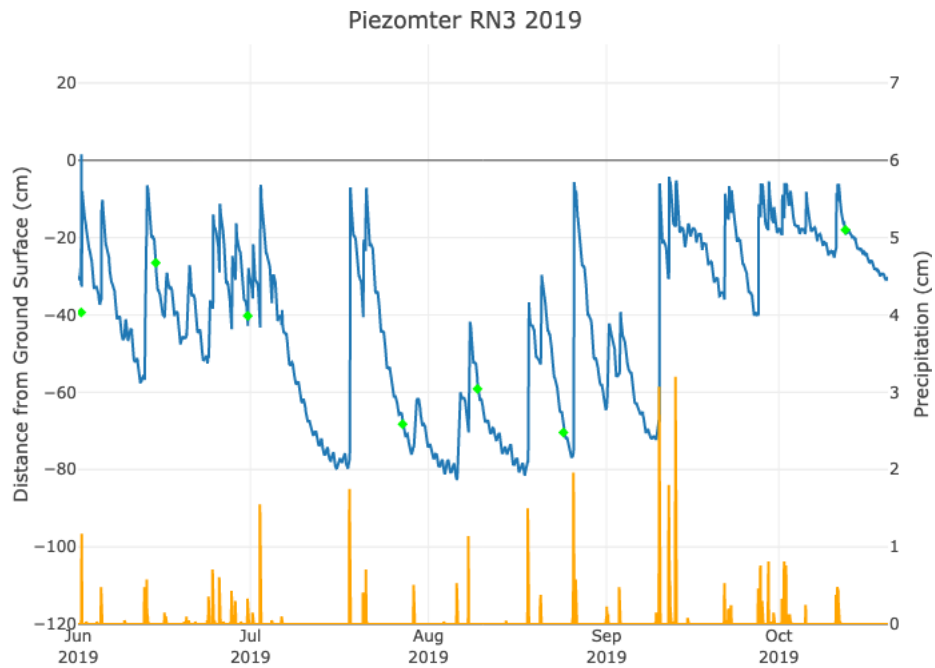
Additional Figure B.14 Water depth in piezometer RN3 during the 2019 field season. The blue line represents the pressure transducer measurements, green diamonds are hand and orange bars are precipitation.

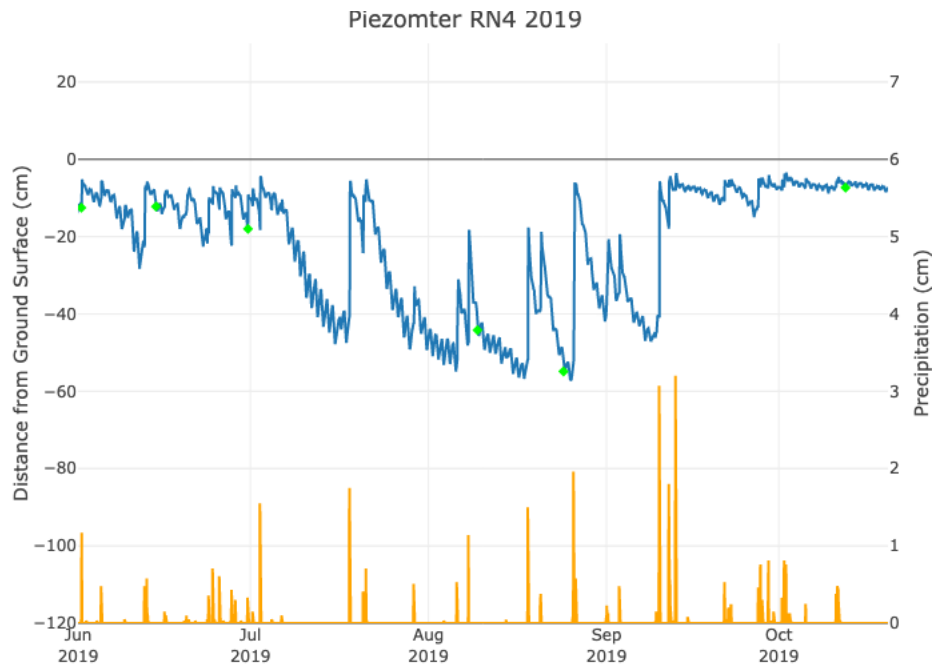
Additional Figure B.15 Water depth in piezometer RN4 during the 2019 field season. The blue line represents the pressure transducer measurements, green diamonds are hand orange bars are precipitation.

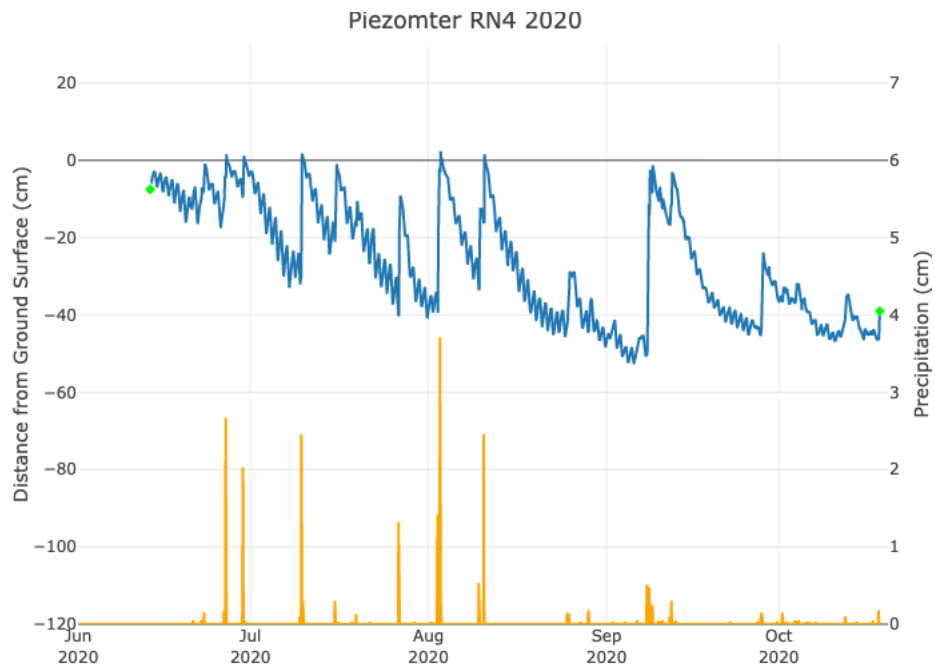
Additional Figure B.16 Water depth in piezometer RN4 during the 2020 field season. The blue line represents the pressure transducer measurements, green diamonds are hand orange bars are precipitation.

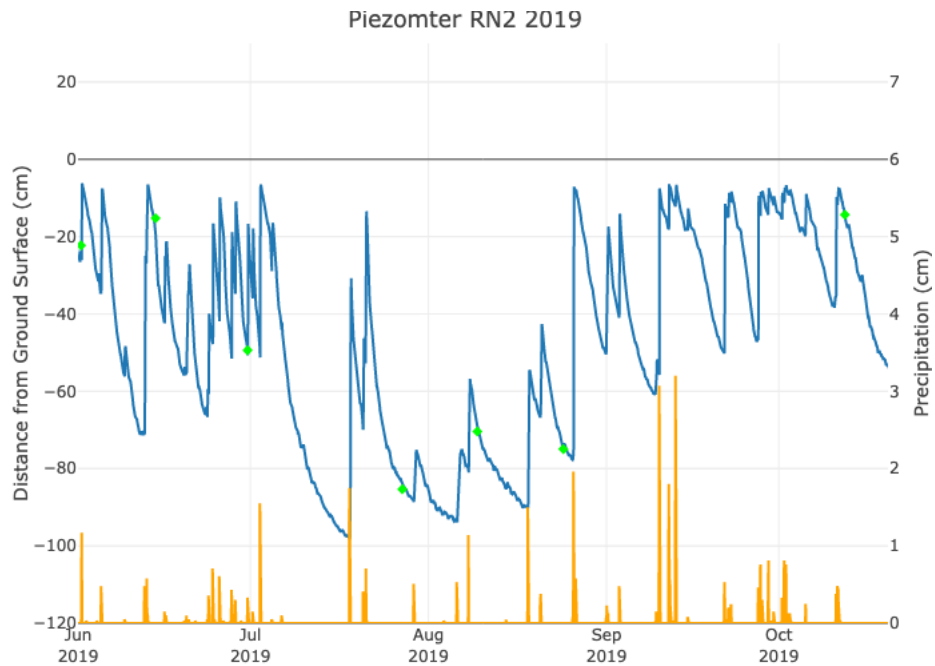
Additional Figure B.17 Water depth in piezometer RN2 during the 2019 field season. The blue line represents the pressure transducer measurements, green diamonds are hand orange bars are precipitation.

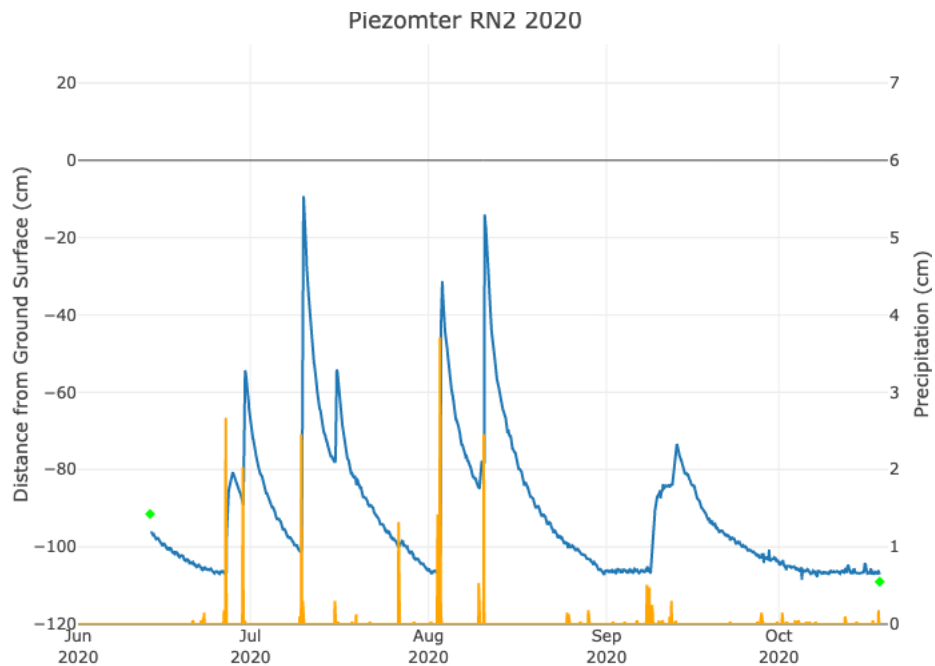
Additional Figure B.18 Water depth in piezometer RN2 during the 2020 field season. The blue line represents the pressure transducer measurements, green diamonds are hand orange bars are precipitation.

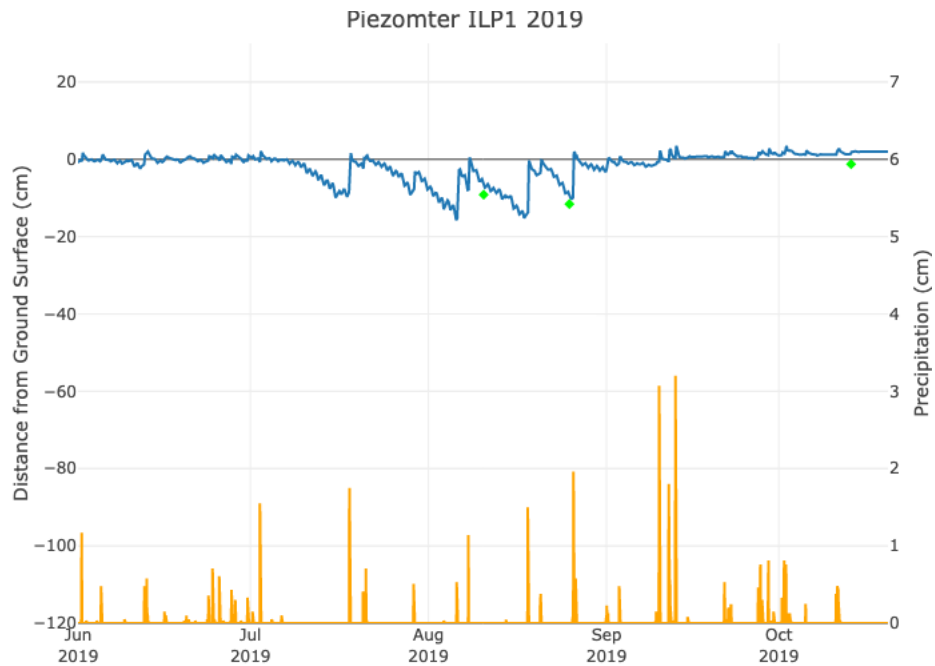
Additional Figure B.21 Water depth in piezometer ILP1 during the 2019 field season. The blue line represents the pressure transducer measurements, green diamonds are hand orange bars are precipitation.

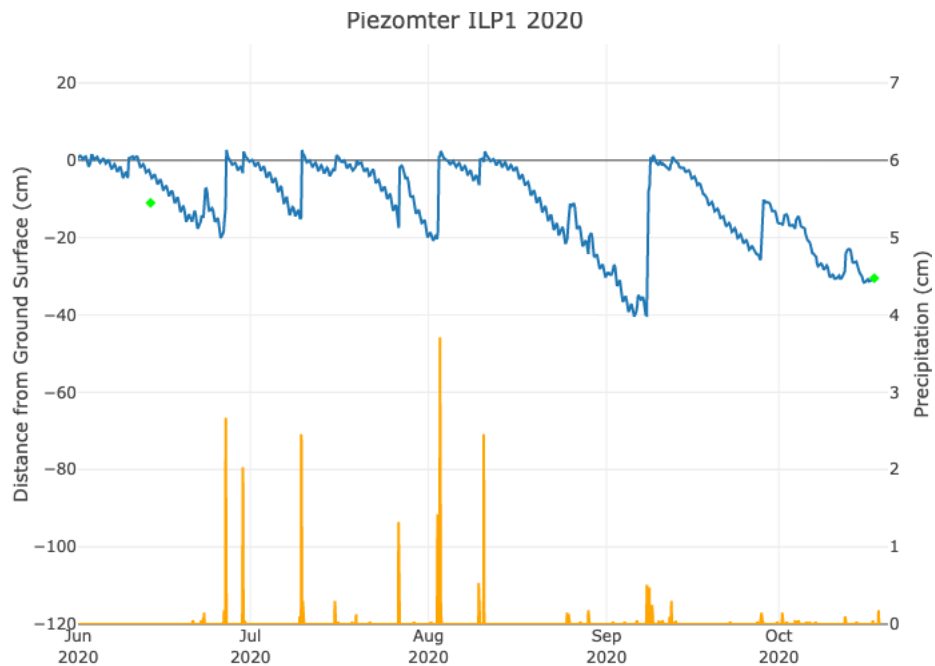
Additional Figure B.22 Water depth in piezometer ILP1 during the 2020 field season. The blue line represents the pressure transducer measurements, green diamonds are hand orange bars are precipitation.

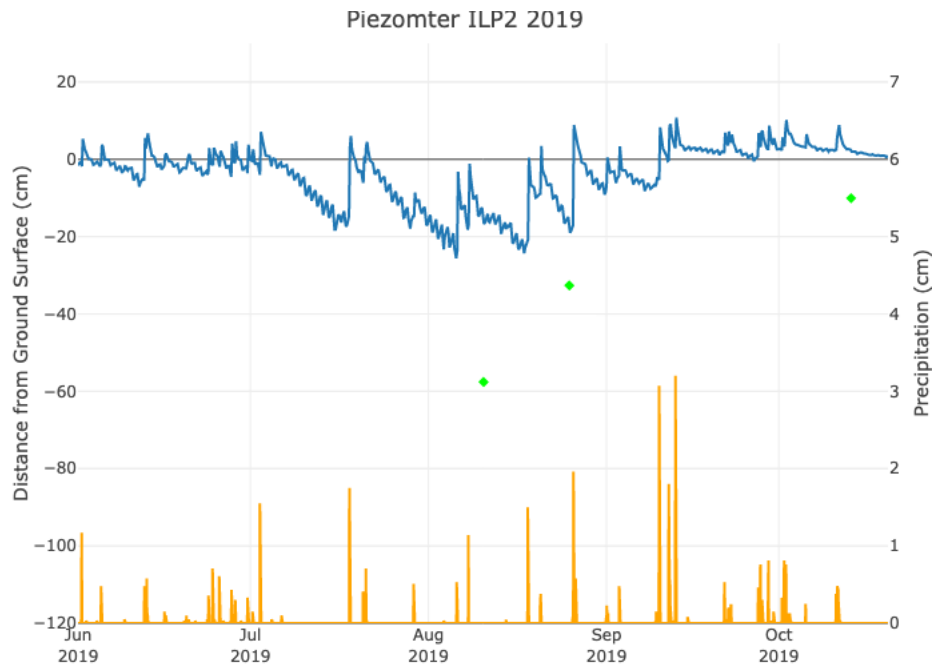
Additional Figure B. Water depth in piezometer ILP2 during the 2019 field season. The blue line represents the pressure transducer measurements, green diamonds are hand orange bars are precipitation.

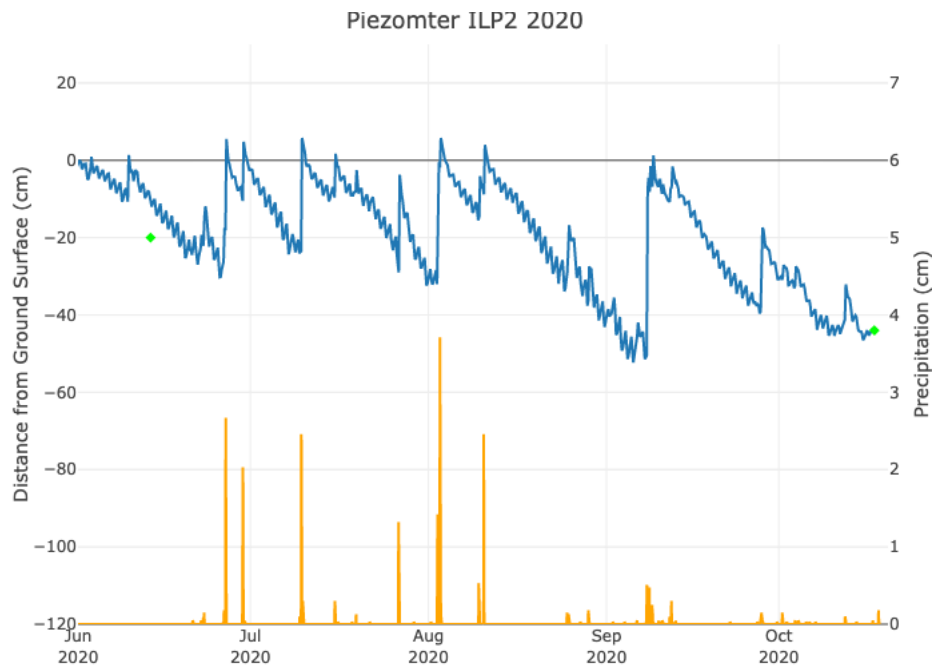
Additional Figure B.23 Water depth in piezometer ILP2 during the 2020 field season. The blue line represents the pressure transducer measurements, green diamonds are hand orange bars are precipitation.

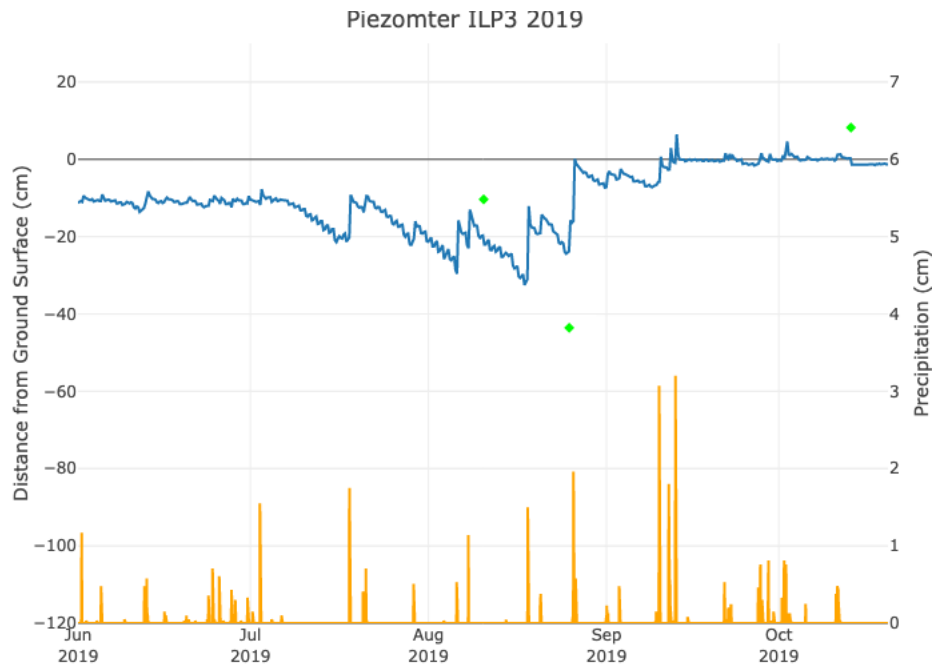
Additional Figure B.24 Water depth in piezometer ILP3 during the 2019 field season. The blue line represents the pressure transducer measurements, green diamonds are hand orange bars are precipitation.

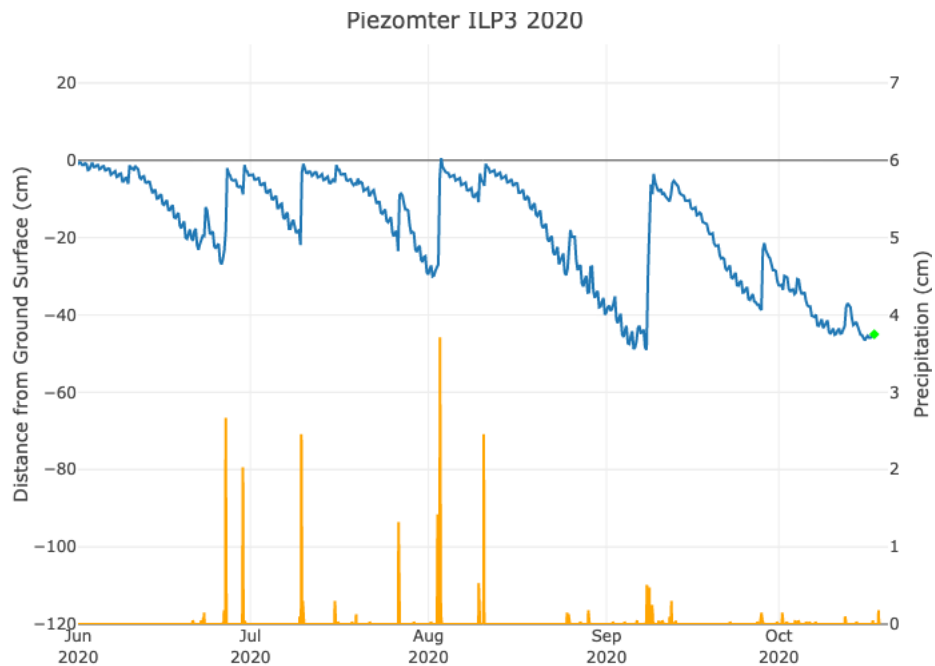
Additional Figure B.25 Water depth in piezometer ILP3 during the 2020 field season. The blue line represents the pressure transducer measurements, green diamonds are hand orange bars are precipitation.

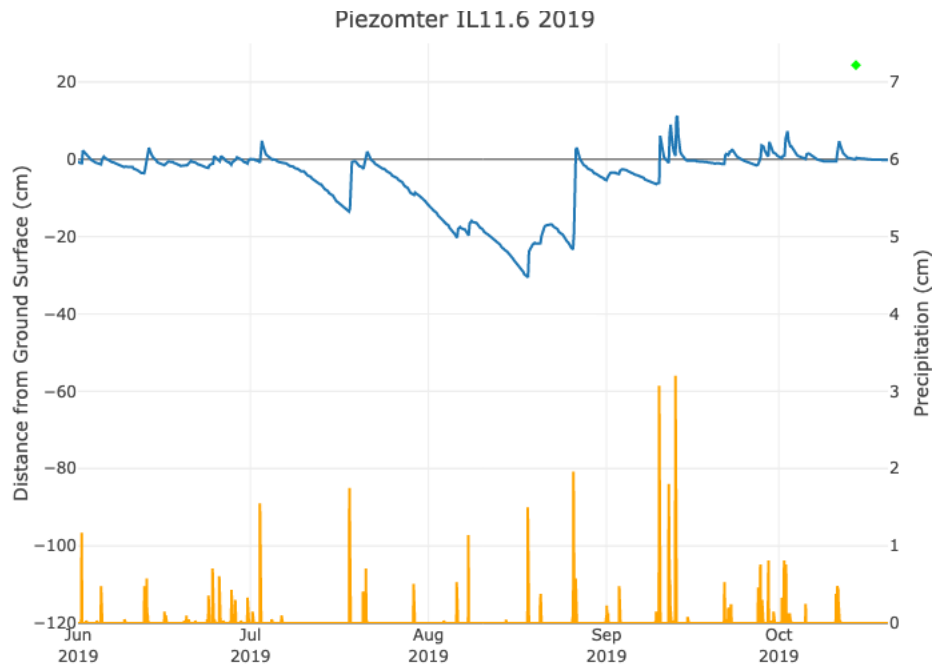
Additional Figure B.26 Water depth in piezometer IL11.6 during the 2019 field season. The blue line represents the pressure transducer measurements, green diamonds are hand orange bars are precipitation.

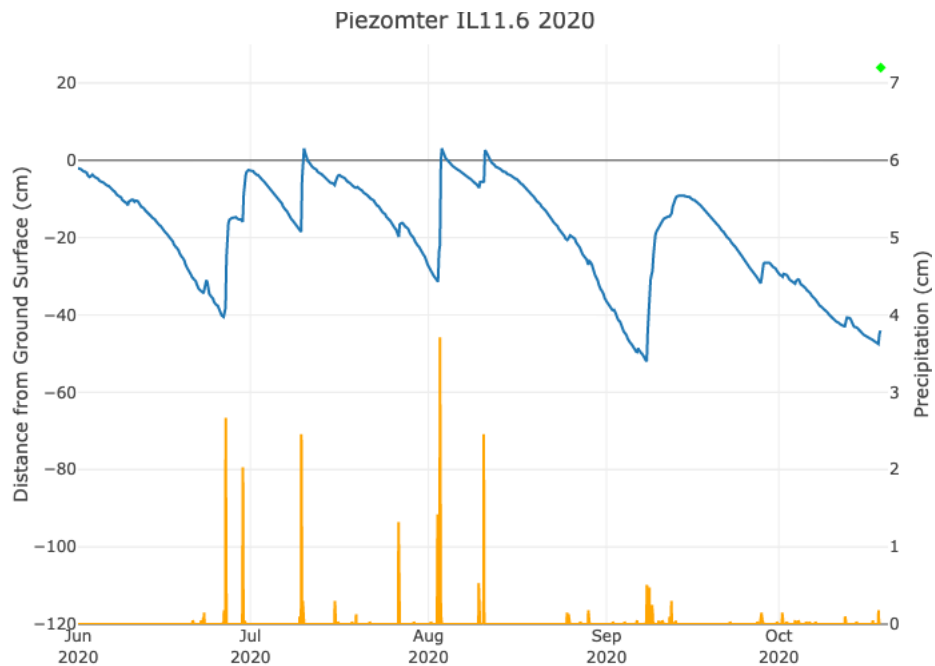
Additional Figure B.27 Water depth in piezometer IL11.6 during the 2020 field season. The blue line represents the pressure transducer measurements, green diamonds are hand orange bars are precipitation.

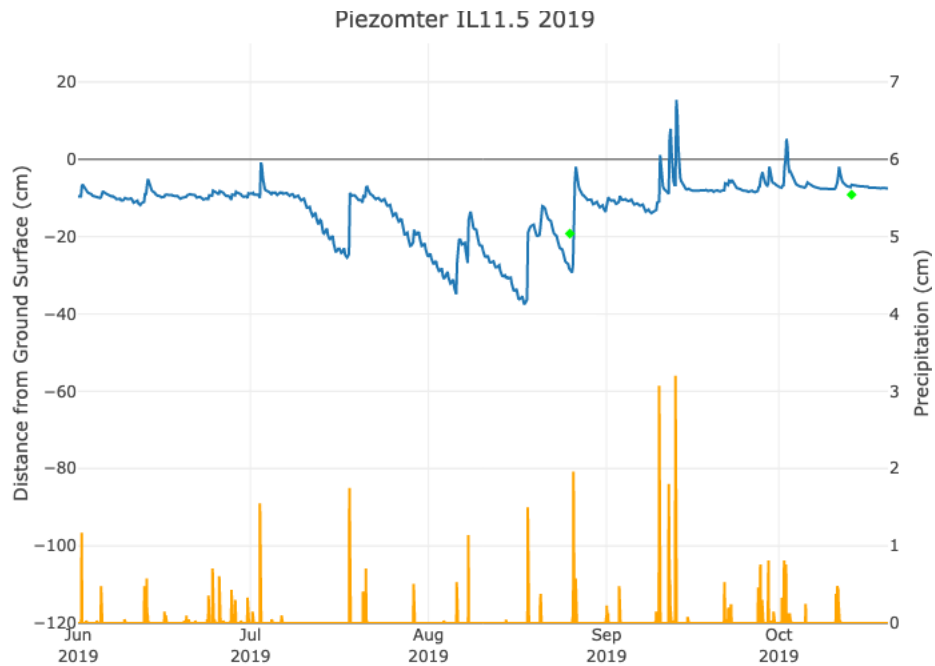
Additional Figure B.28 Water depth in piezometer IL11.5 during the 2019 field season. The blue line represents the pressure transducer measurements, green diamonds are hand orange bars are precipitation.

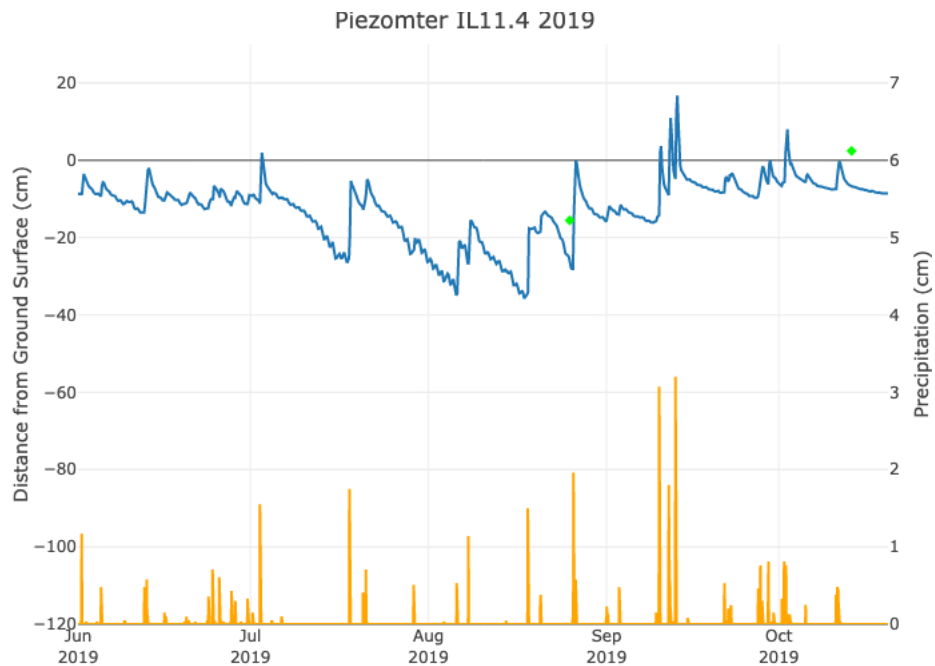
Additional Figure B.29 Water depth in piezometer IL11.4 during the 2019 field season. The blue line represents the pressure transducer measurements, green diamonds are hand orange bars are precipitation.

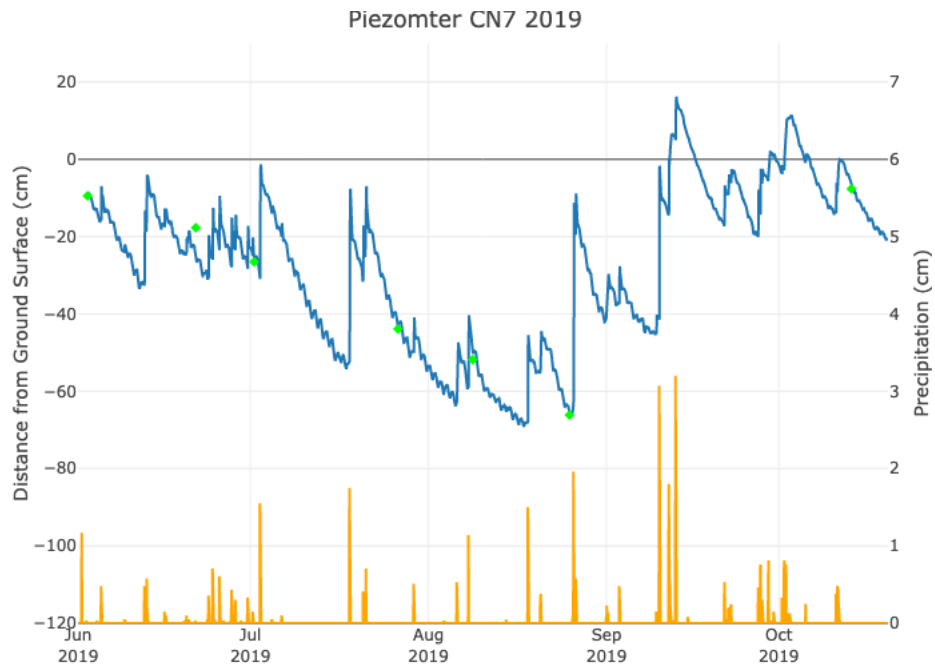
Additional Figure B.30 Water depth in piezometer CN7 during the 2019 field season. The blue line represents the pressure transducer measurements, green diamonds are hand measurements, and orange bars are precipitation.

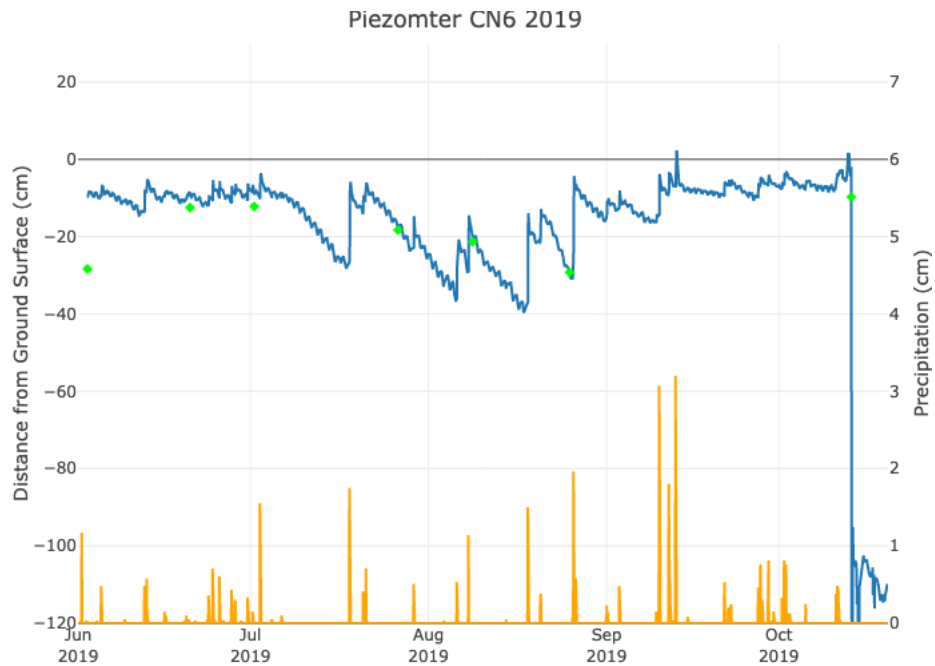
Additional Figure B.31 Water depth in piezometer CN6 during the 2019 field season. The blue line represents the pressure transducer measurements, green diamonds are hand orange bars are precipitation.

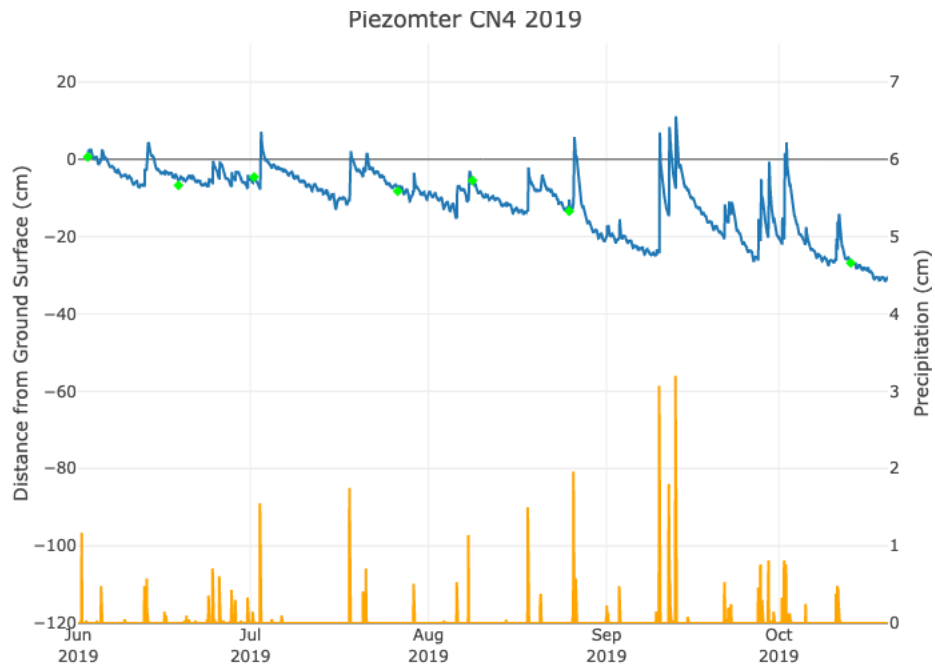
Additional Figure B.35 Water depth in piezometer CN4 during the 2019 field season. The blue line represents the pressure transducer measurements, green diamonds are hand measurements, and orange bars are precipitation.
