HYDROLOGIC INVESTIGATION OF THE CHIWAUKEE PRAIRIE (WISCONSIN) RESTORATION

A REPORT

In Geology

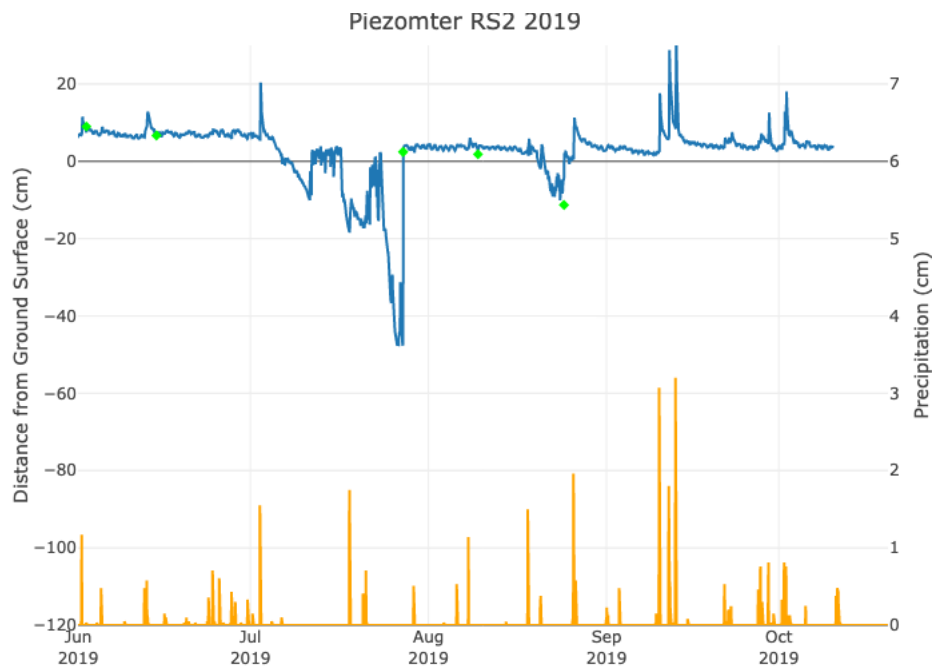
Additional Figure B.40 Water depth in piezometer RS2 during the 2019 field season. The blue line represents the pressure transducer measurements, green diamonds are hand and orange bars are precipitation.

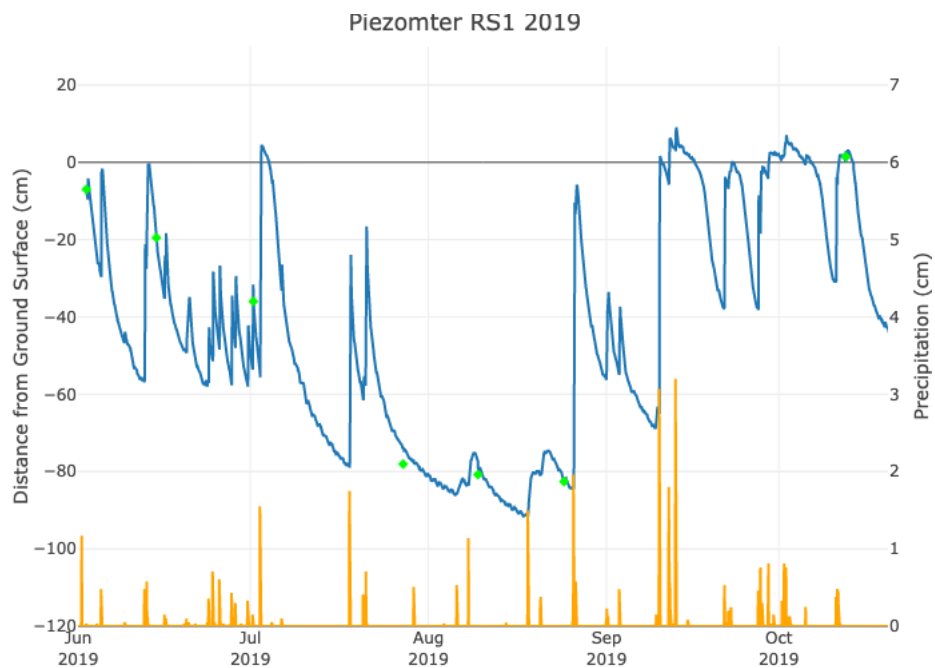
Additional Figure B.41 Water depth in piezometer RS1 during the 2019 field season. The blue line represents the pressure transducer measurements, green diamonds are hand and orange bars are precipitation.

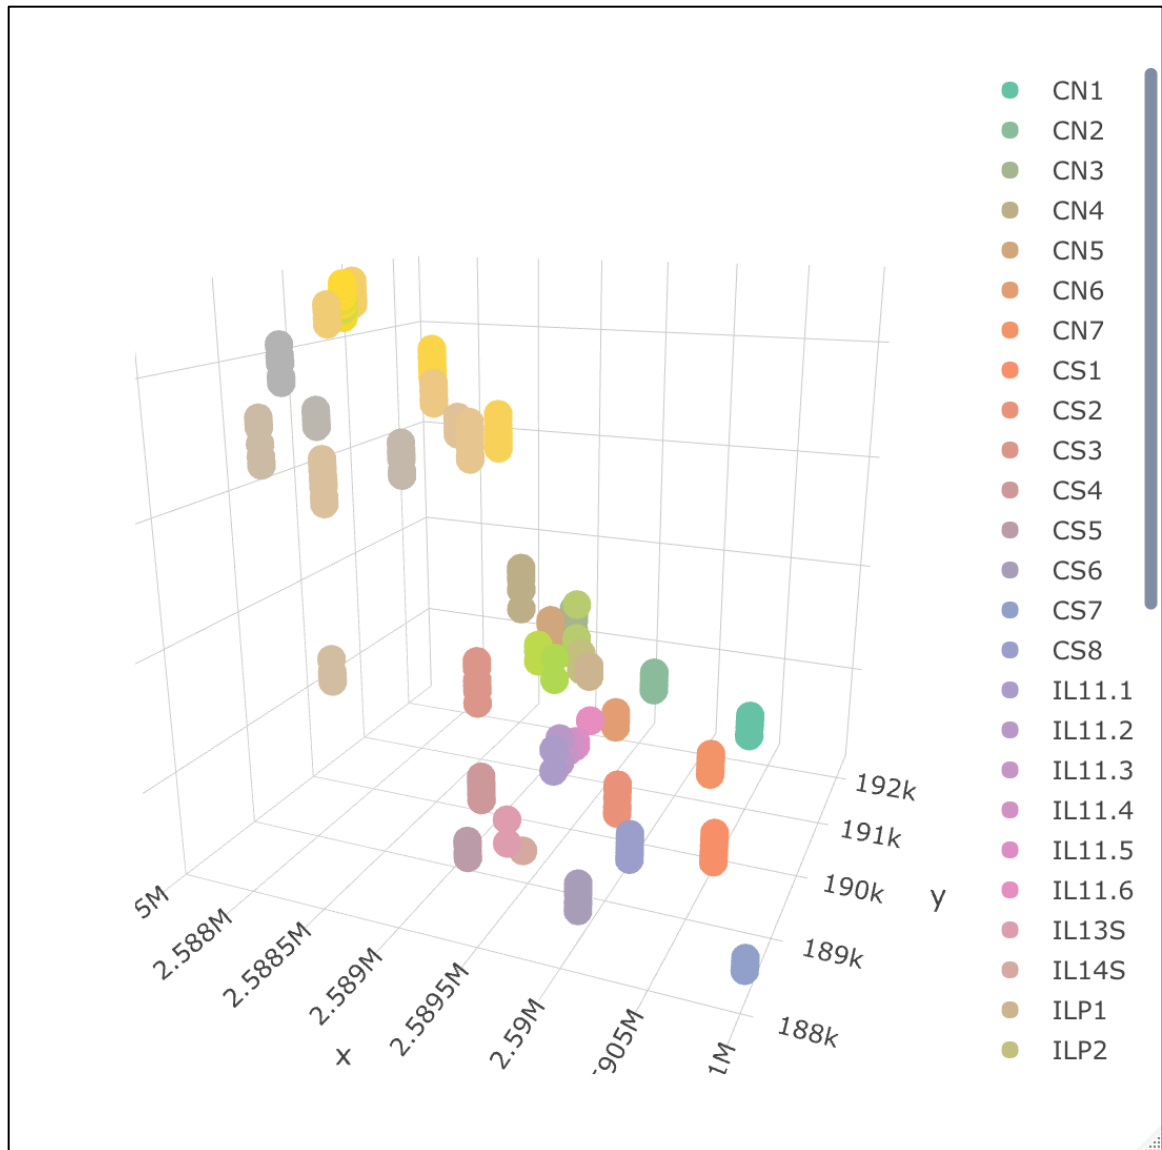
Additional Figure B.47 Three-dimensional scatter plot of all the recorded water table elevations from the hand measurements.
