Light detection and ranging (LiDAR) and multispectral scanner (MSS) studies examine coastal environments influenced by mining

Light Detection and Ranging (LiDAR) and Multispectral Scanner (MSS) Studies Examine Coastal Environments Influenced by Mining

Keywords: LiDAR; MSS; mining; coastal; stamp sands

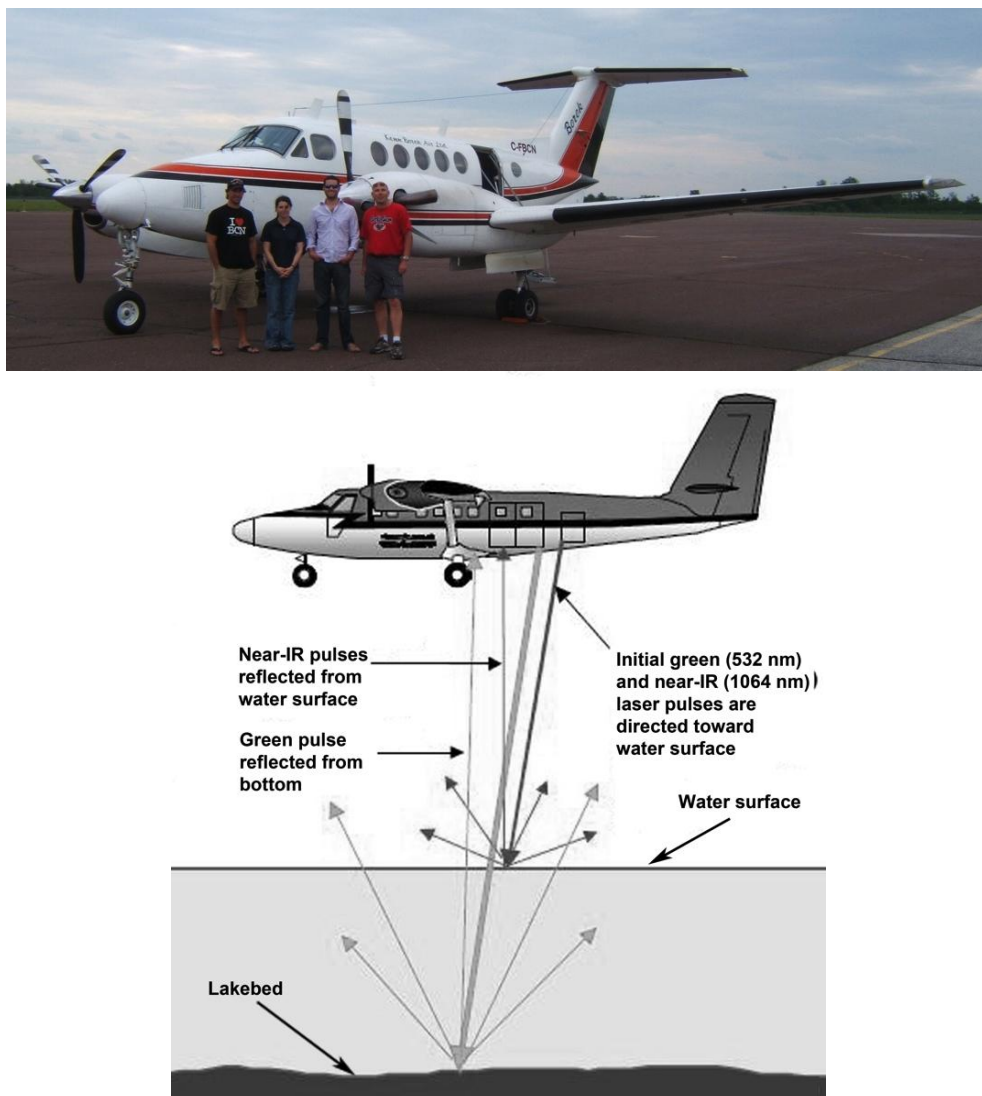
Figure 1. The Compact Hydrographic Airborne Rapid Total Survey (CHARTS) system (see the Methods) operated from a fixed wing King Air Beechcraft 2000, shown with the crew at the Houghton County Memorial Airport. For light detection and ranging (LiDAR), two laser pulses (blue-green 532 nm and near-IR 1,064 nm) are directed downward towards the lake water surface. The near-IR reflects from the water surface, whereas the blue-green penetrates through the water column and reflects off the lakebed. The difference between the two returning pulses gives the depth of the water column (bathymetry) and reveals the fine details of the benthic structure (the plane diagram is modified from LeRocque and West [12]).

Most of the airborne coastal mapping and charting data was collected using the CHARTS system [25]. CHARTS is a NAVOCEANO owned asset shared with the US Army Corps of Engineers (USACE [26,27]), which includes an Optech SHOALS 3000T20 with a 3-kHz bathymetric full waveform LiDAR (a green laser in the 532 nm wavelength) and a 20-kHz topographic discrete return LiDAR (near-infrared laser in the 1,064 nm wavelength), measuring land elevations with high resolution and accuracy (1-m spot spacing, ± 15 cm elevation accuracy), as well as water depths in areas of relatively clear water, or two to three times the Secchi depth (5-m spot spacing, ± 30 cm elevation accuracy [28]). The system also includes an Itres Compact Airborne Spectrographic Imager (CASI)-1500 for hyperspectral imaging, in which many narrow, contiguous spectral bands are measured across the electromagnetic spectrum [29]. The CASI hyperspectral scanner was configured to acquire data over eight bands uniformly spaced between 374 and 1,050 nm, including five visible wavelengths (nominal bandwidth of 84 nm). For distinguishing sediment types, our main focus was on the green and red portion of the visible spectrum (495–750 nm). The delineation of the land-water boundary was best when using near-infrared bands.

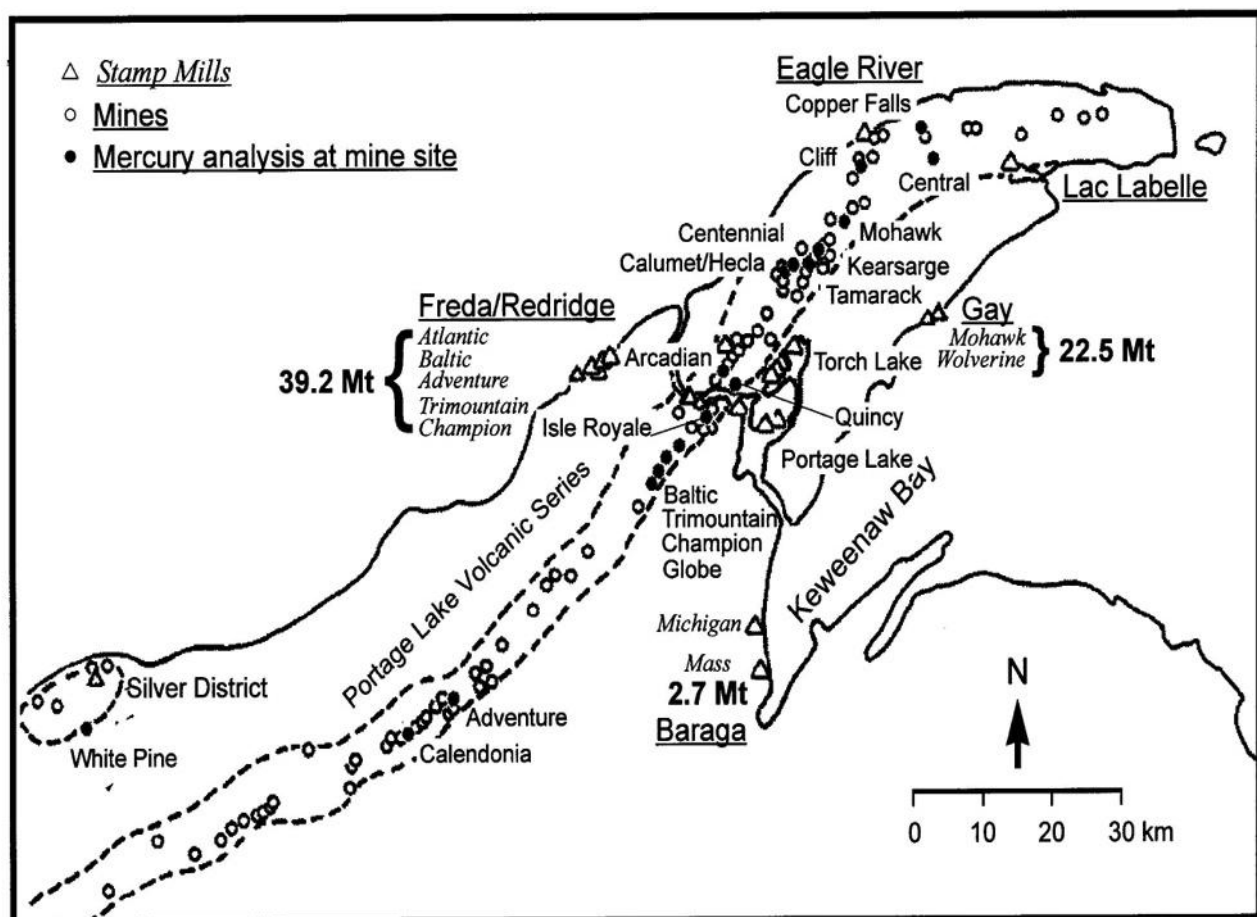
Figure 2. Native copper and silver mine era locations along the Keweenaw Peninsula, Upper Peninsula, of Michigan. The amount of tailings discharged (Mt, million metric tons) from larger, coastline “stamp” mills (1895–1947) are shown. The locations of mines (circles) and mills (hollow triangles) are plotted along the Portage Lake Volcanic Series and on the coast (modified from Kerfoot *et al.*, [9]).

Grand (Big) Traverse Bay is an embayment along the southern coastline of Lake Superior, off the Keweenaw Peninsula (Figures 2 and 3). Between 1850 and 1929, the Keweenaw district was the second largest producer of copper in the world [13]. During that interval, 140 mines worked central deposits and over 40 mills processed stamp rock (Figure 2). In total, 4.8 million metric tons of copper were smelted from native copper deposits by 1968. The concentration of copper in the parent rock averaged between 0.5% and 6.1% of the total mass, producing vast amounts of tailings as a by-product of giant steam-driven stamps [14]. The stamps crushed the amygdaloid and conglomerate ores, and mills sluiced copper-rich stamp tailings into rivers and waterways. Between 1865 and 1968, approximately 360 million metric tons (Mt) of stamp sands were discharged from native copper stamp mills into interior waterways and along Lake Superior shorelines, including 64 Mt directly into Lake Superior [8,9,15].

Large volumes of water were necessary for tailing processing at stamp mills. The success at inland sites required the local damming of rivers, as the milling process required water to discharge large volumes of stamp sands [9]. In the late 1890s, larger steam-driven mills opened on the shores of the largest inland lakes (Torch Lake, Portage Lake) and along the coast (Figure 2). On the western

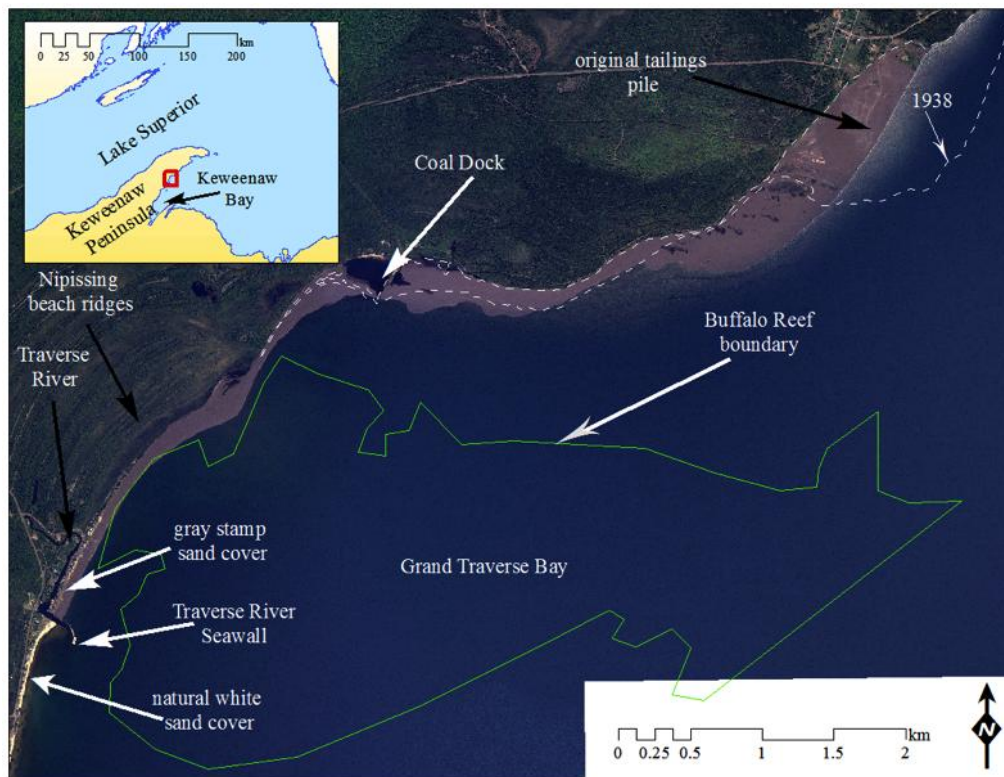
Figure 3. Geographic location of Grand (Big) Traverse Bay on the Keweenaw Peninsula jutting into Lake Superior. Landmarks include the position of the original tailing pile off Gay (the dashed boundary shows the 1938 extent), the Coal Dock, the Traverse River Seawall and the narrow natural white sand beach. The white dashed line outlines the 1938 boundaries of the stamp sand. The boundary of Buffalo Reef is superimposed over offshore waters. Before mining, erosion dominated along the northeastern coastal shelf region, whereas historical deposition dominated the southwestern shoreline (Nipissing beach ridges, natural white beach). Modern-day currents are predominantly southwestward.

Here, we utilize LiDAR and MSS imagery to investigate the spread of tailings from a pile deposited in Grand (Big) Traverse Bay, near Gay (Figures 3 and 4). The native copper (Cu) processed at Gay came from basalt lava flows (amygdale deposits; [16]). Stamp sands contained two fractions: (1) a coarse fraction (sand) with a specific gravity around 2.9; and (2) a fine silt-clay fraction, produced during the stamping and grinding of ore (the so-called “slime clays”, [14]). Grain sizes on the original pile were angular, approximately log-normally distributed, with modal sizes ranging between 0.3 and 3.4 mm [17,18]. The silt-clay (“slime clay”) fraction from above-water portions of the

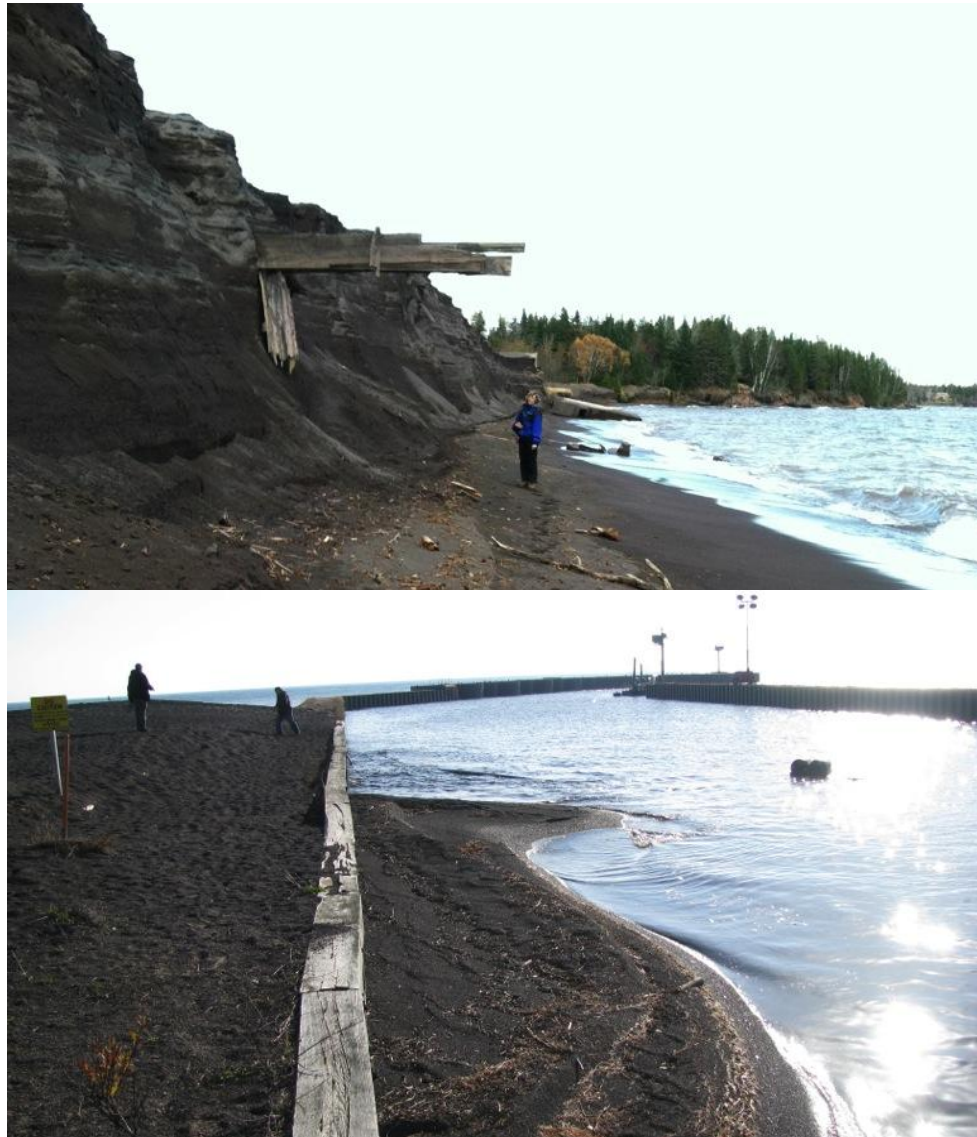
Figure 4. Stamp sands erode from the enormous tailing pile at **(Above)** Gay and over-top the **(Below)** Traverse River Seawall, spilling into the Traverse River channel.

As wave erosion of the original Gay tailing pile proceeds, the coarse fraction is moved from the original deposition cone (Figure 4 top) southward as a sorted black sand lens mixing with or transgressing over Grand Traverse Bay white quartz beach sands (Figures 3 and 5; [3,38,41]). We found that redeposited stamp sands moved 7.4–8.1 km south from the Gay pile as black beach sands, extending to the northern face of the Traverse River Seawall. The stamp sands are now working their way around and over (“over-topping”) the sea wall (Figure 4 bottom). MDEQ [20] samples offshore and immediately south of the Gay stamp sand pile found copper concentrations in bay sediments varying between 1,400 and 4,400 µg g^{−1} (mean = 3,020 µg g^{−1}, *N* = 5). That mean value is close to pure stamp sands, suggesting little admixture with natural beach sands or Tobacco River sediments near the original Gay tailings pile.

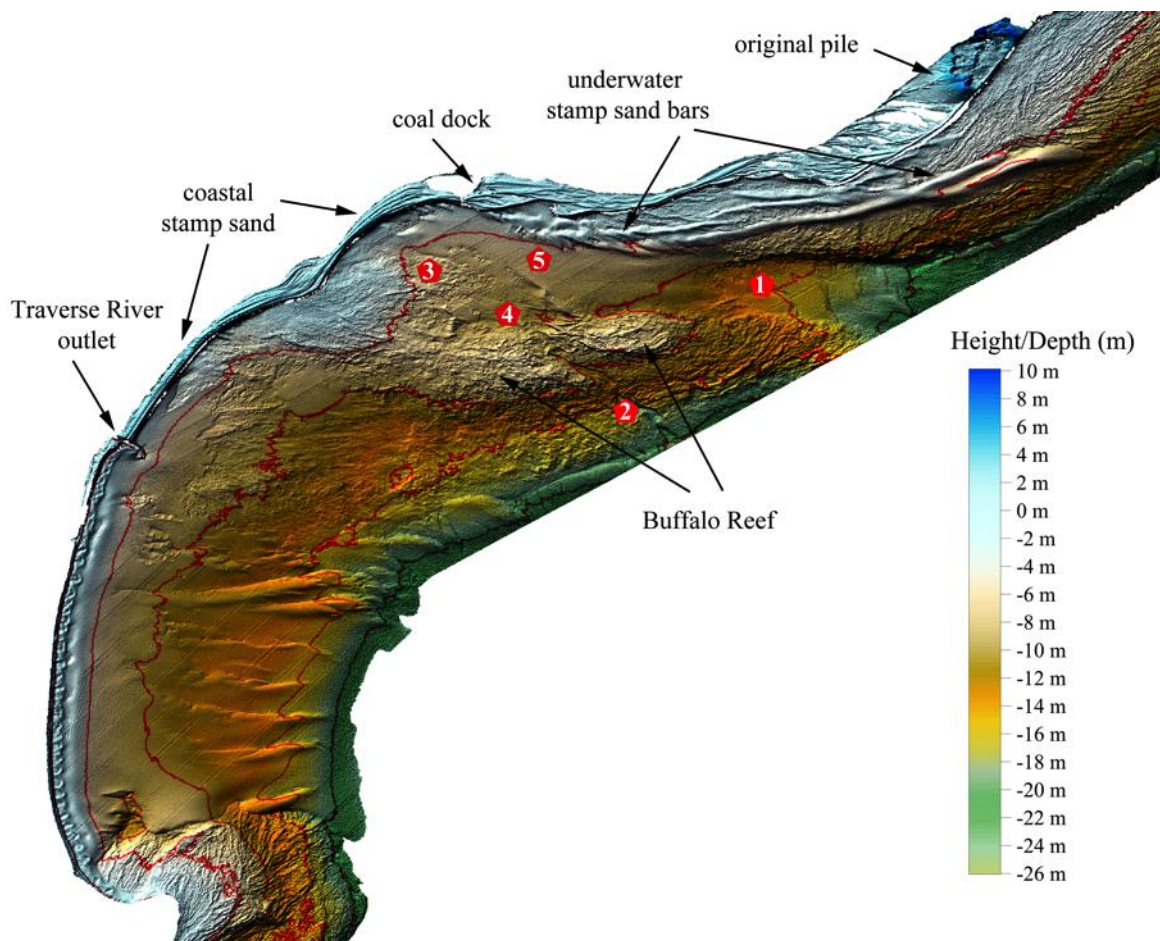
Figure 5. 2010 LiDAR-derived bathymetry of Grand Traverse Bay, showing the positions of the original Gay tailings pile, above-water (deep blue region) stamp sands along the beach stretch from the pile to the Coal Dock and southwestward to the Traverse River seawall and the central Buffalo Reef area. The “trough” region, an old riverbed, is in the center. To the northeast, note the underwater stamp sand bars moving across bedrock (Jacobsville Sandstone) to deposit in the “trough”. To the southwest, natural sands and silts move out of the bay across the bottom into Lake Superior. Red horizontal contour lines are at 5-m depth intervals. ROV and side-scan sonar sites (1–5) are indicated in red.

In Figure 5, the 2010 LiDAR-resolved bathymetry reveals the critical coastline features of Grand (Big) Traverse Bay and the central location of Buffalo Reef. The coastal shelf is flanked by two rivers: the Tobacco River northeast of the original tailing pile and the Traverse River in the southwestern portion of the bay. Both rivers discharge highly colored humic waters that dissipate quickly. East of Buffalo Reef, the “trough” appears to be an ancient riverbed located between the existing two rivers, stretching 2 km, scoured to a depth of 2–3 m into Jacobsville Sandstone bedrock. Underwater regions southwest of the original tailing pile reveal stamp sand bars moving over Jacobsville Sandstone bedrock towards the “trough”. The bars contain substantial mass and reach the “trough” at mid-level below the Coal Dock. ERDC-EL at Vicksburg estimated that the “trough” has a

surface area of *ca.* 1,275,400 m² (1.3 km²) and a volume of 4,205,200 m³. However, because the upper reaches are covered by migrating stamp sands, these channel estimates are only approximate. The deeper, outer reaches of the “trough” appear to show cuts through bedrock, *i.e.*, bedding planes of Jacobsville Sandstone, whereas the upper and middle reaches are filled with stamp sand or mixtures of stamp sands and natural sands.

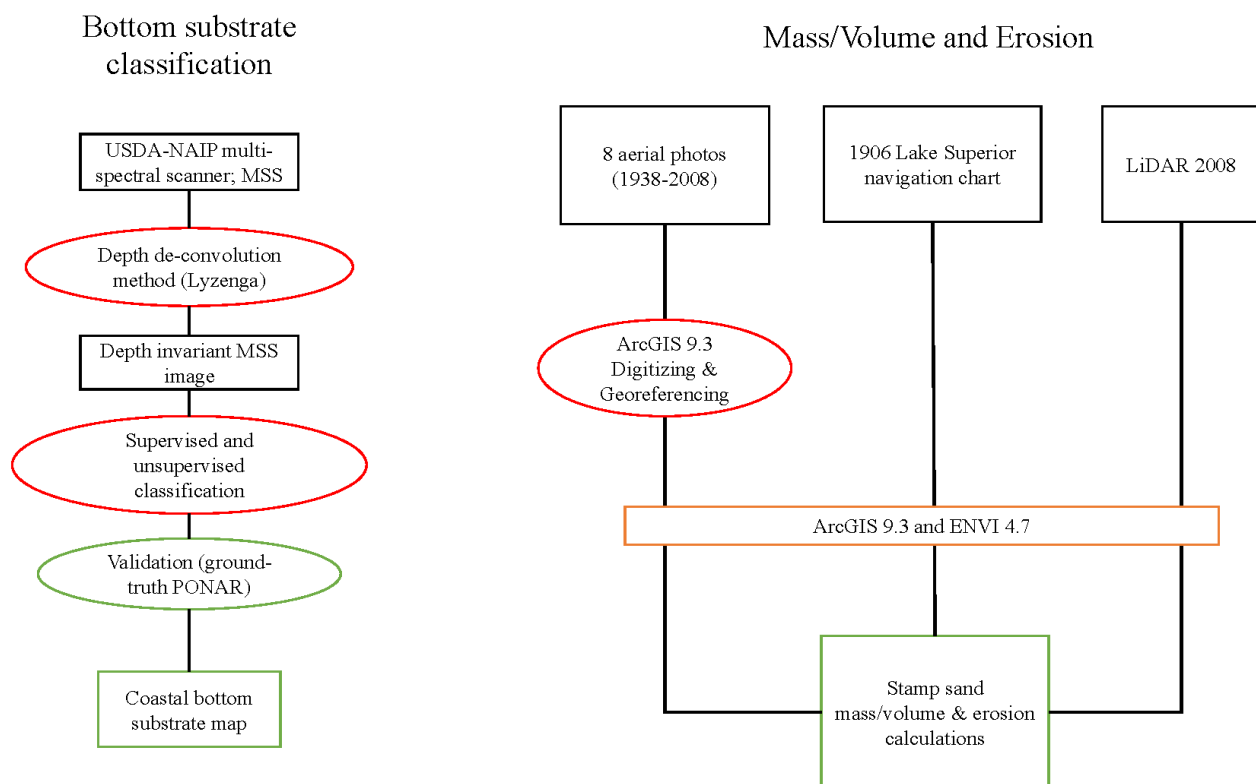
Figure 6. Flow chart for LiDAR, multispectral scanning (MSS) and aerial photography procedures used to calculate mass erosion and deposition and to classify substrates (black = primary data; red = method/tool/procedure; orange = software used; green = products). NAIP, National Agriculture Imagery Program;

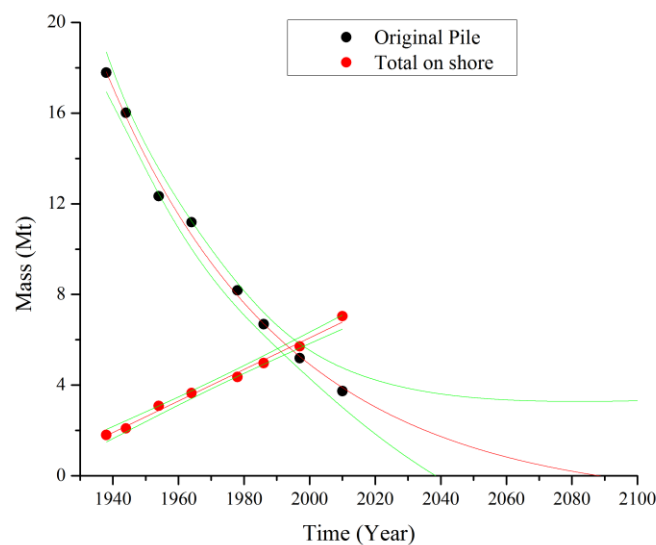
Figure 7. Aerial photo and LiDAR-derived estimates of erosion from the primary Gay tailing pile (black dots) through time and the corresponding accumulation of redeposited stamp sand on beaches south of the pile (red dots). Mass is in million metric tons (Mt), and 95% C.L. around regressions are indicated by green bands. The erosion of the pile closely fits an exponential decline function, whereas accumulation on the beach closely fits a linear increase function.

The reconstructed pile was first used to calculate the volume and mass of stamp sand in 1938. The procedures employed a polygon spatial resolution of 3 m and an area of 9 m². Multiplying area by depth gave an estimate of the volume of stamp sand for each polygon. Integration provided an estimate of total volume in cubic meters. An average of Colin's (internal report 2009; accessible from the US Department of Agriculture's Natural Resource Conservation Service (NRCS)) Web Soil Survey values was used to assign mass. The moist bulk density of the Gay Stamp Sands soil was estimated as being between 1.35 and 1.65 grams per cubic centimeter (g cm⁻³) or 1,350 kg m⁻³ to 1,650 kg m⁻³. We chose the mean bulk density value of 1.65 grams per cubic centimeter and calculated the mass for each eroded slice. An exponential decay equation was fit to the mean erosion curve, giving an intercept estimate of the date when the pile would be gone (*i.e.*, zero mass). For our analysis (Figure 7), erosion values since 2008 were updated to the present.

Using the series of four CHARTS images, the mass of deposited beach sands along various sections of the coast could also be estimated through time (Figure 7; Table 2). The entire mass of stamp sand deposited along the coastline was estimated as 7.0 Mt, about 30.8% of the original stamp sand mass discharged onto the tailing pile (22.7 Mt). Given the LiDAR high resolution and the clear gouges left on the pile by the Road Commission, we could also estimate that winter road application and bed construction removed about 1.01 Mt of the Gay, MI, pile total mass (4.4%). By the difference, the remaining 11.1 Mt (48.9%) has moved out into Grand Traverse Bay, spreading across the underwater substrates. Estimates of above-water shoreline beach cover ranged from 1.6 km² [3,31] to 2.3 km² [41]. The aerial underwater cover of stamp sands across Grand (Big) Traverse Bay was estimated from MSS as 5.1 km² [3], although this estimate does not include cover below the bottom reflectance capability.

Figure 7 summarizes the long-term estimate of mass movement. At present, the mass of stamp sand in the original pile has diminished to the point where it is far less (3.1–3.7 Mt) than the combined amount along the shoreline to the south of the pile (7.0 Mt). The Coal Dock stretch (the pile to Coal Dock) is holding 4.5 Mt of stamp sand. Along the shoreline beach, accumulation over time in the original pile to the Coal Dock section (Section 2) appears to fit a simple linear function through time (slope = 0.035, S.E. = 0.003; R^2 = 0.93). The mass of stamp sand in the Coal Dock to Traverse River section (2.6 Mt) also shows an increasing simple linear trend (slope = 0.035, S.E. = 0.001; R^2 = 0.99). A combination of both accrual estimates gives a single line with double the slope (Table 2; slope = 0.07, S.E. = 0.002; R^2 = 0.99). If the accumulation of beach stamp sands at the Coal Dock section continues in a linear fashion, 52 years from now, there would be an additional accumulation of 1.8 Mt along the shoreline north of Buffalo Reef. That much accumulation would certainly place Buffalo Reef in great peril.

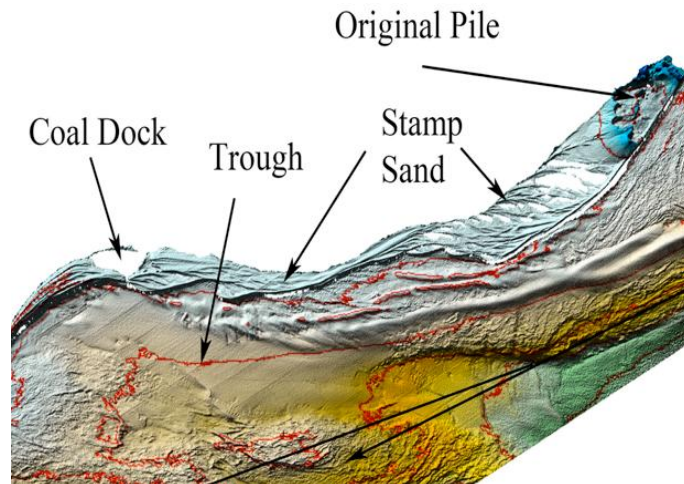
Figure 8. Enlargement of the 2010 LiDAR-derived mosaic documents stamp sands moving into the northern cobble/boulder fields of Buffalo Reef. Migrating stamp sand bars pour into the “trough”, mounding up in the northern reaches of the trough before progressing northwestward onto Buffalo Reef. Red contour intervals are spaced at 5 m.

The deep migrating stamp sand bars move across the Jacobsville Sandstone coastal bedrock, then deposit into the mid-section of the “trough”, creating a mound and a westward migrating wall (Figures 5 and 8). At present, the upper and middle reaches of the “trough” appear filled to the point that westward encroachment of stamp sands into Buffalo Reef has begun. Moreover, the recruitment of wave-sorted material from migrating coastal stamp sand beach deposits has already dispersed southward and westward into and through parts of the northern cobble field (Figures 5, 8–11).

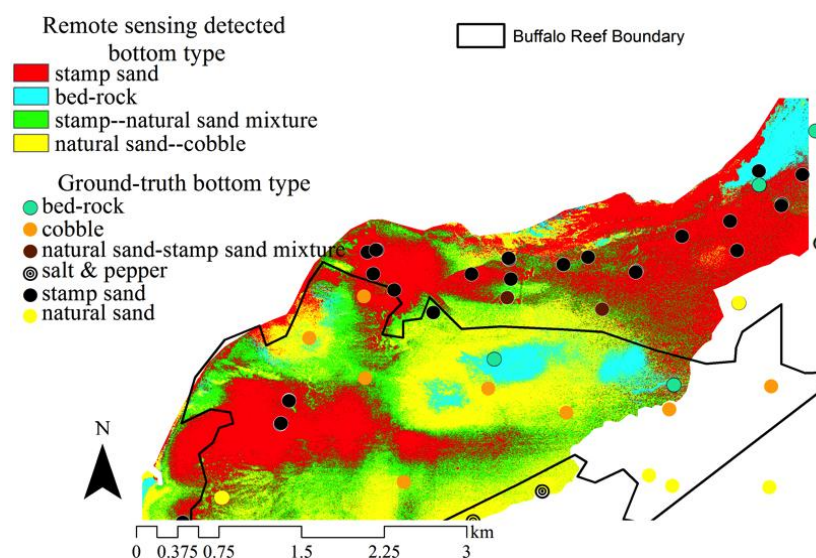
Figure 9. MSS-derived coastal substrate map, based on bottom color reflectance. Dots indicate Ponar and underwater camera ground-truth checks of substrate types (modified from Kerfoot *et al.* [3]). The boundaries of Buffalo Reef are superimposed upon the substrate map. Red regions indicate low reflectance areas where migrating stamp sands have encroached upon Buffalo Reef cobble and boulder fields.

may have helped divert migrating stamp sands. The promontory has a low region where migrating stamp sands have broken through and filled a depression to the west (Figure 9).

MSS substrate classification showed that stamp sands had broken through a bathymetric low northwest of Buffalo Reef and spread westward across the bottom, now surrounding two-thirds of the reef and increasing the urgency for action (Figure 9; [3]). The total underwater surface area covered by stamp sands in the bay was estimated from MSS as 5.1 km², whereas a corresponding 1.3 km² of the beach area was covered by above-water stamp sands [3]. In Figure 9, there are depressions to the west of Buffalo Reef that are now filled with coarse stamp sand.

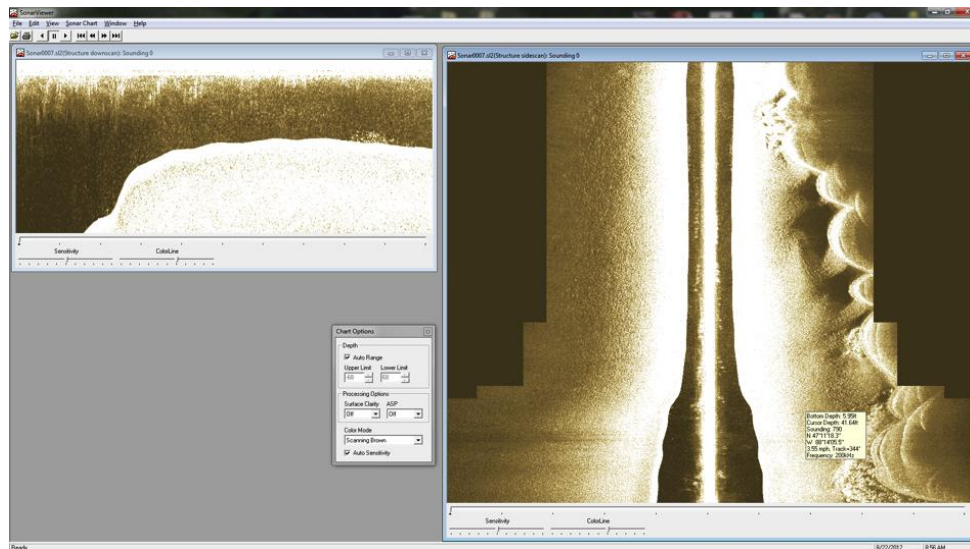
Figure 10. Side-oriented sonar image (Lowrance HDS7 from R/V Polar) of stamp sand falling into the “trough” (site 1 in Figure 5). (**Left**) The vertical scan of the 2.7 m-high “trough” east wall. (**Right**) The lateral scan of the stamp sand moving over the east wall escarpment and cascading into the “trough”. The dark central band in the horizontal image is the unrecorded track directly beneath the boat.

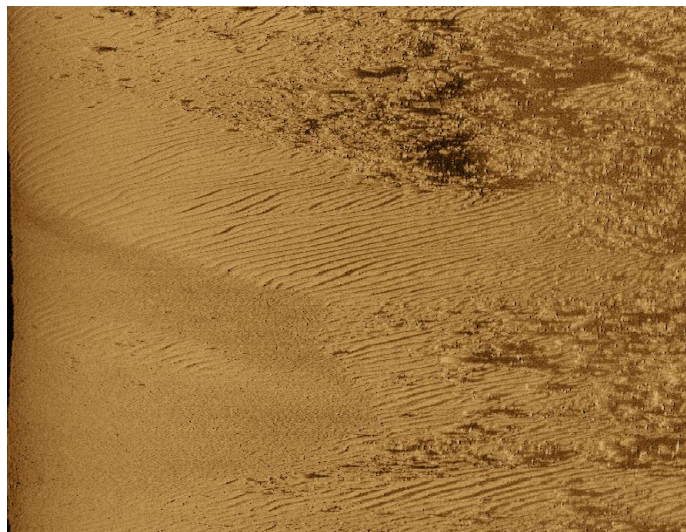
Figure 11. High-resolution side-scan image (New EdgeTech, HRSSS, 600/1,600 kHz from National Oceanic and Atmospheric Administration (NOAA) R/V Storm; 0.6 cm resolution) of stamp sands encroaching into Buffalo Reef cobble fields (site 2; Figure 5). Drifting stamp sands are on the left side of the image, whereas boulder fields are on the right side. Notice the ripples along the leading edge of the stamp sands and how the fine sand particles fill in crevices in the cobble/boulder field.

Side-scan sonar and ROV surveys reveal boulder field details and provide direct evidence for stamp sand encroachment (Figures 11 and 12). MSS and side-scan sonar studies are beginning to answer critical questions about the percentage of encroachment of stamp sands into the northern and middle reaches of Buffalo Reef boulder/cobble fields (Figure 9, site 4 in Figure 5). Cobble fields on Buffalo Reef (site 3 in Figure 5) are characterized by rounded lag boulders and cobbles covered by periphyton (Figure 12a). The coating makes the rocks seem uniform in color under underwater video imaging, but the heterogeneous nature of the rocks can be determined when the periphyton layer is scraped off. ROV dives are demonstrating that sands encroach upon gravel and cobble beds along the northern stretches of the reef (Figure 12b; site 4 in Figure 5).

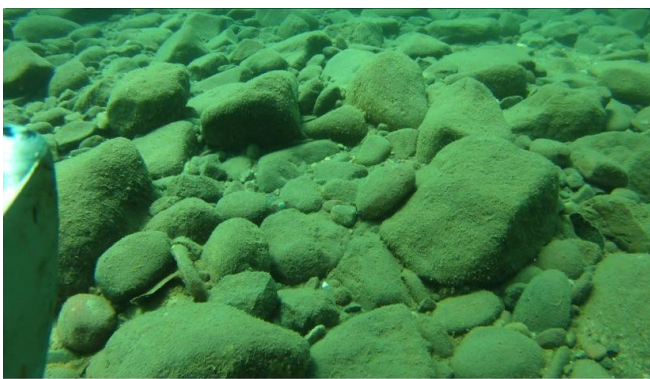
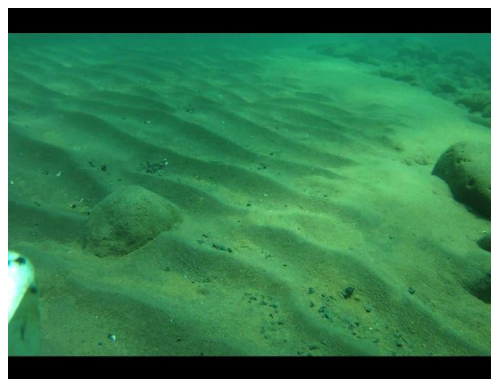
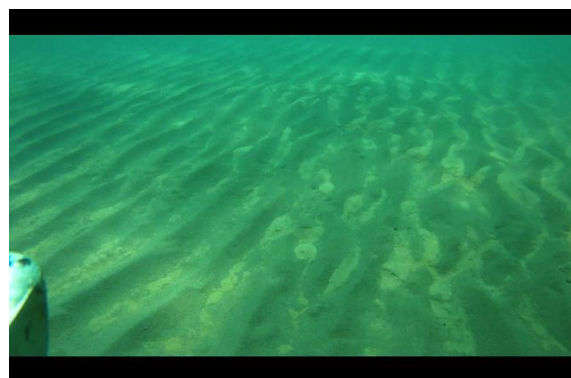
Figure 12. (a) The remote operating vehicle (ROV)-mounted camera view of an undisturbed Buffalo Reef boulder/cobble field (site 4 in Figure 5). Cobbles and boulders are coated with a natural organic diatom and bacterial periphyton film. During spawning, fish eggs drop into the crevices between rocks. Most of the cobbles and boulders are rounded glacial lag erratics, sitting on top of, rather than originating from, the underlying Jacobsville Sandstone. (b) An ROV video of stamp sands (coming from the left; notice ripples) moving into the northern cobble field (to the right) of Buffalo Reef (site 3 in Figure 5). The stamp sands are both filling in crevices and killing periphyton communities on rocks along the leading edge of the encroachment zone. (c) An ROV clip of ripples in a stamp sand field encroaching onto Buffalo Reef's twin promontories. Notice the white flocculent organic material (dead periphyton), sloughing off the boulder field, lying in depressions between ripples (site 5 in Figure 5).

and 2013 with ROV-mounted cameras documented stamp sands filling in edges of boulder fields with the border boulders losing periphyton films (Figure 12b).

Secondly, toxic effects upon periphyton communities (Figure 12a–c) could indirectly limit benthic invertebrates, by indirectly reducing their resources. Fish would avoid the stamp sand regions, because there are no invertebrates, *i.e.*, food or resources. Thirdly, fish may sense copper concentrations directly and avoid regions with high concentrations. Underwater photographs of stamp sand ripples show a white flocc (Figure 12c; site 5 in Figure 5) that settles into depressions between ripples. This flocc is composed of initially living periphyton sloughed off boulders and cobbles from the Buffalo Reef cobble field, but is usually dead in the stamp sand ripples. In untouched boulder/cobble fields, floccs of living periphyton slough off to deposit between rocks, enhancing food for invertebrate fauna.

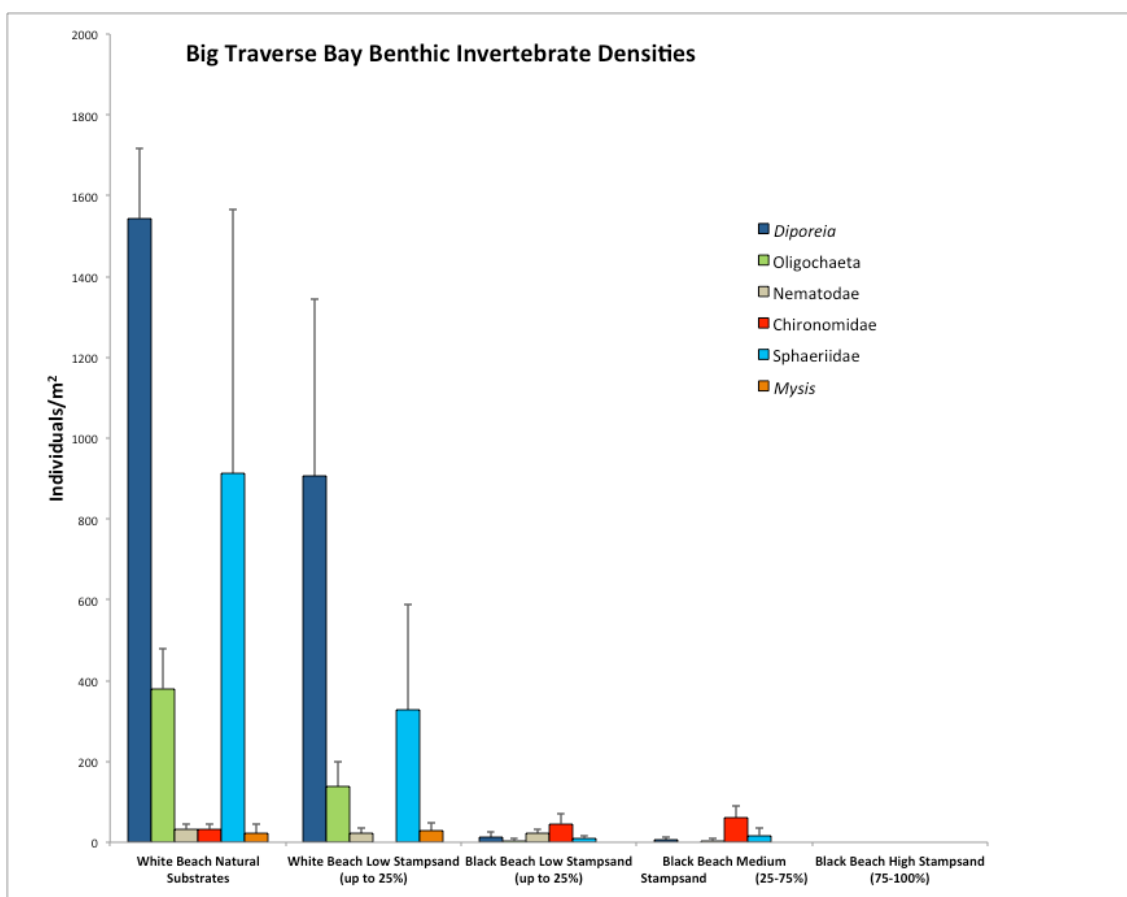
Figure 13. A major decrease in benthic organism density (Ponar samples) with an increase in stamp sand content (0% stamp sands, left panel; 0%–25% in the two middle left panels, 25%–75% in the middle right panel and 75%–100% on the far right panel). The bars give a mean density of $\pm 95\%$ C.L.; individual taxa are listed in the insert.

ROV studies document that underwater encroachment of stamp sand onto Buffalo Reef involves two separate processes: (1) wave and current-driven drift and deposition of stamp sands into cobble fields, filling up crevices and “drowning” the boulder field in a sea of stamp sand (Figures 11 and 12b); whereas the second process includes (2) the toxic effects of copper upon benthic organisms, including periphyton (diatoms and bacteria), invertebrates and fishes (Figure 13). Preliminary surveys in 2012

Coastal regions off stamp sand piles on the Keweenaw Peninsula are characterized by a reduced diversity of benthic macroinvertebrates [42,47]. The freshly worked stamp sand and lake sediments are toxic to *Daphnia* and mayflies (*Hexagenia*), because they release Cu across the pore-water gradient [19]. Additional laboratory EPA toxicity experiments with slime-clay-rich lake sediments from the Keweenaw Waterway and Torch Lake showed that solid-phase sediments and aqueous fractions (e.g., interstitial water) associated with the slime-clay sediments were lethal to several taxa of freshwater macroinvertebrates: chironomids (*Chironomus tentans*), oligochaetes (*Lumbriculus variegates*), amphipods (*Hyalella azteca*) and cladocerans (*Ceriodaphnia dubia*). Moreover, the observed toxicity was due to dissolved copper, as opposed to other metals (principally zinc and lead) present in the sediments [48–50]. These laboratory tests were consistent with field observations of stamp sand effects on benthic organisms, where an increase in the percent of stamp sands suppressed a wide variety of taxa (Figure 13).
