## Determining bridge deck deterioration through the use of 3D photogrammetry

A THESIS

MASTER OF SCIENCE

MICHIGAN TECHNOLOGICAL UNIVERSITY

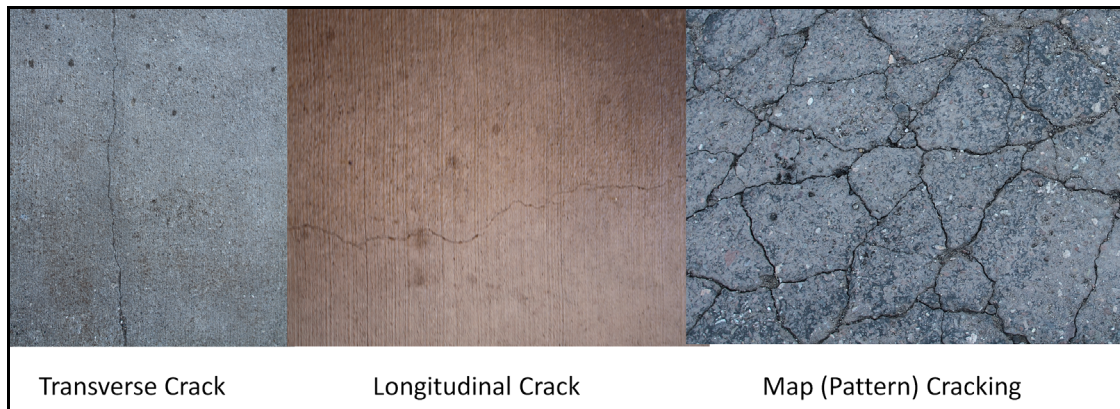
**Figure 2.1: Different Crack Types**

Surface cracks come in a variety of different types and widths with different causes behind them. The most common type of crack in bridge decks are transverse cracks which are often caused by restrained shrinkage and typically occur shortly after construction (Nowak et al. 2000). Pattern cracking or map cracking is cracking that occurs in random directions which can be caused by several factors such as freeze and thaw cycles and the steel corrosion process. There are several other varieties of cracks that can be present including longitudinal and diagonal cracks (Nowak et al. 2000). Examples of the main types of cracks can be seen in Figure 2.1 (Federal Highway Administration (FHWA) 2006). A trained bridge inspector can determine the presence of other problems with knowing the type of cracks present on the bridge. While the size of the cracks can vary from hairline to several inches, the magnitude of the cracks considered ranged from 1/16 in. (1.59 mm) to 3/16 in. (4.76 mm) in width (FHWA 2006).

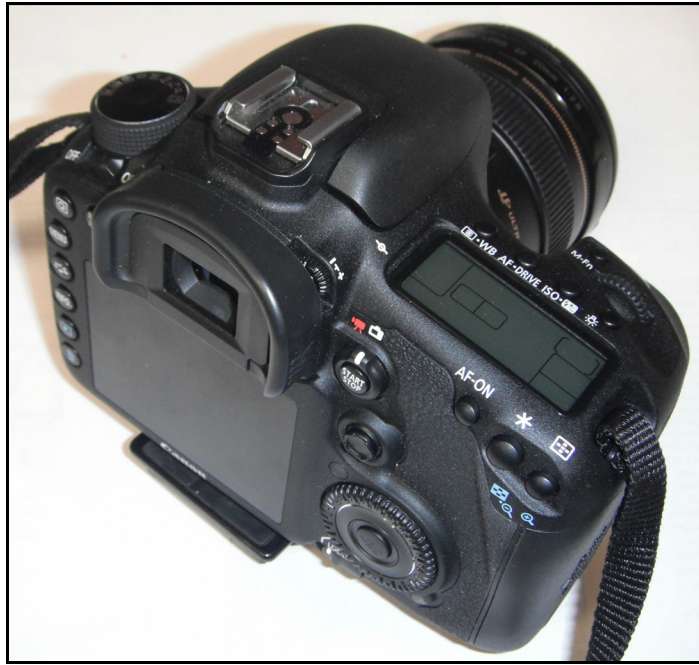
**Figure 3.1: Canon EOS 7D Camera**

The camera that was chosen for this project was the Canon EOS 7D. A high-performance digital SLR camera with a CMOS sensor has about 18 effective megapixels along with capabilities to take approximately 8 frames per second during continuous shooting. Determined to have the best overall properties for the applications in this study, yet affordable enough while providing the necessary speed and resolution. For determining the capability photogrammetry can provide in determining deterioration mechanisms in bridges. Figure 3.1 shows the camera that was used for taking all the images that were used in the modeling applications in this study.

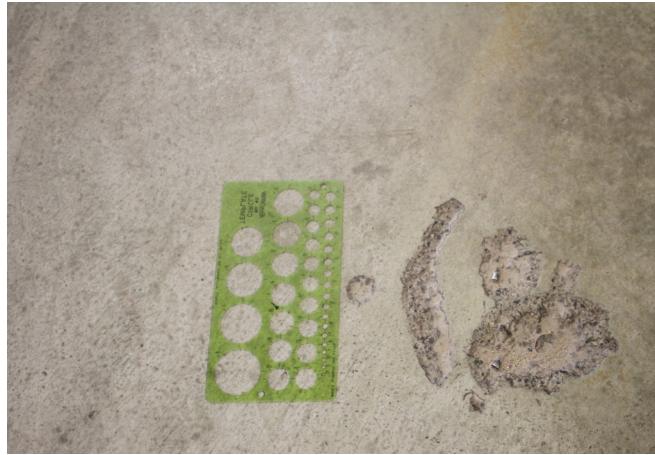
**Figure 4.5: Picture of Scales in Test 1**

The first scaling test was completed using one of the concrete lab floors and is shown in Figure 4.5. The DEM of the scaling is shown in Figure 4.6, and shows the elevation at 0.079 in. (2 mm) of elevation bands. The elevation model shows four different scales that were in this section of the concrete with the smallest one being about 1 in. (2.54 cm) in diameter on the far left. Based on the elevation changes, the deepest scale was 0.157 in. to 0.236 in. (4 to 6 mm) in depth. The results show that scales in this floor were able to be detected using this technique.

The final scaling test was done for the same scales as those in the first scale test shown in Figure 4.5. The scale on the bottom right was 1.5 in. (3.81 cm) in diameter and ¼ in. (6.35 mm) in depth as seen in Figure 4.21. With the difference being the standoff distance was 5.5 ft (1.68 m) from the scales. The scales in this case were any elevation below 3.26 ft (0.994 m) for the whole model where local scaling could be considered on the top center of the model below 3.27 ft (0.996 m) as seen in Figure 4.21. The percentage of scaling was 0.18 percent based on the raster cells from Figure 4.22.

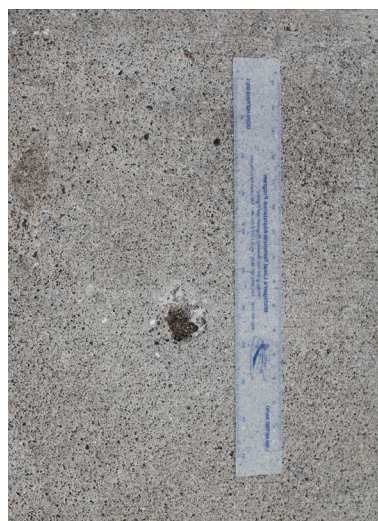
**Figure 4.8: Picture of Scale in Test 2**

The results in second experiment considered a smaller single scale which is shown in Figure 4.8. The DEM is shown in Figure 4.9 in which the spall can be seen to have about a 0.157 in. to 0.236 in. (4 to 6 mm) elevation change. This scale was located by itself which made isolating its measurement possible, and as can be seen it was able to be measured using 3D photogrammetry. The percent area of scaling was calculated in this model taking any elevation below 4065.604 ft (1239.196 m) while extracting the raster cells between -107,503 to 4065.558 ft (-32,767 – 1239.182 m). The percent area scaled was 0.64 percent of the area based on the raster cells from the histogram shown in Figure 4.10.

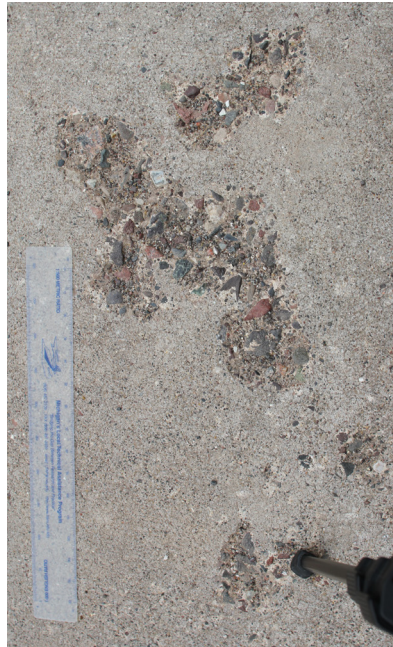
**Figure 4.14: Picture of Scaling in Test 4**

The fourth test completed was taken of an area with significant scaling to show an area with several scales as can be seen in Figure 4.14. The DEM is shown in Figure 4.15 and several different areas can be seen to be scaled as expected. These scales are not very deep with an elevation change of 0.236 in. to 0.315 in. (6 to 8 mm) of change. To calculate the area of scale in this model, any value below 4062.329 ft (1239.198 m) was taken as a scale using the point information from the histogram in Figure 4.16. This percentage was calculated to be 15.38 percent in this model. This showed an area with a much larger percentage of scaling relative to previous experiments, validating that the technique works for larger areas also.

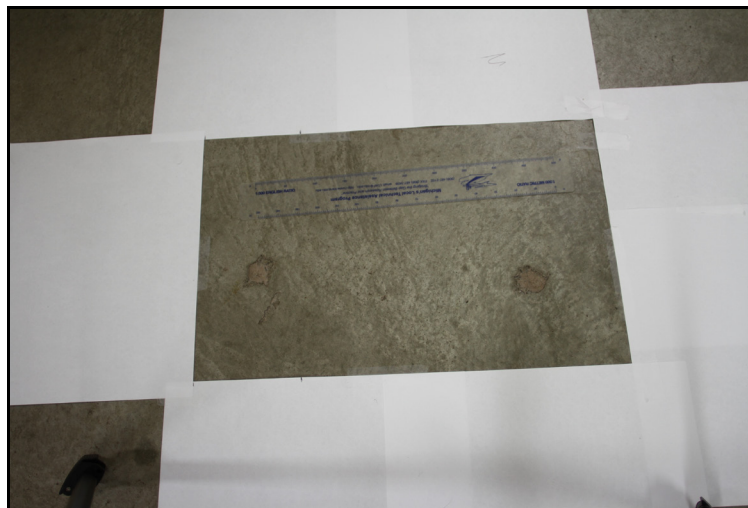
**Figure 4.17: Picture of Scale Test 5**

The fifth scaling test was setup up differently from the first four tests as an area was formed around the scales using paper as seen in Figure 4.17. Allowing the scaling area of the model to be calculated and compared to the actual measured value. For the DEM shown in Figure 4.18 the scales were taken as the raster cells under 3.26 ft (0.994 m). Both scales were visible in the image with the one on the left being 7/8 in. (22.23 mm) in diameter and 1/8 in (3.18 mm) in depth. The scale on the right was 1 in. (25.4 mm) in diameter and 1/4 in. (6.35 mm) in depth.
