Comparative Analysis of Locally Available Materials for Treadle Pump Seals in Senegal, West Africa

COMPARATIVE ANALYSIS OF LOCALLY AVAILABLE MATERIALS FOR
TREADLE PUMP SEALS IN SENEGAL, WEST AFRICA

A REPORT

In Mechanical Engineering

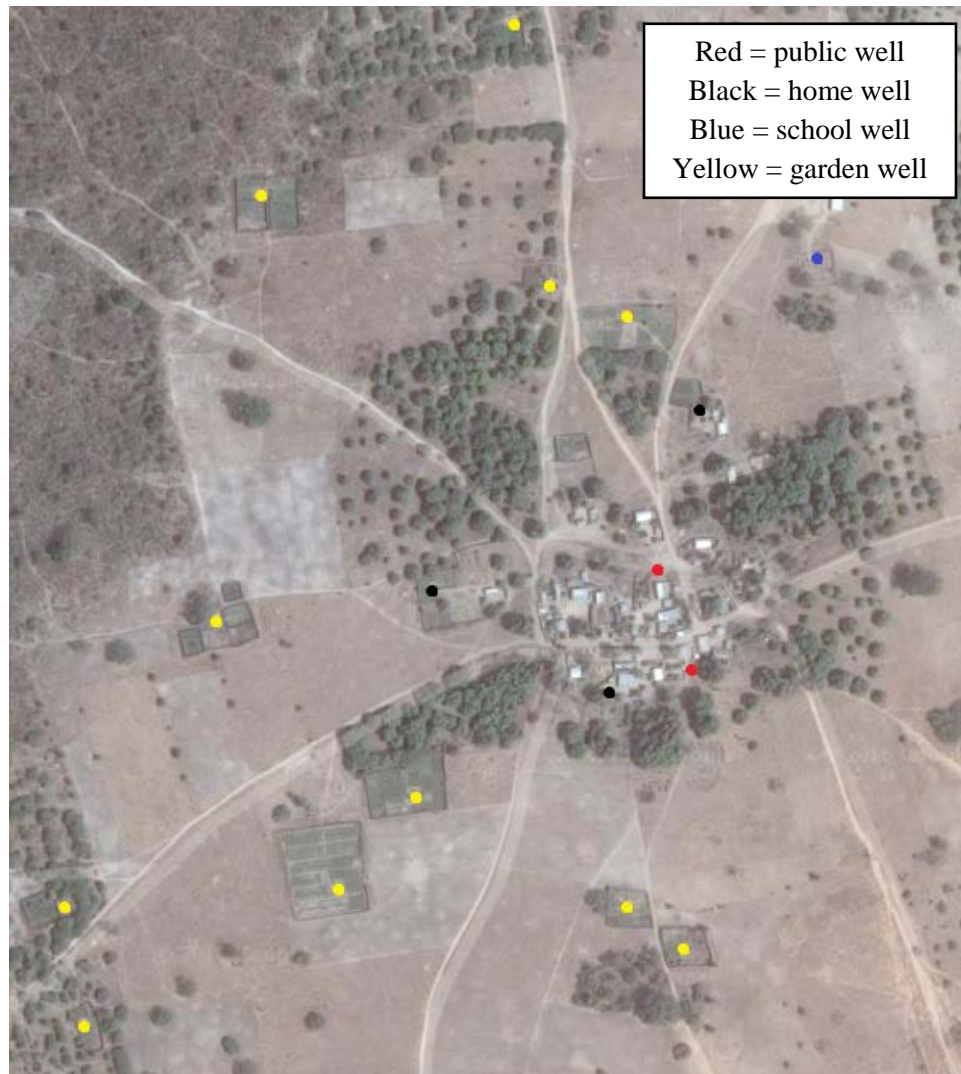
Within the village and surrounding gardens and fields owned by residents of the village, 17 hand-dug wells were in active use in 2015. Figure 1.2 below shows the location of these wells. Of these wells, two were public wells located within the main village and primarily provided water for domestic uses. Three wells were located within the boundaries of their owner's homes and used for both domestic and agricultural purposes.

Another well was located at the village primary school and provided water for a school garden as well as providing drinking water to the students. The remaining 11 wells were located in gardens away from the residential area of the village and used primarily for agriculture while occasionally used for domestic purposes, such as clothes washing.

Figure 1.2: Map of wells in the village and surrounding areas.
(Image adapted from Google Maps)

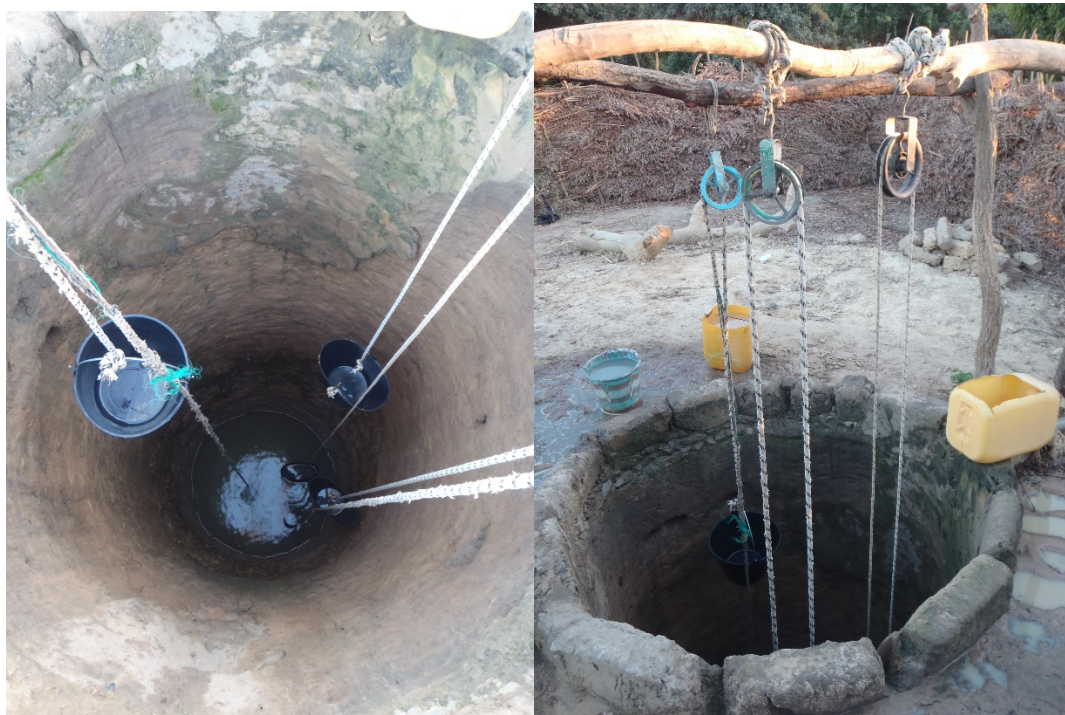
Figure 1.3: Hand dug wells. (a) Inside of an unlined well. (b) Typical well superstructure.

the well is being built or, more commonly, by hired men who dig wells for a living. Wells are circular in shape and vary from 1-2 meters in diameter depending on the requirements of the well owner. Construction features of wells can vary with the desires of the owner and the money available they have to invest in the well. The simplest well is a hole dug in the ground until water is reached and an adequate water depth is available in the bottom of the well. This is achieved by having one person digging in the well with a shovel and pick while another person at the surface uses a rope and bucket to extract the dirt. Figure 1.3a shows the inside of a typical well used by multiple people.

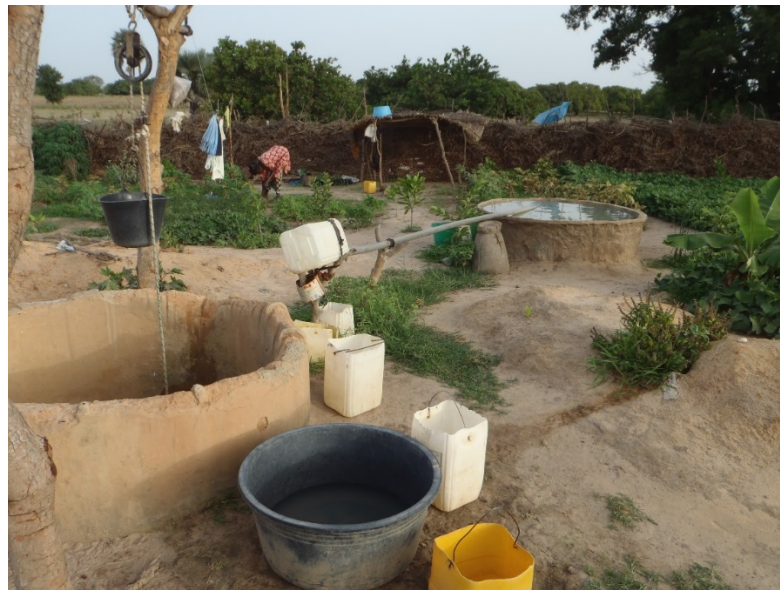
Figure 1.4: A garden utilizing multiple water storage methods. Plastic buckets and a basin are in the foreground with a ferro-cement basin right of center. The well with a rope-bucket-pulley system is on the left.

Different methods of pulling, storing, and delivering water for gardening were used in the village. Observations from visiting and working in the gardens showed the most common method of pulling water from wells was using a rope-bucket-pulley system. Every well had this system regardless of whether it also had a more advanced water pulling method. This method is low cost, simple to maintain, and reliable, allowing both children and adults to use it. Water storage techniques varied based partially on the level of permanence of the garden. Perennial gardens used by the same person for multiple years often had more permanent storage structures, such as ferro-cement basins built at ground level that could be filled with water and then used all at once or partially to water the garden. For gardeners who borrowed land or had less investment in their gardens, the common methods of storing water included only pulling enough water to fill the bucket they had, applying the water to the vegetables, and then repeating the cycle, or bringing large plastic basins to the garden, filling them, using the water, then refilling the basins. Figure 1.4 shows an example of a garden using multiple methods of water storage.

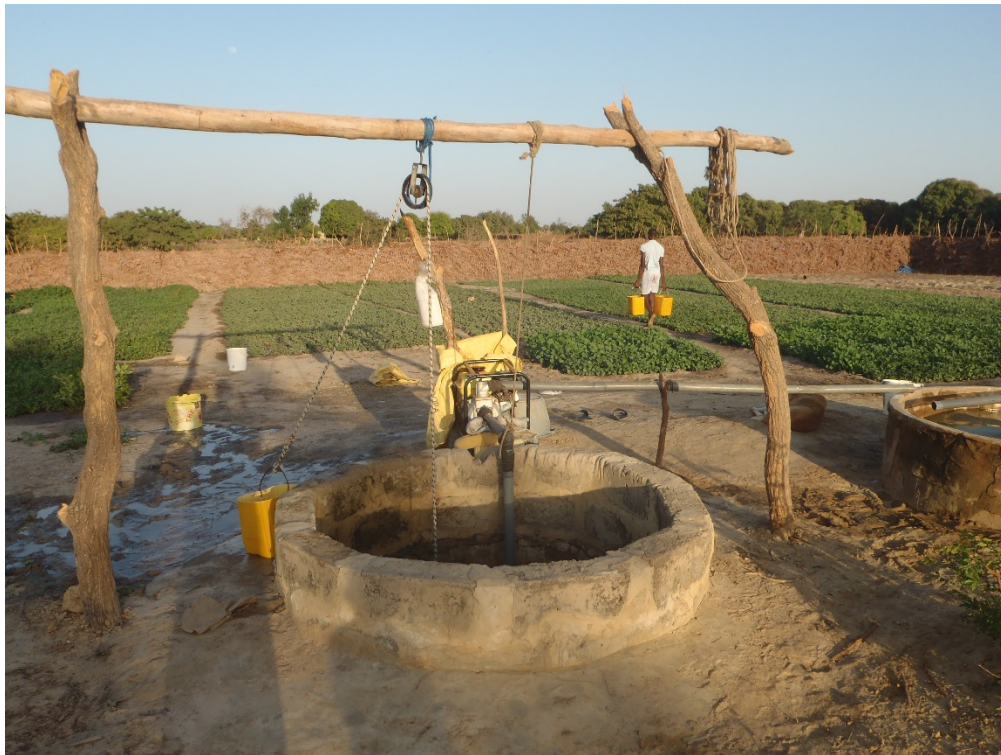
Figure 1.5: Gasoline pump (center) pulling water from well with discharge into ferro-cement basin (right).

More advanced water pulling, storage, and delivery methods, such as gasoline pumps, shown in Figure 1.5, multiple basins, and hoses, were used by certain gardeners in the village. These technologies constituted a small portion of gardeners and were all owned by males. These male gardeners sometimes allowed their wives or female relatives to use these methods, often requiring them to contribute to the cost of fuel.

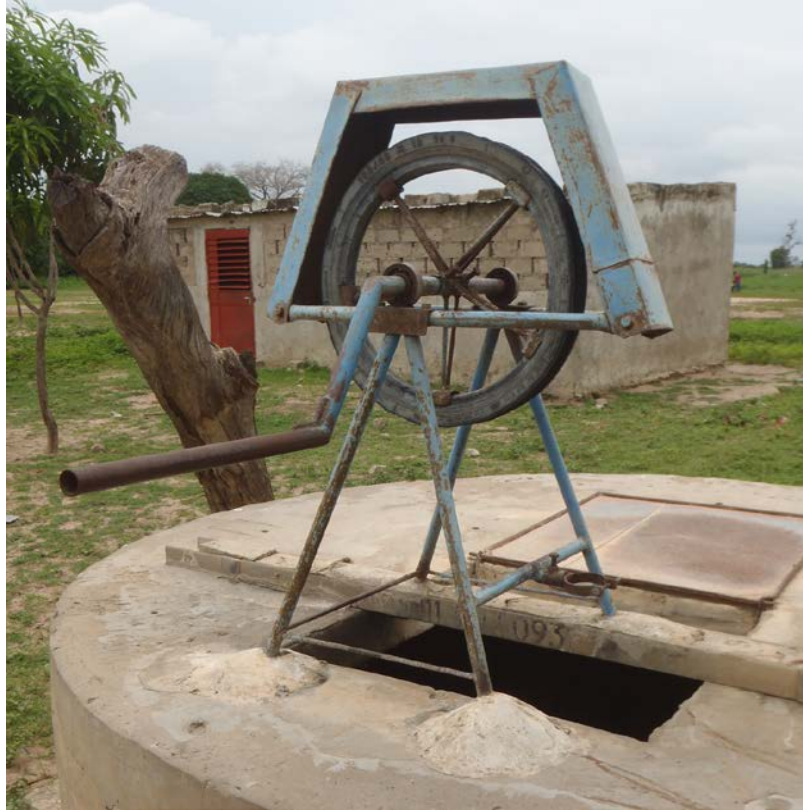
Figure 1.6: Rope pump structure without rope and pipe mounted on well cover.

Since the user must be able to reach the handle at its peak position to properly operate the pump, they must be a certain height which can be taller than the pump itself as rope pumps are usually mounted off the ground above the well. The user must also be strong enough to lift the entire column of water in the pipe and maintain it as there are no valves to prevent the pump from rotating backwards and returning all of the water in the pipe back to the well.

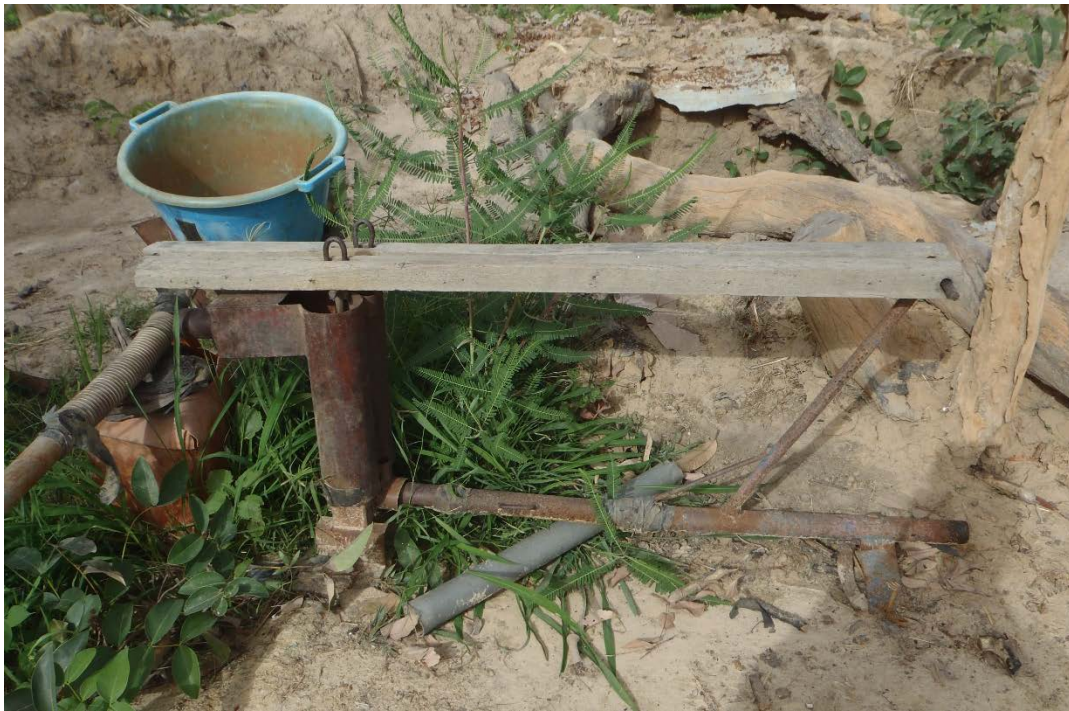
Figure 1.7: Non-functional, abandoned treadle pump.

Another alternative pumping technology, the treadle pump, had been introduced into Senegal in the early 1990's and later promoted in the Fatick region by the USAID Wula Nafaa project in 2008 [6]. This included training three craftsmen in the Fatick region how to fabricate the pumps and setting up demonstrations with various farmers and organizations [7]. In total, the area around Niokholokho had nine treadle pumps installed as a result of this project from 2008-2013 [8]. The closest treadle pump to Niokholokho was located less than 1 kilometer away from the village and was used for pulling water to irrigate a large garden area but had not been functional for a few years. Despite the efforts of the project and having trained craftsmen located in Sokone, treadle pumps were not widely adopted in the area but were known about with some gardeners successfully using them in their gardens before upgrading to gasoline pumps or abandoning them, like the pump in Figure 1.7.

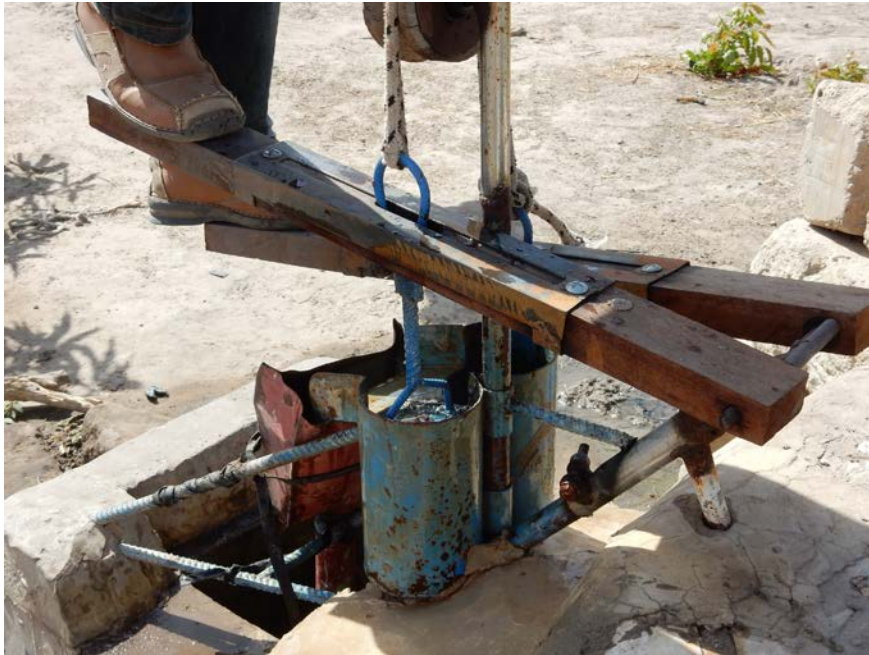
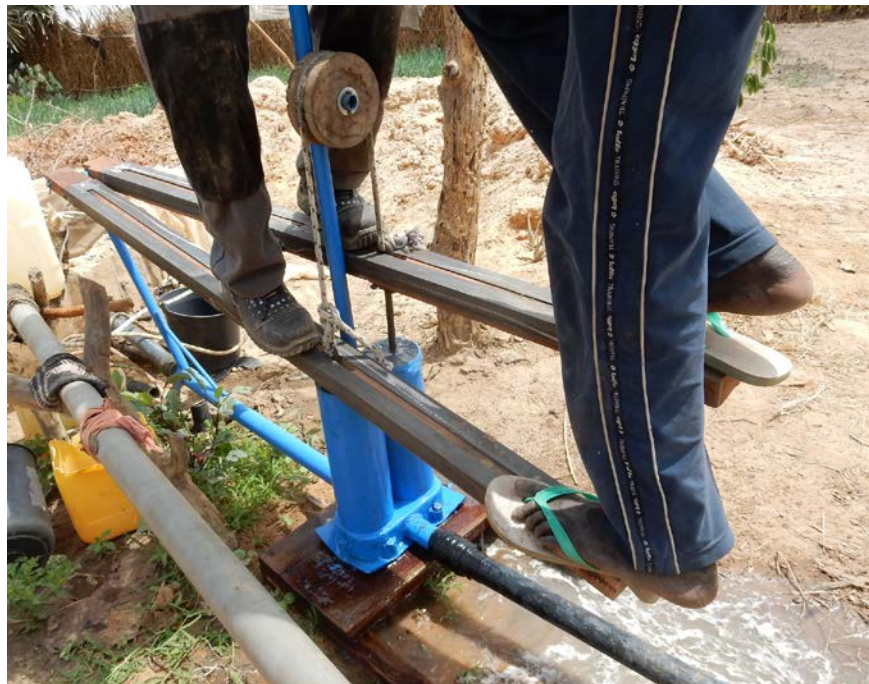
Figure 2.1: Different treadle pump configurations. (a) Suction treadle pump (b) Pressure treadle pump

Treadle pumps generally fall into one of two categories - suction and pressure pumps. Suction pumps, shown in Figure 2.1a, are treadle pumps designed to pull water from a source using suction and then discharge the water unpressurized from the top of the cylinders. A valve located in the piston opens on the downstroke allowing water to move from below the piston to above it. Then during the upstroke, this water is carried by the piston to the top of the cylinder where it exits the pump.

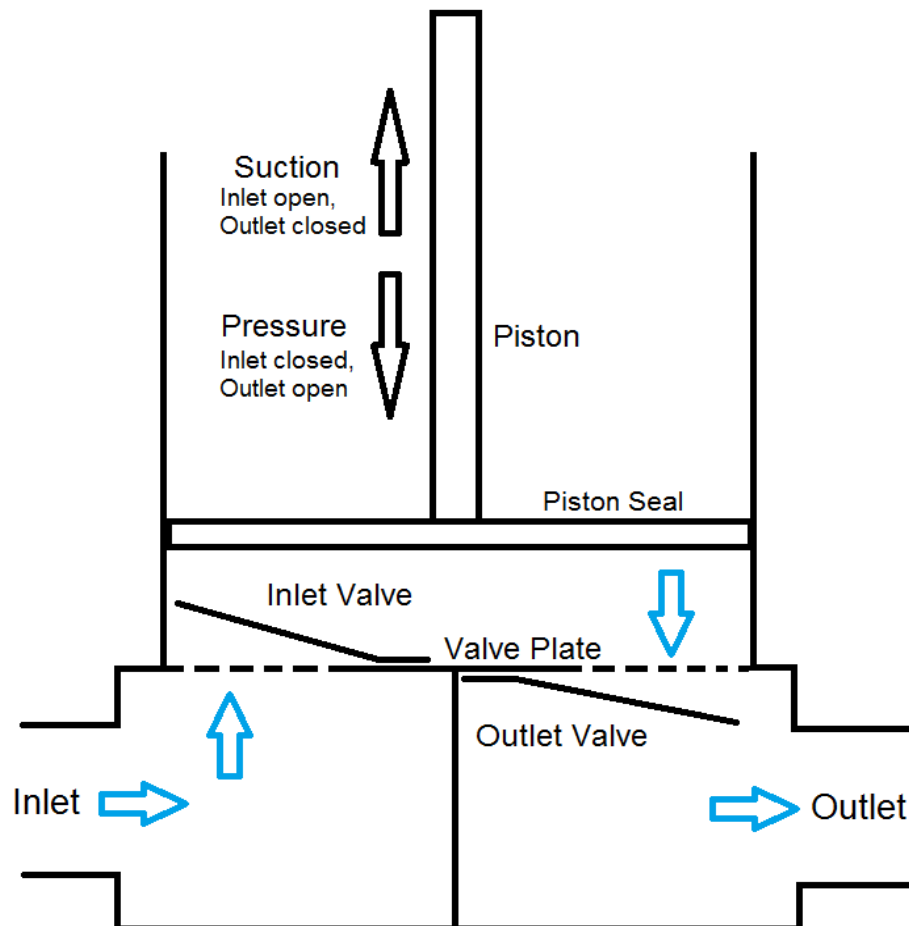
Figure 2.2: Diagram of water flow in a pressure treadle pump.

Figure 2.2 shows a basic diagram of the internal components of a pressure treadle pump and the direction of water flow.

The cylinder is mounted on the pump body which includes the valve plate, valves, inlet and outlet. A separator divides the pump body between the inlet and outlet sides. The valves are attached to the valve plate and shown as flap valves in the figure but can be one of many different designs. Depending on the pump design, the pump body can be completely self-contained or may be left open on the bottom and mounted to a platform with a gasket to seal leaks.

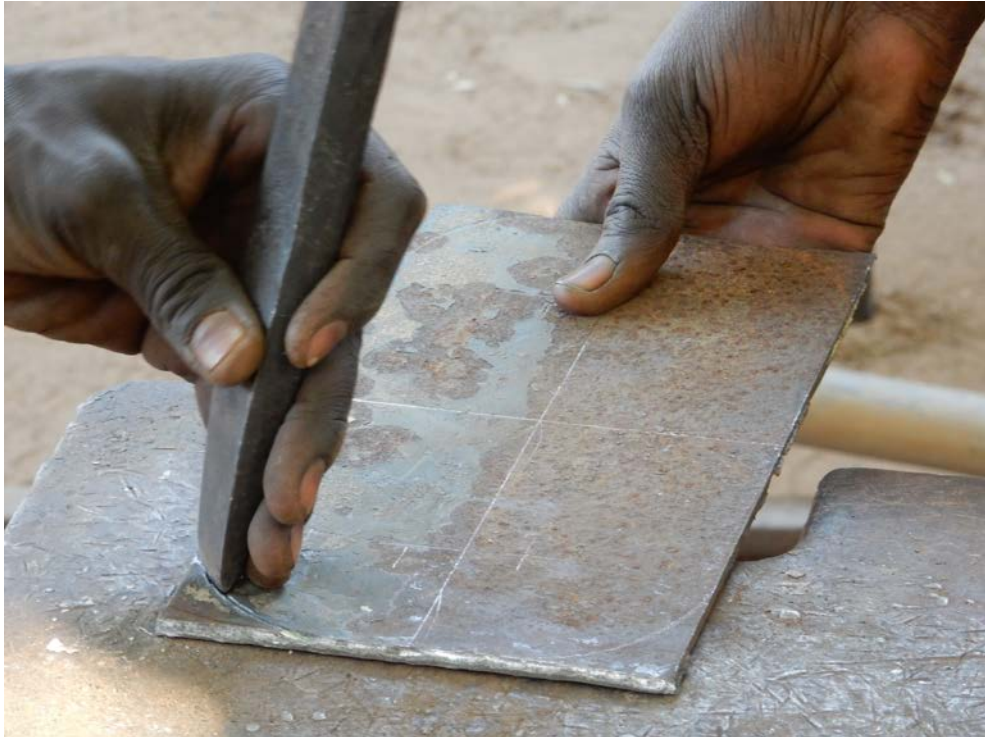
Figure 3.1: Making the valve plate using a cold chisel and hammer.

Due to limited metalworking machines, manual methods were used for fabrication of many of the pump components. Since no bandsaw was available, metal cutting was limited to using a hacksaw, mainly for tubing and rods, a shear, for small plate metal pieces, or a hammer and cold chisel for large plate metal components. The latter method was used often when cutting curved geometries or long pieces of plate steel, such as when making the valve plate in Figure 3.1 and pump body as well as the piston disks, and an angle grinder was usually used to improve the edge of the cuts due to the jagged nature of using a chisel. A drill press was available to drill all of the holes during fabrication and a lathe was used to make the piston disks uniformly circular. Arc welding is a common task in metal shops resulting in multiple arc welders and skilled metalworkers in welding. In some cases, the metal shop did not have the exact size drill bit that was needed, and instead of purchasing the specified size, the closest available size was used.

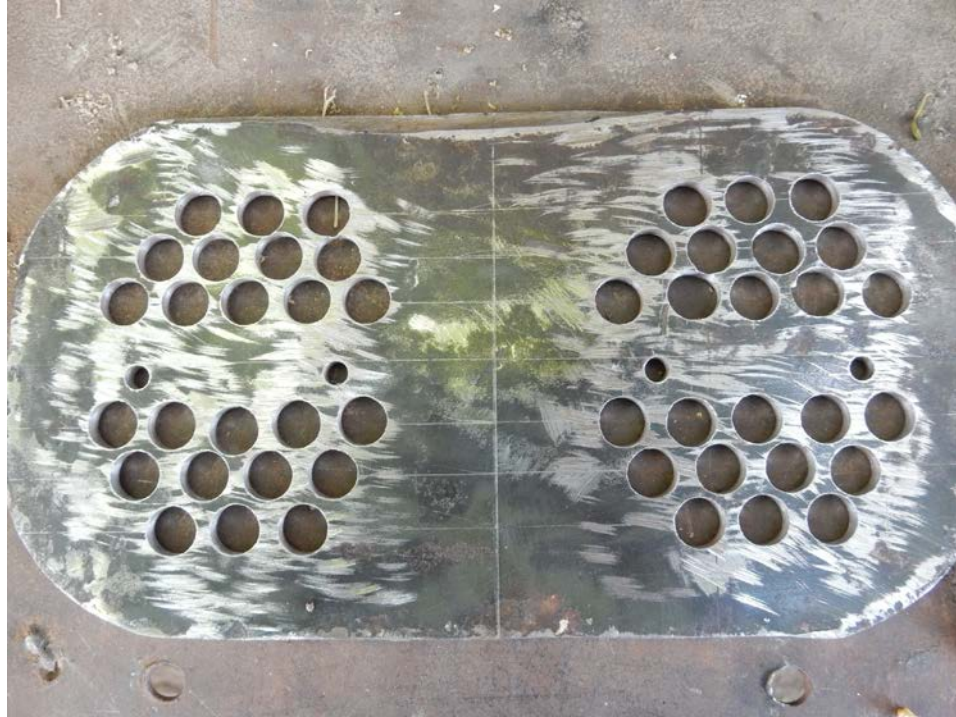
Figure 3.2: Valve plate with complex hole layout.

The most difficult component of the pump to layout was the valve plate. As shown in Figure 3.2, this piece required many holes to be properly marked for the pump to operate correctly. Due to a small figure in the fabrication plans that was difficult to understand, I had to correct the layout of the holes after seeing errors in how it was originally marked.

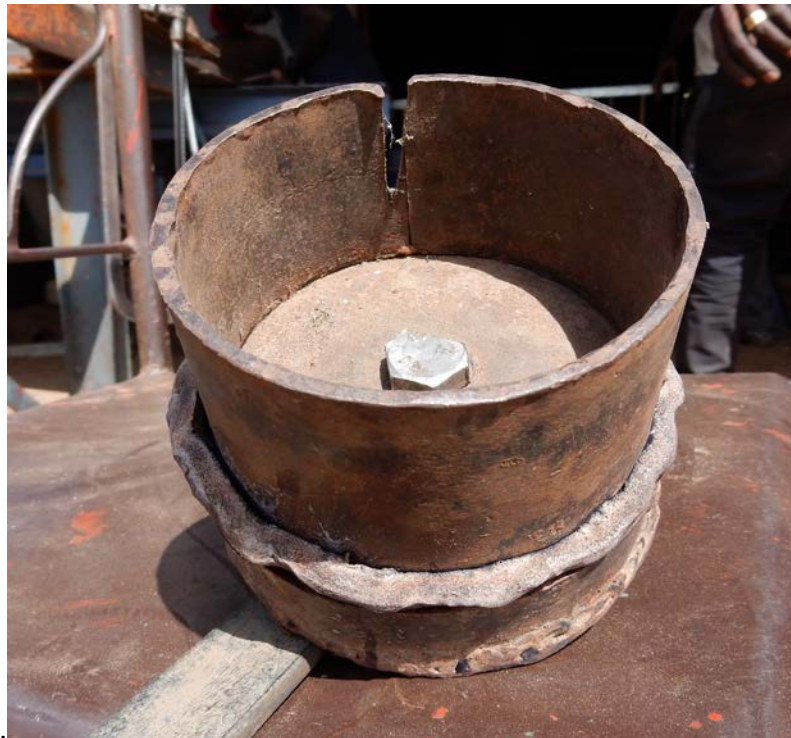
Figure 3.3: Leather cup seal being formed in a two piece mold.

The original seals called for in the fabrication plans were made from cow leather. Proper leather was not available locally and had to be purchased from the capital city, Dakar, and sent to the metal shop. The plans called for four cup seals, two for each cylinder. To form the seals from flat leather, the leather was first soaked in water overnight to make it soft and formable. A mold was then used to form the leather into the cup seal shape. The mold, shown in Figure 3.3, consisted of two circular pieces that the leather was positioned between. A bolt was then put in the center of all three pieces and used to clamp the mold together around the leather. This created a circular cup form out of the planar leather.

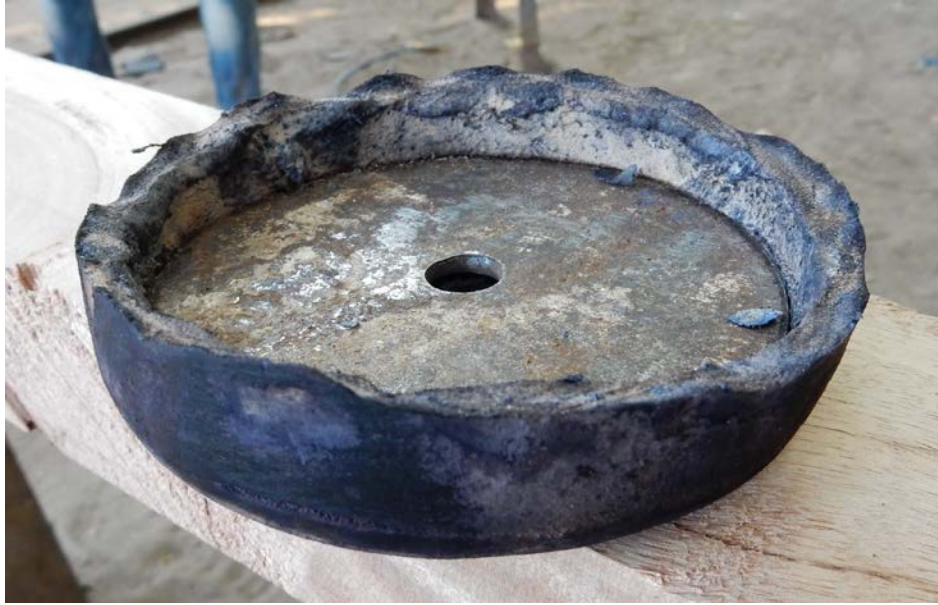
Figure 3.4: Finished leather cup seal with piston disk inserted.

The leather stayed clamped in the mold for several minutes. Before being removed, excess material that protruded out of the mold was trimmed off. The resulting seal is shown in Figure 3.4.

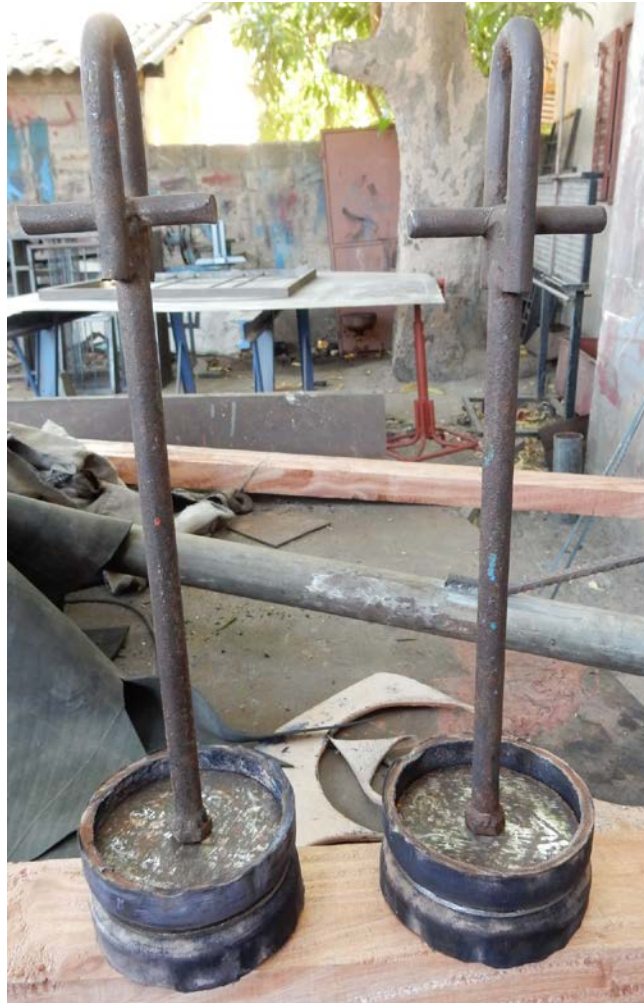
Figure 3.5: Completed pistons with leather cup seals.

The complete piston assembly in Figure 3.5 included two opposing leather cup seals per piston, one for suction and one for pressure. The seals were mounted on the piston with each seal having a 3mm thick metal disk placed in the cup portion of the seal and a metal disk acting as a separator between the two seals. These disks helped the cup seals maintain their form during operation.

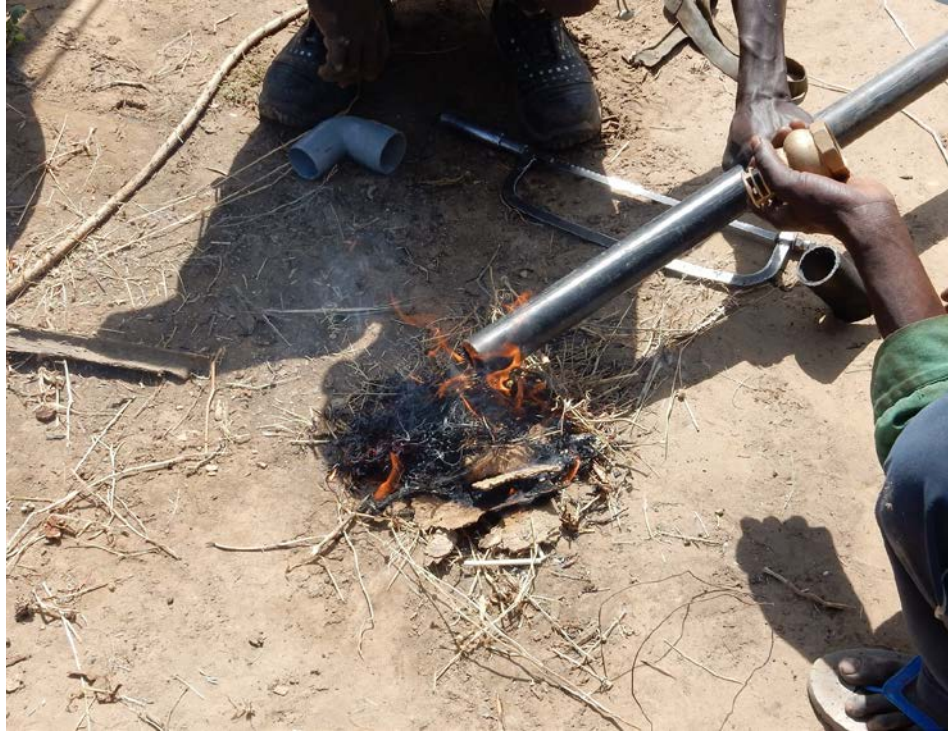
Figure 3.6: Heating plastic pipes over a fire to form pipe connections.

Installation required properly positioning the pump so that it would be close to the well and be aligned with a basin into which the pumped water would be delivered, and installing the necessary piping. Piping included horizontal sections to bring water to the pump inlet from the well and then from the pump outlet to the basin, and a vertical section to go from ground level down to the water in the well. Unconventional methods of joining pipes of the same diameter with no flanged connections had to be used. This involved starting a small fire, heating one end of a pipe until soft as seen in Figure 3.6, then forming it over the other pipe it was to be joined to. While an adhesive was used for pipe connections, this did not always create an airtight seal. To seal the connections further, rubber strips from old tire tubes were wrapped tightly around the connections like those in Figure 3.7. For connections between the plastic pipe and the metal pipe on the pump, only rubber strips were used to attached and seal the connection.

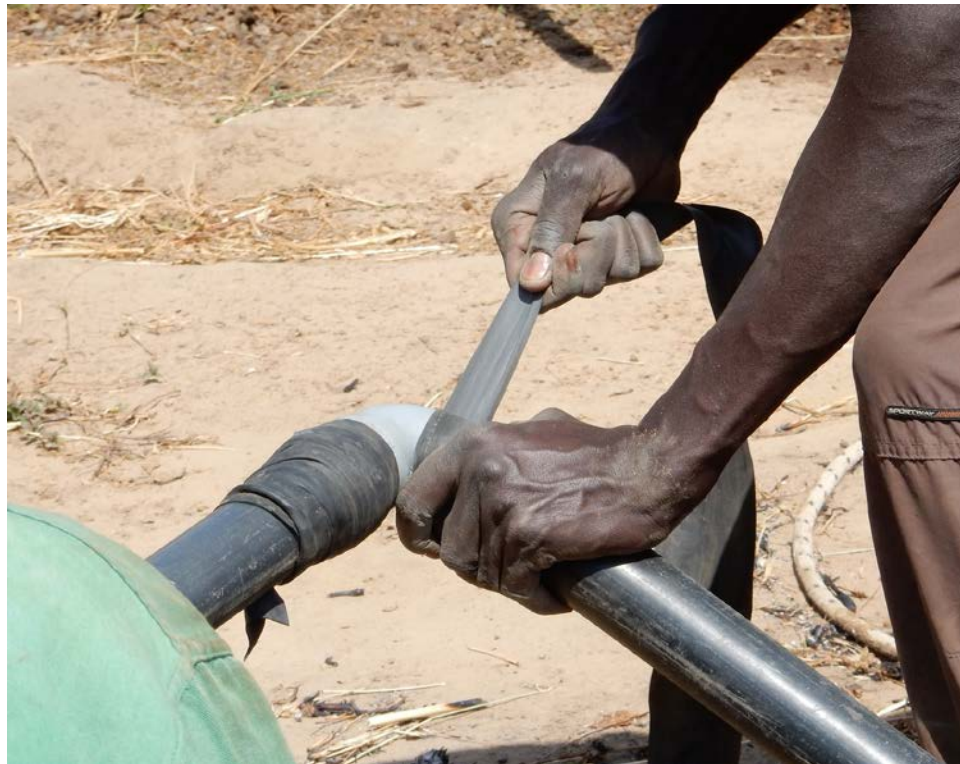
Figure 3.7: Wrapping pipe connections with rubber strips to seal connections.

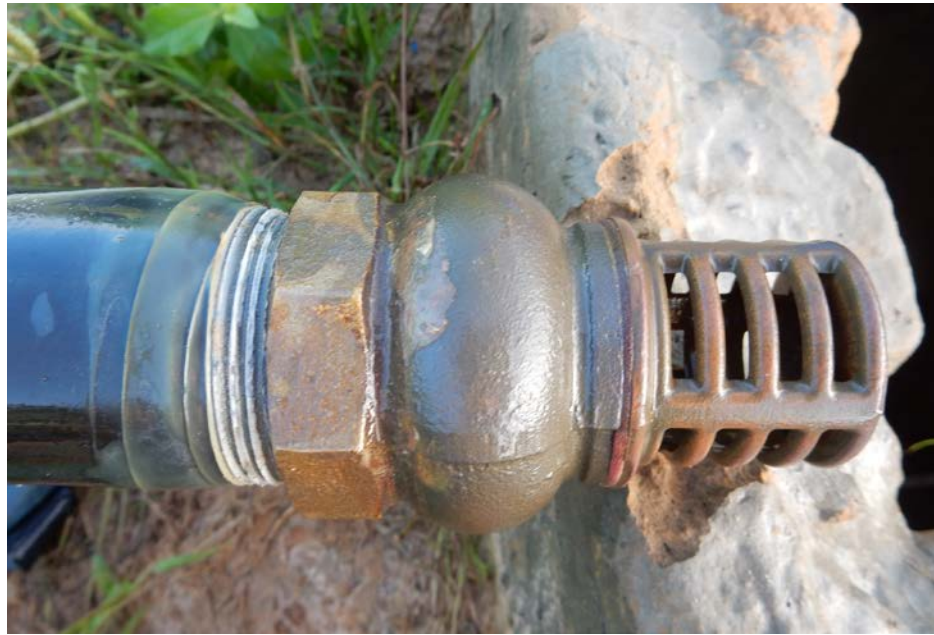
Figure 3.8: Foot valve at entrance of inlet pipe.

A foot valve was installed at the entrance to the inlet pipe placed in the well as shown in Figure 3.8. This valve was a purchased component that acted as a one-way valve to maintain prime in the pump by preventing water in the vertical inlet pipe from flowing back into the well. The metal foot valve was joined to the plastic pipe by heating the pipe until soft and inserting it into the internally threaded connector on the valve. This consequently created matching external threads on the pipe that allowed for the valve to be easily removed from the pipe if necessary.

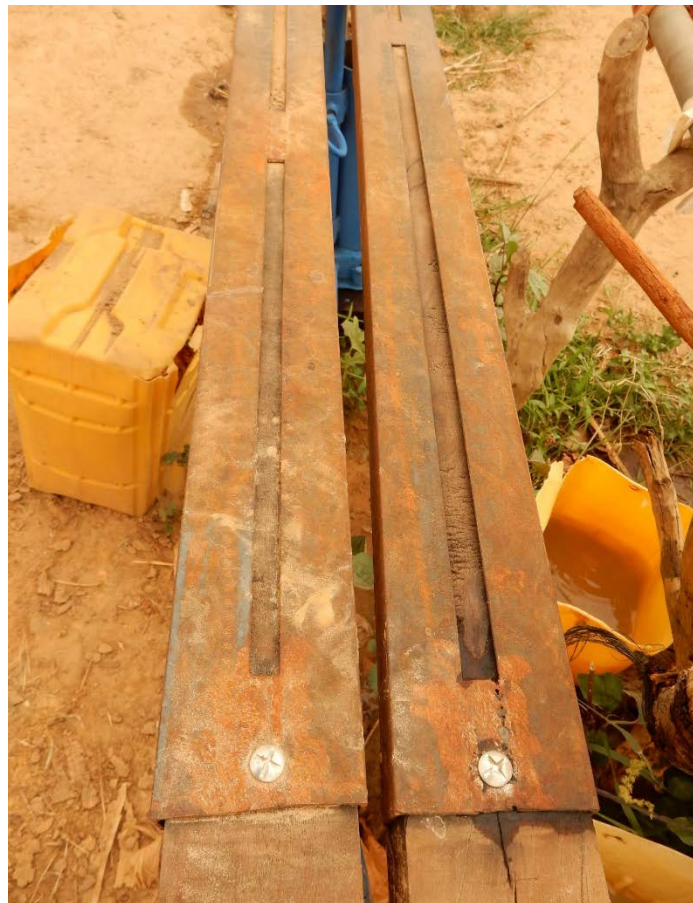
Figure 3.9: Metal reinforcements on wooden treadles.

Initial testing also resulting in the failure of one of the treadles. Due to the orientation of the wood grain in the treadle, force from the operator standing on the treadles was applied in such a way as to cause the wood to break along the grain. Since this happened early on in testing and was not a result of sustained use, it was assumed that this type of failure could happen again, therefore metal reinforcements were designed for the treadles. This design was based off treadle reinforcements seen on a different style treadle pump being used by a farmer in a different village. The reinforcements included adding metal 90 degree angles along the length of two sides of the wood treadle and joining them at various points along their length to create an external structure to support the applied force as shown in Figure 3.9.

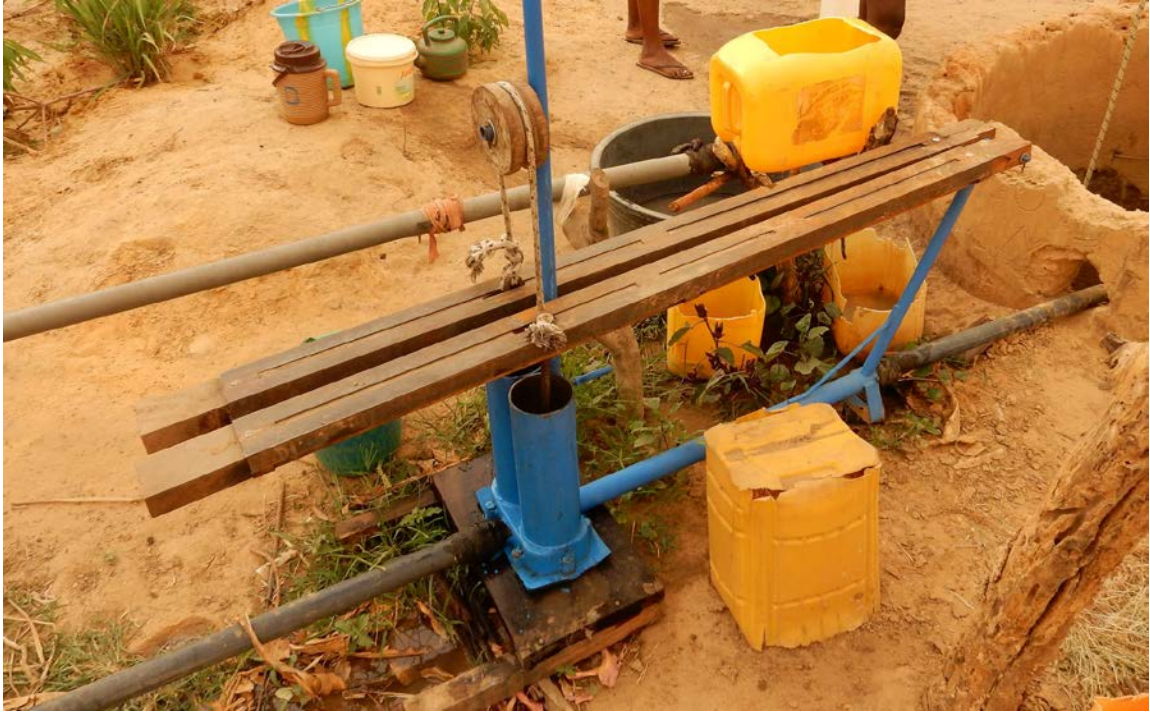
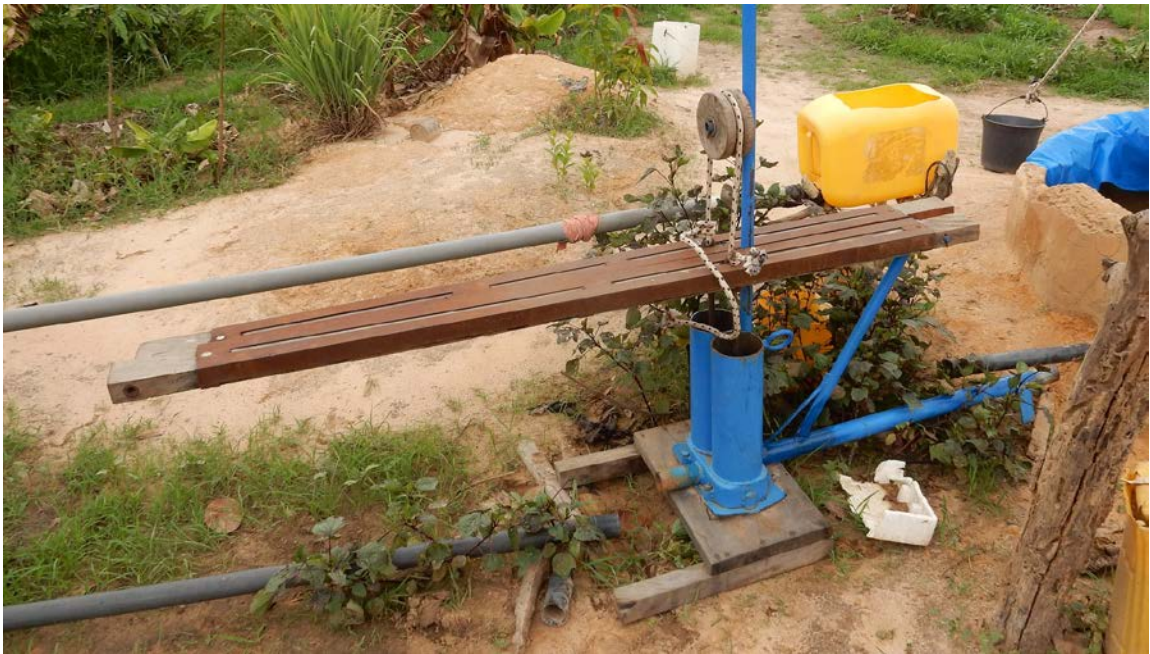
Figure 3.10: Treadle pump in one and two person configurations. (a) Pump with original treadles, (b) Pump with modified treadles

The original pump was designed for two-person operation, which decreased the input demands of a single user but did not allow for single-person use, especially with larger suction heads. To make the logistics of testing the pump easier and to allow for the single garden owner to operate the pump, modifications were made to allow for single user operation. This involved changing the mounting location of the treadles on the pump to increase the mechanical advantage of the user. This was easily done by rotating the treadles 180° to make the end of the treadle that the operator previously stood on the new end mounted to the treadle pivot since the slot in the treadle for the piston was positioned at a location along the treadle to allow for this change to obtain the desired mechanical advantage. The treadle axle mount had to be relocated closer to the cylinders to accommodate this change but was simply accomplished by grinding it off and welding it back on at the correct location. Figure 3.10 shows the pump before and after modification. This modification led to a change in mechanical advantage of approximately 2.25 for two operators to a maximum of 3 for one operator.

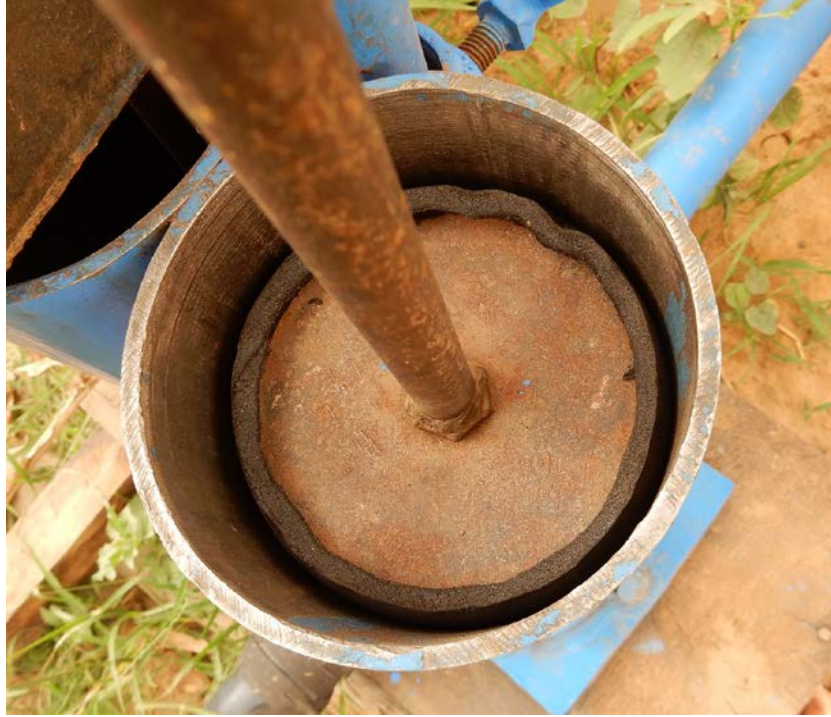
Figure 3.11: Leather piston seal with wrinkled and inward folding edges.

The original leather cups seals that came with the pump were functional in pumping water at the beginning but quickly started to show deficiencies. Problems manifested themselves in one of two ways. Water would either leak around the seal on the downstroke causing it to accumulate on top of the piston and eventually spill out onto the ground around the pump, or air would be pulled into the cylinder on the upstroke meaning water was not filling the cylinder as it should. The latter problem could often be mitigated by pouring water on top of the piston to create a better seal, but this water would soon be pulled into the piston also and had to be replaced, sometimes as often as every 30 seconds. Examination of the seals showed that there were wrinkles present in the leather, as shown in Figure 3.11, which created locations where the seal did not have good contact with the cylinder wall, resulting in leaks.

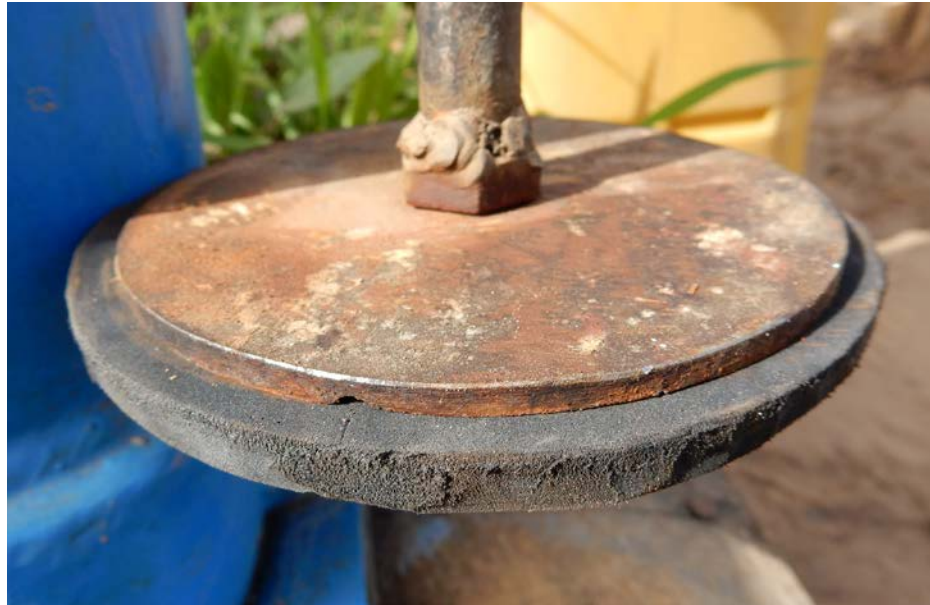
Figure 3.12: Alternative piston seal in a circular disk shape.

The new materials were also accompanied with a change in seal geometry. Due to the materials not having the same formability properties as leather and with the desire to eliminate the need for custom molds to form the seals, the cup seal geometry was replaced with a simple flat circular disk shape. The seal was sandwiched between two metal disks to provide rigidity and prevent it from losing shape during operation. Figure 3.12 shows the alternative seal design.

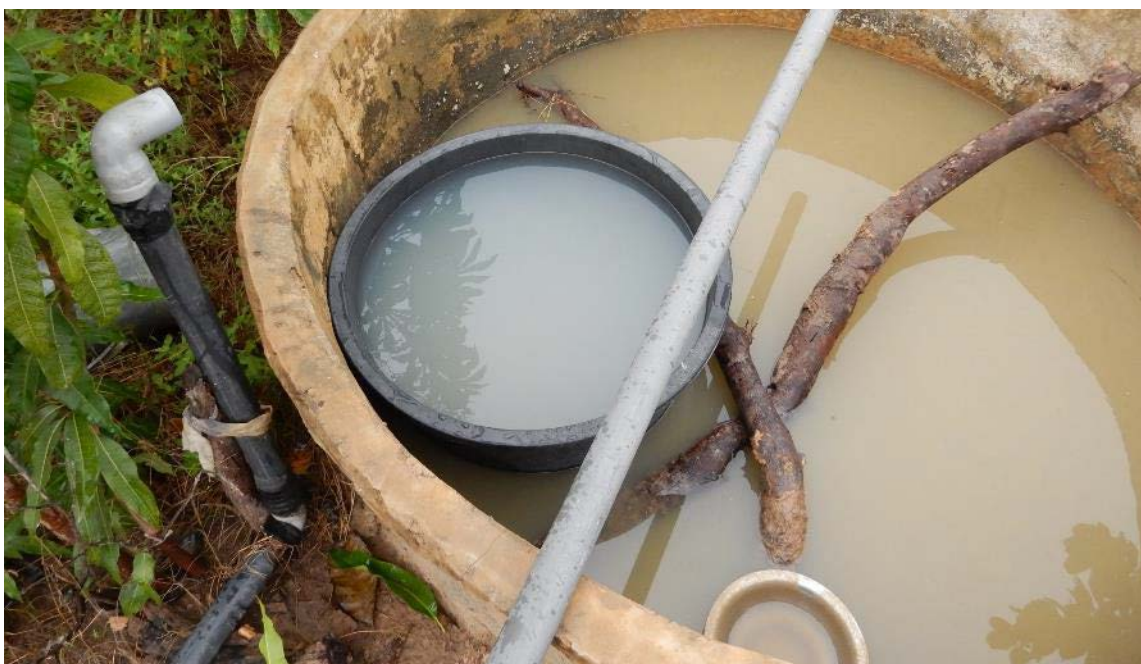
Figure 3.13: Flow rate test setup. The black and grey pipe on the left was attached to the pump with water exiting the grey elbow and entering the black basin.

Basic flow rate testing of the pump was performed to quantify how fast it could pump water. This test included capturing the water from the pump in a basin, shown in Figure 3.13, over a measured time interval and measuring the amount of water pumped. Results are shown in Table 3.3.

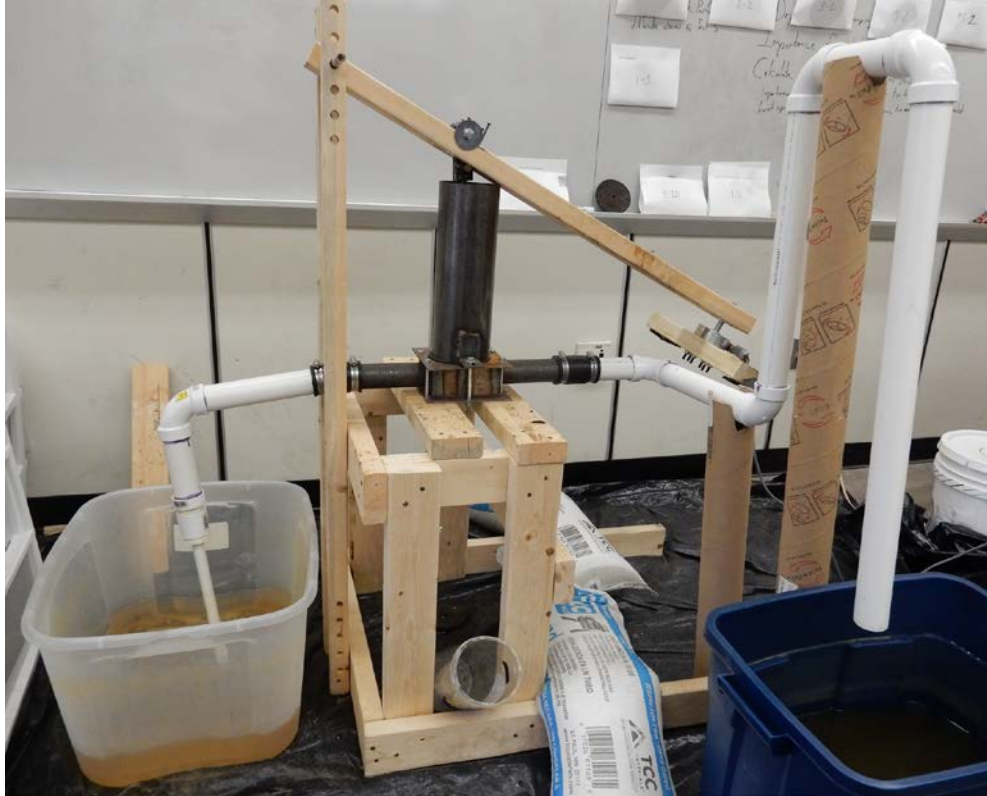
Figure 4.1: Experimental pump for laboratory testing. The pump is mounted on a wooden frame and located in the center with the inlet pipe and basin on the left and outlet pipe and basin on the right.

Since a treadle pump could not easily be brought back to campus from the field, a modified version of the pump used in Senegal was fabricated. This experimental pump, shown in Figure 4.1, maintained the same operating principles of the field pump but in a modified configuration.

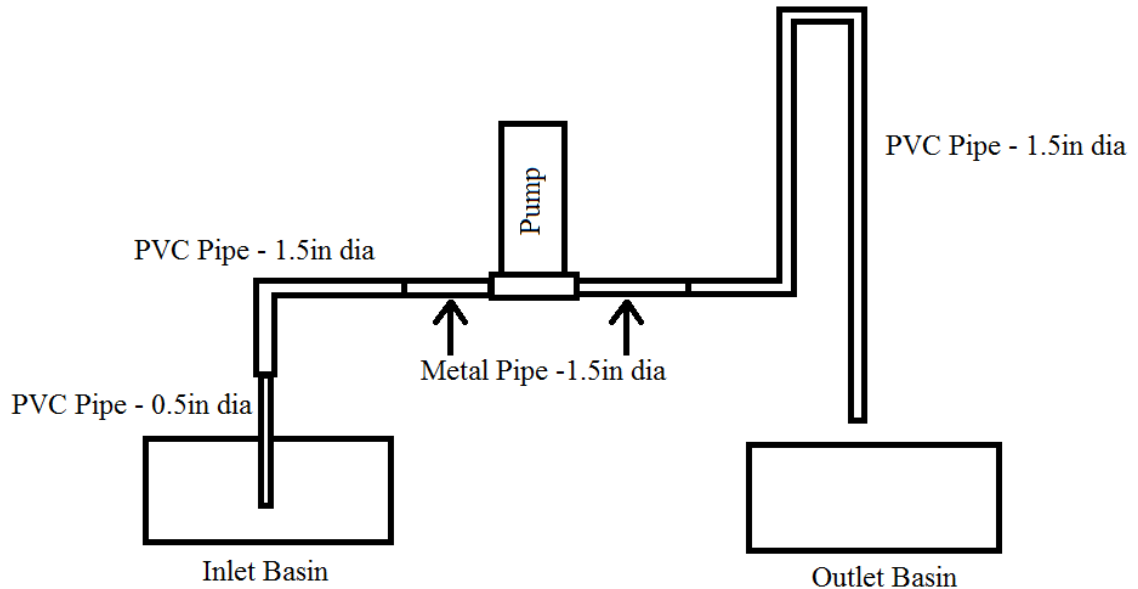
Figure 4.2: Diagram of pipes for laboratory testing.

Water was supplied to the pump from a plastic basin and discharged into another basin. With the pump located in a laboratory setting that had no space to accommodate a large pumping depth, head loss was built into the inlet pipe by reducing the size of the inlet pipe. Figure 4.2 shows a diagram of the pump piping system.

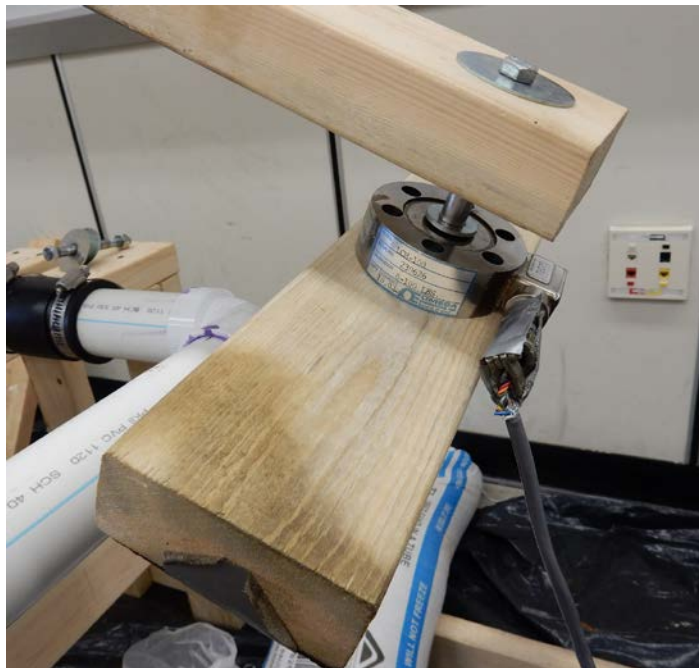
Figure 4.3: Load cell mounted on pump handle arm. The operator holds the wood handle in the foreground while force is transferred through the load cell in the center.

Instrumentation was used to measure the force input by the operator during testing. A 100lb load cell was mounted on the pump handle arm on one side and an operator handle was mounted on the other. This created a connection, shown in Figure 4.3, where all of the operator force would be transferred by the load cell to the pump, therefore the input force could be accurately measured.
