Comparative Analysis of Locally Available Materials for Treadle Pump Seals in Senegal, West Africa

COMPARATIVE ANALYSIS OF LOCALLY AVAILABLE MATERIALS FOR
TREADLE PUMP SEALS IN SENEGAL, WEST AFRICA

A REPORT

In Mechanical Engineering

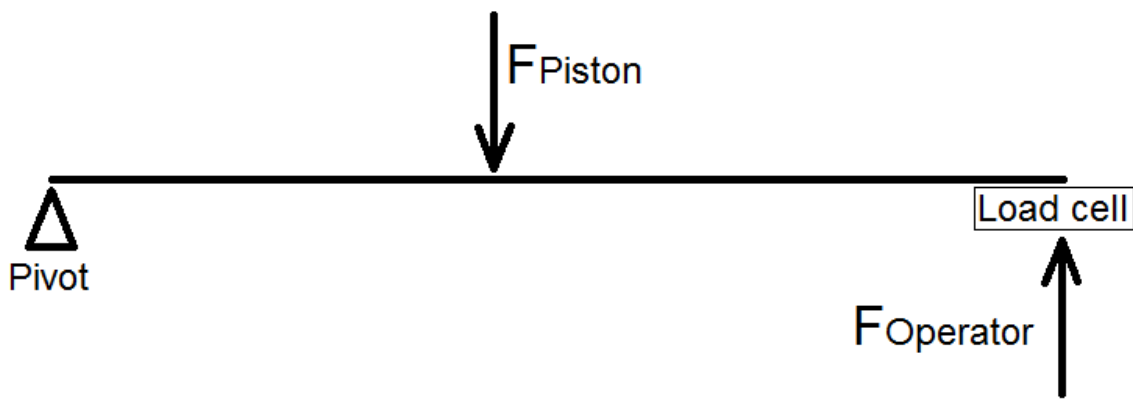
Figure 4.4: Diagram of forces acting on pump arm during testing.

Data acquisition was accomplished by the load cell with a National Instruments NI 9219 analog input module, a 10V power source, and a computer with appropriate software for capturing the raw data. MATLAB was used to post-process the data to convert it from raw data to force values using calibration equations for the load cell output. With the operator force, F_{Operator} , being measured by the load cell, the measured values were then used to calculate the force acting at the piston, F_{Piston} , using the sum of the moments at the pump arm pivot according to the diagram of the pump arm in Figure 4.4.

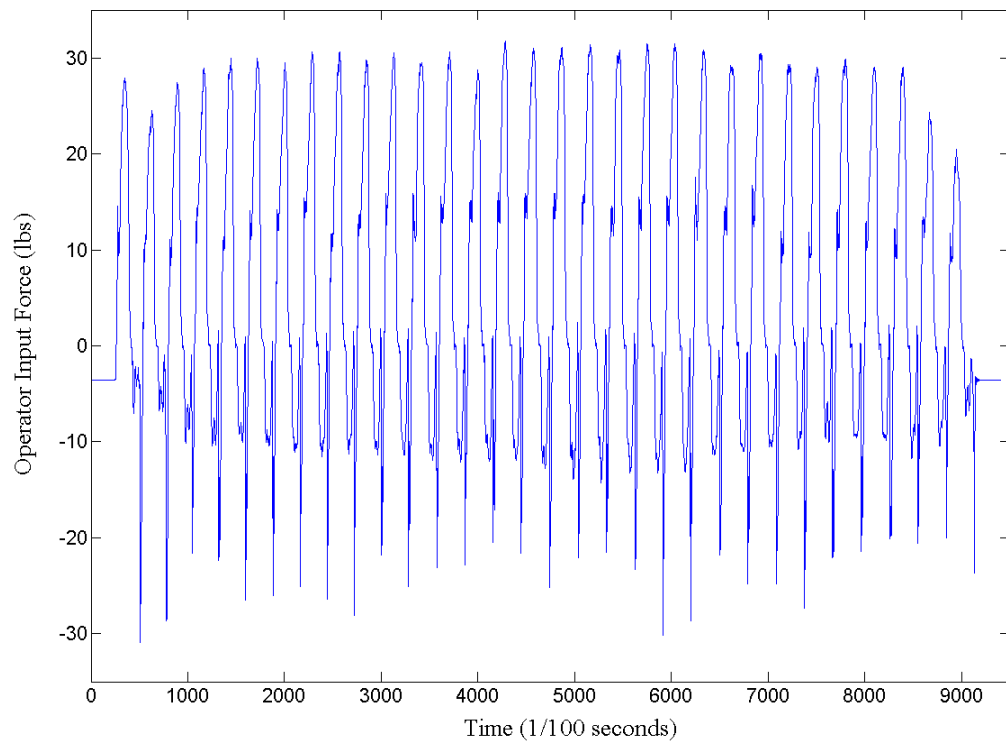
Figure 4.5: Raw data of Seal 0-2 for a single test run

Figure 4.5 shows the raw data for the input force for one test run of Seal 0-2. By taking the average of the peak values in the figure and for the other test runs of the seal and by calculating the force acting at this piston using the mechanical advantage of the pump arm, a complete graph of the force during testing can be created as shown in Figure 4.6

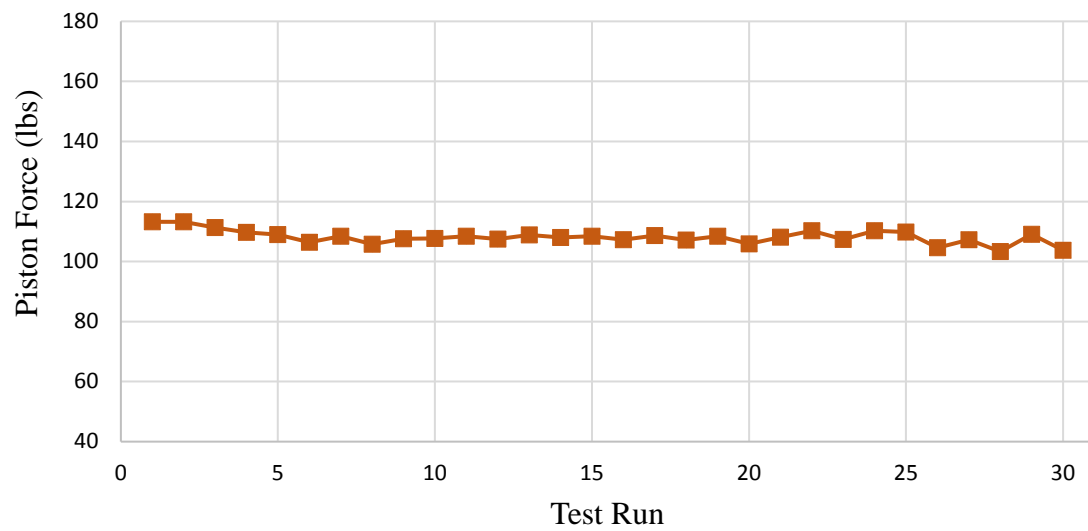
Figure 4.6: Force acting on the piston for Seal 0-2

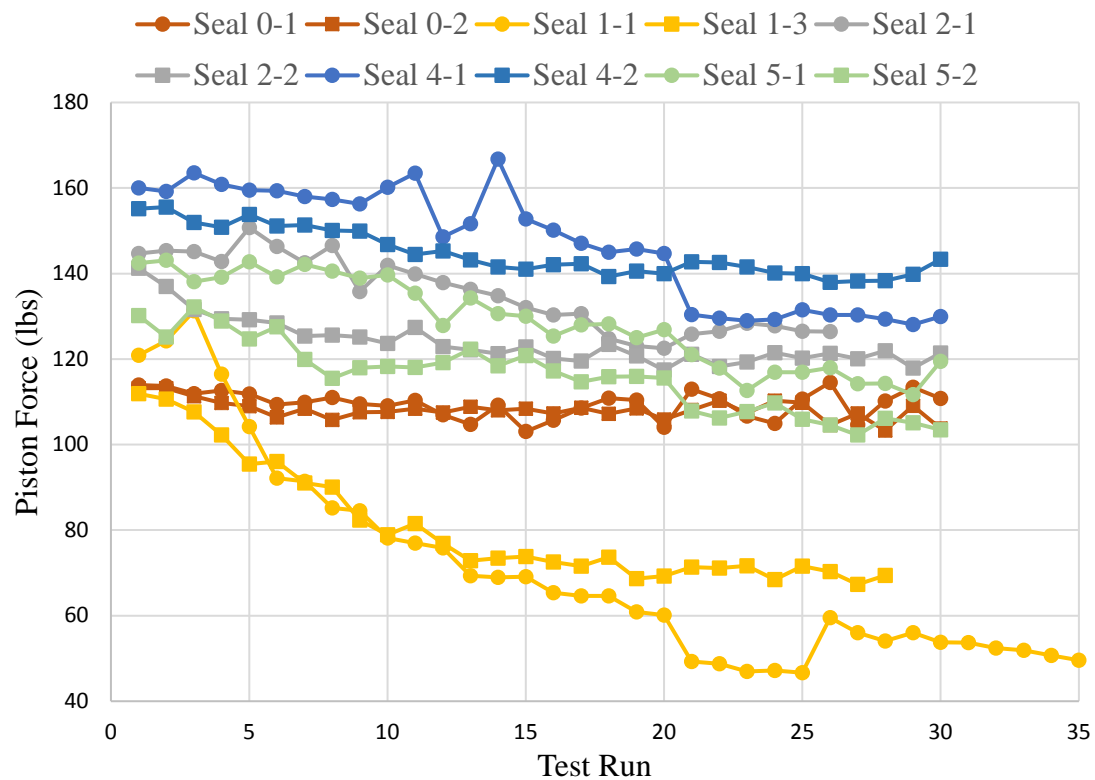
Figure 4.7: Force acting on the piston for each test run

Figure 4.7 shows the test results for all of the seals. It should be noted that these values also included the force to overcome the weight of the pump arm and the attached load cell. This was done since real treadle pump operation would also include the treadle weight in the operation force.

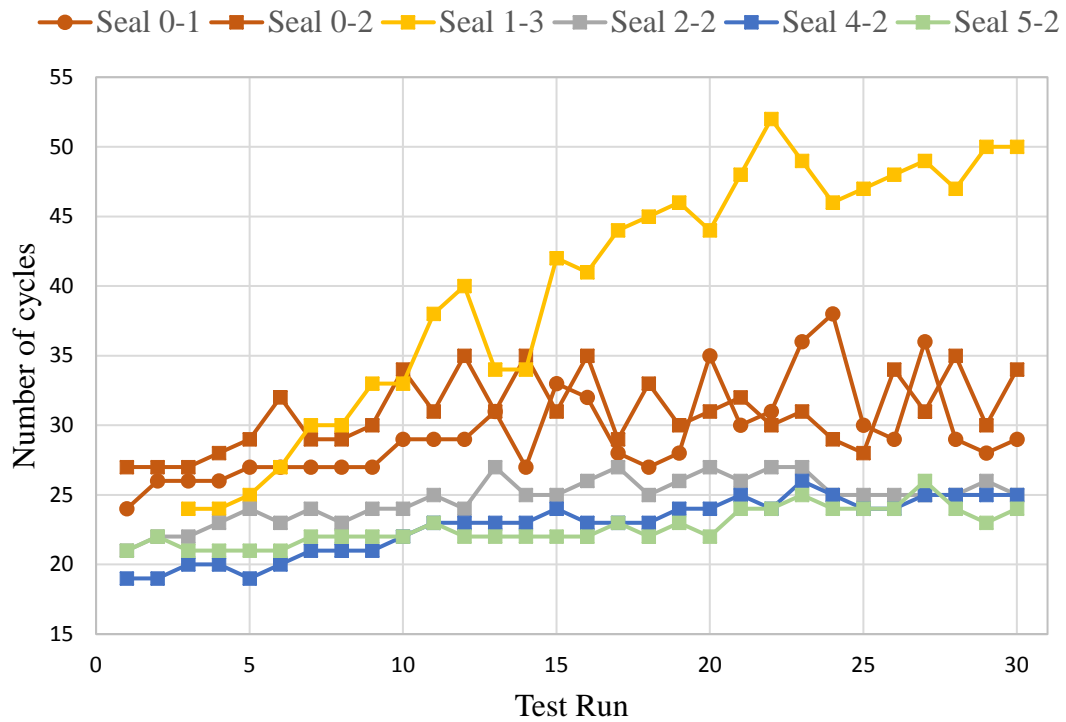
Figure 4.8: Number of cycles per test run for select seals

While having a low force requirement is desirable from the perspective of the pump user, during testing, decreasing force corresponded to a decrease in the amount of water pumped per stroke. Figure 4.8 shows this trend for select seals using the number of piston cycles per test as an indicator of decreased volume per stroke since the same amount of water was used in each test.

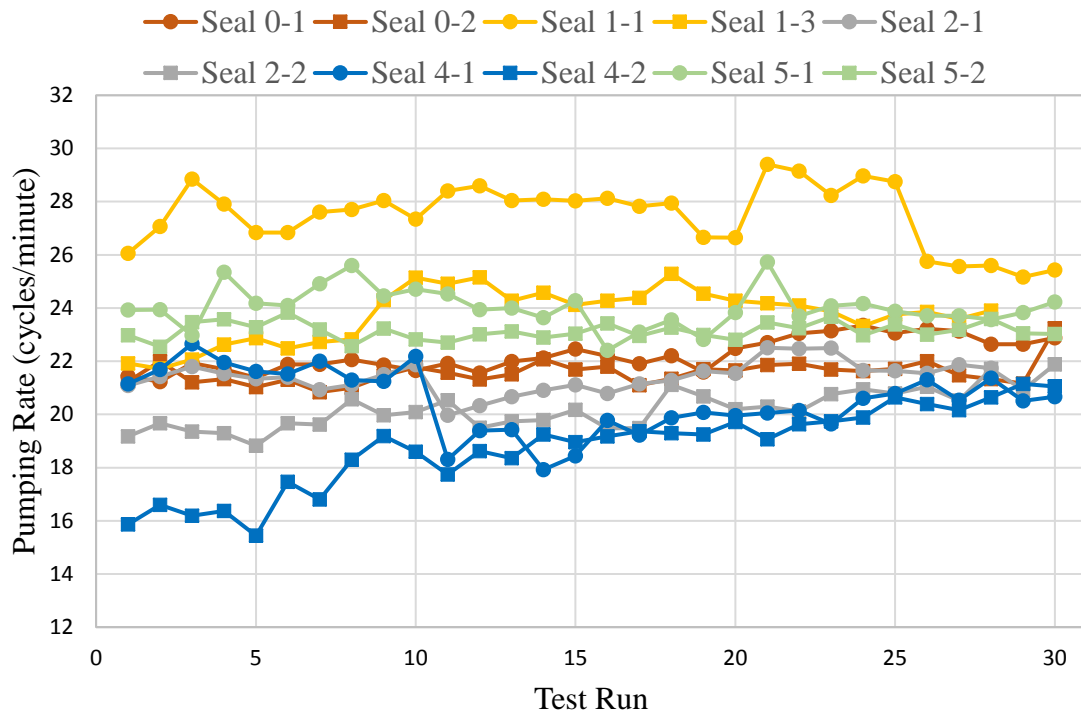
Figure 4.9: Cycles/minute for each test run

materials with lower forces. Figure 4.9 must be used to determine how the pumping rate affected the force.

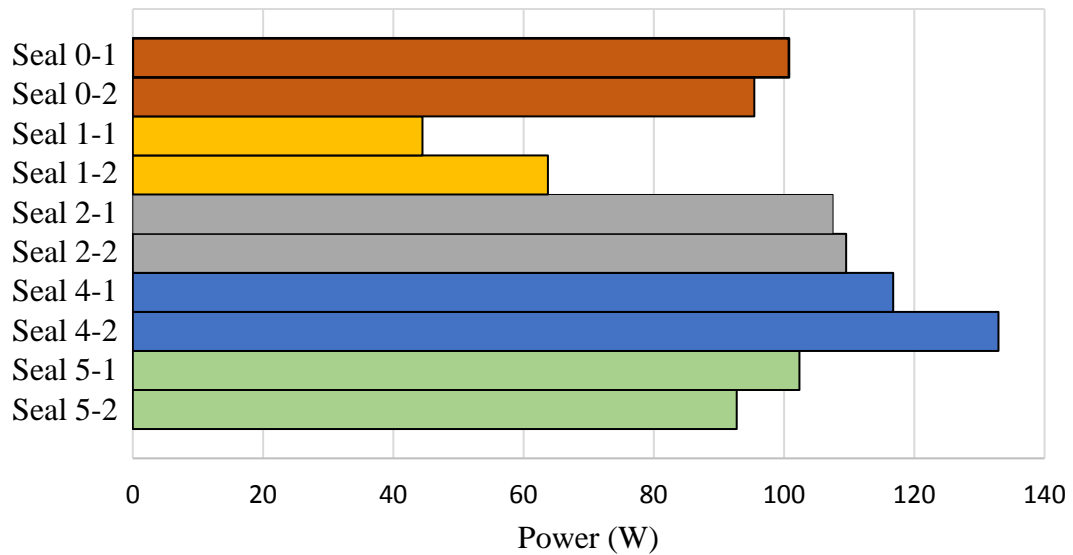
Figure 4.10: Operation power estimates for last test run

From the viewpoint of the user, the operation force is important as it determines the immediate effort to operate the pump. However, for sustained use, the power requirements to operate the pump can also be important as it is an indicator of the user's overall energy use. Calculating power from the test data was made difficult due to the lack of displacement measurement with time. While the raw test data was uniformly periodic, this did not mean that the rate of displacement of the piston during a cycle was constant. If the displacement rate did change, it would result in a varying power input from the operator. Despite these limitations on the data, an estimate of operation power was made by taking the average velocity of the piston based on cycle time and stroke length and multiplying it by the peak force. Figure 4.10 shows the power values for the last test run of each seal.

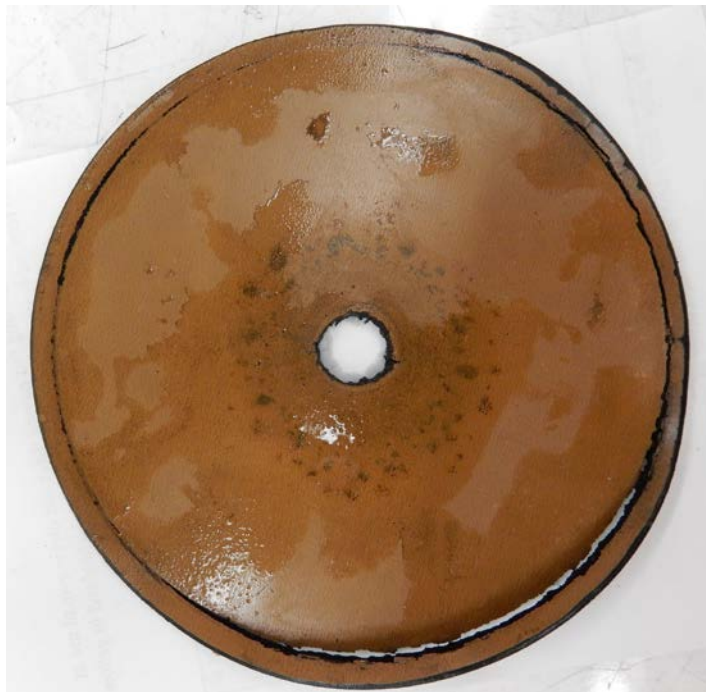
Figure 4.11: Failed seal of Material 3.

Material 3 was the only material to fail during testing. The material tore at the point of contact with the edge of the metal piston disks as shown in Figure 4.11. Although Material 3 was preliminarily tested in the field and did not fail during those trials, it was not tested for as many cycles as it was in the lab yet did start to show signs of wear at the same location that the lab tested seals failed at.

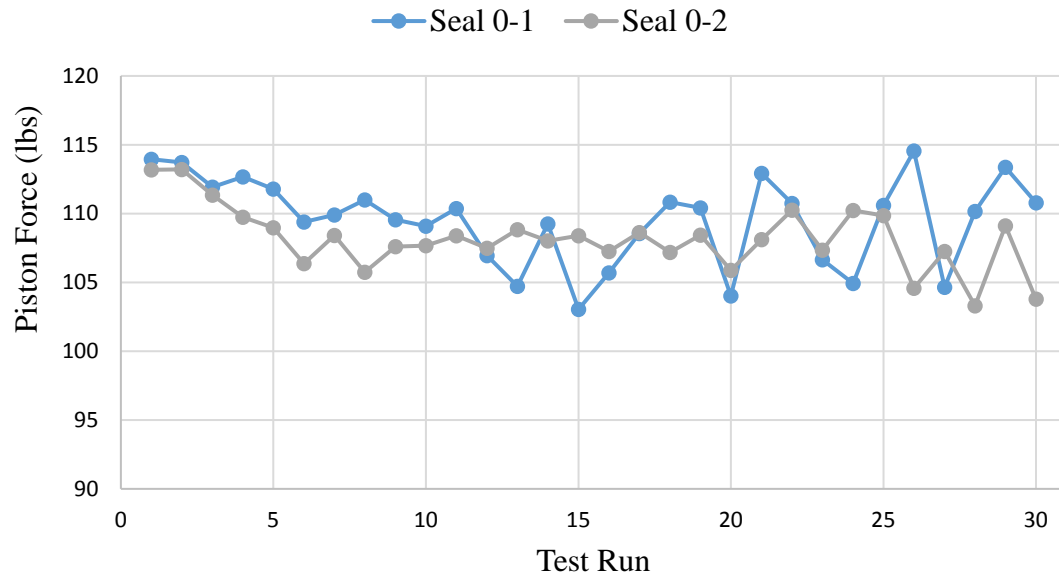
Figure A.1: Pumping force for Material 0

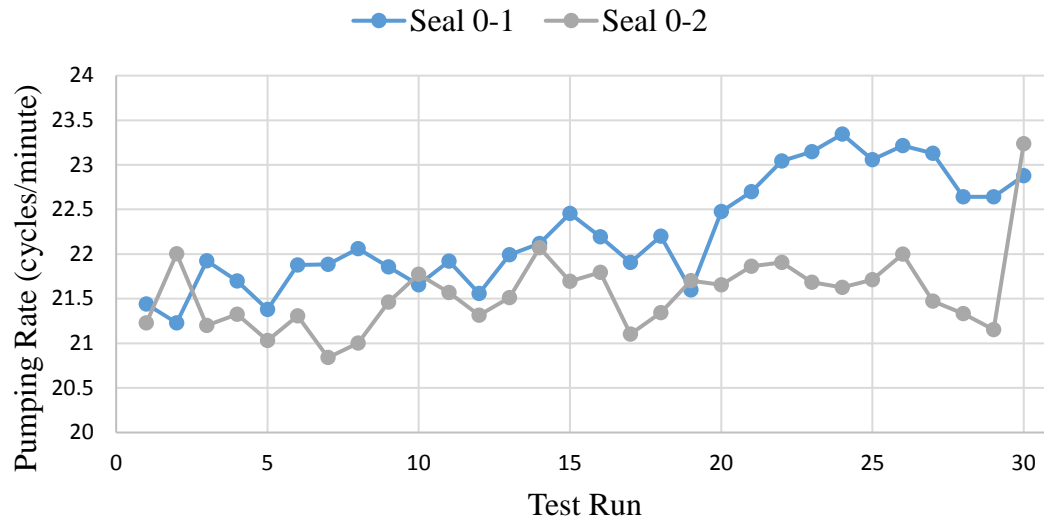
Figure A.2: Pumping Rate for Material 0

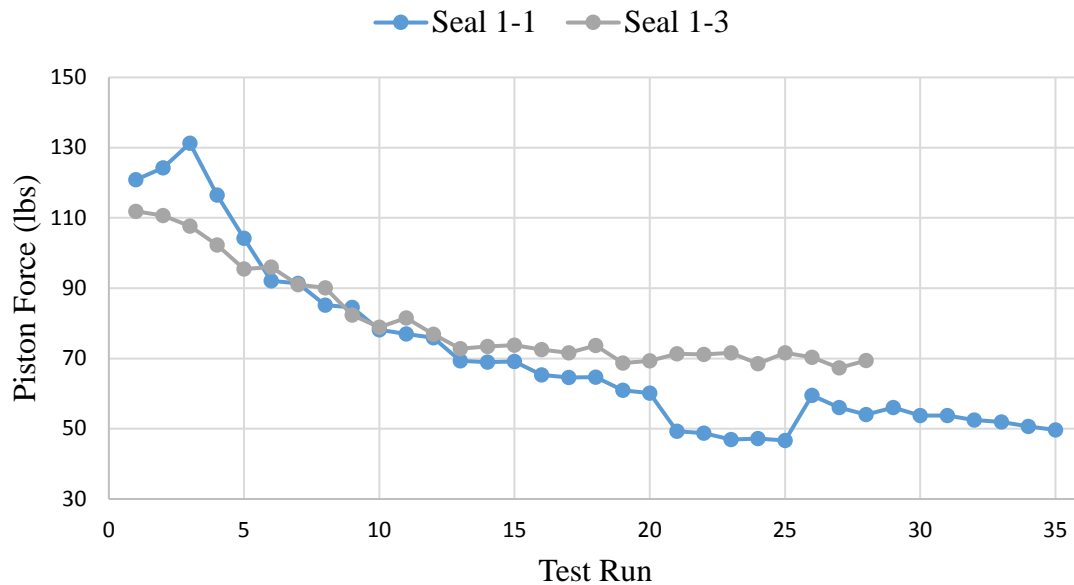
Figure A.3: Pumping Force for Material 1

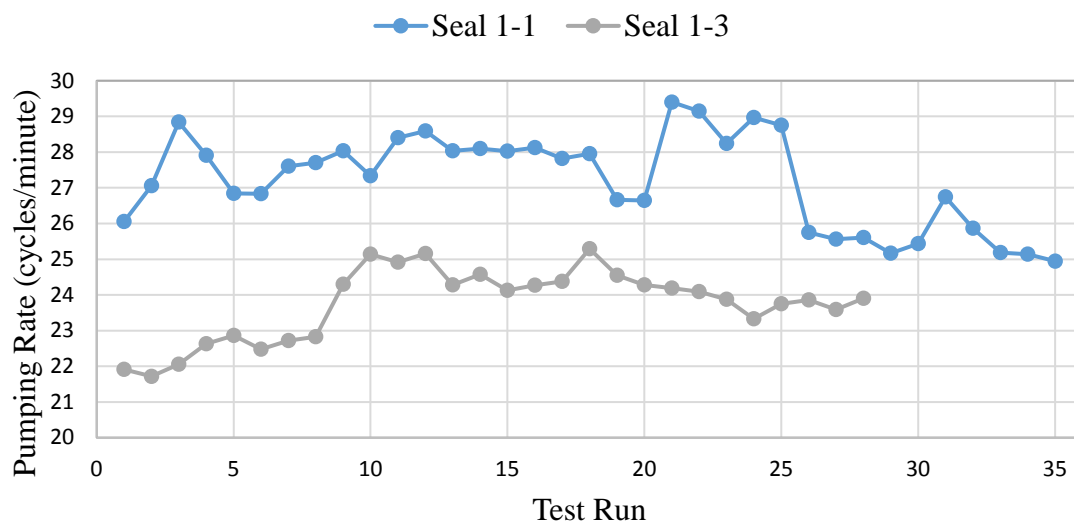
Figure A.4: Pumping Rate for Material 1

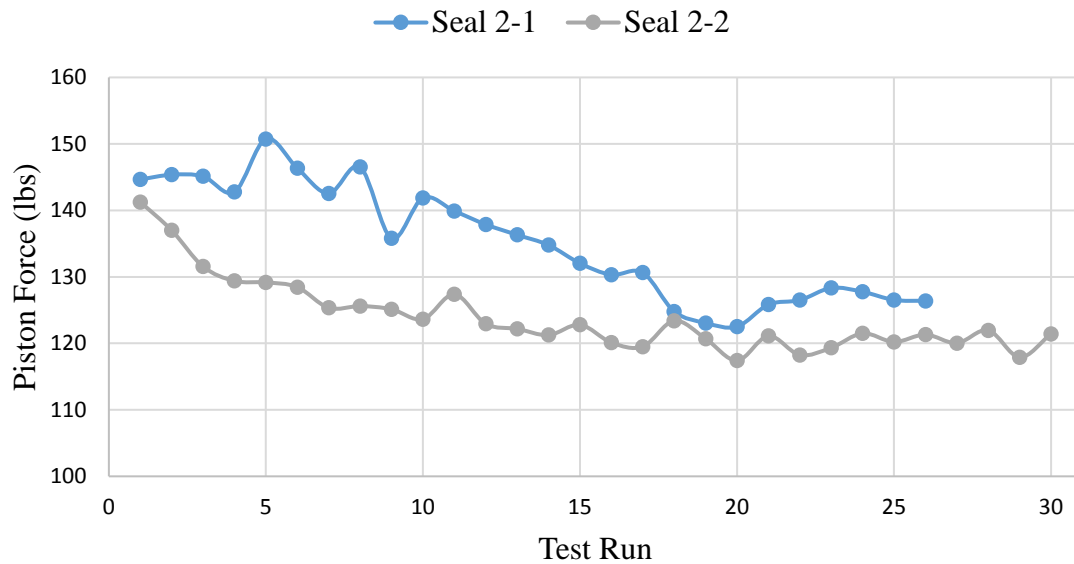
Figure A.5: Pumping Force for Material 2

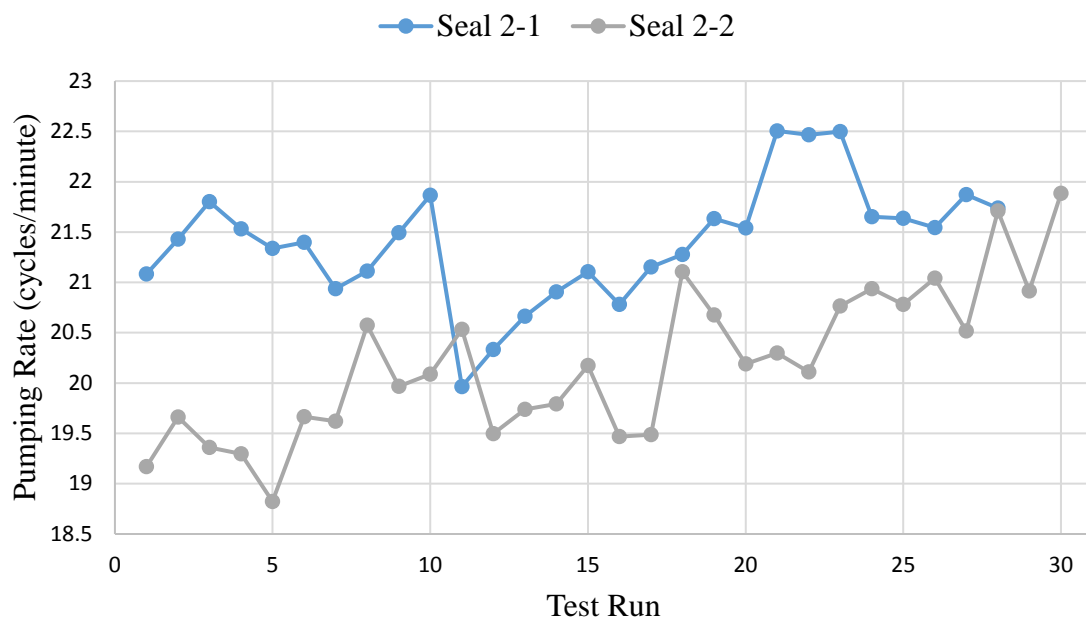
Figure A.6: Pumping Rate for Material 2

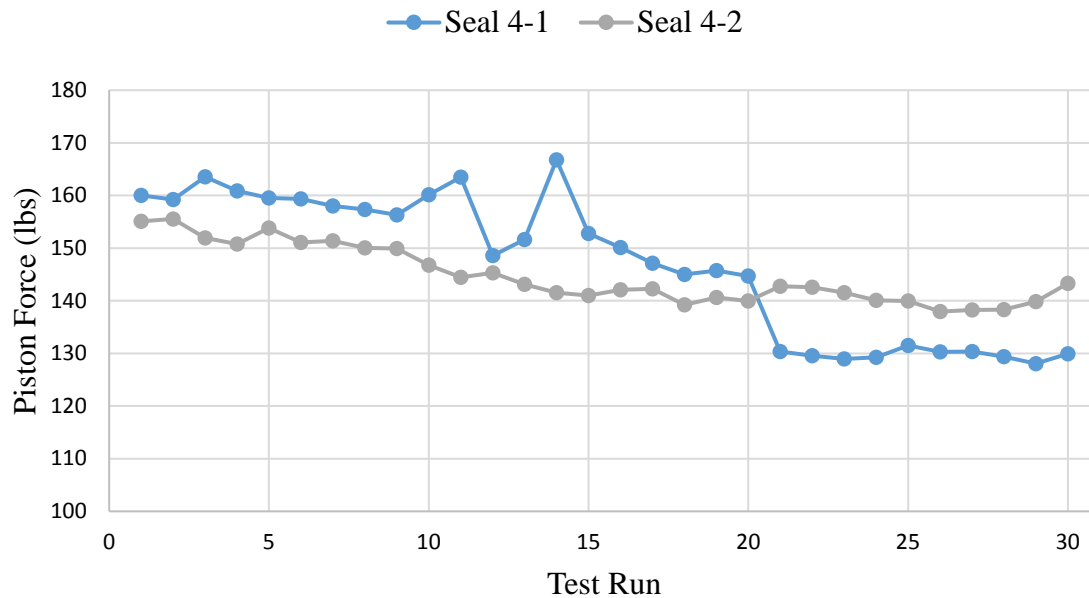
Figure A.7: Pumping Force for Material 4

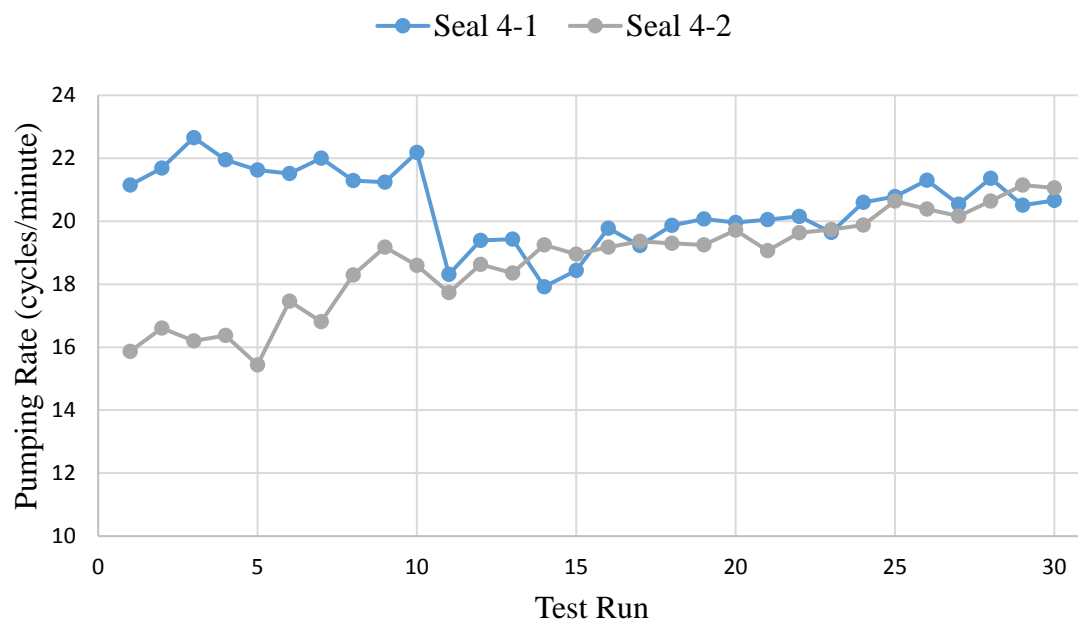
Figure A.8: Pumping Rate for Material 4

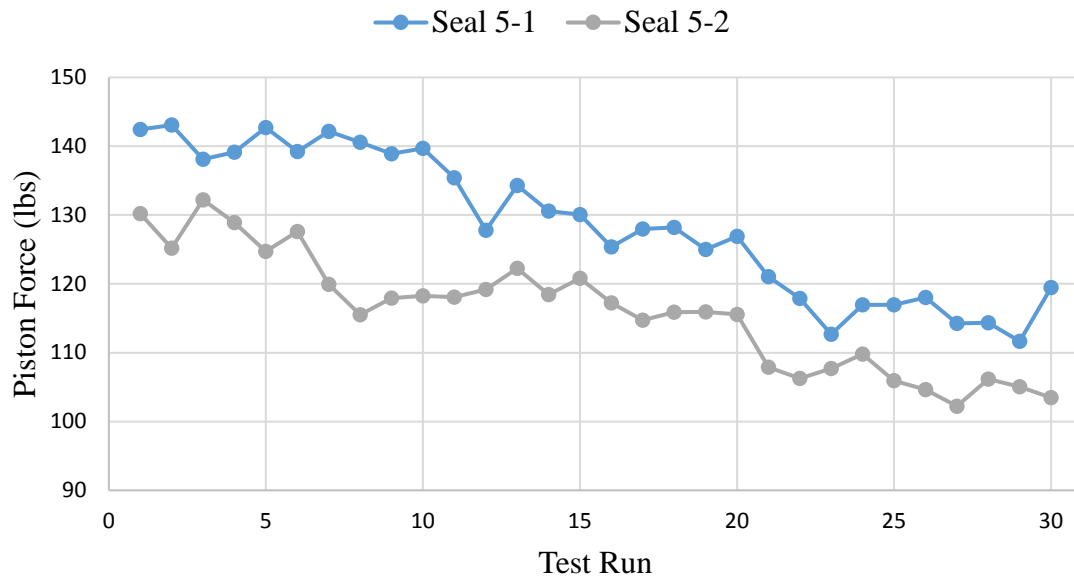
Figure A.9: Pumping Force for Material 5

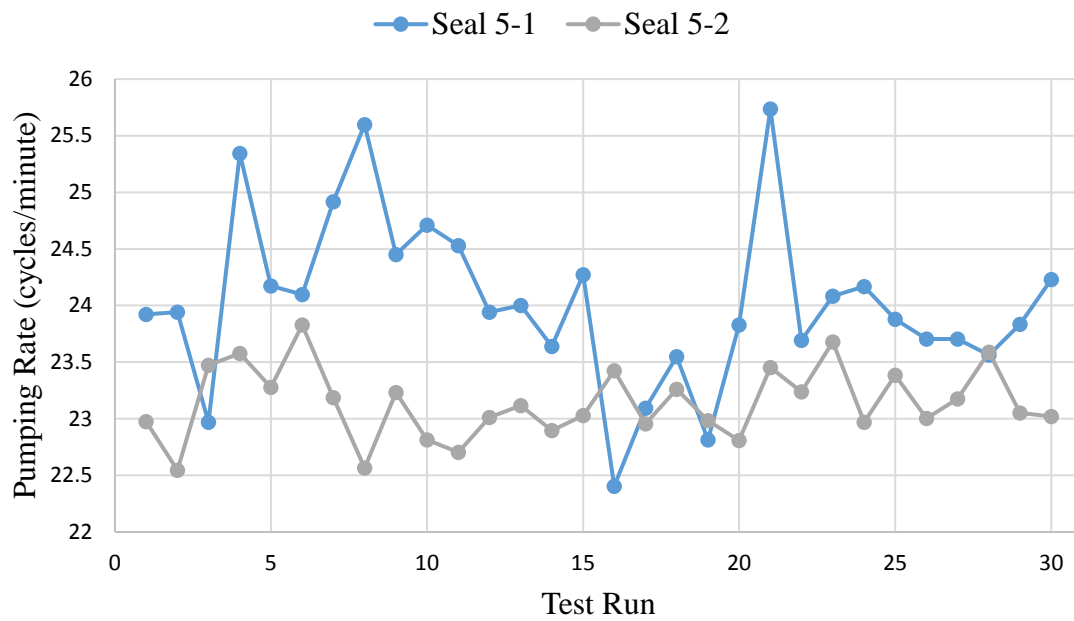
Figure A.10: Pumping Rate for Material 5
