## Waterpower : a geophysical and archaeological investigation of the waterpower system at the West Point Foundry, Cold Spring, New York

WATERPOWER: A GEOPHYSICAL AND ARCHAEOLOGICAL INVESTIGATION  
OF THE WATERPOWER SYSTEM AT THE WEST POINT FOUNDRY, COLD  
SPRING, NEW YORK.

A THESIS

MASTER OF SCIENCE IN INDUSTRIAL ARCHAEOLOGY

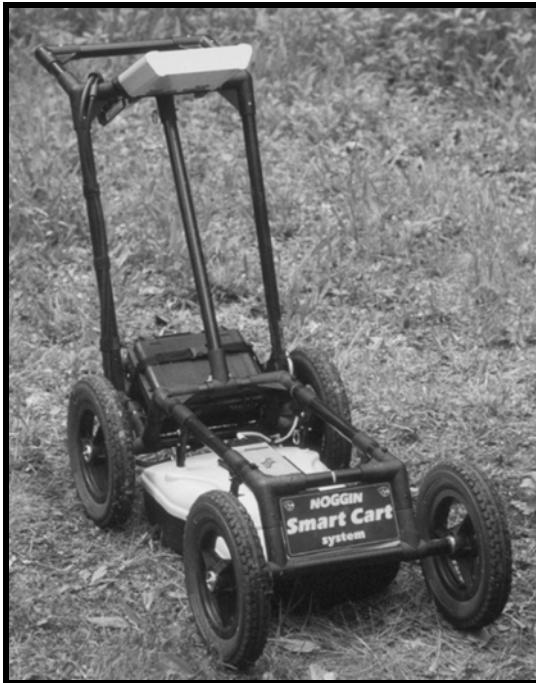
*Figure 4-1:*  
Smart Cart and  
Noggin<sup>Plus</sup> by Sensors  
and Software, Inc.  
Photograph by Pat  
Martin.

was mounted. The cart contained an integrated battery and digital video logger that permitted direct observation of subsurface images as the cart passed over buried features. The Smart Cart also contained a wheel odometer designed to enable quick calibration of radar wave velocity and depth of objects. Under ideal circumstances, the wheel odometer triggers the radar unit to acquire traces at equal intervals, such as five or 10 centimeters, along survey transects. Unfortunately, leaf and brick debris at the foundry interfered with this function.

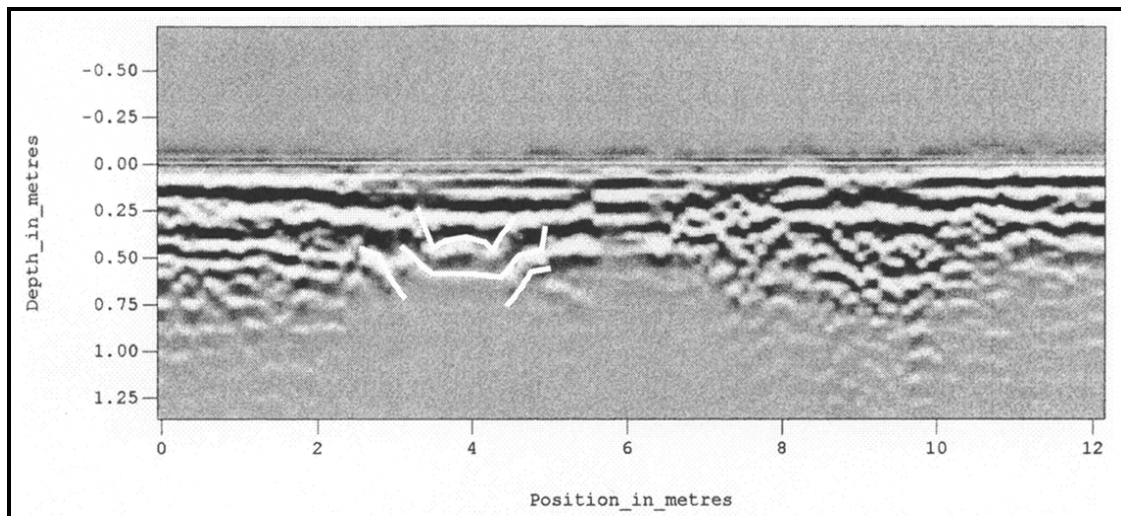
*Figure 4-9:* Depth section of GPR project seven, line three. Depressed soil layers (outlined in white) might represent the top of the stone-capped drain.

Line three began at 8.5 meters along the western axis and extended 12 meters north. The surface drain registered once again on this transect between 7 meters and 10 meters (Figure 4-9). As mentioned above, an anomaly similar to one identified in lines zero and two occurred between 2 meters and 5 meters.

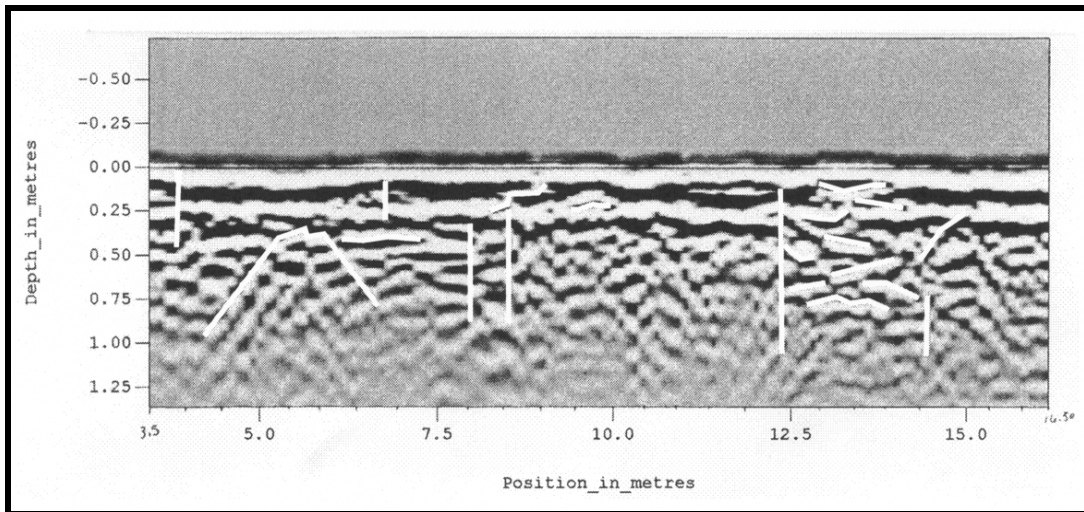
*Figure 4-13:* Depth section of GPR project nine, line 4. An example of the chaotic nature of anomalies in project nine. A sample of point reflections and disrupted soil horizons are outlined in white.

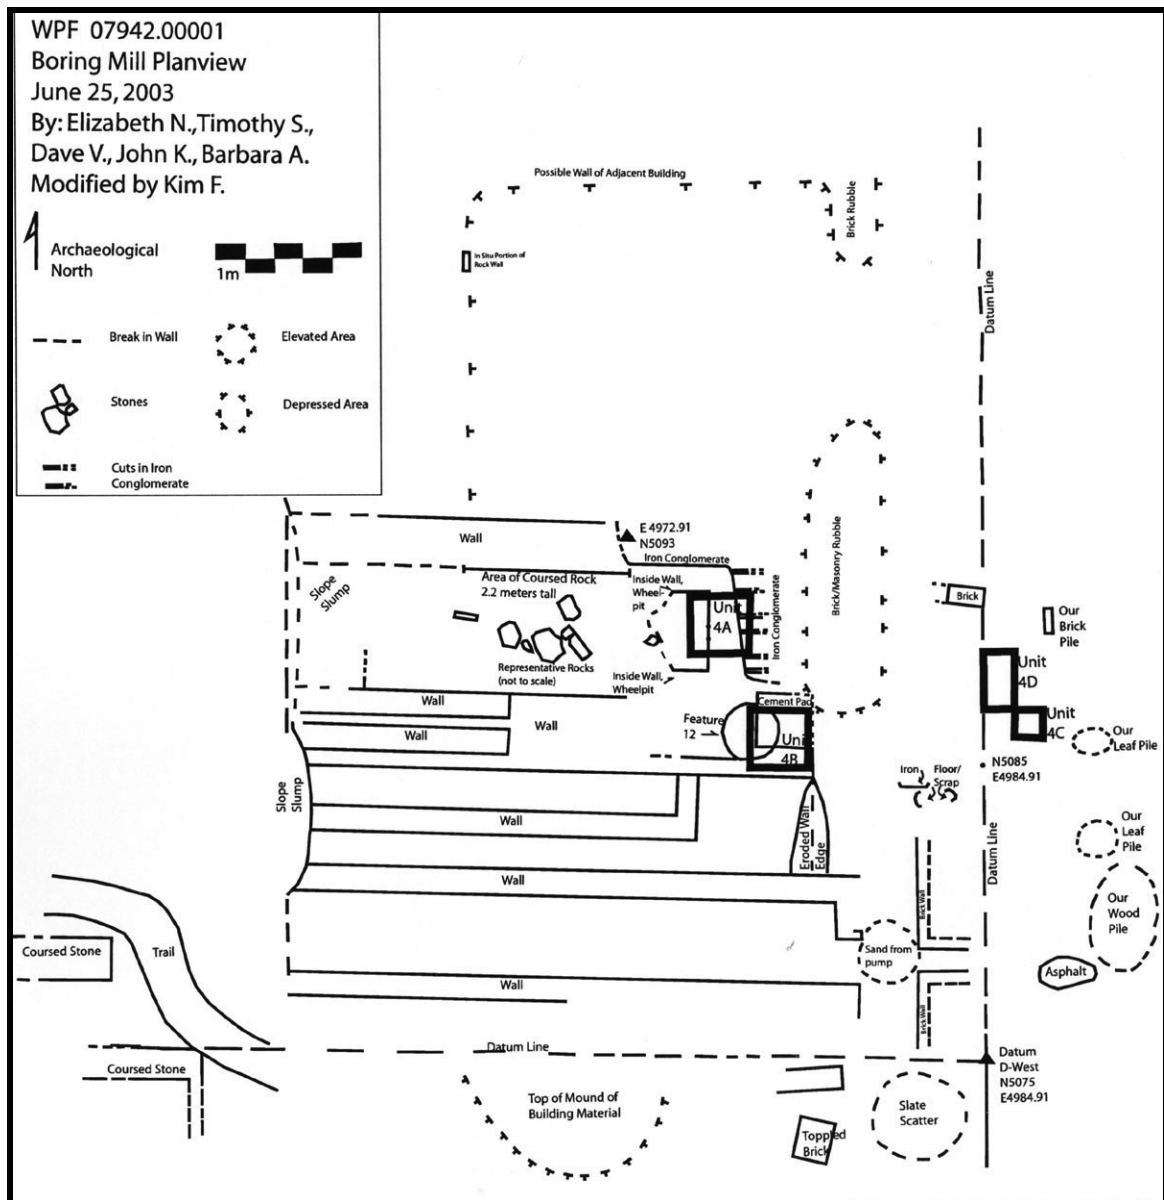
Figure 5-2: Planview drawing of the boring mill at the West Point Foundry outlining excavation units from the 2003 field season.

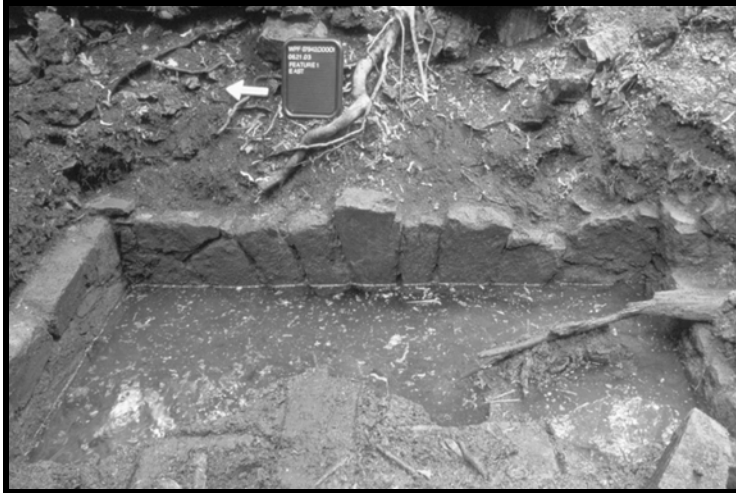
*Figure 5-3:* Eastern wall of the boring mill waterwheel pit (Feature One). Note the stone arch and central keystone, which marks the inlet to a subsurface tailrace. Photograph by Mike Deegan.

Archaeologists removed stone rubble and approximately 20 centimeters of sediment above and below the cut stones, revealing a two meter long cut-stone wall and archway designated as Feature One (Figures 5-3 and 5-4). A 30 centimeter wide and 50 centimeter tall keystone occupied the center of this wall, forming the top of the arch. Water lay at the base of the keystone. As archaeologists removed rock rubble and mud from the front of the keystone, a two meter wide, water filled hole became visible beneath the archway. By removing rocks by the keystone, archaeologists unblocked the hole, and water quickly flooded the western third of 4A. This hole extended at least two

meters east, and sloped down under the keystone approximately 80 centimeters. Due to increasing water levels in front of the arch, archaeologists abandoned conventional excavation techniques and expanded excavation beyond the boundaries of unit 4A.

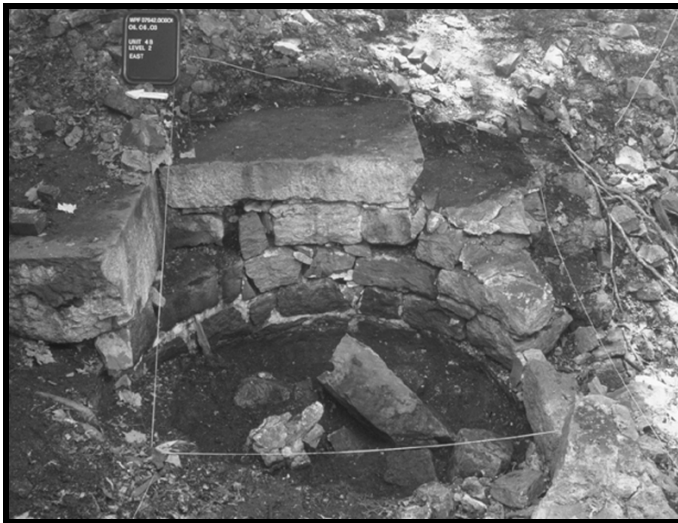
*Figure 5-7:*  
Feature Twelve, a  
round, stone and  
mortar lined pit  
within unit 4B.  
Photograph by Joe  
Wilson.

Unit 4B (N5085, E4976.91) was a two by two meter unit located along the eastern wall of the boring mill. This unit incorporated half of a 2.25 by 2 meter circular, stone-lined pit and an associated stone platform (Feature Twelve). Figures 5-7 and 5-8 illustrate Feature 12 within unit 4B. Archaeologists excavated this feature because of its proximity to the assumed tailrace inlet in the boring mill wheel pit. A break within a wall separating the wheel pit and southern sections of the boring mill suggested a connection between these features. However, the absence of iron conglomerate associated with water-related features such as the water wheel pit and Battery Pond suggested that this feature was not related to the boring mill's waterpower system. Holes six centimeters in diameter in the stone platform and within stones in the pit itself suggested that heavy machinery possibly related to vertical boring or casting once stood near or over this pit.

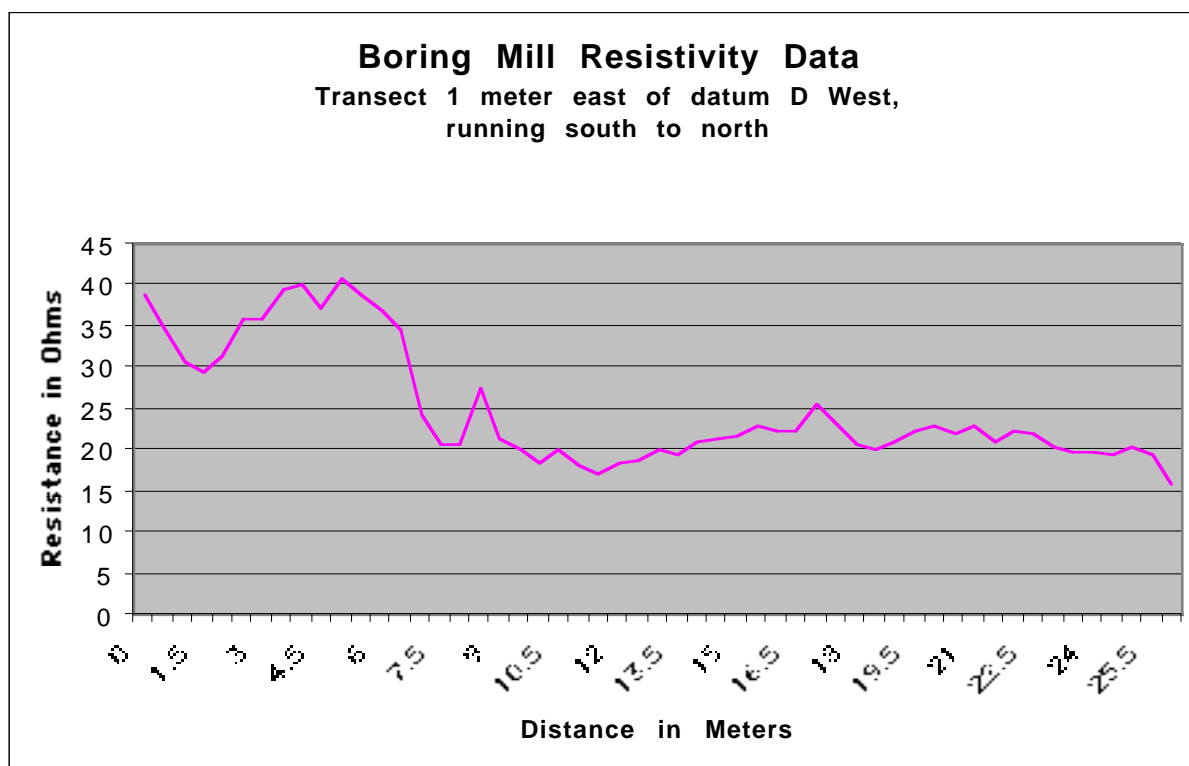
Figure 5-9: Resistivity data from a transect beginning one meter east of datum D West. Note the area of low resistance between 11 and 12 meters, which suggested a possible anomaly lay in this area.

resistance on the second transect suggested that a feature lay between 11 and 12 meters (Figure 5-9). Archaeologists positioned unit 4C based on this data.

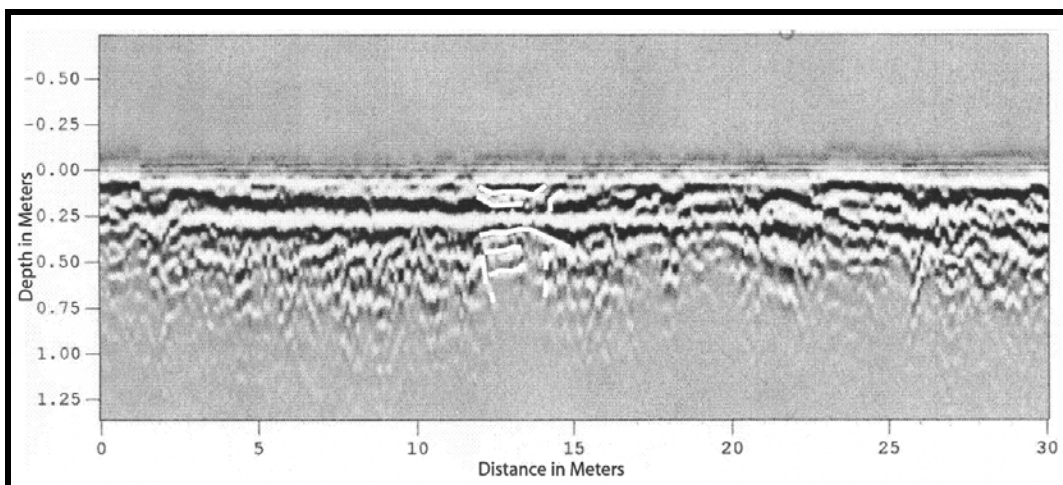
Figure 5-12: Depth section of project 6, line 0 outlining an anomaly between 13 and 15 meters.

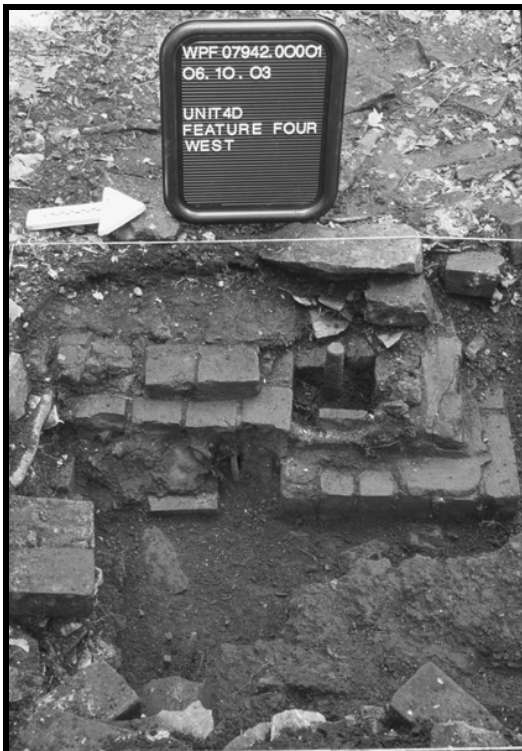
*Figure 5-13:*  
Feature four, a brick machine  
base in the southwestern  
quadrant of unit 4D.  
Photograph by Mike Deegan.

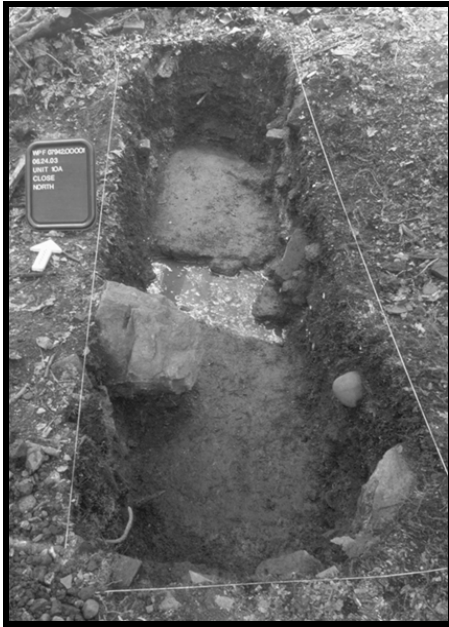
*Figure 5-15:*

Closing photograph of unit 10A, looking north. Water in the center of the unit defines a potential surface drain. Photograph by Pat Baird.

Archaeologists successfully defined the surface drain extending from the blacksmith shop to Foundry Brook (Figure 5-15). The drain was 37 centimeters wide at the western unit edge and 50 centimeters wide along 10A's eastern edge. It formed a 45 degree angle across the center of 10A, from the northwest to northeast sides of the unit. Large stones lined the final meter of this drain where it entered Foundry Brook; similar stones lined the southern boundary of the drain in 10A, but they were not present along the northern boundary. Stones were also absent along the drain's path between the blacksmith complex and 10A, suggesting that stones were only placed at the drain's terminus. It is also possible that stones had been displaced since the drain went into disuse, like many of the bricks across the site. Although the actual purpose of this drain is

not known, it probably channeled waste water from the blacksmith complex into the brook.

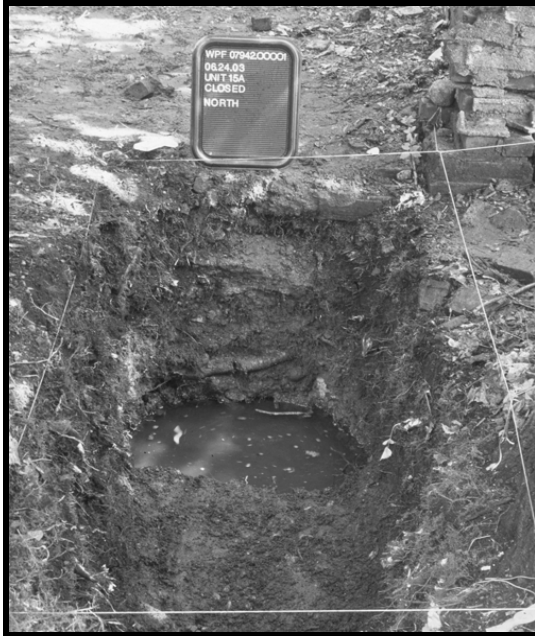
*Figure 5-18:*  
Closing photograph of unit 15A, looking north. Notice water pooling along the northern wall and the masonry in the north wall. Photograph by Mike Deegan.

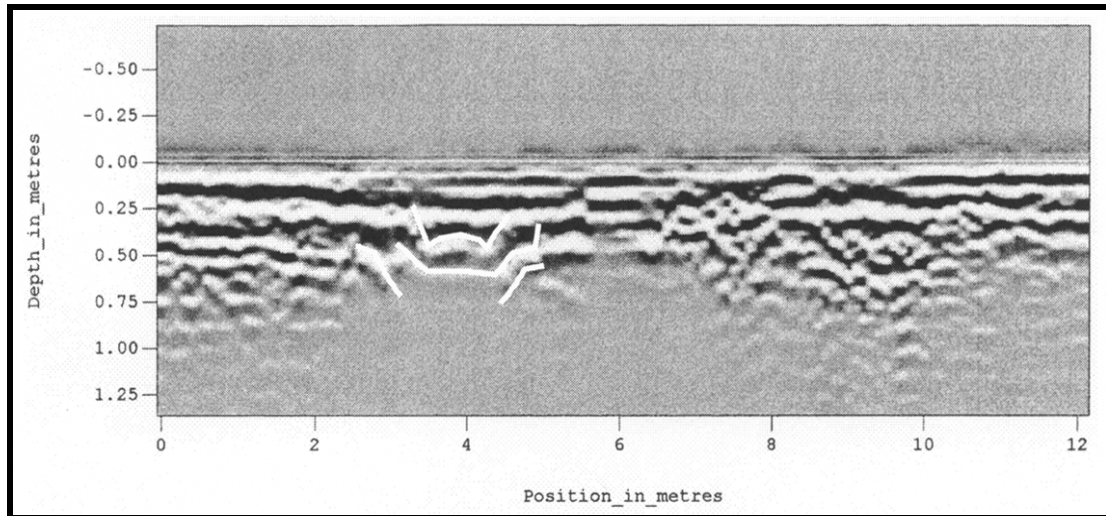
*Figure 5-19:* Depth section of GPR project seven, line three. Depressed soil layers (outlined in white) might represent the top of the stone-capped drain

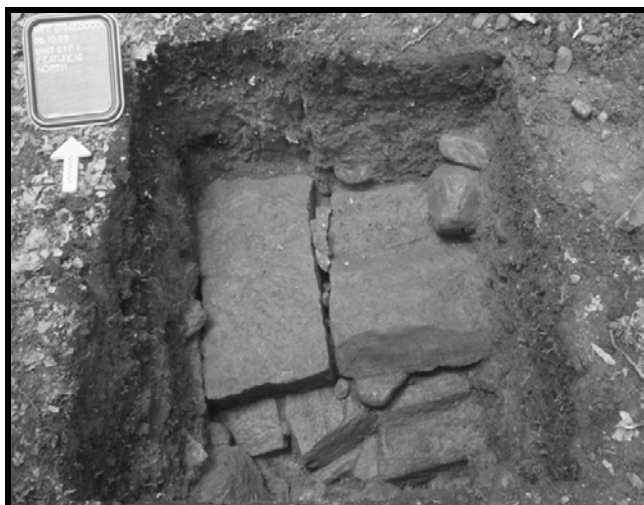
*Figure 5-21:*  
Planview of STP1,  
a subsurface stone  
drain leading to  
Foundry Brook.  
Photograph by  
Kim Finch.

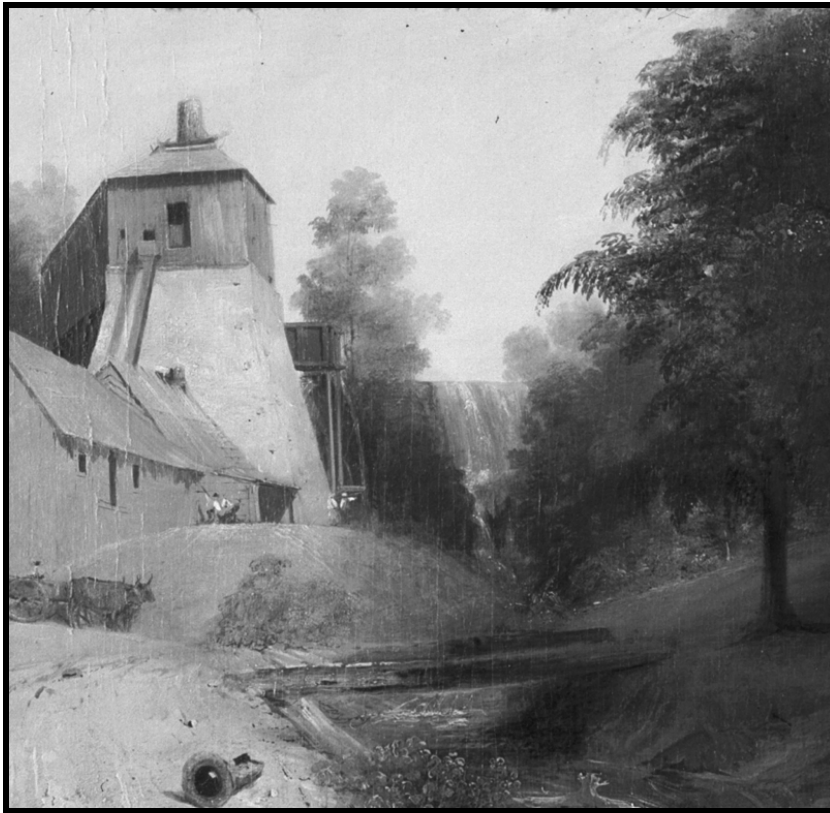
*Figure 6-1:*  
1865 painting of the West Point Foundry blast furnace. Note the possible waterwheel north (right) of the furnace. Image courtesy of the Putnam County Historical Society and Foundry School Museum.

structures at the southern end of the site. An 1865 painting by John Gadsby Chapman, however, provided significant detail about the furnace and its power source (Figure 6-1).

This painting illustrated what appears to be a large overshot waterwheel on the northern side of the furnace and a wooden structure, most likely a penstock, situated above the wheel. Water appears to flow from this wooden structure onto the wheel, turning it in a clockwise direction. The illustration also included a wooden charging deck that backed onto the valley hillside west of the furnace stack, as well as the middle dam and a casting shed south of the furnace.

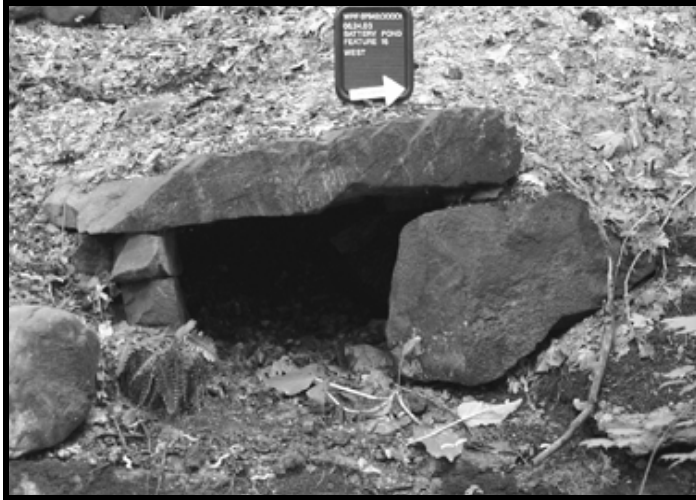
*Figure 6-3:*  
Feature Sixteen. Subsurface  
stone drain outlet south of  
the furnace on the west bank  
of Foundry Brook.  
Photograph by Rachel  
Herzberg.

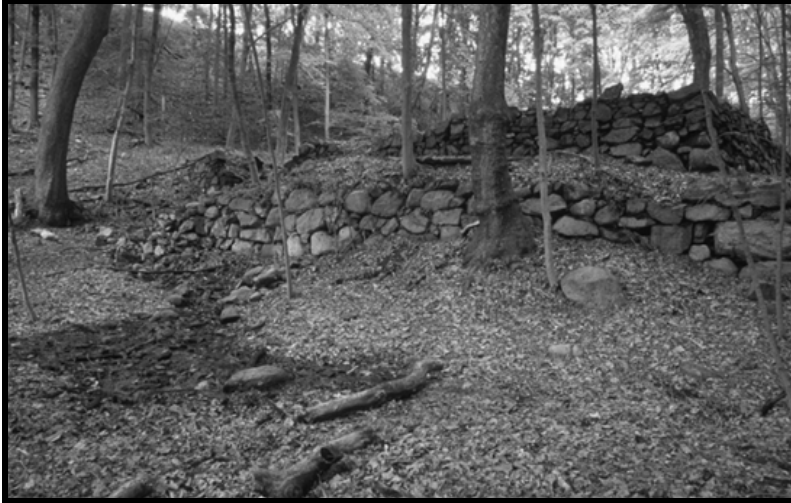
*Figure 6-6:*  
Southern extent of Battery Pond (lower dam). Note the break at the western (left) side in the uppermost wall, which marks the possible origin of a flume to the boring mill. Photograph by Larry Mishkar.

Battery Pond played an essential role in the foundry's water system. Archaeologists examined the reservoir and an area to its south during the 2003 field season. Figure 6-5 illustrates features near Battery Pond. A break in the lower stone dam on the south side of the pond marks the presumed origin of a flume that delivered water to the boring mill (Figure 6-6). Archaeologists noted water leaks at this opening, as well as from several other locations on the south wall. Examination of a flooded area south of the break in the dam wall revealed an opening in the ground through which water appeared to flow west. An exit to an iron drainpipe lay east of this hole in the west wall of Foundry Brook, approximately one meter from the brook's surface (Figure 6-7). A slightly depressed, saturated, 2.5 meter wide feature also extended northeast of the aforementioned drain hole. With the exception of large stones at the end of the depression on the west bank of Foundry Brook, the feature was not lined with stones, which suggested that the depression was probably created by water following a path of least resistance into Foundry Brook. Based on data gathered during physical examination of these features, as well as on preliminary GPR analysis, archaeologists excavated a shovel test pit (STP1) along the drain's projected path and revealed a stone drain.

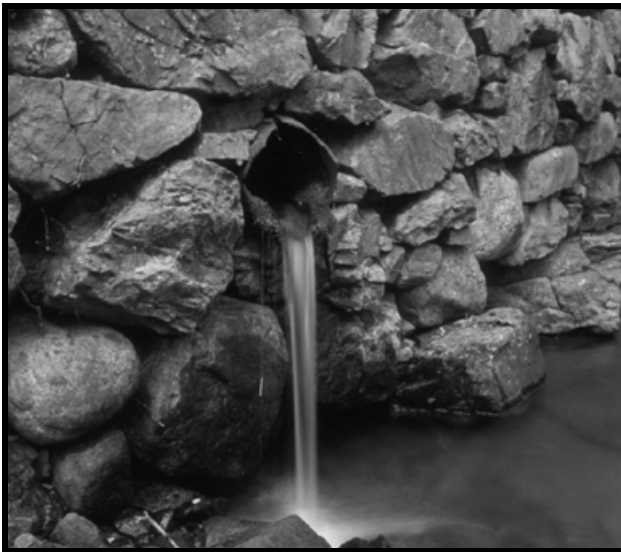
*Figure 6-7:*  
Iron drainpipe in west retaining wall of Foundry Brook, east of STP1. Photograph by Larry Mishkar.

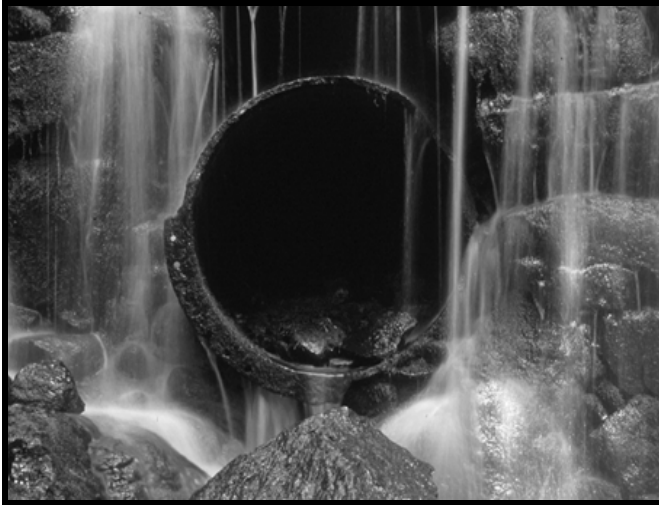
*Figure 6-8:*  
Iron pipe in the middle  
dam. Photograph by  
Larry Mishkar.

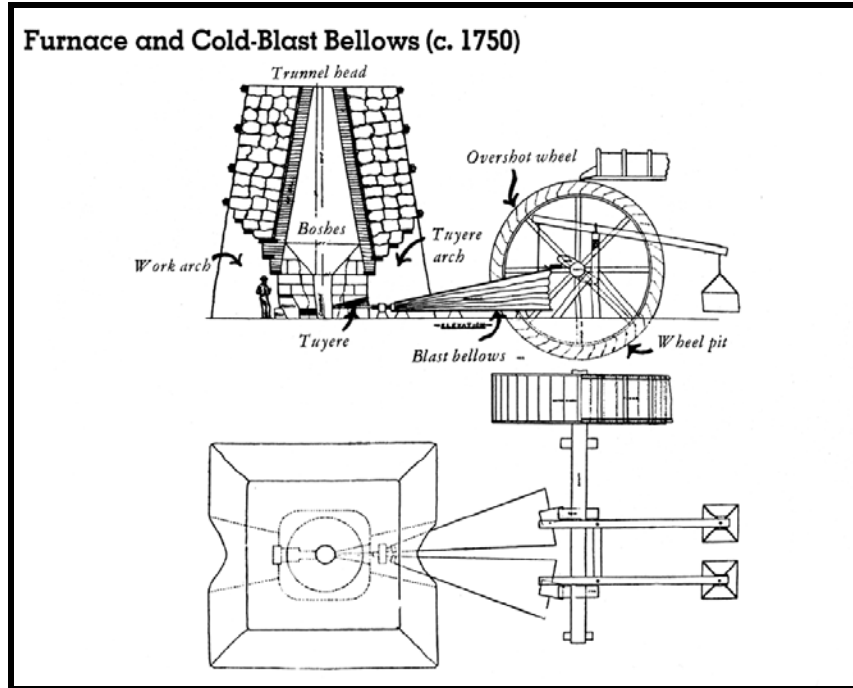
Figure 6-9: Furnace and Cold Blast Bellows (c.1750), Illustrating Water-Wheel Function and Location. Water leaves penstock and falls into buckets on the waterwheel. A shaft transfers power from the wheel to the bellows, which provides air for the furnace blast. From: Weitzman, David. *Traces of the Past: A Field Guide to Industrial Archaeology* (New York: Charles Scribner's Sons, 1980), 168.

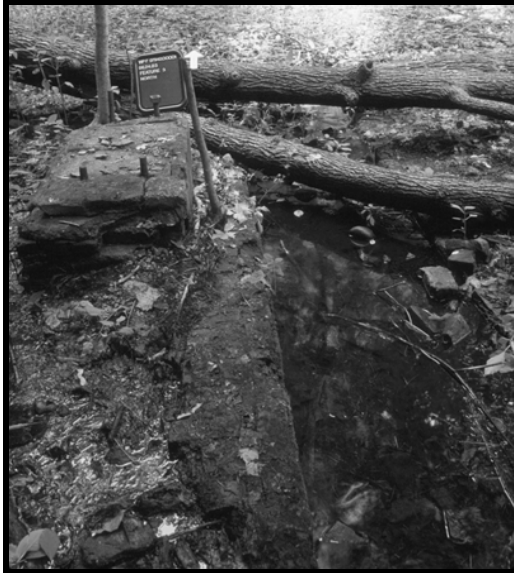
*Figure 6-12:* Feature Three, showing machine base and water-filled channel. Photograph by Mike Deegan.

Field survey during the 2003 field season revealed a feature in the southwestern corner of the blacksmith shop that may relate to a drain illustrated on the 1912 Sanborn map. Archaeologists designated this Feature Three (Figures 6-12 and 6-13). Feature

Three consisted of an approximately one meter deep channel filled with mud and water. A concrete wall lined each side of the channel. Scattered brick lay along the east side of the channel, and a machine base with four threaded bolts lay on the west wall. An iron gutter at the southeast corner of the channel may have guided water away from the feature.

Archaeological evidence suggests that a substantial piece of machinery once rested alongside the channel in Feature Three. Waterwheels often supplied power for large tilt and trip hammers that operated in smith shops (Figures 6-14 and 6-15). It is possible that Feature Three represents the remains of a hammer base and wheel pit described in Wylie's letter. Assuming an undershot wheel 20 or 30 feet in diameter operated at the blacksmith shop, USGS flow data from 1954 suggest that between 2.7 and 5.11 horsepower (for a 30 foot head) or between 1.8 and 3.41 horsepower (for a 20 foot head) was potentially available.<sup>15</sup>

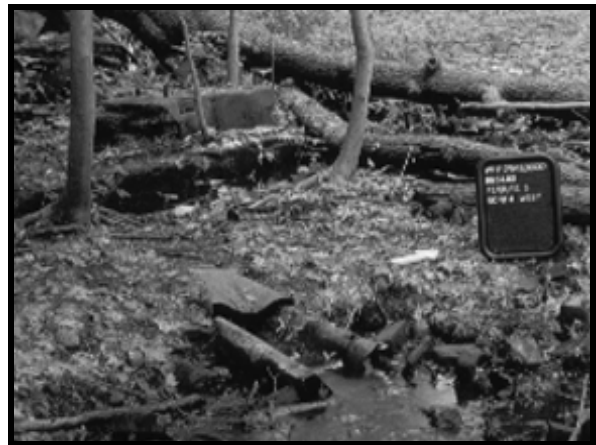
*Figure 6-13:* Feature Three, showing machine base and iron drain pipe. Photograph by Steve Ftaclas.

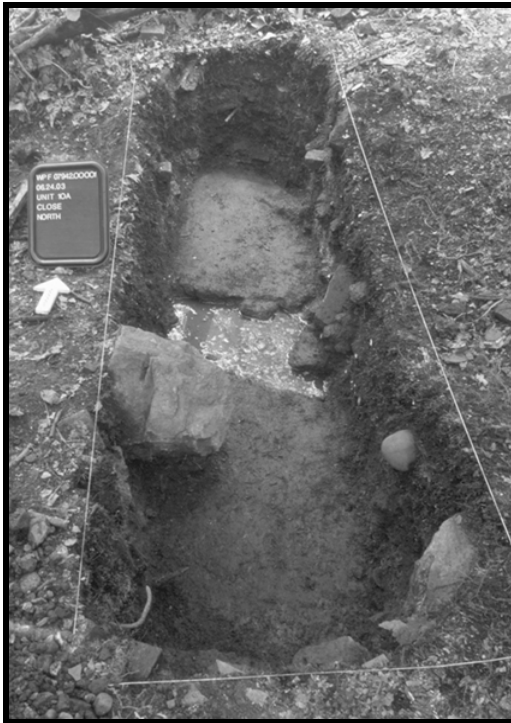
*Figure 6-16:*  
Unit 10A. Closing  
photograph, shooting north.  
The water in the center of the  
unit outlines the trench  
delineated by archaeologists  
during excavation.  
Photograph by Pat Baird.

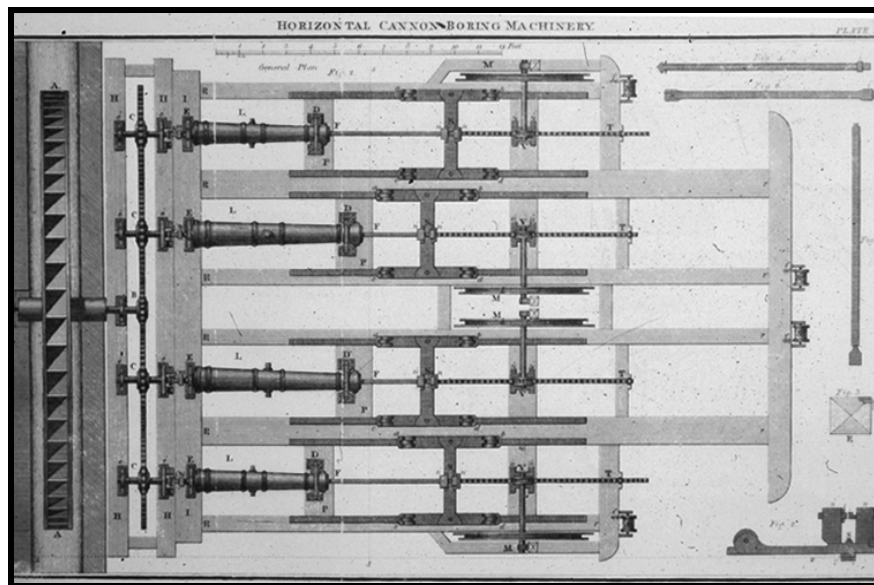
*Figure 6-18: Horizontal boring machinery. Note the wheel powering the machinery. From: Tousard, Louis de. *American Artillerists' Companion or, Elements of Artillery, Treating All Kinds of Firearms in Detail, and of the Formation, Object, and Service of the Flying or Horse Artillery* (Philadelphia: C. & A. Conrad, 1809-1813), pl.lix.*

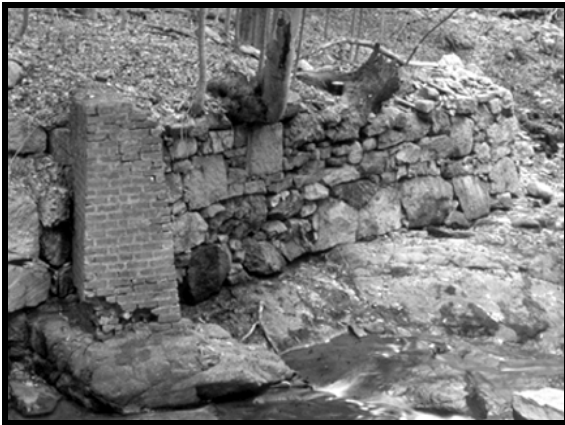
*Figure 6-20:*  
Presumed masonry  
flume support along  
the east side of  
Foundry Brook.  
Photograph by Larry  
Mishkar.

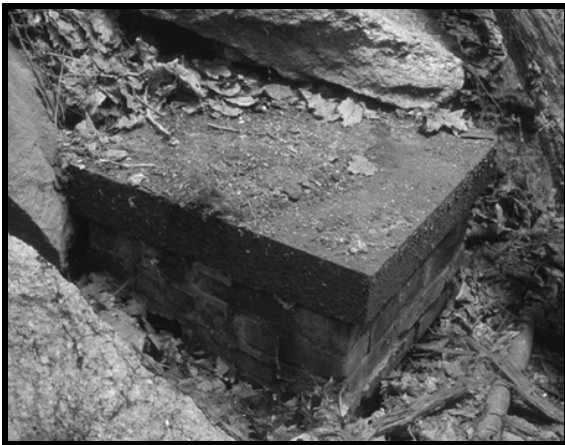
*Figure 6-21:*  
Presumed masonry  
flume support along  
Foundry Brook.  
Photograph by Larry  
Mishkar.

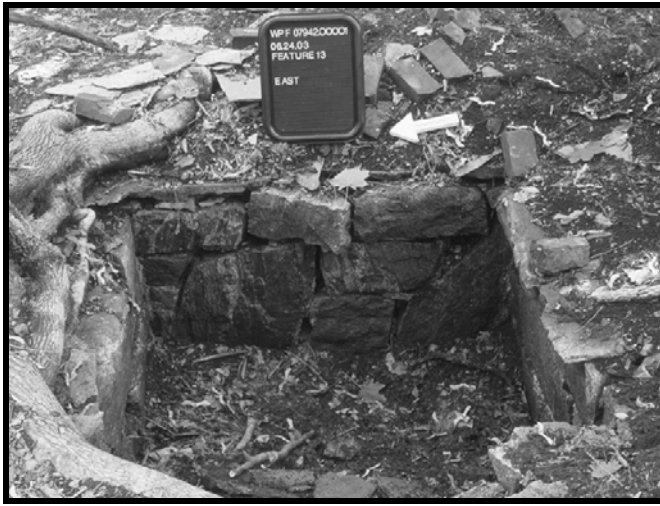
*Figure 6-23:*  
Feature Thirteen. A square, stone-lined pit at the northern end of the machine shop complex. Photograph by Steve Ftaclas.

During a pedestrian survey in the summer of 2003, archaeologists identified a square, stone-lined pit, designated Feature Thirteen, east of the rail line within the northern end of the machine shop complex (Figure 6-23). The 1853 Bevan map identified a fire engine house in the vicinity of this feature. Feature thirteen might be associated with the fire engine house, possibly functioning as a well or access point over an

underground tailrace, but this cannot be ascertained based solely on its location; archaeological investigation is needed before this can be determined.

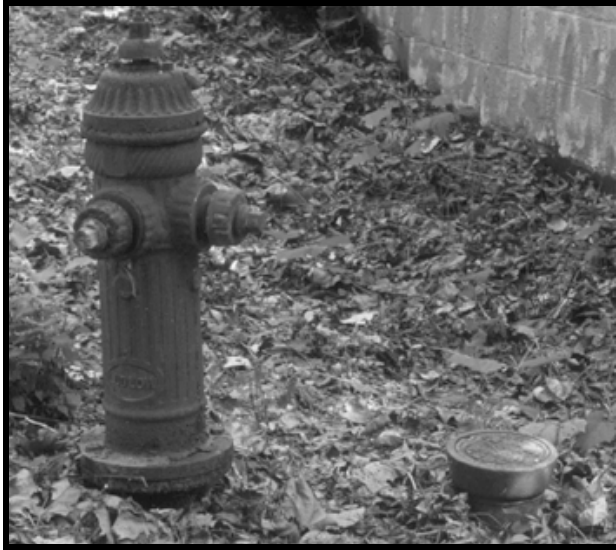
*Figure 6-24: Fire Plug north of pattern shop.*  
Photograph by Larry Mishkar.

Archaeologists also identified fire plugs north of the pattern shop and in an area north of the molding shop complex (Figure 6-24 and 6-25). These plugs formed part of the extensive fire suppression system in place at the foundry from 1857 to 1867, during Parrott's term as manager. An excerpt from the *Highland Democrat* on January 2, 1864, suggests that "A serious fire [was] impossible at the foundry at [that] time, as they have the whole pond with a fall of 100 feet and hydrants and hose in every exposed place throughout the whole establishment."<sup>18</sup>

site dams.<sup>19</sup> The hydrants had only 39 pounds of pressure and therefore were considered insufficient for fire protection.<sup>20</sup>

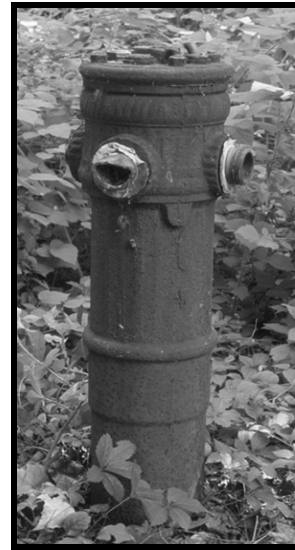
*Figure 6-25: Fire plug north of molding shop complex.*  
Photograph by Larry Mishkar.

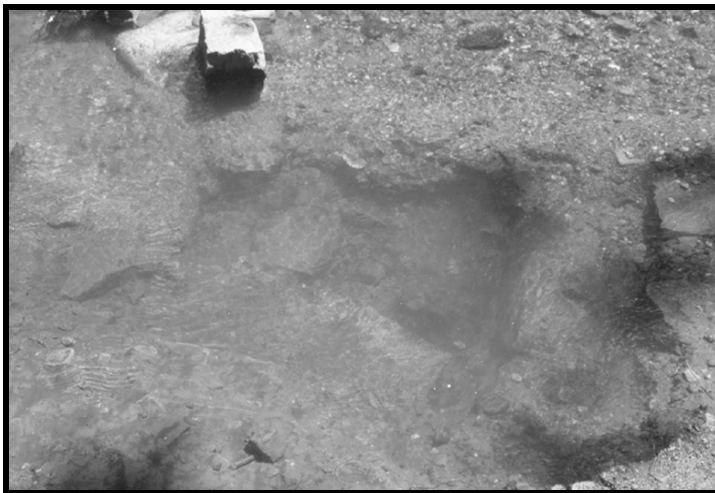
*Figure 6-27:*

Feature Twenty. Welling water and surrounding structure in Foundry Brook, E. of the boiler house. Photo: looking east (top of photo), showing brick structure to the west (middle of photo).

During the 2003 field season, archaeologists identified an area of bubbling water in Foundry Brook. This area, designated as Feature Twenty, lay east of the boiler house. It also lay east of unit 15A and a break within a brick wall that ran parallel to the old pattern shop complex on the west bank of Foundry Brook. Archaeologists cleared gravel and debris from the area during low tide and revealed a stone and masonry structure to the east of the bubbling water (Figures 6-26 and 6-27). On the 1979 historic base map, archaeologists placed the exit of the boring mill tailrace in the vicinity of Feature Twenty. In 2003, excavation in unit 15A uncovered a feature that contained flowing water. This feature may represent the exit of the aforementioned tailrace, or it could represent the

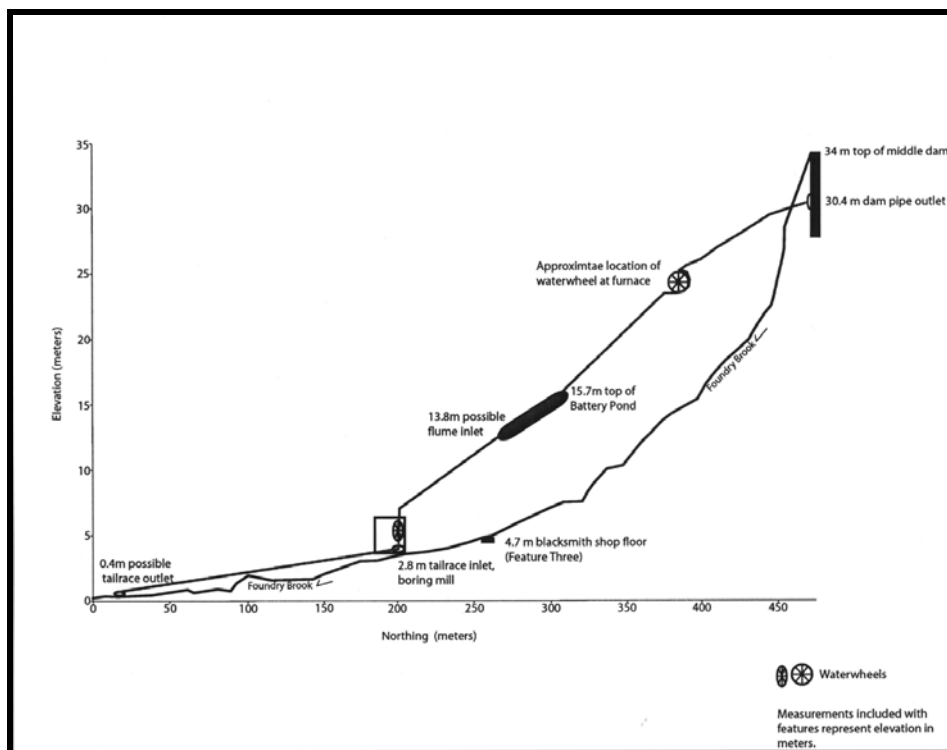
Figure 6-28: Cross-section of elevation changes in Foundry Brook and water-related features. Plot by John Krenzel, 2003. Modified by Kim Finch, 2004.

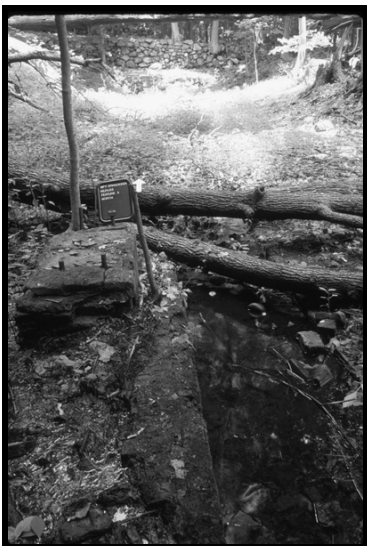
Catalogue Designation: 03-02-F3

Description: Trench, masonry base, & iron pipe, SW blacksmith shop corner

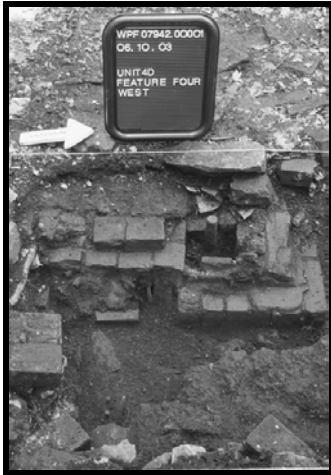
Catalogue Designation: 03-02-4D-F4

Description: Possible coursed brick machinebase. Unit 4D, turning and planing shop.

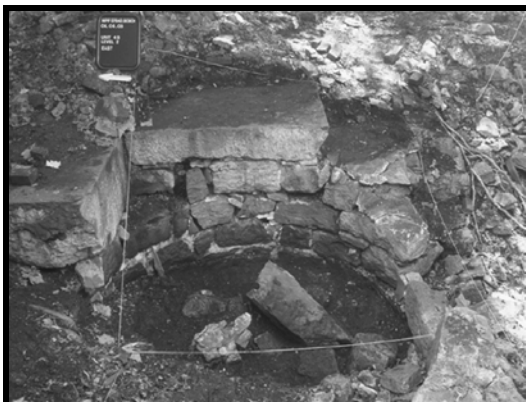
Catalogue Designation: 03-02-4B-F12

Description: Circular, stone-lined pit that incorporates unit 4B. Possible vertical boring pit.

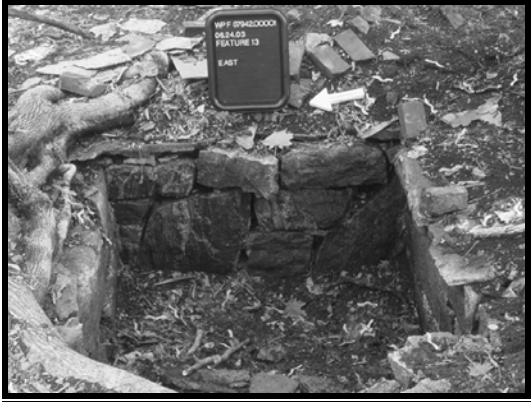
Catalogue Designation: 03-02-F13

Description: Square, stone-lined pit, E of site baseline within machine shop complex

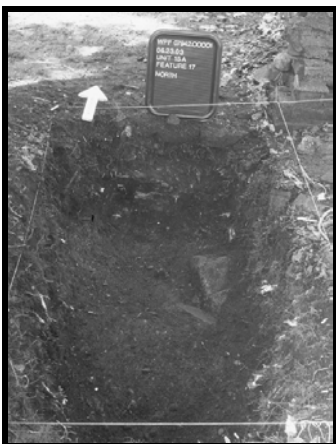
Catalogue Designation: 03-02-15A-F17

Description: Sand-mortar lens and brick wall. North wall, unit 15A.

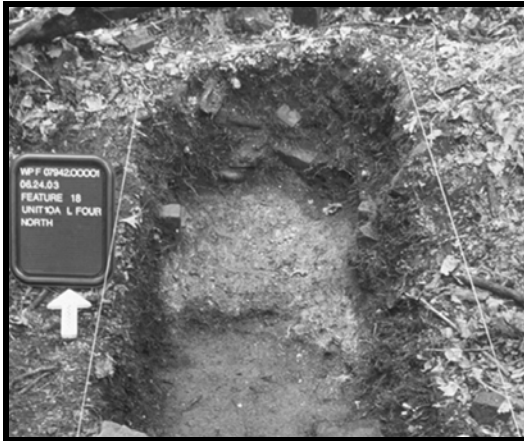
Catalogue Designation: 03-02-10A-F18

Description: Coal cinder lens. Northern 1/3 of unit 10A

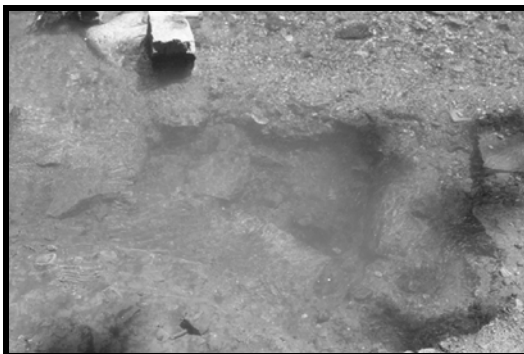
Catalogue Designation: 03-02-F20

Description: Welling water and surrounding structure in Foundry Brook, E. of the boiler house. Photo: looking east, showing brick structure to the west.

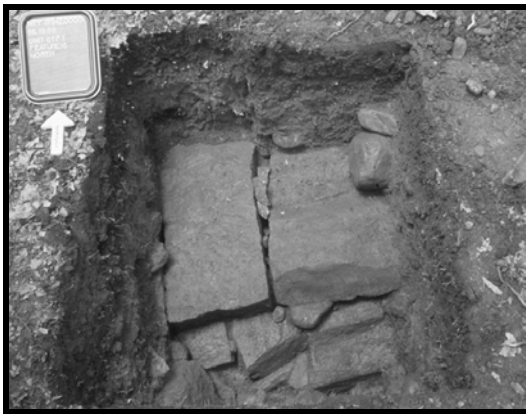
Catalogue Designation: 03-02-F22

Description: Drain hole, STP1, iron pipe outlet S. of Battery Pond. Photo: planview of STP1.
