Winning coal at 78° North : mining, contingency and the Chaîne Opératoire in old Longyear City

Winning Coal at 78° North: Mining, Contingency and the *Chaîne Opératoire*
in Old Longyear City

MASTER OF SCIENCE IN INDUSTRIAL ARCHAEOLOGY

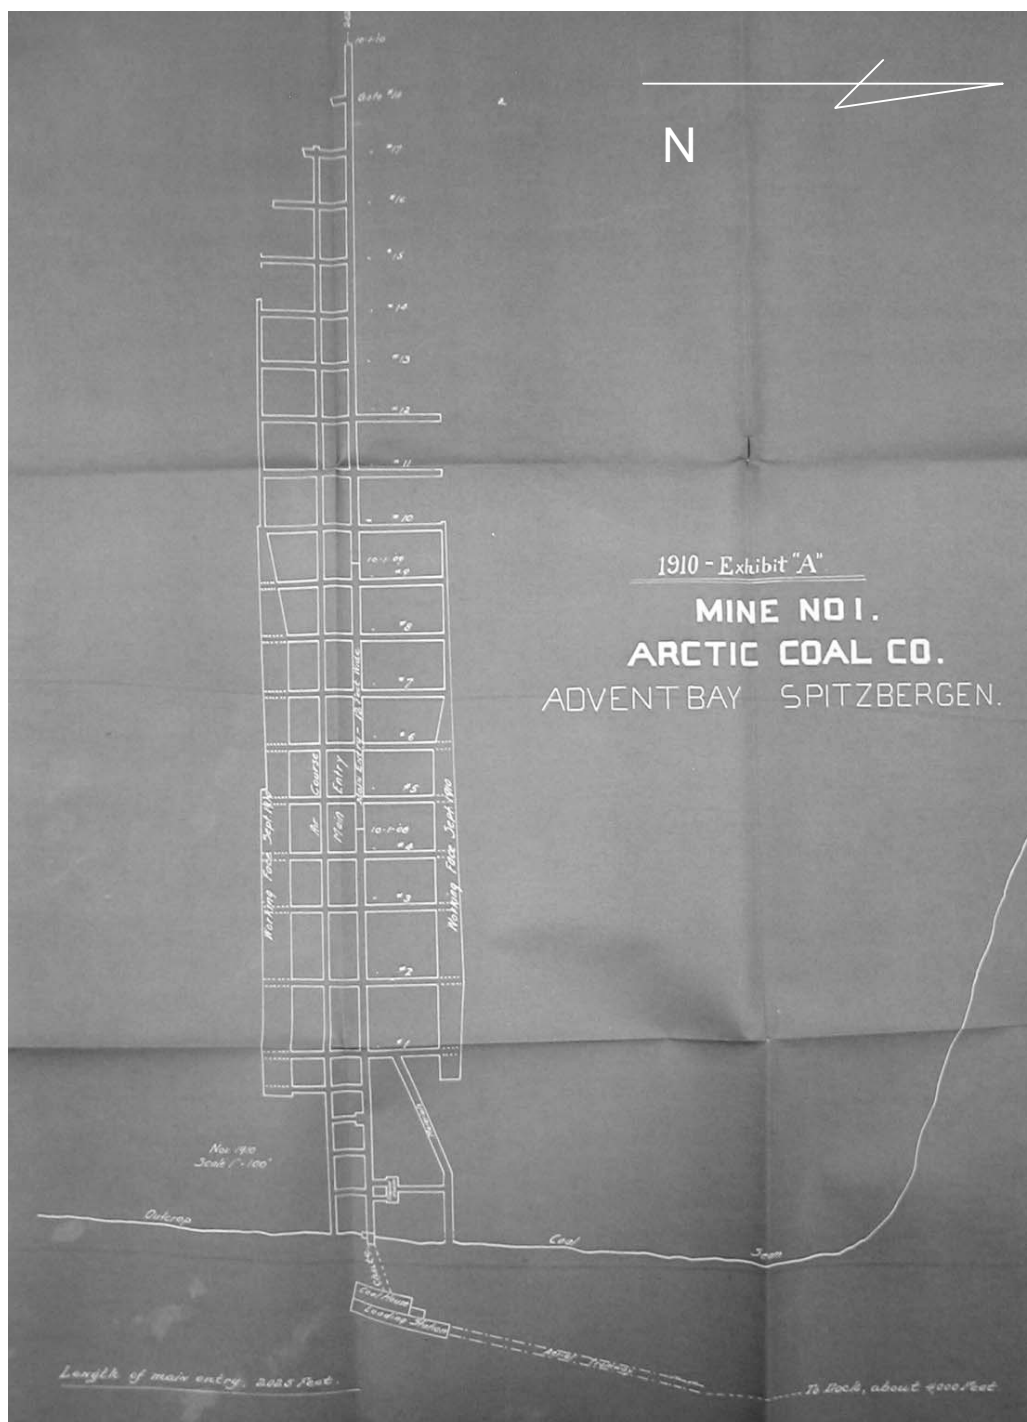
Figure 3.02: 1910 map of Arctic Coal Company Mine No. 1. Mine map presents the longwall mining arrangement after four years of development. Image courtesy of Michigan Tech Archives, Longyear Collection, Box 2, Folder 9.

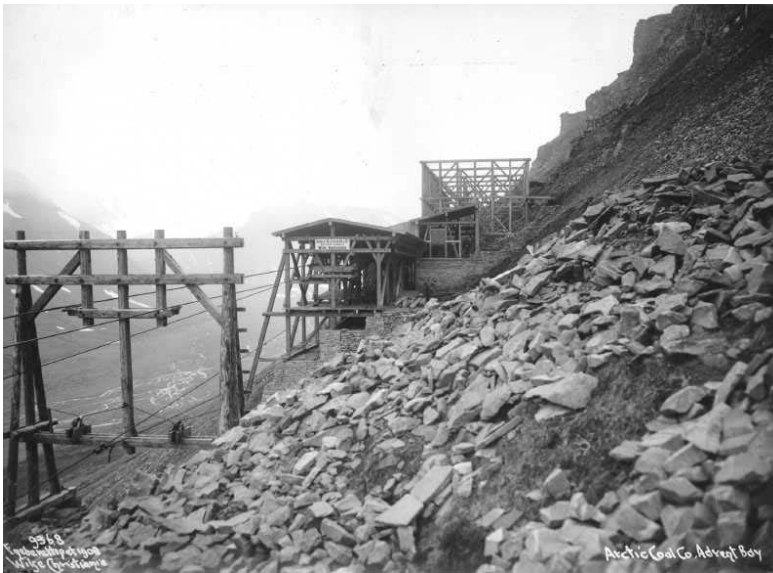
Figure 3.03: 1908 image of the Bleichert aerial tramway and coal hopper. Photograph taken by Anders Beer Wilse. Mine No. 1 is barely visible at top-right corner. Image courtesy of Keweenaw Digital Archive, Image#: MS018-007-02-12.

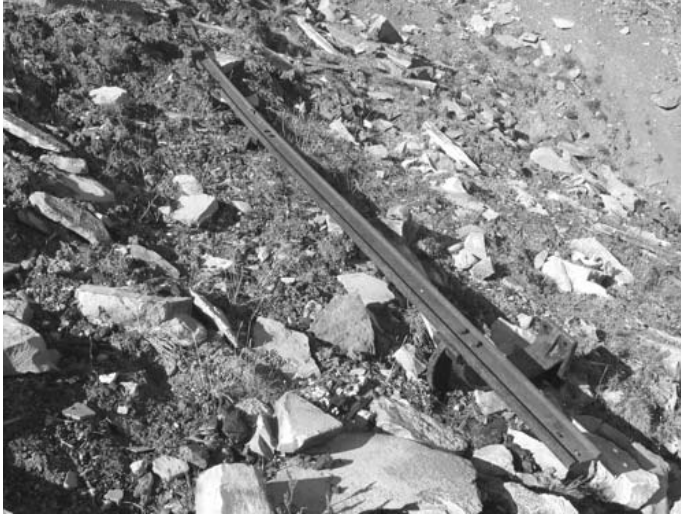
Figure 4.04: Track section with attached suspension hanger. 2008 photograph by Cameron Hartnell/MTU.

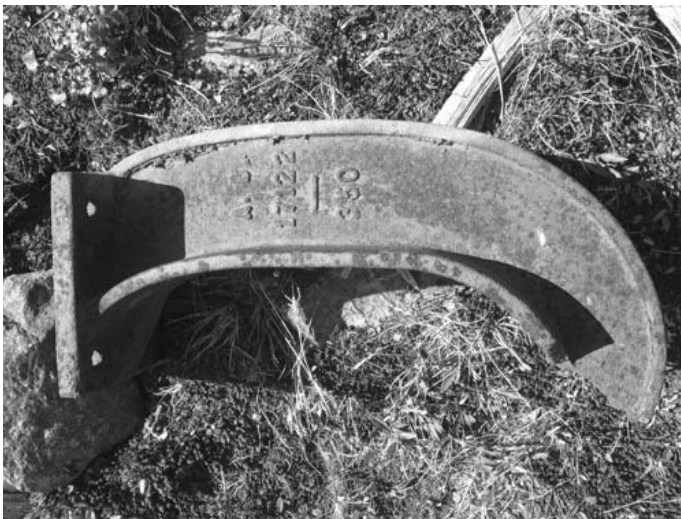
Figure 4.05: Suspension Hanger. Reads "A.B. 17122 - 350." 2008 photograph by Cameron Hartnell/MTU.

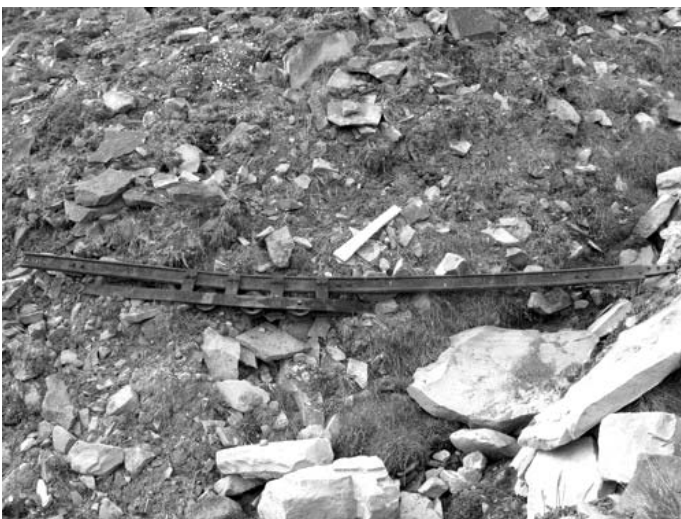
Figure 4.06: Track section with coupling/decoupling assembly. 2008 photograph by Cameron Hartnell/MTU.

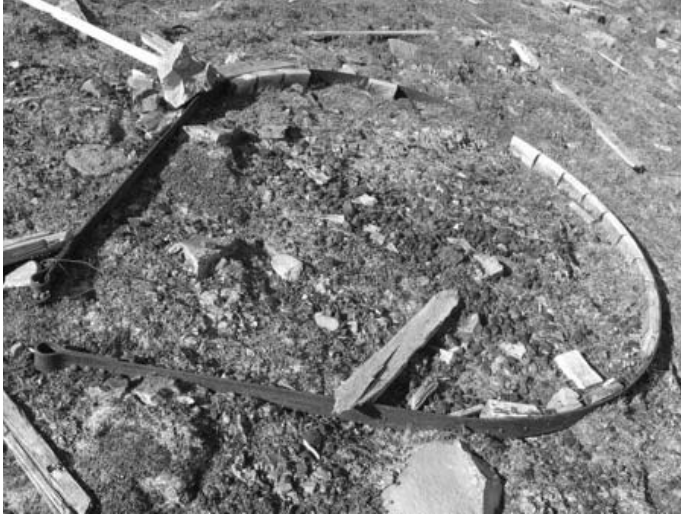
Figure 4.07: Iron band brake with hardwood brake pads. 2008 photograph by Cameron Hartnell/MTU.

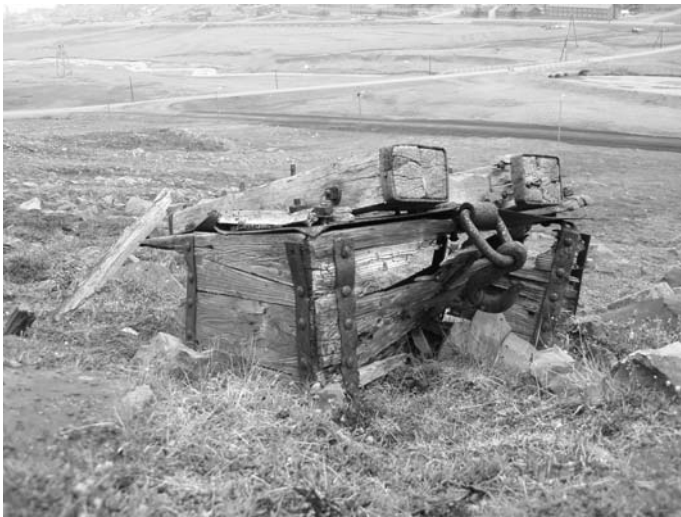
Figure 4.11: Wooden
tramcar. Blazed maker's
mark reads "1908 –
Sheffield." 2008
photograph by Seth
DePasqual/MTU.

A wooden tramcar was observed near the base of the mountain and approximately 60m east of the incline tramway cable (Figure 4.11). It rests upside down and has no axles or wheels. A blazed maker's mark reads "1908 – Sheffield." The Arctic Coal Company ordered much of their mine equipment from Sheffield-based supply houses.

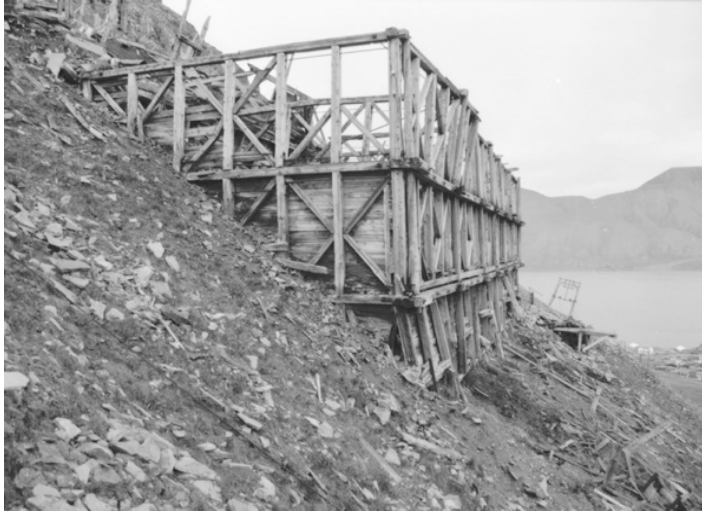
Figure 5.04: Coal hopper's south elevation in 2004. Remains of tramway terminal are visible at bottom right. Photograph by Larry Mishkar/MTU.

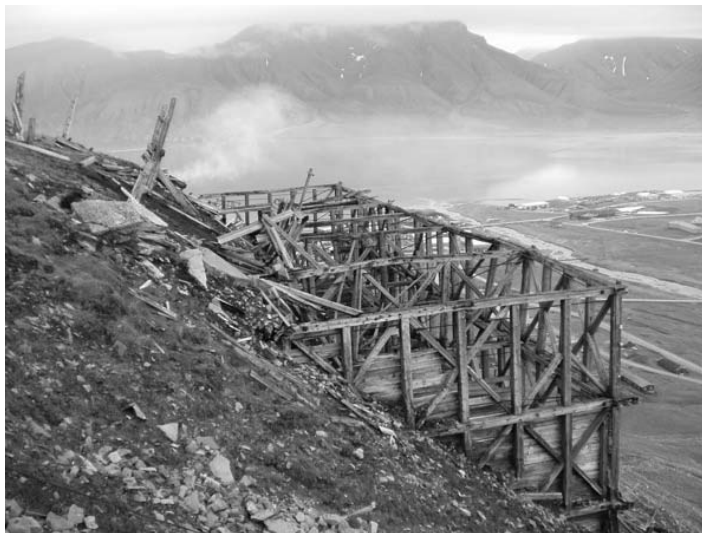
Figure 5.05: Coal hopper's south elevation and top end in 2003. Coal chute remains are visible at top-left. Photograph by Patrick Martin/MTU.

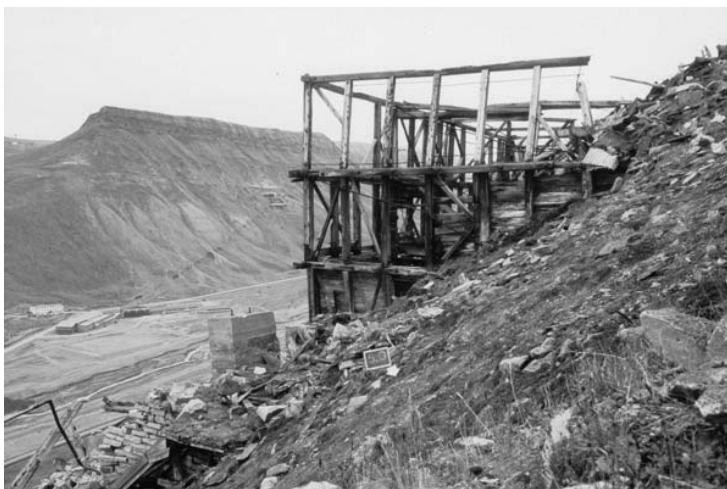
Figure 5.06: Coal hopper's north elevation in 2004. A concrete machinery mount is visible to the left of the hopper. Photograph by Larry Mishkar/MTU.

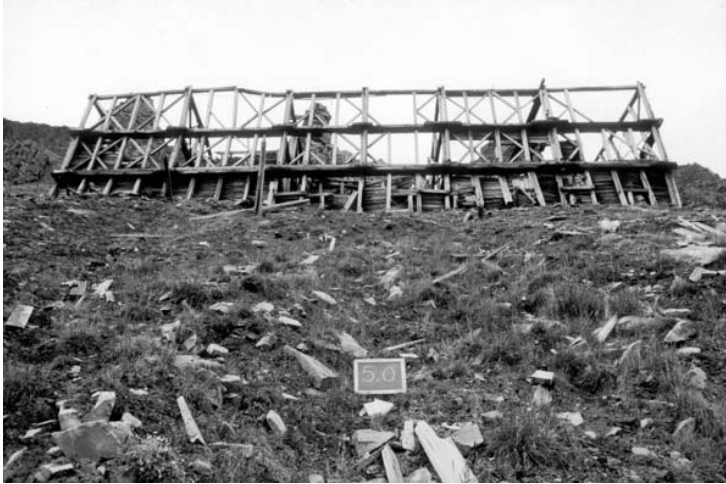
Figure 5.07: Hopper's east elevation. Square coal portals are visible along base of bottom section. 2004 photograph by Larry Mishkar/MTU.

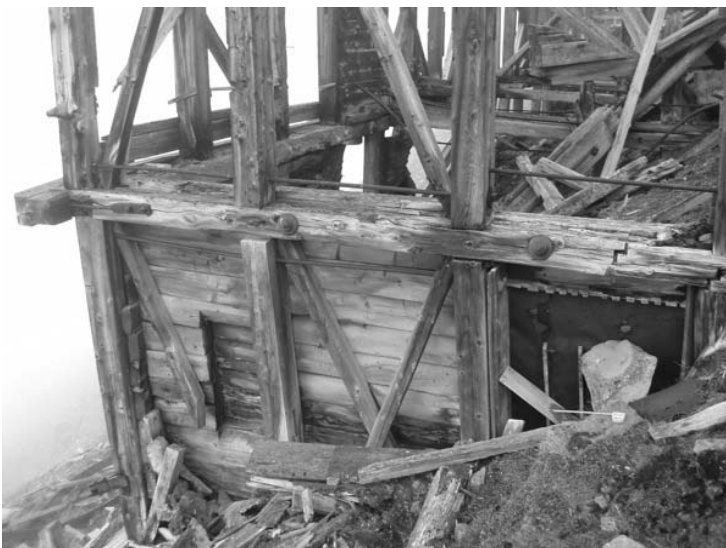
Figure 5.09: Detail of hopper's north elevation. Note cutout coal access at left and tarpaper section at bottom right. Slotted wooden strips are mounted to the tarpaper. 2008 photograph by Seth DePasqual/MTU.

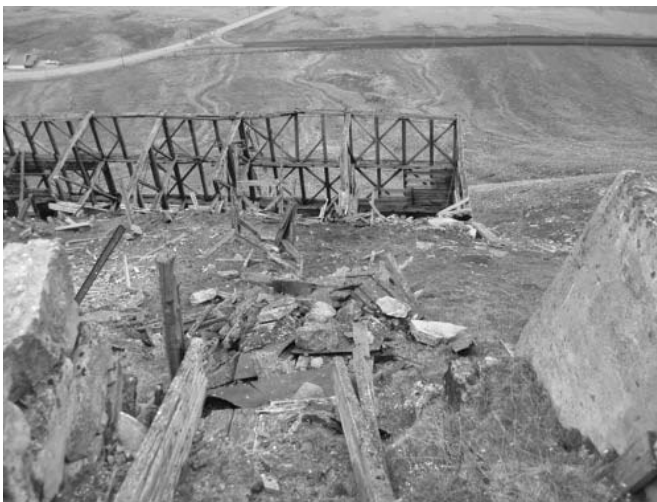
Figure 5.15: View of coal chute arrangement. Image taken from west end of coal chute gap. Compare with historic image depicted in Figure 5.23. 2008 photograph by Cameron Hartnell/MTU.

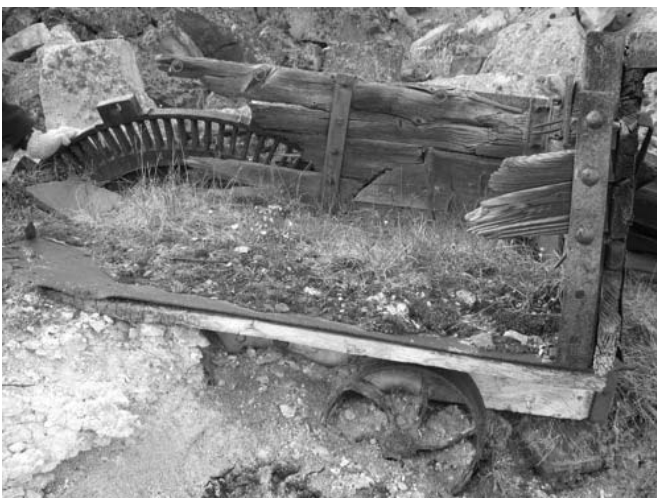
Figure 5.16: 1909 Hadfield Tramcar. Disc cutter at top-left. 2008 photograph by Cameron Hartnell/MTU.

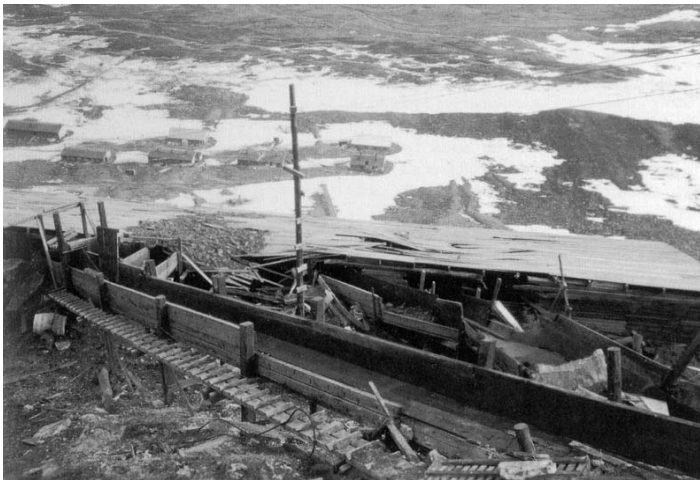
Figure 5.23: 1920 image of coal chute arrangement. The chutes lead into the storage hopper. Compare with Figure 5.15. Photograph courtesy of SNSK Archives.

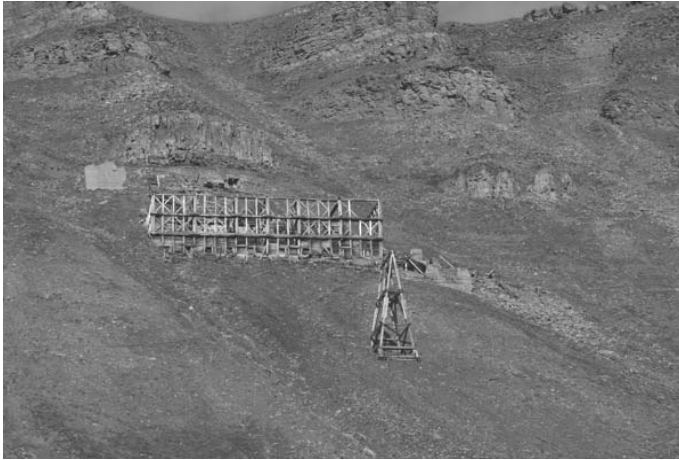
Figure 5.29: Overview of mine complex. The remains of the tramway are located directly beneath the coal hopper. Much of the tramway foundation is part of the large debris field to the right of the standing tower. Other tramway debris is scattered throughout the lower mountainscape. 2004 photograph by Larry Mishkar/MTU.

This section of the upper terminal is located below the northeast corner of the coal hopper and is comprised of foundation ruins, stepped levels of stacked rock, and a collection of cast iron sheaves (See Figures 5.29, 5.30 and 5.32). Although portions of the original foundation work remain intact, most of the northern section has collapsed onto the lower mountain grades. The foundation work is comprised of locally quarried rock and crude mortaring. Intact portions of the foundation are mostly level, although some slumping has occurred. Four rock pillars were observed within the main body of the terminal foundation. These pillars are roughly square with one another. The two uphill pillars are larger in size and height than the two lower pillars. Each pillar is level on its top surface. The location of the pillars is likely related to the placement of heavy equipment and machinery.

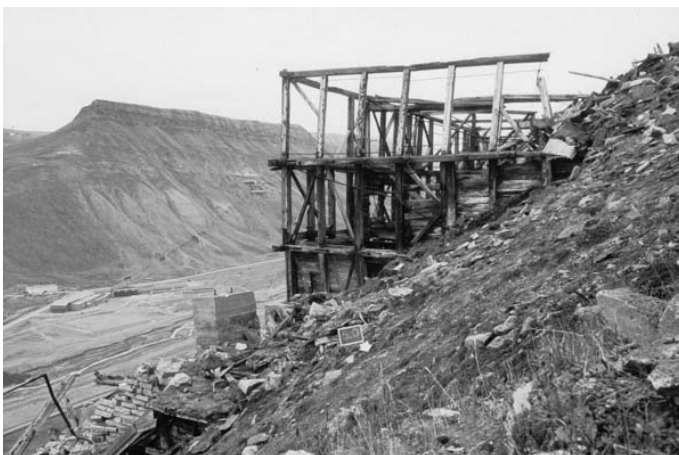
Figure 5.31: Grounded platform at north hopper elevation. Concrete machinery mount is visible left-center. 2004 photograph by Larry Mishkar/MTU.

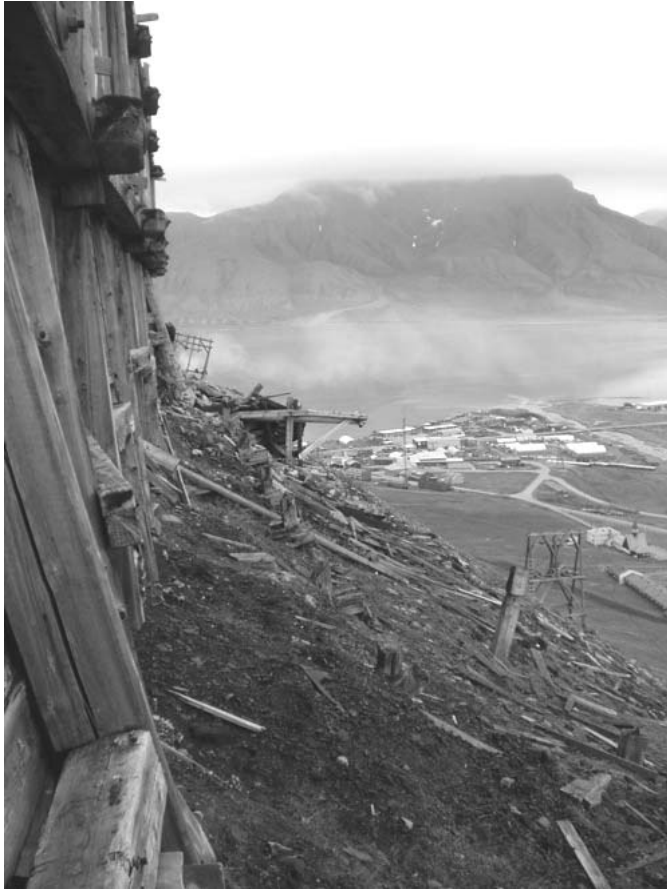
Figure 5.32: View of tram terminal remains from base of coal hopper's east elevation. Note square pilings in foreground and standing timber support in background. 2003 photograph by Patrick Martin/MTU.

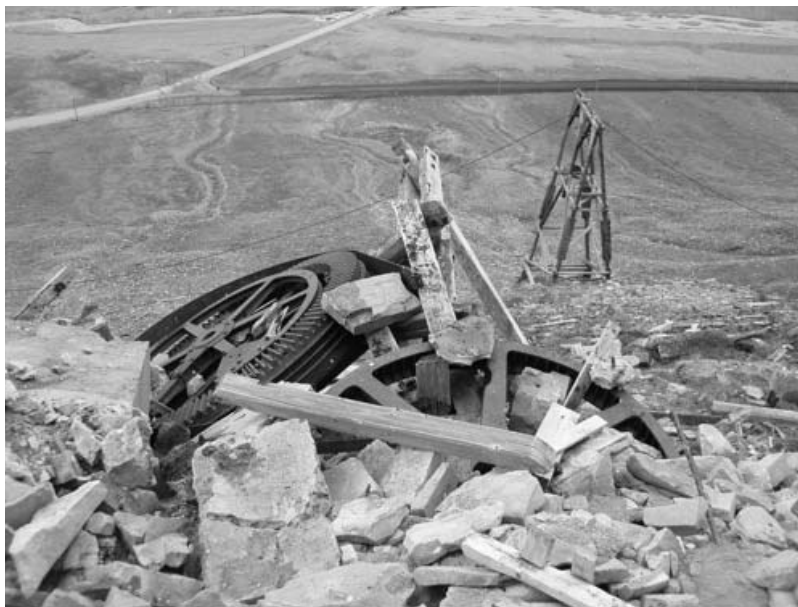
Figure 5.33: Tramway sheaves and standing timber support. The counter-rope and drive sheaves are to the left. The counter-rope is resting on top of the larger drive sheave. The brake/belt sheave is partially obscured by rubble in the foreground. 2008 photograph by Seth DePasqual/MTU.

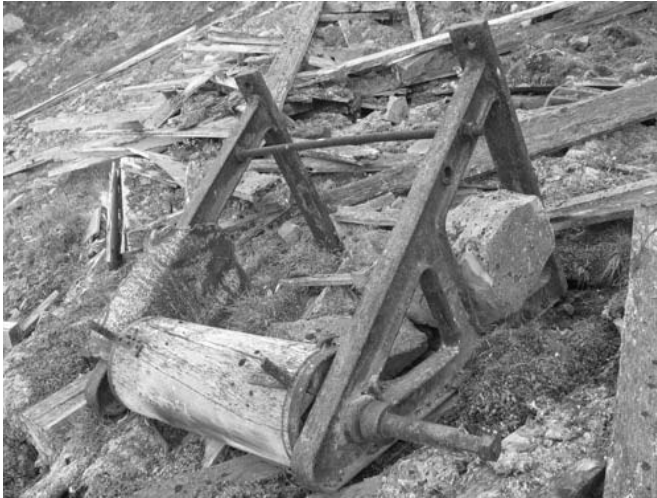
Figure 5.34: Hand hoist at south end of tramway terminal / loading platform. Hand crank on opposite side of wooden spindle. 2008 photograph by Seth DePasqual/MTU.

The hand hoist is comprised of a cast iron frame with wooden spindle and steel crank (Figure 5.34). The overall dimension of the hoist is 1m x 1m. A connecting rod joins the two separate iron frames. Although its specific purpose remains unclear, the hoist may have been used for general maintenance of the tramway. A hoist and related cable arrangement would have been useful for manipulating heavy objects associated with the tramway system. Historic photos of the mine present an enclosed section of the terminal at its southern end. This section may have been used as a shop area for servicing elements of the tramway system, perhaps that related to tramway buckets.

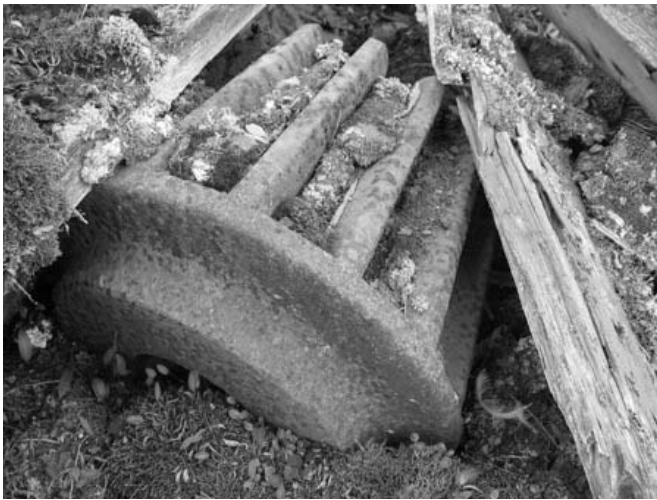
Figure 5.35: Beveled pinion gear at south end of tramway terminal / loading platform. The gear teeth measurements match those found on the drive shaft. 2008 photograph by Seth DePasqual/MTU.

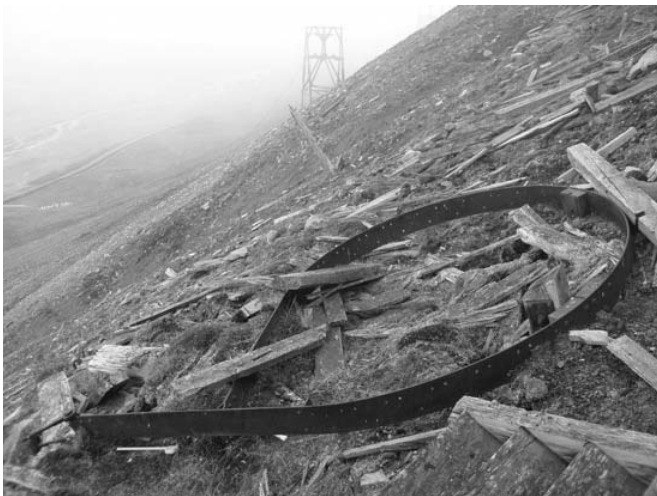
Figure 5.36: Band brake at mid-section of tramway terminal. Metal blocks are visible at right side of band. 2008 photograph by Seth DePasqual/MTU.

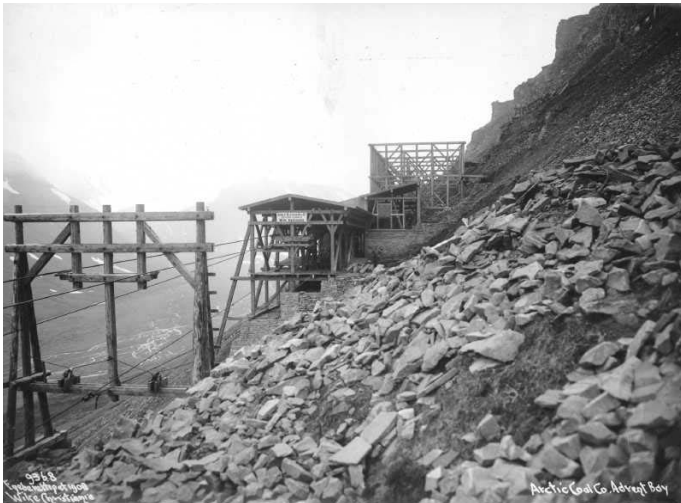
Figure 5.38: 1908 image of the coal hopper and Bleichert Tramway. Both the hopper and tramway are still under construction. Note the small structure in front of the hopper. This is the grounded platform, which hosts the machinery mounts. Image courtesy of Keweenaw Digital Archive: Image# MS018-007-02-12.

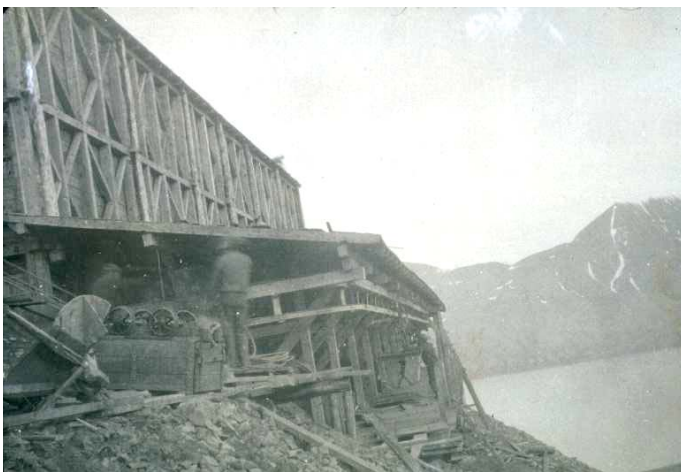
Figure 5.39: 1908 image depicting the south end of the tramway terminal. Note suspended track and hanging tramcar. A laborer is manipulating the loaded tramcar. Image used with permission from Fred Tibbitts.

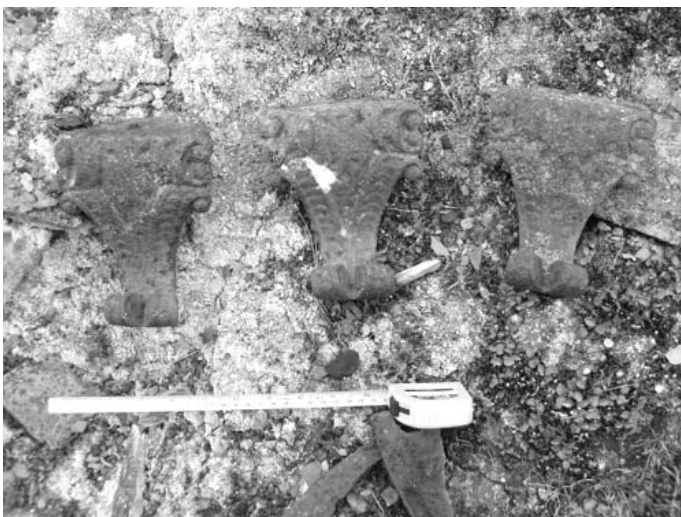
Figure 5.44: Cast-iron stove legs. 2008 photograph by Seth DePasqual/MTU.

A pile of heavy timbers rests on the ground approximately 15m southwest from the collapsed entry. The feature is composed of approximately ten individual beams resting parallel to each other. Most of the beams run parallel with the slope contours; a few round timbers rest at perpendicular angles. Many of the timbers measure 16cm x 25cm thick and vary in length between 160 and 230cm. The size and dimension of all related timberwork suggests they were intended for use either inside the mine or around the entryway. Three small iron legs were identified on the hillside approximately 2m below the timber pile. All three are equal in size and shape and resemble those found on small cast-iron box stoves (Figure 5.44).

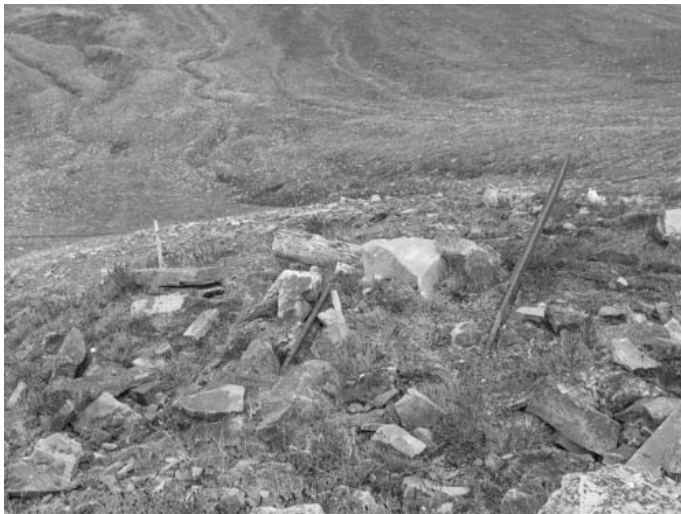
Figure 5.47: View from top of rock dump depicting the two narrow-gauge rails. 2008 photograph by Cameron Hartnell/MTU.

The Lower Rock Dump is comprised of a large waste rock dump and two narrow-gauge tramcar rails (See Figures 5.45 – 5.48). The feature is approached today by following an old miner's trail from the bottom of the valley up to the base of the Coal Hopper (Fea.5.00). The dump is located south of the hopper, on a level similar to the tramway terminal. The rails are located at the top of the rock dump at the center of a small, leveled surface. The present angle of the rails suggests that they ran back towards the incline tramway corridor, which is between the dump and the hopper. Both rails are parallel to each other and feature an 80cm gap between them. Approximately 1m of the northernmost rail is exposed while 2m of the south rail is visible. The rest of the rails is covered with earth and rock.

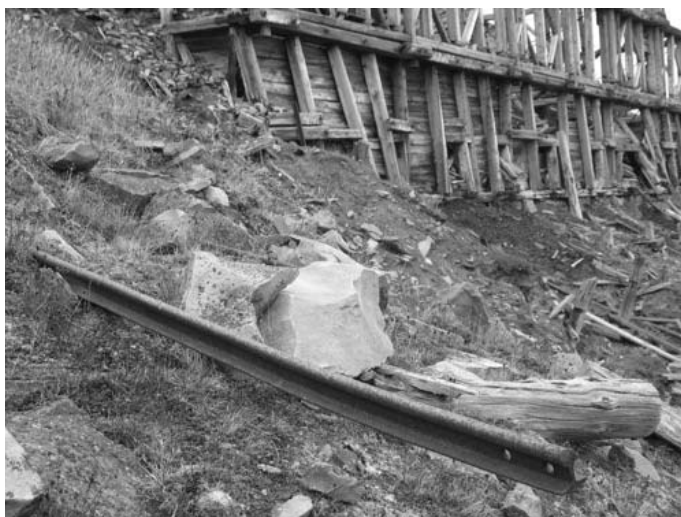
Figure 5.48: View of north track rail with respect to Coal Hopper. 2008 photograph by Cameron Hartnell/MTU.

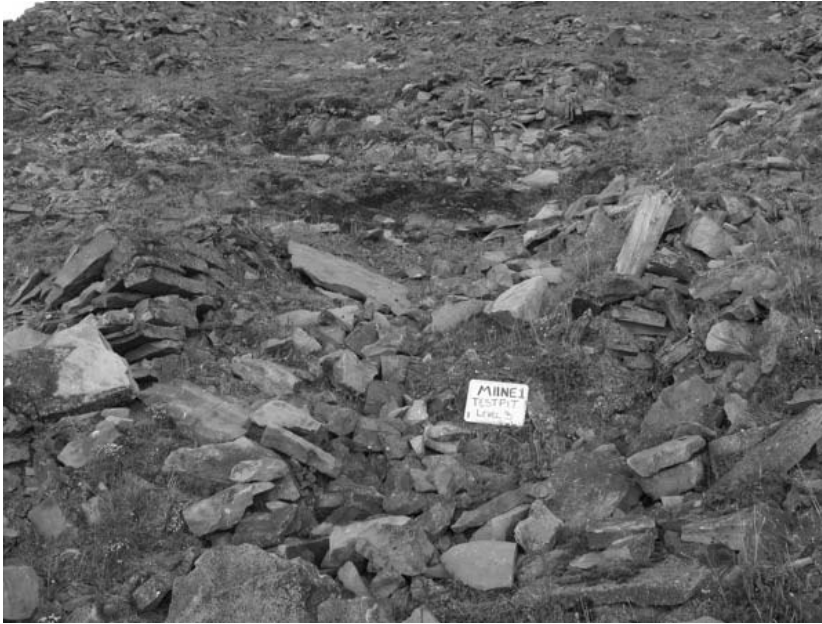
Figure 5.49: Level 3 Entry when viewed from footprint exterior. 2008 photograph by Cameron Hartnell/MTU.

The Level 3 mine feature is comprised of a single, collapsed mine entry and related walls and timbers (See Figures 5.49 and 5.50). Mountain rubble obscures much of the feature. A partially intact rock wall is visible at the south side of the entry; the north wall is covered with rubble. Two vertical beams were noted, one at the western end of the south wall, the other at the east end of where the north wall would be. No other timbers were observed in the area. The entry measures 2.6m wide E/W by 4.8m long N/S and runs on a 76°/256° axis. The rear (westernmost) section of the entry is obscured by rubble.

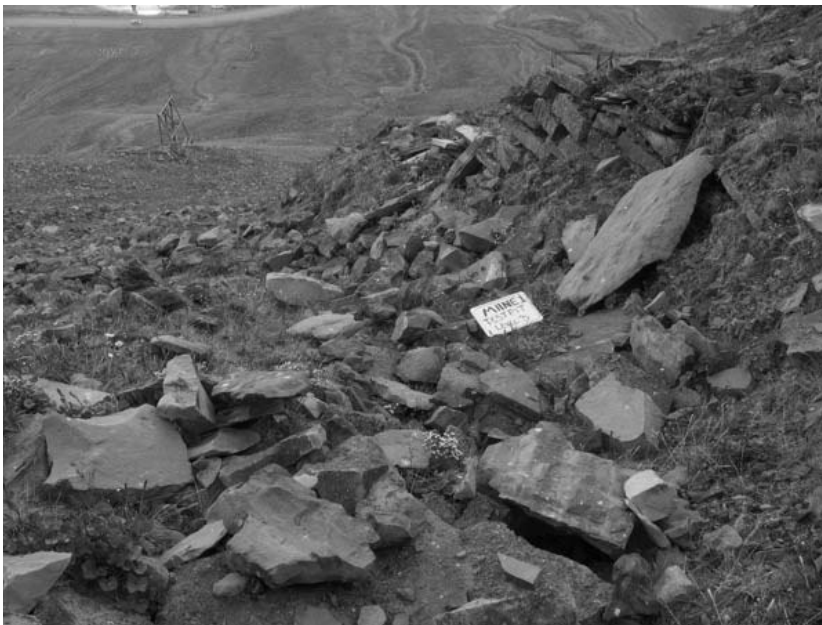
Figure 5.50: Overview of Level 3 Entry. 2008 photograph by Cameron Hartnell/MTU.

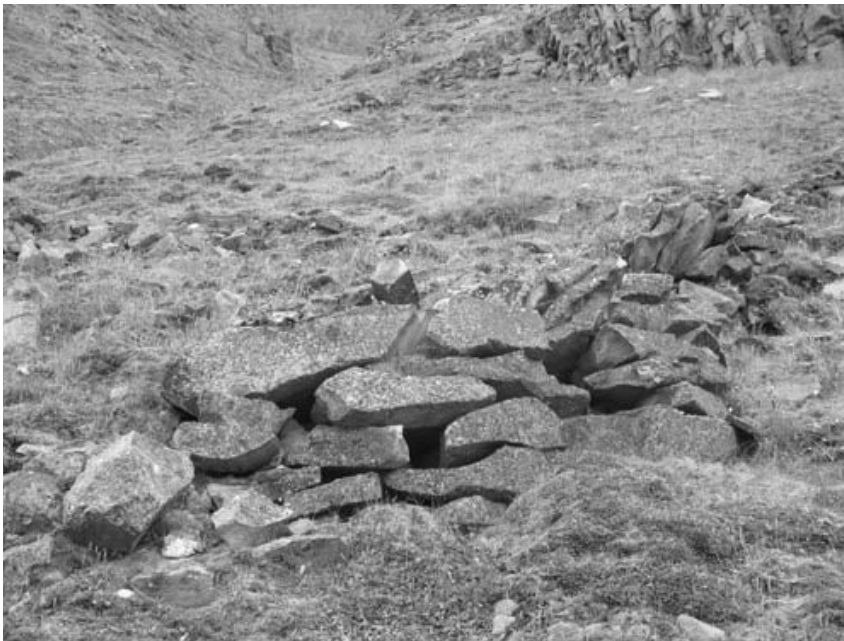
Figure 5.53: Rock wall entryway. Collapsed entry at right. 2008 photograph by Cameron Hartnell/MTU.

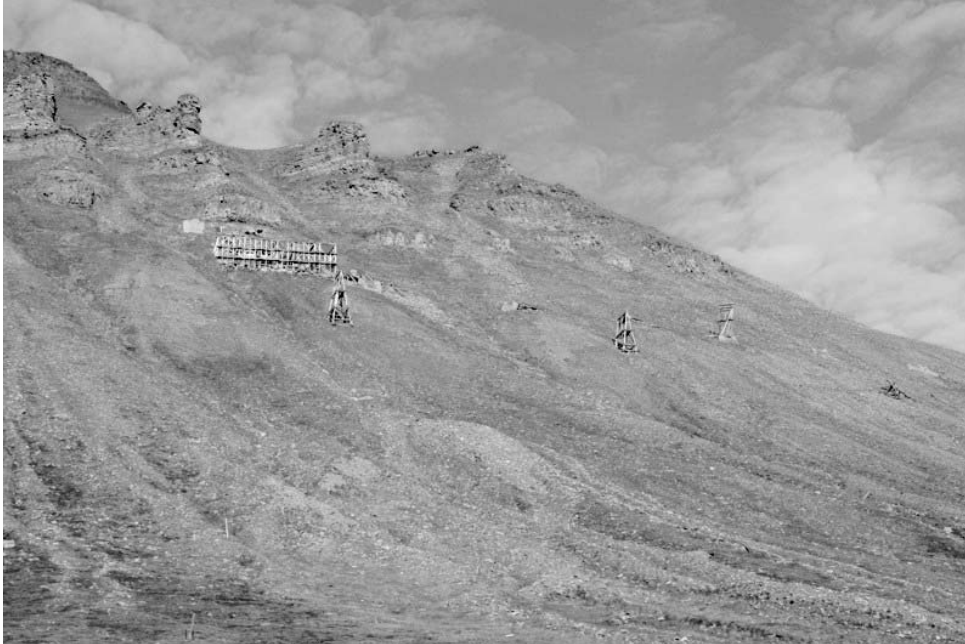
Figure 5.55: See Figure 5.56 for description

The remains of twelve individual tram towers were identified during the 2004 and 2008 MTU/LASHIPA surveys of Longyear Valley (See Figures 5.54 – 5.56). The towers are best accessed from the Upper Terminal (Fea.5.02) beneath Mine No. 1. The Tower 1 foundation is located immediately north of the Upper Terminal remains. The remaining tower foundations can be approached by continuing north/northeast down towards the Store Norske “changehouse.” Two footings related to Tower 16 were identified at a bluff edge above the old Store Norske Powerhouse.

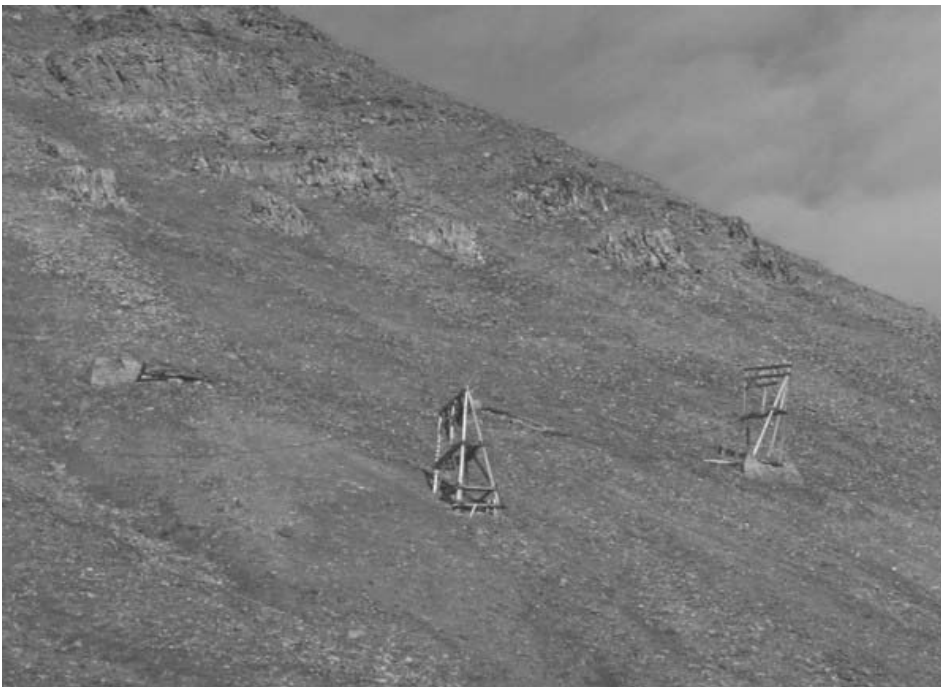
Figure 5.56: Original and cropped image of tram tower alignment from floor of Longyardalen. The photograph was taken in 2004. Figure 2 includes the location of Towers 1-3. Tower 1 foundation is at left. The Tower 2 framework is above and to the right of the middle, more recent Mine 1b tower. Tower 3 is still standing at right. This tower has since collapsed. Photograph by Larry Mishkar/MTU.

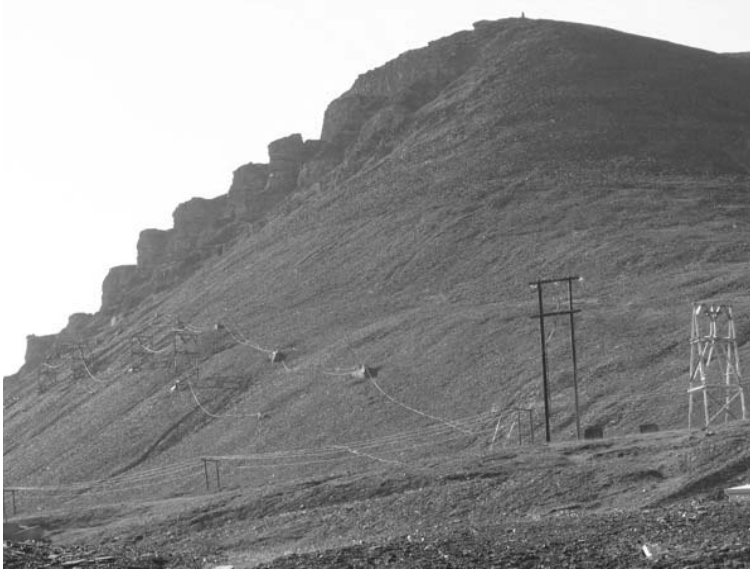
Figure 5.57: View of tramway alignment from northeast. The foundations visible at center-left are Towers 9-11. Note track cables spanning from tower to tower. Standing tower at right is a reconstruction erected by Svalbard Sysselmannen. 2008 photograph by Cameron Hartnell/MTU.

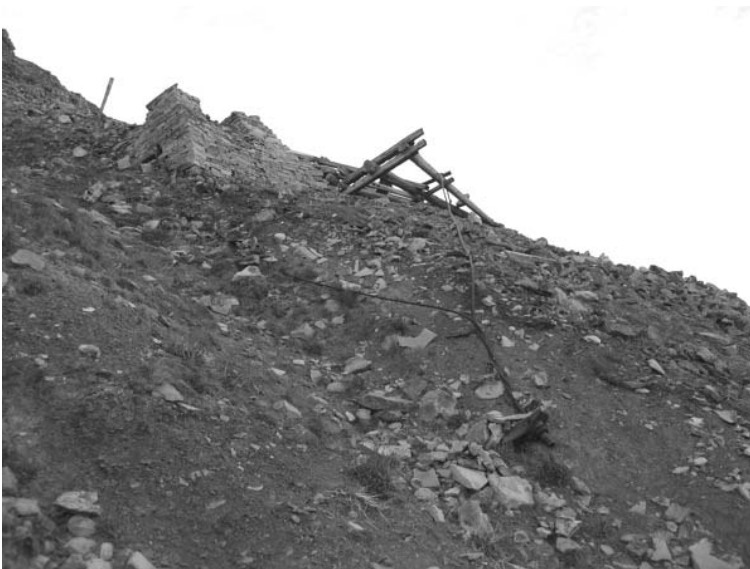
Figure 5.58: Tower 1 foundation and framework. The track cable anchor plate is located at bottom-right. Note how track cables have twisted. 2008 photograph by Seth DePasqual/MTU.

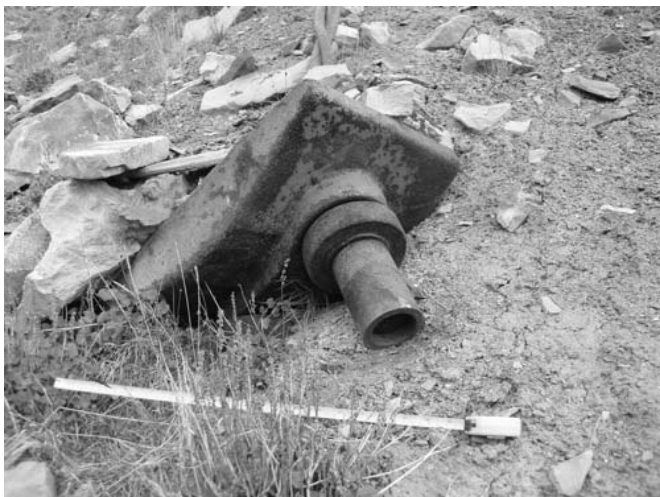
Figure 5.59: Anchor plate for tramway track cables. Located beneath Tower 1 foundation. 2008 photograph by Seth DePasqual/MTU.

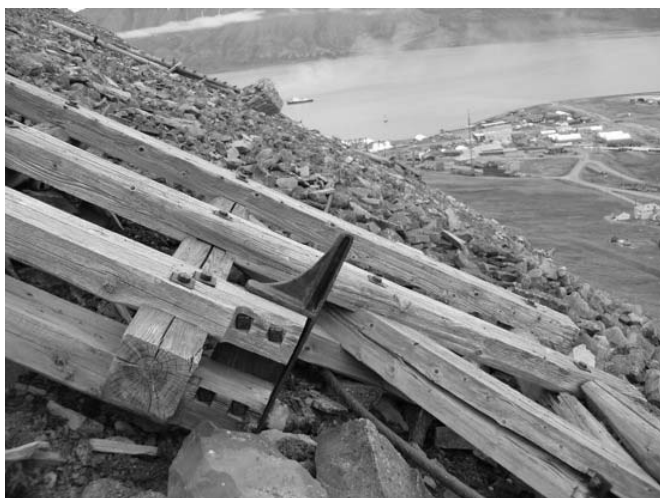
Figure 5.60: Tower 1 framework with attached Protection Saddle. 2008 photograph by Seth DePasqual/MTU.

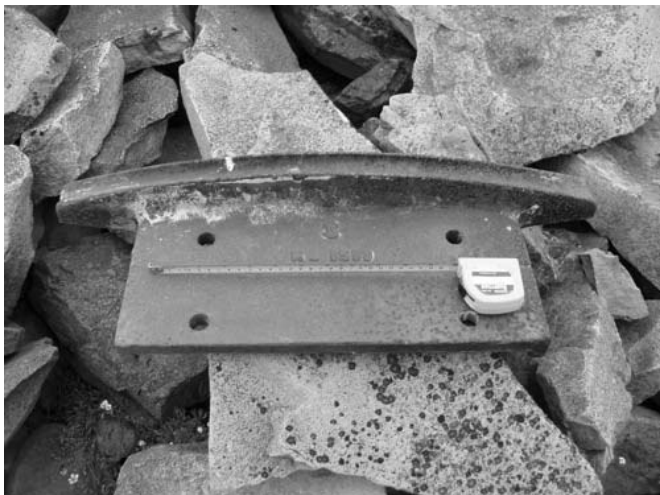
Figure 5.61: Detached Protection Saddle found beside tower framework. Embossing reads "3, R - 1500." 2008 photograph by Seth DePasqual/MTU.

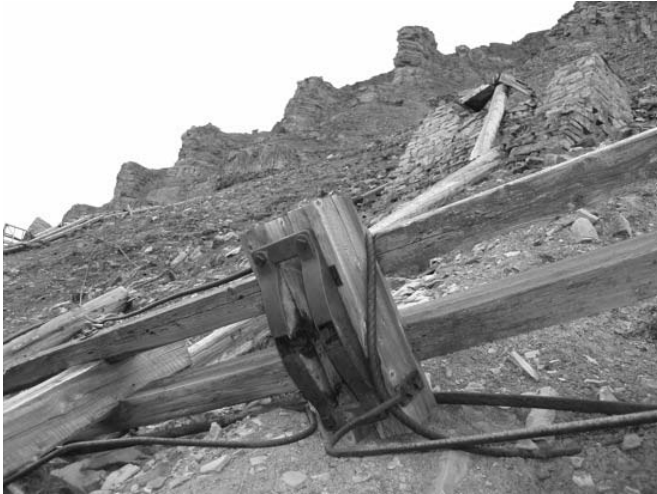
Figure 5.62: Saddle for Protection Roller. Note bent iron guide rods at side of roller saddle. 2008 photograph by Seth DePasqual/MTU.

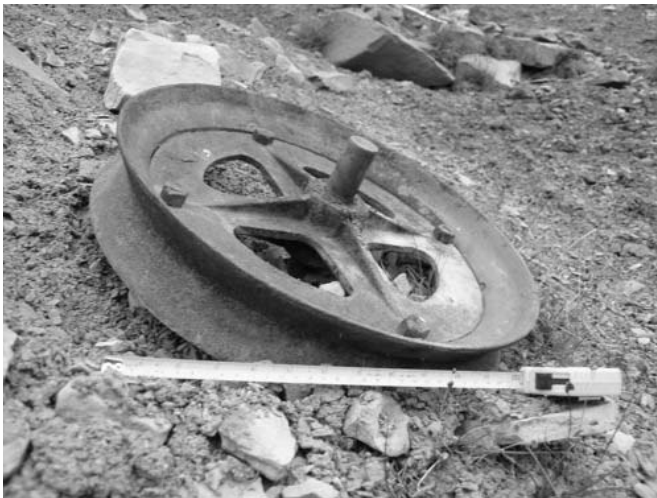
Figure 5.63: Protection Roller. The roller rested within the saddle depicted in Figure 6. 2008 photograph by Seth DePasqual/MTU.

Tram tower ironwork consists of assembly rods and that related to operation of the conveyance system. The latter is comprised of protection rollers, guide rods and protection saddles. Protection rollers were used to keep the traction rope from rubbing against the timber framework. The rope was relatively loose in comparison with the fixed carrier cable, and often sagged between each tramway bucket. The rollers identified on the Mine 1 towers measured 44cm in diameter (Figure 5.63). Each tower featured two of these rollers, which were situated on a cross timber about halfway up the tower. The rollers nested into an iron housing and spun on an axle (Figure 5.62). Beside

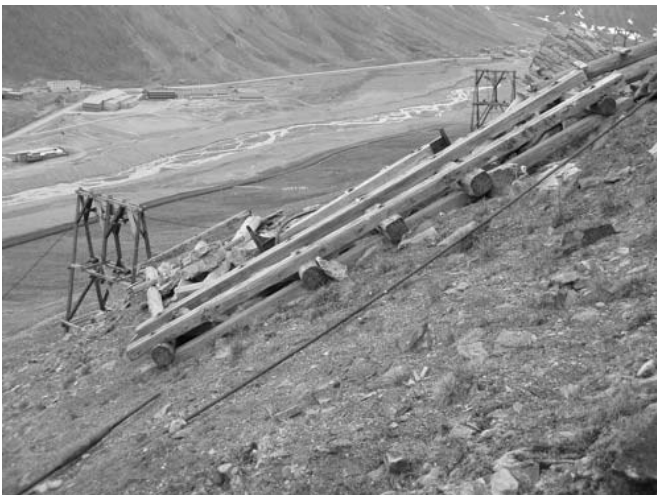
Figure 5.64: Tower 2 framework and foundation. Note carrier cable coupler at bottom-left. 2008 photograph by Seth DePasqual/MTU.

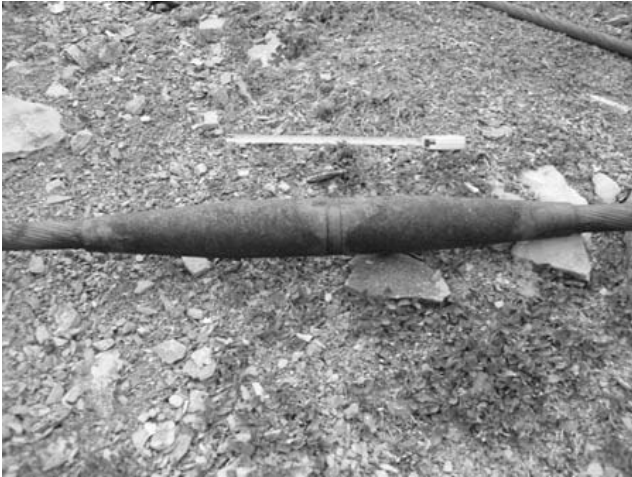
Figure 5.65: Detail of coupler for “loaded” track cable. 2008 photograph by Seth DePasqual/MTU.

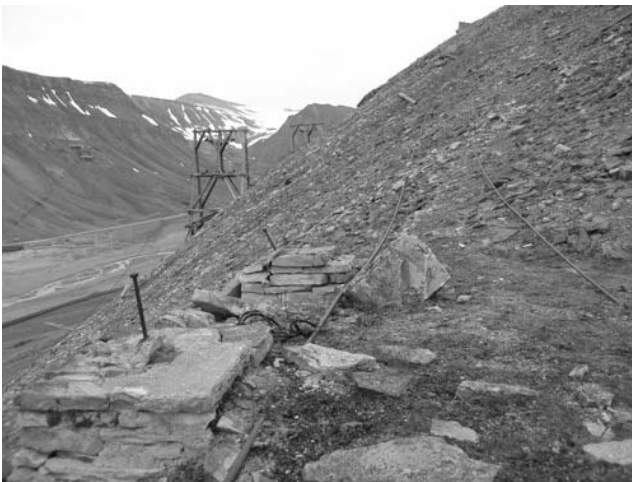
Figure 5.66: Tower 11 foundation footings. Note iron mounting rods and track cables. 2008 photograph by Seth DePasqual/MTU.

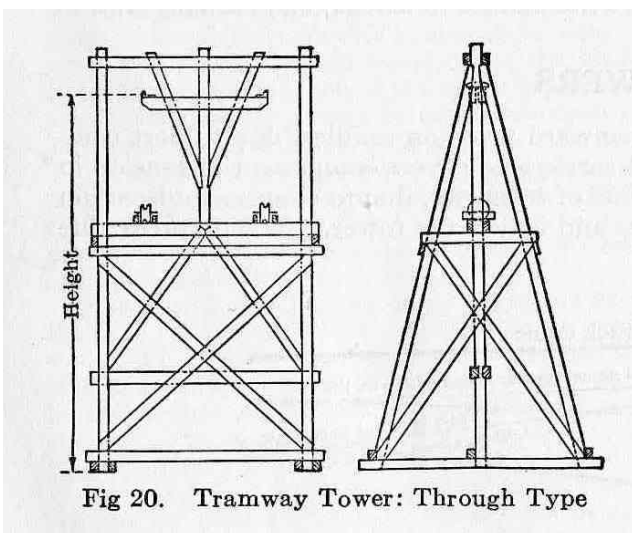
Figure 5.67: Diagram of a through-tower similar to those constructed in Longyear City. From Robert Peele’s *Mining Engineer’s Handbook*, Vol. II. New York, John Wiley & Sons, Inc. 1914.

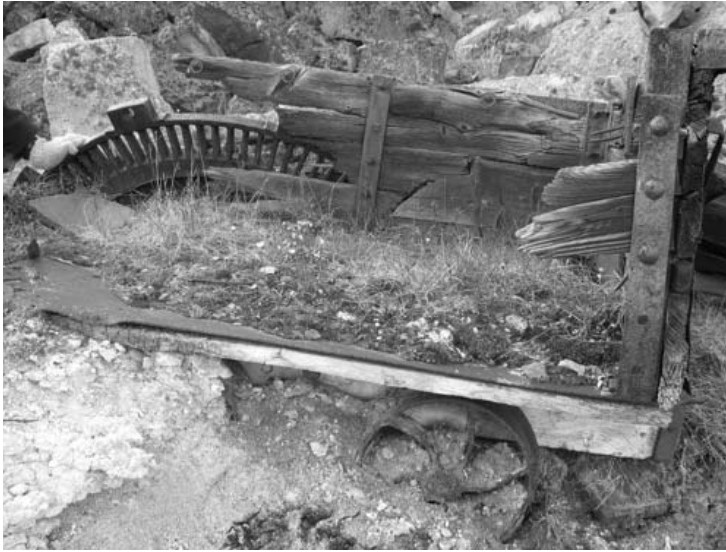
Figure 6.03
Cutting-disc (upper-left) and pit-tub located near the entry of Mine No. 1. The tab at the top of the cutter-disc once featured a 'cutter-box', which housed replaceable iron cutter bits. The disc is buried within a rubble pile. 2008 photograph by Cameron Hartnell/MTU.

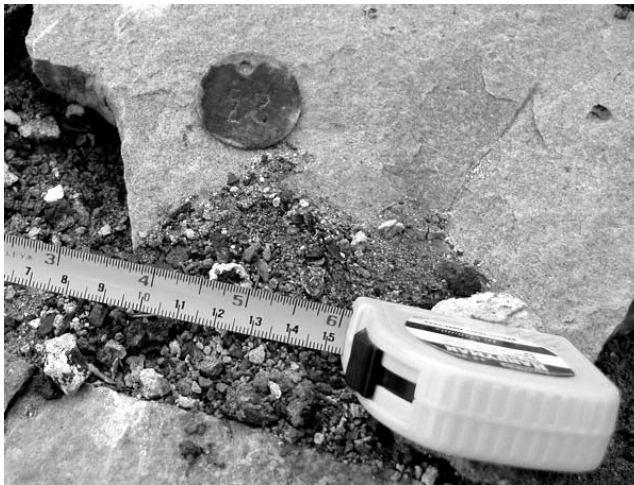
Figure 6.04: Brass “check-tag” discovered in refuse pile beneath mine entry. The tags were used to keep track of miners during a particular shift. 2008 photograph by Seth DePasqual/MTU.

A small check-tag found in a refuse dump outside the mine is suggestive of a safety-system used to keep track of laborers within the mine (Figure 6.04). Each mine laborer had a personal identification number, which he carried with him on two separate tags. Before entering the mine, the miner placed one tag on a large peg-board with designated mine sections. The other tag was kept on his person for the rest of his shift. At the end of his shift the miner retrieved his tag from the peg-board. If he did not, a mine official would recognize the potential dilemma and take appropriate action.

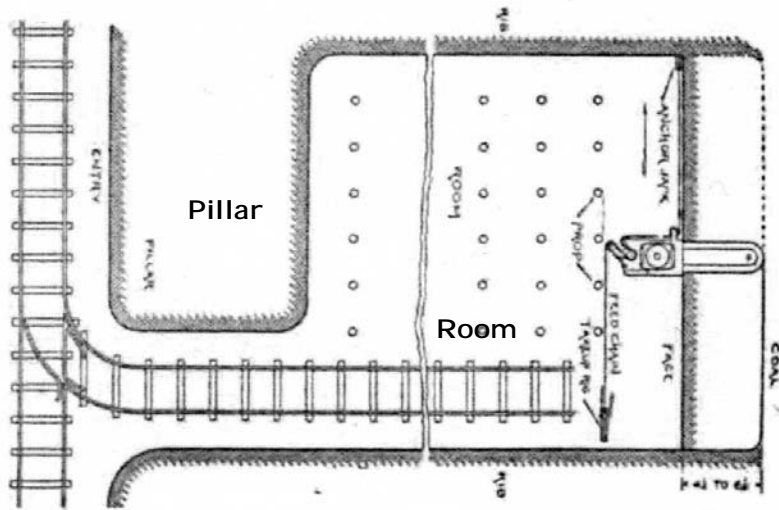
Figure 6.08: Room-and-pillar mining with Sullivan chain-cutter. The design is similar to that used in Mine No. 1. (From S. B. King, ref. 28).

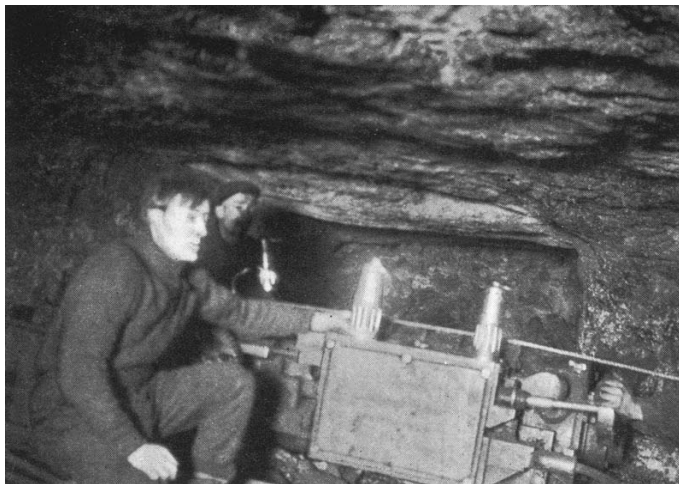
Figure 6.09: Miners using a short-wall coal-cutter in Mine No. 1. Photograph courtesy of Keweenaw Digital Archive, Image#: MS018-001-031.
