Winning coal at 78° North : mining, contingency and the Chaîne Opératoire in old Longyear City

Winning Coal at 78° North: Mining, Contingency and the *Chaîne Opératoire*
in Old Longyear City

MASTER OF SCIENCE IN INDUSTRIAL ARCHAEOLOGY

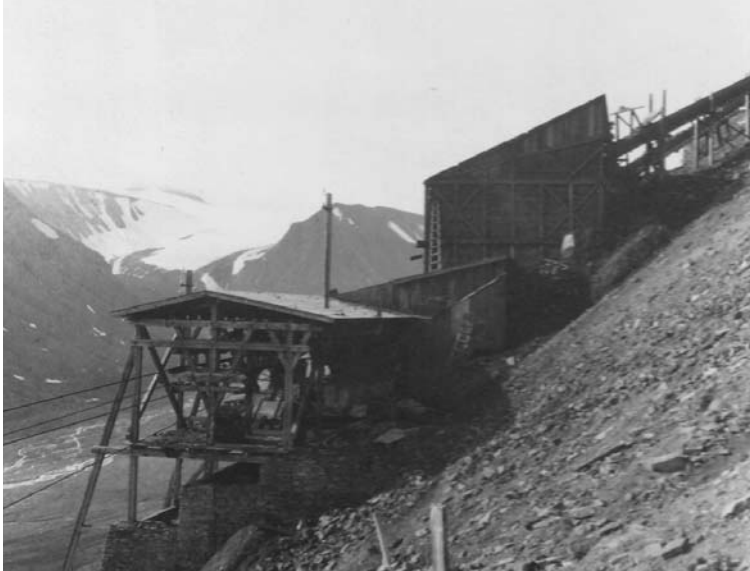
Figure 6.11: ca. 1915 image of the Bleichert aerial tramway and coal hopper. Enclosure at center sheltered tramway braking machinery. Photograph courtesy of Statsarkivet i Tromsø, Box 241.

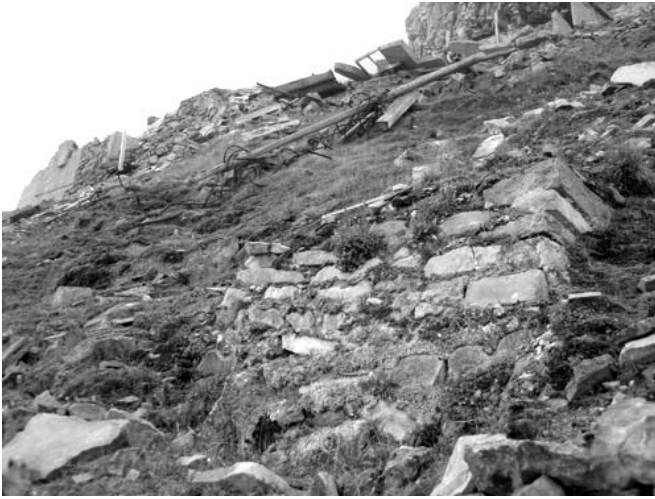
Figure 6.12: Foundation footing for proposed coal hopper. The footing was constructed in 1908 as part of an effort to increase storage at the mine. The idea was abandoned by the following summer. 2008 photograph by Seth DePasqual/MTU.

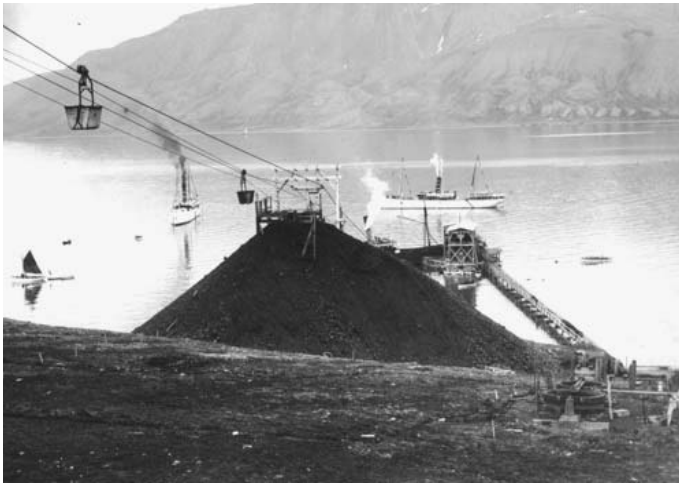
Figure 6.13: 1909 photograph of coal stockpile between tram towers 15 and 16. A wooden scaffold is visible at the top of the pile. The incline cable system is seen at lower-right. Photograph courtesy of Keweenaw Digital Archive, Image#: MS031-01-01-15.

The creation of the winter stockpile introduced a number of modifications to the transportation system and organization of labor. To facilitate dumping at the pile, an elevated platform was constructed to bring at least four workers to the level of the descending tram buckets (Figure 6.01, Column 5). When a bucket passed by, a worker tripped a lever and the coal dumped onto the ground below (Figure 6.13). As the stockpile grew in volume, it expanded from the aerial tramway at right angles. On top of the growing pile, the team of laborers carted the coal from the elevated platform across a narrow track system. The company installed a small railway at the base of the pile to facilitate the transfer of coal to a separate surface incline. This incline bisected a prominent bluff and ran down to the lower pier. The lower incline tramway utilized gravity to transfer its load.

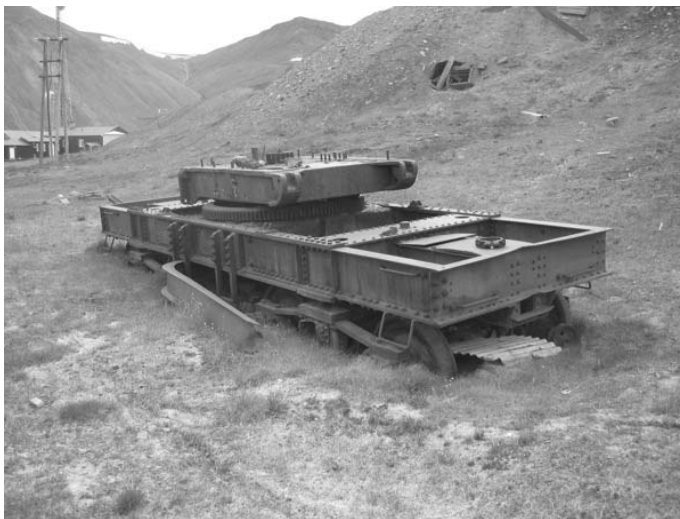
Figure 6.15: Carrier chassis for *Brownhoist* crane. The crane was brought to Advent Bay in 1913 to assist with haulage at the stockpile. 2007 photograph by Seth DePasqual/MTU.

Since the 1916 transfer of ownership, the stockpile site has seen a variety of industrial events that have obscured many of the features related to Arctic Coal Company activity. However, some features related to the former stockpile site are still present on the landscape. For example, the carrier chassis for the Brown hoist remains in situ on top of a sunken section of railway (Figure 6.15). The crane was brought to the site in 1913 as part of Scott Turner's expansion project for the auxiliary loading system. This feature is evidence of the company's constant attempt to improve the efficiency of its delivery system for transport ships. The crane represents a period of flexibility within the transportation and haulage system. The hoist was not brought to Advent Bay because of its significance within a larger company plan; instead, the crane was purchased as a reaction to changes in a technical chain that had preceded it.
