A DIGITAL PROCESSING AND DATA COMPILATION APPROACH FOR
USING REMOTELY SENSED IMAGERY TO IDENTIFY GEOLOGICAL
LINEAMENTS IN HARD-ROCK TERRAINS: AN APPLICATION FOR
GROUNDWATER EXPLORATION IN NICARAGUA

A Thesis

MASTER OF SCIENCE
GEOLOGICAL ENGINEERING

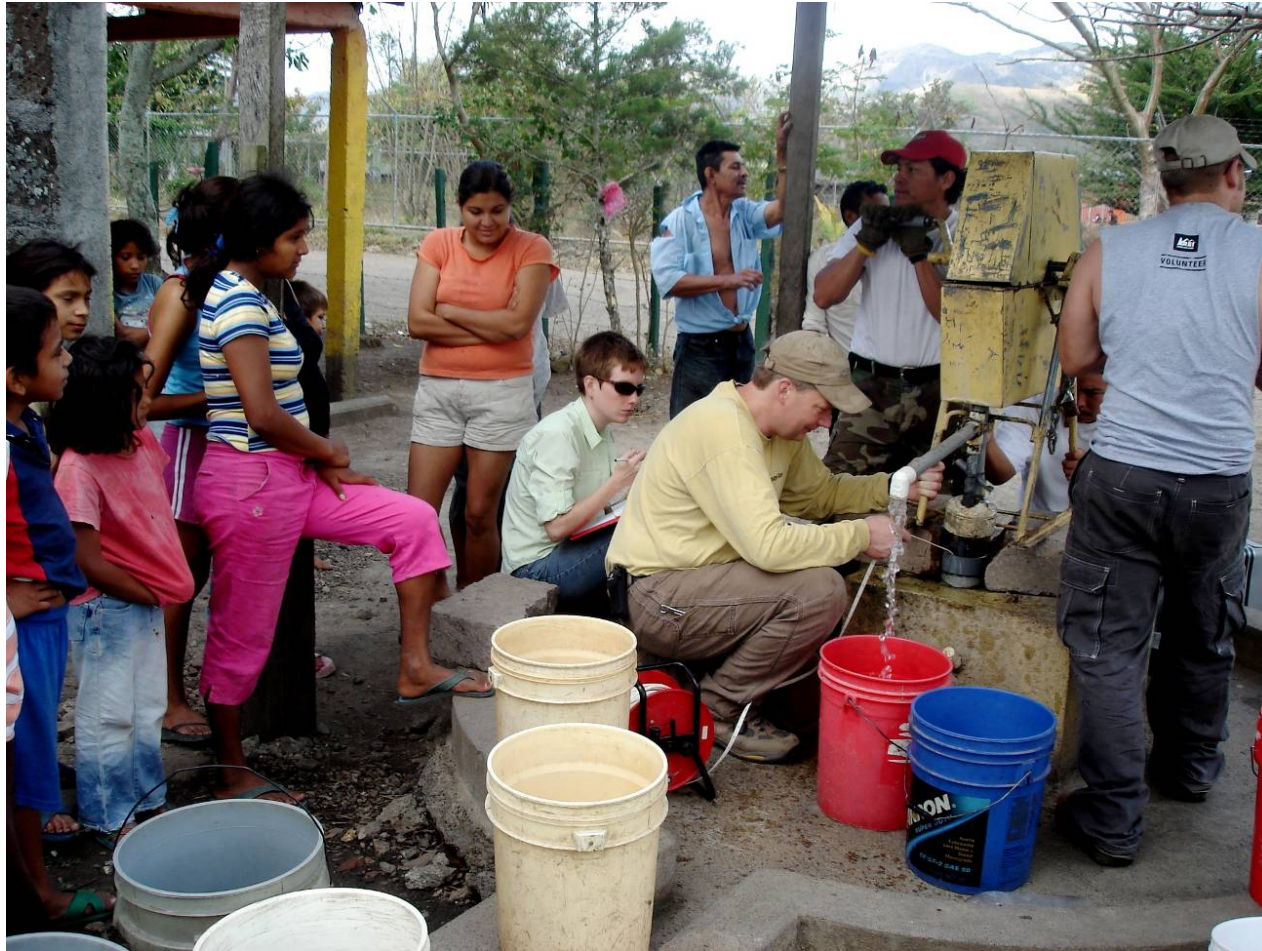
Figure 11: Manual pump test in progress. Notice the pump apparatus is set up on blocks, sounder measurements being continuously taken and recorded during pumping, and community involvement. Typically, manual pump tests require five people; two to turn pump, one to deploy sounder, one to organize buckets for filling, and one to record data. Photo by author.

Well characteristics and pump test conditions varied for each of the nine wells and deviations from the above procedure are shown in Table 6. Each well was only tested once, which is justified by the results presented by Gross (2008). Specific conductivity and temperature measurements were made from water samples taken during pumping with a flow through cell. These results are provided in Appendix 5 and are not discussed in this paper.

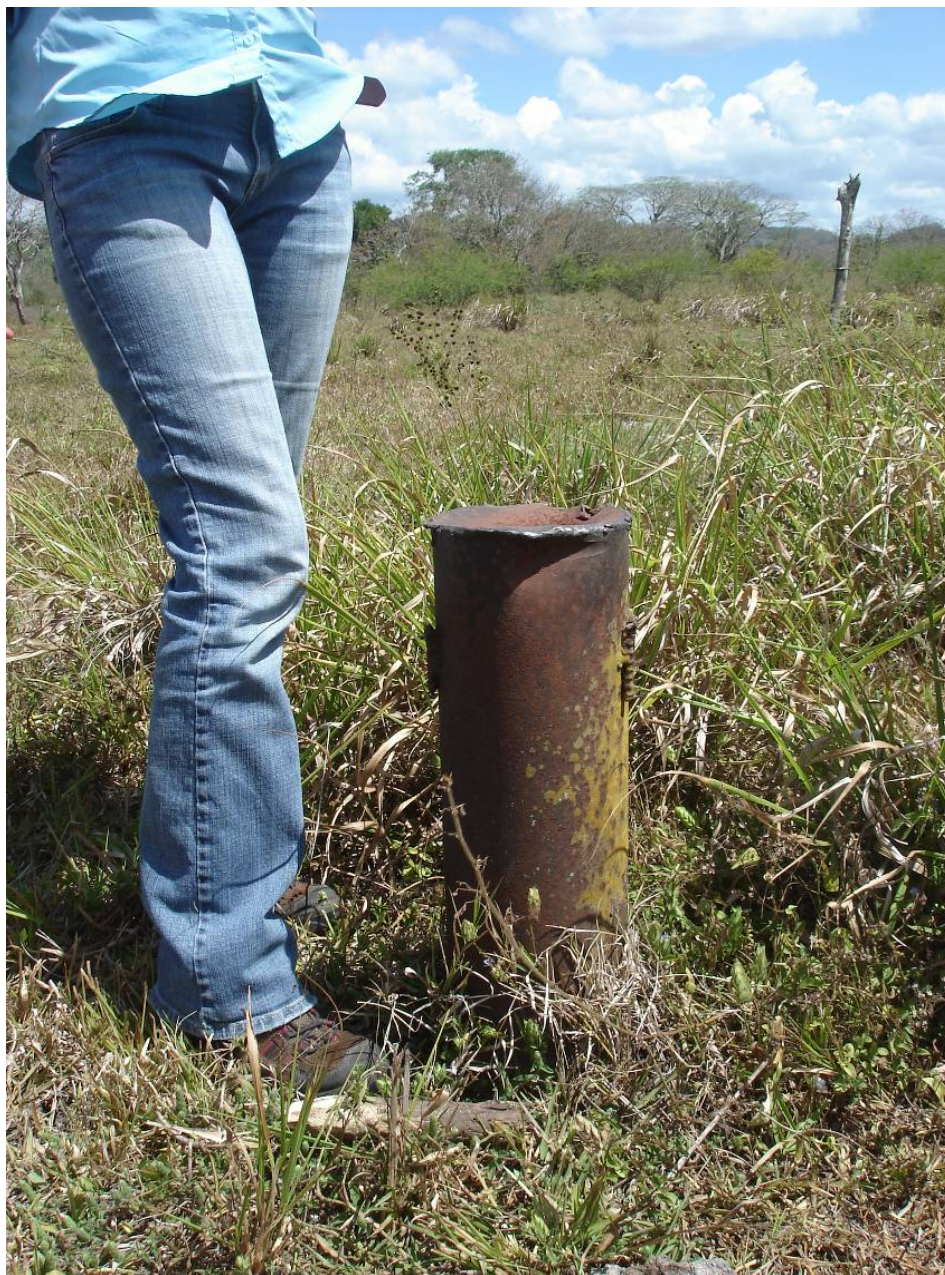
Figure A4-3: Photograph of Santa Blanca well (survey well 11). Photo by author.

Additional notes: top is sealed metal - need to puncture away from road

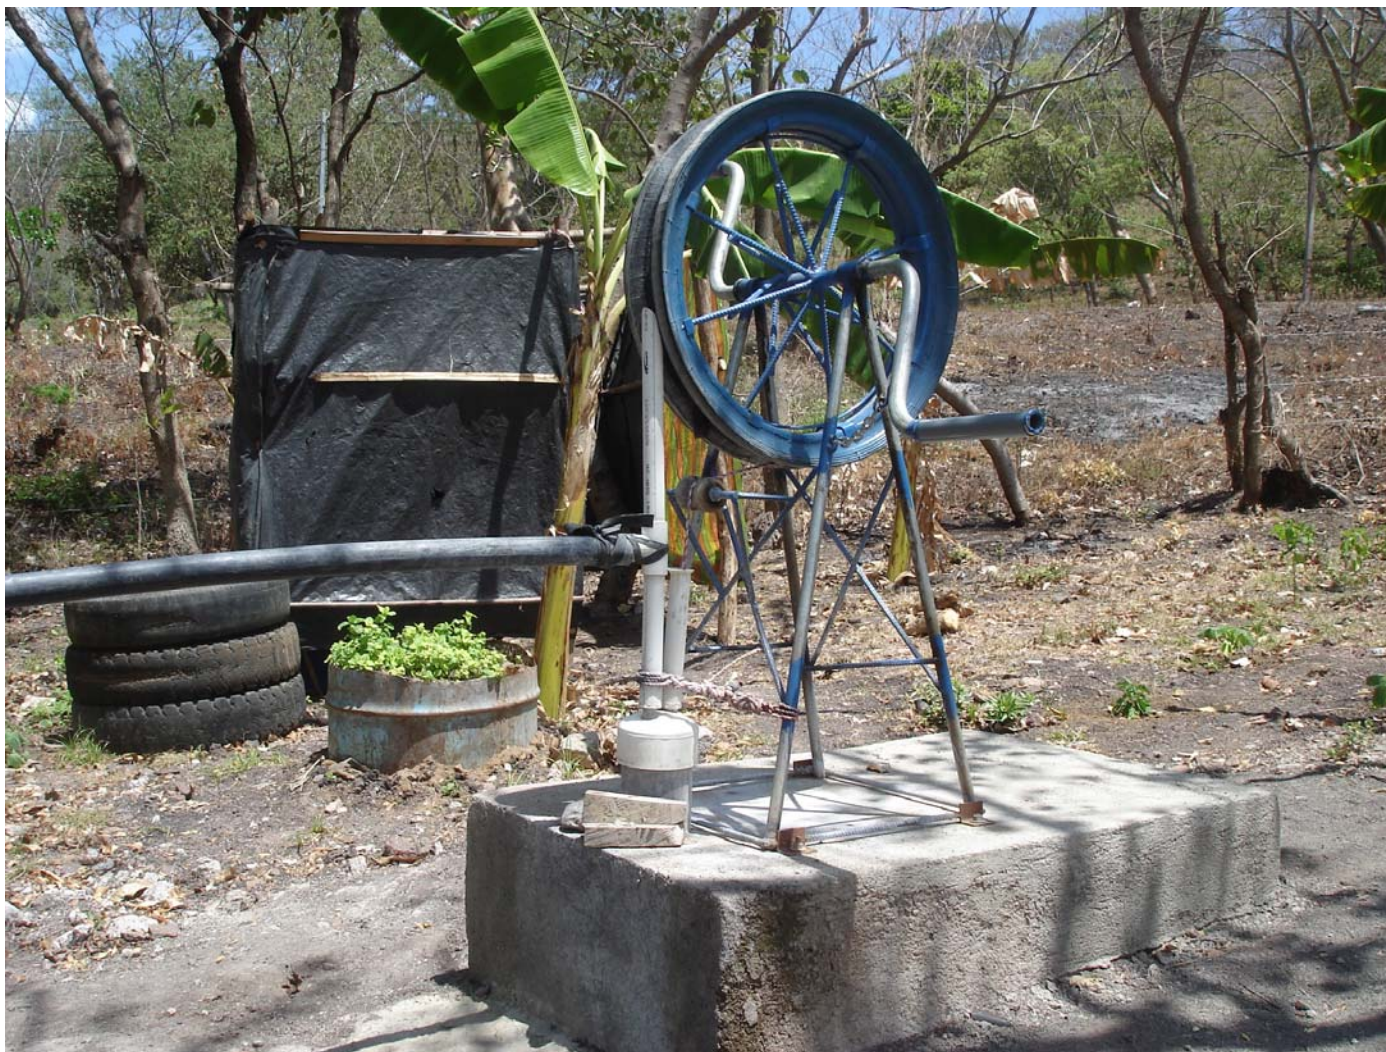
Figure A4-4: Photograph of S. Boaco well (survey well 12). Photo by author.

water table 4m
rope pump goes to 48'
rate 20 gal/min.

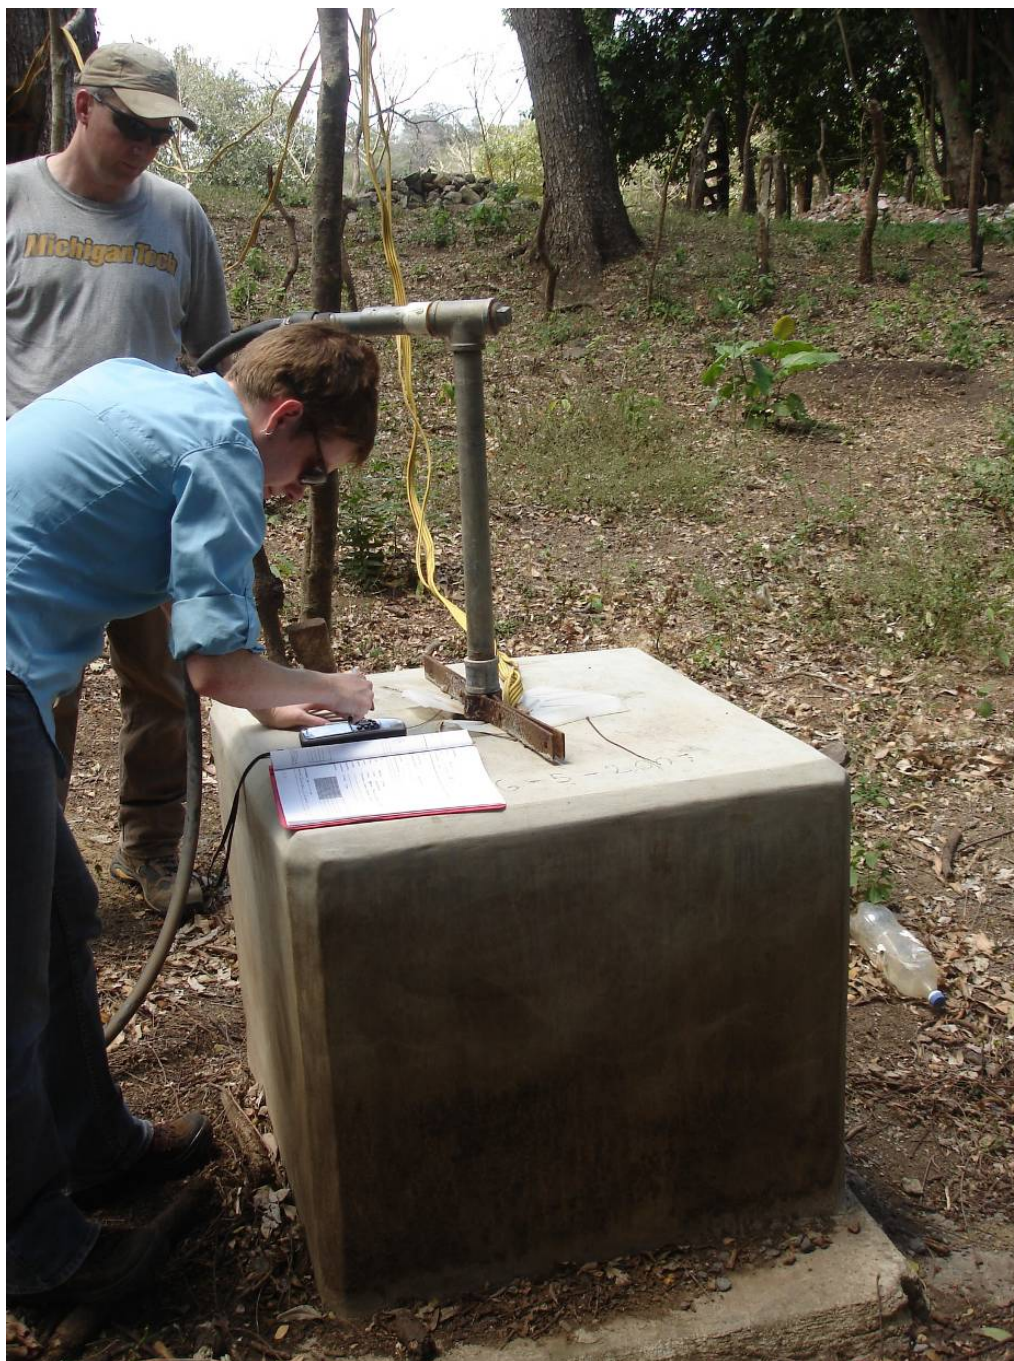
Figure A4-5: Photograph of Municipal Slaughter House well (survey well 13).
Photo by author.

Additional notes: 50m deep, 8" diameter pump fills tank, pumps ~5hrs. every day, every other day.
how to measure this flow rate?
~~* GPS pt.~~

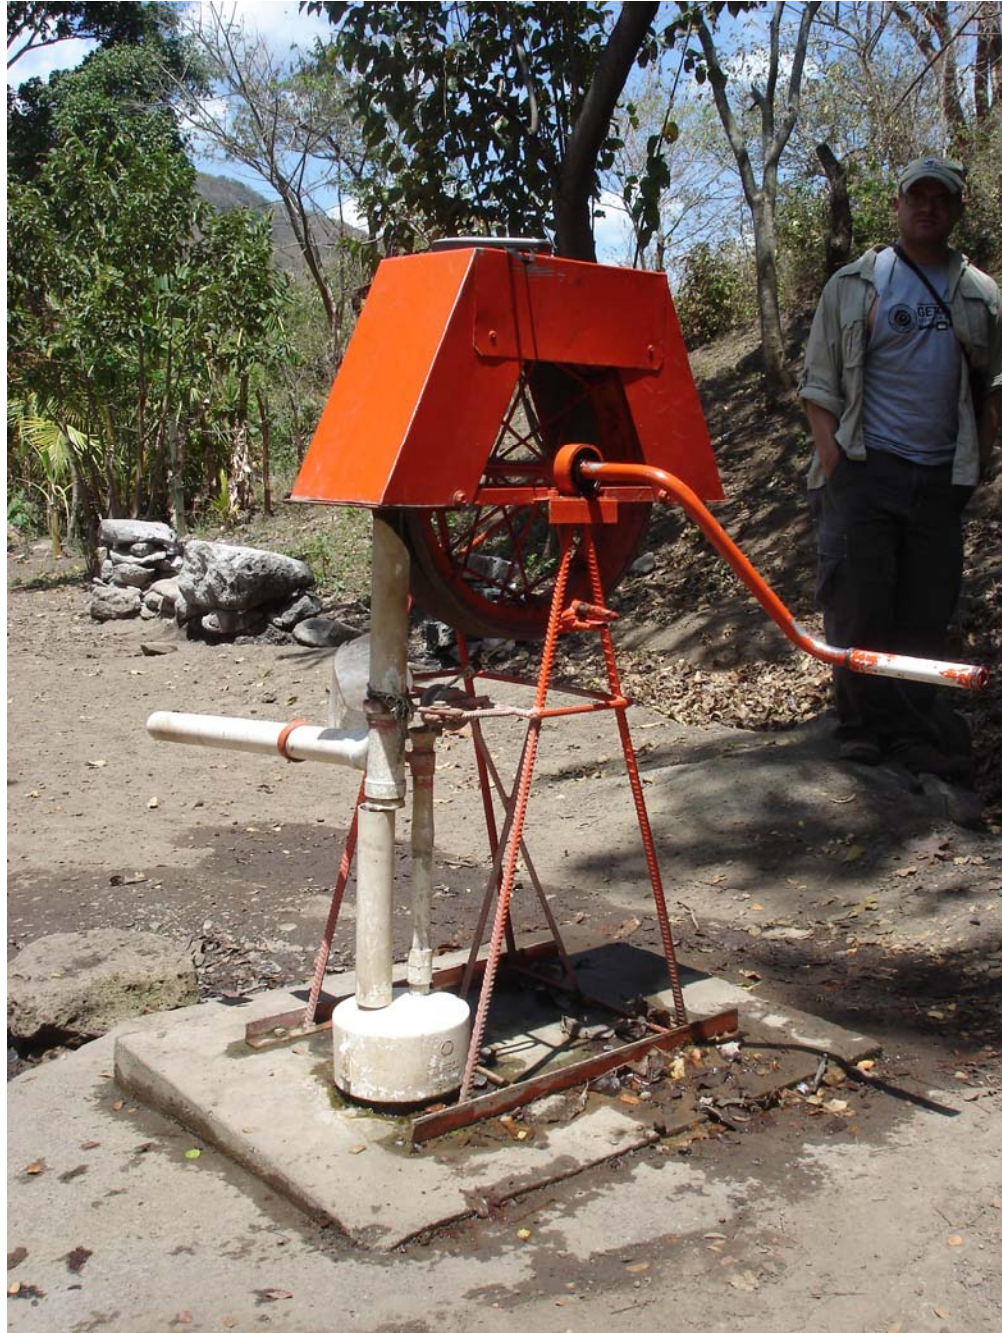
Figure A4-6: Photograph of S. Paso de Laja well (survey well 14). Photo by author.

Additional notes: well diameter looks somewhat large pump @ least 1 gal/min.

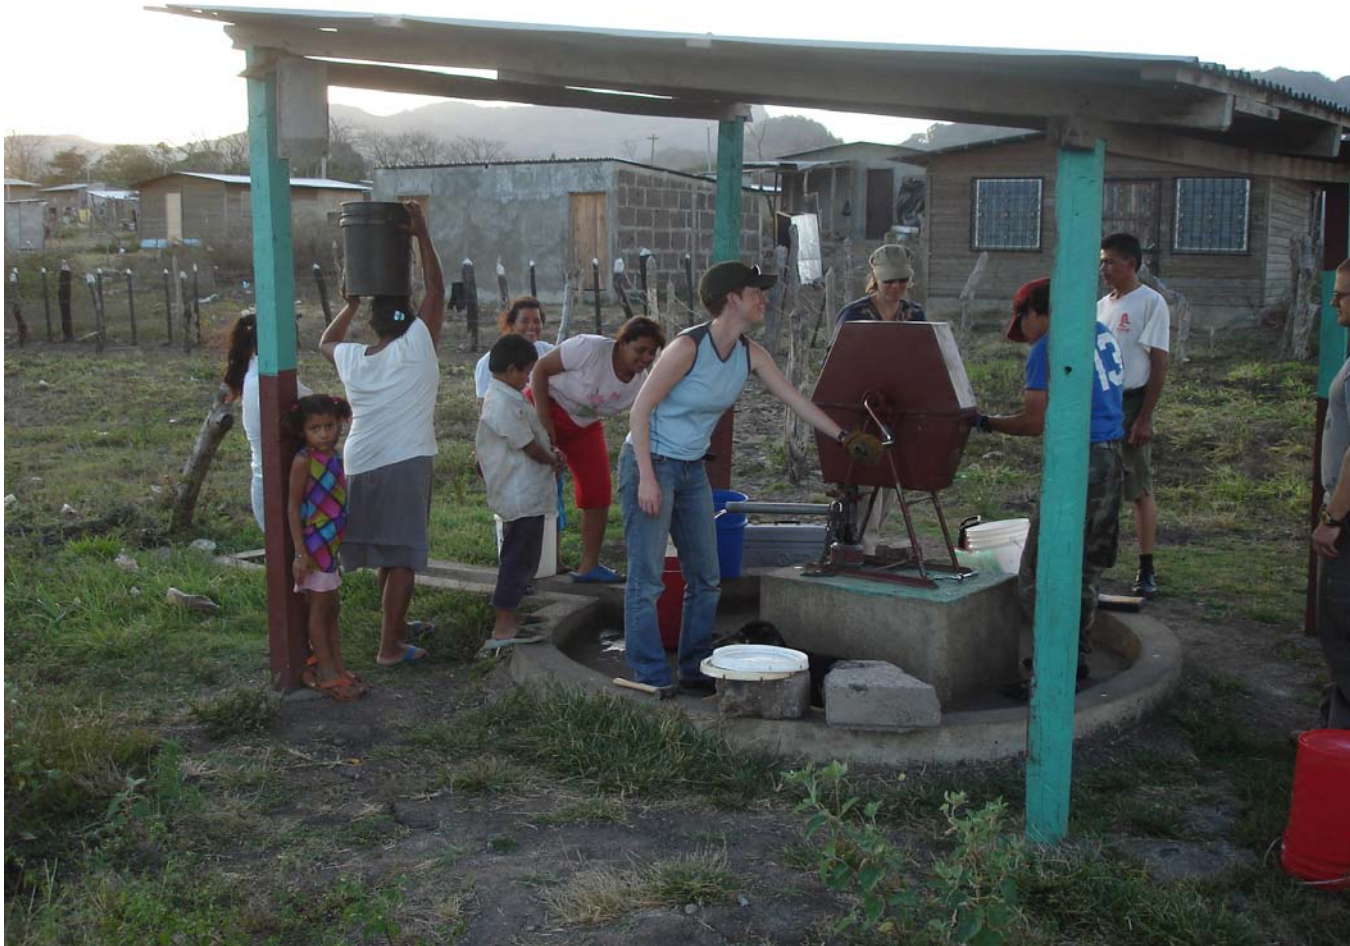
Figure A4-8: Photograph of S. San Nicolas (A) well (survey well 16). Photo by author.

bad bolts

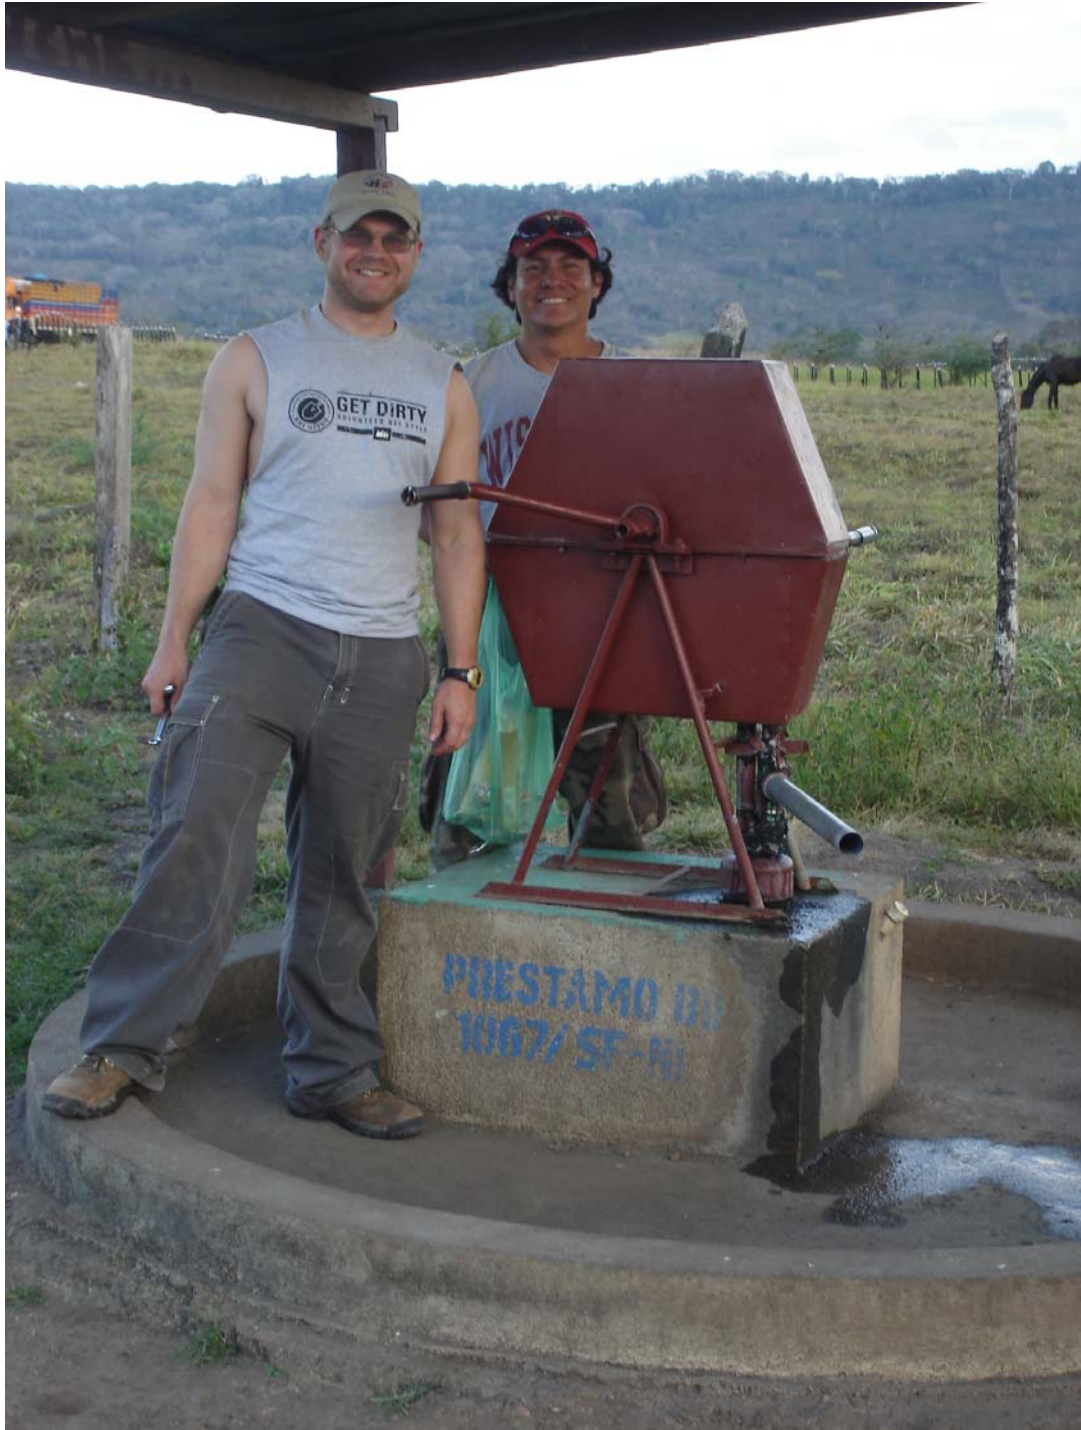
Figure A4-9: Photograph of S. San Nicolas (B) well (survey well 17). Photo by author.

Additional notes: can only pump @ 2 gal/min?
~~had bottles~~

It would be interesting to compare pump test results to well 16 - same aquifer?

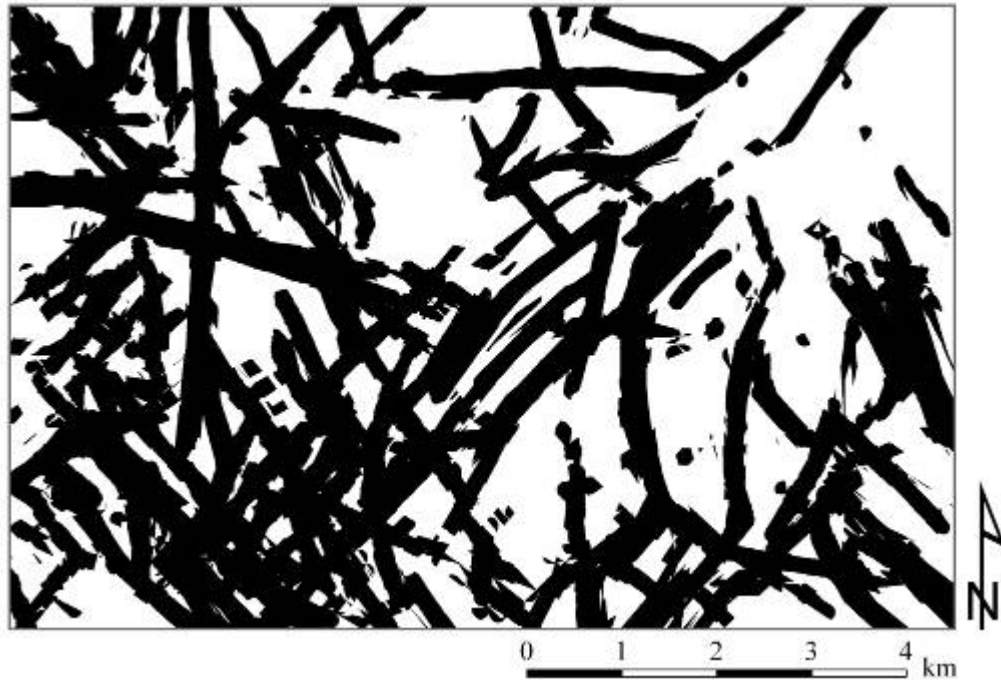
Figure A6-5: Reclassified coincidence raster with coincidence number = 2, step 3F. Areas in black show where coincidence number is greater than or equal to 2, meaning that in these locations, lineaments have been observed two or more times. Areas in white are either where no lineaments were observed or only observed once.
