Performance Evaluation of VIP Latrines in the Upper West Region of Ghana

A REPORT

Submitted in partial fulfillment of the requirements for the degree of
MASTER OF SCIENCE IN ENVIRONMENTAL ENGINEERING

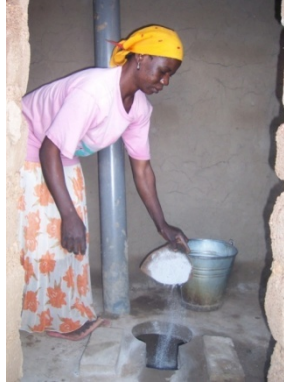
Figure 3: Woman adding wood-ash inside the pit of a VIP latrine
Photo by Author

Another method of insect and odor control is to apply regular doses of carbonaceous materials into the pit after every use. Applying carbonaceous materials with high pH, such as wood ash, can raise the overall pH of the pile to as high as 12.5. For most pathogens microbial growth is known to be hampered at a pH of 9 or greater, and the speed at which pathogens are removed increases with pH (Kaiser, 2006). If the ash is put in while it's still hot it can kill off maggots (Myre, et al. 2007) and, "cause bubbles of gas to explode, which flies do not like!" (Pickford, 1995, p. 109) This practice could also be used in VIP latrines as the photograph below demonstrates.

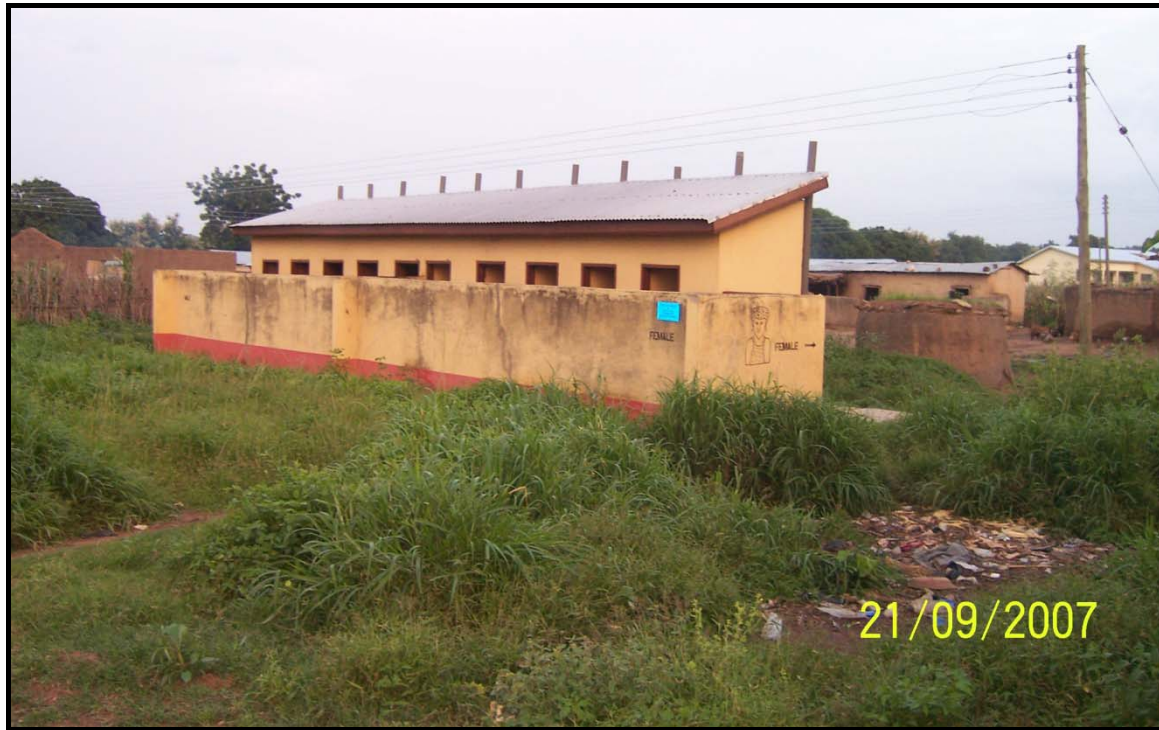
Figure 5: Photograph of an institutional latrine in Ghana
Photo by Author

In the past, the government of Ghana attempted to address the lack of sanitary excreta disposal by constructing large communal latrines, also known as institutional latrines. These were intended to service all of the households in an area. However experience has shown that communal latrines have been relatively ineffective due to a number of social and economic reasons. For instance, many communities face the problem of enforcing payment for the use of communal latrines, which eventually leads to a lack of funds to cover the operations and maintenance costs. The people’s attitude toward communal latrines can be generalized by a frequently used Ghanaian expression: “Everybody’s problem is nobody’s problem.” Once communal latrines fall into disrepair they are likely to become sanitary hazards with lower user acceptance. For this and other reasons the United Nations does not recognize communal latrines as improved sanitation. Ghana’s

sanitation policy has also turned away from institutional latrines, and instead is now focusing on providing sanitation access to individual households.

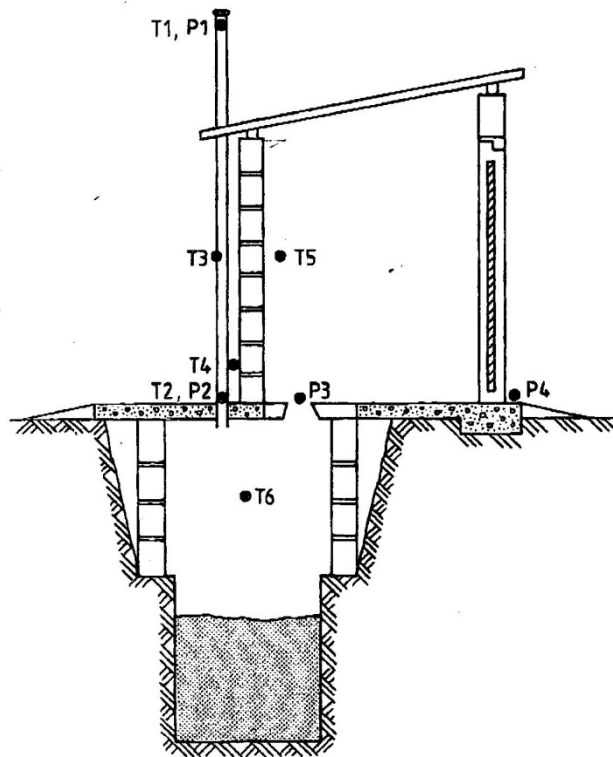
Figure 7: Location of temperature probes T1 through T6 and air pressure measurement points P1 through P4
Source: Mara & Ryan, 1983, p. 10

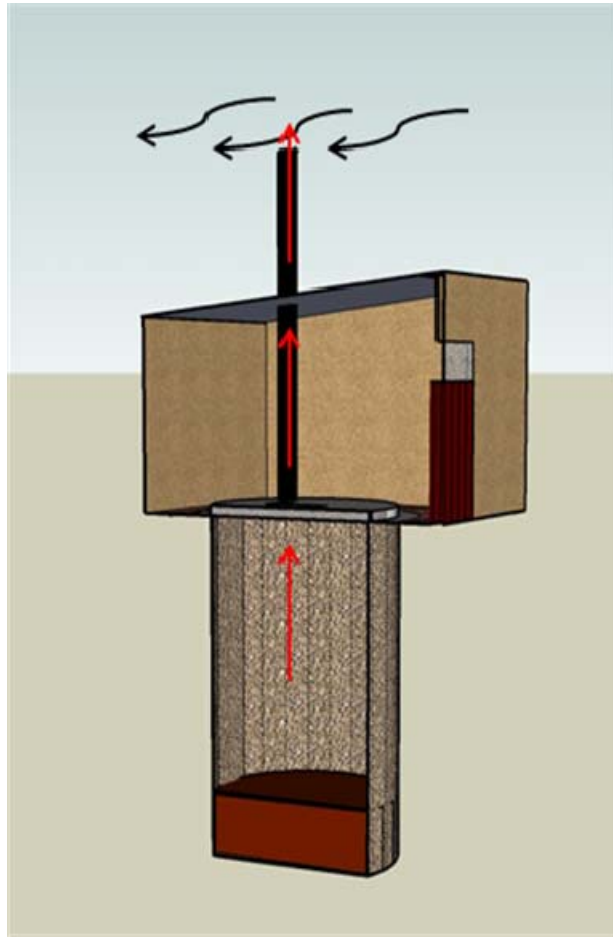
Figure 8: Cross sectional diagram of a VIP latrine showing wind passing over the vent pipe

3.4.1 Wind across the top of the vent pipe

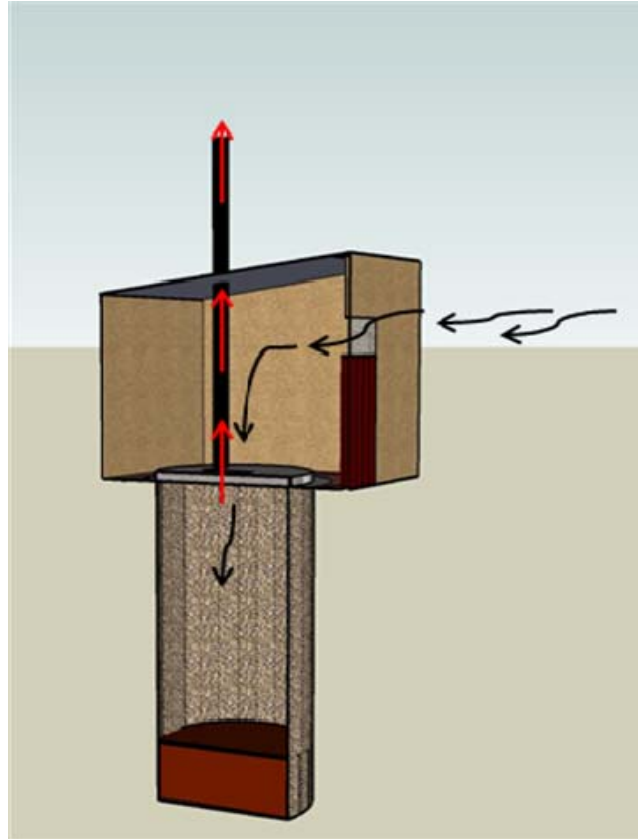
Figure 9: Cross sectional diagram of a VIP latrine showing wind passing into the superstructure

3.4.2 Wind passing into the superstructure

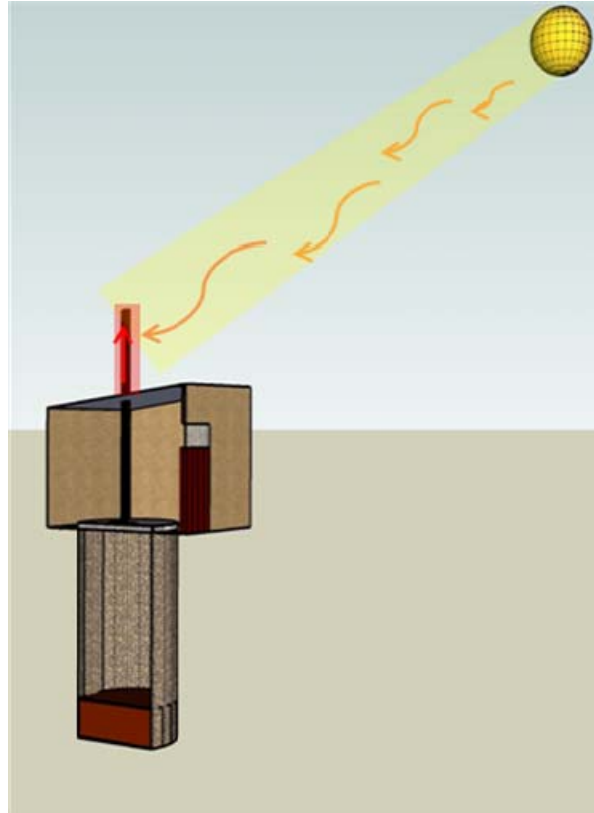
Figure 10: Cross sectional diagram of a VIP latrine showing solar radiation heating the vent pipe

3.4.3 Solar Radiation

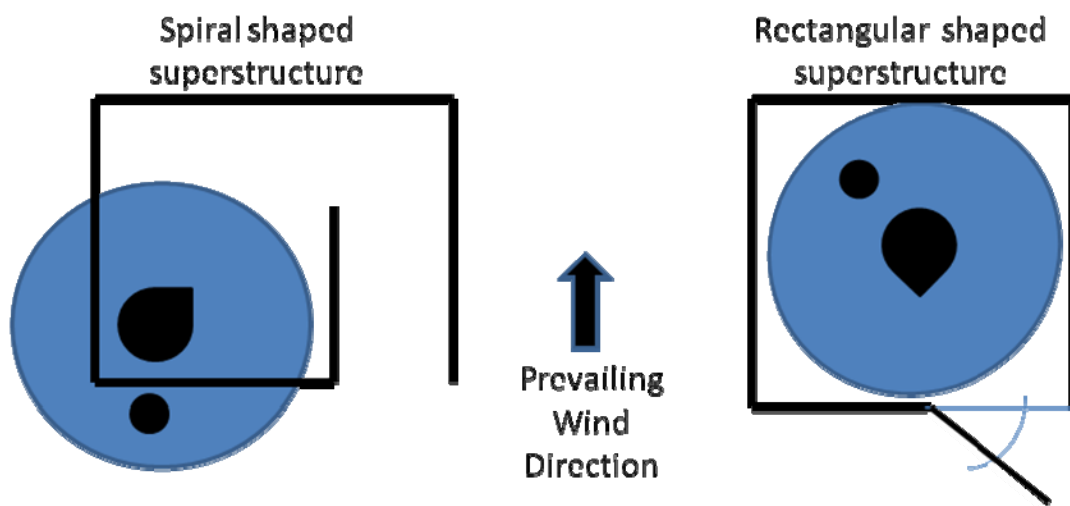
Figure 11: Top view of spiral shaped and rectangular shaped superstructures.

From the design perspective the differences between the Zimbabwean VIP latrine and the UWR VIP latrine include the shape of the superstructure, and the air volume of the superstructure. A typical Zimbabwean design uses a spiral shape superstructure, which allows for darkness, privacy and unimpeded airflow without the need of a door. The UWR VIP latrines in this study were typically made in a rectangular box shape, which require a door of some kind for adequate darkness and added privacy. However if the latrine lacks an added ventilation opening the presence of a doorway could adversely affect air flow.

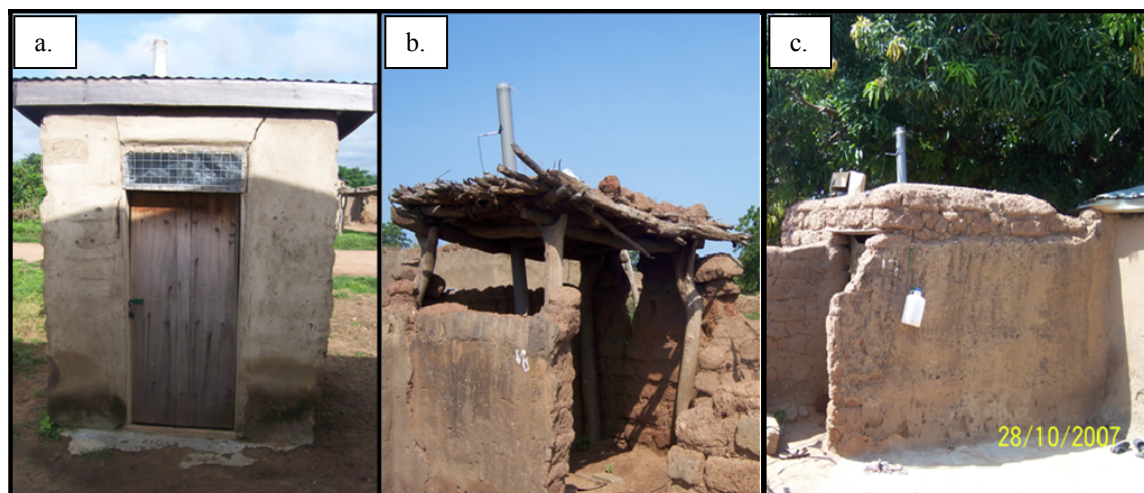
Figure 13: Photo of three unique Kulkpong latrines; a) the author's latrine; b) three-quartered walled latrine; c) shaded latrine
Photos by Author

To account for variation in VIP latrine design, three additional Kulkpong latrines were selected due to a unique property with each of the latrines. The first was the author's personal VIP latrine which was constructed by a professional water and sanitation consultant based out of the regional capital, Wa. The second possessed walls that reach approximately three quarters of the height to the roof, and the third latrine was located in a heavily shaded area. All three unique Kulkpong latrines are shown in Figure 13 below.

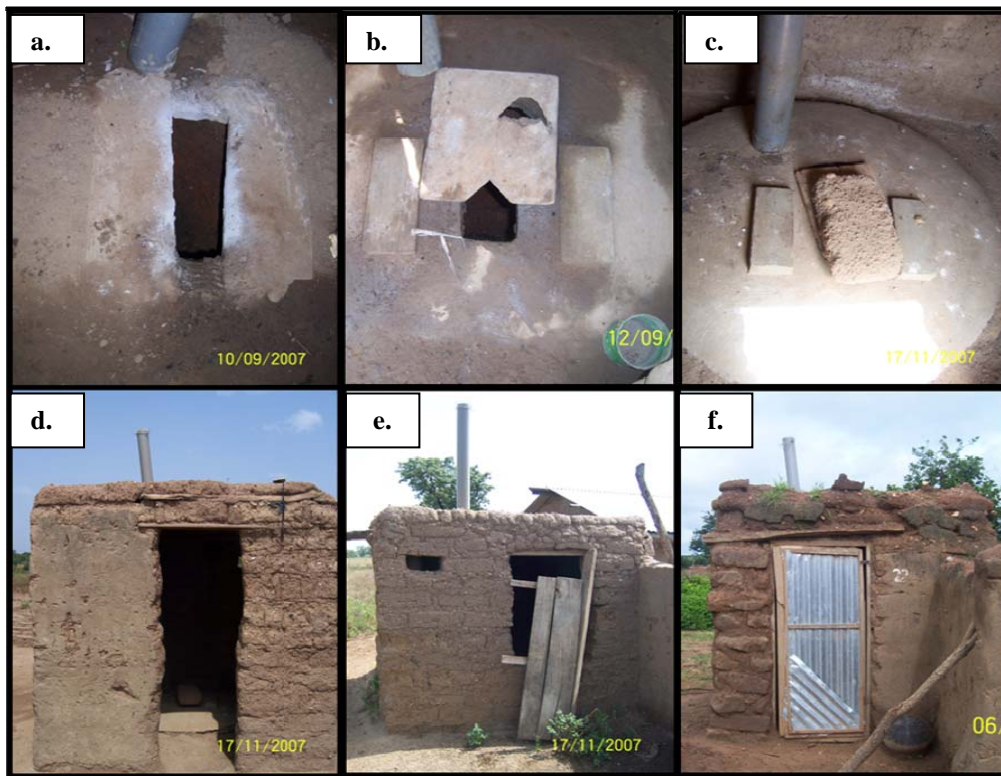
Figure 14: Photo examples of; a) ‘none’ drop hole lid covering; b) ‘partial’ drop hole lid covering; c) ‘complete’ drop hole lid covering; d) ‘none’ entrance way covering; e) ‘partial’ entrance way covering; f) ‘complete’ entrance way covering. Photos by Author

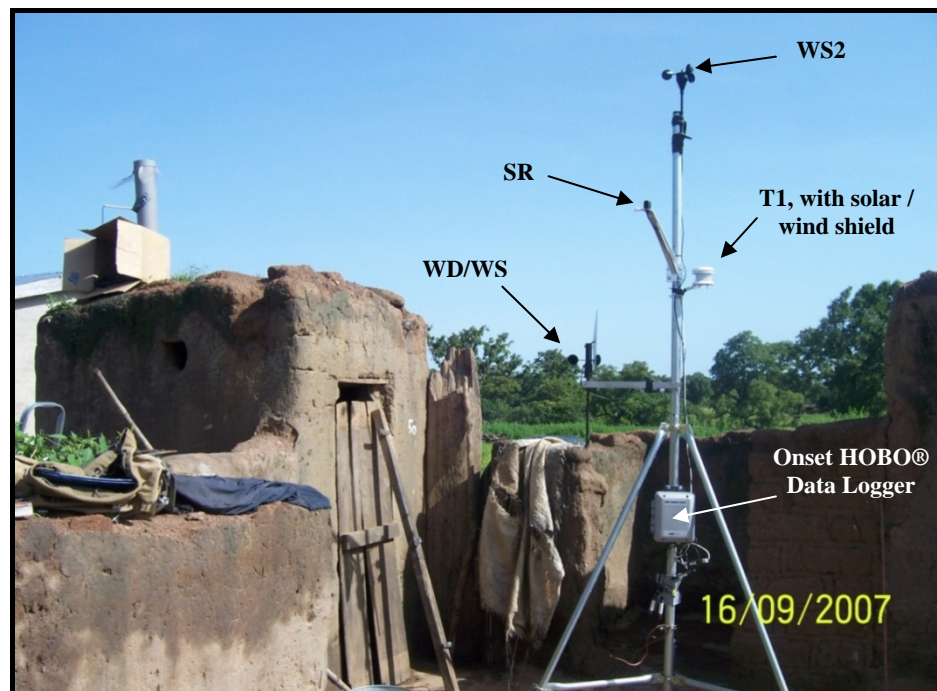
Figure 15: Photo of weather station setup. Photos by Author

(see Figure 15 and Figure 16). To monitor the outside microclimate an Onset HOBO® weather station was set up and leveled within close proximity (less than 2 meters) to the main ventilation opening of the latrine superstructure (typically the entranceway). The Onset sensors located on the weather station included one temperature and barometric sensor (T1), one pyranometer to measure solar radiation (SR), a dual wind directional and wind speed sensor (WD/WS) placed near the mid height of the superstructure to record wind behavior in front of the ventilation opening (In cases where the ventilation opening was in close quarters or due to the short height of a particular latrine, the WD/WS was removed from the tree and attached to a smaller, one meter high, quad-pod; which was then set in front of the ventilation opening and leveled). One additional wind speed sensor (WS2) was set at the top of the weather station assembly at a height of approximately three meters; the relative height of the top of the vent pipe to measure wind velocity passing perpendicular to the mouth of the vent pipe. All of the above sensors were connected to an Onset data logger, programmed to average and record data every 10 minutes.

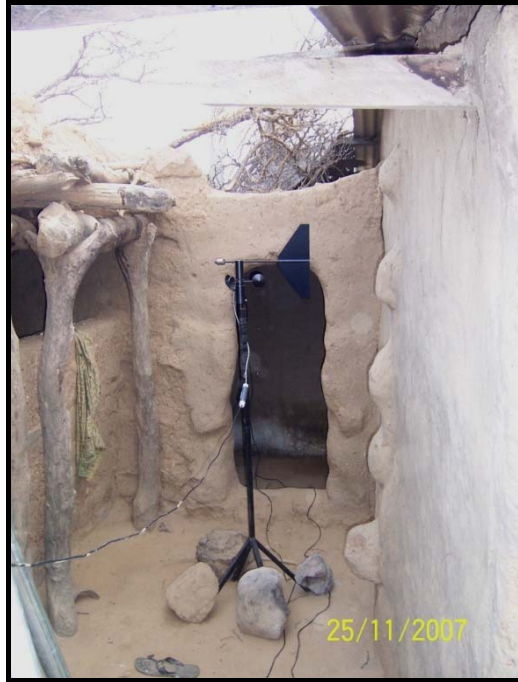
Figure 16: Photo of alternative WD/WS setup. Photo by Author

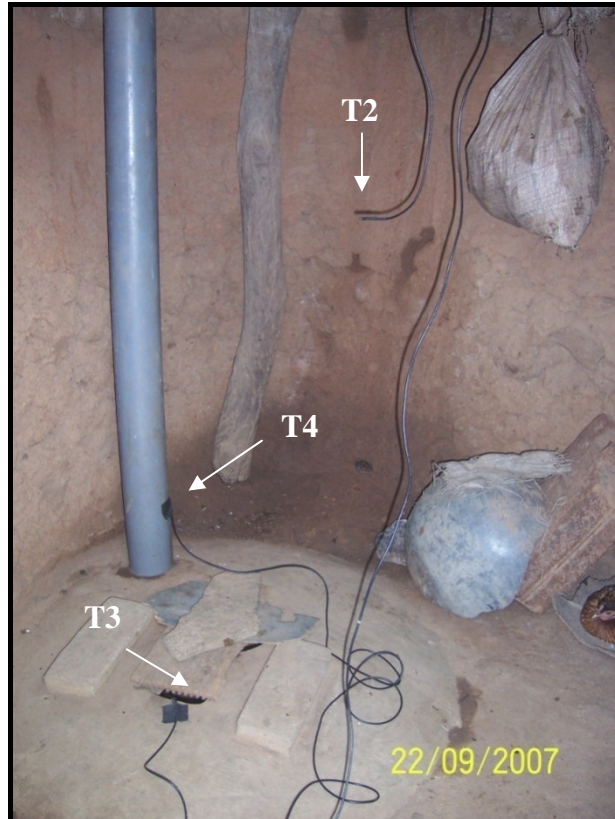
Figure 17; Photo of interior temperature probes setup. Photo by Author

Also attached to the Onset data logger were three additional temperature probes used to measure the interior environment within the latrine. The first temperature probe (T2) was suspended near the three-dimensional mid-point of the superstructure's interior in order to measure the air temperature inside the superstructure. The second probe (T3) was fed a meter through the drop hole in order to measure the air temperature within the pit. A third temperature probe (T4) was placed into the bottom of the vent pipe. This was done by drilling a small hole into the bottom of the vent pipe of approximately 1 cm (0.4 inches) in diameter, placed at a height of roughly 15 cm (6 inches) from the latrine slab. The temperature probe was then fed through the hole, and any space between the probe feed wire and the hole's edge was sealed using duct tape.

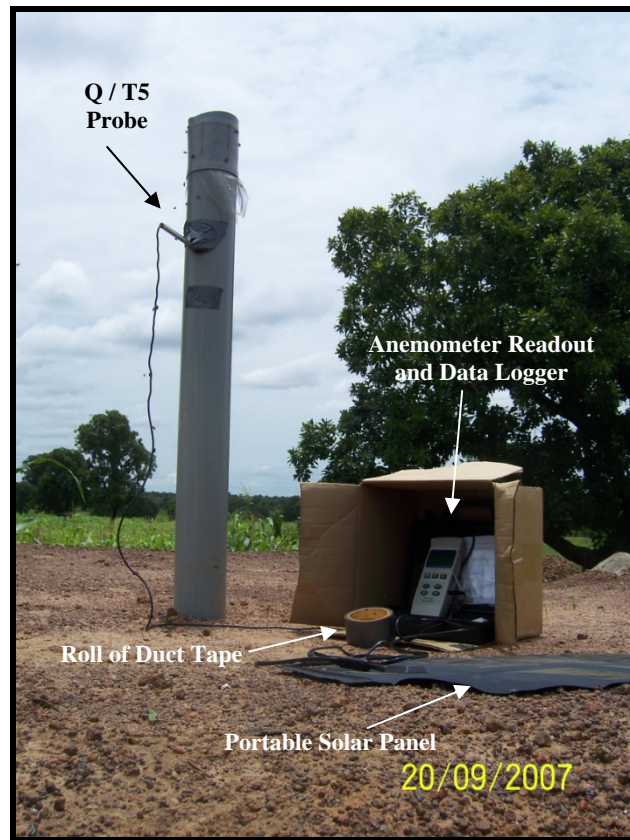
Figure 18: Photo of Hot-wire anemometer setup. Photo by Author

a hole of approximately 2 cm (0.8 inches) in diameter, placed down from the top of the vent pipe at roughly 30 cm (12 inches). The probe was carefully fed through so that the sensor would be located near the mid-point of the pipe's diameter and facing perpendicular to theoretical airflow path. It was then secured, and sealed into place, using duct tape from the outside of the vent pipe. The hot-wire anemometer came with its own programmable data logging function, which was set to record temperature and air velocity measurements every 2 minutes.

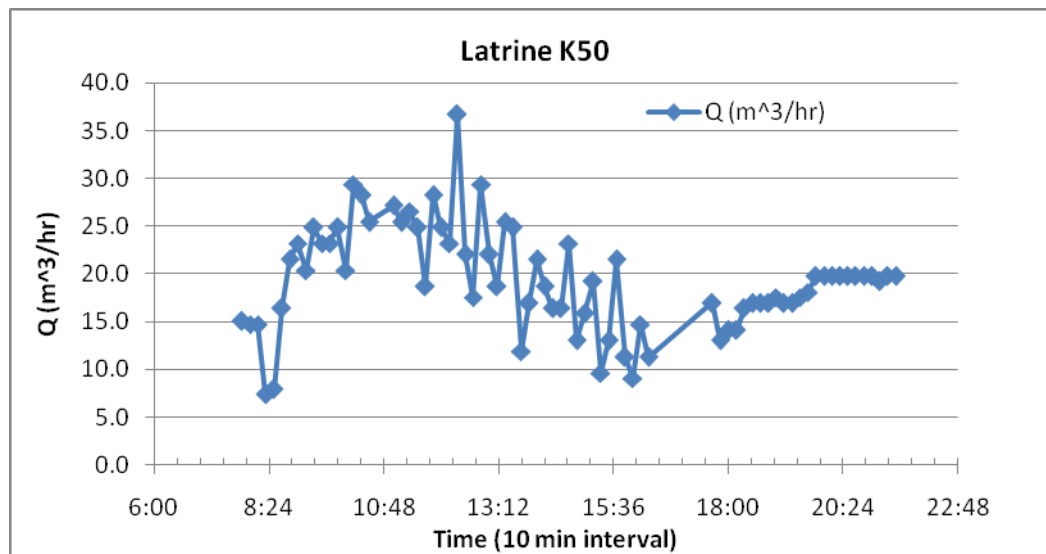
Figure 19: Flow rate data for one latrine during one measurement setup.

The data collected in this study shows that the ventilation flow rate (Q) varies within a latrine from minute to minute. A typical flow rate pattern in a latrine over the course of one day in ten minute intervals is shown in Figure 19.

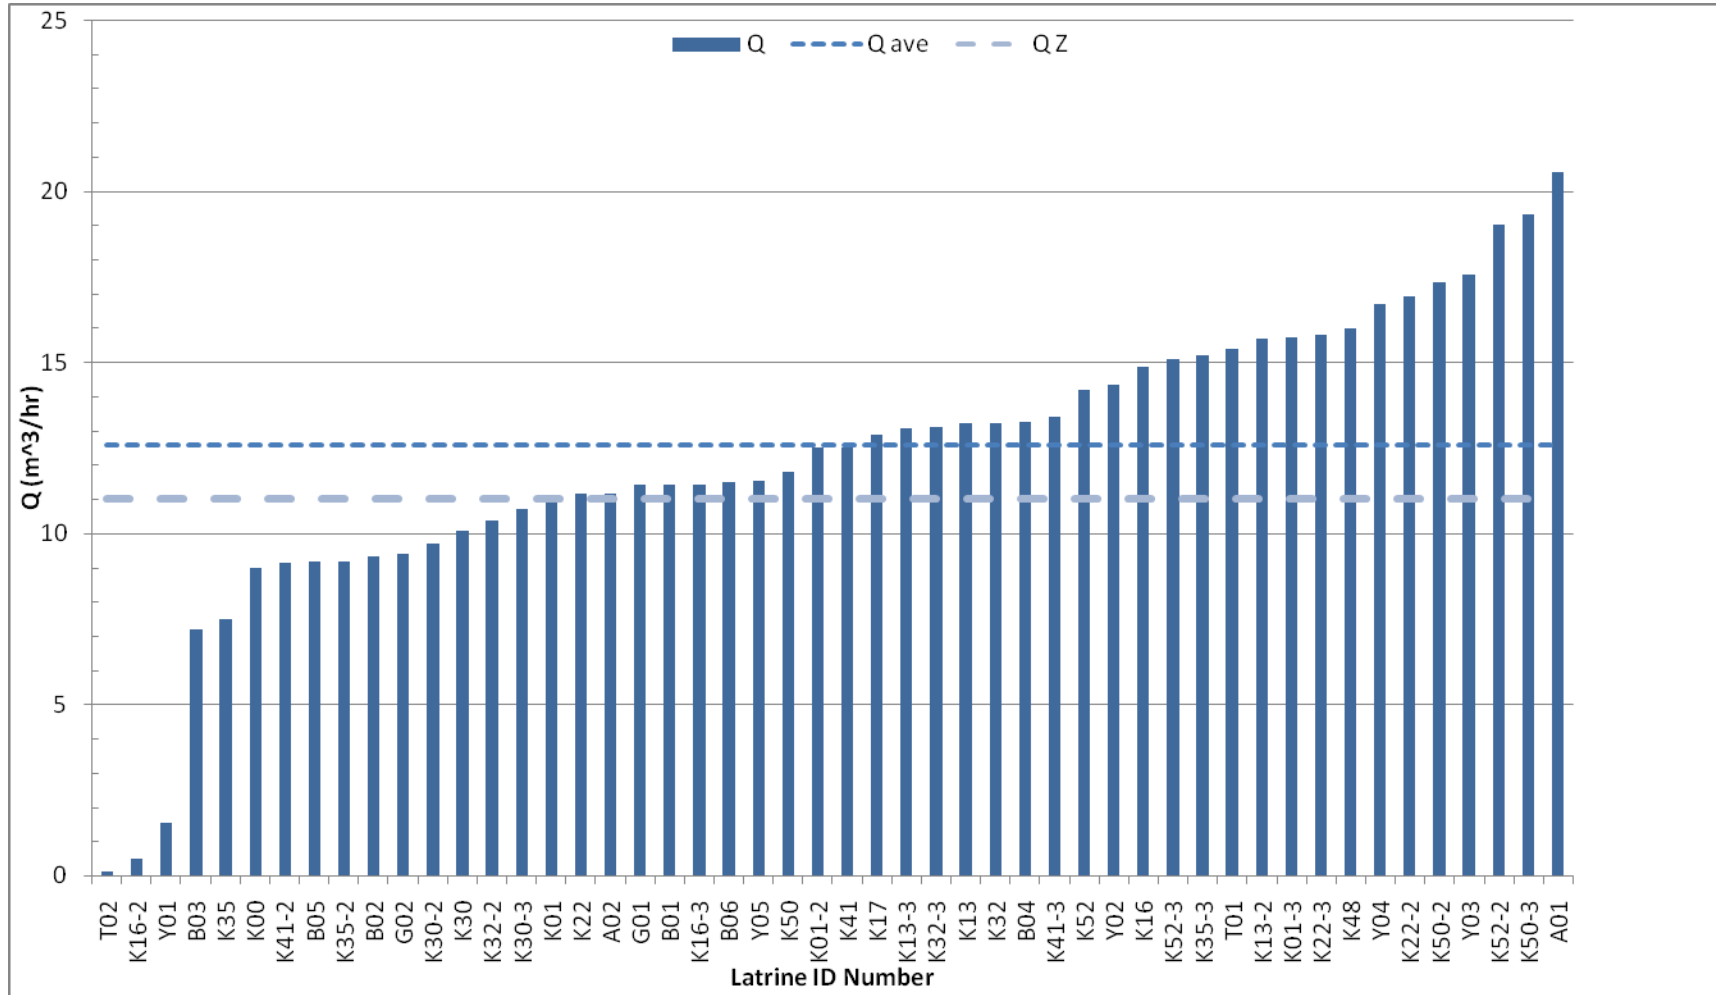
Figure 20: Average flow rate observed for each setup plotted with Q_{ave} and Q_Z .

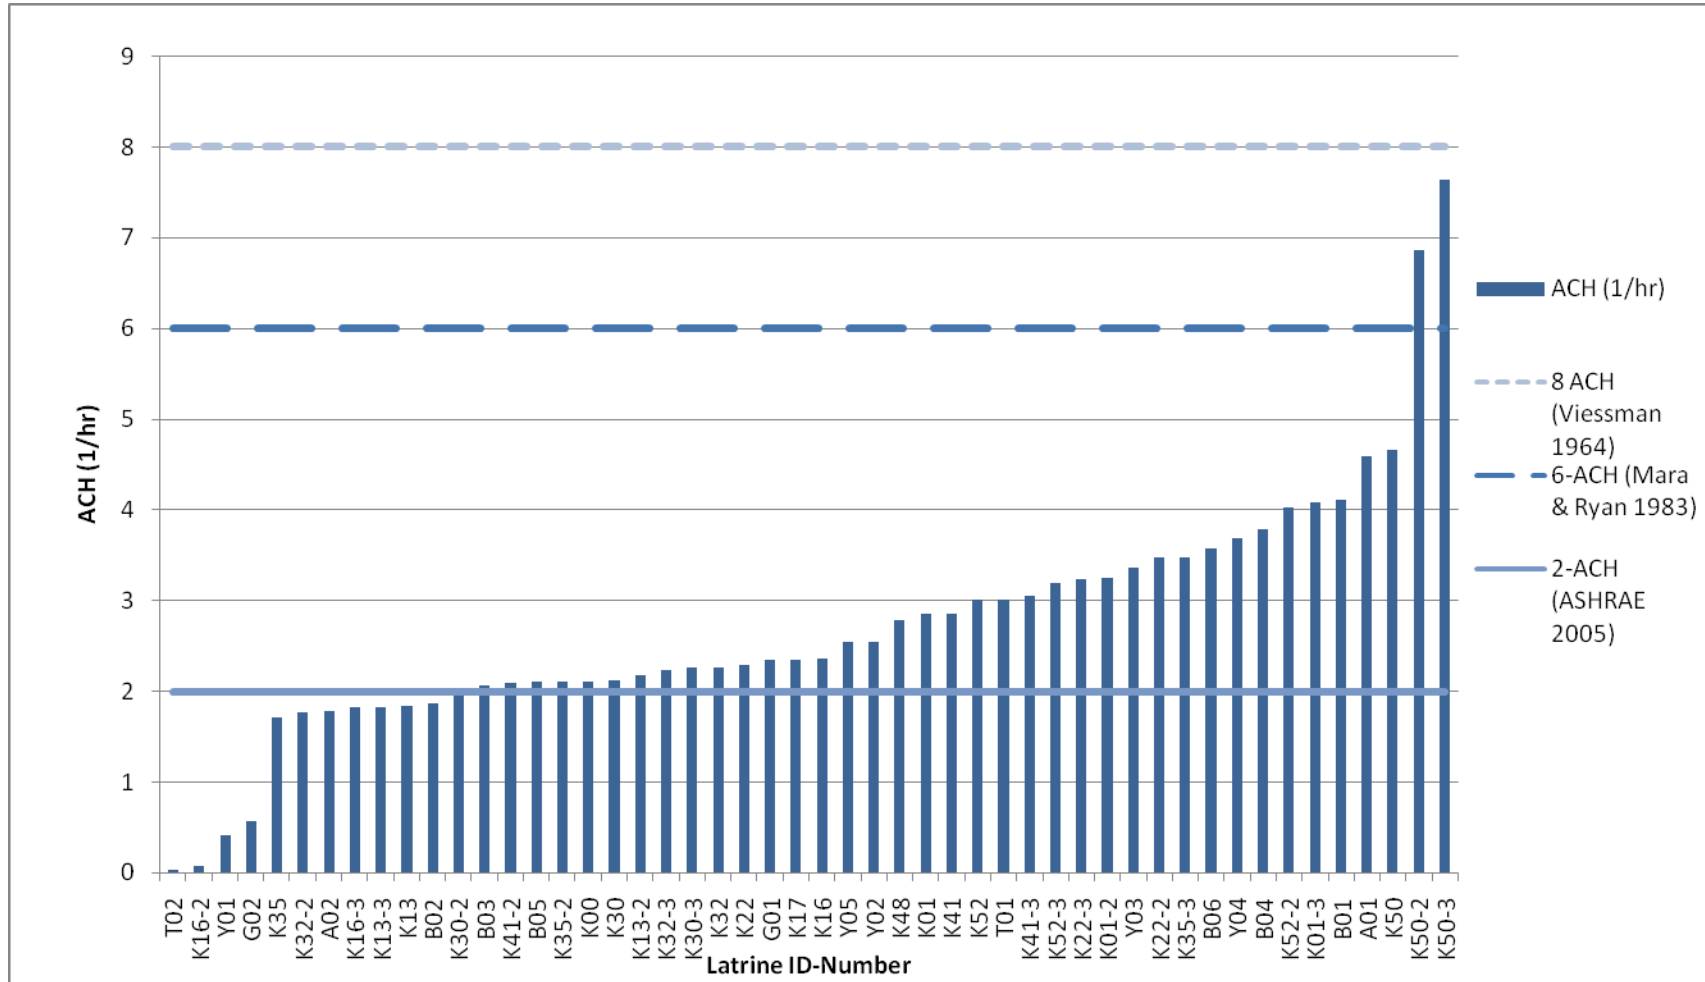
Figure 21: Average observed ACH for each setup plotted with recommended ACH values

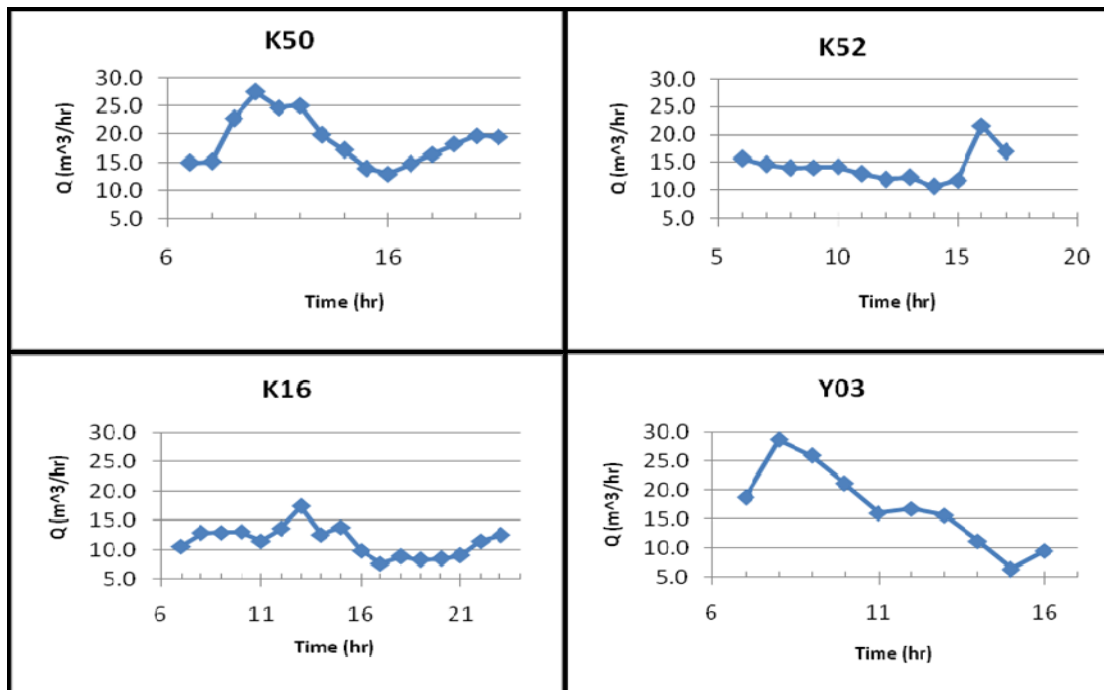
Figure 22: Plotted flow rates of latrines K50, K52, K16 and Y03

throughout the day. By early evening all of the latrines showed an increase in ventilation flow rate.

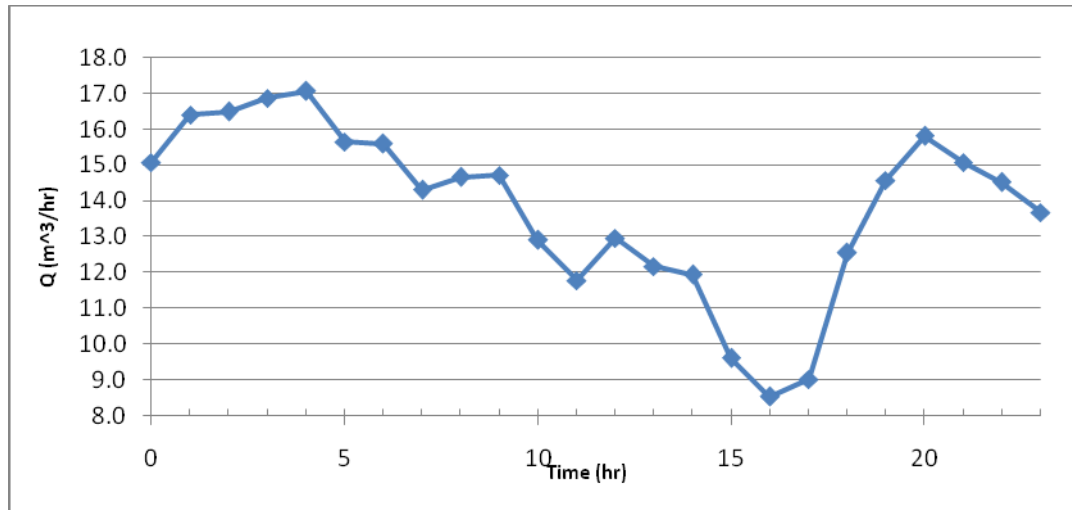
Figure 23: Cumulative average flow rate of full sample

The average flow rate signal appears to fit the description used for the similarities among individual latrines. It can again be observed that in the early morning hours there is a slow increase in flow rate. Then, starting around 4:00 there appears to be an overall negative sloping trend, with intermittent peaks and valleys, until about 16:00 hours. At which point Q rapidly increases, tapers off, and then begins to decrease. Due to this being a continuous cycle, it is likely that the flow rate would increase again towards the early morning hours. However, the certainty of this last point is questionable.

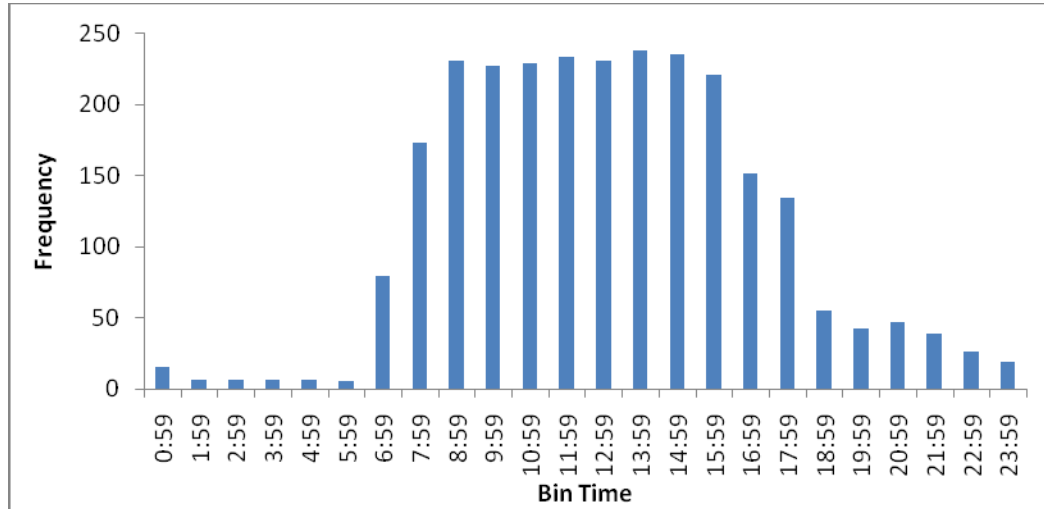
Figure 24: Histogram of the number of contributing data points to hourly averaged Q values (n=2649)

One of the limitations of the dataset is the few observations made during the late evening and early morning hours. The number of data observations averaged to make one hourly data point is shown by the histogram on Figure 24. The reason for the lack of information during the late evening and early morning hours is primarily due to technical difficulties of maintaining power to the Mannix hot-wire anemometer during these times. Therefore, our confidence in the values for Q_{avg} between 18:00 to 5:00 hours are not as strong as those between 6:00 and 17:00 hours.

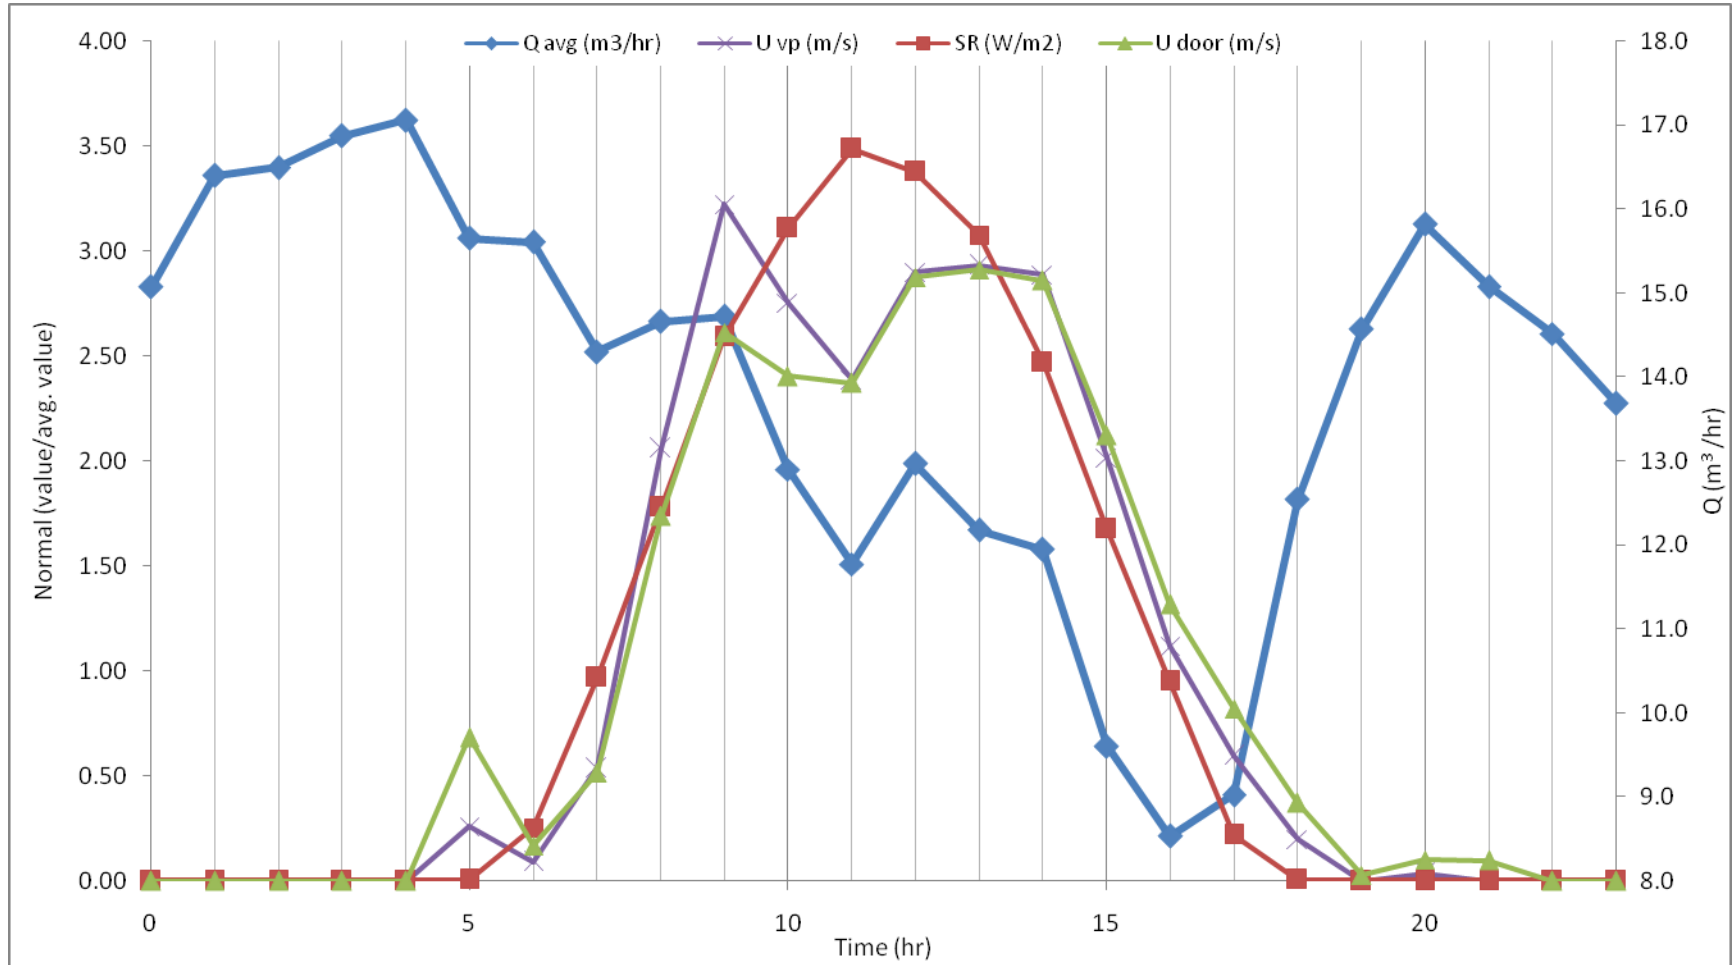
Figure 25: Averaged values for flow rate (Q_{avg}), and averaged normalized values for Vent Pipe (U_{vp}) Wind Speed, Solar Radiation (SR), and Door Wind Speed (U_{door})

When focus is returned back to when values for U_{VP} , U_{Door} and SR are at their highest, a similar signal pattern was identified between wind speed and Q_{ave} . This indicated that a relationship between the two variables did exist throughout much of the midday. By isolating data throughout the midday, and through trial and error, the strongest correlations between the three factors and Q_{avg} was determined to exist from 9:00 till 17:00 hours. Table 14 shows the correlation coefficients for each of the three variables, and how at different, but closely related time steps, stronger R values were not found. Of the three factors, the strongest correlated variable was found to be wind speed passing over the mouth of the vent pipe.

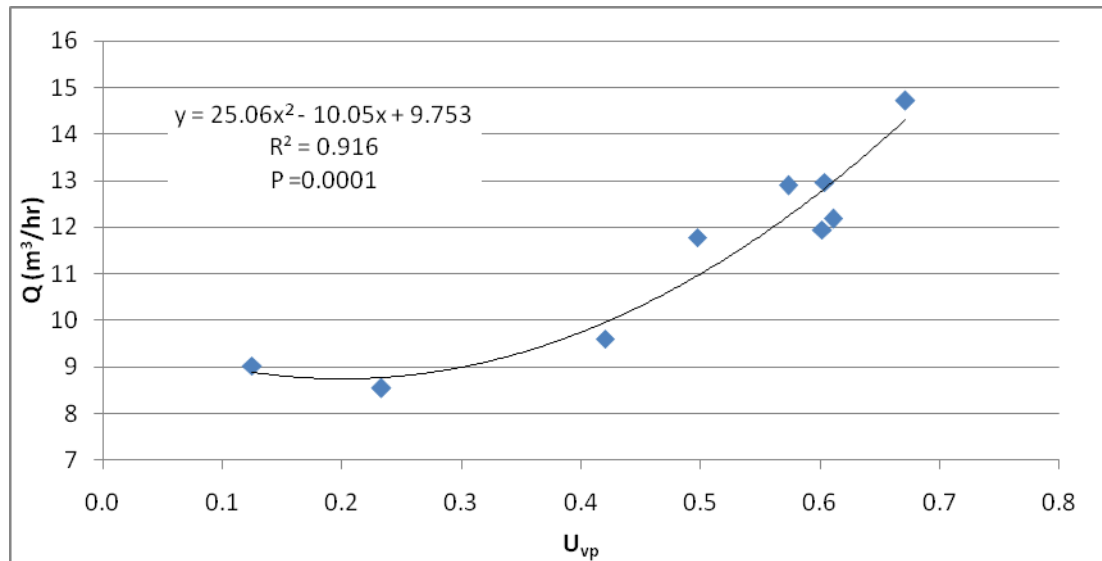
Figure 26: Wind speed at the height of the vent pipe (U_{vp}) vs. the average flow rate, Q_{avg} (9:00-17:00hrs).

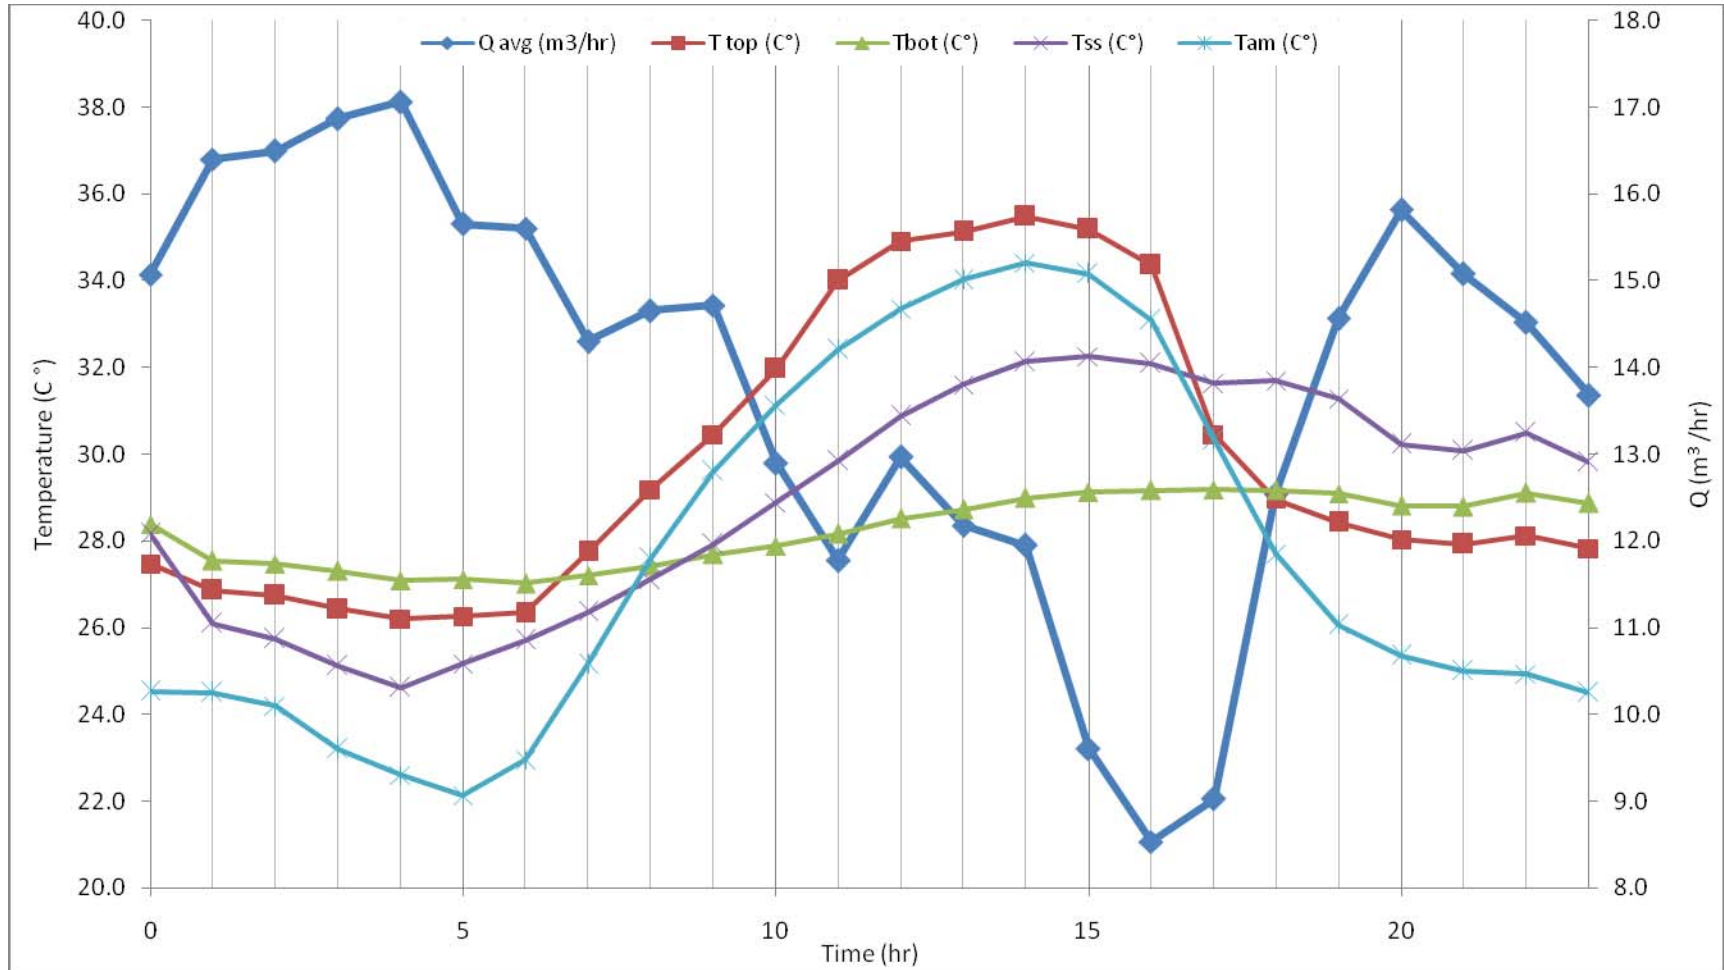
Figure 27: Averaged values for flow rate (Q_{avg}), the ambient temperature (T_{am}), and temperatures at the top of the vent pipe (T_{top}), bottom of the vent pipe (T_{bot}), inside the superstructure (T_{ss}), over time.

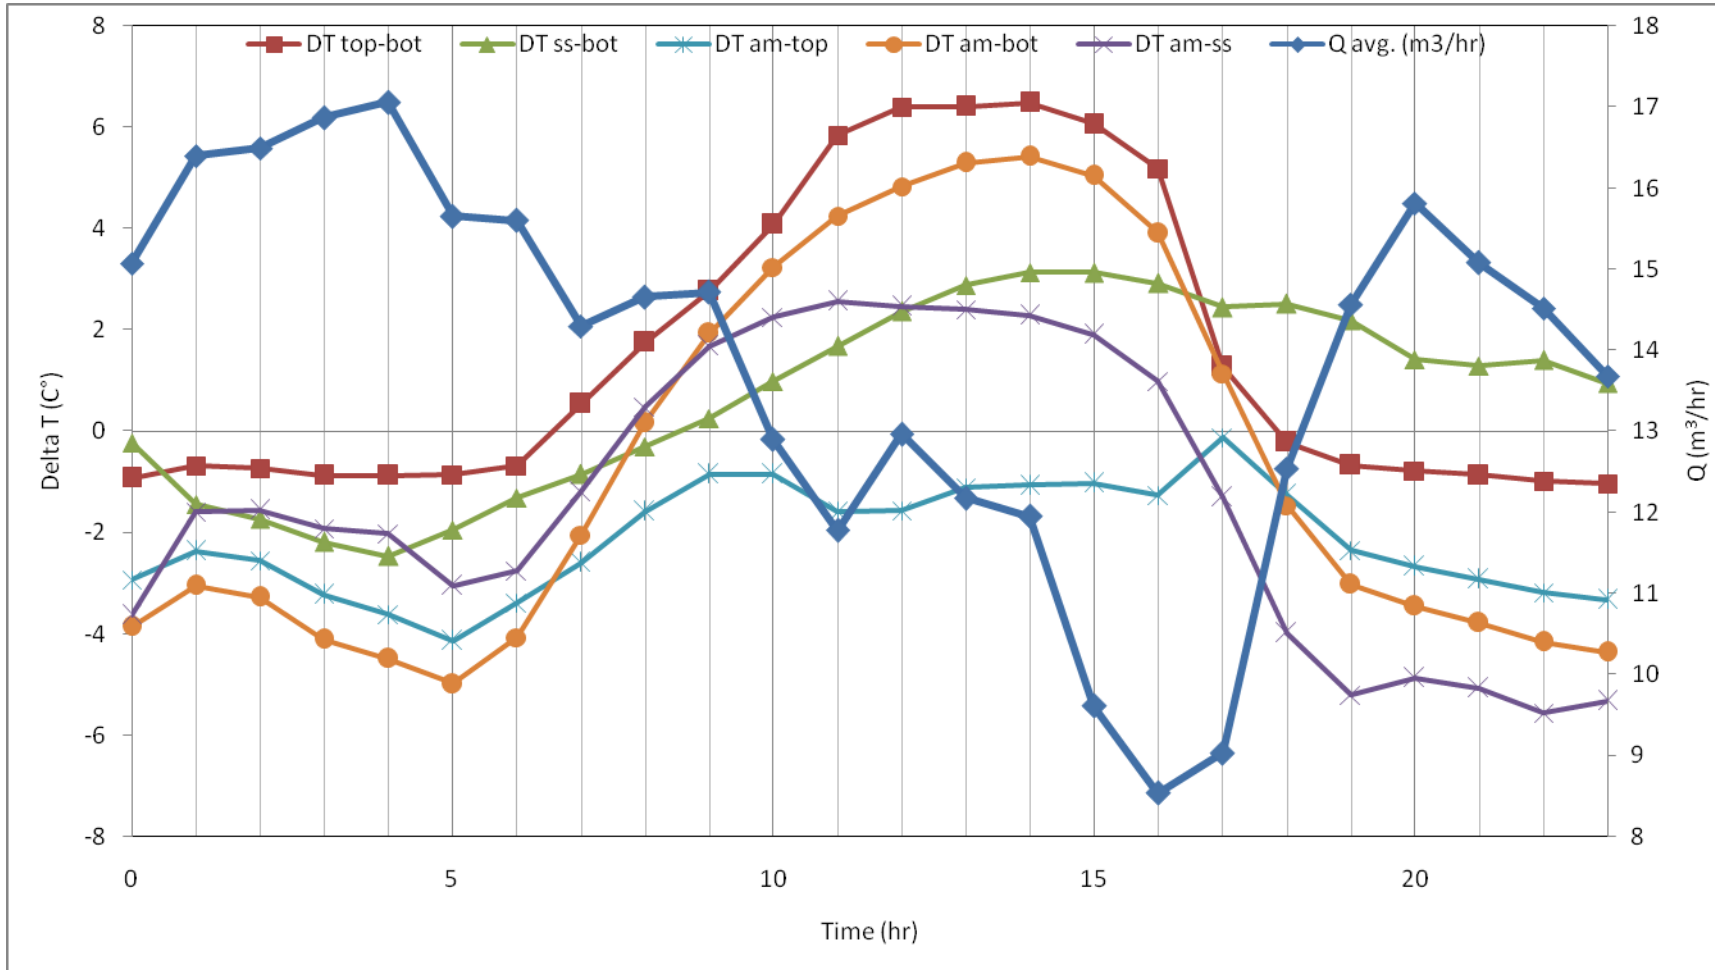
Figure 28: Averaged values for flow rate (Q_{avg}), $\Delta T_{top-bot}$, ΔT_{ss-bot} , ΔT_{am-top} , ΔT_{am-bot} , ΔT_{am-ss} , over time.

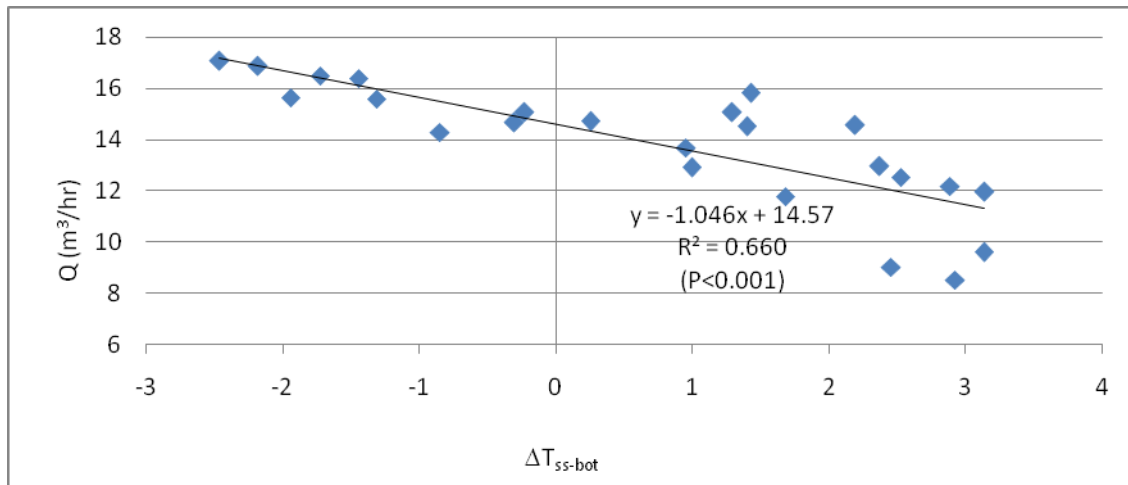
Figure 29: Average flow rate (Q_{avg}) vs. ΔT superstructure – bottom of the vent pipe/pit

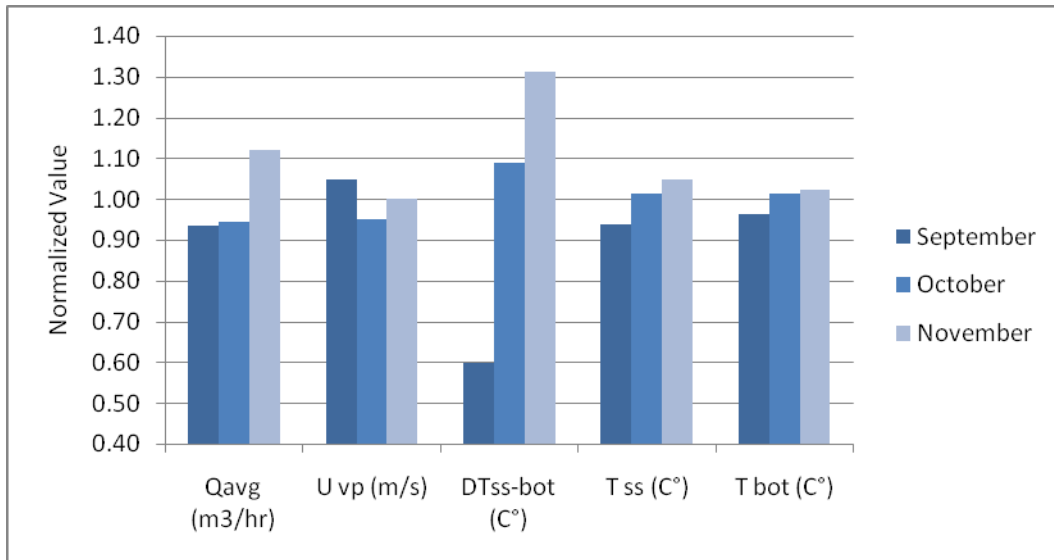
Figure 30: Monthly variation among average values for flow rate, wind speed and temperatures.
