Performance Evaluation of VIP Latrines in the Upper West Region of Ghana

A REPORT

Submitted in partial fulfillment of the requirements for the degree of
MASTER OF SCIENCE IN ENVIRONMENTAL ENGINEERING

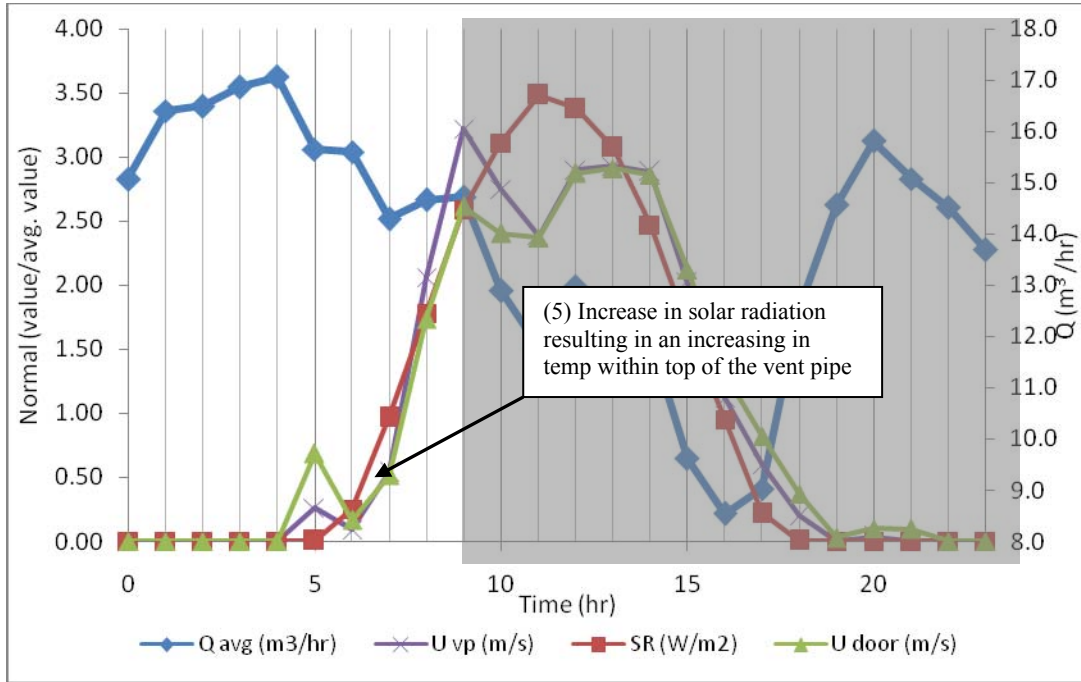
Figure 33: Averaged values for flow rate (Q_{avg}), and averaged normalized values for Vent Pipe (U_{vp}) Wind Speed, Solar Radiation (SR), and Door Wind Speed (U_{door}) over time 0:00-8:00.

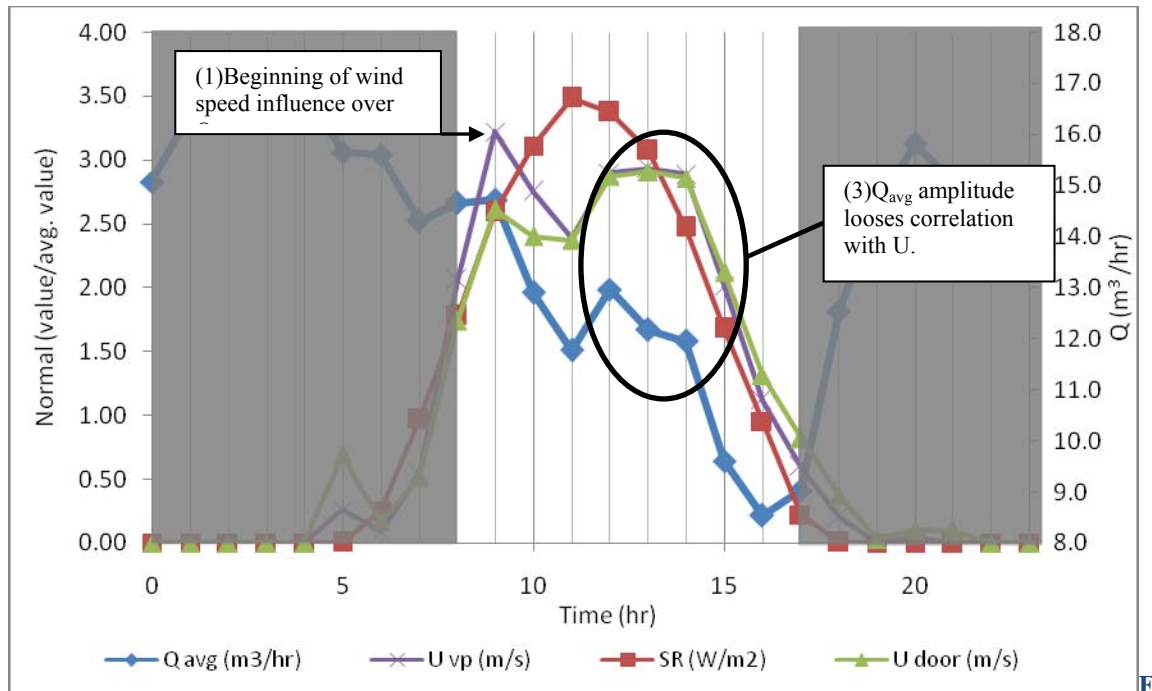
Figure 34: Averaged values for flow rate (Q_{avg}), and averaged normalized values for Vent Pipe (U_{vp}) Wind Speed, Solar Radiation (SR), and Door Wind Speed (U_{door}) over time 8:00-17:00.

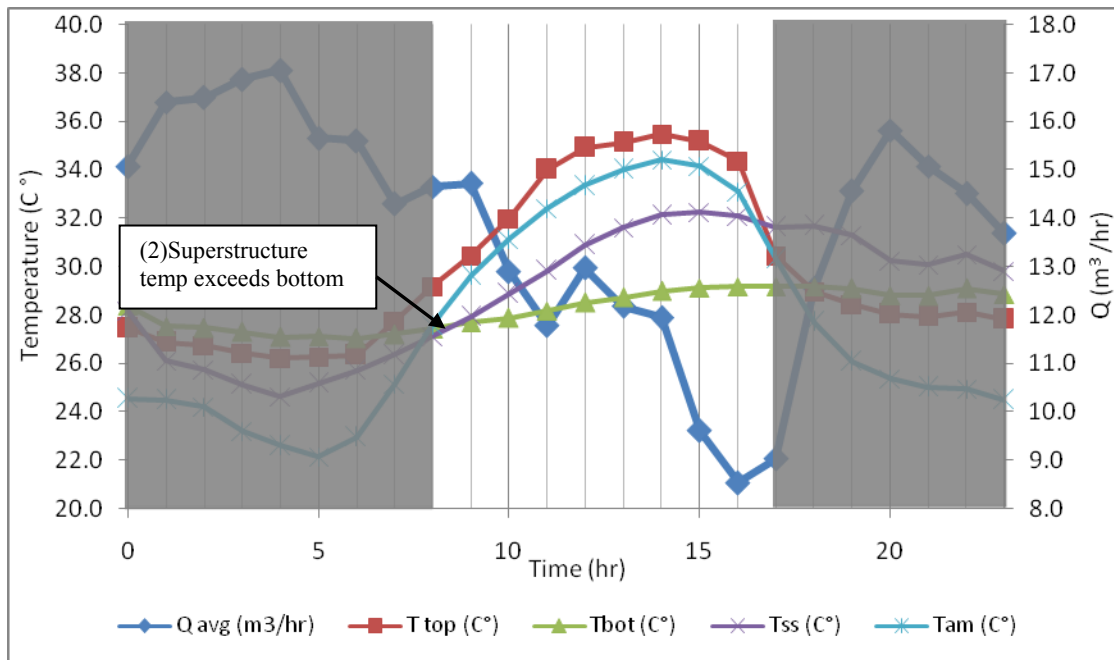
Figure 35: Averaged values for flow rate (Q_{avg}), the ambient temperature (T_{am}), and temperatures at the top of the vent pipe (T_{top}), bottom of the vent pipe (T_{bot}), inside the superstructure (T_{ss}) over time 8:00-17:00.

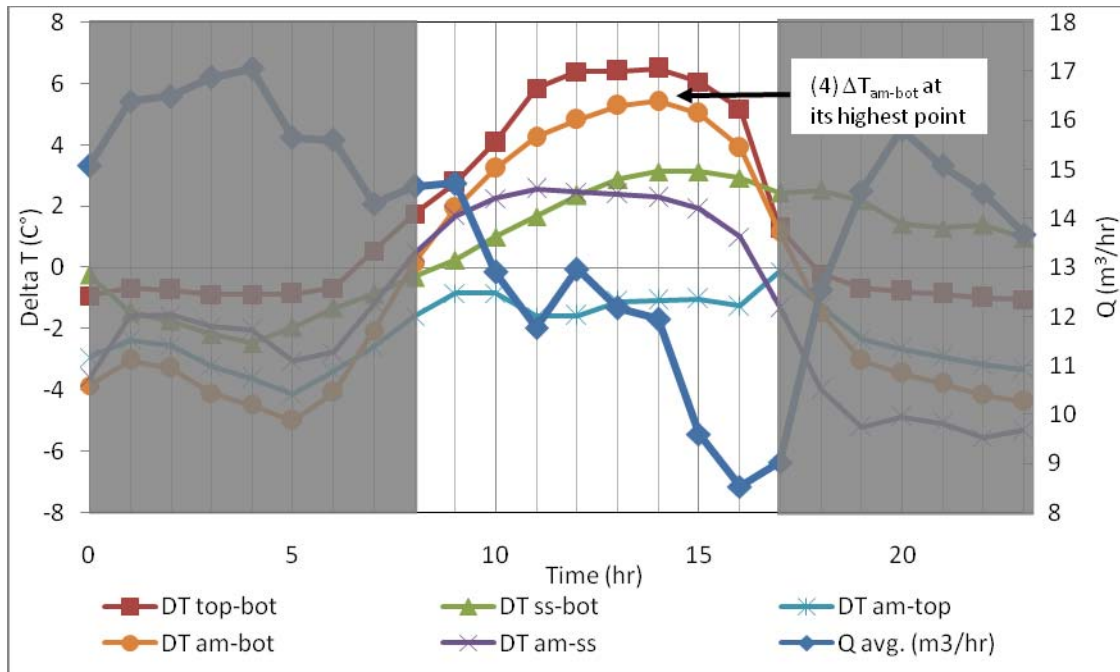
Figure 36: Averaged values for flow rate (Q_{avg}), $\Delta T_{top-bot}$, ΔT_{ss-bot} , ΔT_{am-top} , ΔT_{am-bot} , ΔT_{am-ss} , over time 8:00-17:00.

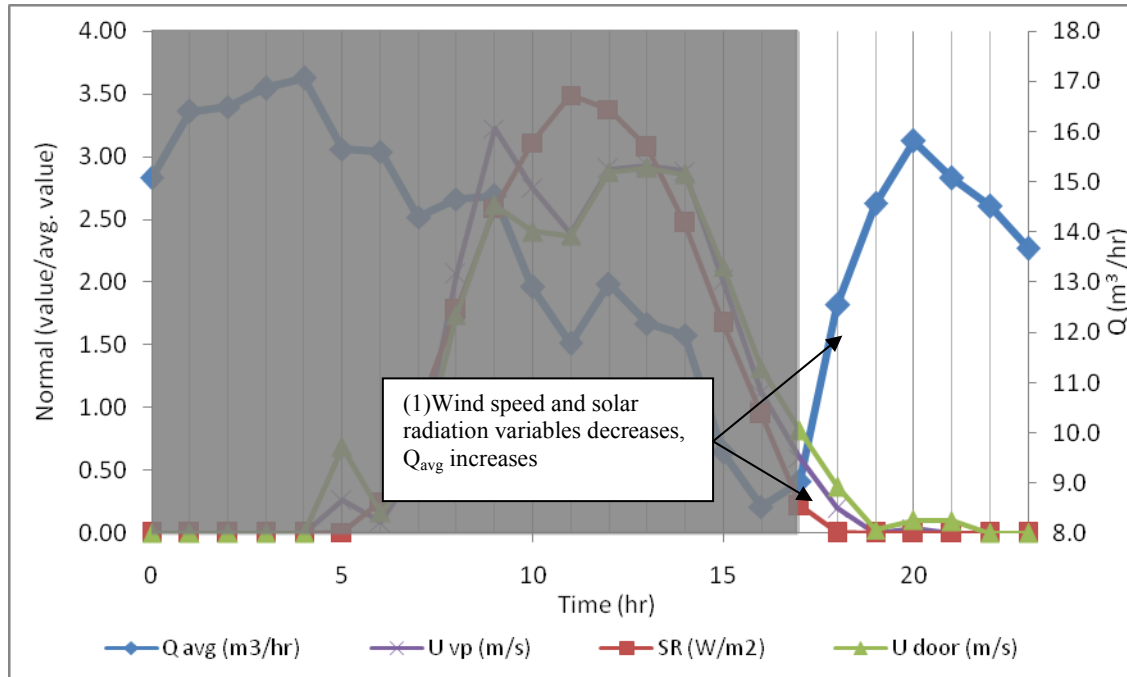
Figure 37: Averaged values for flow rate (Q_{avg}), and averaged normalized values for Vent Pipe (U_{vp}) Wind Speed, Solar Radiation (SR), and Door Wind Speed (U_{door}) over time 17:00-23:00.

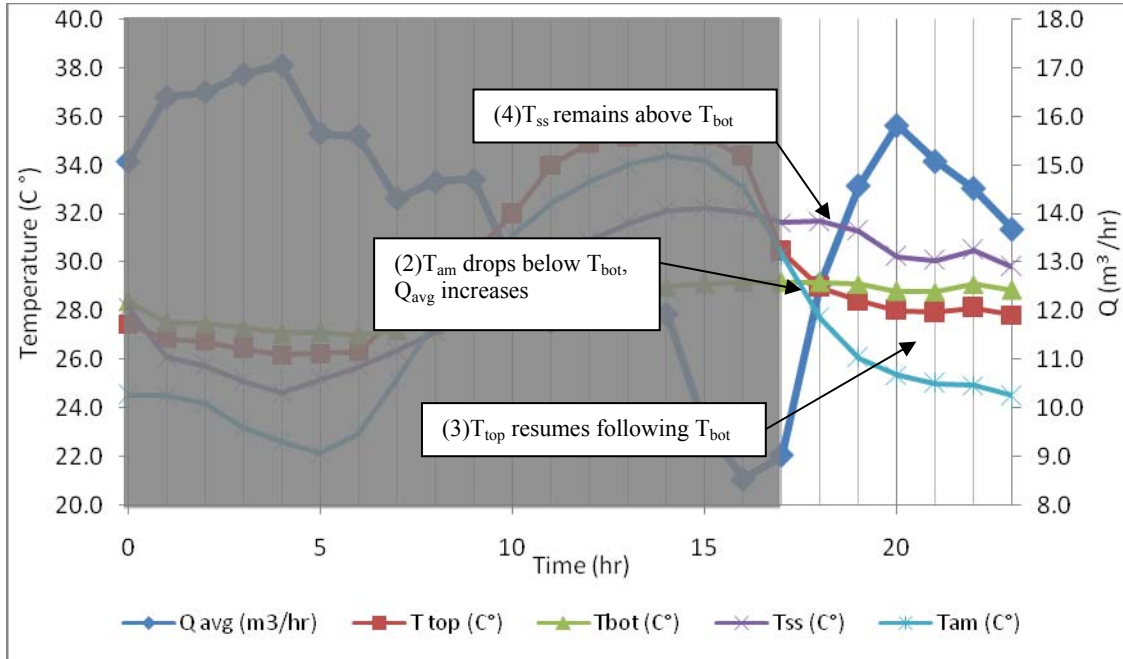
Figure 38: Averaged values for flow rate (Q_{avg}), the ambient temperature (T_{am}), and temperatures at the top of the vent pipe (T_{top}), bottom of the vent pipe (T_{bot}), inside the superstructure (T_{ss}) over time 17:00-23:00.

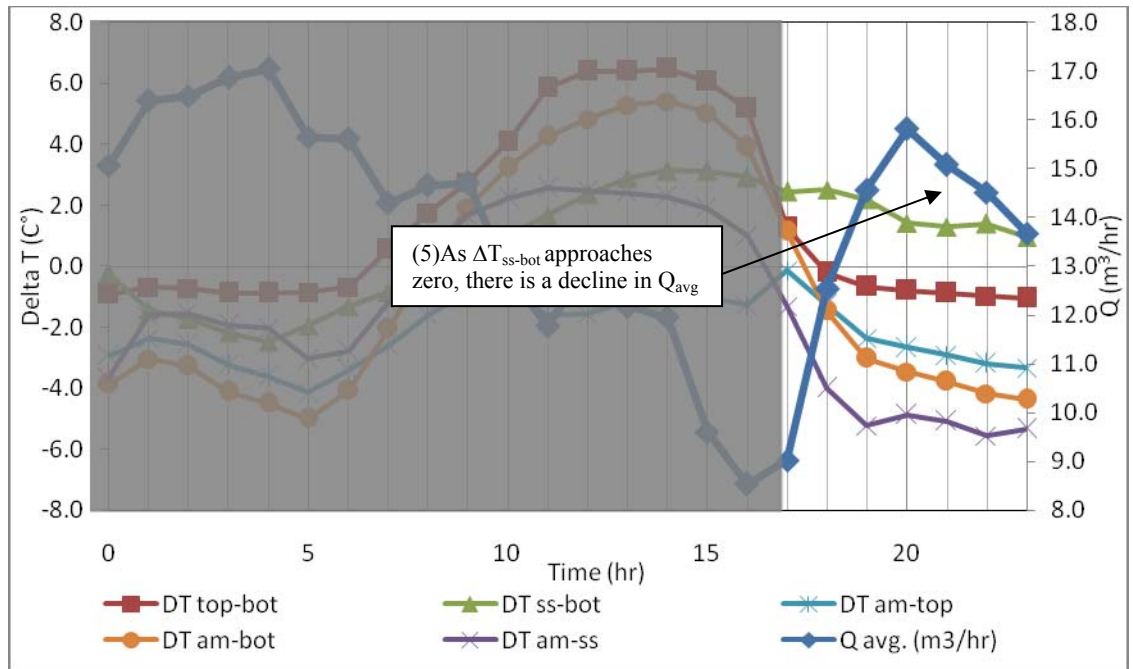
Figure 39: Averaged values for flow rate (Q_{avg}), $\Delta T_{top-bot}$, ΔT_{ss-bot} , ΔT_{am-top} , ΔT_{am-bot} , ΔT_{am-ss} , over time 8:00-17:00.

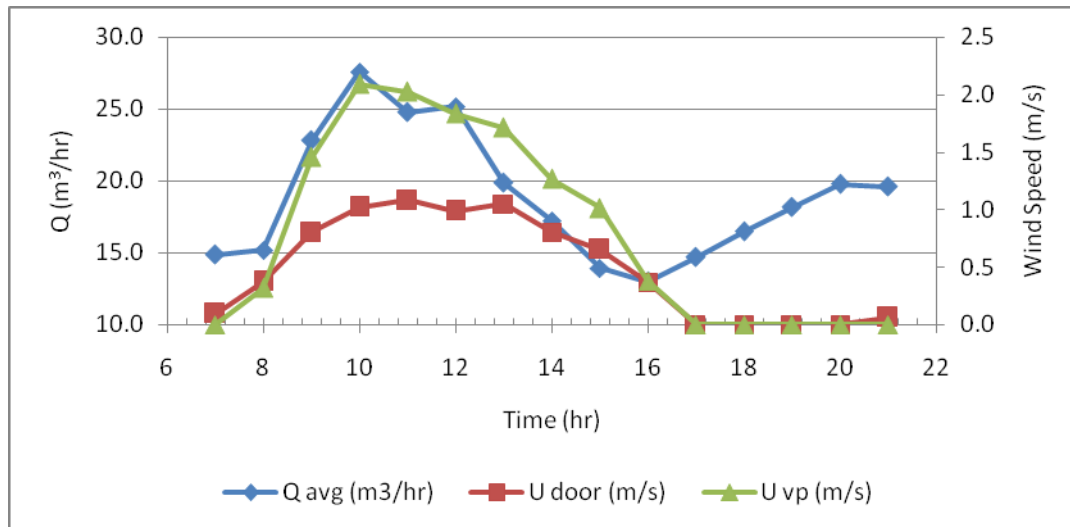
Figure 40: K50, Q vs. Wind Variables

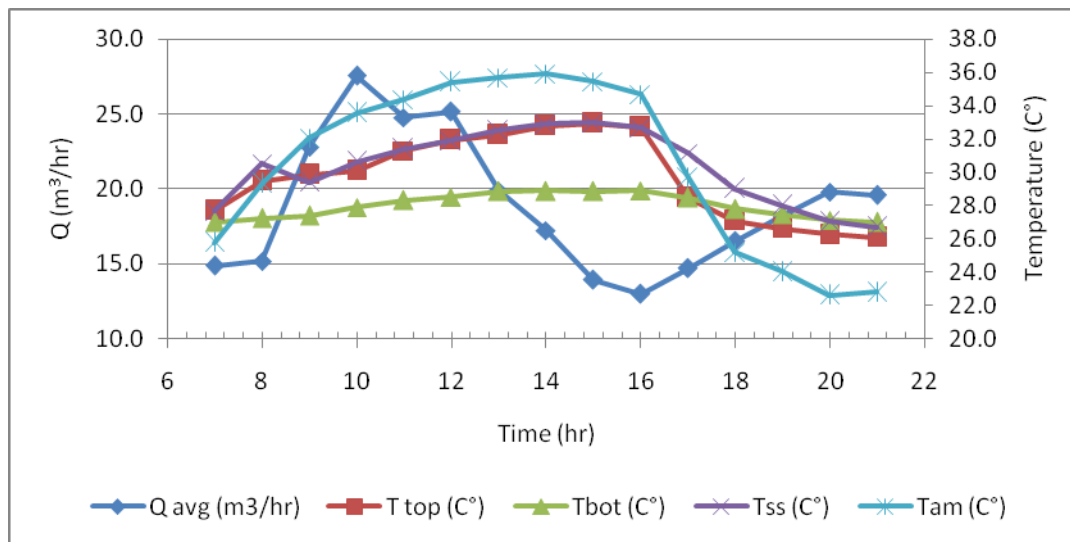
Figure 41: K50, Q vs. Temperature Variables

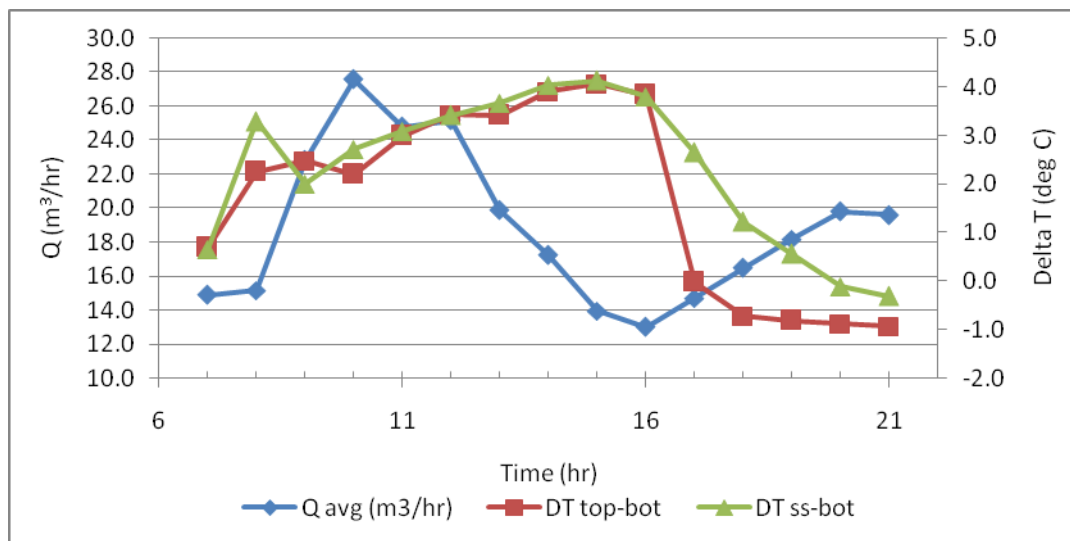
Figure 42: K50, Q vs. Delta T variables

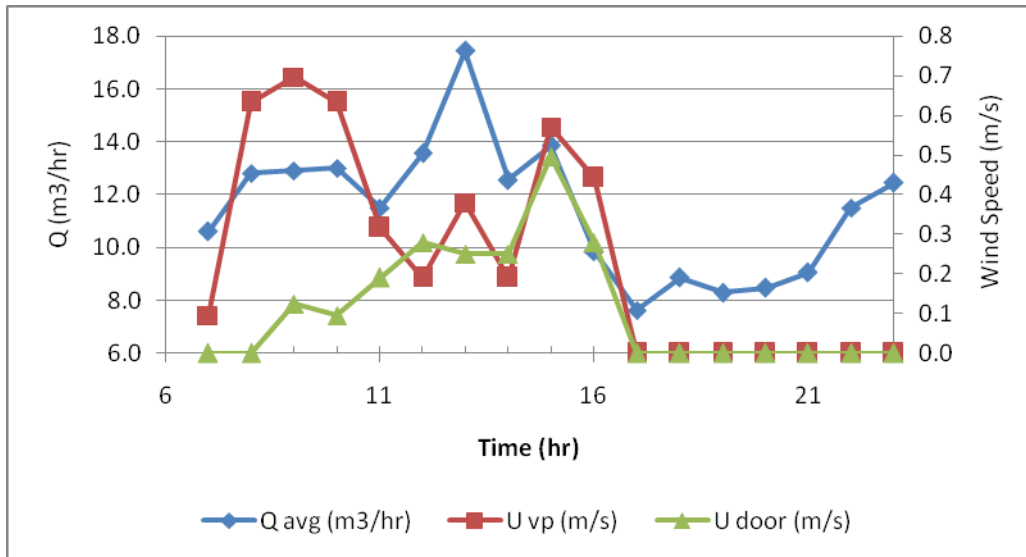
Figure 43: K16 – Q vs. Wind Speed Variables

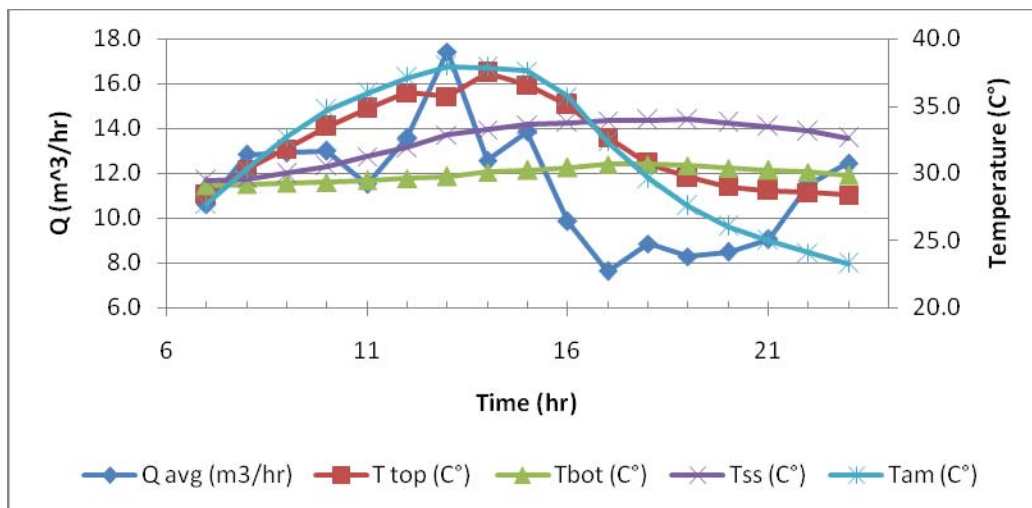
Figure 44: K-16, Q vs. Temperature Variables

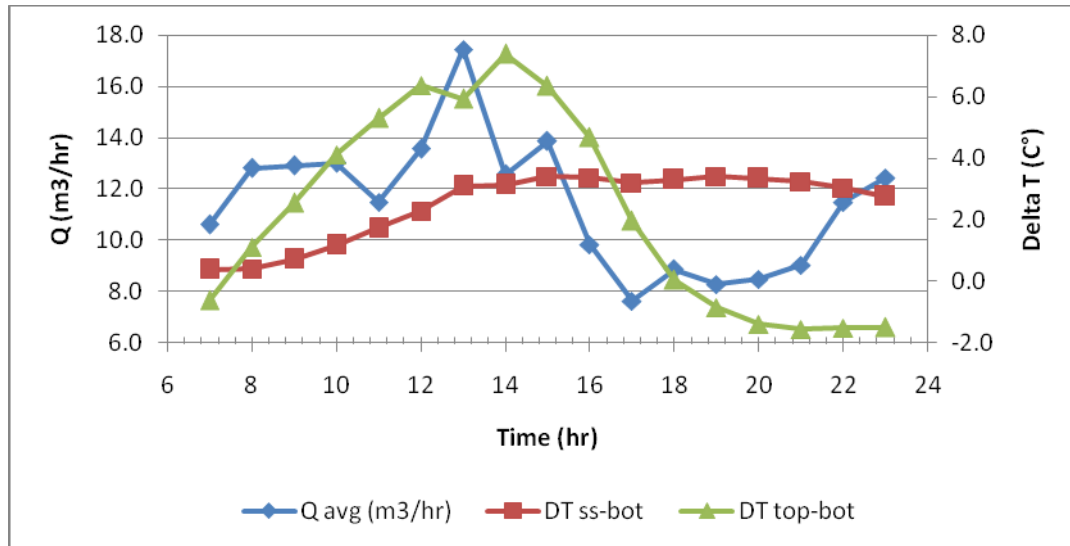
Figure 45: K-16, Q vs. Delta T variables

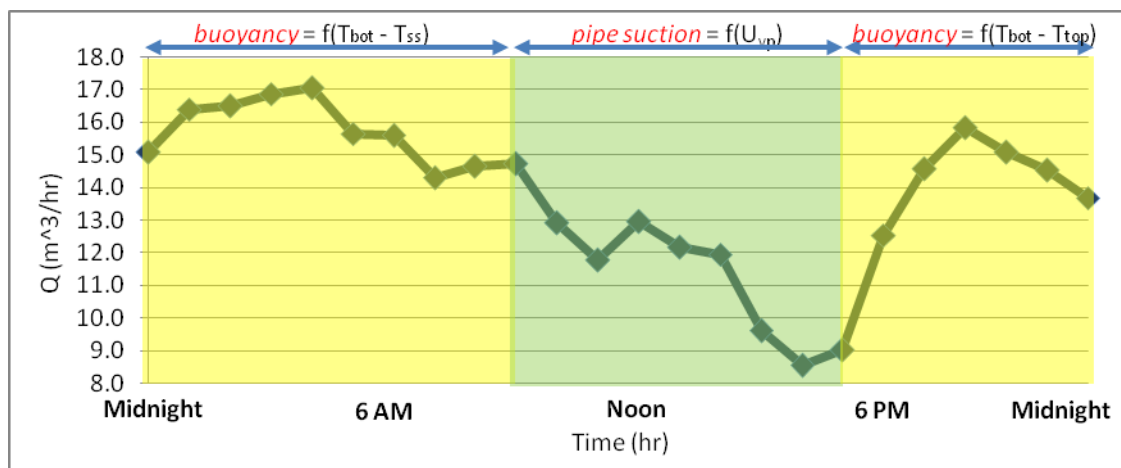
Figure 46: Cumulative average flow rate highlighted by the key driving mechanisms over the relative time in which they occur.

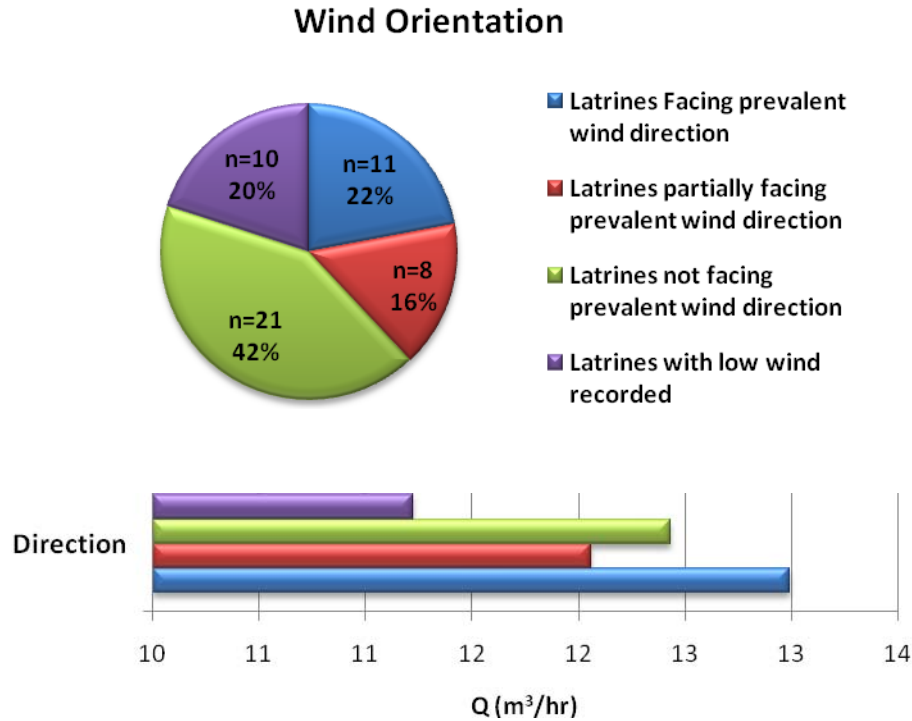
Figure 47: Latrine/Wind Orientation and its effects on flow rate

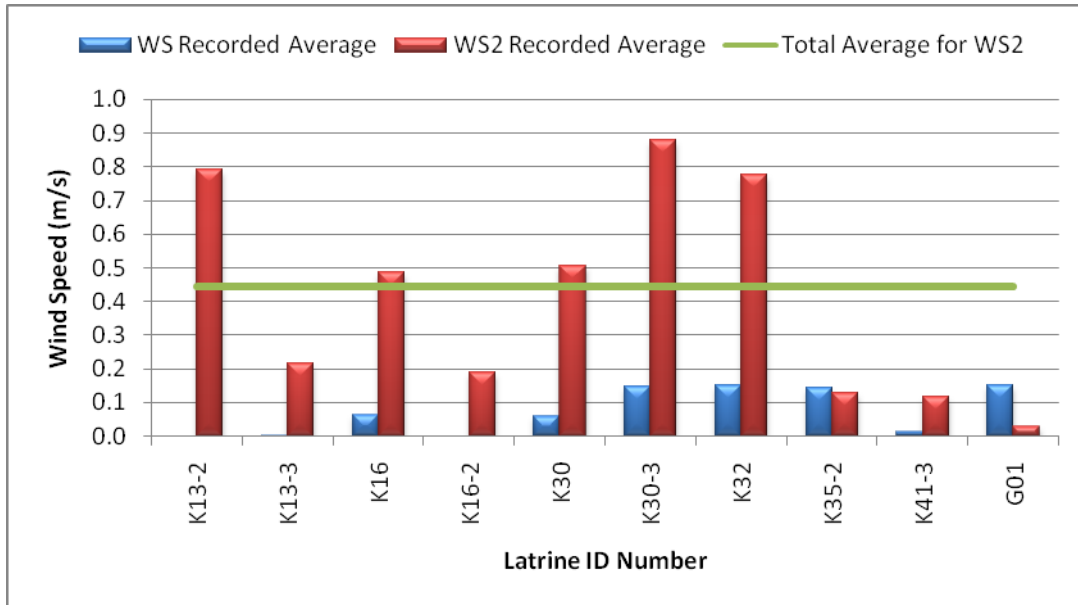
Figure 48: Setups with ‘low wind’ recorded by anemometer WS compared to the average wind speed recorded by WS2

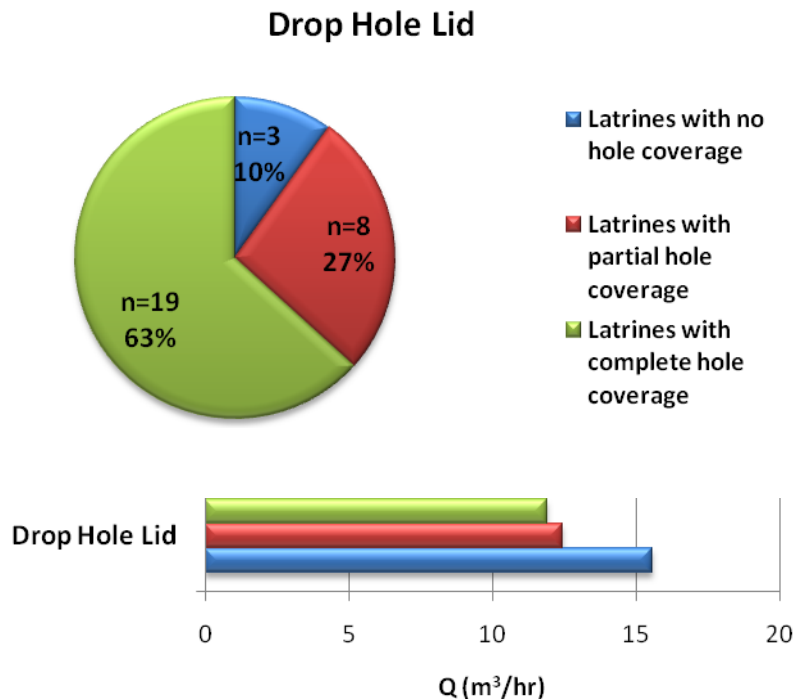
Figure 49: Proportion of sample with no, partial and full lid over the drop hole and the respective effect on flow rate.

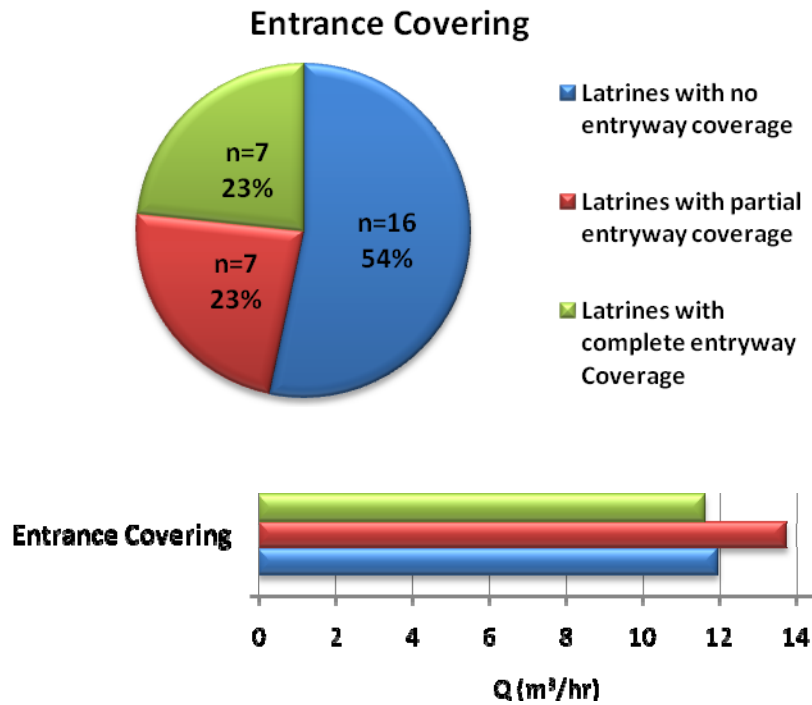
Figure 50: Proportion of sample with no, partial and full entrance covering and the respective effect on flow rate.

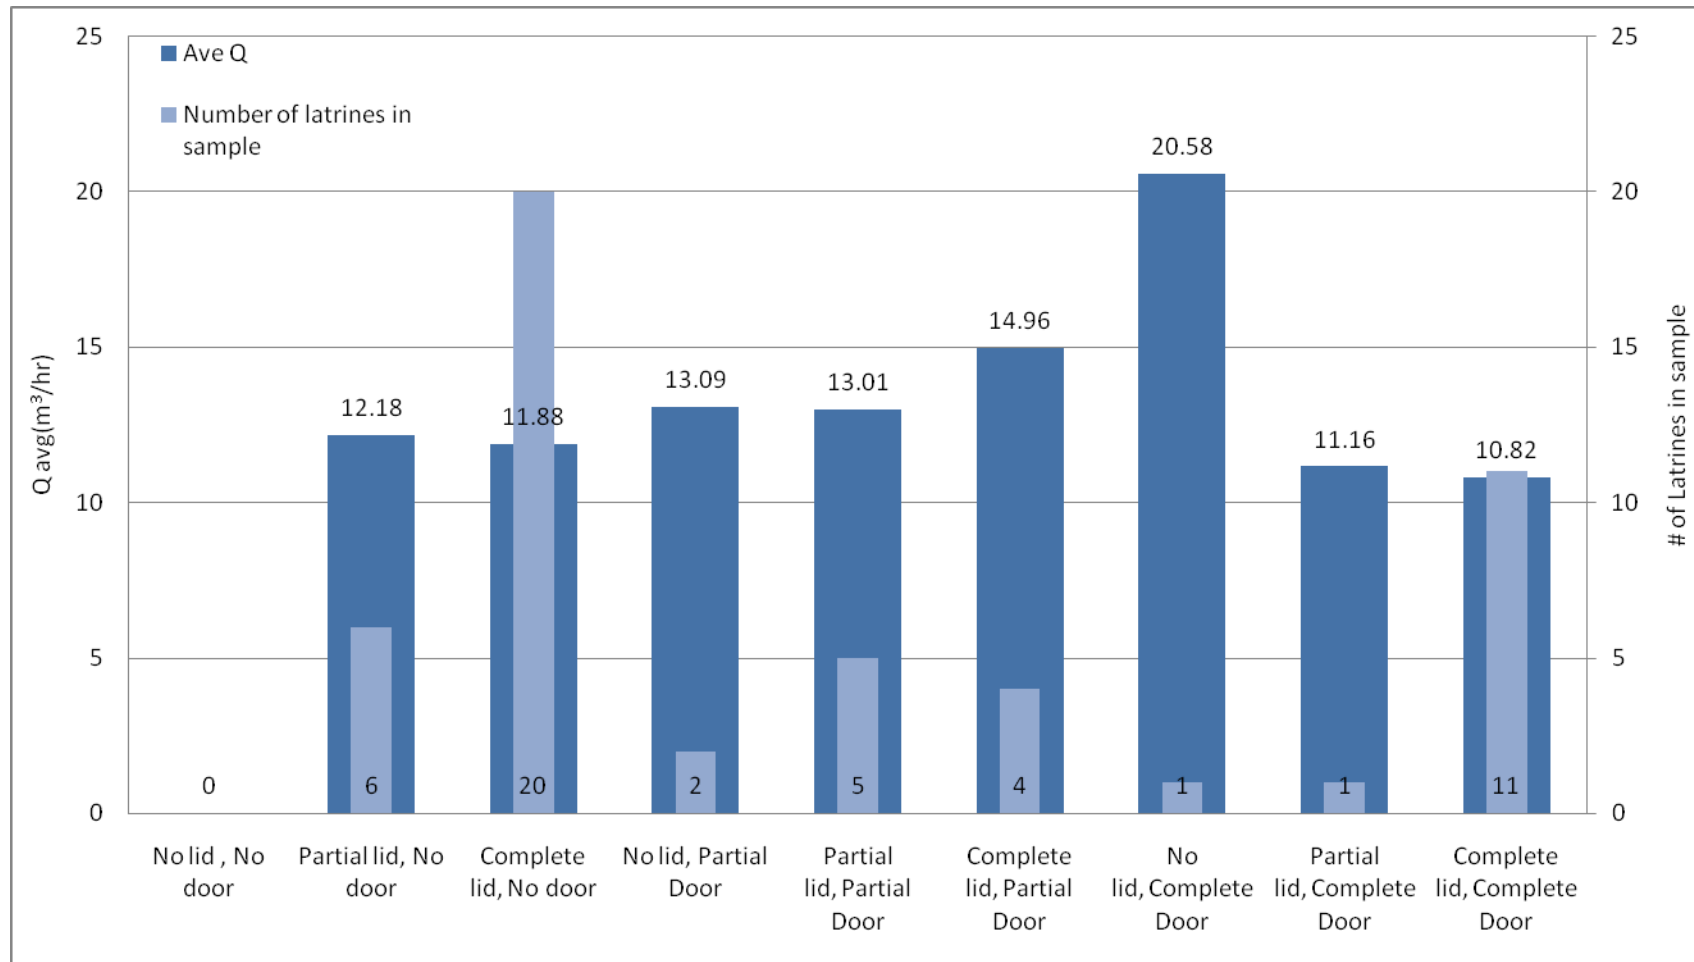
Figure 51: Combined average flow rate for latrines categorized by the presence of a door over the entrance way and or a lid over the drop hole.

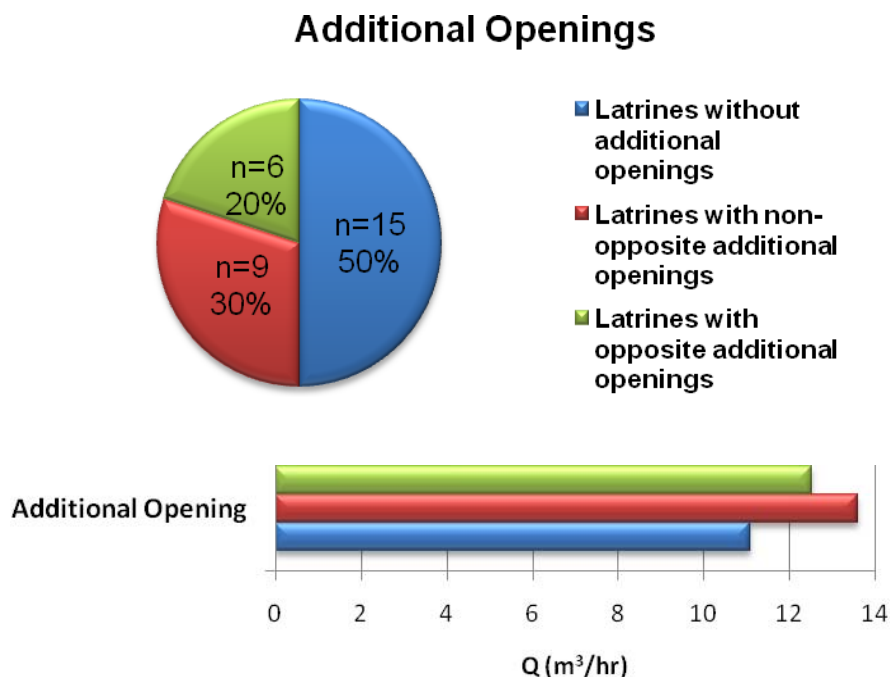
Figure 52: Combined average flow rate for latrines categorized by presence of an additional opening in the superstructure

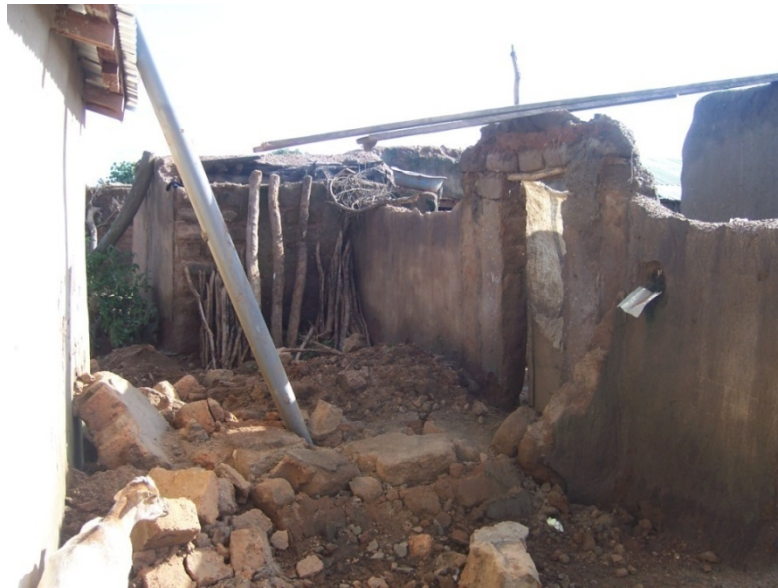
Figure 53: A collapsed superstructure, in this case the vent pipe remained intact. Photo by Author

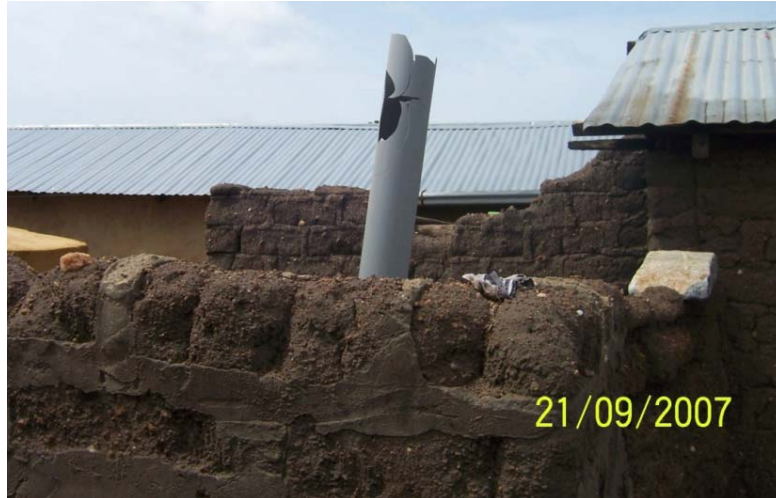
Figure 54: A broken PVC vent pipe, cause unknown. Photo by Author

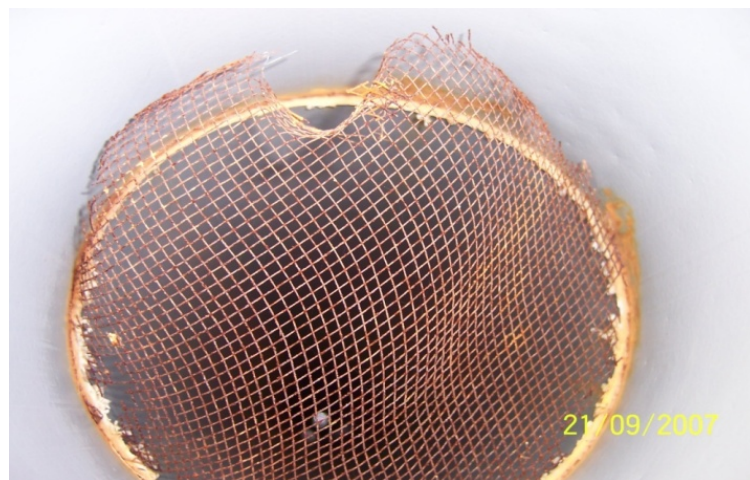
Figure 55: Looking down into the top of a vent pipe, with a fly screen that has almost completely rusted away. Photo by Author

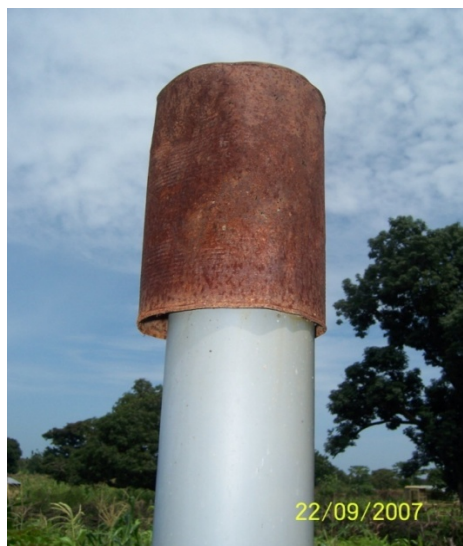
Figure 56: A capped vent pipe. Photo by Author
