Post-project assessment and follow-up support for community managed rural water systems in Panama

POST-PROJECT ASSESSMENT AND FOLLOW-UP SUPPORT FOR COMMUNITY MANAGED
RURAL WATER SYSTEMS IN PANAMA

A REPORT

ENVIRONMENTAL ENGINEERING

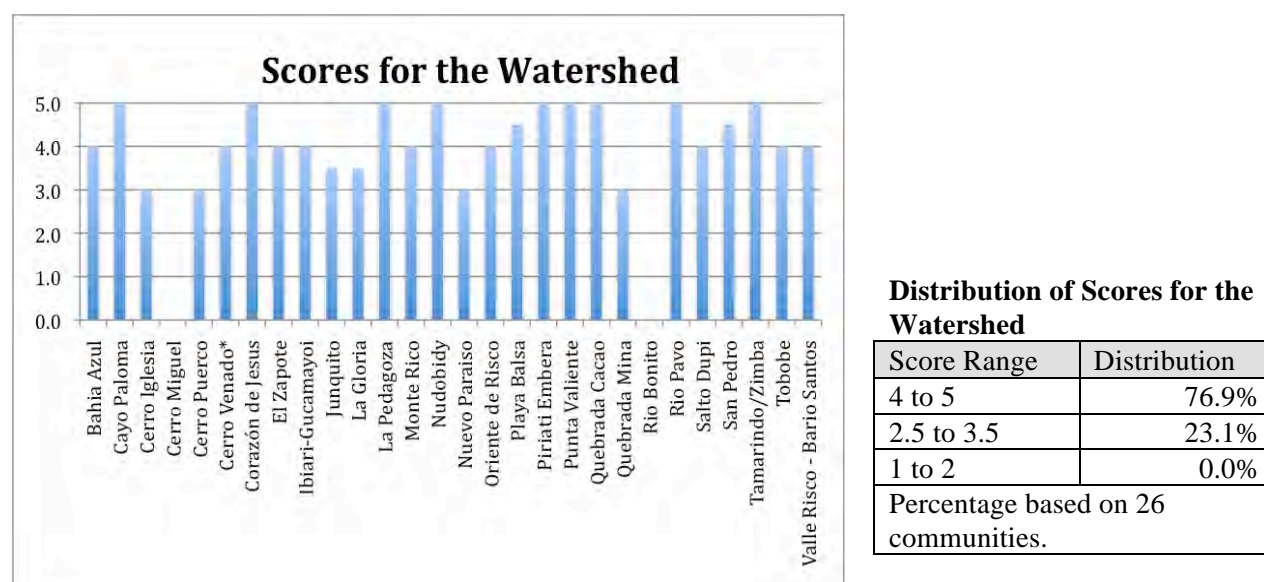
Figure 3. Results for the watershed indicator.

The scores for watersheds were determined based on the tree coverage around the source, presence of contaminants or their sources, such as latrines, agrochemicals, and domestic animals, and existence of a written contract with the owner. Although a high score does not necessarily mean that source provides acceptable quality and quantity of water, it serves as an indicator to the community initiative to protect their source.

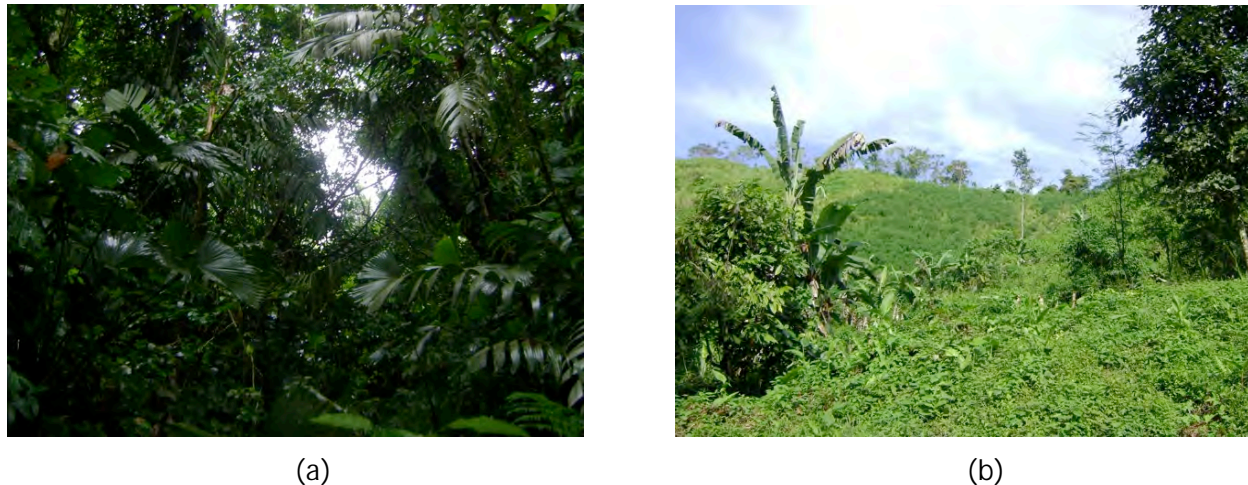
The MINSA regulation states that there must be a written contract with the owner before starting any water supply projects, but only nine out of 28 communities possessed such documents. Some communities with low scores expressed interest in receiving additional help in the negotiation process with the landowner. Figures 4(a) and (b) demonstrate examples of well-protected and degraded watersheds, respectively.

Figure 4. Photos of the watershed. (a) - Example of a well-protected watershed taken in Bahia Azul, Comarca Ngäbe-Buglé (CNB) Ñukribo. (b) – Land surrounding the source has been cleared off for agriculture use in Cerro Puerco, CNB Kadri region.

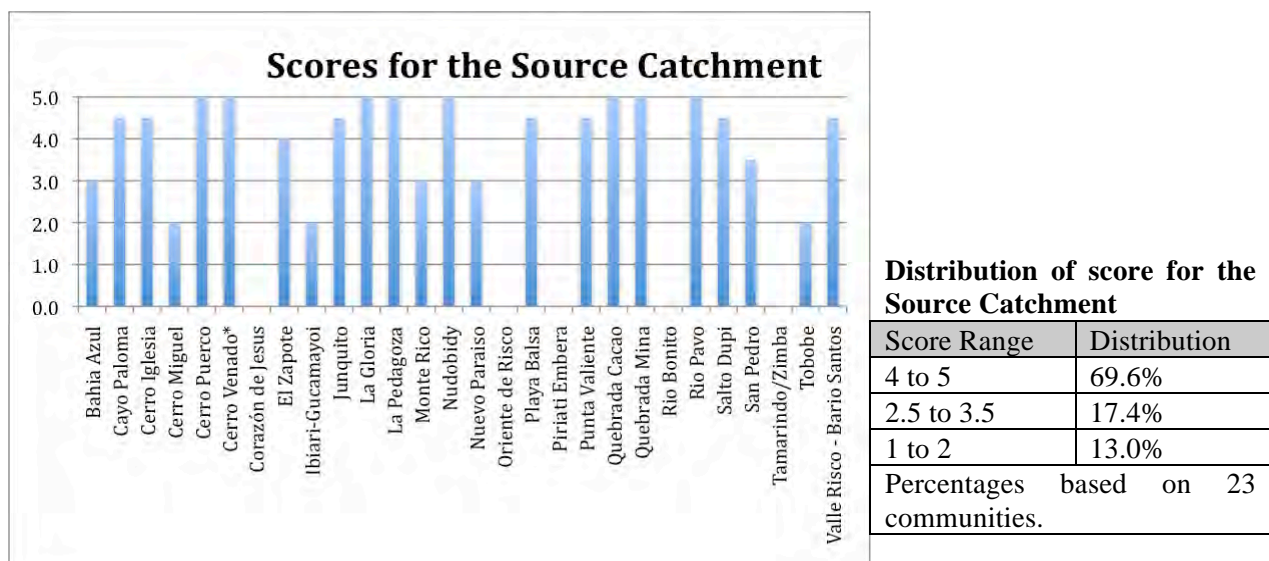
Figure 5. Results from the source catchment indicator.

The source capture or spring box was evaluated based on how well the spring source was protected from the surface water runoff and its effectiveness in capturing the water necessary to

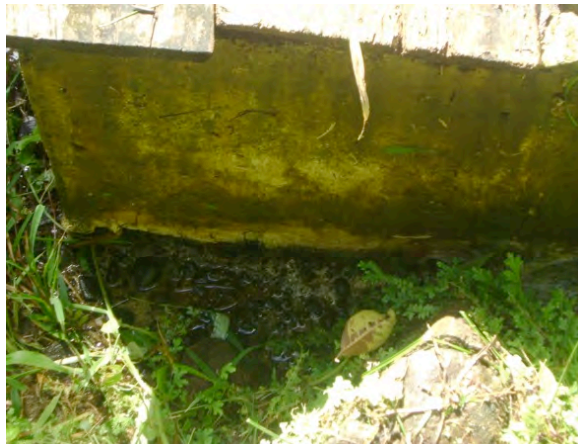
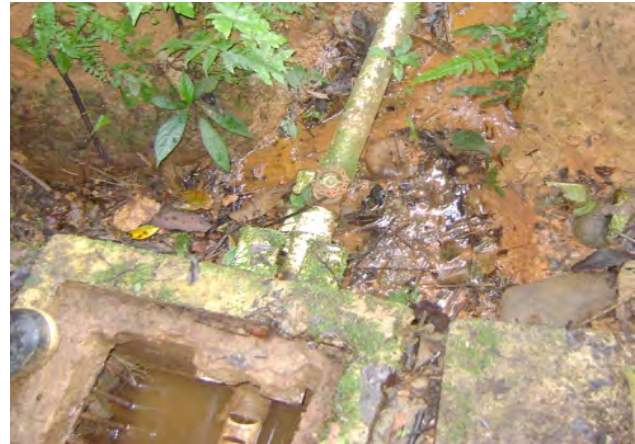
meet the community demand. The communities without ideal source catchment such as Tobobe and Ibiari-Gucamayo, had problems with the water carving out a new path and leaking from the bottom of the spring box as demonstrated in Figures 6(a) and (b). In these cases, the water committee members usually expressed that they do not have the technical skills to repair the leaks on their own and would like to receive additional assistance from the Peace Corps. Others also solicited training to build a spring box so that masons in their communities can repair or build new ones on their own.

Figure 6. Spring boxes with major water loss. (a) – Photo taken in Tobobe, CNB Ñukribo. (b) – Photo taken in Oriente de Risco, Bocas del Toro.

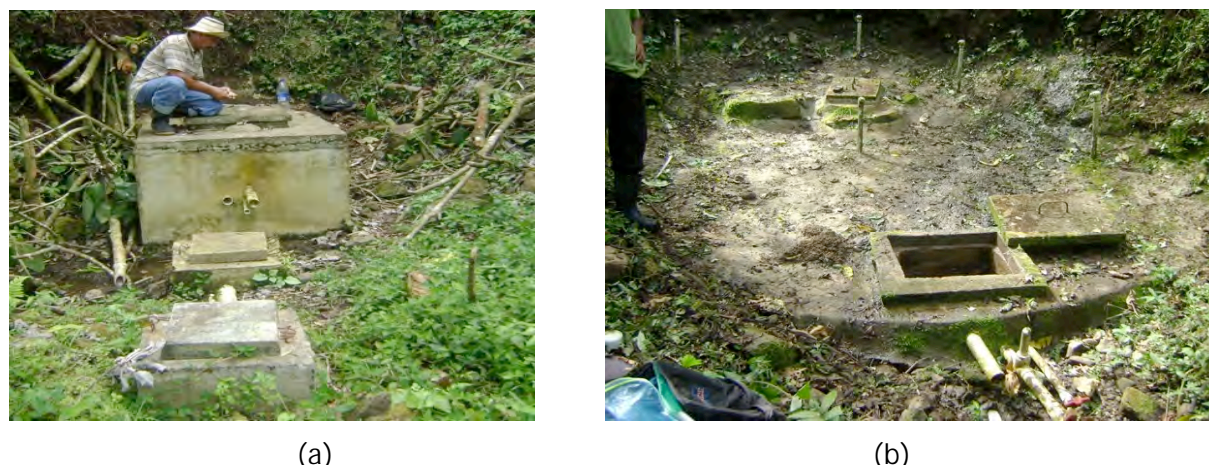
In general, there were two types of spring box design. The first type resembles a typical spring box design with a larger collection box as shown in Figure 7 (a). The second type is an original design invented by a mason Nicolas Arcia who has worked closely with Waterlines for many years. As shown in Figure 7 (b), the outlet and overflow pipes are installed as low as possible. Nicolas believes that when water accumulates within the catchment area, it will attempt to find a path of least resistance by carving out a new path below the current catchment area. This design is also more effective in protecting and capturing water from the sources with larger catchment area. Although most spring boxes built by Nicolas were less than five years old, none of them had a problem with water leaking from the bottom.

Figure 7 Two types of spring boxes. (a) – Traditional design with a taller collection box (photo taken in San Pedro, Cocle). (b) – Nicolas Arcia's original design with much lower placement of outlet and overflow pipes. (Photo taken in Quebrada Cacao, Bocas del Toro).

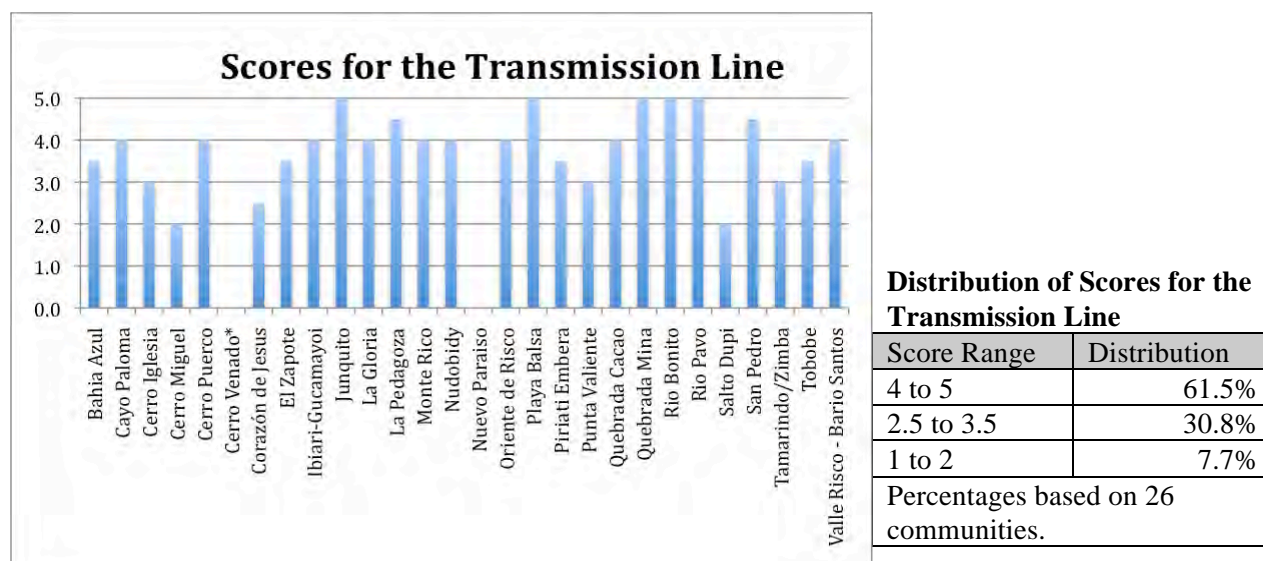
Figure 8. Results for the transmission line.

The transmission line was evaluated based on the tube exposure, leakage, damage, and proper installment of key components such as air releases valves, bridge-crossings, and break-pressure tanks. The scores recorded in Figure 8 do not necessarily reflect the construction quality or community capacity or will to replace damages in the line. In some communities such as Playa

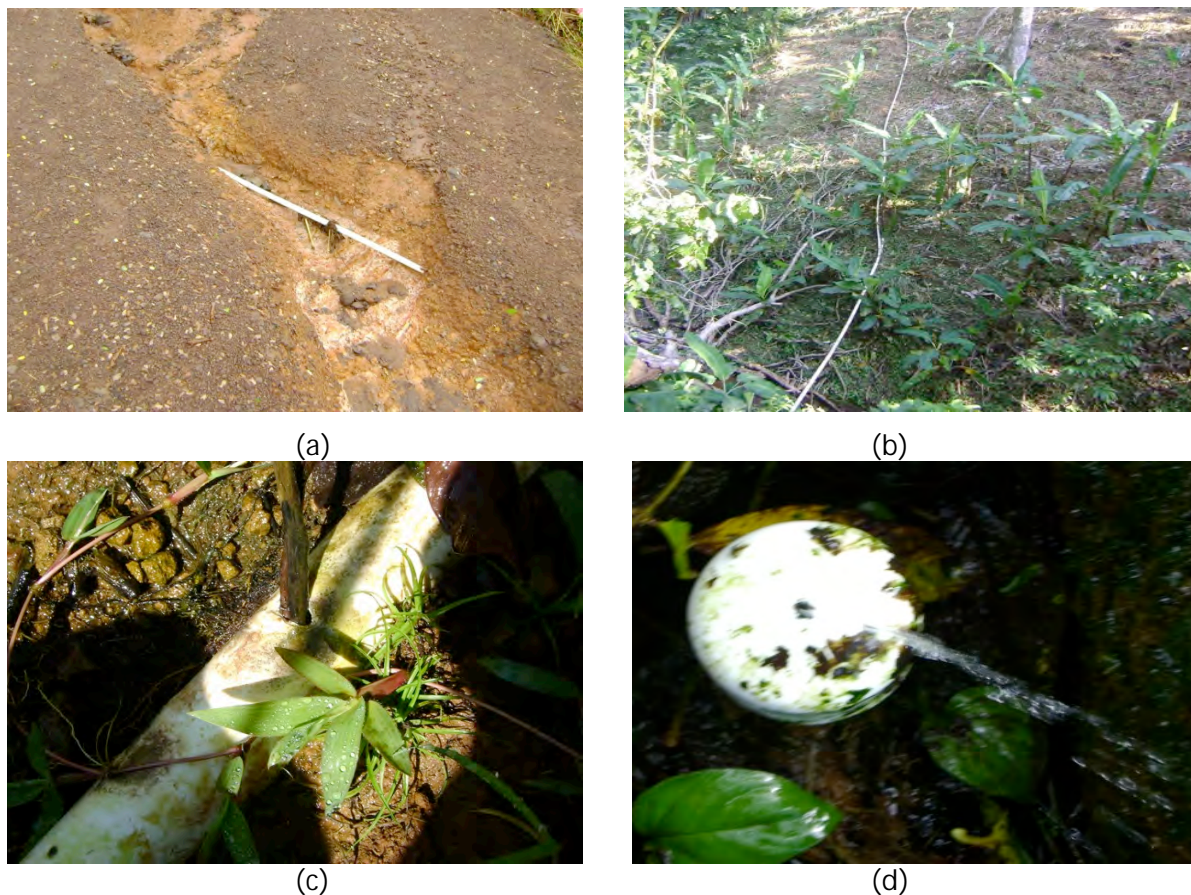
Depending on the terrain, it may only take a few years for erosion to expose buried tubes as shown in Figure 9 (a). In other cases, the tubes were never buried because the line crossed a terrain with many roots and rocks or there was a lack of oversight during the construction phase (Figure 9 (b)). The air release valves are fairly expensive and hard to find in Panama, and therefore, many communities are forced to puncture a hole through the tube to release the air for air blockage. A piece of wooden stick is often used to cover the holes as shown in Figure 9 (c), but the water still leaks out and the stick decomposes quickly. Seeking to find a better solution for the air blockage, a volunteer designed an air release valve that can be fabricated with readily available and less expensive materials. However, many of these valves were found to be leaking as shown in Figure 9 (d).

Figure 9. Common problems with the transmission line. (a) – Tube exposed by erosion in Cerro Puerco, CNB Kadri. (b) – Tubes that were never buried in Punta Valiente, CNB Ñukribo. (c) – Hole covered for air release covered with a piece of wooden stick in Salto Dupi, CNB Nedrini. (d) – Homemade air release valves that was found to be leaking in Cerro Puerco, CNB Kadri.

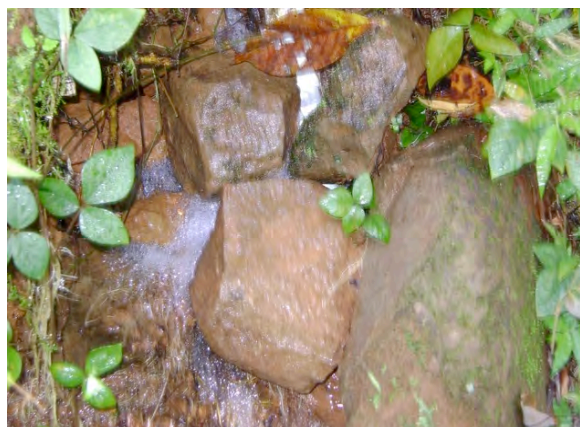
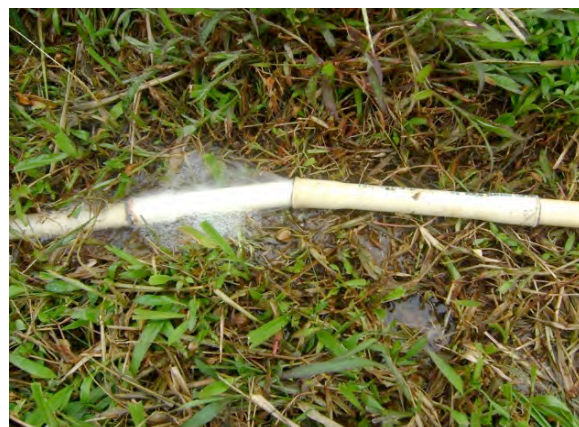
Another common problem with the transmission line is that the damages are repaired inadequately (Figure 10 (a)). Many plumbers prepare the female end of the PVC tube by heating it directly with fire. The joints made with this method are much weaker and generally do not make a tight seal (Figure 10 (b)). Additionally, some communities repair damages without using PVC glue or they do not know that once the can of PVC glue has been opened, the quality of glue starts to deteriorate. Finally, in many cases, the damages are much more difficult to detect and repair when the lines pass through terrain with thick vegetation.

Figure 10. Problems with poor repair job of transmission lines. (a) – Rocks used to weigh down poorly made joints in Salto Dupi, CNB Nedrini. (b) – Joints fabricated over direct fire and connected without any PVC glue in Playa Balsa, CNB Ñukribo.

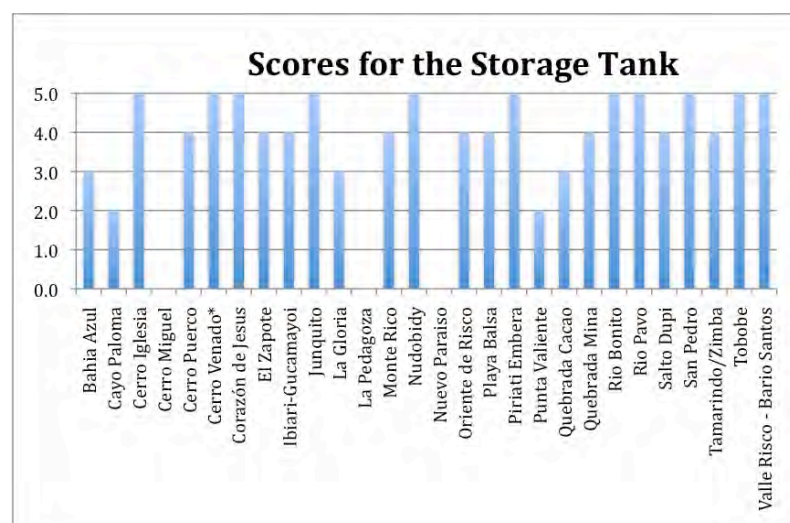
Distribution of Scores for the Storage Tank

Score Range	Distribution
4 to 5	80.0%
2.5 to 3.5	12.0%
1 to 2	8.0%
Percentages based on 25 communities.

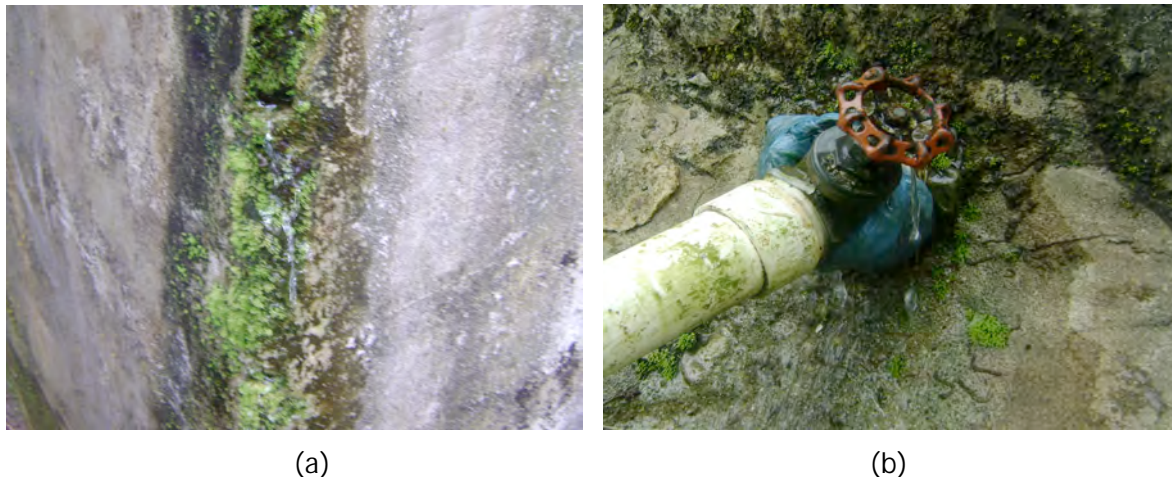
The most common problem observed for the storage tanks is leaks forming on the corners (Figure 12 (a)). The corners of square tanks are more susceptible to leaks since they are subject

to the highest hydraulic pressure. Although cylindrical-shaped tanks are preferable, none of the communities had concrete cylindrical tanks. There were some that had factory-made plastic cylindrical tanks. Leaks were also observed on the sections of the tank where the outlet and cleanout pipes are inserted (Figure 12 (b)).

Figure 12. Common problems with storage tanks. (a) – Corners of the storage tank leaking in Cayo Paloma, CNB Ñukribo. (b) - Outlet pipe connection leaking in Cayo Paloma, CNB Ñukribo.

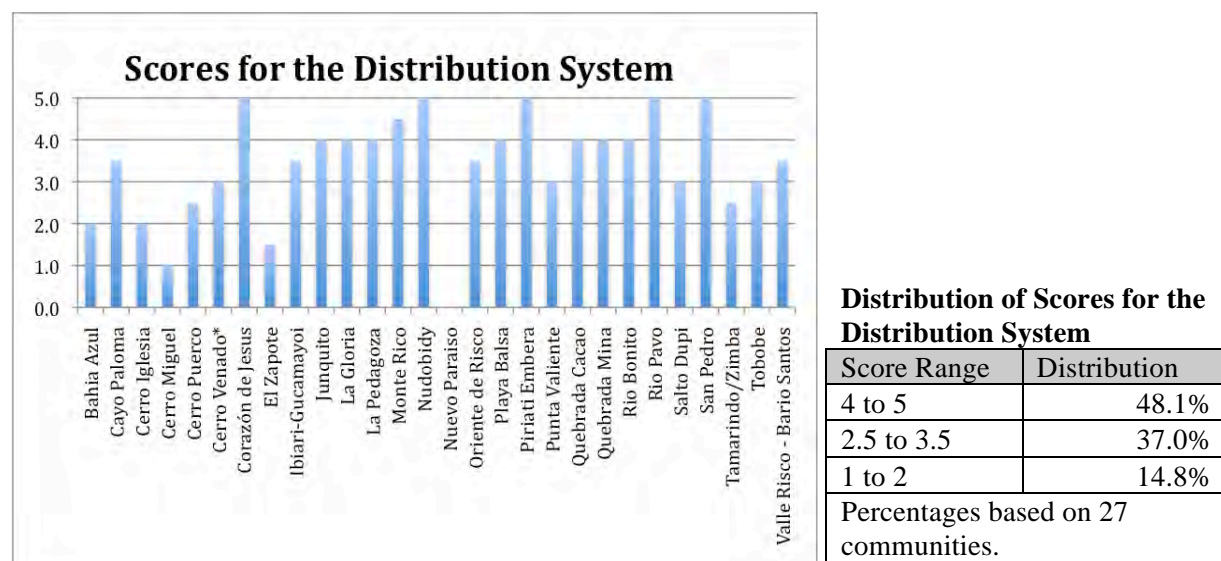
Figure 13. Results for the distribution system.

Many of the communities such as Valle Risco and Cerro Puerco with lower scores for the distribution system typically have major elevation differences between the houses. The elevation difference and distance from the tank creates inequity in pressure and flow amongst the houses, especially when the tube sizes were not designed properly. One indicator of pressure inequity are the houses that have lowered the tap stand as low as possible in an attempt to increase the pressure. For example, in Figure 14, the owner had to excavate in order to place a bucket in front of the tap. Speaking with users living in various parts of town also helped to triangulate the claims made by the water committee members.

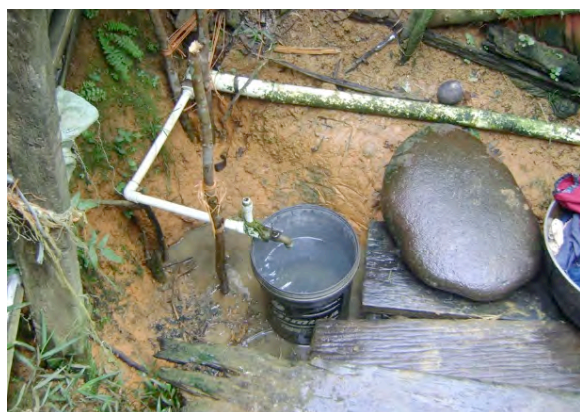
Figure 14. Tap stand lowered to the ground level due to lack of pressure (Photo taken in Oriente de Risco, Bocas del Toro).

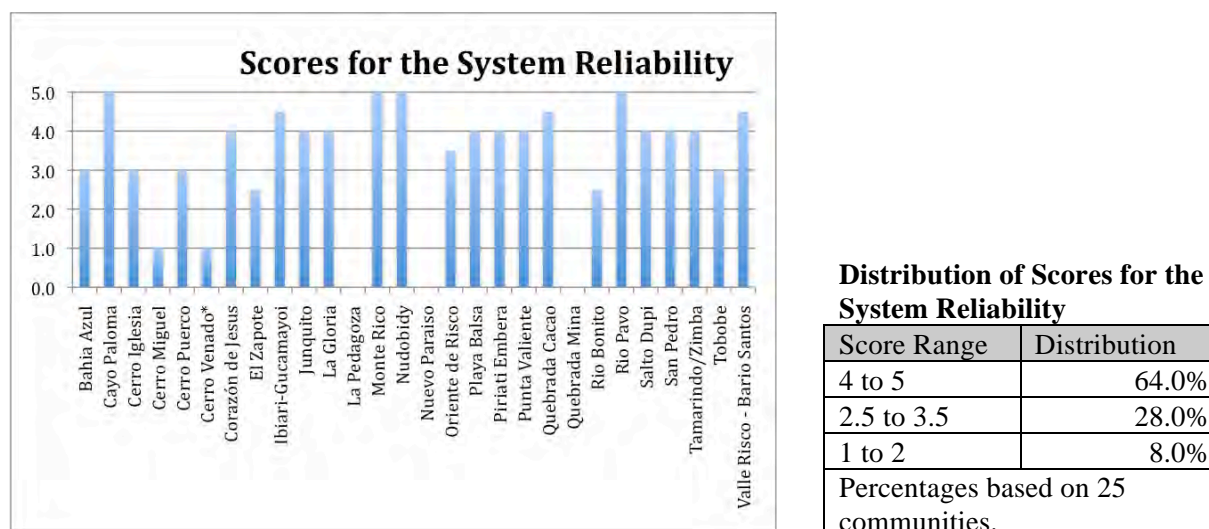
Figure 15. Results for the system reliability.

The system reliability was determined by triangulating responses of various water committee members and users regarding the availability of water throughout the years. As illustrated by Figure 15, there were only four communities where all of the users had enough water throughout the year. This means that communities that have the right combination of a year round reliable water source and well-functioning infrastructure were very rare in this sample.

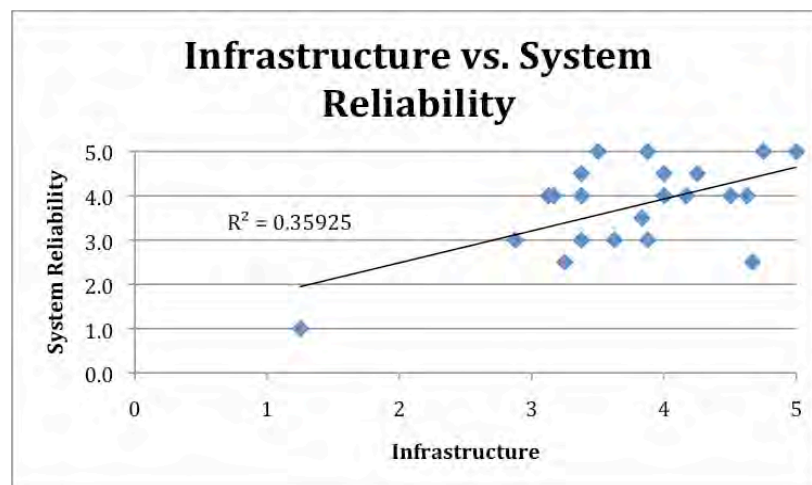
Figure 16. Linear regression analysis between the infrastructure and system reliability.

Figure 16 indicates that there is little or moderate correlation between the state of infrastructure and system reliability. However, the result from this analysis is not conclusive for various reasons: 1) Since the score of infrastructure was determined by taking the average score of source catchment, transmission lines, storage tank and distribution system, these four components are weighted the same. In reality, the weight of each component to estimate the overall state of the infrastructure would vary significantly depending on the scale of each water system. 2) The score of each component represents factors such as protection from runoff, tube exposure, cleaning schedule, and existence of control valves, which do not directly affect the water quantity. 3) 24 communities with data on system reliability may not be a sufficient sample size.

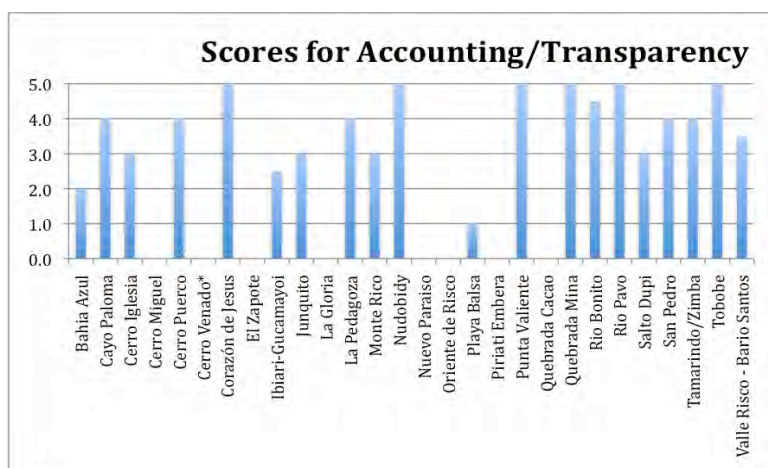
Distribution of Scores for the Accounting/Transparency

Score Range	Distribution
4 to 5	60.0%
2.5 to 3.5	30.0%
1 to 2	10.0%
Percentages based on 20 communities.

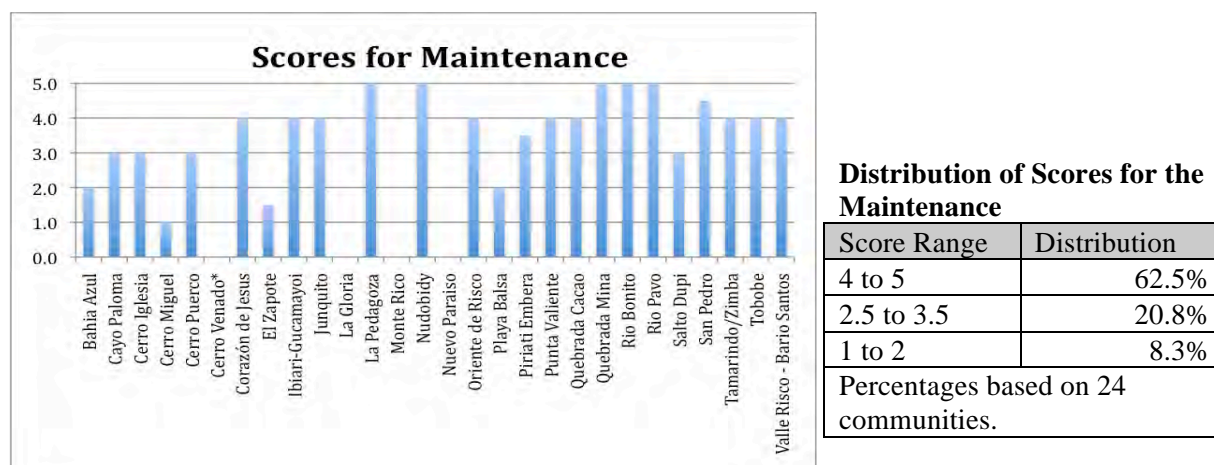
Figure 21. Results for the maintenance.

The level of maintenance was estimated by asking questions such as; who is the person responsible for repairing the damages, when was the last time that the maintenance work was carried out, and how much money has been spent on materials. Their responses were triangulated with the observations made during the transect walk regarding the extent of damages and leaks.

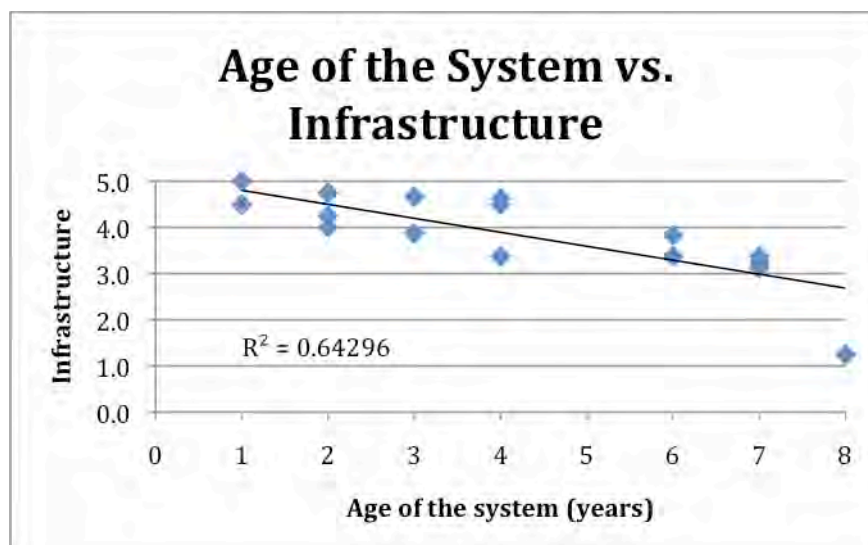
Figure 23. Age of the system (years) vs. infrastructure score.

Figure 23 suggest that the age of the system is correlated with the deterioration of infrastructure for this sample. Additionally, as these systems approach closer to their design life, the rate of deterioration would increase as well. However, the scale of each water system, quality of construction and level of maintenance could also affect the deterioration of infrastructure.

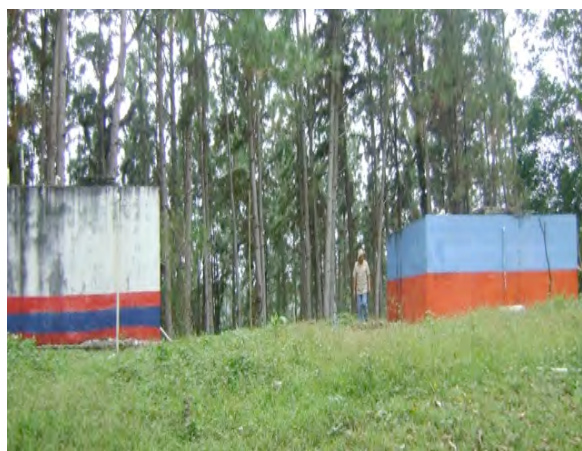
For example, the community of San Pedro in the Cocle province had been soliciting MINSA for many years to receive assistance with the extension of their water system to connect to another water source. Frustrated by the years of inaction, they solicited for a PCV and worked together to construct a spring box, install about one mile of 2" tubes to connect to the existing system, and construct a 5,000-gallon storage tank. However, a year after the project was complete, MINSA came in and installed a 3" transmission line along the same path and constructed a 10,000-gallon storage tank right next to the tank built a year before, as seen in Figure 24.

Figure 24. 5,000-gallon tank constructed by a PCV and 10,000-gallon tank constructed by MINSA a year later.
