# RETROFITTING BOREHOLES CONTAMINATED WITH IRON IN RURAL UGANDA

A REPORT

Civil Engineering

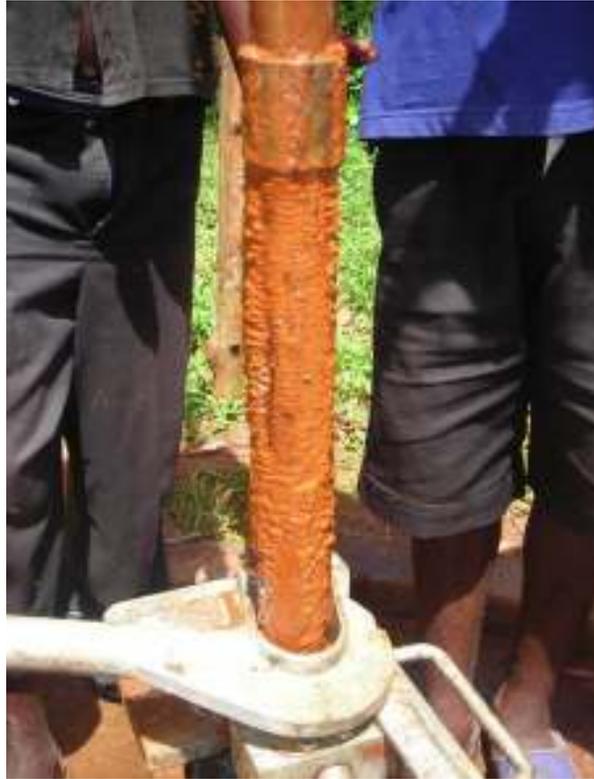
Visual observation of these wells gave a few clues as to potential factors that might be contributing to the problem. After the water was pumped and allowed to sit for a short while, an oily sheen appeared on the surface, almost as if there were a petroleum product in the water. The pipes of these wells also had some unique characteristics. Some of the pipes were covered in a black slime and smelled of rotten eggs. Other wells had pipes that were covered in a thick orange slime. Most of the pipes and rods suffered from a pitting form of corrosion.

**Figure 1.2** Orange slime found on galvanized iron riser pipes extracted from the well in Bulegete (photograph by author)

The community of Bulegete is unique compared to other villages in the area. Strong community leadership and attention to maintenance had kept their well functioning since its construction in 2003. The iron level in the water was diluted enough, as a result of serving many people, that it was used for all purposes, even drinking. However, the community had grown weary of repairing their well. The pipes ruptured repeatedly, and the rods frequently failed due to extremely high rates of corrosion. We did not chlorinate the well since it was being used at the time of the 6-pipe conversion. The pipes extracted were covered in a thick orange slime (Figure 1.2). This work was completed on May 6, 2010.

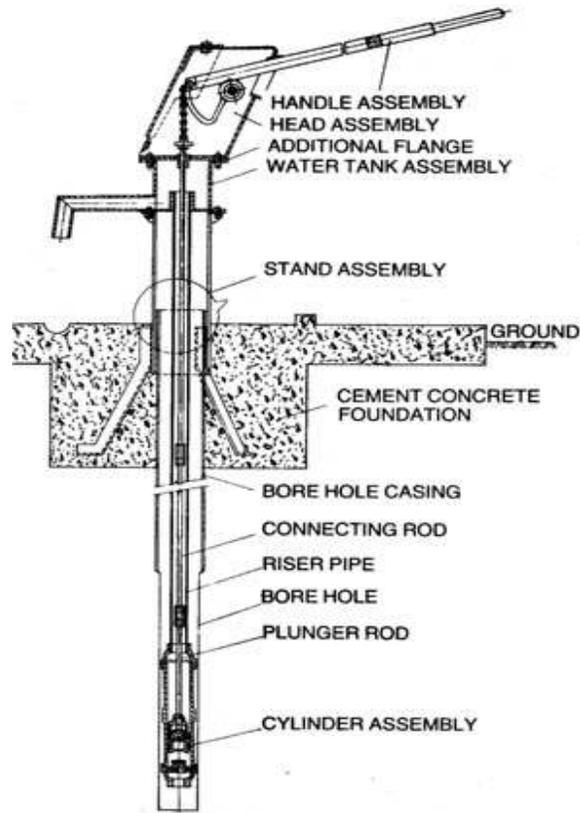
The India Mark II hand pumps (U2) are the most commonly used pump in the rural areas of Uganda for harvesting groundwater. The U2 system maintains a good track record for durability (S.K. Industries 2008). Spare parts are readily available in larger towns. The India Mark II employs galvanized iron rods for raising/lowering the plunger and galvanized iron riser pipes for conveying the pumped water at depth to the surface. Under normal conditions, the only parts that should need periodic replacement, every 2-5 years depending on use, are the rubber seals and buckets in the cylinder assembly. This requires some technical know-how and specialized tools. Communities are encouraged to allow only trained technicians to do this maintenance due to the risk of dropping the pipes inside the borehole or further damaging pump components.

**Figure 2.1** Diagram of the India Mark II hand-pump (skipumps.com)

The U2 system has long been the most popular setup used in Uganda. It uses the 3-cm (1.25-inch) galvanized iron riser pipes in conjunction with galvanized iron rods (Figure 2.1). The U3M setup uses 6.3-cm (2.5-inch) PVC riser pipes and stainless steel rods connected to a brass-lined plastic pumping cylinder. All pipes and rods are a standard 3-m (10-foot) length. The two systems share components such as the handle, head, and pedestal. These parts can be salvaged from a U2 pump and used in the conversion to a U3M. The main components

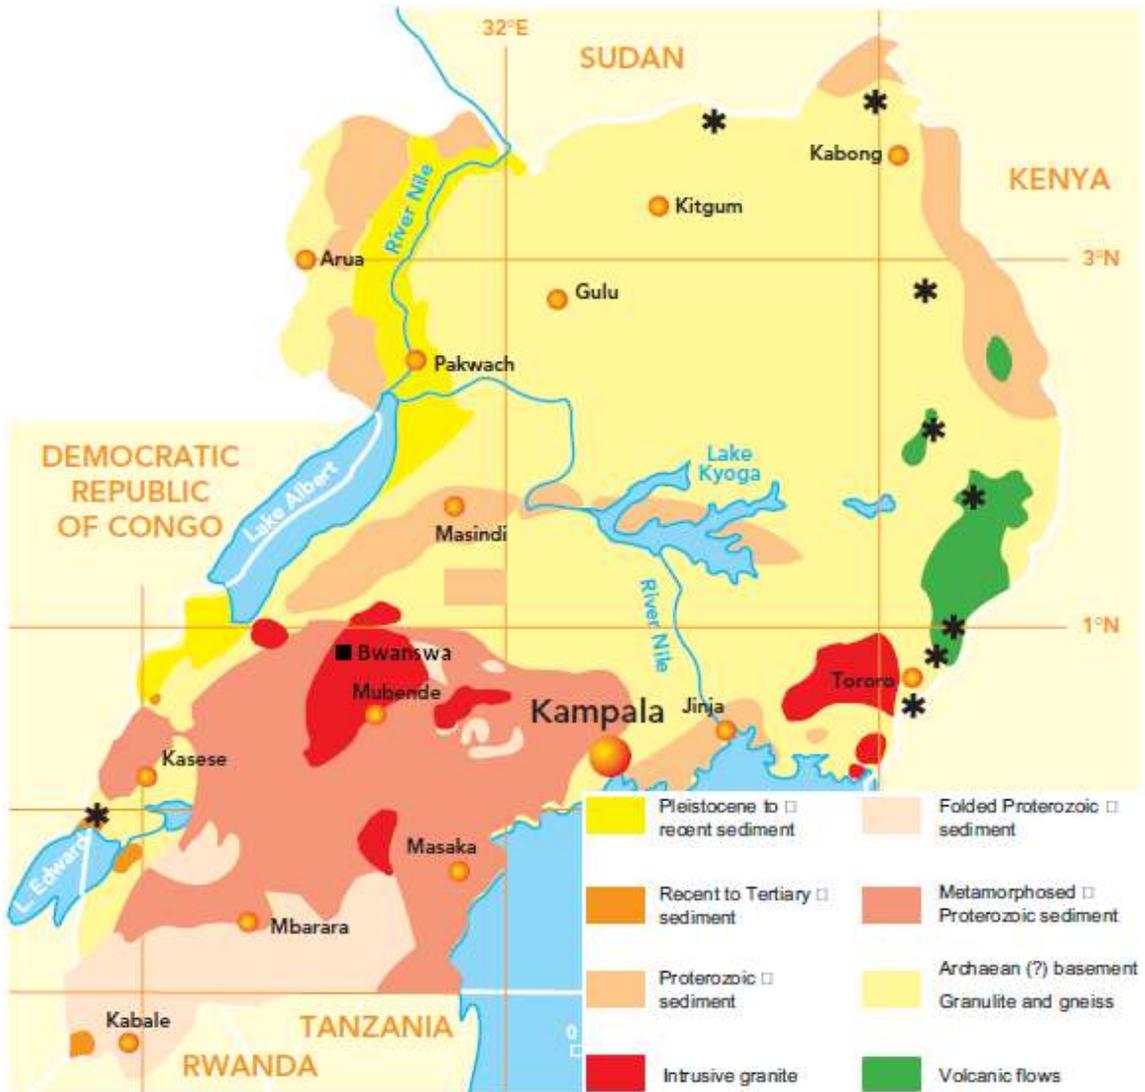
Under the vast majority of Uganda lies a pre-Cambrian crystalline basement complex (WWAP 2006). In Bwansa a regolith about 20-30 meters thick overlies this granite bedrock. According to the drilling logs shown in Appendix D, this overburden is generally divided into two parts: a 1-12 meter thick top layer of a loamy soil with laterite, and a lower layer of clay about 10-18 meters thick.

**Figure 2.2** Basic geology of Uganda (Adapted from the Government of Uganda 2006)

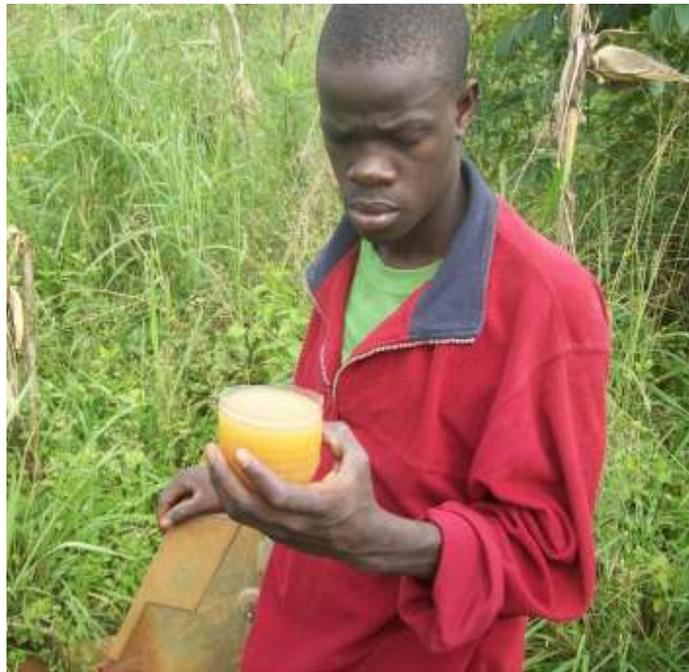
**Figure 2.3** Bujune Aloysius reflects on the iron-rich water he just drew from the Kigoli borehole (photograph by author)

The well in the community of Kigoli was constructed on June 21, 2003. It produced good water for one month before starting to produce reddish/yellow-colored, iron-rich water (Figure 2.3). It was then completely abandoned. We converted the 10 pipes and chlorinated the well on March 30, 2010. The galvanized iron riser pipes removed from the well were covered in a black slime and smelled of hydrogen sulfide. The driller's log for this well and the following wells can be found in Appendix D.

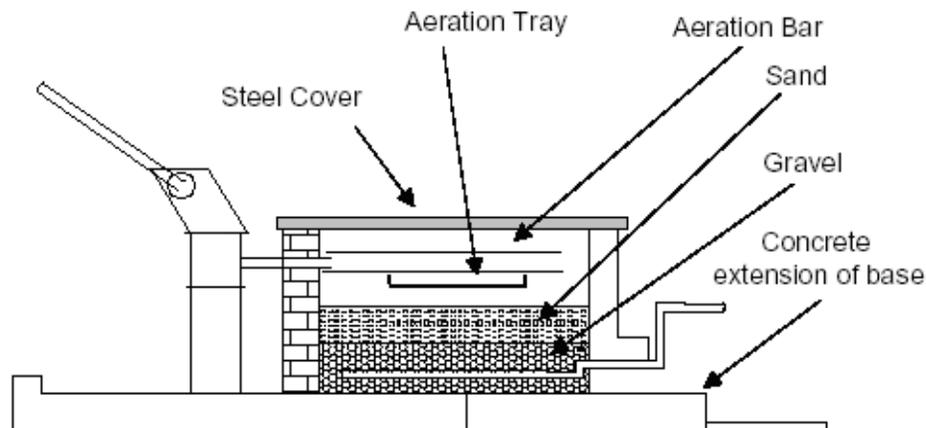
The lead water engineer at the Ministry of Water and Environment in charge of all rural water development in Uganda has experimented with a solution to the iron issue in other areas of the country. He believed that a majority of the iron contamination originated in the geologic formations and hence required a system to remove iron from the water as it is pumped. Working with university students from the United Kingdom, he developed the Silsoe Iron Removal Plant (IRP, see Figure 2.5), which could be retrofitted onto existing boreholes. It consists of an aluminum aeration tray followed by a slow sand filter. In a few pilot projects the

filter performed sufficiently, although not consistently, removing approximately 90% of the iron (Kaciel 2004).

**Figure 2.5** Schematic profile of iron removal plants being retrofitted onto India Mark II hand pumps in Uganda (Graphic by Ahmed Sentumbwe)

The Silsoe Iron Removal Plant experienced widespread difficulties over time due to the lack of maintenance performed by the communities. The training given to the water user committees instructed them on the need for and method of cleaning the sand every 2 to 4 weeks. Some communities failed to clean these IRPs even a single time and eventually abandoned the source when the flow reduced to almost nothing. Despite great efforts to foster a sense of ownership and a maintenance schedule, many of these filters failed due to lack of up-keep.

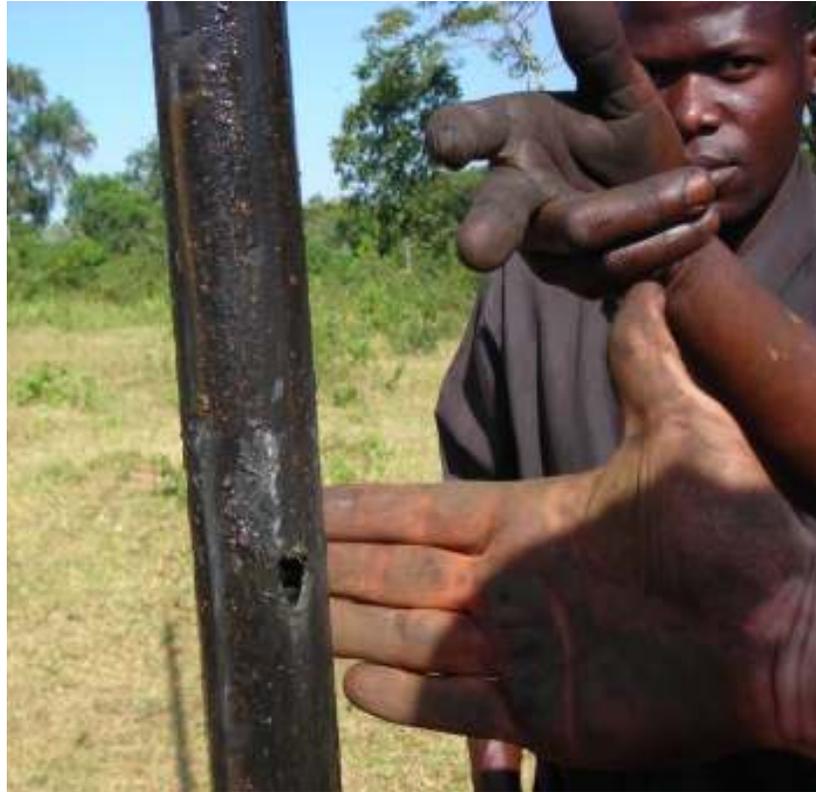
gas), tubercles and corrosion, and black slimes (Cullimore 1993). The presence of  $H_2S$  gas is of concern because it triggers a series of complex electrolytic corrosion processes on the surface of metal components (Cullimore 1993). The black slime covering the pipes is a metallic sulfide which is a product of hydrogen sulfide reacting to large amounts of metallic materials in the water such as iron or manganese (Cullimore 1993). SRB are controlled in the same way as IRB. As they cannot be completely and permanently eradicated, periodic dosing of the well with a strong oxidant is necessary.

**Figure 2.6** A hole eaten into an iron riser pipe from the Kyabasaija well (photograph by author)

The well at Kyabasaija church was drilled on June 19, 2003. It functioned for about 5 years until it started producing 'yellowish' water. The pump failed shortly thereafter. The community put forth no effort to fix it because of the unpalatable water it had started to produce. The pipes pulled from this well were black and had obvious instances of localized corrosion as seen in Figure 2.6. Disinfection and a 13-pipe conversion were completed on June 23, 2010.

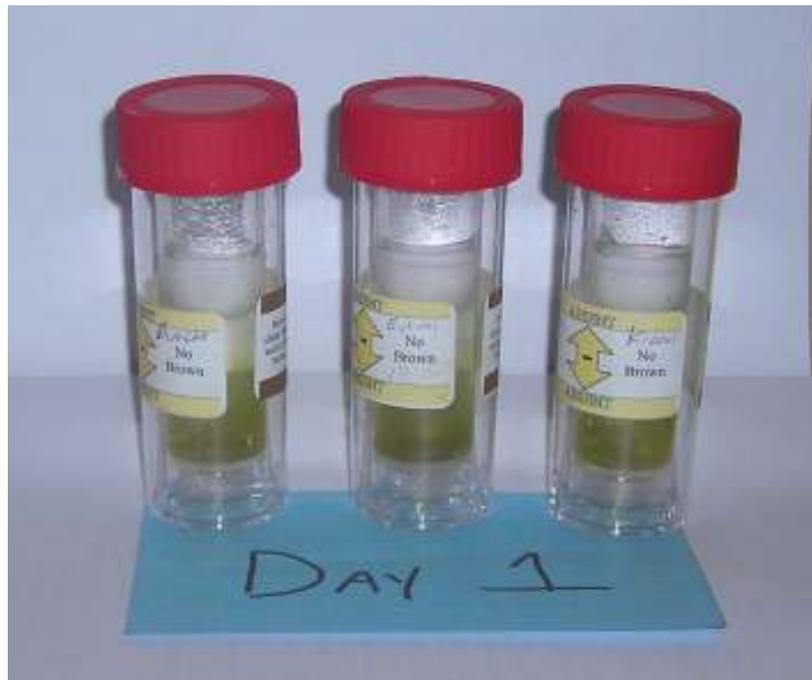
**Figure 3.2** First day of testing for IRB using IRB-BART™ test kits (photograph by author)

IRB-BART™ test kits are simple to use, whereby a user pours 15 ml of a water sample into the inner test tube which has certain nutrients at the bottom and white plastic ball. It is then placed in the outer test tube for odor control and spill containment. The sample is then incubated at room temperature, out of direct sunlight, for a period of 9 days as the user observes and records changes. Given the infrastructure challenges in Uganda, this serves as a very practical and appropriate test, although slightly expensive (each tube displayed in Figure 3.2 costs about US \$14 in 2010, including shipping to Uganda).

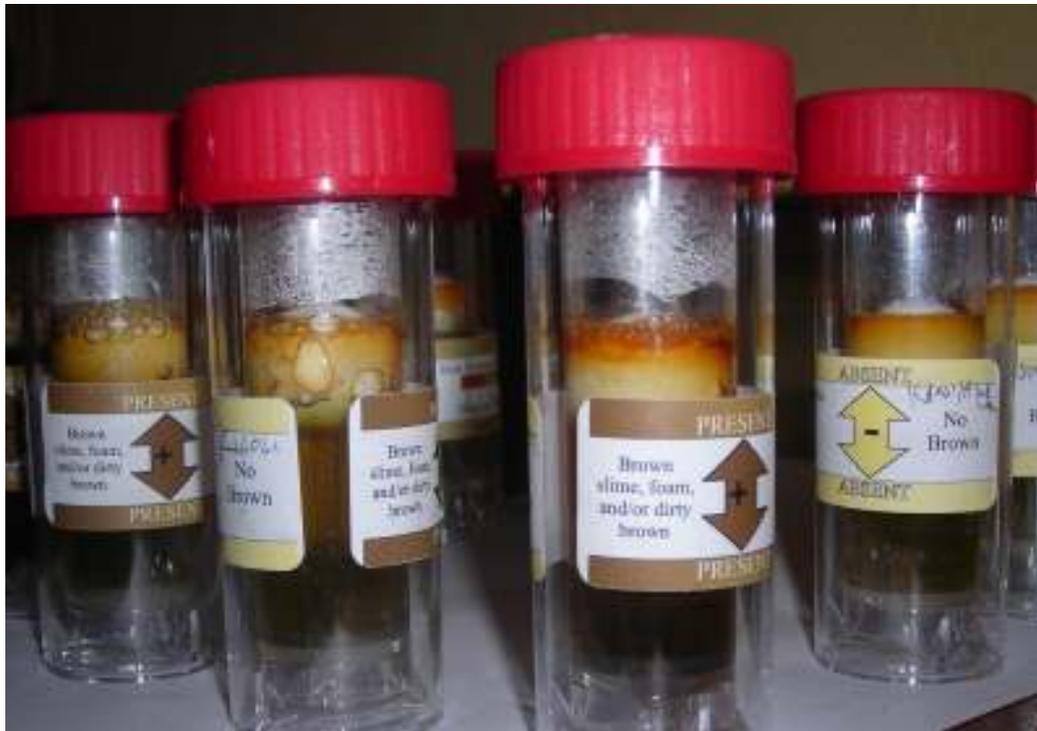
Eleven of twelve wells tested showed a positive reaction for anaerobic bacterial activity. This is referred to as Reaction 5 and is indicated by bubbles or foam appearing under and around the floating ball of the IRB-BART™ kit as shown in Figure 4.2. The literature states that a correlation potentially exists between Reaction 5 and the presence of sulphate reducing bacteria (Cullimore 1993).

**Figure 4.2** From left to right: bubbles appearing in IRB-BART™ samples taken from Bukumi, Kigoli, and Bulegete. No bubbles in Kanyawawa’s sample. (photograph by author)

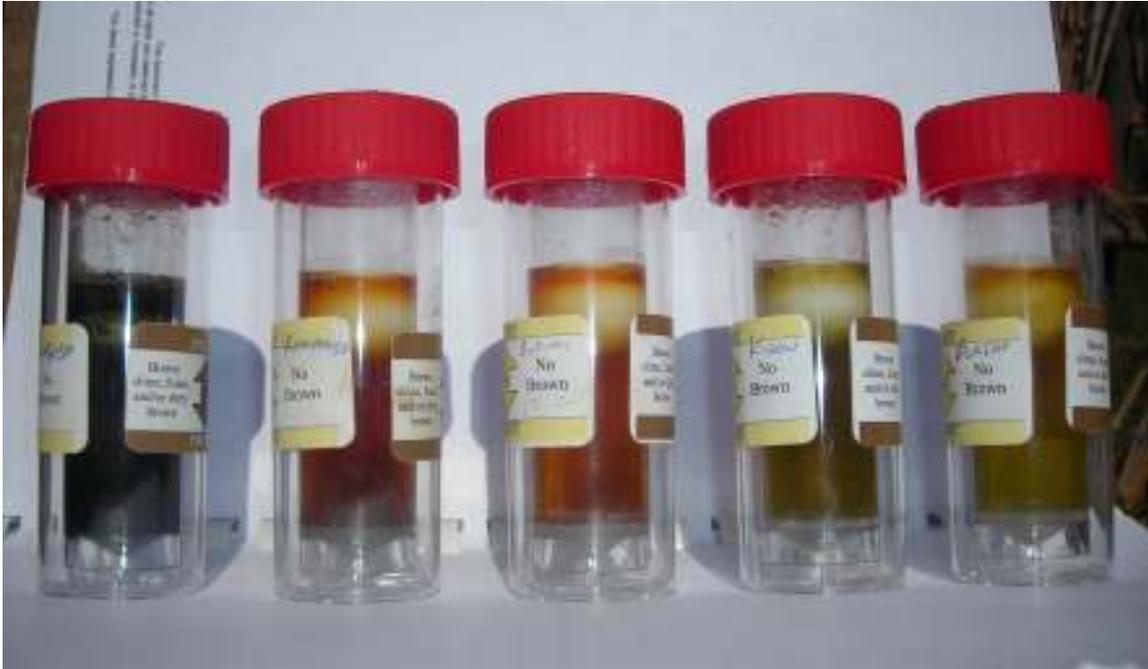
All of the samples that showed the signs of enteric bacteria did so as a secondary reaction following Reaction 5. The bacteria of a secondary reaction are not as dominant as those of the primary reaction. Enteric bacteria can be indicated by a scarlet red hue, seen in Figure 4.3, which is characterized as Reaction 7. The two major genera of bacteria causing this reaction are klebsiella and enterobacter (Cullimore 1993). Enteric bacteria can also be indicated by a blackening of the sample as shown by Kasojo in Figure 4.3. This is characterized as Reaction 10, which can also indicate the presence of sulphate reducing bacteria.

**Figure 4.3** From left to right: black reaction from Kasojo, scarlet samples from Kihurumba and Bukumi, and clear green reaction from Kigoli and Bulegete. (photograph by author)
