Retrofitting boreholes contaminated with iron in rural Uganda

RETROFITTING BOREHOLES CONTAMINATED WITH IRON IN RURAL UGANDA

A REPORT

Civil Engineering

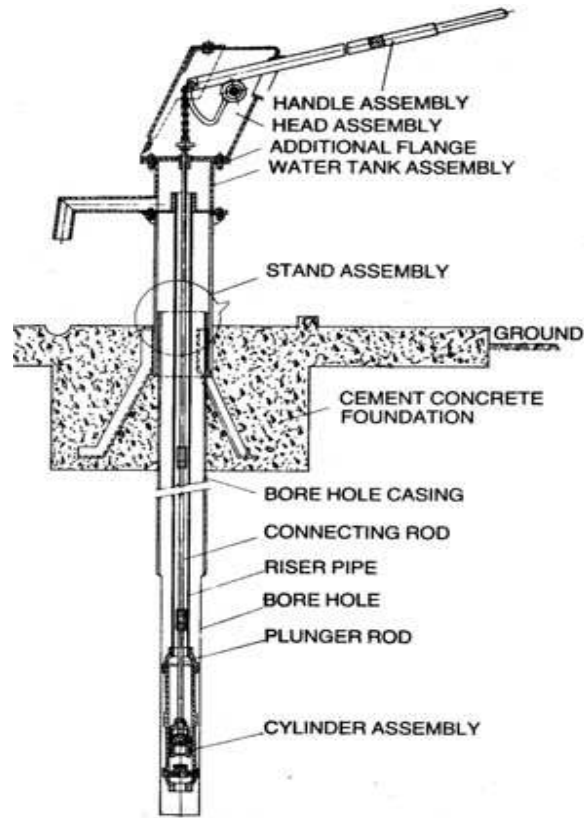
The India Mark II hand pumps (U2) are the most commonly used pump in the rural areas of Uganda for harvesting groundwater. The U2 system maintains a good track record for durability (S.K. Industries 2008). Spare parts are readily available in larger towns. The India Mark II employs galvanized iron rods for raising/lowering the plunger and galvanized iron riser pipes for conveying the pumped water at depth to the surface. Under normal conditions, the only parts that should need periodic replacement, every 2-5 years depending on use, are the rubber seals and buckets in the cylinder assembly. This requires some technical know-how and specialized tools. Communities are encouraged to allow only trained technicians to do this maintenance due to the risk of dropping the pipes inside the borehole or further damaging pump components.

Figure 2.1 Diagram of the India Mark II hand-pump (skipumps.com)

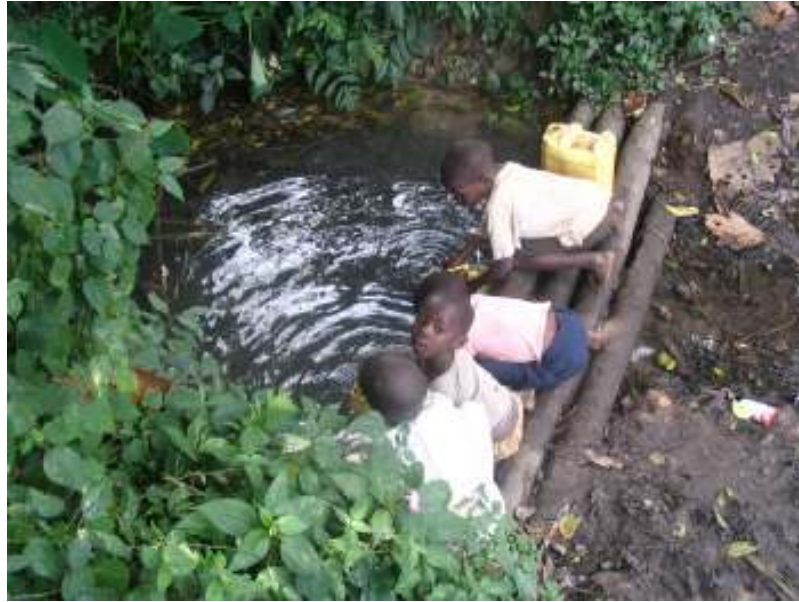
Consuming excessive iron does not pose an immediate health threat. Excessive iron does, however, make water unpalatable and thus results in the abandonment of the source and the return to traditional, unprotected sources. These traditional sources are usually small springs that are dammed to form small pools (Figure 2.4), which are highly susceptible to contamination and create potential breeding grounds for mosquitoes.

Figure 2.4 Children fetching water from a traditional unprotected spring (photograph by author)

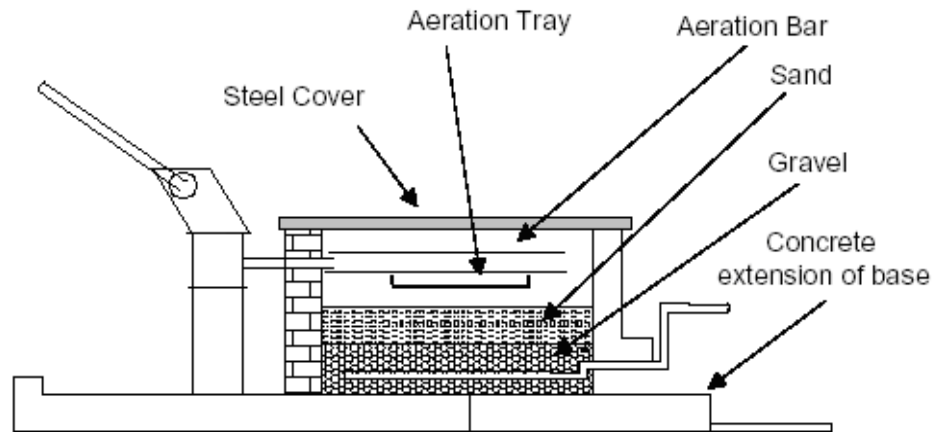
Figure 2.5 Schematic profile of iron removal plants being retrofitted onto India Mark II hand pumps in Uganda (Graphic by Ahmed Sentumbwe)

The Silsoe Iron Removal Plant experienced widespread difficulties over time due to the lack of maintenance performed by the communities. The training given to the water user committees instructed them on the need for and method of cleaning the sand every 2 to 4 weeks. Some communities failed to clean these IRPs even a single time and eventually abandoned the source when the flow reduced to almost nothing. Despite great efforts to foster a sense of ownership and a maintenance schedule, many of these filters failed due to lack of up-keep.

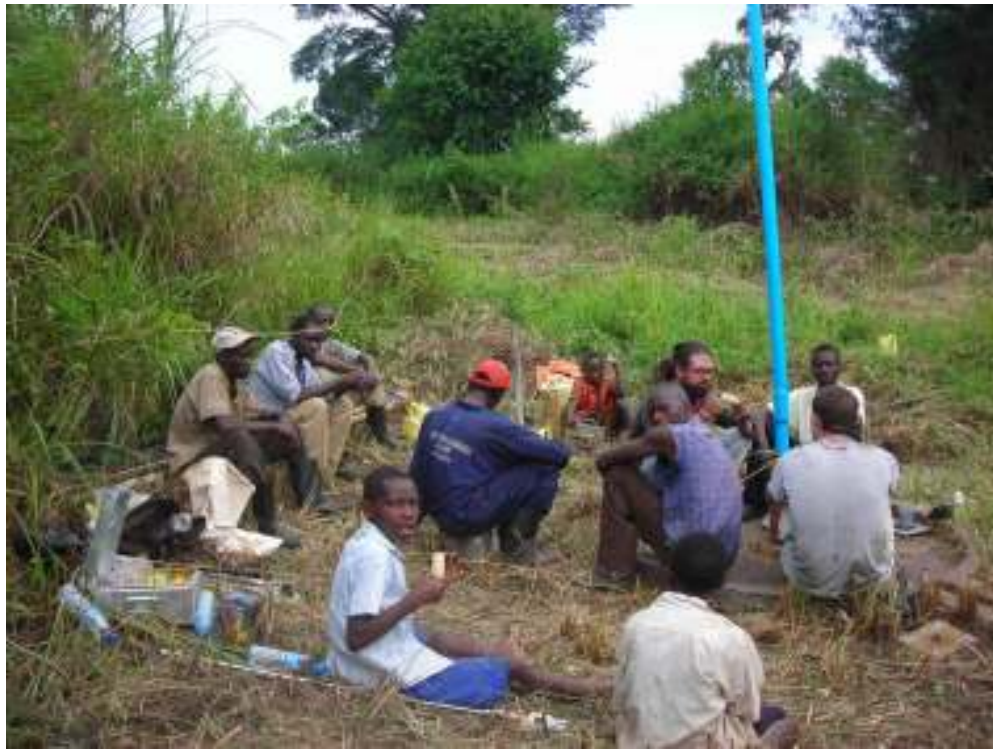
Figure 3.1 Taking a boiled corn break during the borehole conversion at Kihurumba (photograph by author)

changed were the pipes, pumping cylinder, rods, and water tank. The conversion from U2 to U3M usually takes one day, with the help of community volunteers (Figure 3.1) and costs between US \$400 and \$850 depending on the depth required. Table 3.1 shows the cost for a 15-pipe-length conversion. This is the deepest recommended depth that PVC should be used due to its tensile strength limitations.

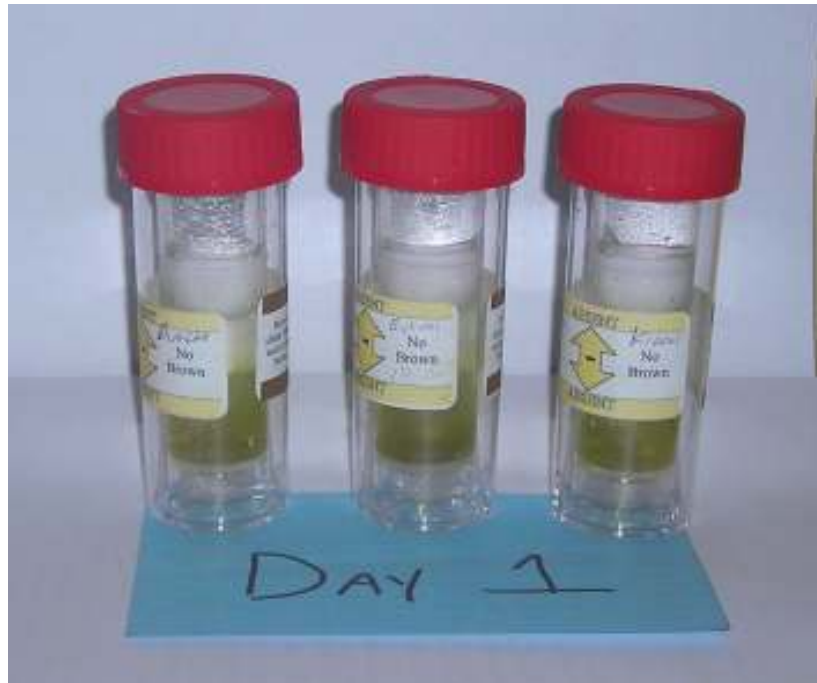
Figure 3.2 First day of testing for IRB using IRB-BART™ test kits (photograph by author)

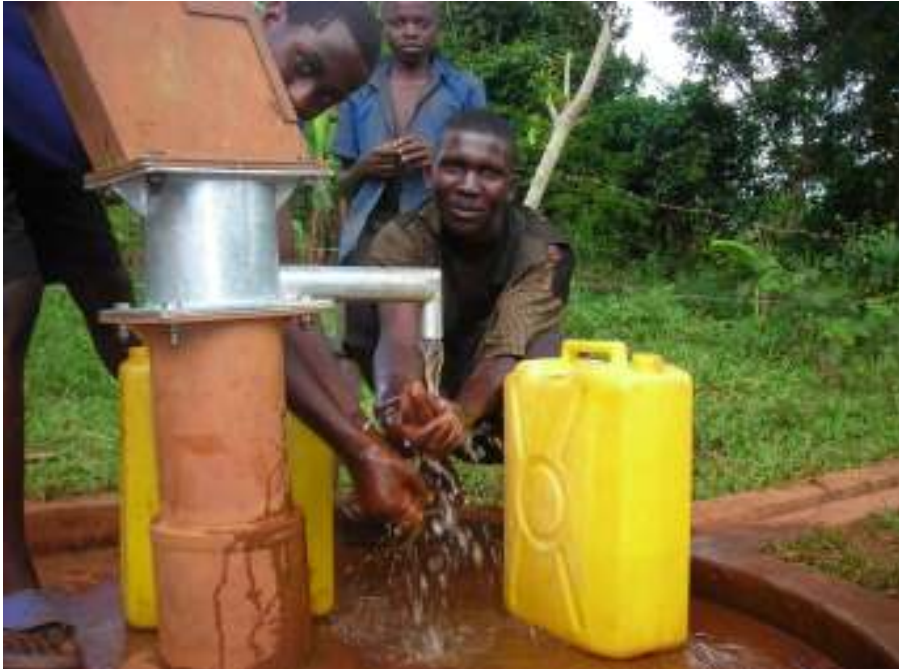
The results were very encouraging from a practical standpoint. These wells, which were sitting idle for years while the communities drew their drinking water from unprotected sources, are now functioning and producing very clear water (Figure 4.1). A community member from Bukumi commented, “Thank you for your work. Our water now tastes better than Rwenzori (bottled water)!”

Figure 4.1 Members of the Bulegete community enjoying their restored water source (photograph by author)
