A STUDY OF A LANDSLIDE IN BIRMINGHAM, ALABAMA

A REPORT

In Civil Engineering

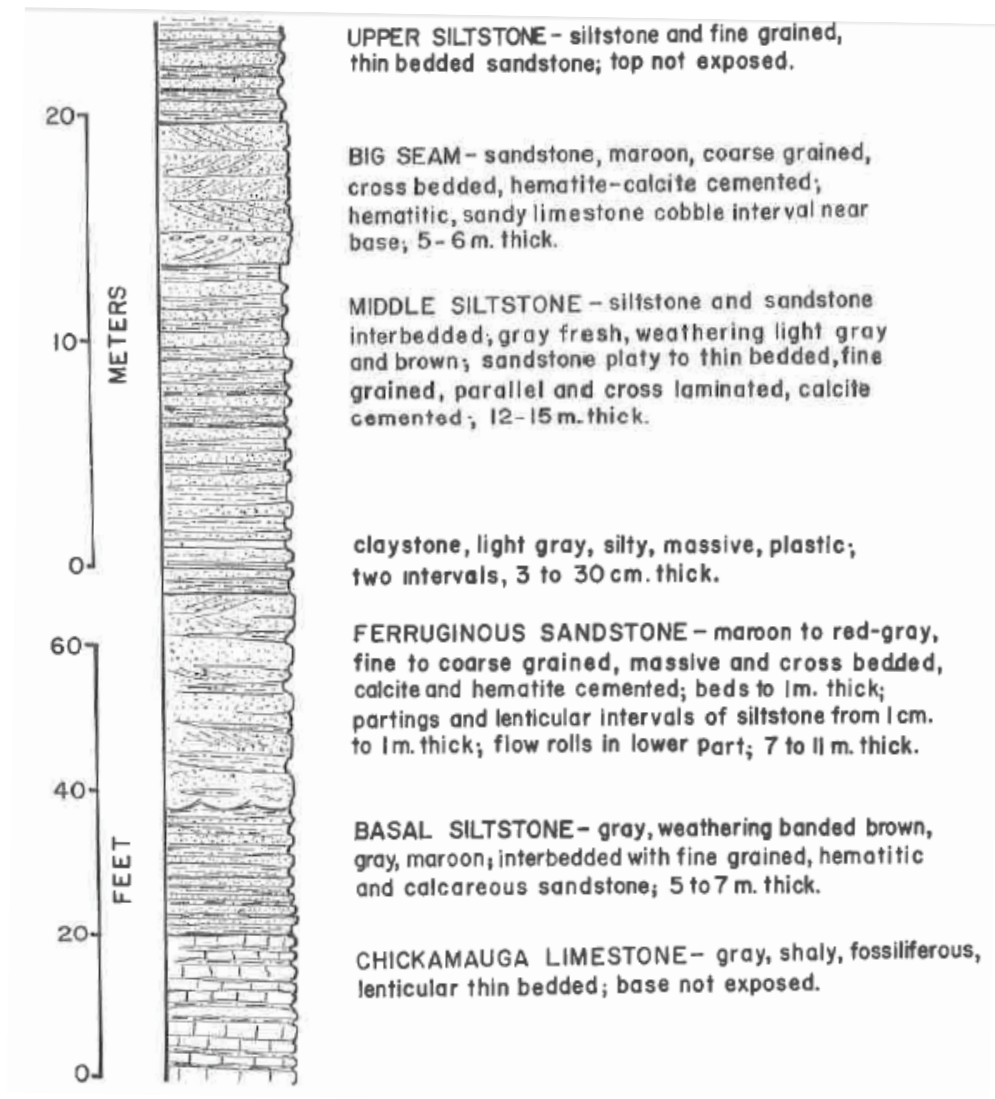
FIGURE 5: ASSUMED STRATIGRAPHY FROM BORING 1.^[2] SEE APPENDIX FOR PERMISSIONS.

layer. The strength values were averaged within those groups though the actual test values in each grouping varied widely. The averaged strength parameters are reported in Table 1. In addition, no strength tests were reported from Boring 1. The design company used a cohesion of 1152 psf and a friction angle of 10 degrees to estimate of the stability of the final slope. The final slope encompassed the silt/sandstone and clay/siltstone layers, which included the clay seam that failed.
