## A STUDY OF A LANDSLIDE IN BIRMINGHAM, ALABAMA

Caitlin L. Bukovitz  
*Michigan Technological University*

A REPORT

In Civil Engineering

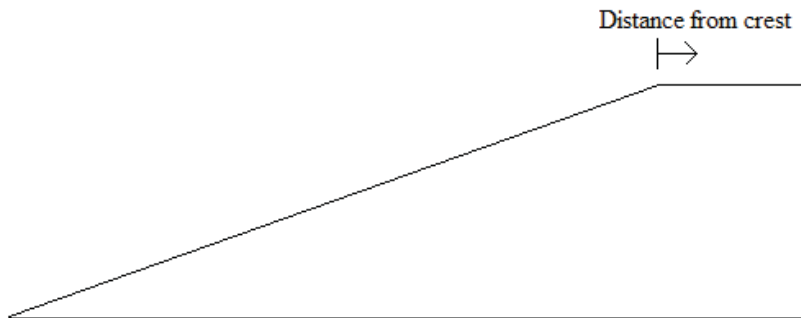
**FIGURE 10: DEMONSTRATION OF ROCPLANE'S FRACTURE INPUT SYSTEM.**

After the baseline analysis was conducted, fractures were added. A single fracture could be input at a distance behind the crest of the slope, as shown below (Figure 10). In addition, the maximum pore water pressure was added to the base of the fractures, since the fractures would allow for easier water infiltration and correlate with the report of water seepage during the excavation. Also, Crane described water pouring into underground mines. The fractures would allow for the amount of water that Crane describes.<sup>[4]</sup> In order to test the height at which a fracture could cause failure, the upper and lower slope faces were both set to 45° (Figure 11), while the height versus factor of safety was graphed to determine the failure point (Figure 12).
