## Characterization of edge damage induced on REBCO superconducting tape by mechanical slitting

William N Hartnett<sup>1</sup>, Javier Ramirez<sup>1,2</sup>, Tanner E R Olson<sup>1,3</sup>, Christopher T Hopp<sup>1</sup>, Matthew C Jewell<sup>1</sup> , Allan R Knoll<sup>4</sup>, Drew W Hazelton<sup>4</sup> and Yifei Zhang<sup>4</sup> <sup>1</sup> University of Wisconsin-Eau Claire, Eau Claire, WI, United States of America<sup>2</sup> University of Wisconsin-Madison, Madison, WI, United States of America<sup>3</sup> Michigan Technological University, Houghton, MI, United States of America<sup>4</sup> SuperPower, Inc., Glenville, NY, United States of AmericaE-mail: [jewellmc@uwec.edu](mailto:jewellmc@uwec.edu)**Keywords:** REBCO, coated conductor, superconductor, tape slitting

## Abstract

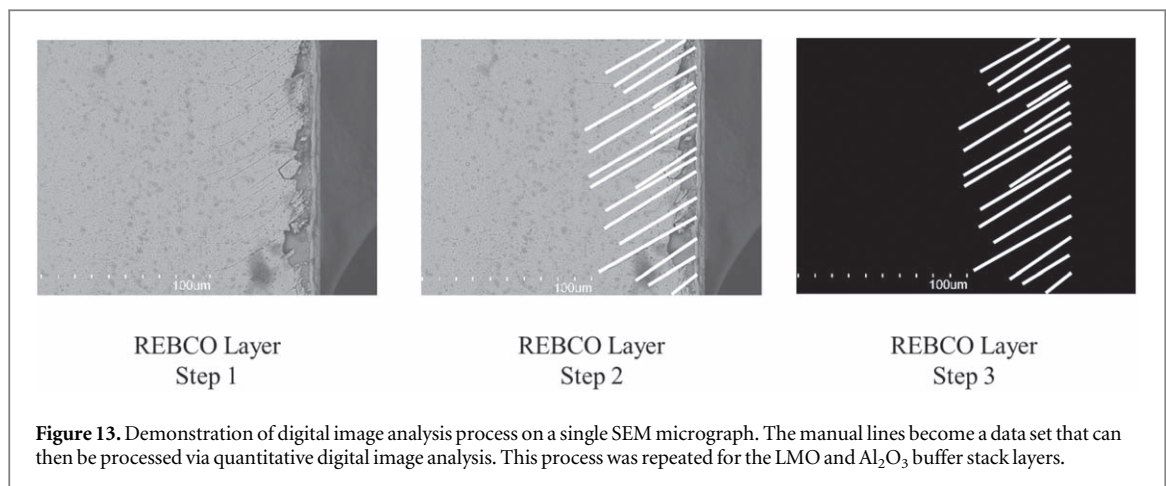
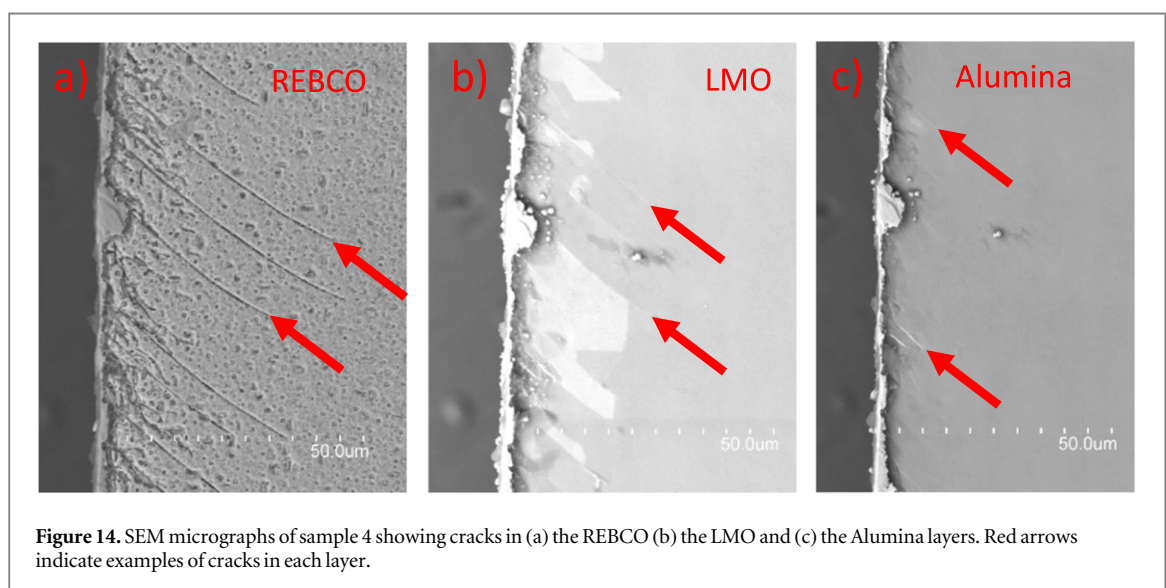
Cracks were measured over the full 4 mm length of each sample. SEM micrographs showing representative sections of the REBCO, LMO, and Al<sub>2</sub>O<sub>3</sub> layers that were utilized for this analysis are provided in figure 14. In general, similar crack orientations and morphologies were observed across the three layers, however the cracks differed in length and density among the three layers. In nearly all samples, the REBCO and LMO layers had a similar number of cracks (6.4% higher density in the LMO on average), but the REBCO cracks were on average 21% longer. Moreover, the cracks in the alumina layer were on average 50% shorter and 74% more numerous than the cracks in the other two layers. The crack statistics from each of the two samples analyzed (four locations

in each) are summarized in table 1, and the full crack distributions from one location in each samples is shown in figures 15 and 16. Our interpretation of these results is found in section 4 of this paper.

**Figure 15.** Crack distribution of all three analyzed layers in sample 4 (UP).

**Figure 16.** Crack distribution of all three analyzed layers in sample 5 (DOWN).

In the crack length distribution results section, we investigated cracks in narrow damage samples that were a result of slitting. A general trend observed across all samples was that the LMO layer showed more total cracks than the REBCO layer, with the REBCO cracks averaging 21% longer. Another trend that was observed was that the alumina layer showed 74% more cracks than the other two layers, with cracks averaging 50% shorter than those in the other two layers. Spatially, there is excellent matching between the location of cracks in the REBCO layer and those in the LMO layer, indicating that the cracks initiate in one layer and propagate to the adjacent layer. Since the REBCO layer is thicker than LMO by an order of magnitude and located at the maximum bend radius as it goes through the slitter (see figure 17), we can infer that the cracks most likely begin in the REBCO layer and propagate to the LMO layer.

The cracks in the alumina layer, by contrast, are much shorter and more numerous than those in the REBCO or LMO layers. As a result, it is not clear that the alumina cracks propagate to the REBCO/LMO layers or vice versa. Rather, it is more likely that there is a separate crack initiation mechanism governing the damage seen in the  $\text{Al}_2\text{O}_3$ . For example, the mechanically weak  $\text{Y}_2\text{O}_3$  layer may be heavily cracked and initiating the cracking in the  $\text{Al}_2\text{O}_3$  (keep in mind that the  $\text{Y}_2\text{O}_3$  layer was too thin to isolate via etching and observe in this section of the experiment). Alternatively, the strong and very thick (50  $\mu\text{m}$ ) Hastelloy layer adjacent to the  $\text{Al}_2\text{O}_3$  may determine its mechanical behaviour. The nature of the crack initiation mechanism in the  $\text{Al}_2\text{O}_3$  layer requires further investigation.
