## STABILITY ANALYSIS OF THE SLOPE ALONG US-2 BETWEEN EPOUFETTE BAY AND THE CUT RIVER BRIDGE

**STABILITY ANALYSIS OF THE SLOPE ALONG US-2  
BETWEEN EPOUFETTE BAY AND THE CUT RIVER  
BRIDGE**

A REPORT

*In Civil Engineering*

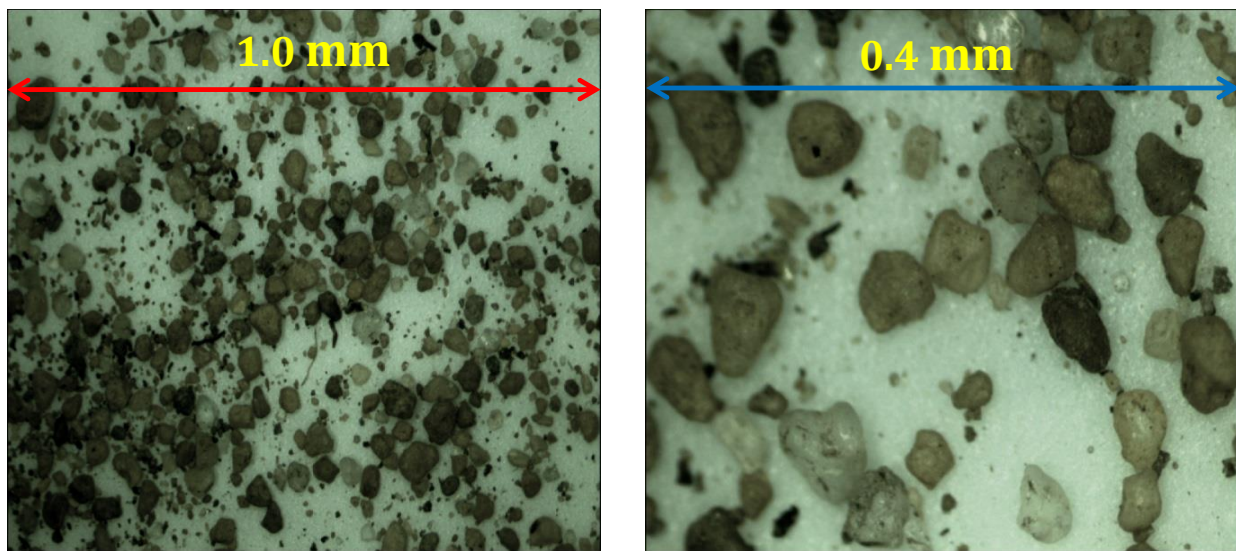
Figure 7: Top Slough Surface Soil Morphology

As mentioned in section 3.1, the sand from the top portion of the slough was considerably darker than the other samples taken at the site; the particles seem to have a consistent soil morphology that mostly resembles sub-rounded grains. From Figure 7, left, it is clear that the majority of the particles are composed of quartz (the grains near the bottom); it also seems to have traces of basalt (the very dark grains scattered about).

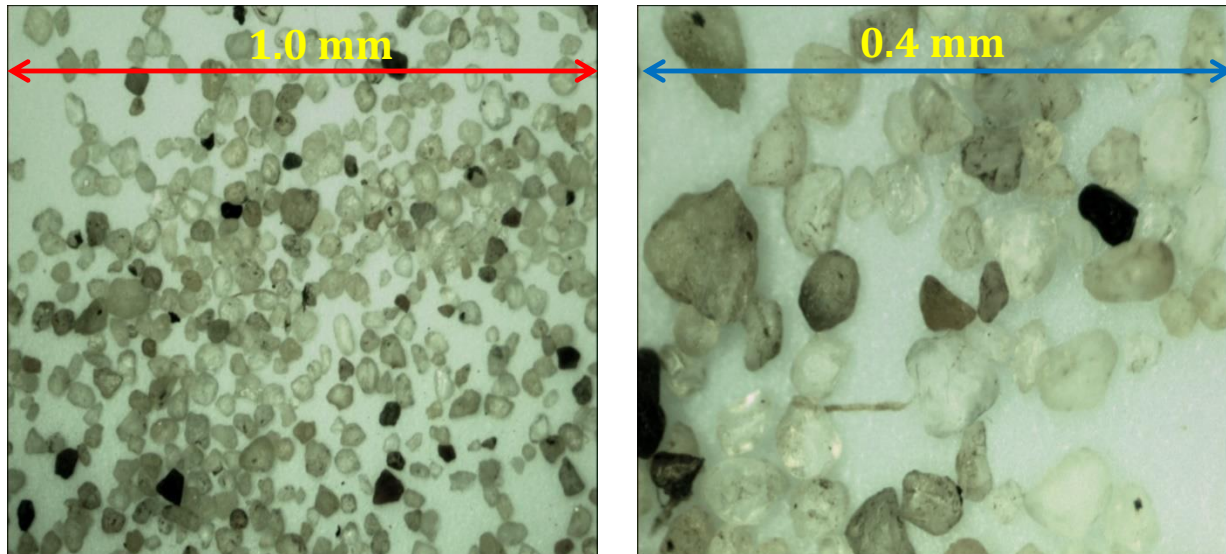
Figure 8: Middle of Slough Surface Soil Morphology

From Figure 8 it becomes very obvious that there is a heavy content of quartz in the make-up of this specimen.

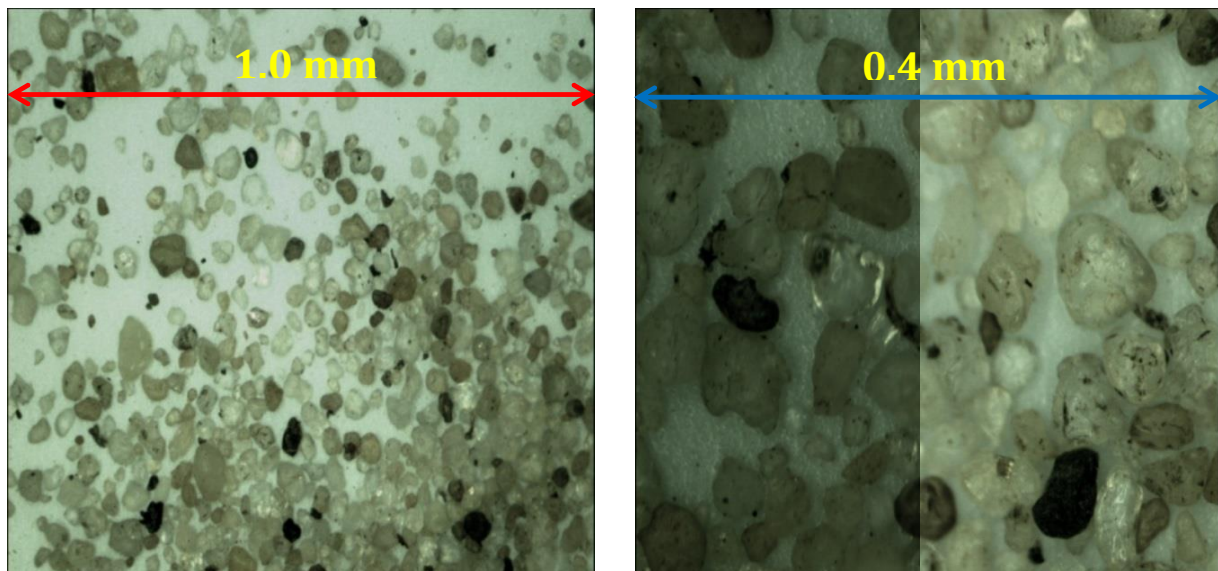
Figure 9: 3' Below Surface of Middle Slough Soil Morphology

Viewing Figure 9, it is seen that the soil particles look similar to the particles in Figure 8.

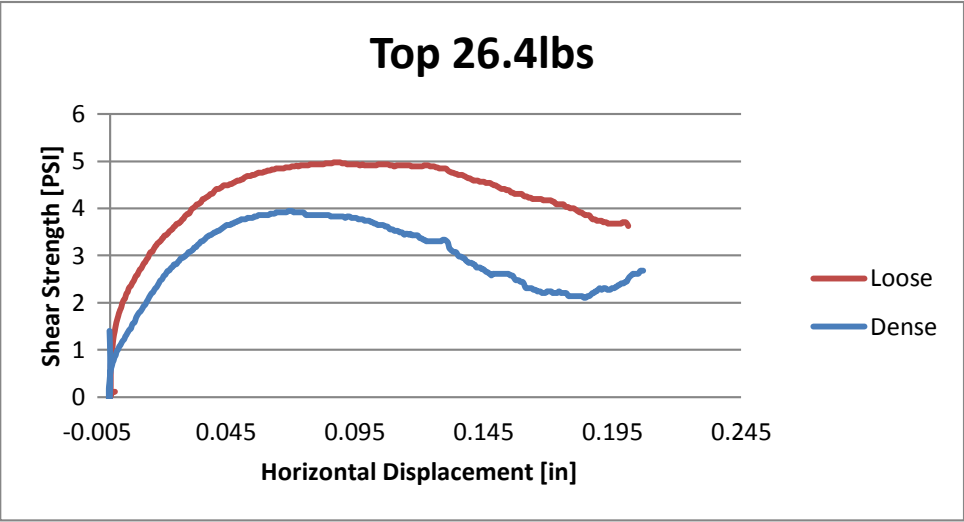
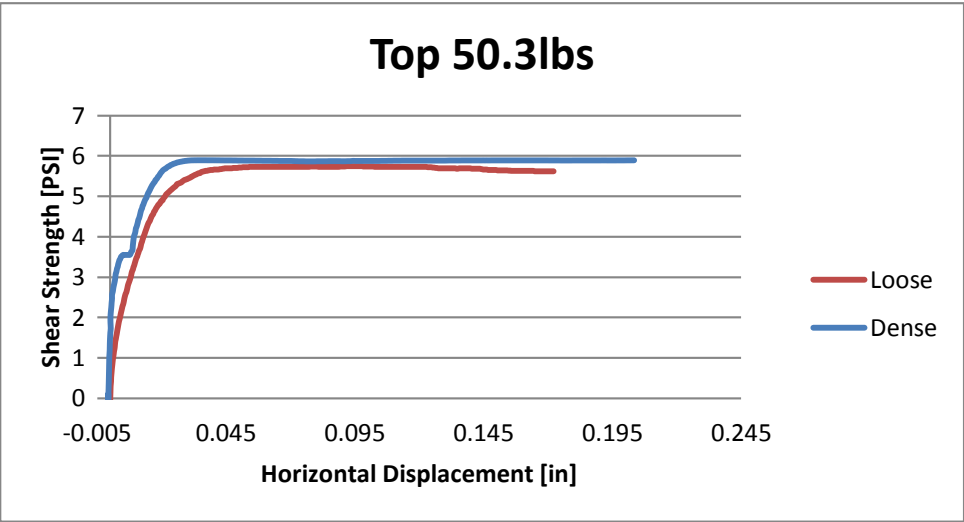
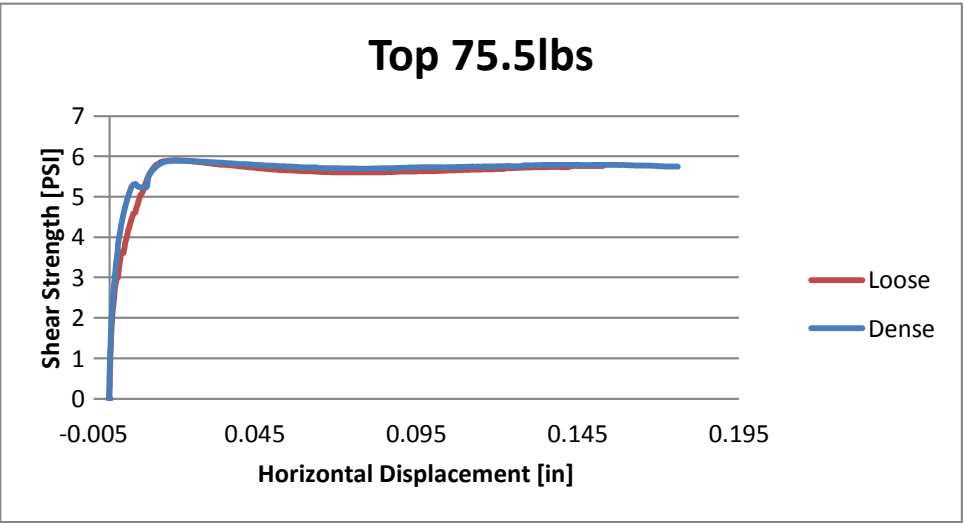
Figure 13: Shear Strength vs Horizontal Displacement for the Top Slough

On the following pages Figure 13 and Figure 14 display the shear strength vs horizontal displacement of the two samples. It was noticed that the loosely compacted and densely compacted samples gave very similar outcomes. Because the results show similarities between the dense and loose compaction stages, it confirms the grain-size analysis of uniform sand as well as the mostly rounded shape seen in the soil morphology—which is very similar to the results of Ottawa 20-30 sand—a sand that also has troubles being compacted.

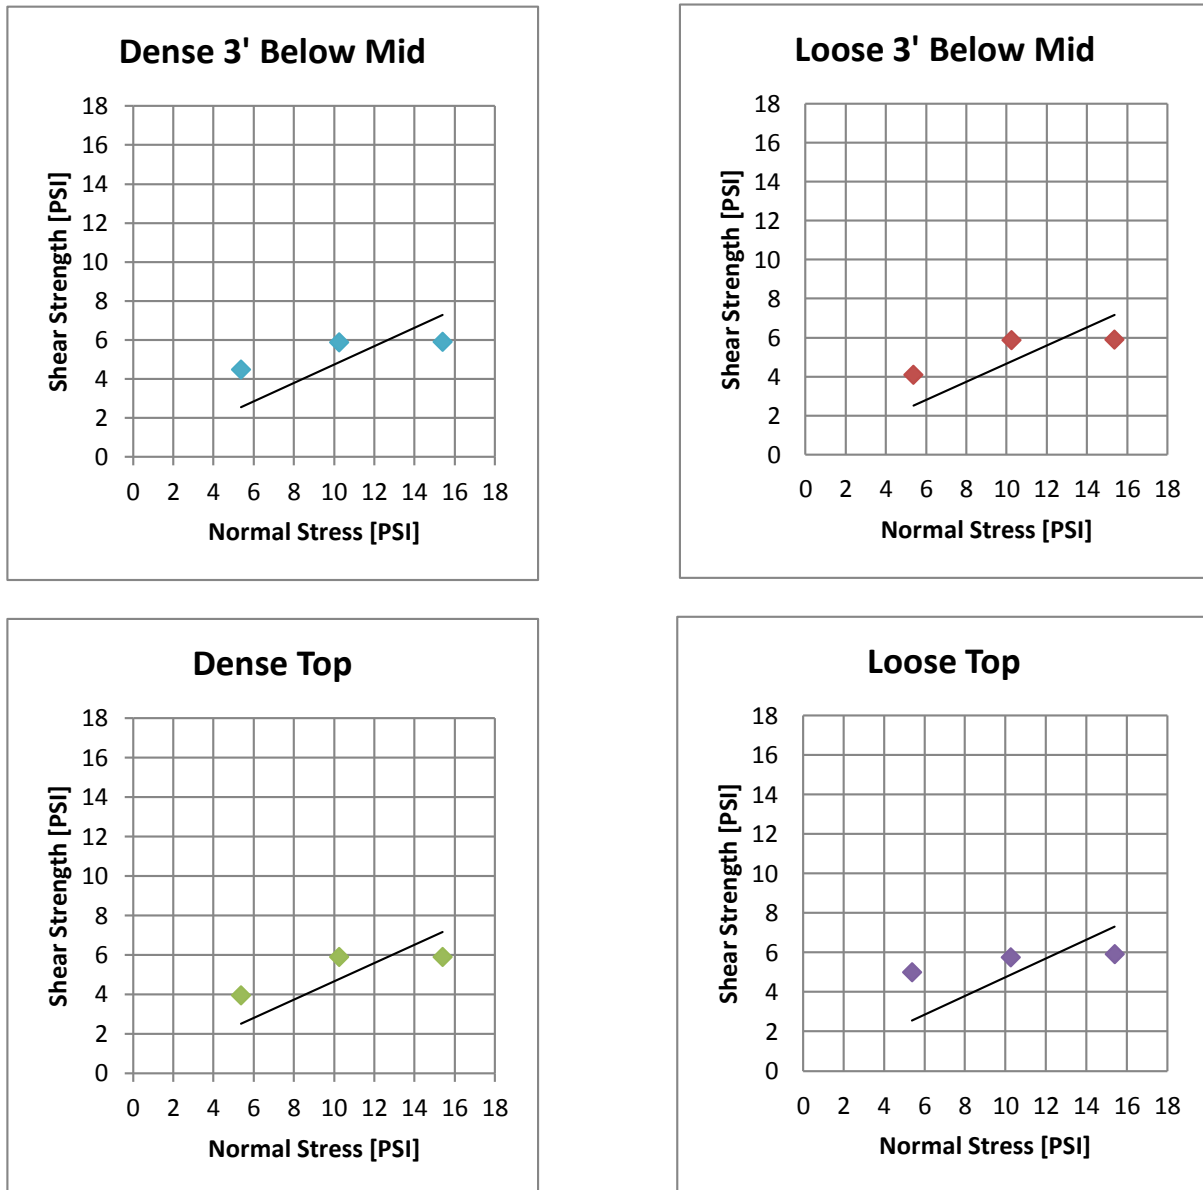
Figure 15: Normal vs. Shear Stress for Dense & Loose Samples of both Top and 3' below Mid Slough

These angles were graphically measured to have an average  $\phi$  of  $24^\circ$ . Considering a  $\phi$  angle of  $24^\circ$  is quite low, an average  $\phi$  was calculated to be about  $30^\circ$ . Table 2 below, shows the graphically interpreted  $\phi$  versus the calculated  $\phi$ .

When looking at Table 2 it becomes obvious that the calculated phi is much higher than the graphically interpreted phi. It is typical to gather useful phi angles from a graphical interpretation because the angle the trendline forms, relative to the horizontal, is the failure envelope. If you were to draw Mohr's circle on these graphs you would be able to tell where the strength of the soil will fail (in shear) with varying values of normal stress, as well as the angle of internal friction (phi)—assuming the grids are perfectly square. Also, since Figure 15 was adjusted manually and is not likely a perfect square; hence the fact that the graphically interpreted method (in this case) is probably not the most accurate.

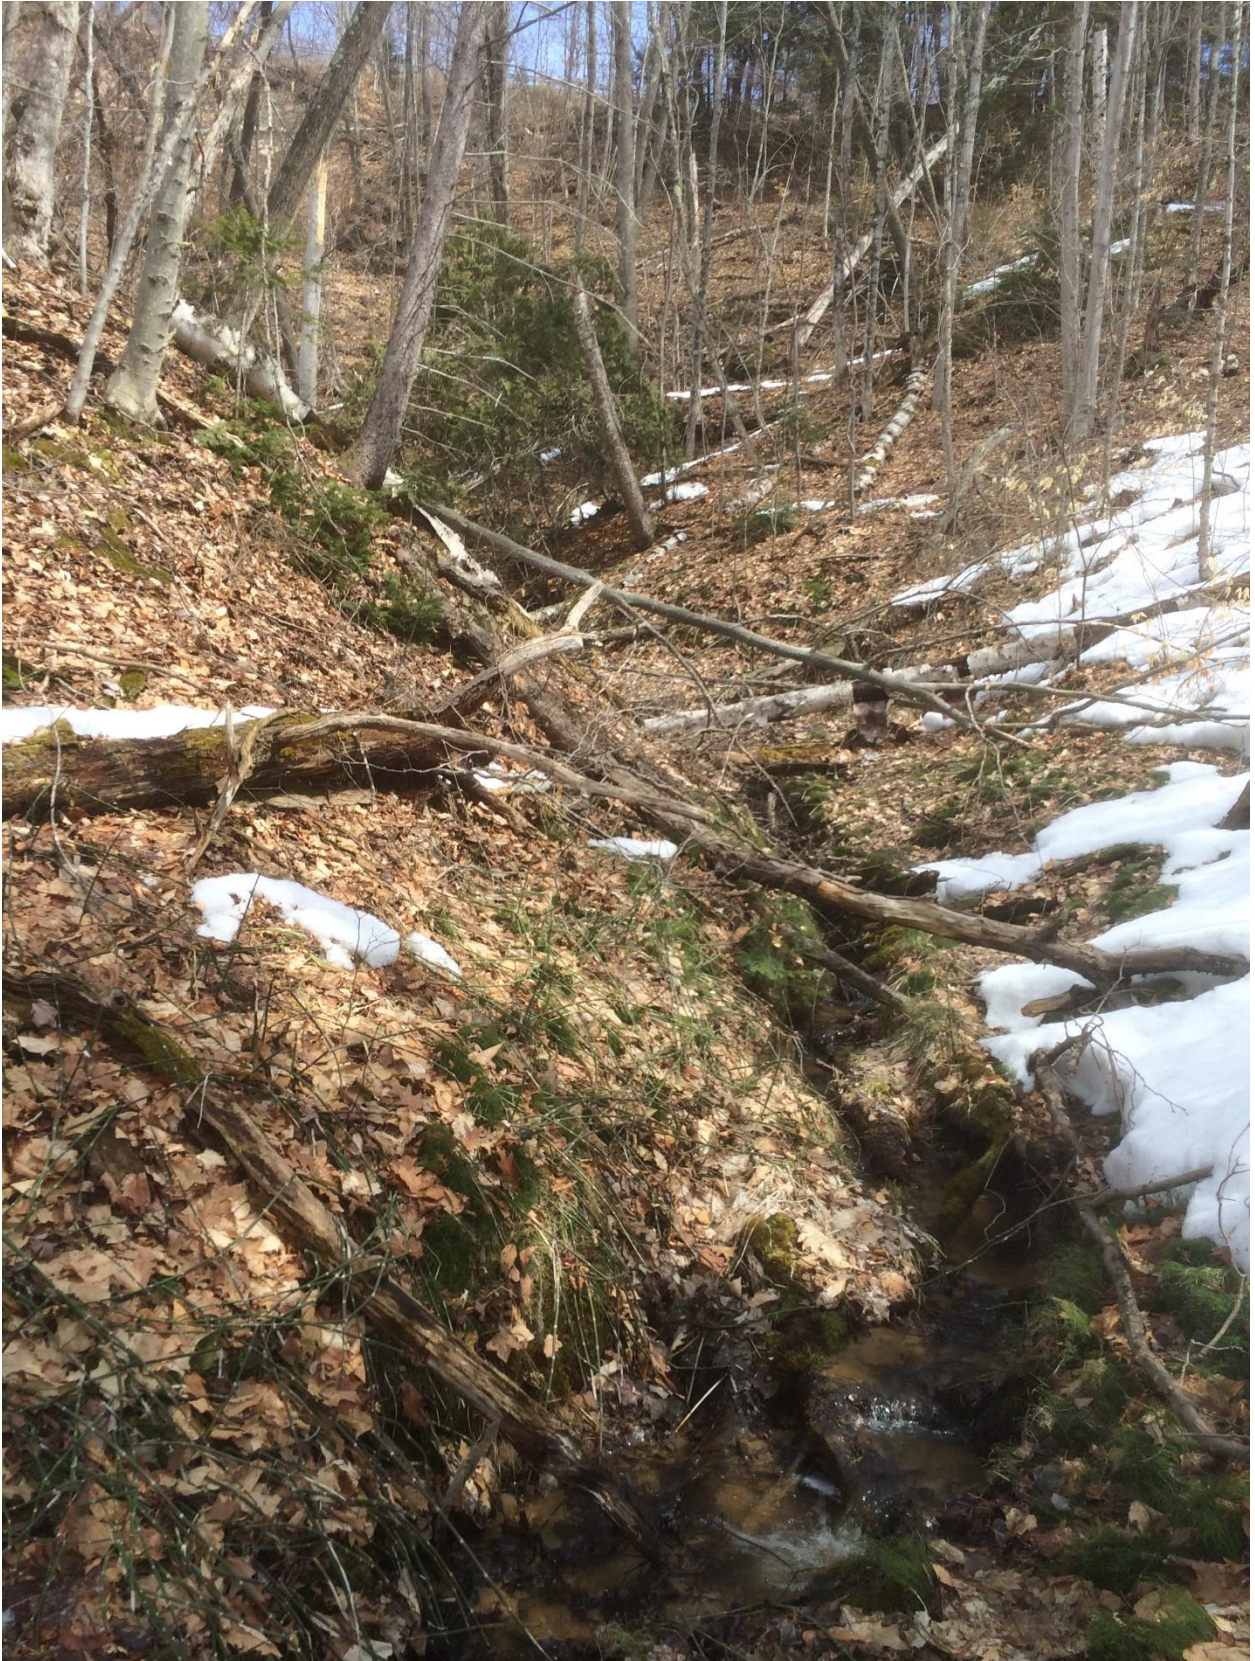
*Water Flow April 2014 (Looking North)*

A small water flow was observed coming out of the slough. The water flow was about 6 inches wide by about 3-4 inches deep and can be seen in Appendix D: Visual Walkthrough, [Small Stream 2012, 2013 respectively (Looking South), Stream April 2014].

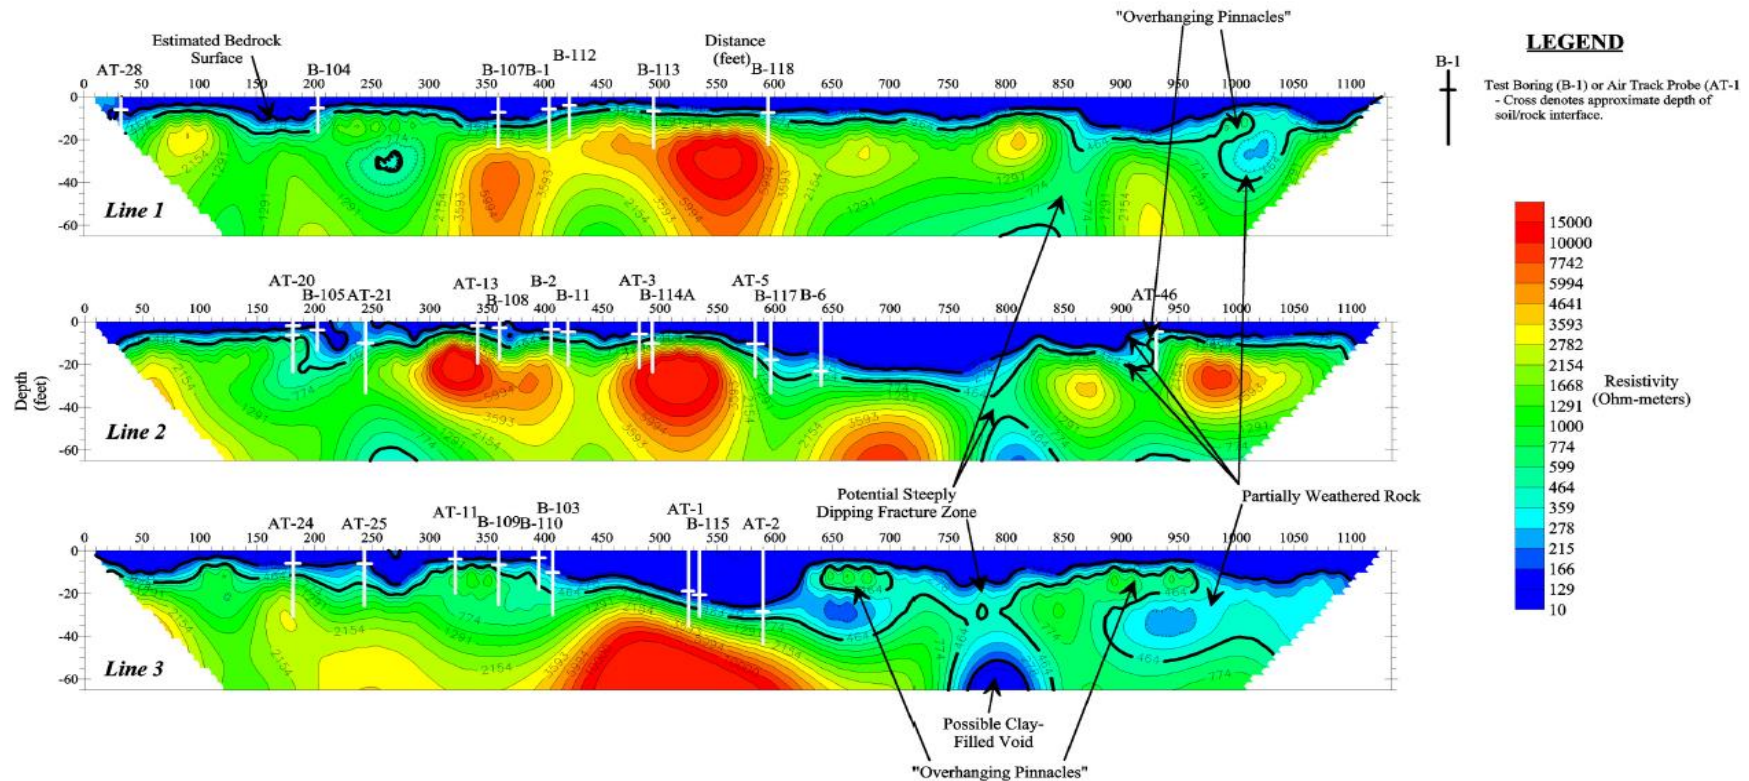
### Bedrock Mapping in Karst Terrain

- › Boring lines show approximate locations and depths. Most borings were not located directly over the resistivity traverse and therefore some variation from the resistivity profile should be expected.
- › Resistivity measurements were obtained at discrete electrode spacings.
- › Resistivity contours were interpolated from the data points.
- › Data was recorded in a dipole-dipole electrode array, using a Sting/Swift automatic resistivity system, with electrodes at 5 meter intervals.

- › The three two-dimensional resistivity profiles presented show correlation between test borings and air track probes and the estimated bedrock surface from resistivity data in karst terrain. The thickened contours show estimated dissintegrated rock and bedrock surfaces, respectively. Areas of very high resistivity were probed and determined to be dry, competent limestone.
