## Local Watershed Analysis for Hubbell and Lake Linden, Michigan

A REPORT

Submitted in partial fulfillment of the requirements for the degree of

In Civil Engineering

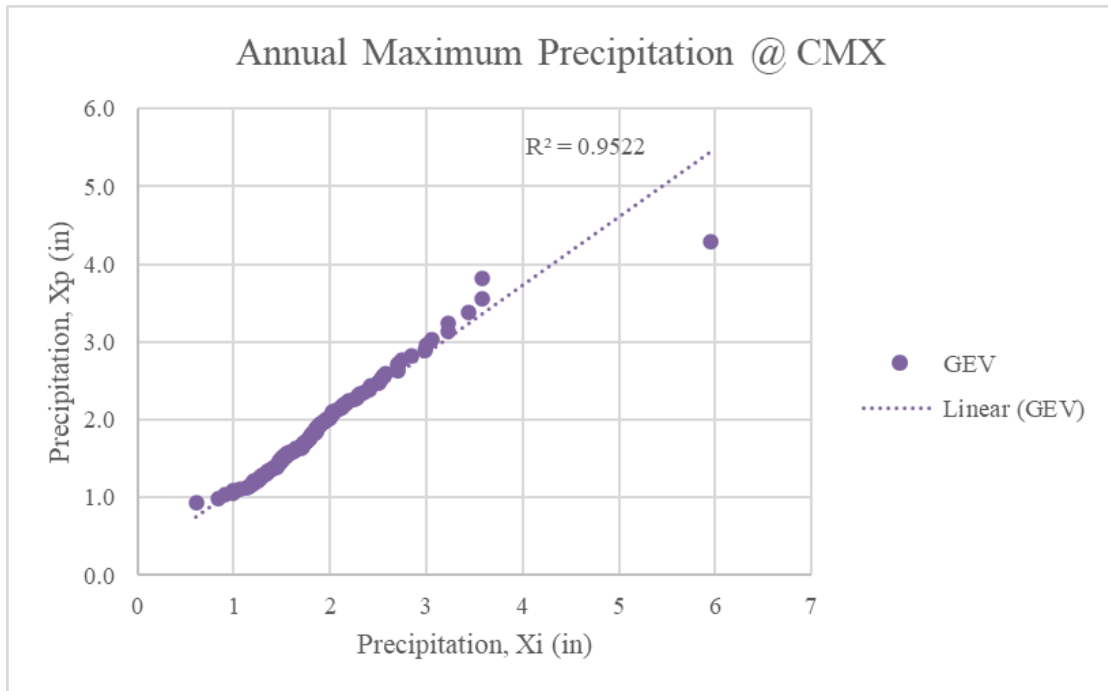
Figure 2.4. Generalized Extreme Value Plot.

Gumbel, Log-Pearson III (LP3), and Generalized Extreme Value (GEV) distribution models were used to predict the recurrence frequency for the Father's Day storm event. Annual maximum precipitation data for the Hancock Houghton County Airport (CMX or Houghton AP) is provided by the National Oceanic and Atmospheric Administration (NOAA), National Weather Service (NWS) [3] and the Western Regional Climate Center (WRCC) [4]. Specifically, precipitation data was obtained using stations COOP 201213, 203908, 201215 (Calumet 1887-1937), and GHCND-USW0014858. Figures 2.4, 2.5, and 2.6 show quantile-quantile plots for GEV, Gumbel, and LP3 distributions. A linear trendline and R-squared analysis is used to assess each probability model. R-squared values of 0.95, 0.93, and 0.86 were computed for GEV, Gumbel, and LP3 models, respectively. Results indicate the GEV distribution using L-moment parameters best modeled annual maximum rainfall events observed at CMX over the past 133 years. This model can be used to estimate the recurrence frequency for an X-year rainfall event within USGS HUC-12 Torch Lake Watershed, and thus, local level watersheds at the Site as well. For the 50, 100, 500, and 1000-year rainfall event, the GEV distribution model estimates approximately 3.6, 4.1, 5.3, and 5.86 inches of precipitation, respectively. On June 17, 2018, Keweenaw Research Center (KRC) weather station recorded 6.72 inches of rainfall in 24-hours [5] and NOAA CMX weather station recorded 5.86 inches of rainfall in 24-hours [3]. NOAA precipitation frequency tables currently designate 6.79 inches of rainfall for the 1000-year 24-hour rainfall event [6]. Refer to Appendix B: Calculations.

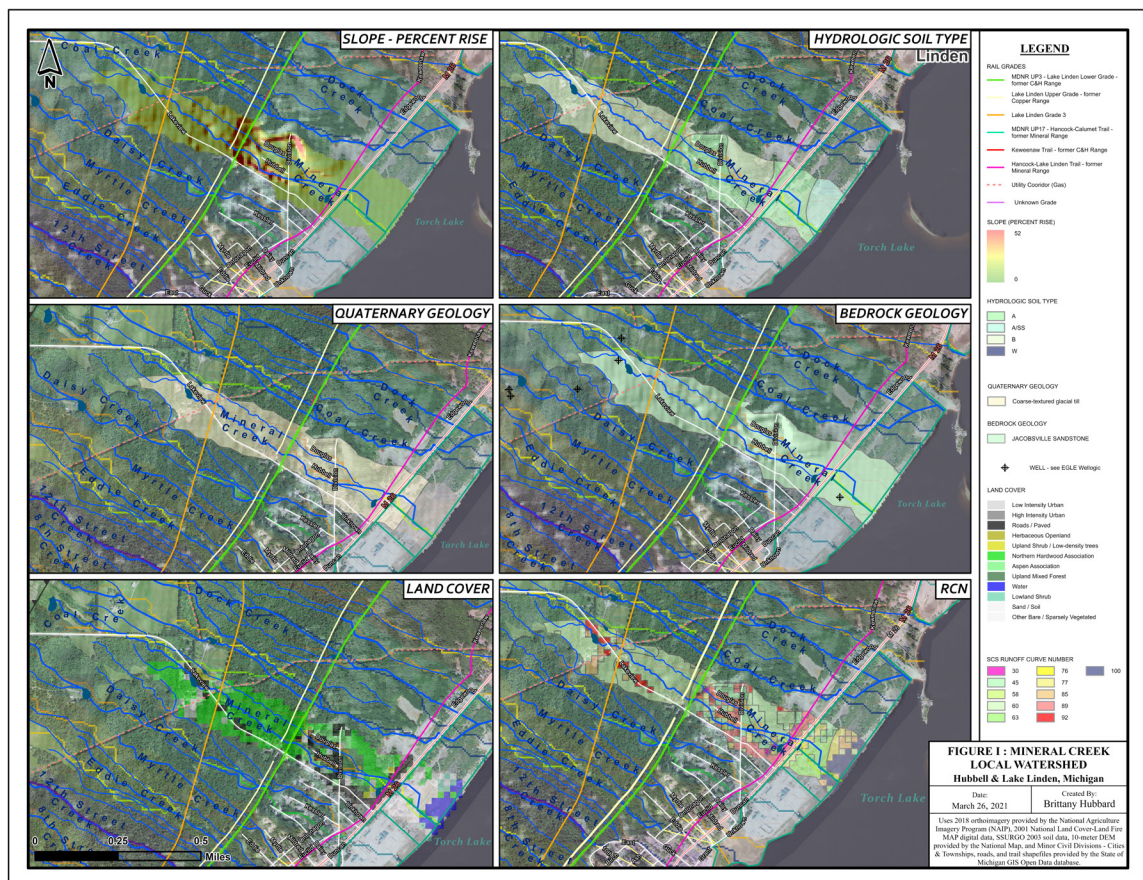
Figure 3.10. Mineral Creek Local Watershed Characteristics.

Mineral Creek local watershed ranges from 602 feet to 942 feet MSL. The main hydrologic soil group is type B in the hillside region. Developed urban areas in the lower region consist of soil type A and stamp sands. Bedrock geology is Jacobsville Sandstone and quaternary geology is primarily coarse-textured glacial till. Land use is primarily northern hardwood, barren, and residential. Twenty-one percent of the land use in the lower region is occupied by impervious surfaces. The weighted average RCN for the local watershed is 68. Subdivided into hillside and lower regions, the weighted average RCN becomes 64 and 70, respectively.

Refer to Figure 3.10. Mineral Creek Local Watershed Characteristics, Figure 3.1, Figure 2.3, Figure 4.30. Mineral Creek Drainage and LID, and Table A.1 for details.

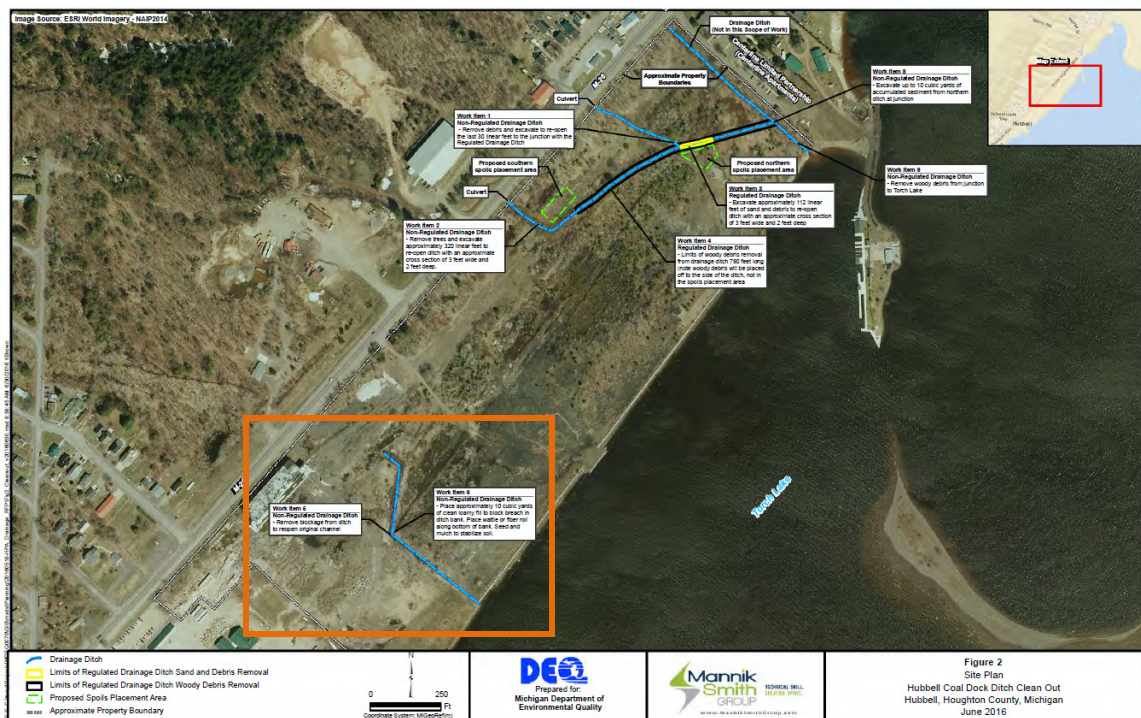
Figure 4.39. MSG Coal Dock Ditch Clean Out Site Plan [18]. Modified by author.

Downstream from M-26, a drainage ditch, identified as being cleaned out by the EGLE abandoned mining waste project as recently as 2017 [18], exists to convey stream flow through the former coal docks property to the outlet at Torch Lake. Excess runoff exceeding drainage ditch banks uses the historical coal docks mining property as a floodplain. The partially vegetated property contains contaminated stamp sands and is prone to erosion. Drainage ditches are recommended to be inspected and maintained often as sediment accumulation may be more likely due to commercially used barren land upstream and historical stamp sands on site. Prior to the stream outlet into Torch Lake, a sedimentation basin or infiltration trench is suggested on the coal docks property to contain transporting sediments and pollutants on-site.

Refer to Figure 4.30. Mineral Creek Drainage & Suggested Locations for LID, Figures 4.31 and 4.32. 2018 L Avenue culvert plan and profile by the Houghton County Road Commission, Figure 4.39. 2016 Mannik Smith Group Hubbell Coal Dock Drainage Ditch

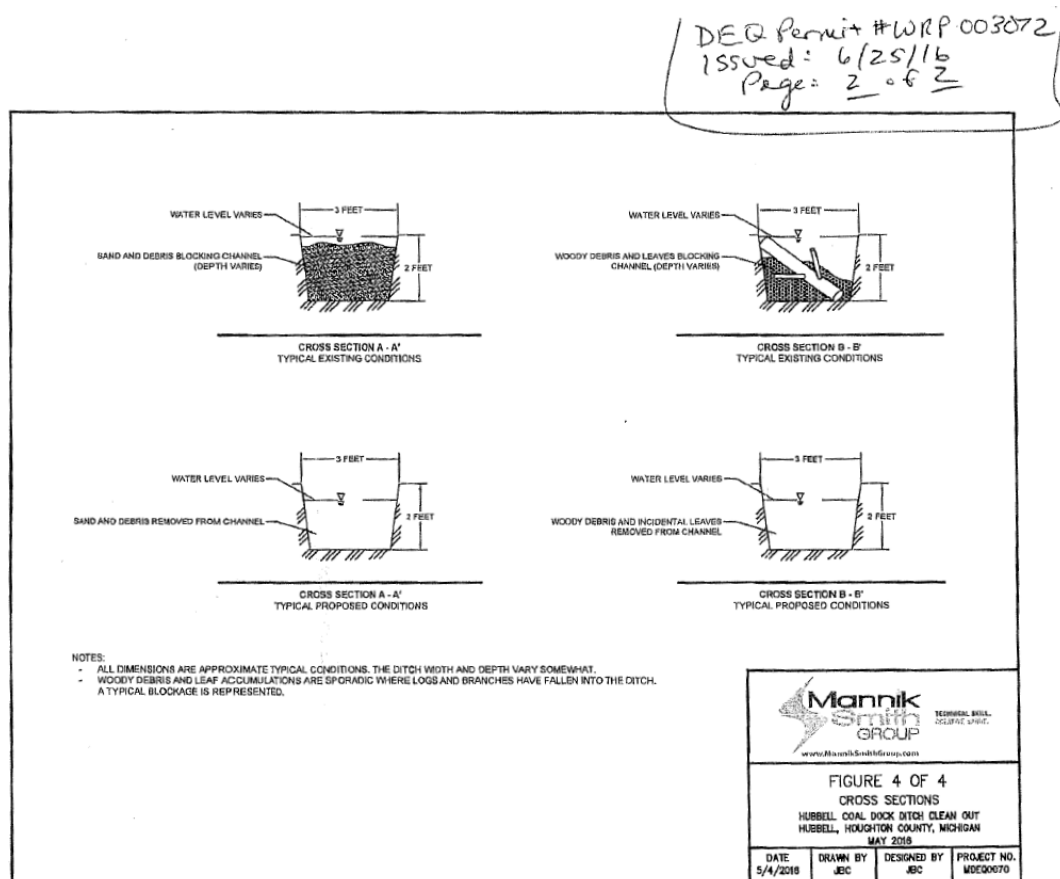
Figure 4.45. MSG Coal Dock Ditch Clean Out Site Plan [18]. Modified by author.

Refer above to Figure 4.40. Coal & Dock Creek Drainage & Suggested Locations for LID, Figure 4.45. MSG Coal Dock Ditch Clean Out Site Plan, and below to Figure 4.47. MDNR Rail Grade Plan – North Hubbell, Coal Docks, & South Lake Linden, and Figure 4.48. Dock Creek Stream Restoration at Northern Natural Gas Utility Pipeline provided by EGLE MiWaters [18].

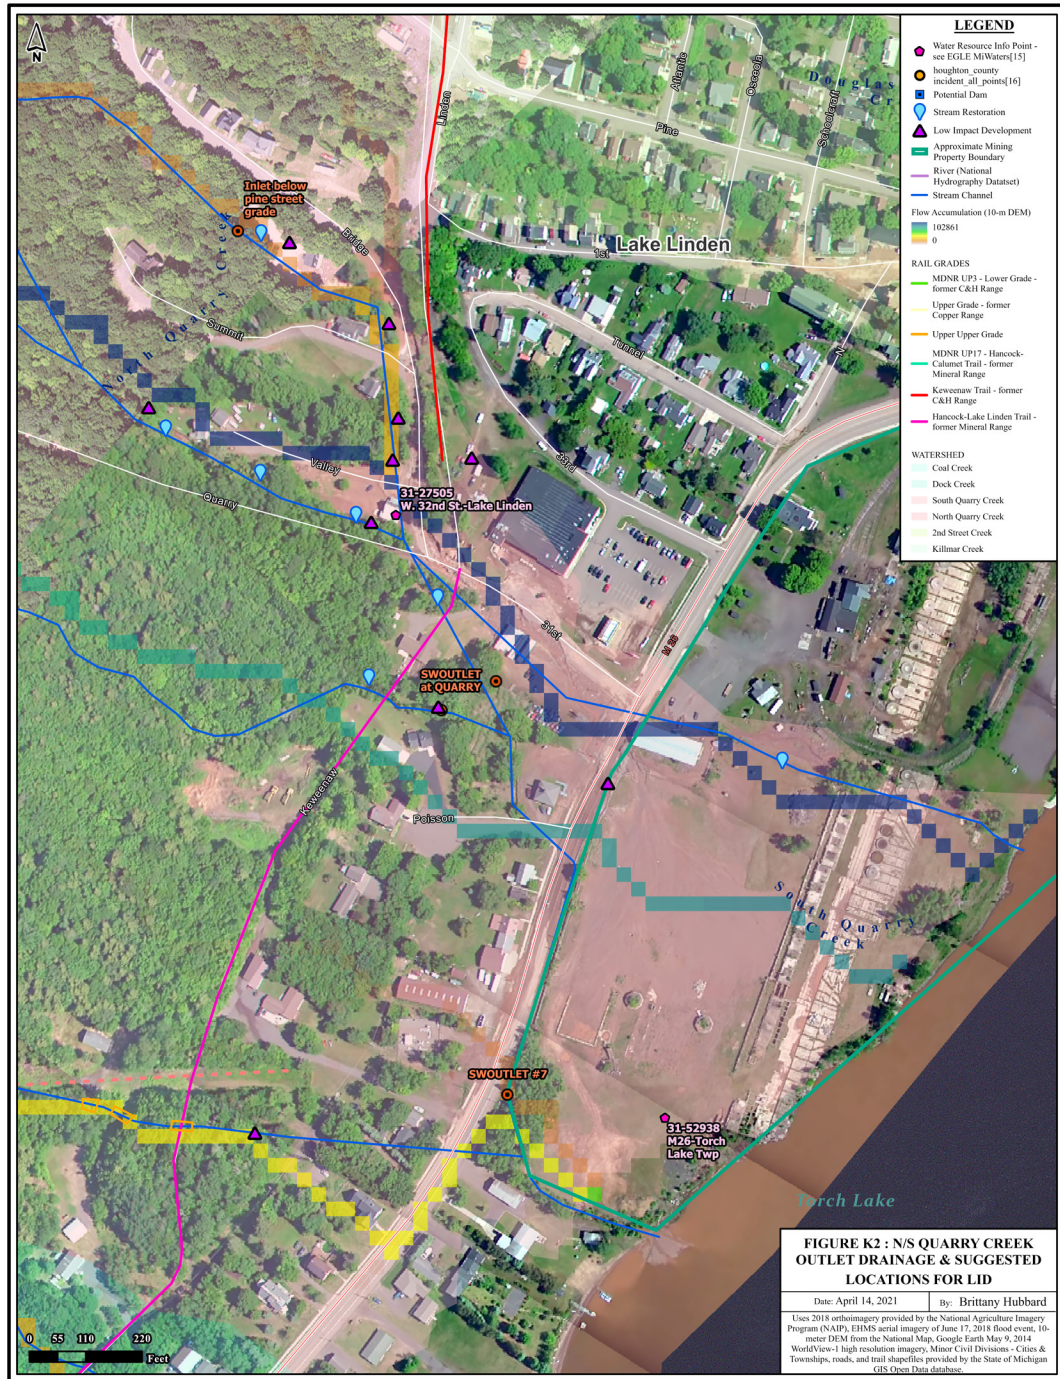
Figure 4.50. North & South Quarry Creek Drainage & Suggested Locations for LID.

Refer below to Figure 4.50. North & South Quarry Creek Drainage & Suggested Locations for LID and Figure 4.49. Quarry Creek Outlet Channel Easement showing drainage channel easement on residential property provided by EGLE MiWaters database [18].

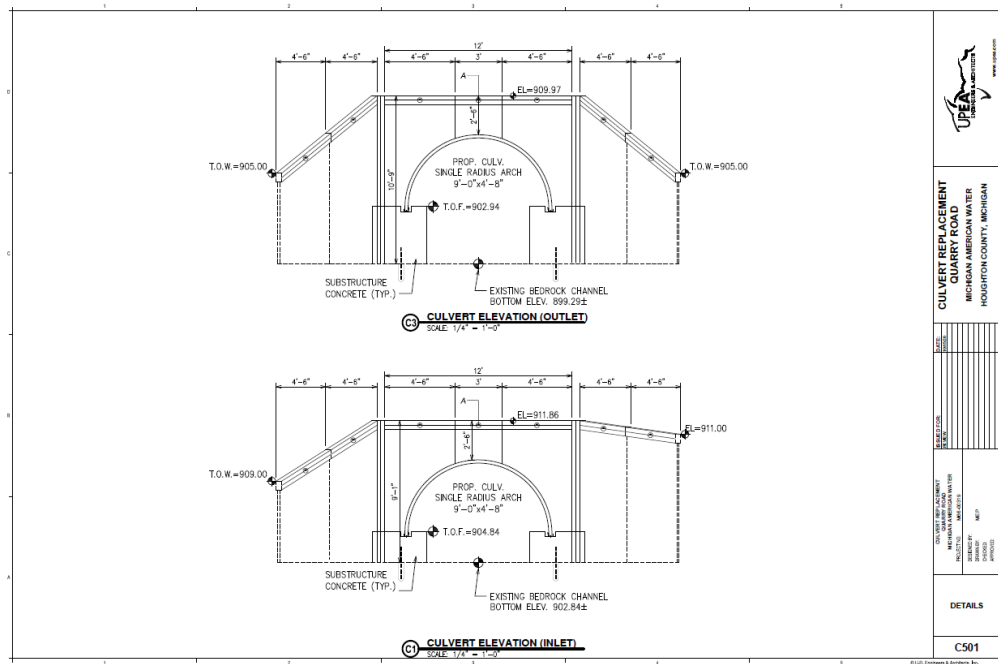
Figure 4.52. UPEA Quarry Creek at Quarry Rd Culvert Site Plan [18].

Refer below to Figure 4.51. N/S Quarry Creek Outlet Drainage & Suggested Locations for LID and Figures 4.52 through 4.56. Quarry Creek at Quarry Road Culvert Replacement figures designed by Upper Peninsula Engineers & Architects (UPEA) provided by EGLE MiWaters database [18].

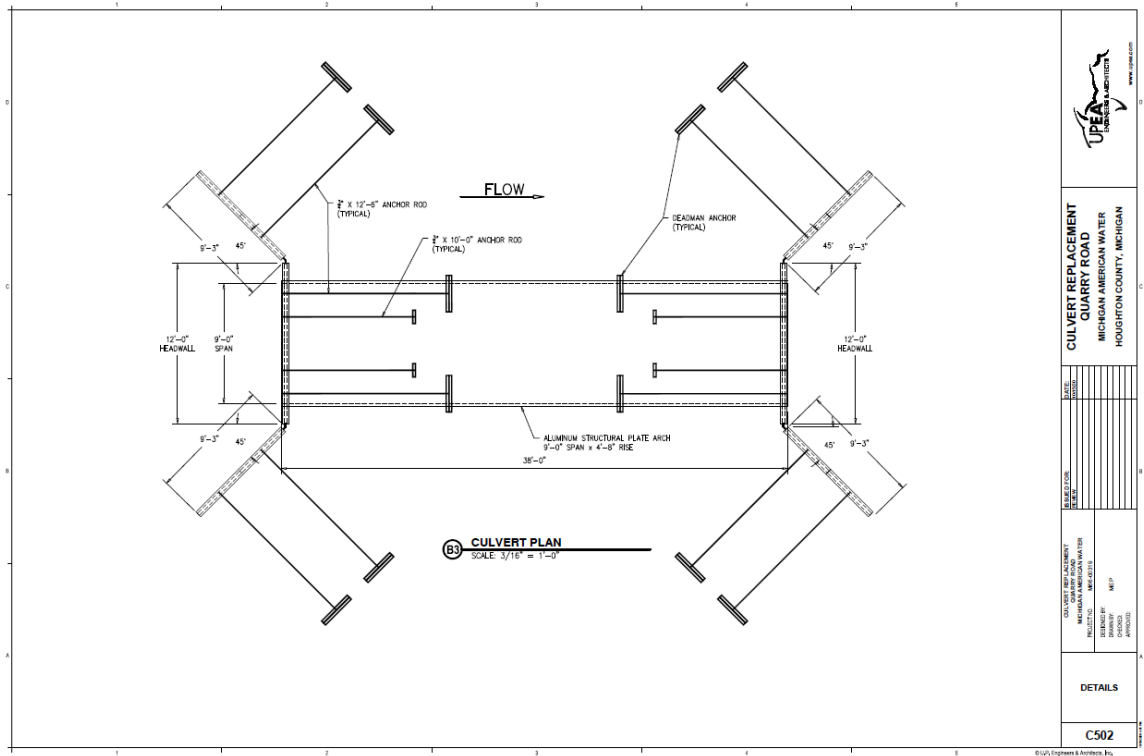
Figure 4.53. UPEA Quarry Creek at Quarry Rd Culvert Inlet-Outlet Plan [18].

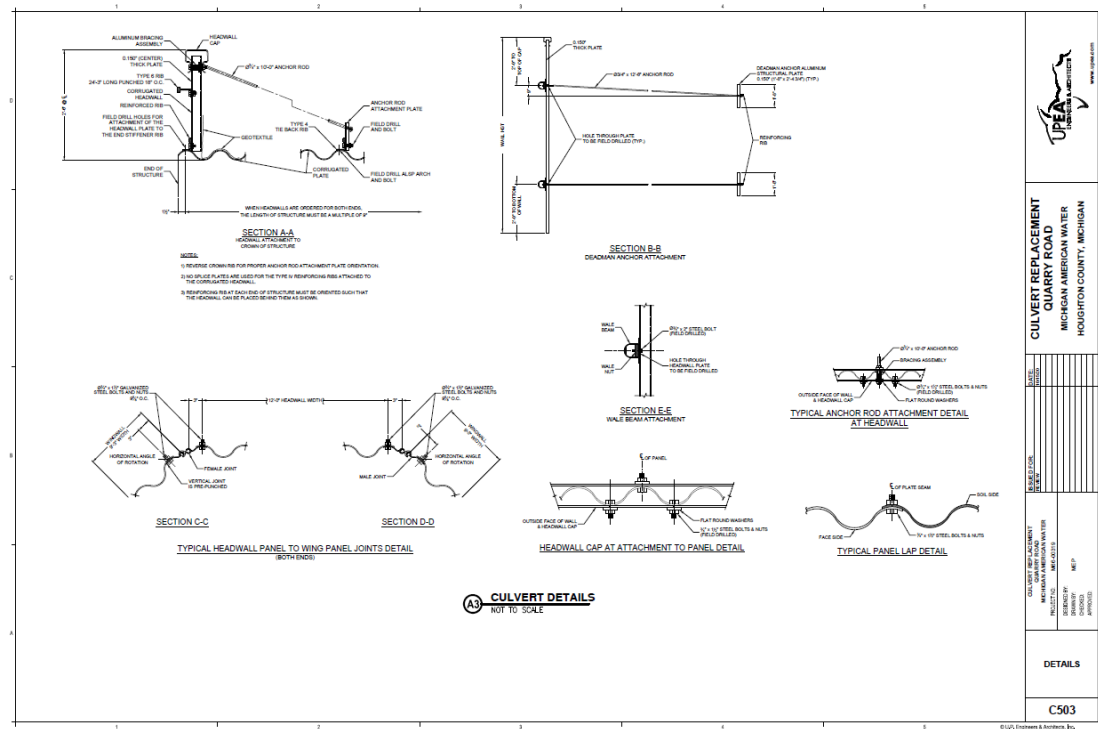
Figure 4.54. UPEA Quarry Creek at Quarry Rd Culvert Plan [18].

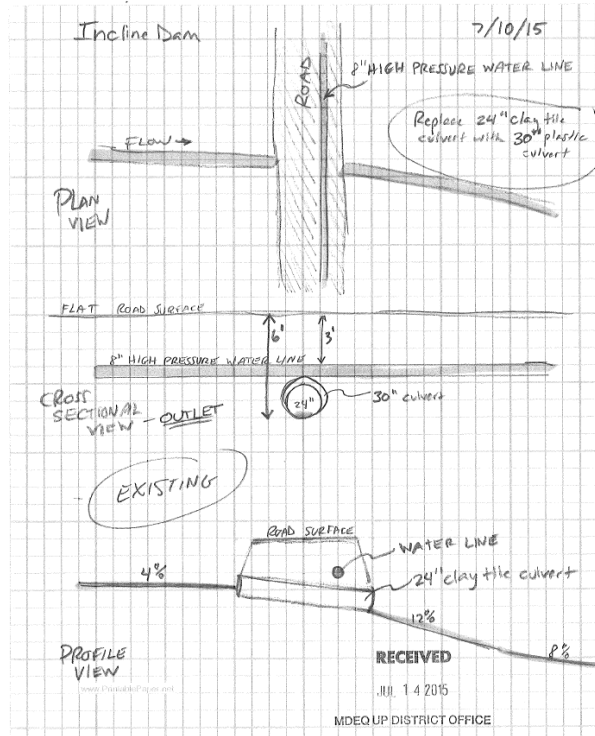
Figure 4.59. AFM Douglas-Houghton Creek at Quarry Rd Culvert Location Map [18].

Refer below to Figure 4.58. Douglas Houghton Creek Outlet Drainage & Suggested Locations for LID and Figure 4.57. Douglas-Houghton Creek at Quarry Rd Culvert Summary, Figure 4.59. AFM Douglas-Houghton Creek at Quarry Rd Culvert Location Map, and Figures 4.60 and 4.61. Douglas-Houghton Creek at Quarry Rd Proposed & Existing Culvert plans provided by EGLE MiWaters database [18].

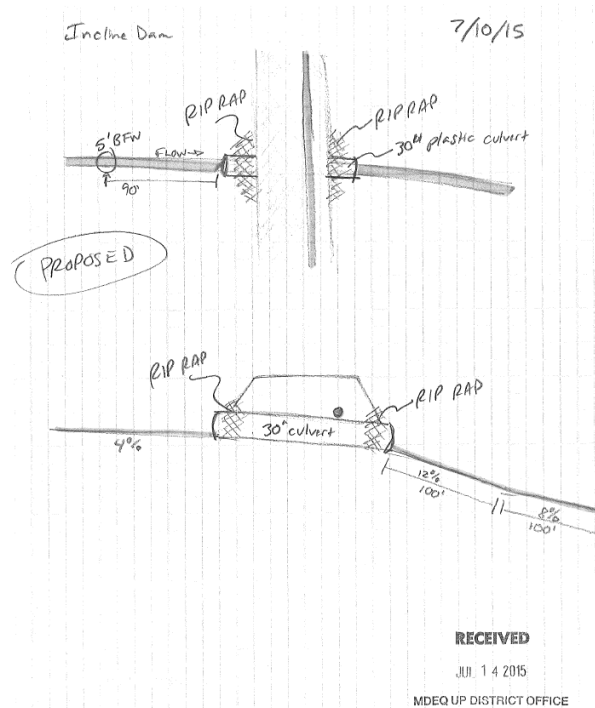
Figure 4.60. Douglas-Houghton Creek at Quarry Rd Existing Culvert [18].

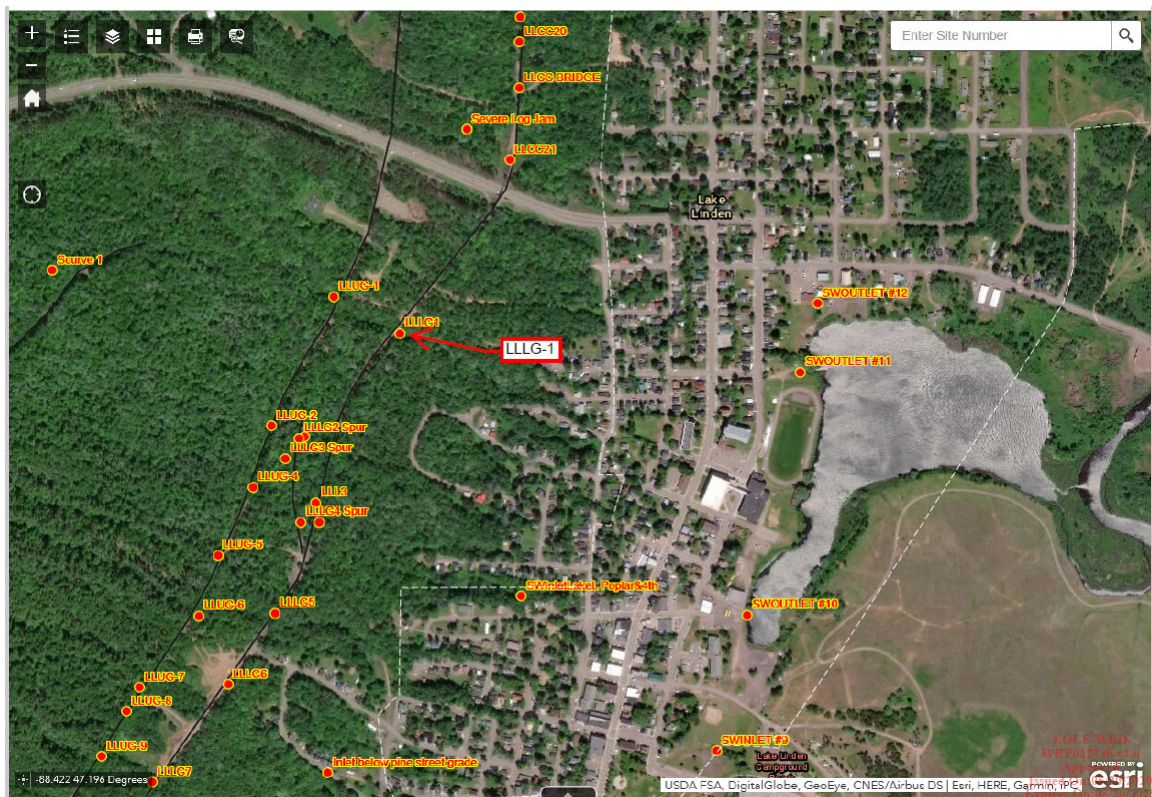
Figure 4.62. MDNR Rail Grade Plan - Lake Linden [18].

Refer below to Figure 4.63. Kilmar Creek Outlet Drainage & Suggested Locations for LID and Figure 4.62 MDNR Rail Grade Plan – Lake Linden.

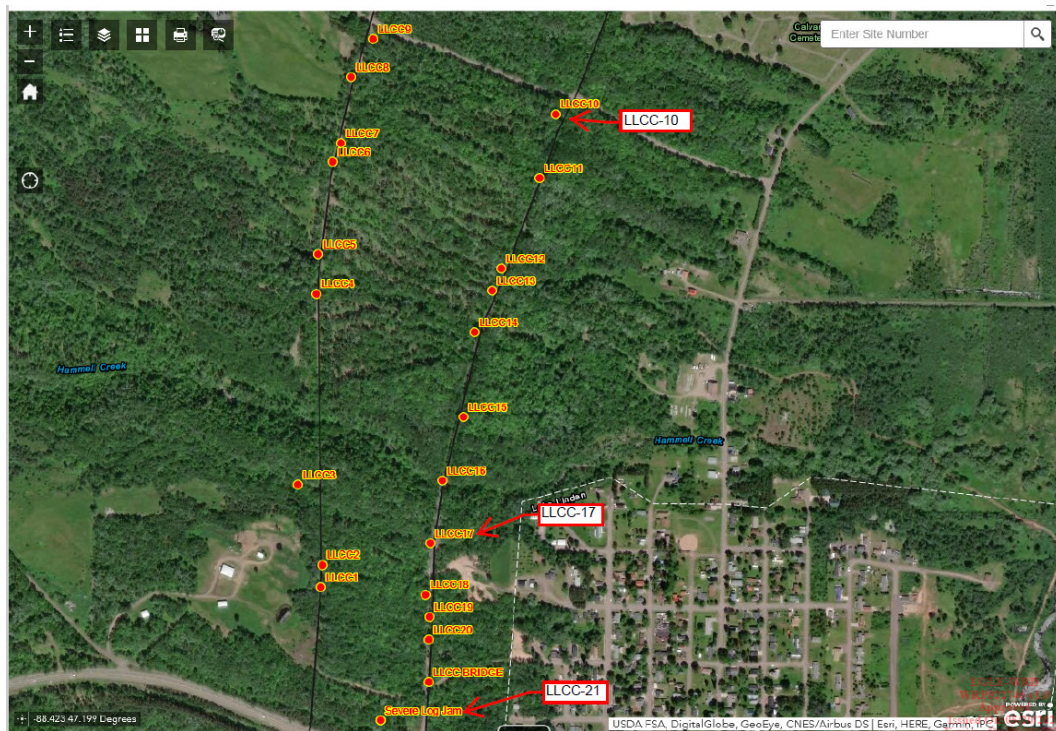
Figure 4.66. MDNR Rail Grade Plan – North Lake Linden [18].

Refer below to Figure 4.67. Henwood Creek Outlet Drainage & Suggested Locations for LID, Figure 4.66. MDNR Rail Grade Plan – North Lake Linden, and Figure 4.68. OHM – MDNR Rail Grade Plan – LLCC21 [18].
