Archaeological Investigations And Historical Survey, Fort Wilkins Historic State Park: Keweenaw County, Michigan

ARCHAEOLOGICAL INVESTIGATIONS AND HISTORICAL
SURVEY, FORT WILKINS HISTORIC STATE PARK:
KEWEENAW COUNTY, MICHIGAN

Submitted in partial fulfillment of the requirements for the degree of
MASTER OF SCIENCE
In Industrial Archaeology

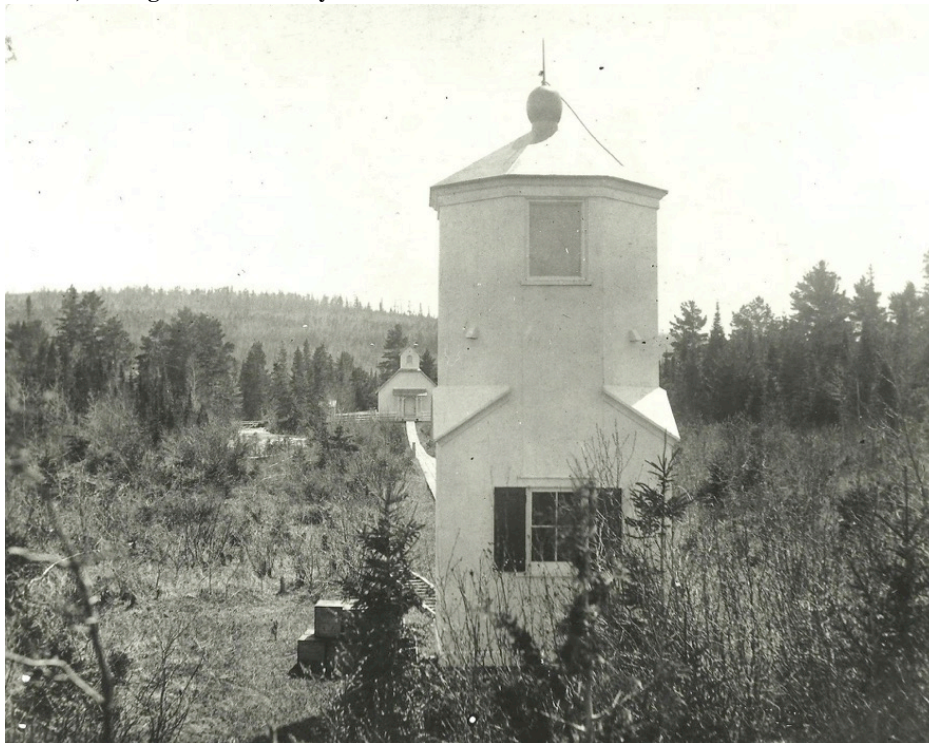
Figure 7. The front range light as built. Photograph from 1912. Image courtesy of the Michigan Historical Center, Michigan Iron Industry Museum.

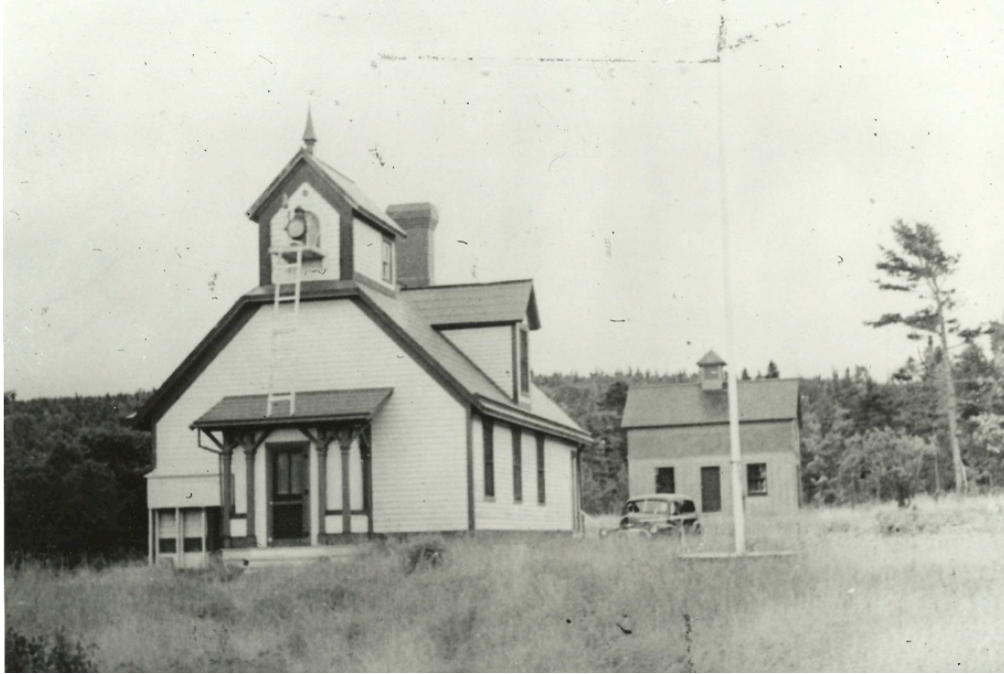
Figure 10. 1945 Photograph showing electric lamp mounted outside of original light bay. Also note lack of fencing. Image courtesy of the Michigan Historical Center, Michigan Iron Industry Museum.

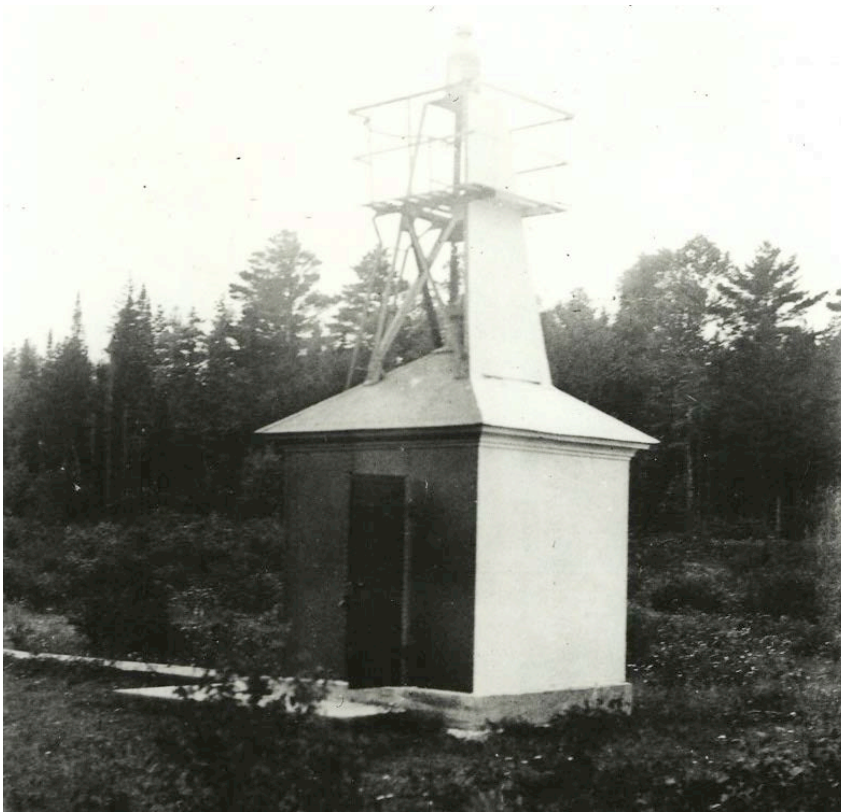
Figure 11. 1924 Photograph showing the new front range. Image courtesy of the Michigan Historical Center, Michigan Iron Industry Museum.

lighthouses at Copper Harbor.⁵⁷ In 1924, the original wooden front range was replaced by an iron box-like structure which remains in place today. Following Davis' retirement Charles Haven served as keeper from September 1, 1930 to June 30, 1937. By the time Haven retired from his position the Copper Range Lighthouse was no longer of much importance as noted by the District 11 Superintendent who said that it was only being operated for "aged and deserving keepers" who were unable to work at more difficult stations.

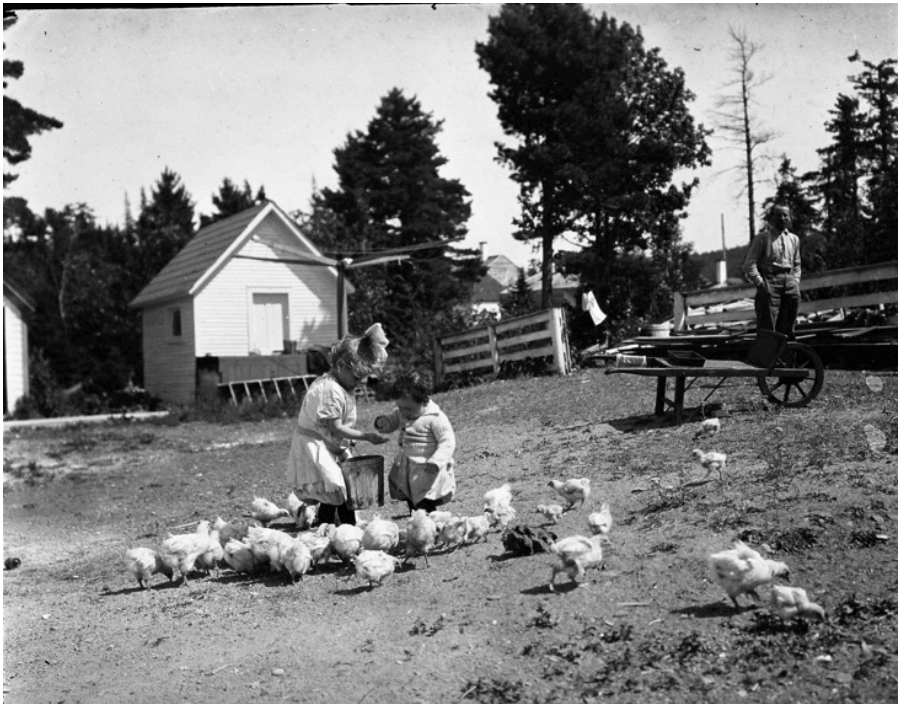
Figure 19. Photograph showing washhouse with privy just in frame to left. Note fencing and paved walkway. Unknown date. Image courtesy of the Michigan Historical Center, Michigan Iron Industry Museum.

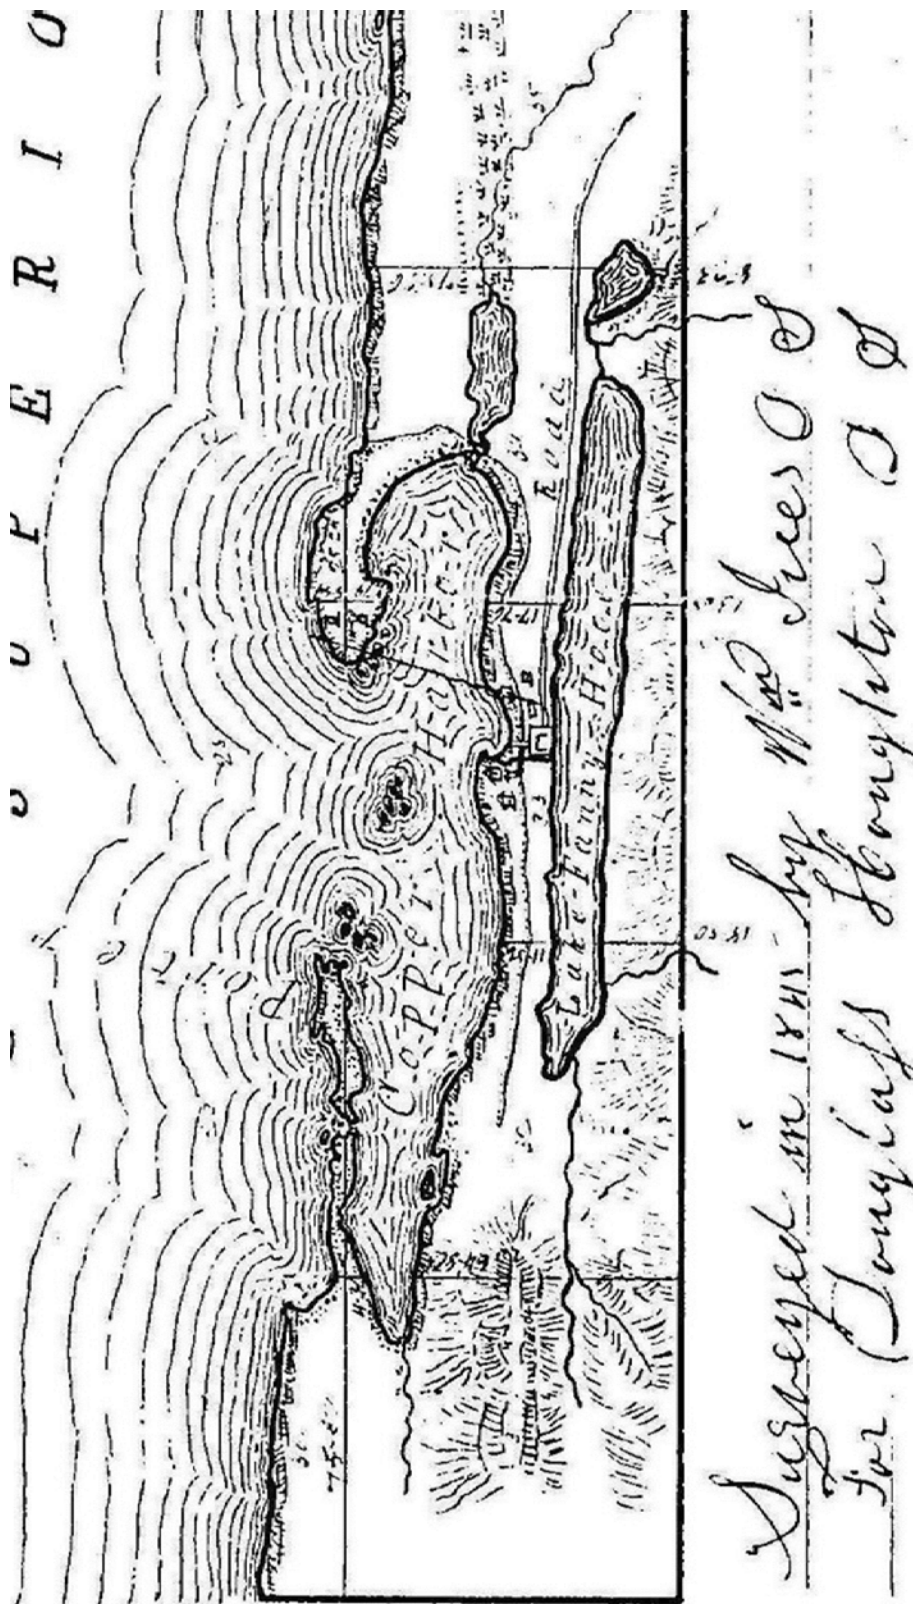
Figure 25. 1845 William Ives Survey Map. Note building on North of Fort Wilkins on the West Side of Fanny Hooe Creek. Probable depiction of the Astor House. Image courtesy of the Michigan Technological University and Copper Country Archives.

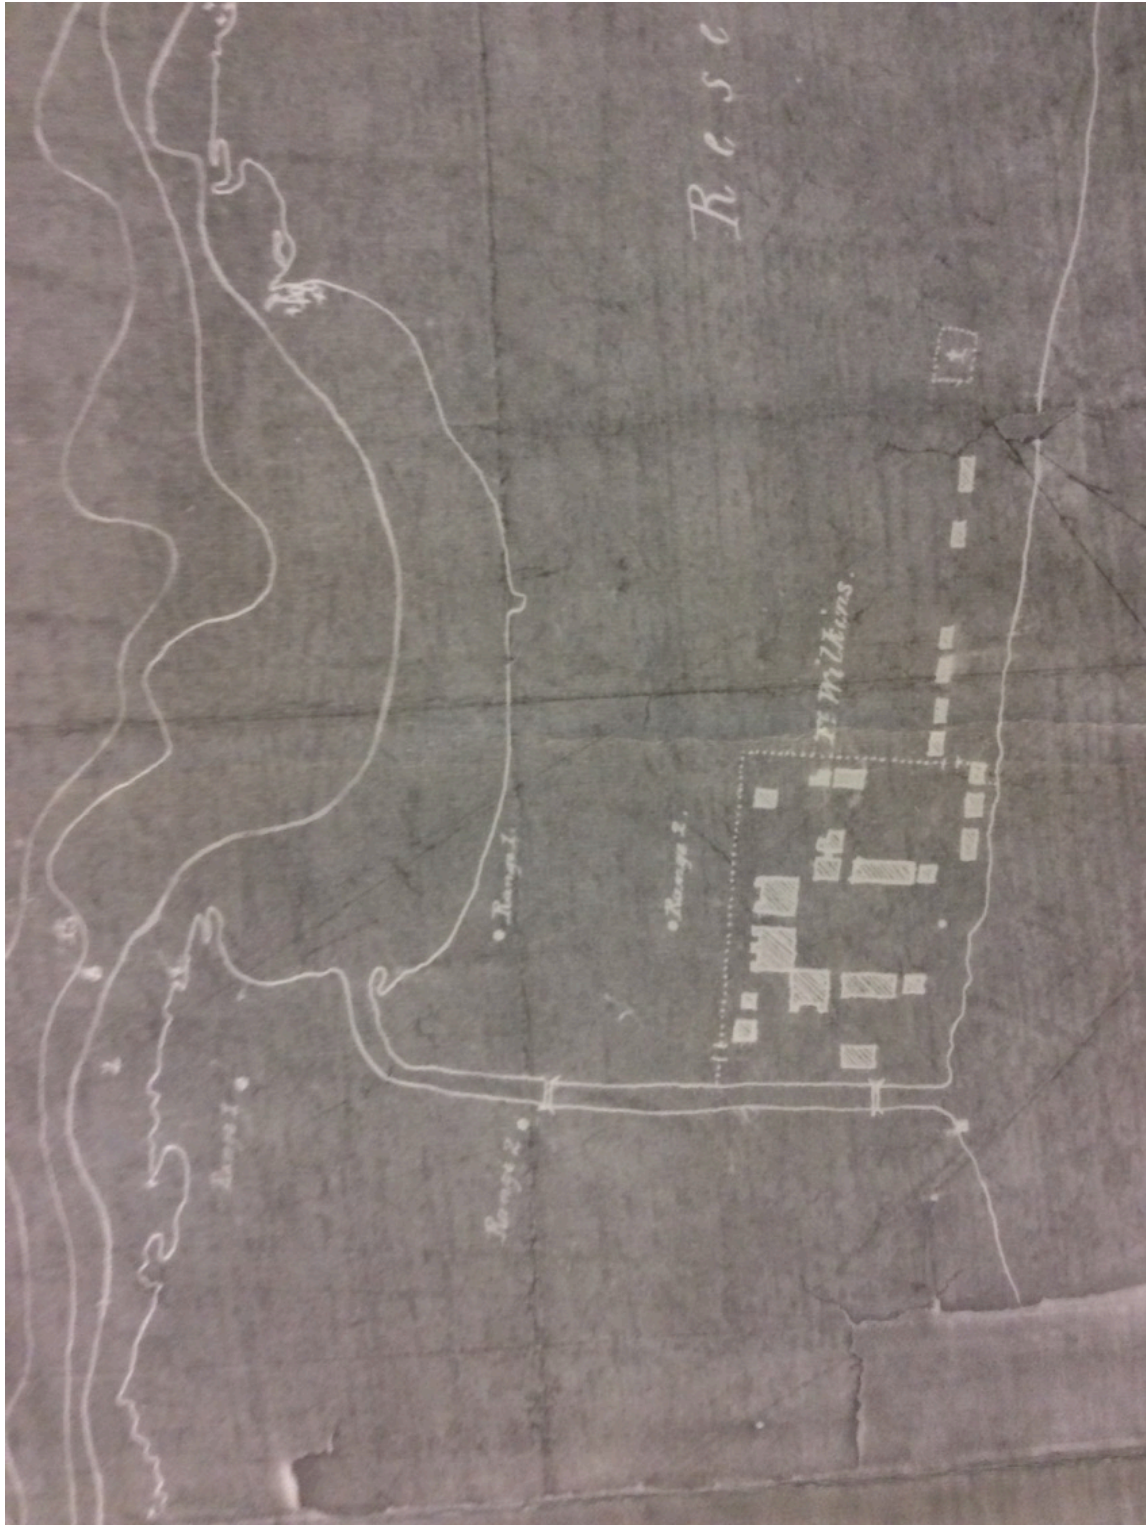
Figure 29. From the records of the Lake Survey. Wm. F. Reynolds, Fort Brady, Office Lake Survey, Detroit, February 28, 1865. Bridge visible near "Range 2". Image courtesy of the Michigan Historical Center, Michigan Iron Industry Museum.

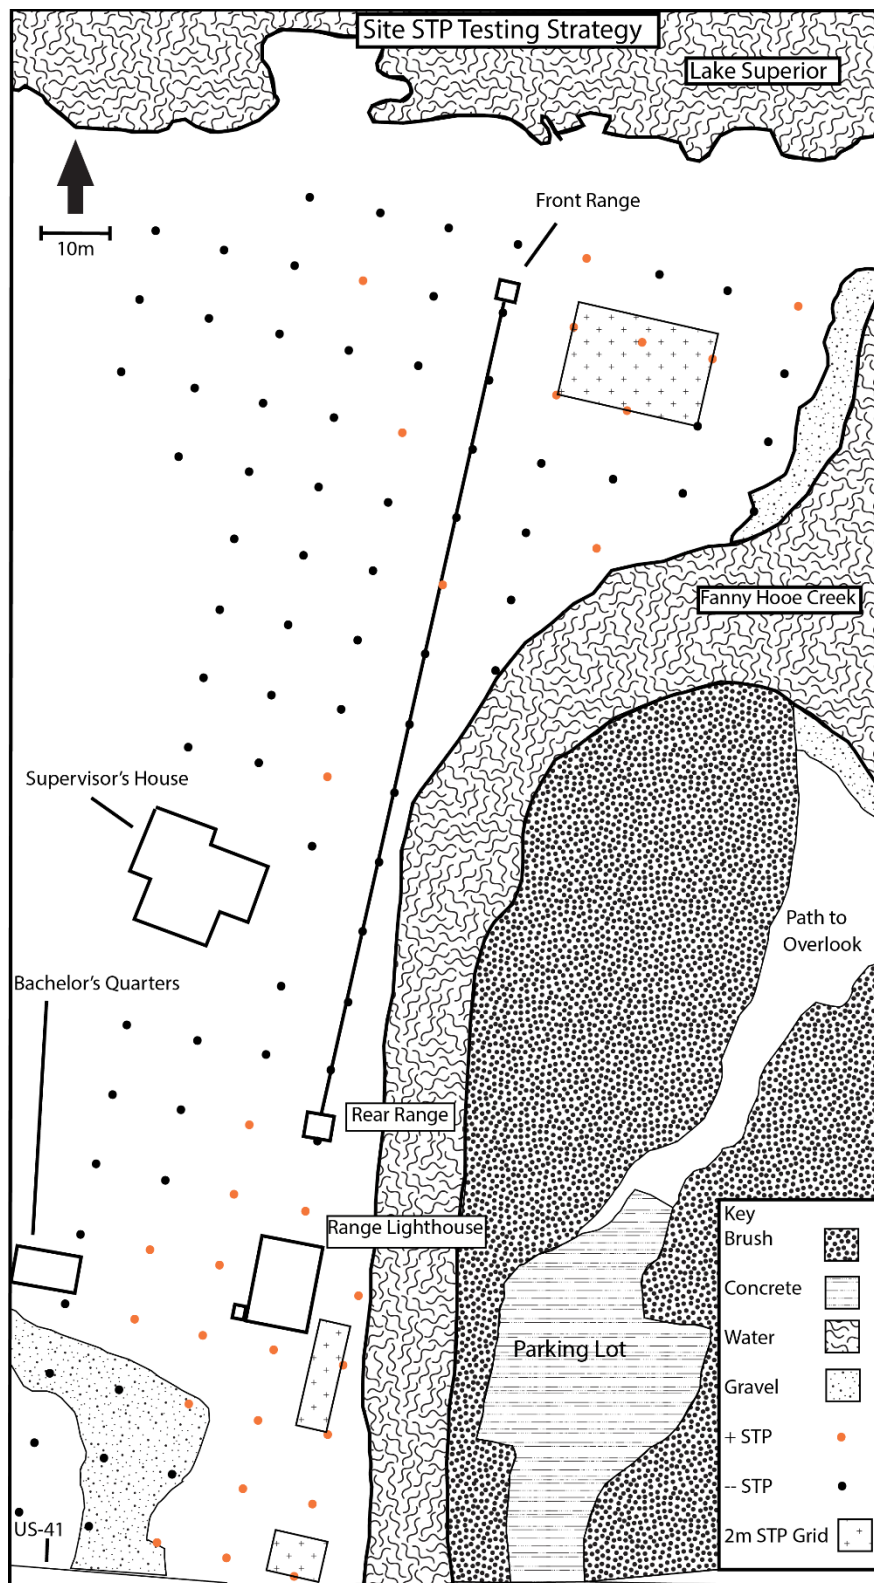
Figure 33. STP testing strategy. Ground cover in testing area omitted for clarity. Map by author, 2015.

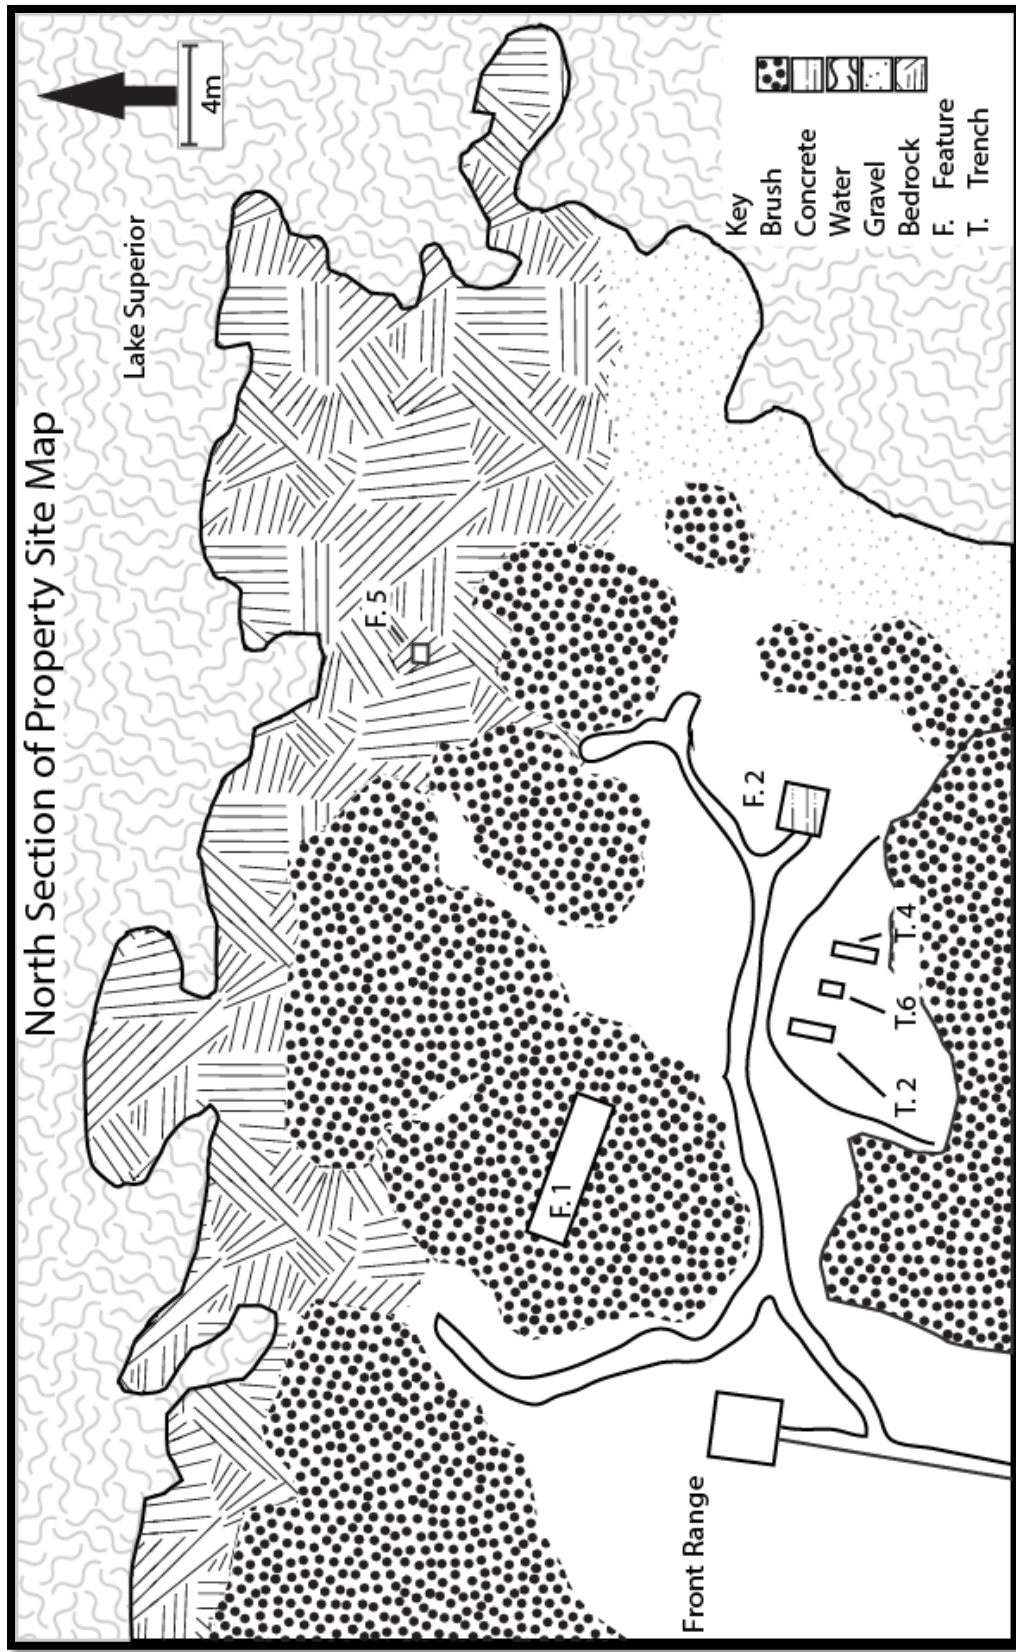
Figure 36. North Section of Property Site Map. Map by author, 2015.

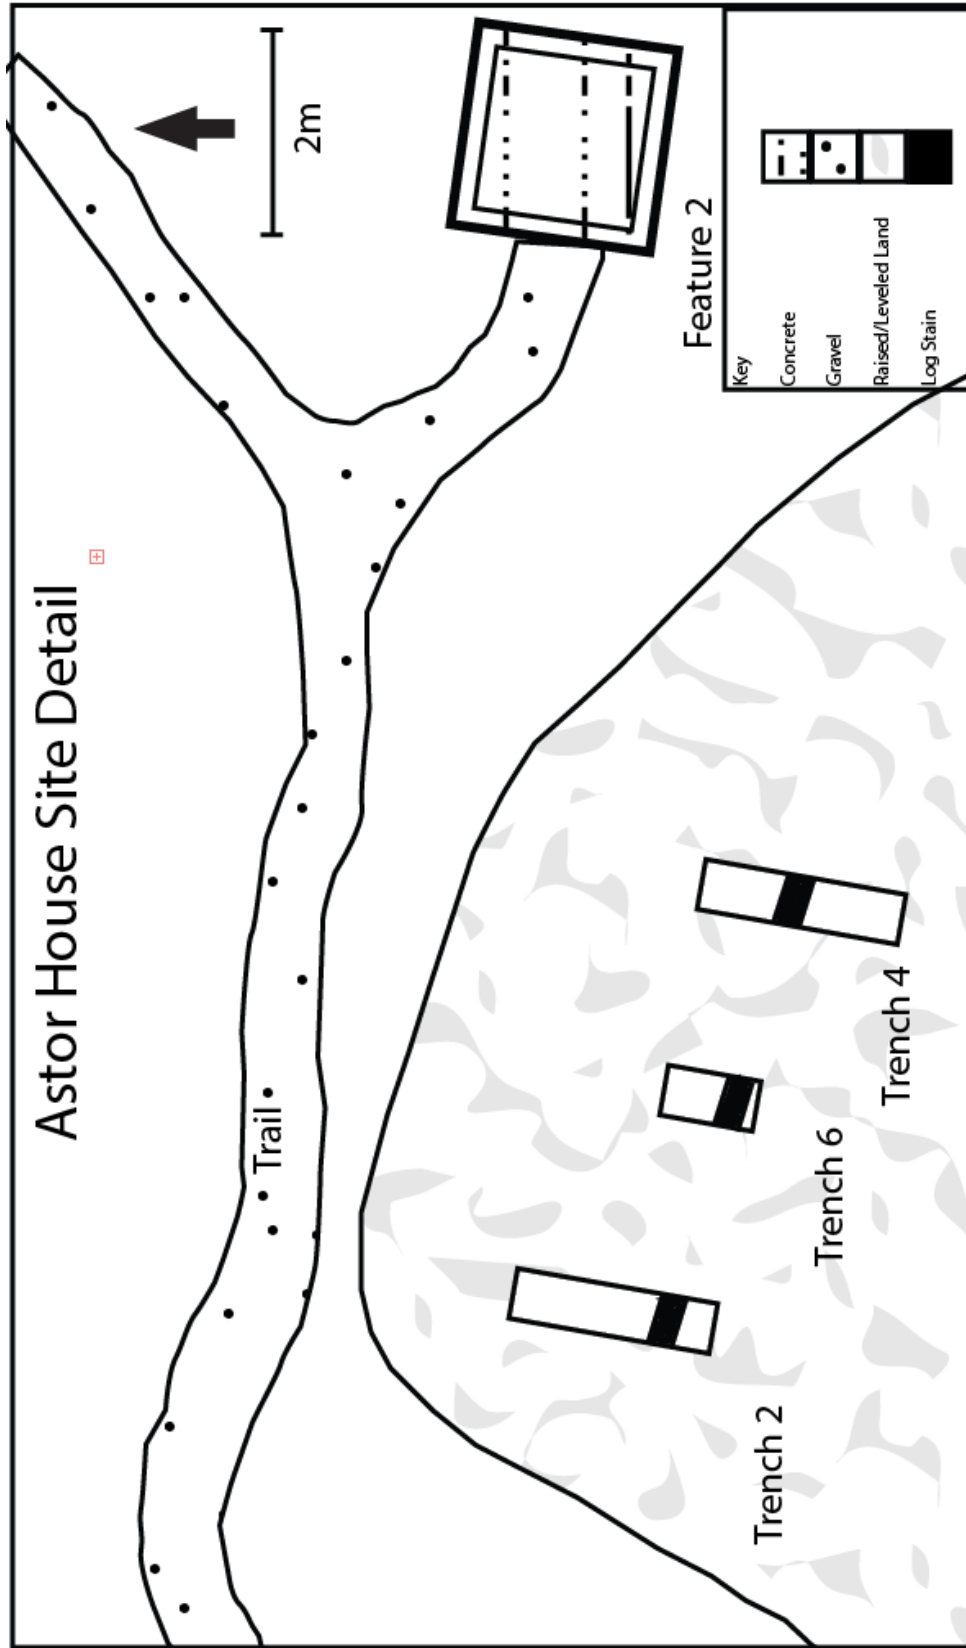
Figure 37. Astor House Excavation Detail. Map by author, 2015.

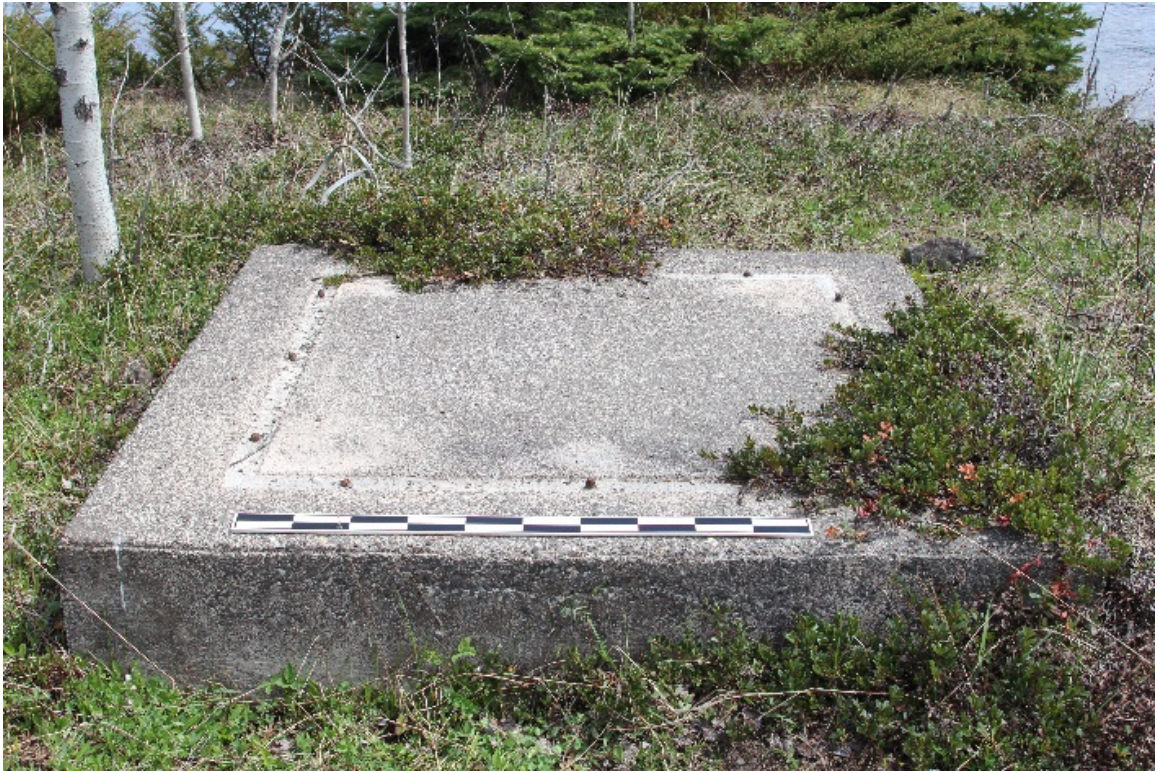
Figure 38. Feature 2 showing bolt mounting pattern. Photo by author, 2015.

Feature 2 is a concrete pad located 10m to the Southeast of the base of Astor Point. It is 1.8x1.8m square and has twelve mounting bolts cast into it which have been cut off. Park maintenance maps from 1964 show that this was once the base for a light although the type of light or its purpose is not clear. Given the location slightly inland of the

point it would not serve as a particularly useful navigation aid. This feature is in relatively good condition.

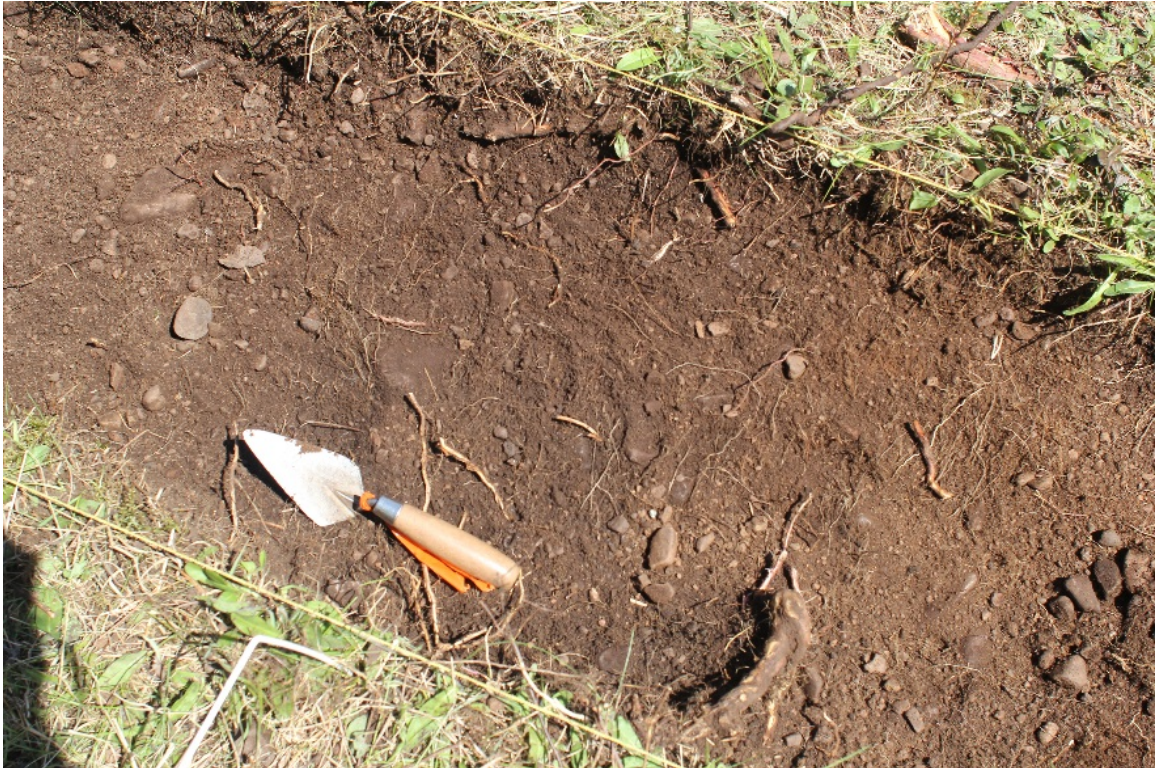
Figure 39. Detail Trench 2, Level 2 showing subtlety of stain 20 minutes after excavation. Stain extends from point of trowel to roughly 10cm behind handle. Photo by author, 2015.

The goal of excavation was to locate the structure. With this in mind a .5x2m long trench (Trench 2) was laid out to cross over where it was believed the wall of the building would have been in hopes of locating a foundation. 7cm below the surface a dark soil stain approximately 30 cm wide was encountered. A level was called and initially this was believed to be a charcoal deposit but within 5 minutes of being exposed to the bright sun the stain largely disappeared. Further excavation revealed that this stain extended roughly 5cm deep and that its edges were well defined and consistent throughout although it continued to quickly disappear when exposed to sun thus drying out the soil. Sterile soil was encountered beneath this depth.

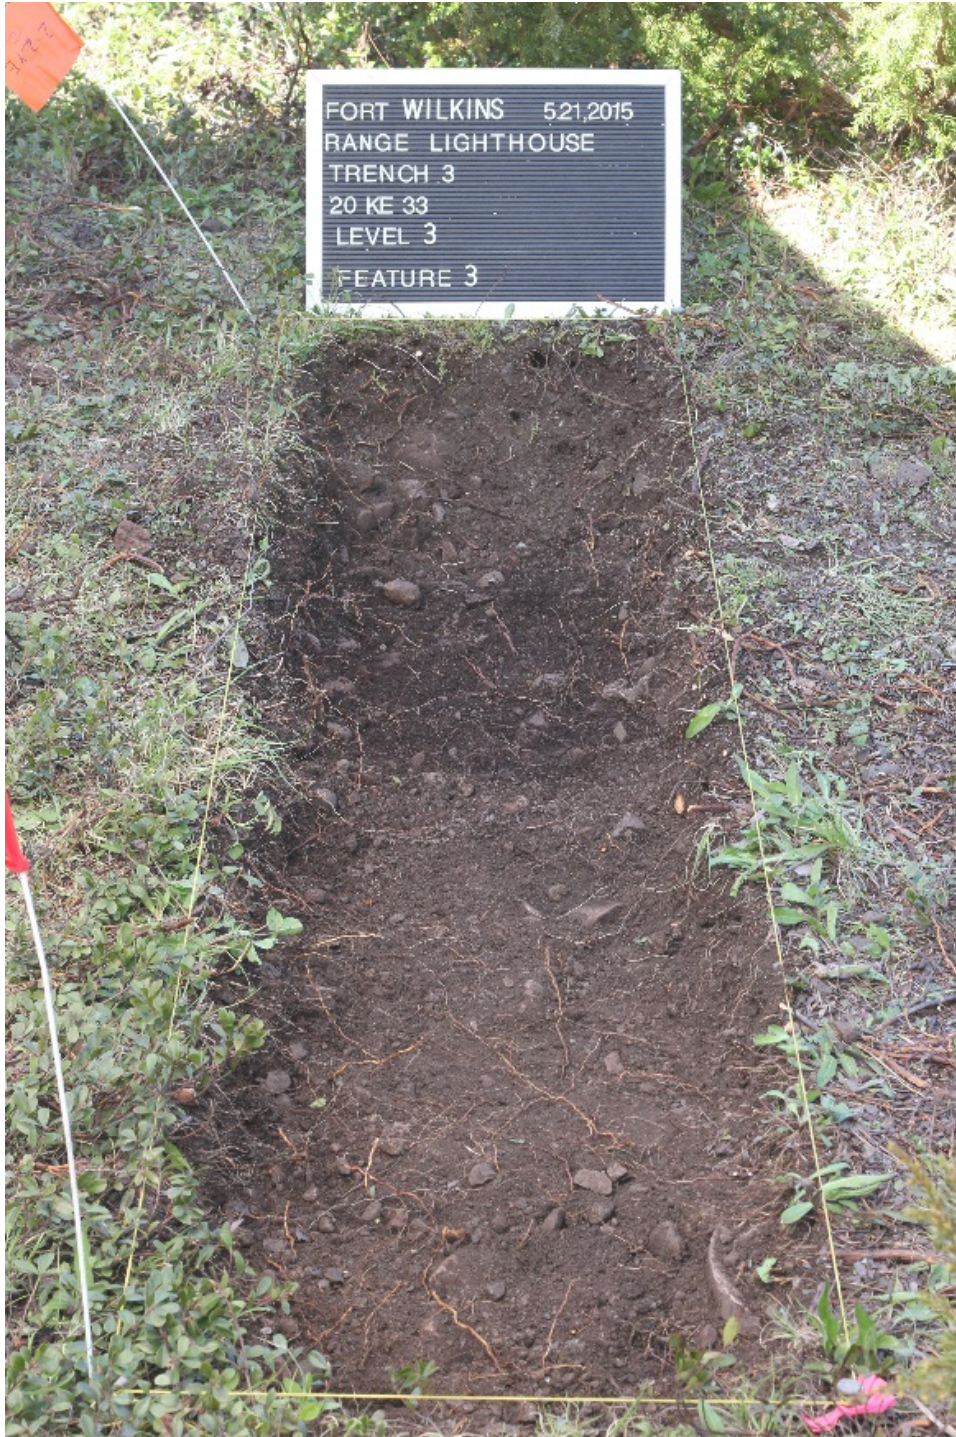
Figure 40. Trench 4, Level 3 showing stain approximately 10 minutes after excavation. View North. Photoboard Trench # is incorrect. Photo by author, 2015.

The stain was not square to the unit and in fact roughly matched the angle that was derived through fitting the measuring tapes to the site. This angle was projected 4 meters to the east and the survey team placed another .5x2m trench (Trench 4) to cross cut where it was believed the stain would be. 8cm below the surface excavators encountered a white stain approximately 30cm wide and in line with the dark stain found in Trench 2. This stain was less than .5cm in depth. Immediately under this stain (which was less than

.5cm thick) a dark stain was again encountered. This stain also extended roughly 5cm deep.

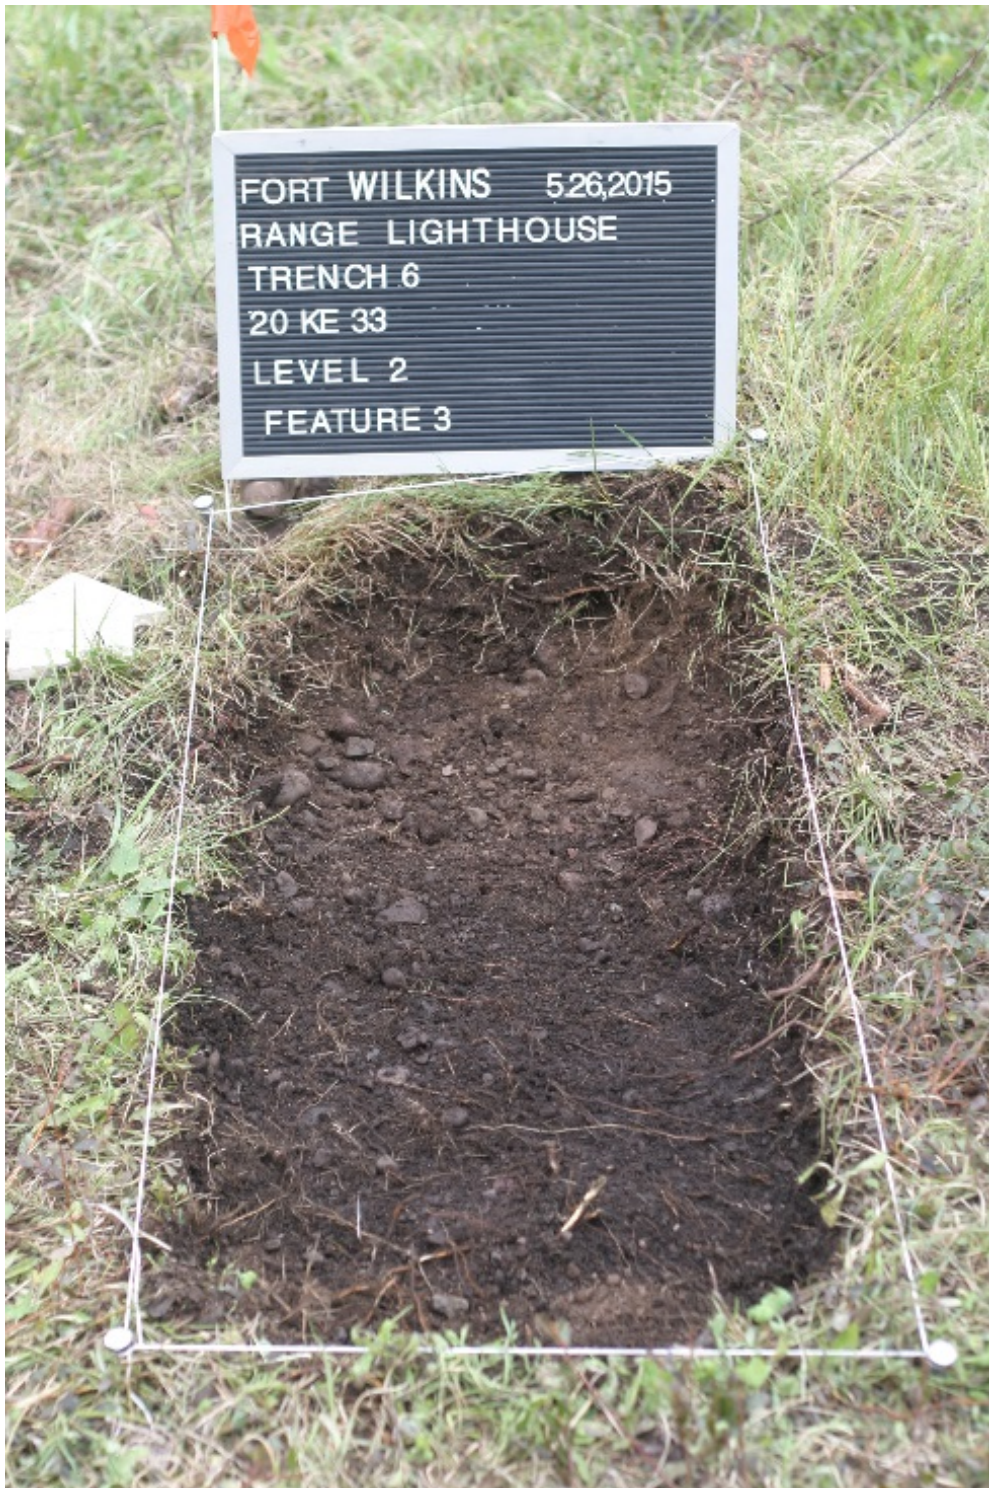
Figure 41. Trench 6, Level 2 showing stain immediately after excavation. View North. Photo by author, 2015.

Excavators placed a third trench measuring .5x1m (Trench 6) midway between Trenches 2 and 4. If the stain could be found where predicted it would make a three point line reaffirming suspicions that the dark stain was in fact a log stain. Excavators quickly dug this unit to 5cm below the surface with the photography equipment in place in order to get a clear photograph of the stain immediately when it was exposed. At 8cm the stain was once again located passing through the unit on an angle consistent with that found in Trenches 2 and 4.

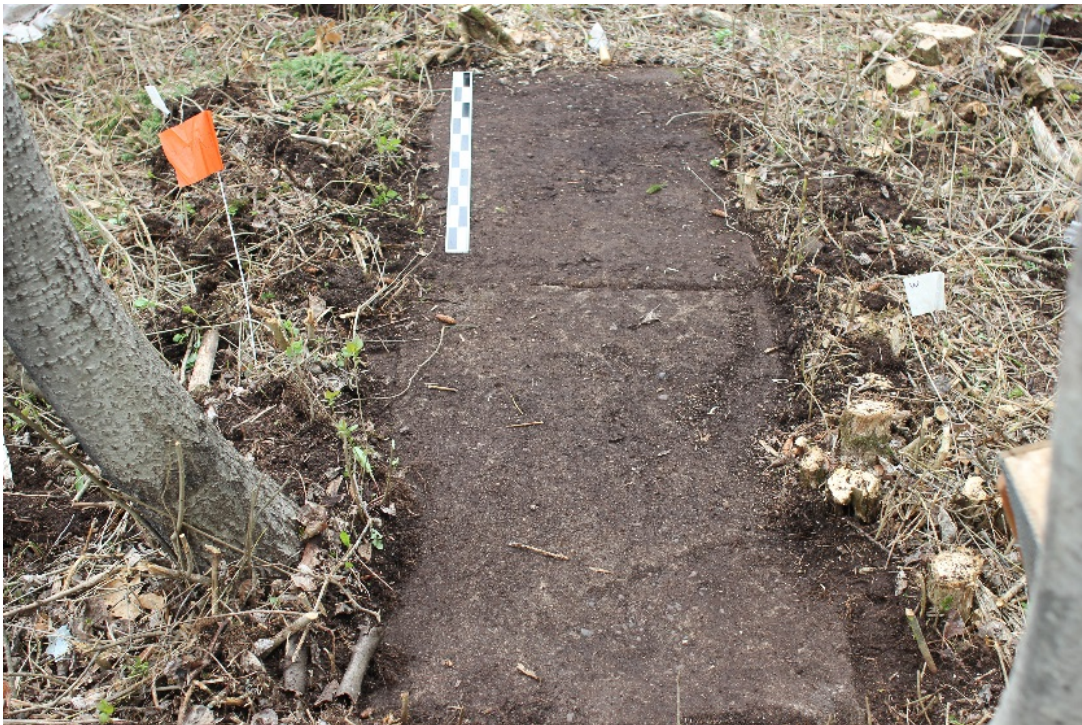
Figure 46. Sidewalk slabs uncovered during test pitting. View North. Photo by author, 2015.

Team members found during initial shovel test pitting on the 10m grid that there was a consistent background level of artifacts spread in the area that was once the yard on the south and west side of the Range Lighthouse. Using the historic photographs of the site a 2m grid was established within the 10m grid in the area of the privy and wash house despite finding no particular concentration of artifacts there. This grid of test pits was to the east and south of the Range Lighthouse. During shovel pit testing two slabs of sidewalk concrete were uncovered that were part of the walkway that led from the Range Lighthouse to the outbuildings. Further probing showed that these were the only remaining sidewalk slabs. Based on the location of the slabs relative to the Range Lighthouse it was concluded that these were likely those shown in the extreme right hand side of Figure 44 in front of the privy. Why these slabs were left in place when all of the others were removed is not clear.

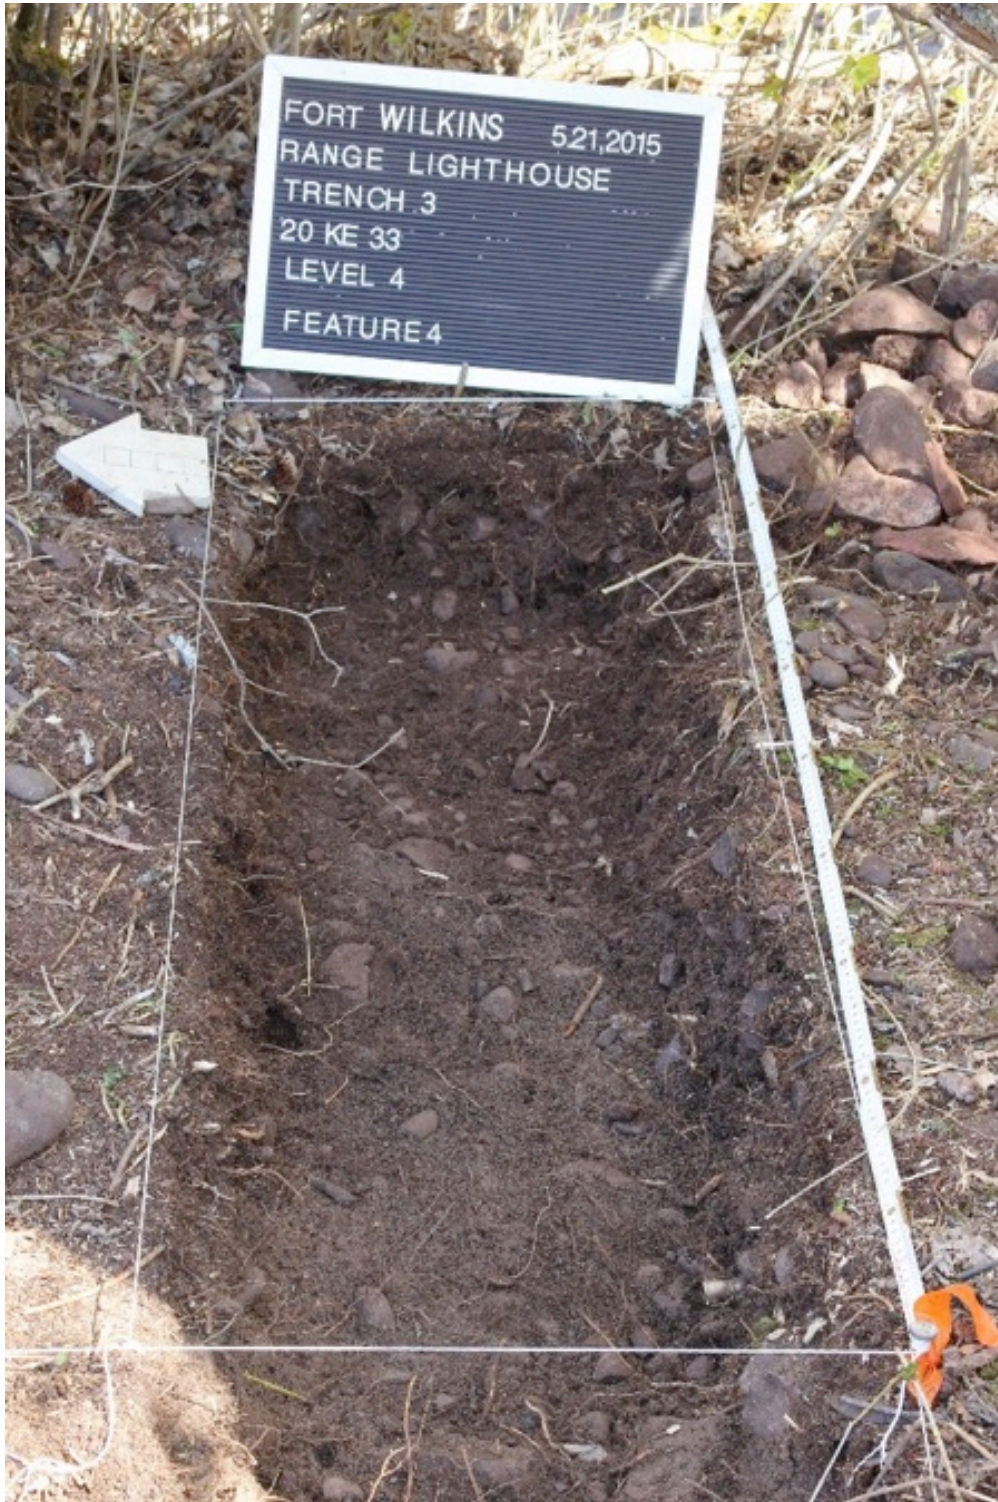
Figure 48. Trench 3, Level 4 showing sandy soil in west side of unit. View East. Photo by author, 2015.

Excavators laid a second trench of .5x1.5m (Trench 3) extending from the southeast corner of Trench 1 to the east. Proximity to the bank limited the length of this trench. The goal of this was to either locate another wall or expose the privy hole. Neither was accomplished. At 9cm below the surface a sandy soil was encountered in the western end of the trench. This soil abutted the foundation and extended for another 10cm of excavation when the unit was called without reaching a new soil. The survey team concluded that this sandy soil was most likely fill for the privy hole.

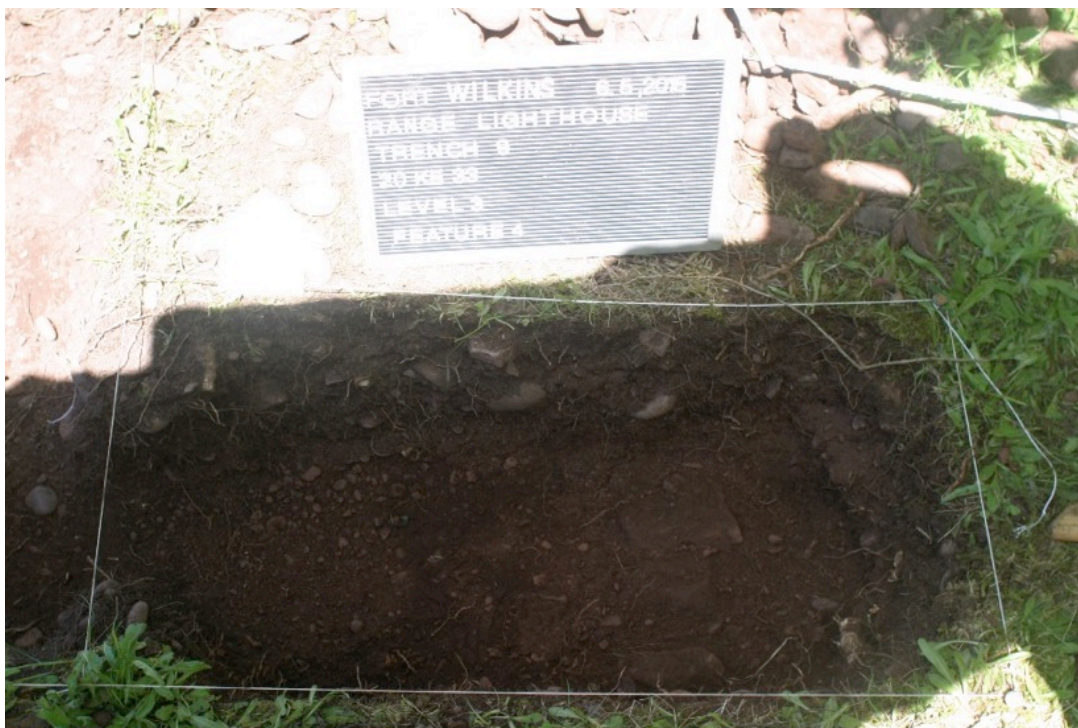
Figure 49. Trench 9, Level 4. Stone alignment on left in shaded area. View North. Photo by author, 2015.

The alignment of stones unearthed in Trench 9 is plausibly identified as part of the foundation for the wash house/summer kitchen. The location is consistent with historical photographs and the artifact scatter is consistent with a space that was used for food processing and preparation. Relatively few artifacts were uncovered in Trench 9, those being limited to some small pieces of building material, nails and glass fragments. This is in contrast to Trenches 5 and 7 (and the surrounding test pits) which were rich with artifacts that included building materials but also butchered bone, window glass, bottle fragments, a serving fork, and numerous ceramics. Ceramics included a mix of coarse materials as well as some mid-grade stonewares. The area surrounding the wash

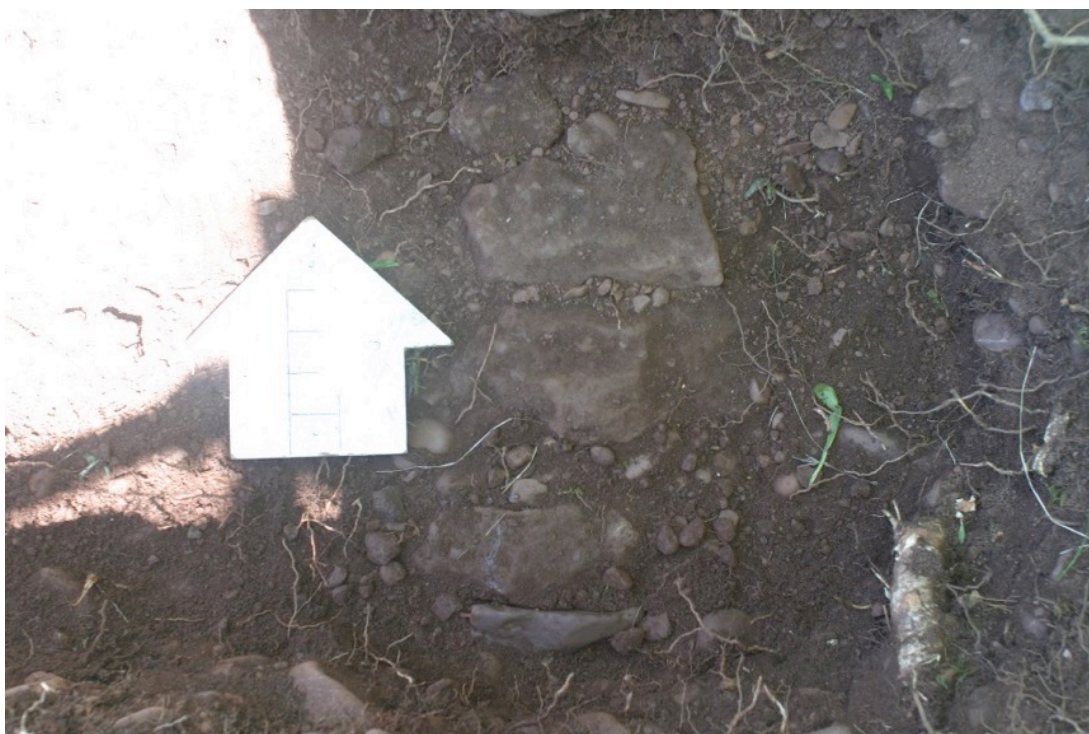
Figure 50. Detail of stone alignment in Trench 9. Note small balls of mortar. View North. Photo by author, 2015.

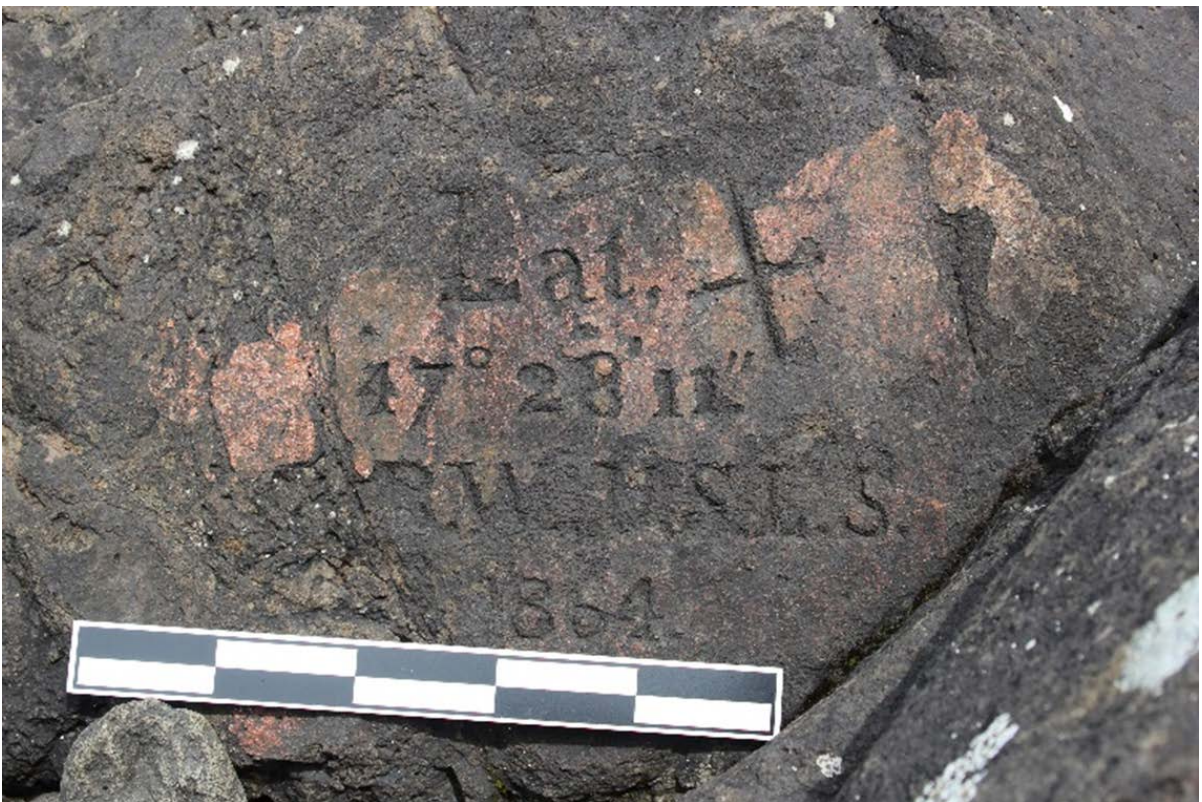
Figure 55. Detail Feature 5. Photo by author, 2015.

Feature 5 is a survey benchmark that has been carved into the bedrock on the shoreline 5m west of the base of Astor Point. The benchmark reads “Lat. 47°28’11” O.B.W. U.S.L.S. 1864”. This feature was made by the United States Lake Survey which was performed by the U.S. Army Topographical Engineers (later merged with the U.S. Army Corps of Engineers) who were charged by Congress with preparing and publishing nautical charts beginning in March of 1841. The survey was completed by 1882. Benchmarks of this type served as datums from which topographic features could be mapped. O.B.W. are the initials of Orlando B. Wheeler, a University of Michigan graduate who was in charge of astronomical and geodetical triangulation parties for the United States Lake Survey from 1863-1871. The 29 year old Wheeler surveyed the Copper Harbor shoreline from June 25th-28th under Henry Gillman working from west to east. This feature is 20KE25.

The benchmark is still quite legible although there is damage to the bottom left portion of the engraving and general weathering as would be expected given its location on the shoreline. This benchmark also appears in Gillman’s notebook of the survey.
