Archaeological Investigations And Historical Survey, Fort Wilkins Historic State Park: Keweenaw County, Michigan

ARCHAEOLOGICAL INVESTIGATIONS AND HISTORICAL
SURVEY, FORT WILKINS HISTORIC STATE PARK:
KEWEENAW COUNTY, MICHIGAN

Submitted in partial fulfillment of the requirements for the degree of
MASTER OF SCIENCE
In Industrial Archaeology

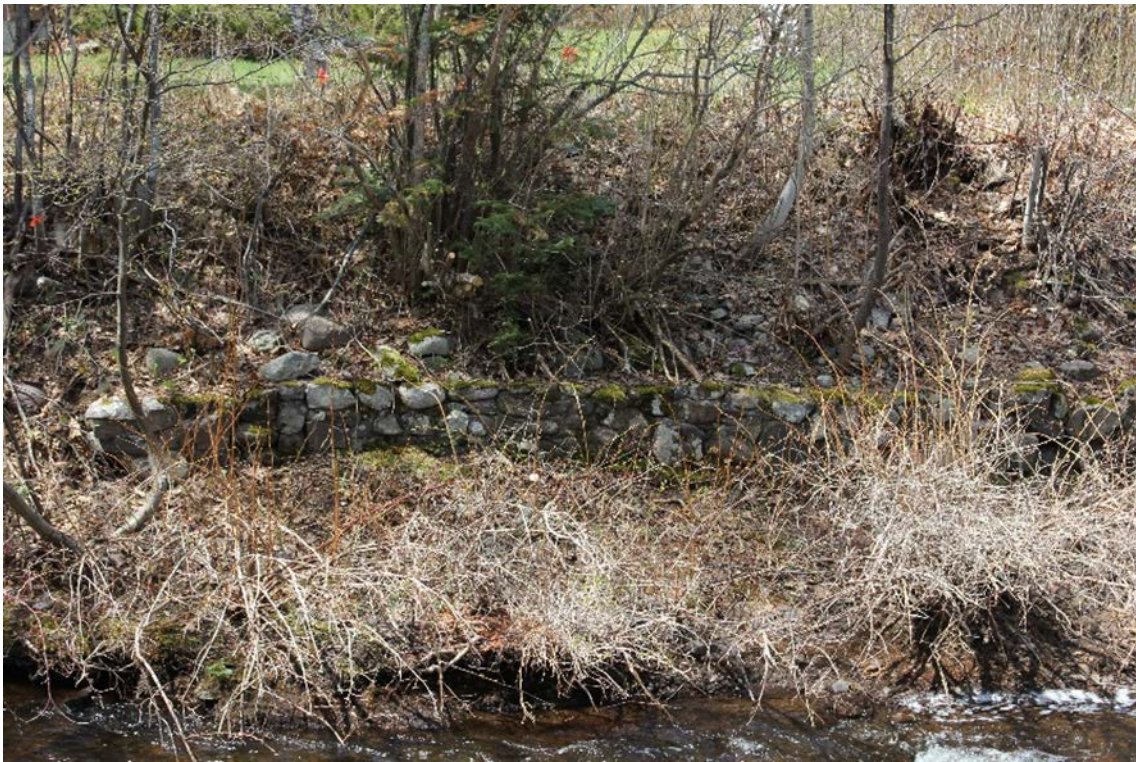
Figure 58. Feature 7. Note right angle notch to left. Photo by author, 2015.

Feature 7 is located roughly halfway between the Rear and Front Range Lights on the west bank of Fanny Hooe Creek. Originally suspected of being a bridge abutment, this feature is most likely a retaining wall. It is a wall of laid stone 3.6m long built into the bank. It was apparently built of whatever stone was at hand being a mix of broken pieces of conglomerate and glacial cobbles such as those found along the beach on the opposite side of Fanny Hooe Creek. There is no evidence of there having been a matching feature on the opposite bank supporting the idea that this is not a bridge abutment. On June 10th, 1896 the light keeper noted in his journal that he had “Braced up the walk where the creek has washed out”, Feature 7 may be either the bracing referred to or a later and more permanent solution. The bank on either side of this wall is severely eroded and threatening to undermine the sidewalk leading between the Range Lights. This feature is suffering from the roots of plants intruding between the stones although it continues to prevent erosion in this location.

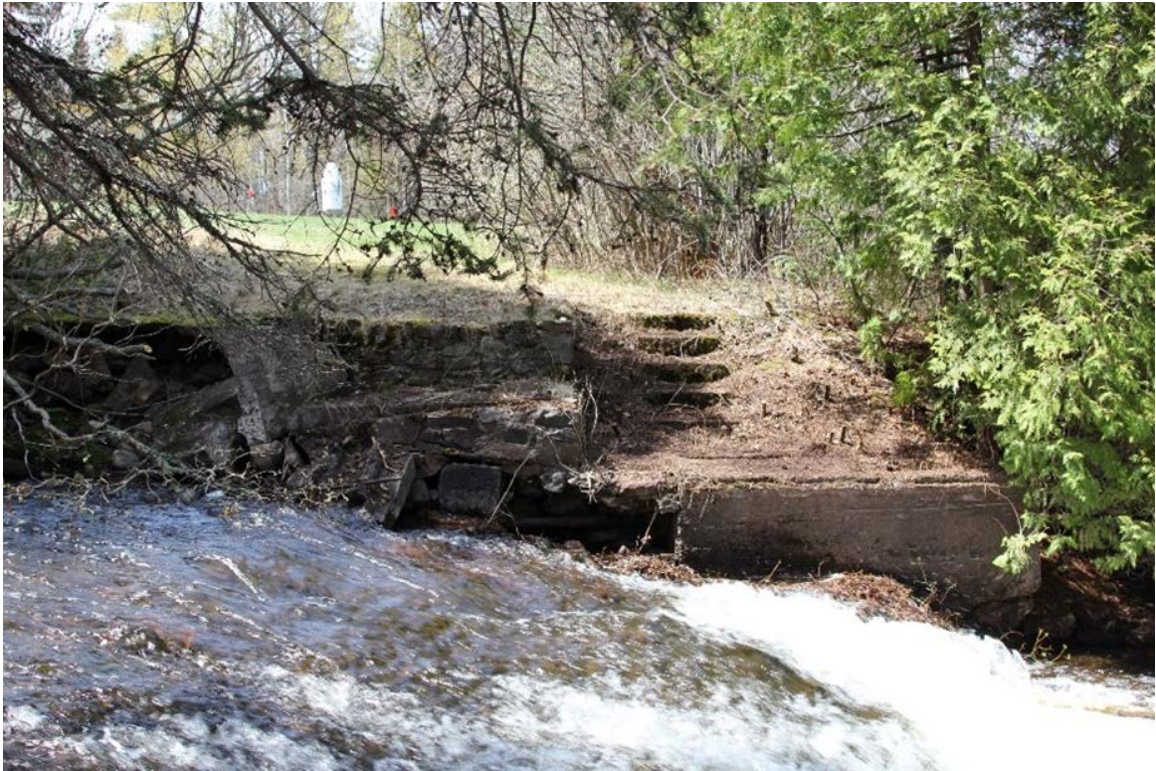
Figure 59. Feature 8 from east bank of Fanny Hooe Creek. Severe erosion on left. Photo by author, 2015.

Feature 8 is an historic bridge abutment north of the Range Lighthouse. This abutment is made of concrete over stones laid in course. It appears to have been built directly over an earlier abutment on the same site. This feature appears in numerous maps both historic and recent. A wagon road once crossed Fanny Hooe Creek at this point. This feature has a flat concrete pad (2.5x2.25m) with a bolt and pipe cast into it on the North side. Four stairs head up to ground level to the West. To the South there is another pad (2.3x1.25m) sitting roughly 40cm higher with two stairs on the South side leading to a third pad (2.2x1m) at ground level.

The bank has been severely eroded on the south side, undermining this feature and exposing wooden timbers, some of which are now in the stream bed. There are also a number of stones and concrete fragments from the feature in the water. It appears that this portion is in danger of collapse.
