Evaluation of surface defect detection in reinforced concrete bridge decks using terrestrial LiDAR

AN EVALUATION OF SURFACE DEFECT DETECTION IN REINFORCED
CONCRETE BRIDGE DECKS USING TERRESTRIAL LiDAR

A THESIS

(Civil Engineering)

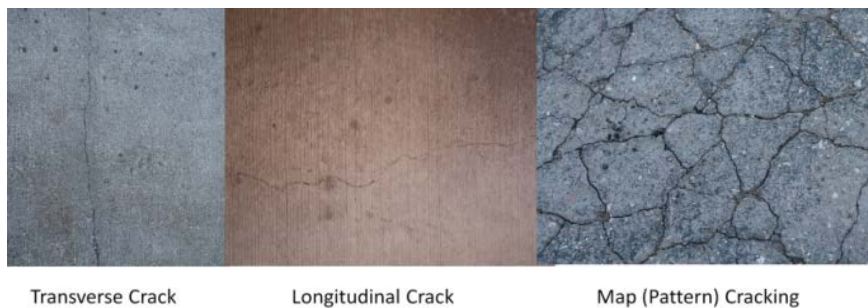
Figure 2.3: Classification of concrete cracks (FHWA 2006) (See Appendix D)

The most common type of crack present in bridge decks are transverse cracks, which are often caused by restrained shrinkage and typically occur shortly after construction (Nowak et al. 2000). Transverse cracking propagates as a non-structural crack, but can cause localized stresses resulting in serious structural cracking. As the name implies transverse cracks develop transverse to the traffic flow. Common bridge construction techniques require the reinforcing steel closest to the concrete surface to be placed longitudinal to the traffic flow for flexural strength. With inadequate concrete cover over longitudinal reinforcing steel, chloride ingress is capable of initiating the steel corrosion process, developing tensile forces and causing longitudinally oriented cracking. The cracks resulting from the longitudinal steel corrosion process is referred to longitudinal cracking. Pattern or map cracking is associated with random, multi-directional cracking commonly resulting for inadequate freeze-thaw protection and the steel corrosion process. Examples of the three discussed crack varieties can be seen in Figure 2.3 (FHWA 2006). The traffic flow on Figure 2.3 is moving from left to right on the paper.

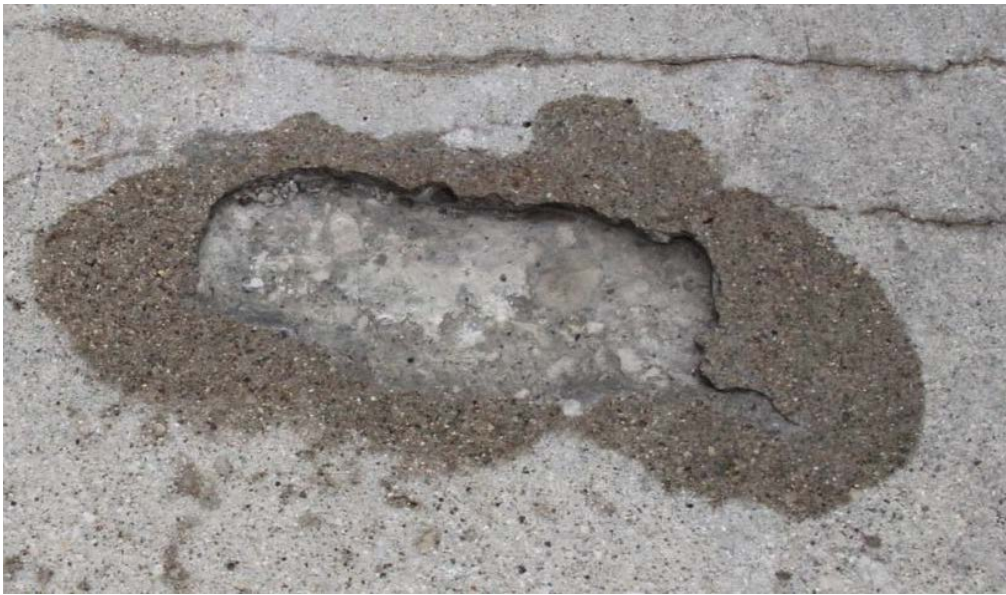
Figure 2.4: Example of concrete spalling (Courtesy of Renee Oats) (See Appendix D)

An additional deterioration mechanism, delamination, is the direct result of the steel corrosion process. When the reinforcing steel corrodes, the cross sectional area increases due to the growth of corrosion products causing the bonded concrete surrounding the steel to crack and separate from the expanding metal. This subsurface deterioration mechanism is referred to as concrete delamination, but commonly this subsurface issue generates surface defects such as a spall. Theoretically, the delamination does not physically rise to the surface, but rather the now separated concrete material, which possesses little flexural capacity, breaks away under the applied cyclic vehicular loading. An example of a spall on a concrete bridge deck can be seen in Figure 2.4. Similar in appearance, scalling is a deterioration mechanism caused by material degradation resulting in material loss as seen in Figure 2.5. Current inspection practice denotes that any measurement of ¼ in (6.35 mm) in depth is the minimum consideration for spalled or scaled defects (FHWA 2006).

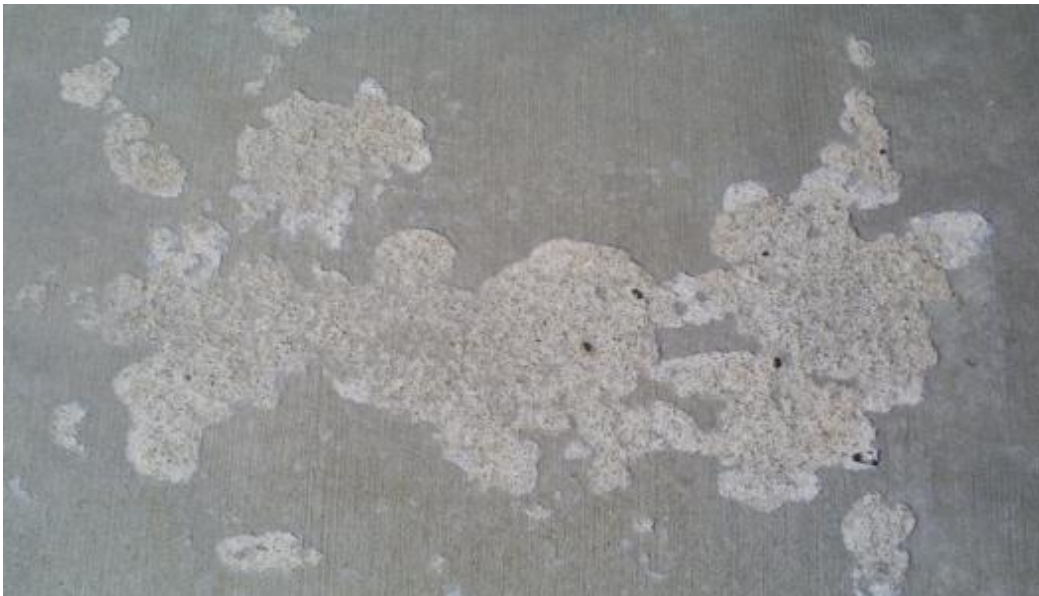
Figure 2.5: Example of concrete scaling (Courtesy of Renee Oats) (See Appendix D)

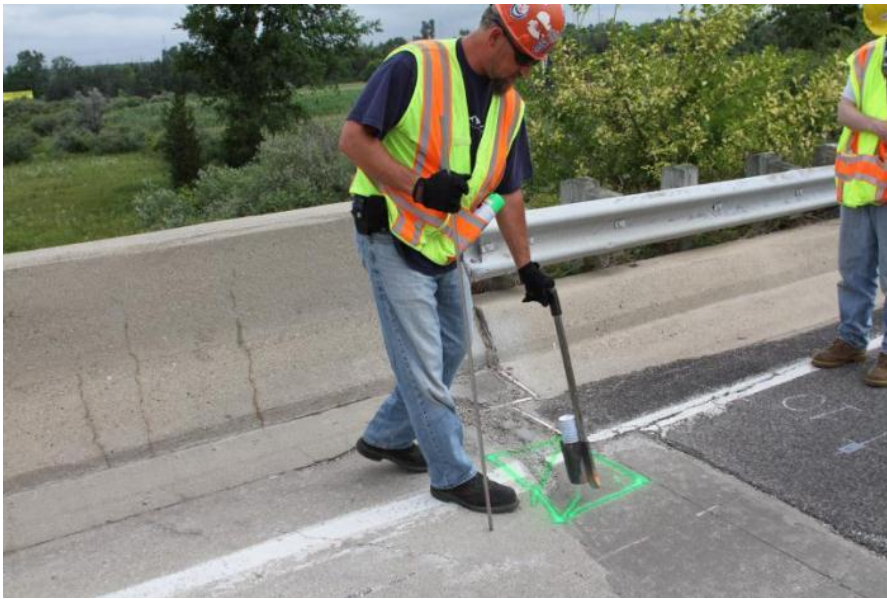
Figure 2.6: MDOT performed hammer sounding (Courtesy of Renee Oats) (See Appendix D)

Both surface and subsurface defect detection are influenced by human interpretation. Knowing the dependence of human interpretation for distinguishing delaminated concrete from sound concrete and the high variability between inspectors, one can understand the issue. During detailed scoping inspections, delaminations are located through the inspector's interpretation of the concrete's acoustical response when struck by an inspection hammer or a chain drag is performed as depicted in Figure 2.6 and Figure 2.7, respectively. Both methods require the inspector to excite the concrete surface by either sticking the surface with a mallet or drag a chain across the surface. An area is

considered to contain a delamination if the acoustic response changes pitch from low to high. The Nondestructive Evaluation Validation Center (NDEVC) reported that the delamination inspection method can result in variability ranging from 2% to 69%. (Scott et al. 2002). This range of variability was the result of 22 independent pairs of state bridge inspectors from various state agencies inspecting a bridge with known delaminations and a total percent delaminated area.

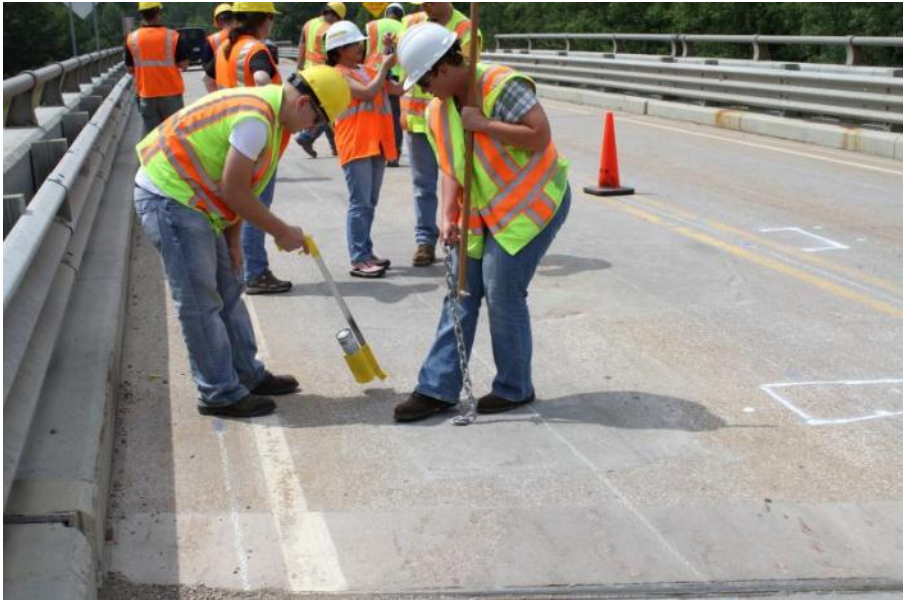
Figure 2.7: MDOT performed chain-drag testing (Courtesy of Renee Oats) (See Appendix D)

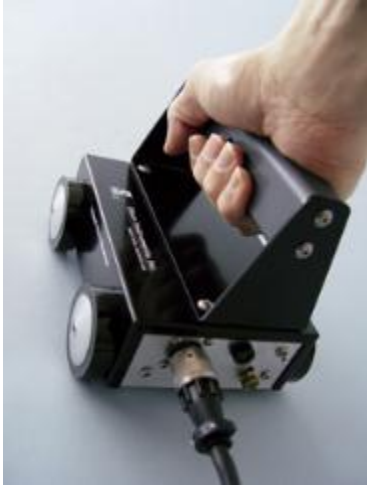
Figure 2.8: Hand held impact-echo equipment

Impact-echo is similar to the hammer sound or chain drag bridge inspection techniques for detecting subsurface defects through acoustical responses. The method was developed in 1983 as a result of a shift in the National Bureau of Standards' research on NDT detection of internal defects within concrete structures. Impact-echo was based on the knowledge of stress wave propagation in a solid, which is directly affected by the mechanical properties of the material. The theory is that if an internal defect were present in the concrete test media, the mechanical properties changes resulting in varying stress wave propagation. Typical designs revolve around a four wheeled device, which has a built-in striker to produce the acoustic wave and a microphone to measure the reflected response, Figure 2.8.

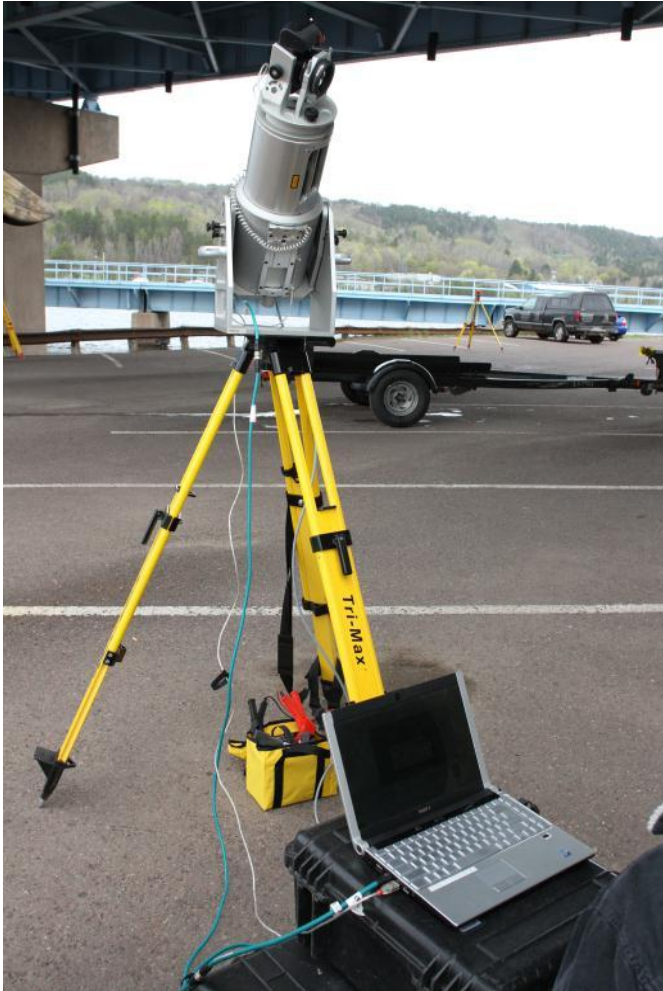
Figure 3.1: Riegl LMS-Z210ii system (Courtesy of Renee Oats) (See Appendix D)

the true color optical camera, which was mounted to the top of the scanning unit. This optical camera allowed for the integration of true target surface color. The generated color channel allowed for straightforward texturing of three-dimensional models by unequivocal correspondence of color pixels and range measurements. Figure 3.1 shows the instrument setup.

The instrument is a pulsed, dual-axis compensated LiDAR unit in a monostatic configuration. For the LiDAR transmitter, a class 1, near infrared laser is utilized for radiating the target object. Instrument specific performance specifications can be found in Table 3.1 (Riegl 2011).

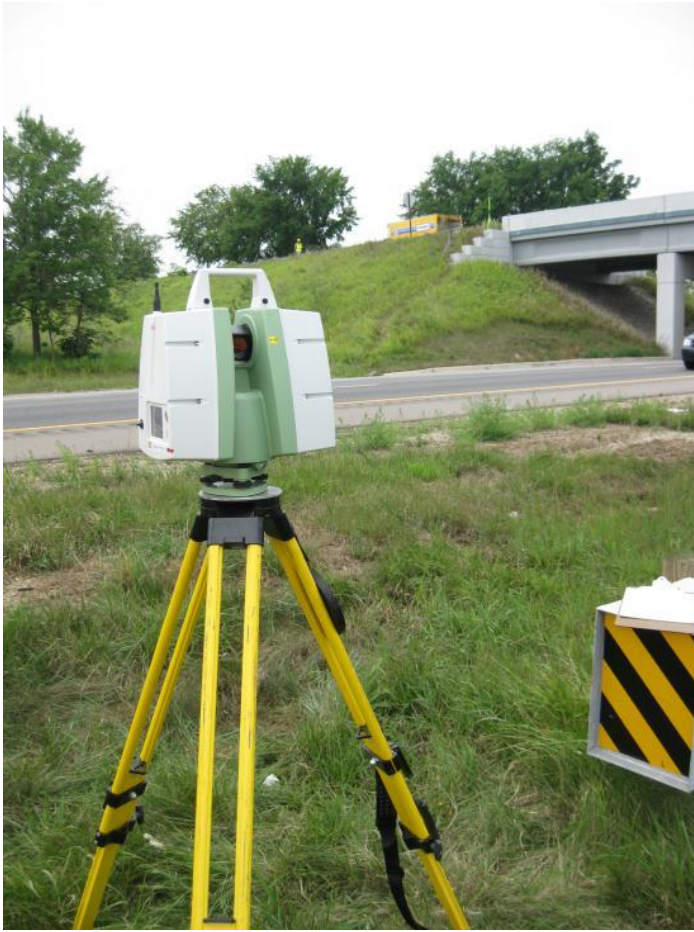
Figure 3.2: Leica ScanStation C10 system (Courtesy of MTRI) (See Appendix D)

Currently, MDOT utilizes the Leica ScanStation C10 as a surveying and inventory generator tool. By acquiring the services of experienced MDOT surveyors, Kelvin Wixtrom and Shawn Roy, the operational confidence produced negligible error in the data collection. This terrestrial LiDAR system, the Leica ScanStation C10 is an “All-in-One” High-Definition Surveying™ (HDS™) portable surveying instrument. With a full field-of-view, high-speed, high-accuracy, long range scanner with unmatched versatility allowed for rich point cloud generation of the all sampled bridges (Geosystems 2011). The instrument is a compact, pulsed, dual-axis compensated LiDAR unit with the following system details listed in Table 3.2 (Geosystems 2011). Figure 3.2 shows the instrument setup.

All of the accomplished system performance measures listed above were achieved through the use of state-of-the-art components and proprietary software. The system utilizes a *ns* pulsed class 3R green laser transmitter for radiating the target object. A vertically rotating mirror on a horizontally rotating base comprises the scanning optics projecting the transmitted laser over the selected field-of-view. The projected laser produces a minimal spot size of 4.5 mm or 7 mm over a distance of 50 m based on FWHH- and Gaussian-based testing, respectively. With the two systems defined, field demonstration locations were established.

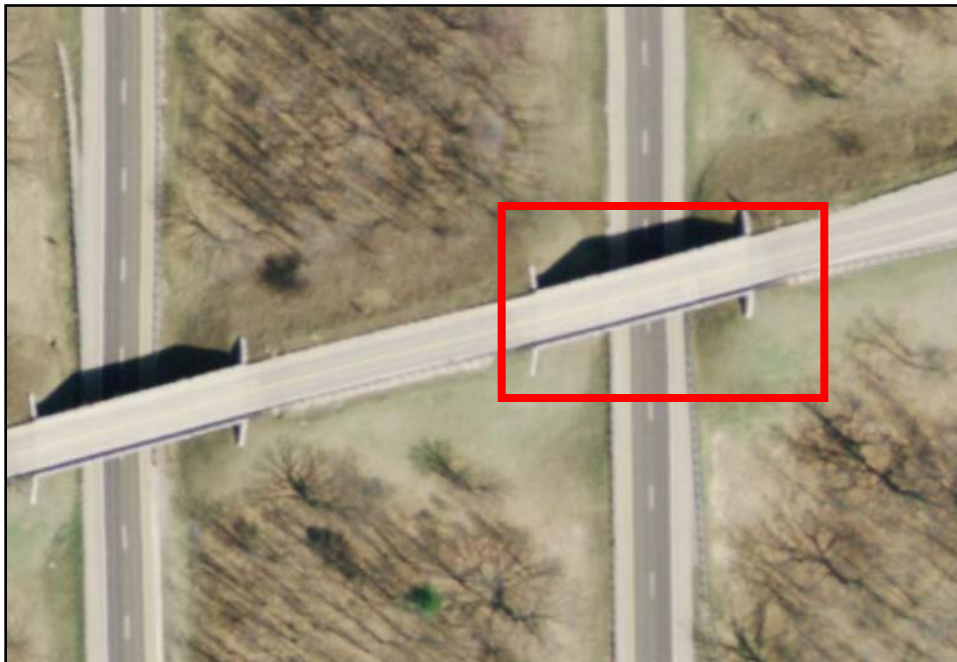
Figure 3.4: "Poor" bridge selection

The “Poor” bridge selection, MDOT structure n^o 1713 – Mannsiding Road over US-127 north bound is located in Clare County approximately ten miles north of Clare, Michigan (Figure 3.4) and was determined to be the best candidate for field demonstration purposes.

The field demonstration candidate structure serves Mannsiding Road; a “Major Collector” road. The bridge was constructed in 1966 and is a three-span pre-stressed concrete multiple I-beam composite structure. The structure is 130 ft-11 in in length, 31 ft-2 in in width, which translates into 26 in of riding surface. During 1996, the average daily traffic (ADT) over the structure was found to be 1,000 with 3% being commercial (MDOT 2011b).

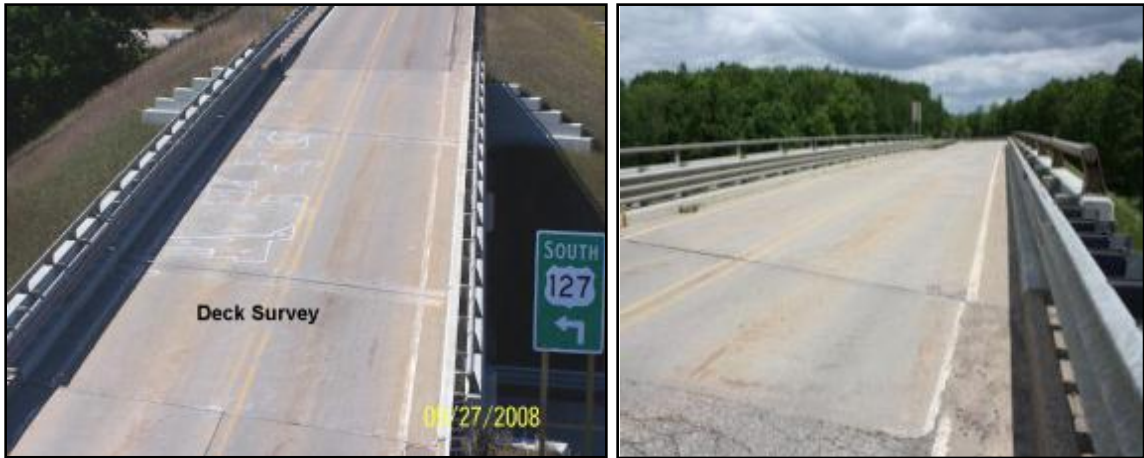
Figure 3.5: Mannsiding Road photographs (Courtesy of MTRI) (See Appendix D)

approximately 5.5 miles south of Harrison on US-127. The structure is part of an interchange serving the greater Harrison area, which is considered to be a rural environment. Figure 3.5 shows two photos of the bridge, one taken in 2008 during a MDOT scoping/inspection that provided detailed condition information, and the other by the research team during a site visit in June 2011. The structure is located in Hatton Township within Clare County.

The condition of the concrete deck surfaces, both top and bottom, were an area of major concern. A 2008 MDOT scoping inspection classified the deck with a NBI rating of “4”. The scoping revealed that on the top surface of the concrete deck 176 ft² or 4.4% of the deck was delaminated. Additional testing on the bottom surface revealed that 623 ft² or 15% of the deck was in distress (MDOT 2011b). The deck also possessed light scaling throughout and numerous transverse, longitudinal and diagonal cracks were present. Additionally, several high-load hits have resulted in scrapes and spalls of the superstructure underside, but currently there is no sign of exposed reinforcing steel or pre-stressing strands. The bridge is scheduled for complete replacement in 2012-13. Additionally, during the on-site inspection of the selected “Poor” bridge, it was found to have a complementing twin bridge, Mannsiding Road south bound overpass. The collection of LiDAR data was completed allowing for an additional case study, but was not in the original scope of work. The Mannsiding Road south bound overpass bridge is described in further detail in the “Supplemental” bridge selection section.

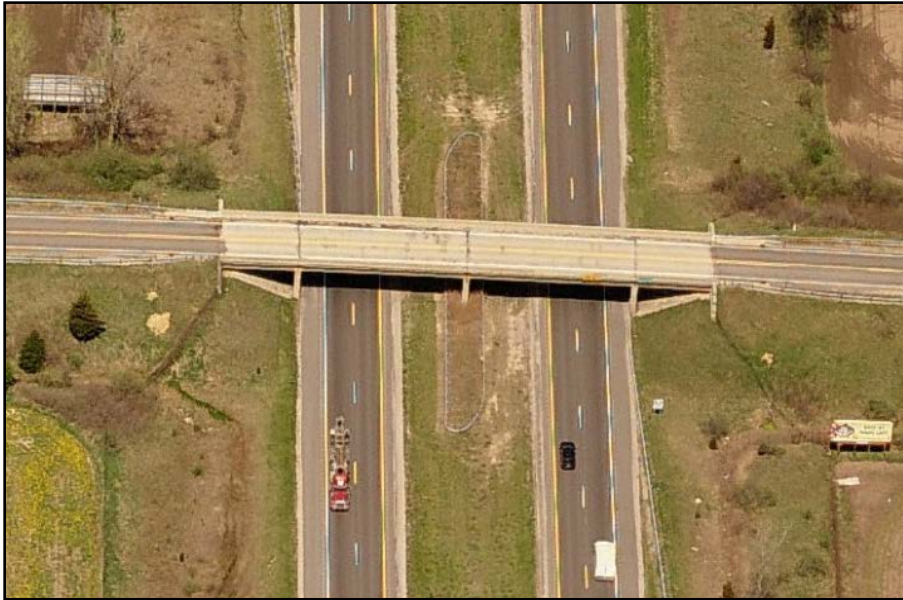
Figure 3.6: "Fair" bridge selection

MDOT structure n^o 10892 – Willow Road over US-23 was selected for the “Fair” field demonstration bridge. The bridge is located in Washtenaw County approximately three miles north of Milan, Michigan. An aerial photograph of the selected site is shown in Figure 3.6.

The “Fair” field demonstration structure serves Willow Road; a “Major Collector” road. The bridge was constructed in 1962 and is a four-span pre-stressed concrete multiple I-beam composite structure. The structure is 209 ft in length, 30 ft-10 in in width, which translates into 26 ft of drivable surface with no availability for shoulder room. During 1997, the ADT over the structure was found to be 2,220 with 3% being commercial (MDOT 2011b). Currently the bridge has no posted speed limit restriction. The crossing spans both north and south bound US-23; a NHS route that is not within any federal-aid urban boundary. The bridge does not meet the desired minimum vertical clearance for NHS routes. The structure is located in York Township within Washtenaw County.

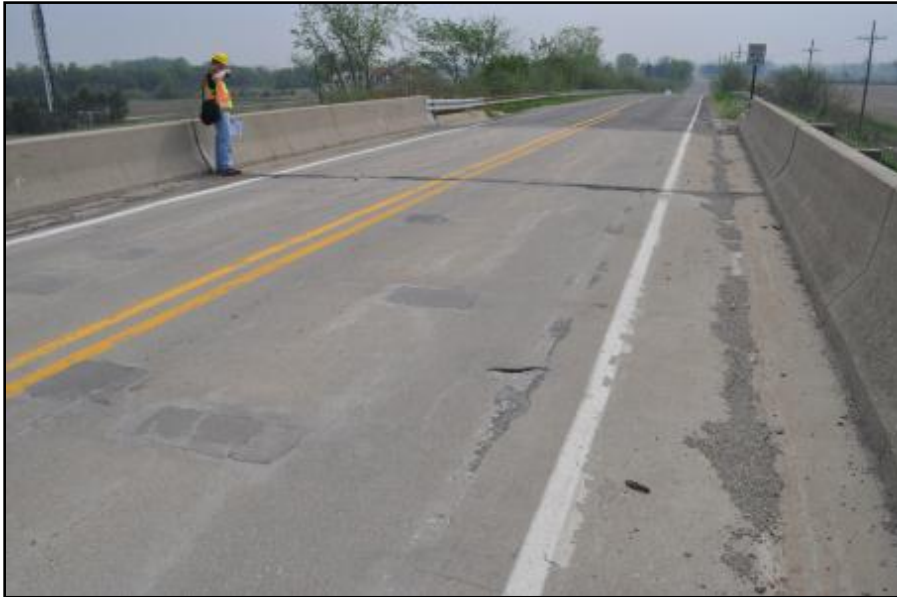
Figure 3.7: Willow Road photograph (Courtesy of MTRI) (See Appendix D)

The current condition of the deck surface is rated at a “5” on the NBI scale. In 2010, the inspection report indicated that open transverse cracks, diagonal cracks and areas of delamination were present throughout the deck. Concrete patching had been completed to help minimize deterioration and prolong the service life of the bridge. Additionally, areas on the bridge superstructure displayed desired sensing deficiencies over both the north and south bound lanes. This is attributed to several high-load hits, which had resulted in scrapes and spalls, but there was no sign of exposed reinforcing steel or pre-stressing strands. Figure 3.7 shows a photograph of the current condition of the concrete bridge deck.

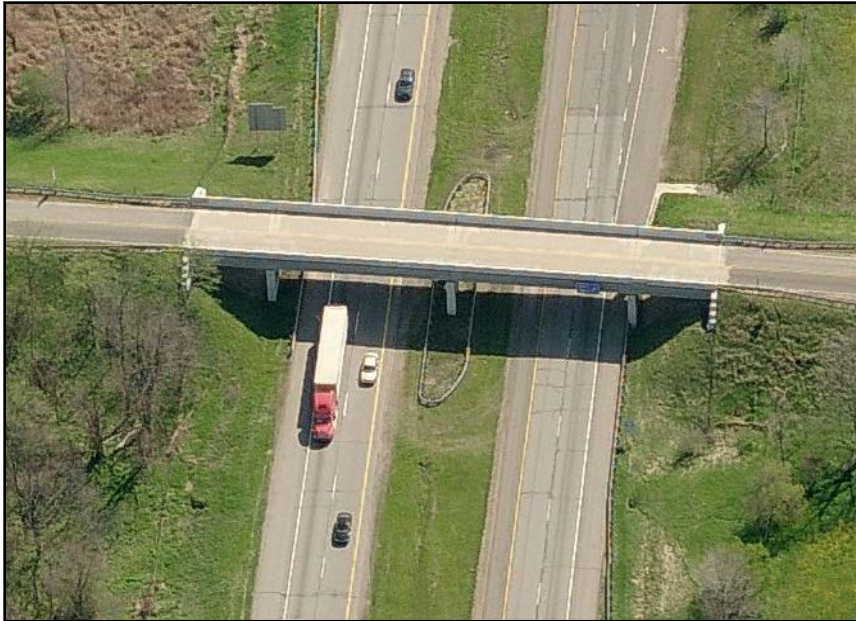
Figure 3.8: "Satisfactory" bridge selection

Lastly, the “Satisfactory” bridge was chosen to be the MDOT structure n^o 10940 – Freer Road over I-94 located in Washtenaw County, approximately one mile east of M-52 in Chelsea, Michigan. An aerial photograph of the selected site is shown in Figure 3.8.

The field demonstration candidate structure serves Freer Road; a “Major Collector” road. The bridge was constructed in 1960 and is a four-span pre-stressed concrete multiple I-beam composite structure. The structure has dimensions of 209 ft in length, 30 ft-10in in width, which translates into 26 ft of open roadway riding surface with no shoulder.

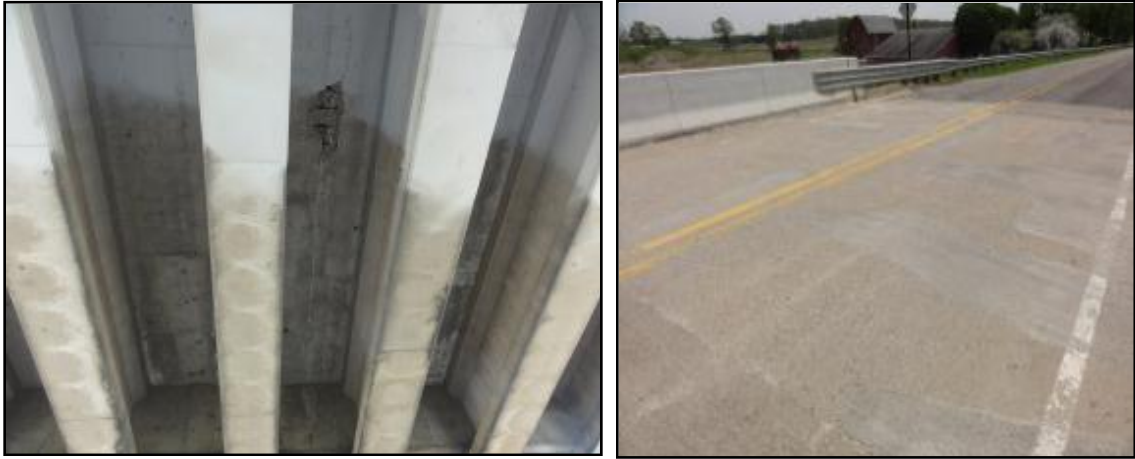
Figure 3.9: Freer Road photographs (Courtesy of MTRI) (See Appendix D)

The NBI rating assigned to the concrete deck surface is a "6". In 2010, the inspection report indicated that there were several areas of concrete patching accompanied by few tight transverse and diagonal cracks present on the deck (MDOT 2011b). Concrete patches were applied to help minimize deterioration and prolong the service life of the bridge. The report indicated that there were also areas of interest on the superstructure where the concrete material had spalled and cracked. These areas of interest were located

at the beam-end locations on the bottom flange. None of the spalled sections were deep enough revealing any reinforcing steel or pre-stressing strands allowing for corrosion to occur as shown in Figure 3.9.

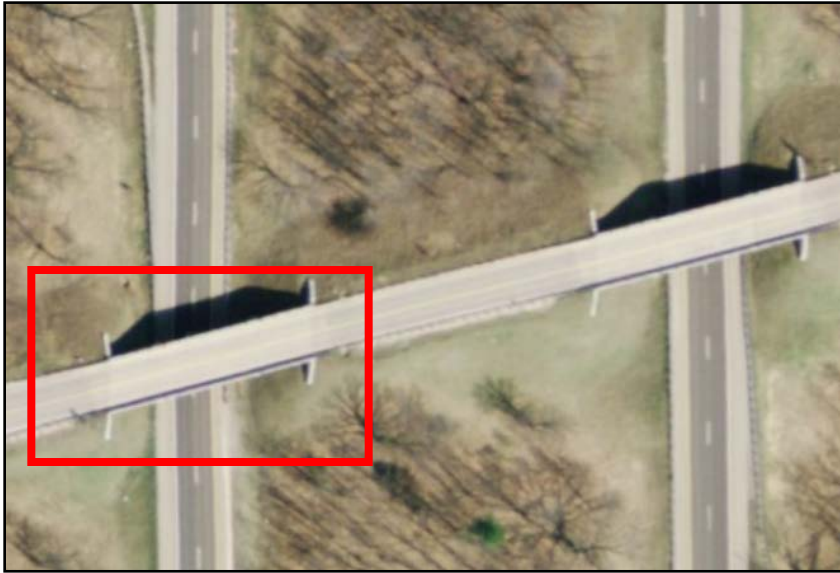
Figure 3.10: "Supplemental" bridge selection

The “Supplemental” bridge selection, MDOT structure n^o 1712 – Mannsiding Road over US-127 south bound is located in Clare County approximately ten miles north of Clare, Michigan and was not originally in the scope of work for the field demonstration. However, the close proximity of the bridge to the “Poor” selection location allowed for data acquisition with no additional traffic disruption and permitting. An aerial photograph of the selected site is shown in Figure 3.10.

The field demonstration candidate structure serves Mannsiding Road; a “Major Collector” road. The bridge was constructed in 1966 and is a three-span pre-stressed concrete multiple I-beam composite structure. The structure is 130 ft-11 in in length, 31 ft-2 in in width, which translates into 26 ft of riding surface. During 1996, the ADT over the structure was found to be 1,000 with 3% being commercial (MDOT 2011b).

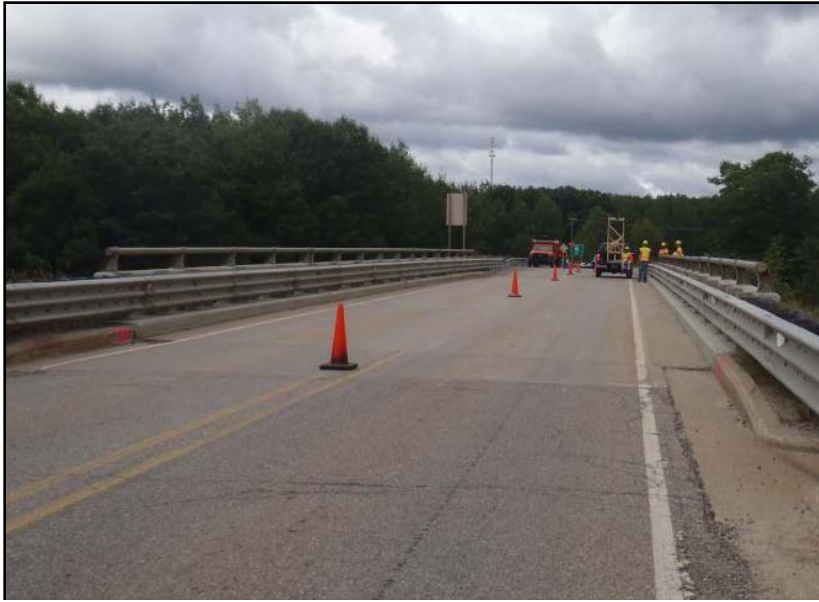
Figure 3.11: Mannsiding Road photographs (Courtesy of Renee Oats) (See Appendix D)

When comparing the condition of the concrete deck surface, top and bottom, of the “Supplemental” and “Poor” bridge selections drastic differences in the state of deterioration were noted. The two bridges had been constructed at the same time, but large variations in the deteriorated state on the concrete deck are documented. An inspection conducted in 2010, classified the deck with a NBI rating of “7” (MDOT 2011b). The inspection notes stated that minor cracking and shallow scaling in the deck surface was present, however was not substantial enough to cause structural issues. When comparing the “Supplemental” bridge deck rating of “7” to the “Poor” bridge selection’s deck rating of “4” on the NBI scale, questions of construction procedure, inspection consistency and environmental effects were raised.

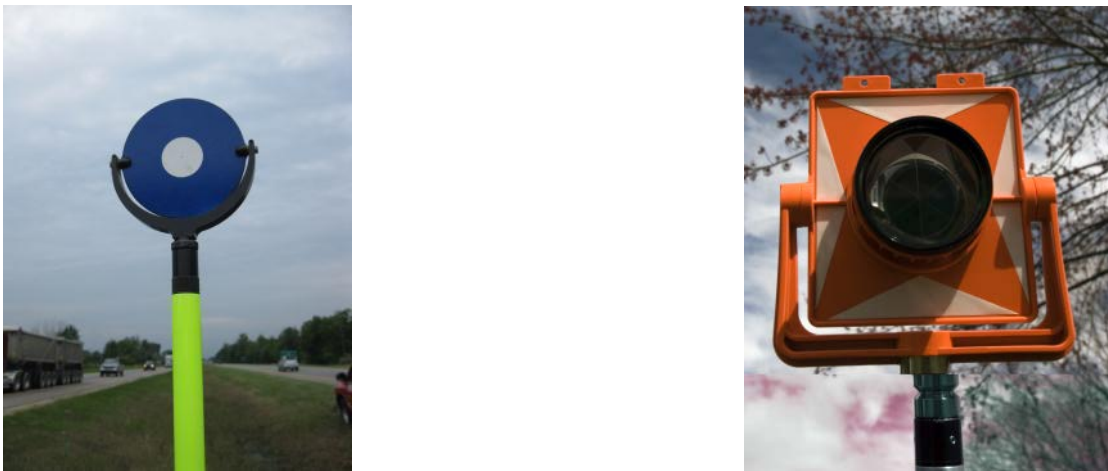
Figure 3.12: Vendor specific targets (Leica to left, Riegl to right) (Courtesy of MTRI) (See Appendix D)

Prior to initializing the LiDAR data collection, a minimum of four points of commonality had to be established to triangulate and validate a local coordinate system. These points of commonality were represented as vendor specific targets mounted on sturdy tripods. Each LiDAR unit required different targets, because of varying manufacturer requirements. As a result, two local coordinate systems were established. The Leica ScanStation C10 required vendor specific targets, while the Riegl LMS-Z210ii used retro-reflective surveying prisms. The two different targets can be seen in Figure 3.12.

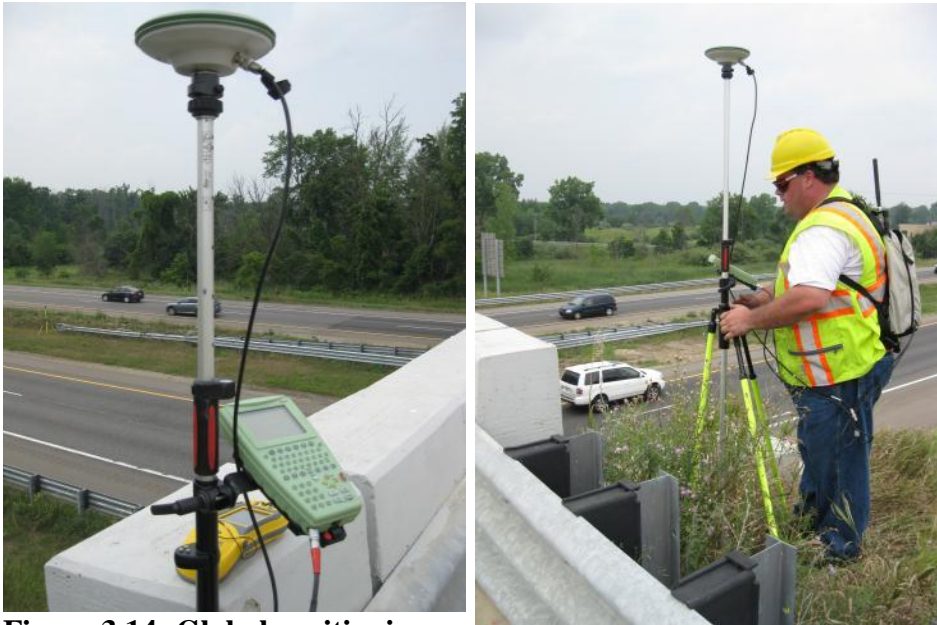
Figure 3.14: Global positioning system for geo-referencing (Courtesy of MTRI) (See Appendix D)

Prior to reception of the fused point clouds for each bridge, registration and geo-referencing was completed on the Leica ScanStation C10 data, which was performed by MDOT. The data sets generated with the Leica ScanStation C10 were geo-referenced to the State Plane coordinate system, Michigan South zone 2113, High Accuracy Reference Network 1983 generated from MDOT's high-accuracy Leica global positioning system (GPS), as shown in Figure 3.14. The vendor specific targets were the points geo-referenced, because the targets were constant from scan to scan. By geo-referencing the data, the point clouds were projected and layered with real time satellite imagery and high-resolution optical images allowing for visual comparison. With the incorporation of optical imagery, determination of potential defects was established allowing for the user to disregard artifacts within the data, which could produce false positives. Additionally, MDOT assigned boundary conditions to the point clouds eliminating unnecessary data not associated with the bridge.

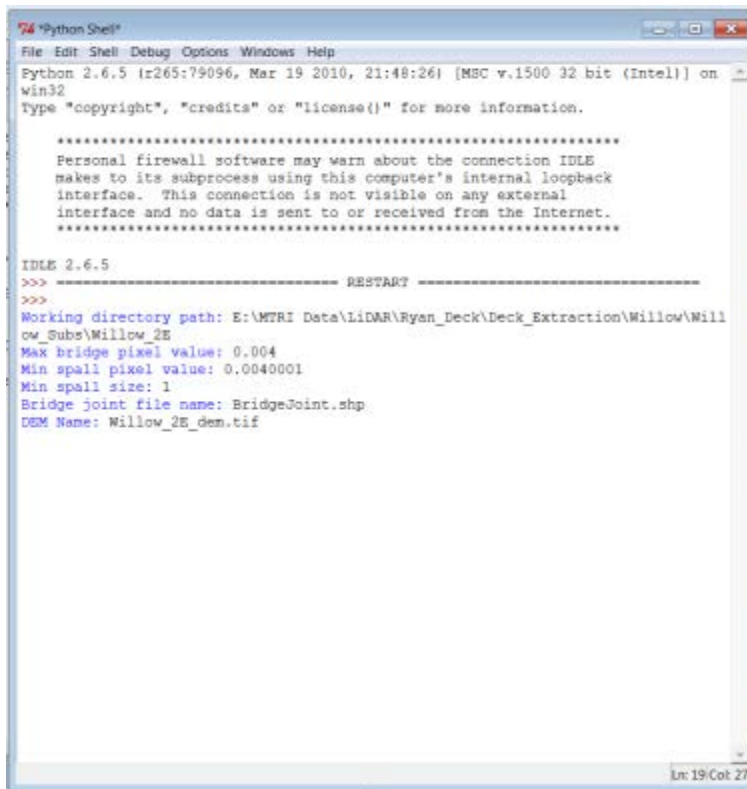
IDLE 2.6.5
>>> ----- RESTART -----
>>>
Working directory path: E:\MTRI Data\LIDAR\Ryan_Deck\Deck_Extraction\Willow\Will
ow_Sub\Willow_2E
Max bridge pixel value: 0.004
Min spall pixel value: 0.0040001
Min spall size: 1
Bridge joint file name: BridgeJoint.shp
DEM Name: Willow_2E_dem.tif

Figure 3.32: MTRI 3DOBS spall detection algorithm user prompt (MTRI 2011)

By selecting to run the module, the Python shell user prompt was populated with multiple system required inputs, as shown in Figure 3.32 (MTRI 2011). Six user defined parameters were required to be inputted in the Python shell user prompt. Important to note is that when inputting the *working directory path*, *bridge joint file name* and *DEM name*, the information provided in the user prompt must match exactly to the actual. If any character was incorrectly defined the algorithm would fail.

Additionally, spall detection parameters were established within the Python shell user prompt. The *max bridge pixel value* requested during this process allowed for the user to define the maximum allowable standard deviation value that would be considered undamaged concrete. Once the defined standard deviation value was exceeded, that pixel pertaining to that exceeded standard deviation value was classified as a spall, as defined by the *min spall pixel value*. With a spall typically being defined as a volume of removed material caused from various concrete deterioration mechanisms, surface area also was required to be defined. The surface area parameter was inputted during the *min spall size* request, which established a pixel based minimum area, which was required to be met or exceeded to be classified as a spall.

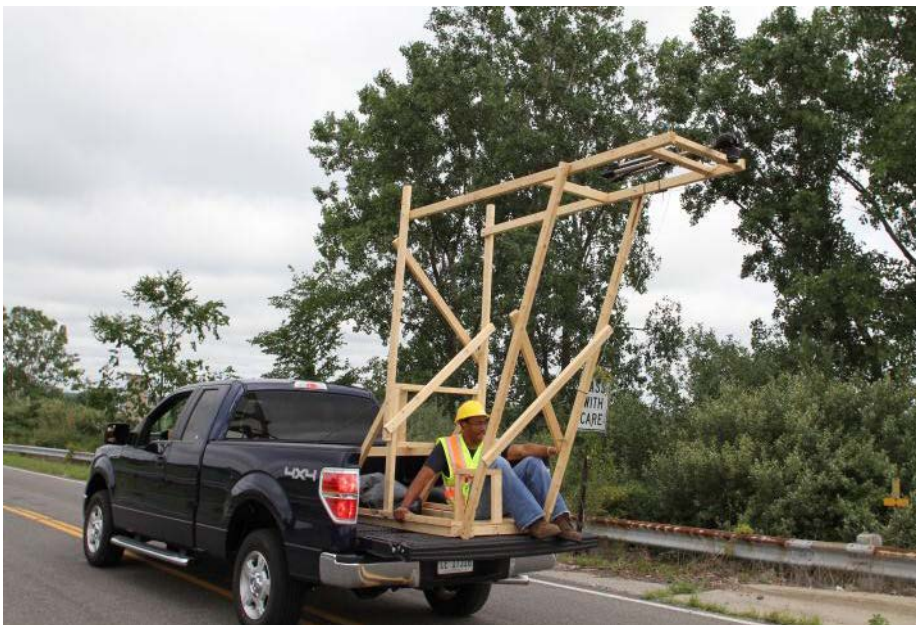
Figure 4.11: 3DOBS field demonstration data collection system (Courtesy of Renee Oats) (See Appendix D)

A technique developed by the Michigan Tech Research Institute, 3D Optical Bridge-evaluation System (3DOBS), was chosen to be the ground truth for comparison to the LiDAR technique. 3DOBS utilizes 3D photogrammetry to generate three-dimensional models from stereo pairs of electro-optical (EO) imagery. The developed models provide depth and height information that could not otherwise be determined from individual EO images. A digital single-lens reflex (DSLR), high-quality camera is the main component of the field system. The system implemented during the field demonstration consisted of a Nikon D5000 DSLR camera, vehicle mount and a camera triggering device as shown in Figure 4.11(de Melo e Silva and Brooks 2011).

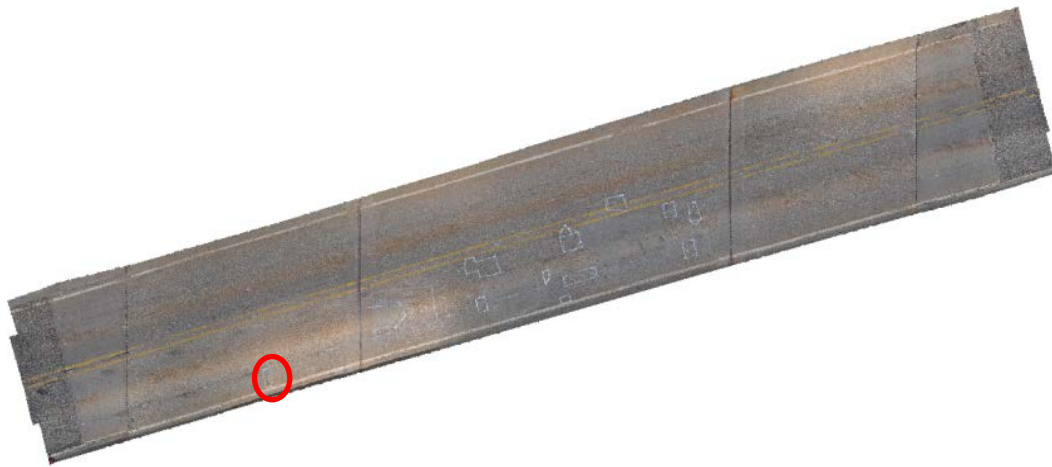
Figure 4.12: Optical image of Mannsiding Road NB showing evaluated spall location (Courtesy of MTRI) (See Appendix D)

A spall of significant size was present within the established 56.2 foot capture radius of the southwest approach scan allowing for an evaluation of the capabilities of terrestrial LiDAR under ideal conditions. Figure 4.12 shows the location of the spall in reference to the entire deck, which is highlighted in red. The spall was evaluated with the algorithm under the established input spall parameters. Results from the analysis estimated that the surface area, volume and percent surface area were 2.065 ft² (0.285 m²), 0.067 ft³ (0.002 m³) and 0.06% respectively. Figure 4.13 shows an optical image and the predicted spall area image from the algorithm for visual comparison. The green color in the predicted spall area image represents the assumed spalled area.
