Coastal Environments: Mine Discharges and Infringements on Indigenous Peoples' Rights

Article Coastal Environments: Mine Discharges and Infringements on Indigenous Peoples' Rights

Citation: Kerfoot, W.C.; Swain, G.; Verissimo, L.M.; Johnston, E.; MacLennan, C.A.; Schneider, D.; Urban, N.R. Coastal Environments: Mine Discharges and Infringements on Indigenous Peoples' Rights. J. Mar. Sci. Eng. 2023, 11, 1447. https:// doi.org/10.3390/jmse11071447

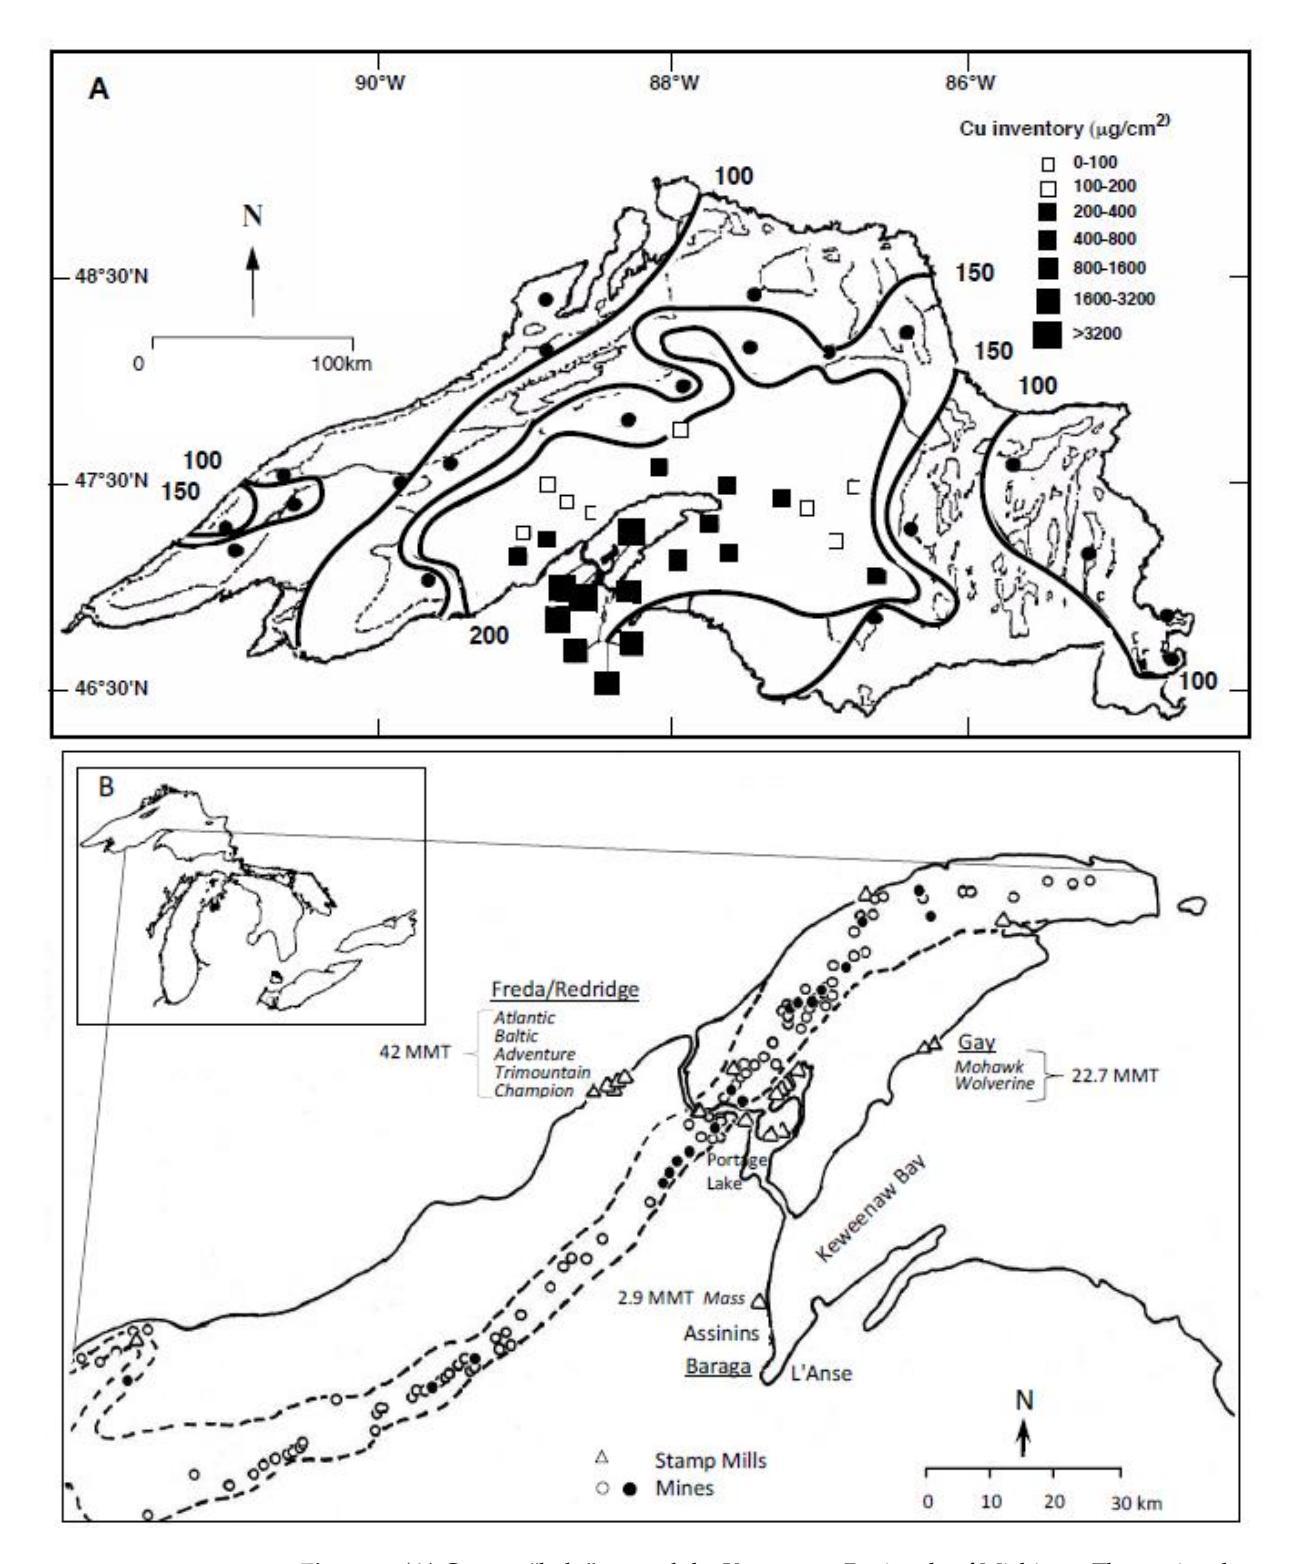
Figure 1. (**A**) Copper "halo" around the Keweenaw Peninsula of Michigan. The peninsula protrudes into Lake Superior and is surrounded by high sediment inventories of copper. Units of anthropogenic copper inventory in sediments are in μ g/cm² (see scale, upper right). (**B**) Distribution of copper mines and major shoreline stamp mills along the Keweenaw Peninsula midrib (Portage Volcanics Series). Three major Lake Superior locations (Freda/Redridge, Gay, and Mass Mill) list amounts discharged into coastal environments (MMT, million metric tonnes).

The Keweenaw Peninsula of Michigan juts into Lake Superior (Figure 1A) and was once one of the great metal mining regions of North America, contributing to the Industrial Revolution. Between 1850 and 1929, the district was the second-largest producer of copper in the world [1,2]. Native copper in the Portage Lake Volcanic Series came from two principal kinds of ore: basalt lava flows (amygdule deposits) and interbedded sediments (conglomerates) associated with a midcontinental rift [3,4]. Both ores were crushed with early gravity and later giant steam-driven stamps to release native copper and silver, producing "stamp sand" tailings [5]. During the native copper and silver mining interval (1844–1968), mines, mill sites, and stamp sand piles dotted the regional landscape (Figure 1B). More than 140 mines worked the central deposits, and >40 mills released stamp sands [6]. Smelters produced 4.4 million metric tonnes of copper, whereas stamp mills sluiced around 360 million metric tonnes (MMT) of copper-rich tailings into rivers and waterways, including 64 MMT directly along Lake Superior shorelines [6–9].

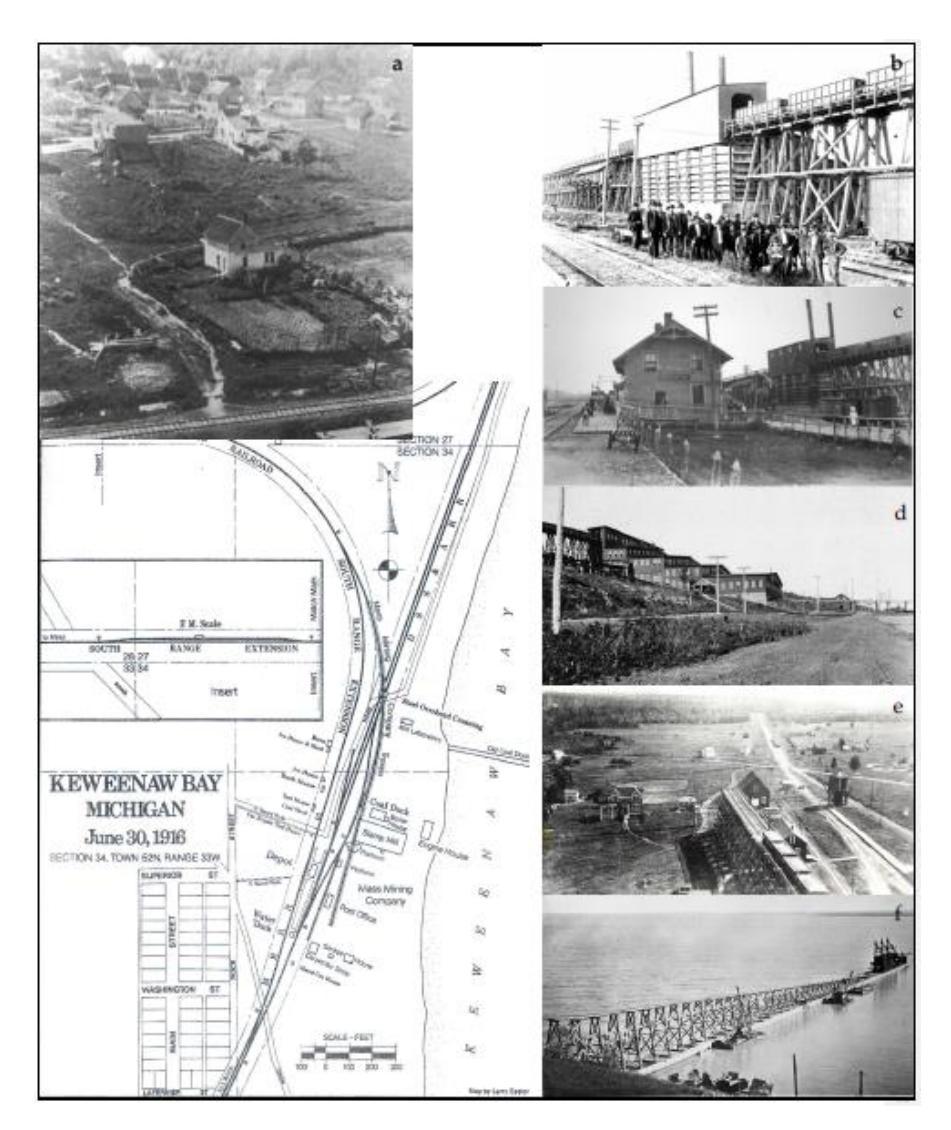
Figure 2. Mass Mill at the "Keweenaw Bay" town location: (**a**) photo of the town of "Keweenaw Bay" inserted along with a period map (1916), which shows locations of the mill, depot, rail lines, and coal dock; (**b**) workers in front of the trestle that delivered ore to the top mill level; (**c**) depot with Mass Mill trestle in the background; (**d**) Mass Mill descending from the trestle works down to the bay, (**e**) water tank, carpenter shop, and train tracks leading south to Baraga; (**f**) elevator track from the Old Coal Dock (all photos courtesy of Baraga County Historical Museum).

Copper ore came from multiple lodes (Evergreen, Knowlton, and Ogima; i.e., in seven amygdaloid beds [3]) of the Portage Lake Volcanics Series (basalt lava flows). Two railways, the Duluth, South Shore & Atlantic Railway (DSS&A) and the Mineral Range Railroad South Range Extension (the latter constructed to convey stamp rock to the mill from Mass City mines), intersected at the town site (Figure 2). Past the depot, railroad lines led southward to Baraga and northward to Portage Lake, while a coal dock ("Old Coal Dock") extended out into the waters of Lake Superior (Figure 2e,f).

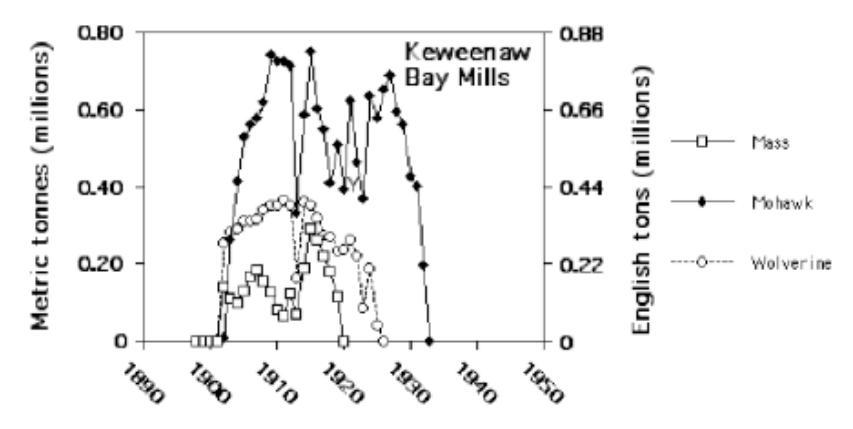
Figure 3. Amounts and times of tailings (stamp sand) discharges from the 3 large Traverse Bay mills (22.7 MMT total from the Mohawk and Wolverine Mills at Gay, Michigan; 2.7 MMT from the Mass Mill at "Traverse Bay Community"). Notice the effects of the 1913 Strike on production from all three mills.

Compared to international operations and other mills along the Keweenaw Peninsula shoreline (Table 1), the amounts released during discharge (1902–1919) were relatively small. Company reports for the Mass Consolidated Mining Company record 2,709,000 tonnes (ca. 2.7 MMT) of ore between 1902 and 1919 (Figure 3), whereas custom work for the Michigan Mill (1902–1906) added another 354 thousand tonnes from the Calico, Branch, and Minesota [sic] lodes, giving a grand total of around 3.1 MMT. Releases occurred in two peaks, interrupted by a district-wide copper miners' strike in 1913 [17] and trestle repairs. Soon after the strike, the company shipped 1143 tonnes of rock to the mill per day, reaching a maximum of 1800 tonnes of ore hoisted per day as World War I began. Copper concentrate was sent northward to the Quincy Smelter at Ripley or to the Coles Creek Smelter at Houghton, both on the shores of Portage Lake [15]. The Michigan Mine utilized one of the stamp heads at the Mass Mill to process rock (1902–1906), while it constructed what became a nonoperational Mill north of the Mass Mill (1906). By 1911, stamp sand accumulating around the Old Coal Dock was interfering with the water intake crib, and became a nuisance. Mass Consolidated had its peak copper production in 1916. Monthly production from 1916 through 1918 remained between 17,200 to 20,000 tonnes of stamp rock, yielding an average grade of 7.45 kg of copper per tonne of ore. Nearly all the rock mass, at least 2.92 million tonnes of stamp sands, left the mill as tailings deposited into Keweenaw Bay.

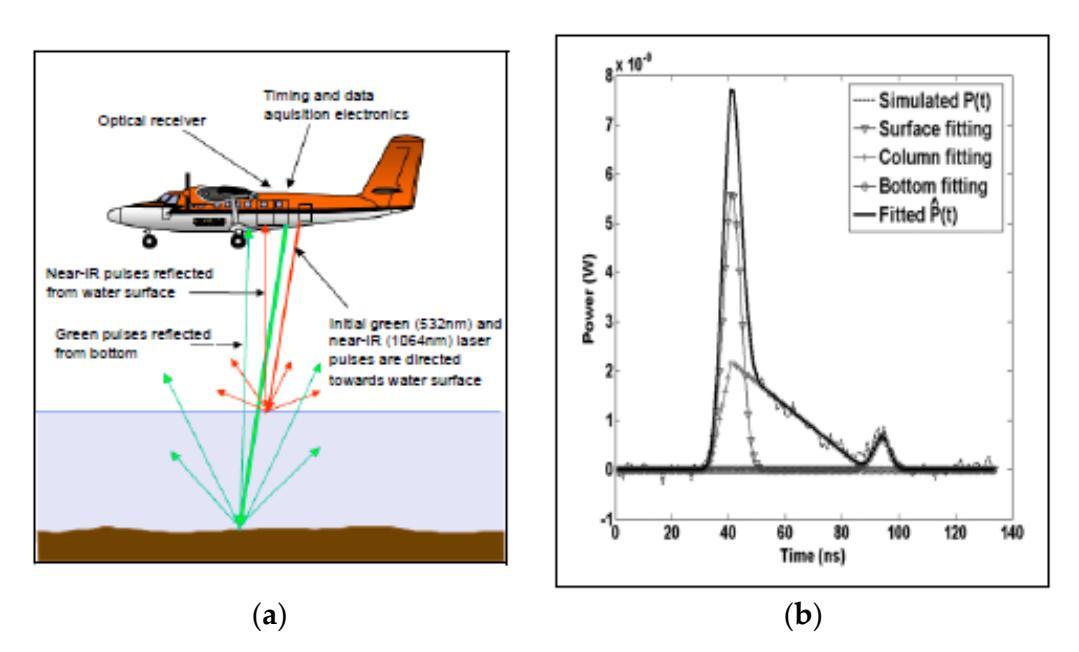
Figure 4. For LiDAR, two laser pulses (blue-green 532 nm and near-IR 1064 nm) sweep across the lake surface: (**a**) The near-IR reflects off the water surface, whereas the blue-green penetrates through the water column and reflects off the lakebed. The difference between the two returning pulses gives the depth of the water column and details of bathymetry (modified from LeRocque and West [21]); (**b**) Simulated LiDAR waveform fitted with Gaussian function (water surface peak), a triangle function (water column reflectance), and a Weibull function for bottom reflectance (after Abdallah et al. [22]).

The laser technique, LiDAR, is an active remote sensing technique used over Traverse Bay in the ALS (airborne laser scanning) version, where an airborne laser-ranging system acquires high-resolution elevation and bathymetric data [20]. The Compact Hydrographic Airborne Rapid Total Survey (CHARTS) and the Coastal Zone Mapping and Imaging LiDAR (CZMIL) systems are separate integrated airborne sensor suites used to survey coastal zones, in which bathymetric LiDAR data are collected with aircraftmounted lasers (Figure 4). In coastal surveys, an aircraft travels over a water stretch at an altitude of 300–400 m and a speed of about 60 m s⁻¹, pulsing two varying laser beams in a sweeping fashion toward the Earth through an opening in the plane's fuselage: an infrared wavelength beam (1064 nm) that is reflected off the water surface and a narrow, blue-green wavelength beam (532 nm) that penetrates the water surface and is reflected off the underwater substrate surface (Figure 4, left). The two-beam system produces a complex wave form (Figure 4, right) that when processed, quantifies the time difference between the two signals (water surface return, bottom return) to derive detailed spatial measurements of bottom bathymetry in addition to ancillary light scattering data.

Laser energy is lost due to refraction, scattering, and absorption at the water surface and lake bottom, placing limits on depth penetration as the pulse travels through the water column. Corrections are incorporated for surface waves and water level fluctuations. LiDAR surveys from 2009, 2015, and 2019 were used for this Project (Supplementary Materials Figure S2). USACE 2009 and 2019 LiDAR overflight data were preprocessed by the U.S. Army Corps of Engineers Joint Airborne Lidar Bathymetry Technical Center of Expertise (JALBTCX). Quality control and editing were done in GeoCue's LP360, bulk datum transformations with NOAA's VDatum, then products were generated using Applied Imagery Quick Terrain Modeler and ESRI ArcGIS (ArcMap and ArcGIS Pro). However, the error associated with LiDAR DEMs (digital elevation/bathymetry models) is sensitive to several variables: mechanical collection (GPS coordinate system, scan altitude and speed, scan pattern, pulse-repetition rate, aircraft yaw, and roll) and signal processing, weather, sea state, depth, water clarity, and wave-form clarity. Depth is important; for example, the horizontal and vertical accuracy of the CZMIL system has been described as $3.5 + 0.05 \times d$ meters and $[0.32 + (0.013 \times d)^2]1/2$ m (Optech Manual), respectively, where d is the water depth. Details of resolution and accuracy in oceanic projects are discussed in several recent works [21–25]. With multiple instrument measurements, vertical LiDAR accuracy can be enhanced to 0.2 m in shallow coastal waters [25], and can be as good as 0.22 (range 0.16–0.31 m) along terrestrial strips [26]. In particular, under low-flying, high-density scanning characteristics of coastal and Great Lakes shorelines, horizontal resolution is listed by JALBTCX as 0.5–1.0 m (0.7 m) along inland beach environments, with vertical accuracy of 15 cm (Optech Manual) [27]. Spatial resolution decreases to ca. 2 m in deeper waters (10–20 m). Underwater DEMs are usually delivered with tiled 3 m resolution. For high-resolution coastal topographic data, we used MISAL Airborne LiDAR 2015.

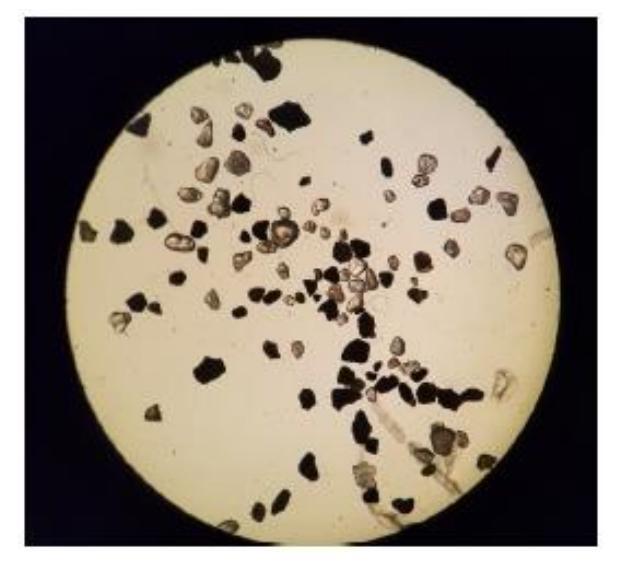
Figure 5. Sample of sand grains from Sand Point (ca. 55% stamp sands) under transmitted light from a microscope, showing the contrast between rounded natural sand (transparent quartz) and dark stamp sand grains (dark, irregular, slightly larger).

The two major sand types in the bay come from quite different end members. The crushed Portage Lake Volcanics, the so-called "stamp sands", are basalts (K, Fe, Mg plagioclase silicates; augite, and minor olivine), whereas the coastal bedrock (Jacobsville Sandstone) and glacial till produces rounded quartz sands that make up the white beach sands. Under a microscope (Olympus LMS225R, 40–80X), particle grains from beach or Ponar samples could be separated into crushed opaque (dark) basalt versus rounded, transparent quartz grain components (Figure 5), allowing calculation of the percent of stamp sand particles in particle (sand) mixtures (see Supplementary Materials Tables S1 and S2). Percentage stamp sand values were based on means of randomly selected subsamples, with 3-4 replicate visual counts, around 300 total grains in each subcount. Standard deviations and errors were calculated for individual samples and the means used to calculate confidence intervals for typical counts. Technically, mixed grain counts followed a binomial distribution, where there was an inverse relationship between the coefficient of variation (CV = mean/SD) and the mean % stamp sand (Figure 6a,b). That is, if the mean % stamp sand is high (>50%), the coefficient of variation (CV = mean/SD) is relatively low (3.1%, n = 12), but if it is <10%, the value could be much higher (mean = 25.3%, n = 30).

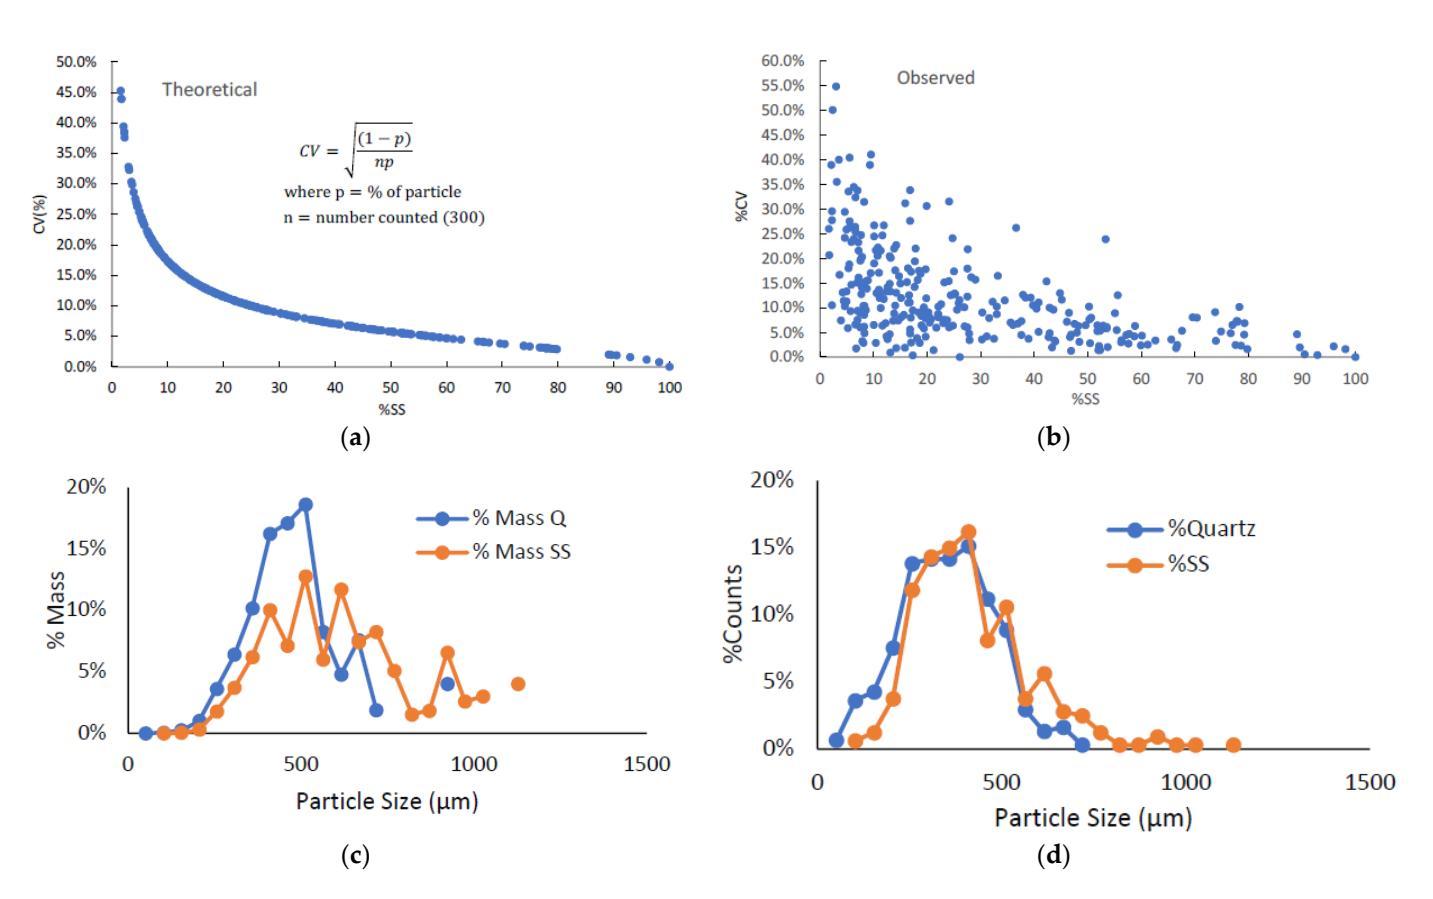
Figure 6. In a mixed sand sample, grain counts (natural sand, stamp sand) follow a binomial distribution: (**a**) the coefficient of variation for the % stamp sand calculation is known (see equation under "Theoretical"); (**b**) field counts closely correspond to the expected values ("Observed"). For particle sizes, see comparison of (**c**) % particle counts and (**d**) % particle mass from the Sand Point beach sample. Particle sizes are similar, but notice the slightly larger sizes and mass for stamp sands (SS) compared with natural quartz (Q) sands in the mixed sand sample.

In selected beach and Ponar samples along Assinins transects, we measured particle sizes for mixtures of stamp sands and natural quartz sands, to compare relative sizes of particles from the two end members (e.g., Figure 6c,d). Otherwise, we used Wildco Stainless Steel Sieves (5 Mesh, 4000 μ m; 10 Mesh, 2000 μ m; 35 Mesh, 500 μ m; 60 Mesh, 250 μ m; 120 Mesh, 125 μ m) on a Cenco-Meinzer Sieve Shaker Table (Central Scientific) to separate particles from mixed grain samples into specific size classes. See Supplementary Materials Table S3 for locations and particle size distributions.

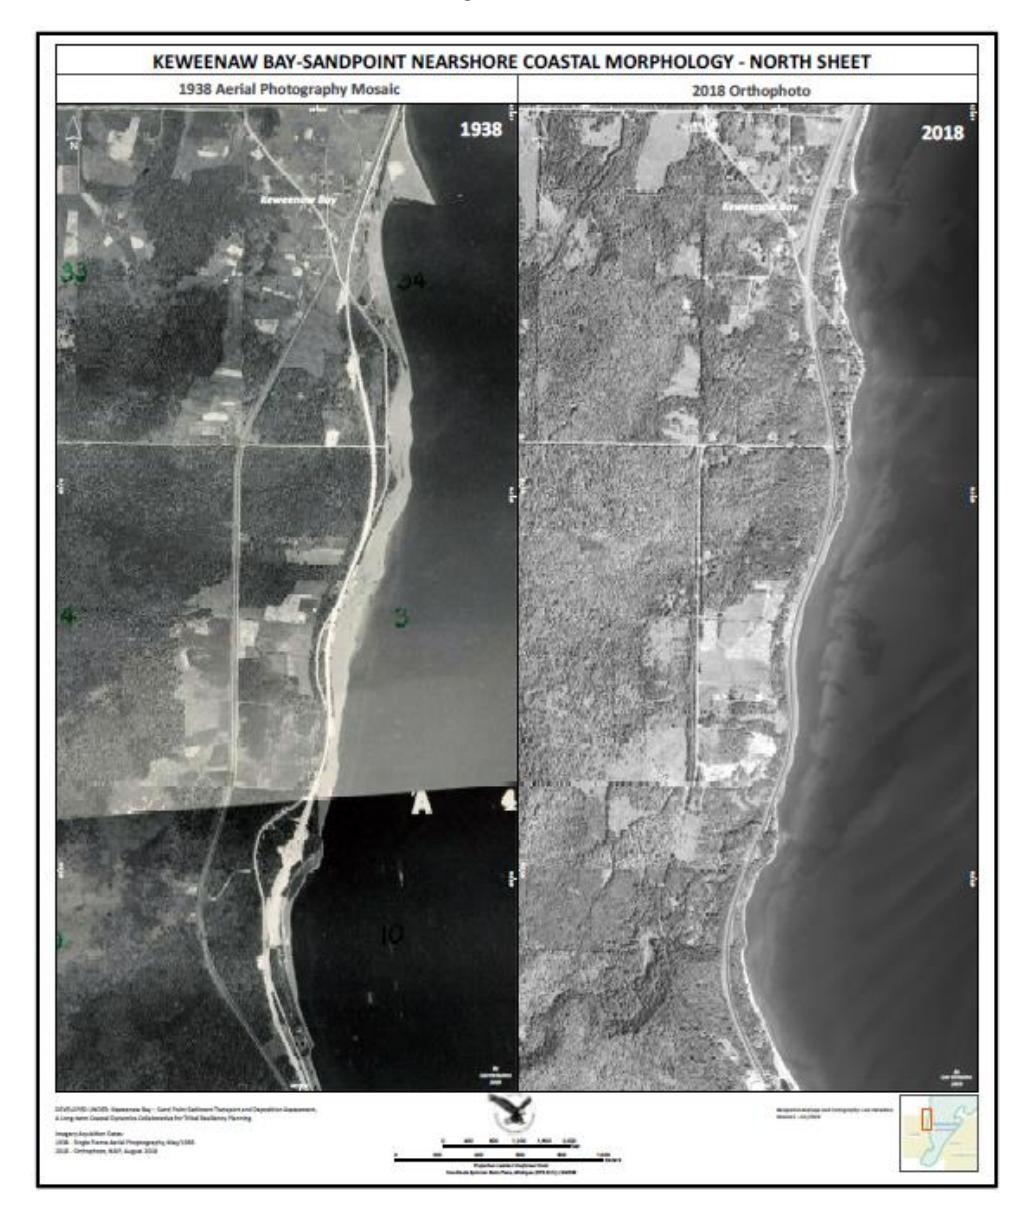
Figure 7. Aerial photos, comparing the coastlines of the Lower Keweenaw Bay in 1938 (**left**) and more recently in 2018 (**right**). In the 1938 northern image, broad stamp sand beaches extend down the shoreline halfway to Sand Point.

Side-by-side aerial photos in Figure 7 (North Sheet) compare a 1938 image of the coastline with a modern-day 2018 image. The coastline stretches from the Mass Mill location on the north to Assinins. The Mass Mill stamp sand discharges were an 18-year (1902–1919) massive point release of particles with two fractions. The fine fraction (slime clay; 10–17% of mass; [32,33]) dispersed widely and rapidly, whereas dispersal of the coarse fraction (sand; 83–90% of mass) was slower and followed the path of natural shoreline sand erosion, migrating down to and adding onto Sand Point [18]. On the 1938 aerial image, we see scattered houses around the former town of "Keweenaw Bay Community", a working railway, several small roads, and a minor highway (M-15). A large triangular wedge of stamp sand lies against the northern side of the "Old Coal Dock". The coal dock stamp sand beach diminished with time, leaving only a slight bulge in 2018. By 1938, the stamp sands have migrated halfway down to Sand Point as an extensive grey beach with a width of 50–100 m and are near Assinins (Figure 7).

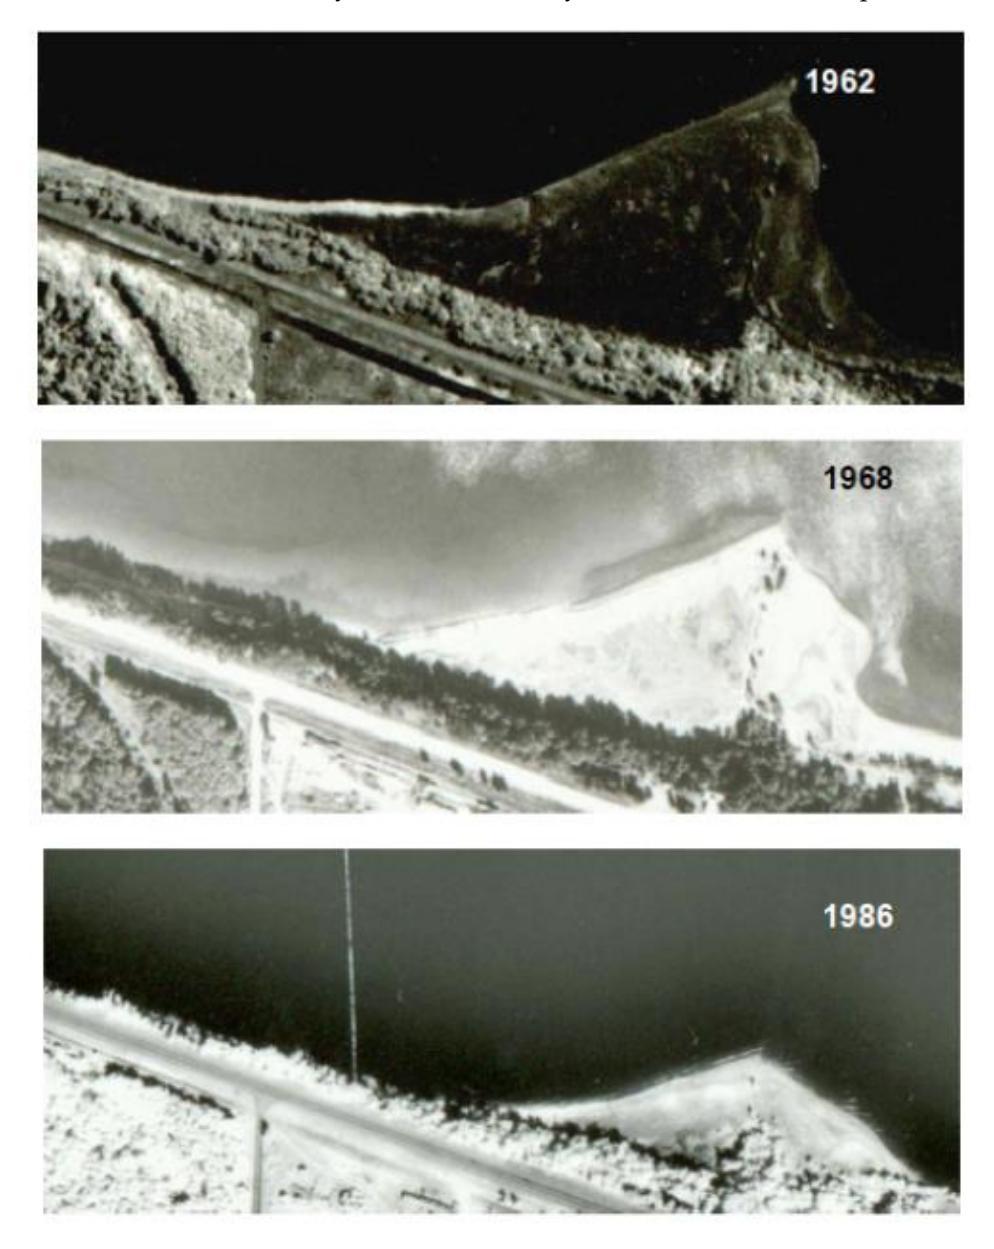
Figure 8. Tailings accumulated around the Mass Mill Coal Dock during operations (1901–1919). Tailings eventually interfered with water intake operations, causing suspension of the "Coal Dock"

operations. Subsequent erosion of this remnant mass is caught by aerial images (1962, 1968, and 1986). For an interval, the stamp sands were so pervasive, they protected the shoreline from erosion (Vitton & Williams [38]). The Coal Dock cribbing still reaches out into Lake Superior at right angles to the shoreline and remains a nautical hazard. The main Highway is U.S. 41. Notice how the northern bluff cliff edge eroded closer to the highway through time (compare 1960s to 1986), resulting in a slight relocation (in 2010, 30 m) of the highway.

Aerial photos in Figure 8 provide more details about the northern coal dock stamp sand beach remnant through time (1962, 1968, and 1986). The large wedge dwindles down to a small triangular bulge at the base of the dock. Over a span of 40 years, the wide stamp sand beach, similar to one at Gay to the north [36,37], was an anomaly that momentarily protected the nearby cliff and coast from wave erosion. Recently, there has been great concern about enhanced, or more appropriately, resumed, coastal erosion threatening Highway #41, the large highway in Figure 7 (2018) and a scenic heritage route. The recent erosion is evident in comparisons of the 1960s with the 1986 cliff edge. Cliff erosion [38] resulted in the relocation of Highway #41 some 30 m inland, at a cost of \$2.3 million, near the Mass Mill site in 2010. The 1938 coastline image (Figure 7, left), shows that a wide southern band of stamp sand formed a beach deposit stretching from the Mass Mill site halfway down to Sand Point. In the 2018 image (Figure 7, right), the upper coastal regions have now reverted to rocky coastline with only a few remnants of stamp sand.

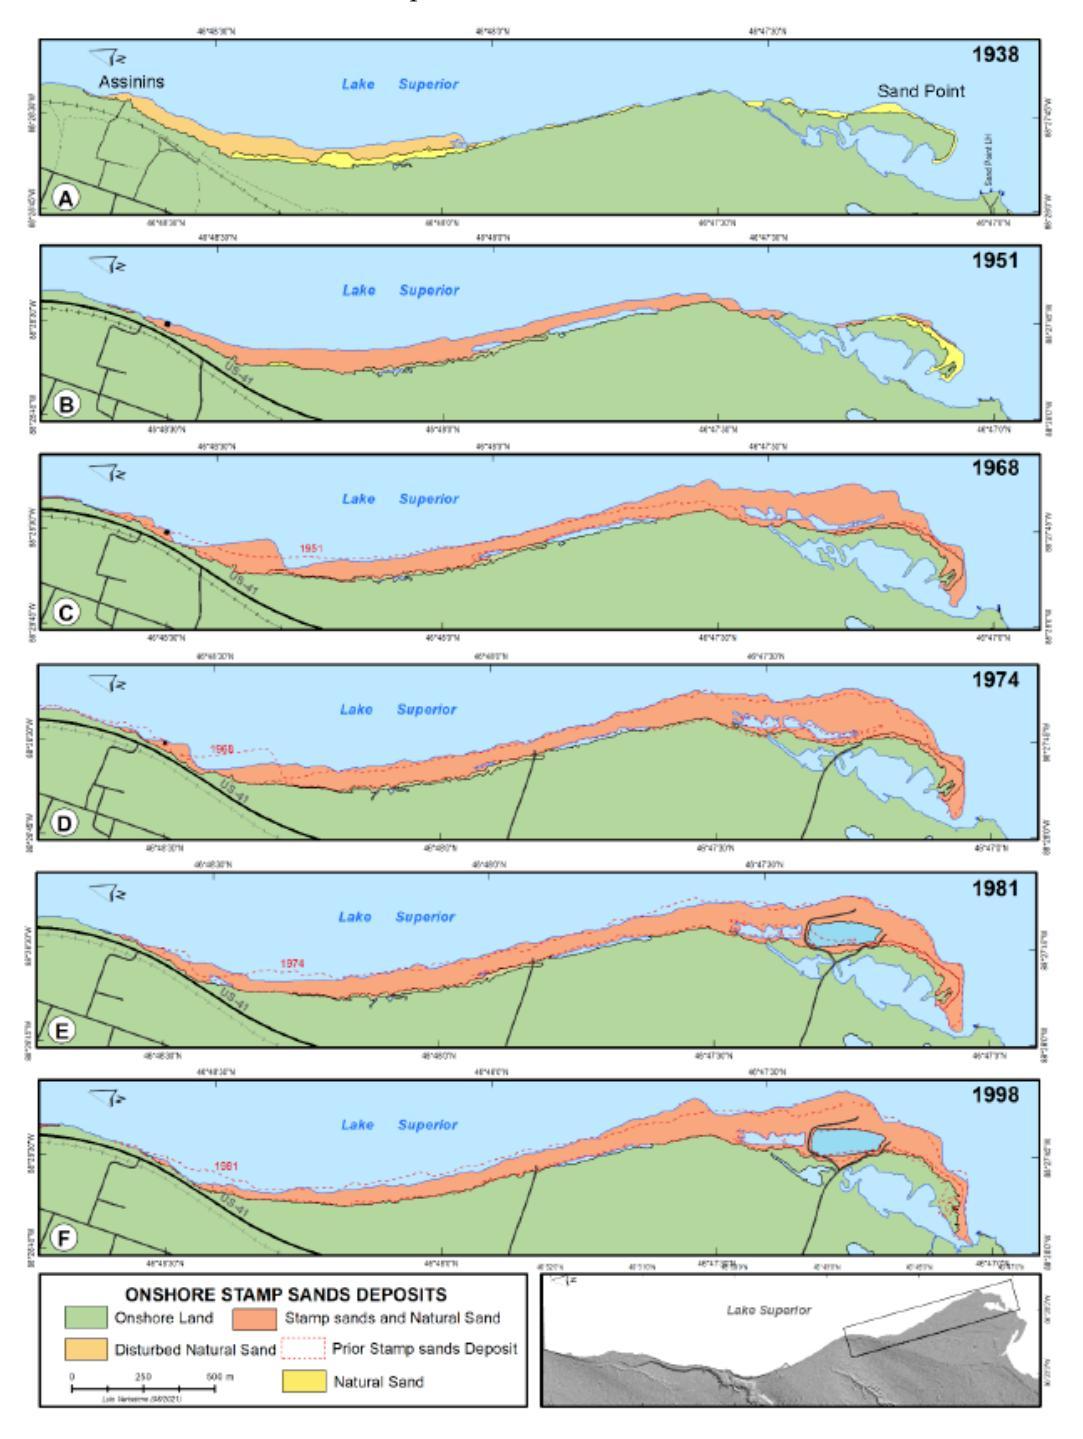
Figure 9. Migration of stamp sand southward along the coast from Assinins to Sand Point (**A**–**F**: 1938–1998). Yellow represents natural sand beach; orange is a mixed (stamp sand/natural grains) beach; whereas reddish indicates a largely stamp sand beach. The various panels also show the progressive transformation of the coastline and Sand Point to a mixed wetland and multiple pond environment.

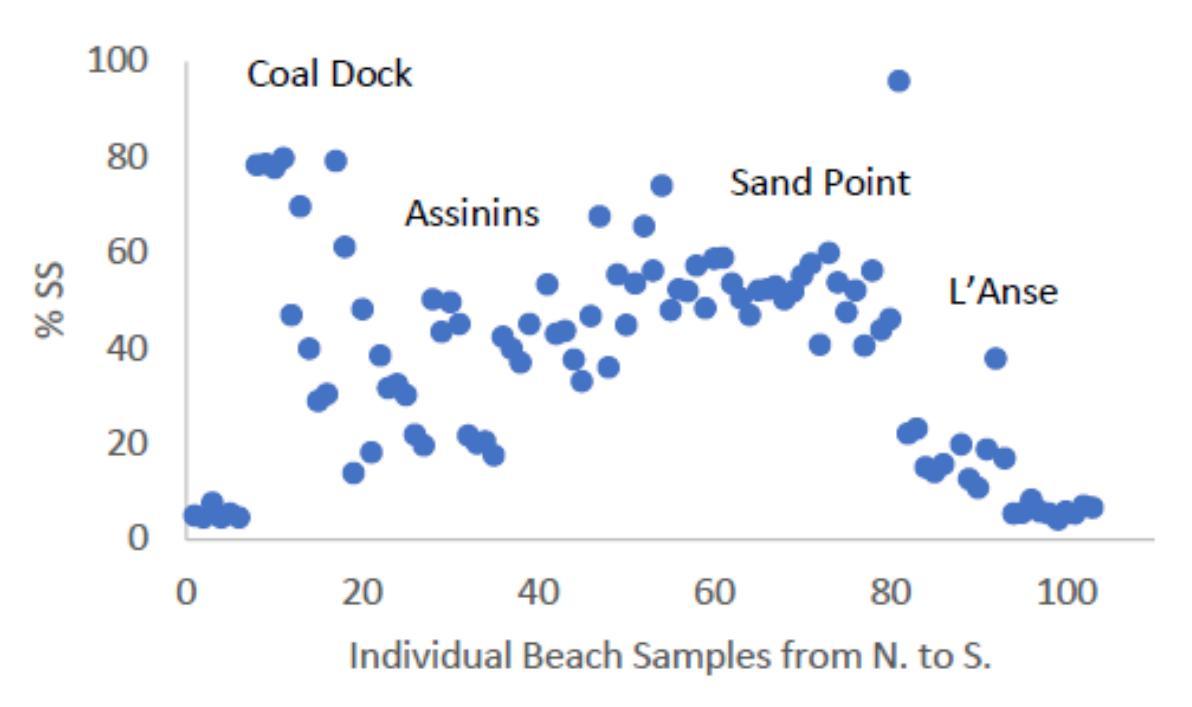
Figure 10. Stamp sand percentages from shoreline beach deposits plotted from north to south along the western side of the lower Keweenaw Bay onto Sand Point. Tallies start north of the Mass Mill site, reach a 70–80% peak at the Coal Dock, then decline across scattered remnant patches. Around site 40, continuous beach deposits from Assinins to Sand Point show values between 40 and 60% SS. At the Lighthouse on Sand Point, stamp sand values decline along the lee white beach region into L'Anse Bay. Points are plotted by their site number from north to south, not by latitude.

We sampled the remnant and continuous stretches of stamp sand beaches with plastic spades, as well as conducting surveys of underwater sediments with Ponar grabs. The percentages of stamp sand at various north to south beach sites are shown from slightly north of the Old Coal Dock to the lee of Sand Point in Figure 10. Stamp sand percentages are low in beaches north of the Old Coal Dock, whereas they are highest at the Coal Dock (70–80%), in the remnant small triangular patch of dark grey beach sands at the base of the dock. Values decline in other remnant spots between the Old Coal Dock and Little Carp River, ranging between 50 to 20%, then increase slightly to 30–50% from Assinins to Sand Point. On Sand Point before the Lighthouse, stamp sand percentages appear similar,

ranging between 40% to 60%, with a couple of spurious points. South of the Lighthouse along the white beach region to the lee side of Sand Point, there is a major decline from 50% stamp sand down to around only 5% stamp sand. Clearly, one of the major processes that distinguishes Mass Mill beaches from other larger mill sites is the active incorporation of natural sands that dilutes stamp sand concentrations.

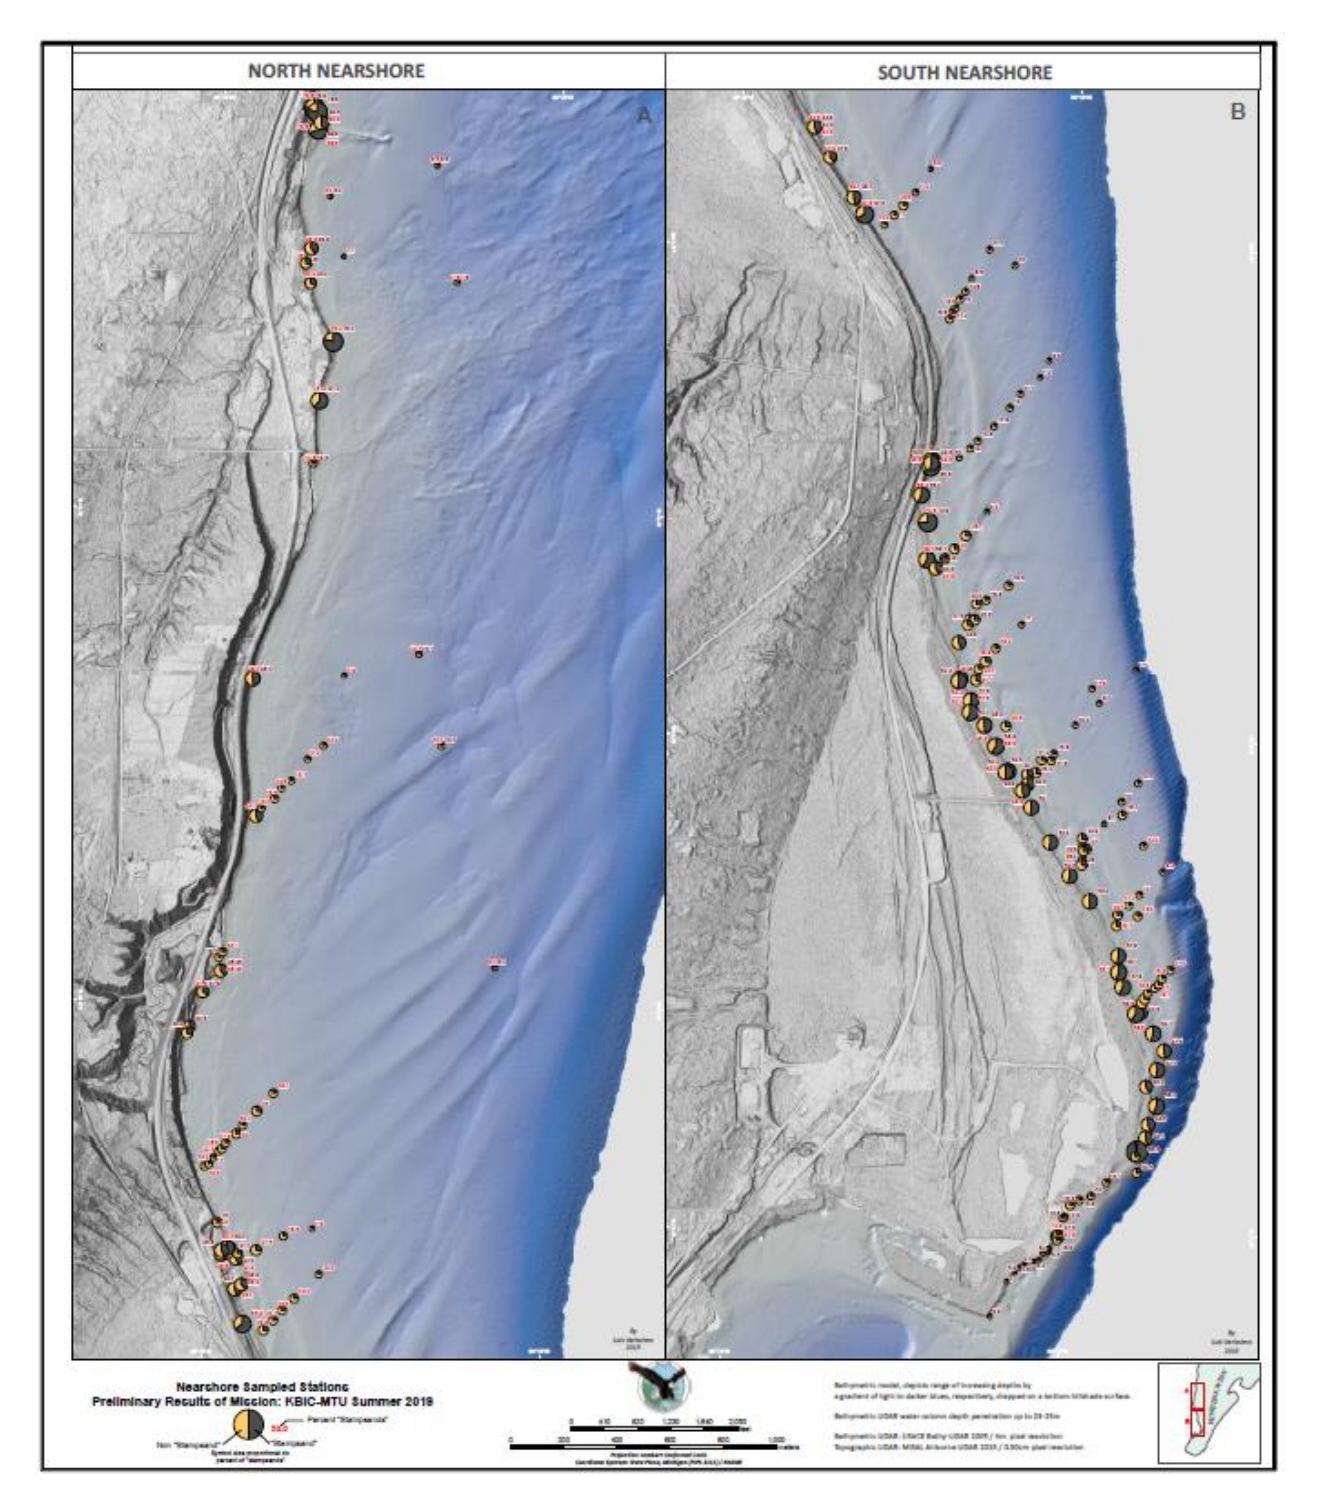
Figure 11. LiDAR DEM of Lower Traverse Bay (west coastline) with superimposed beach and Ponar offshore transect surveys. Left panel (**A**) shows the upper portion of the shoreline, whereas the right panel (**B**) shows the lower portion. LiDAR surfaces include shelf bathymetry and distribution of underwater structures (bedrock, cobble/boulder fields, migrating sand bars and fields), plus detailed topography and infrastructure (highway, roads, trails, river, streams, woods). Note the close proximity of Highway #41 to the shoreline north of Sand Point. Percentage stamp sand is indicated for beach site sand mixtures by both the pie diagram size and shading (fully black = 100% SS).

Here we utilize the LiDAR DEM in Figure 11 to document modern-day details of shoreline features, elevations, and corresponding shallow offshore underwater bathymetric surfaces (Coastal Shelf) from slightly north of the Mass Mill to Sand Point. We have superimposed surveys of percentage stamp sand upon the LiDAR topographic and bathymetry panorama. The first section (North Nearshore) stretches from slightly north of the Mass Mill site, where Jacobsville Sandstone bluffs dominate, down to the Little Carp River and Assinins. Currents and waves aided southward migration of the coarse stamp sand beach material, now leaving only a few lingering remnants of once pervasive stamp sand beaches, indicated by sampling locations. LiDAR DEMs aided construction of benthic substrate maps (Supplementary Materials Figure S3).

However, from Assinins onto Sand Point, there is still a continuous stretch of stamp sand beach. In the LiDAR DEM (Figure 11), notice that Highway #41 comes very close to the coastline at several spots, causing the USACE (U.S. Army Corps of Engineers) to temporarily armor the shorelines with concrete boulders and to construct fortifications (walls, revetments) to reduce shoreline erosion. On the Sand Point portion of the shoreline (Figure 11, South Nearshore), there is a large continuous dark grey stamp sand beach that stretches down to the Lighthouse, then a natural thin white quartz sand beach that curls around the corner into L'Anse Bay and the Baraga Marina region. Samples along the grey beach generally range from 40 to 60% stamp sand, with a mean % SS of ca. 55% (Figures 10 and 11). Past the Lighthouse and along the white sand beach, samples start at 10–20% SS, whereas around the corner, the furthest are generally below 5–10% SS. The coastal shelf becomes a nearly vertical face right before the Lighthouse, with a 24 m drop-off along the beach edge. Past the Lighthouse and the underwater sill that marks the beginning of L'Anse Bay, the sediments are much more shallow, more organic, and filled with macrophyte beds and wood fragments from early sawmill activity [19]. Moreover, L'Anse Bay has a separate bay circulation pattern, plus more fine-grained sediments, a consequence of lower wave action plus sedimentation from several streams and a river (Six Mile, Menge, and Linden Creeks; Falls River). The

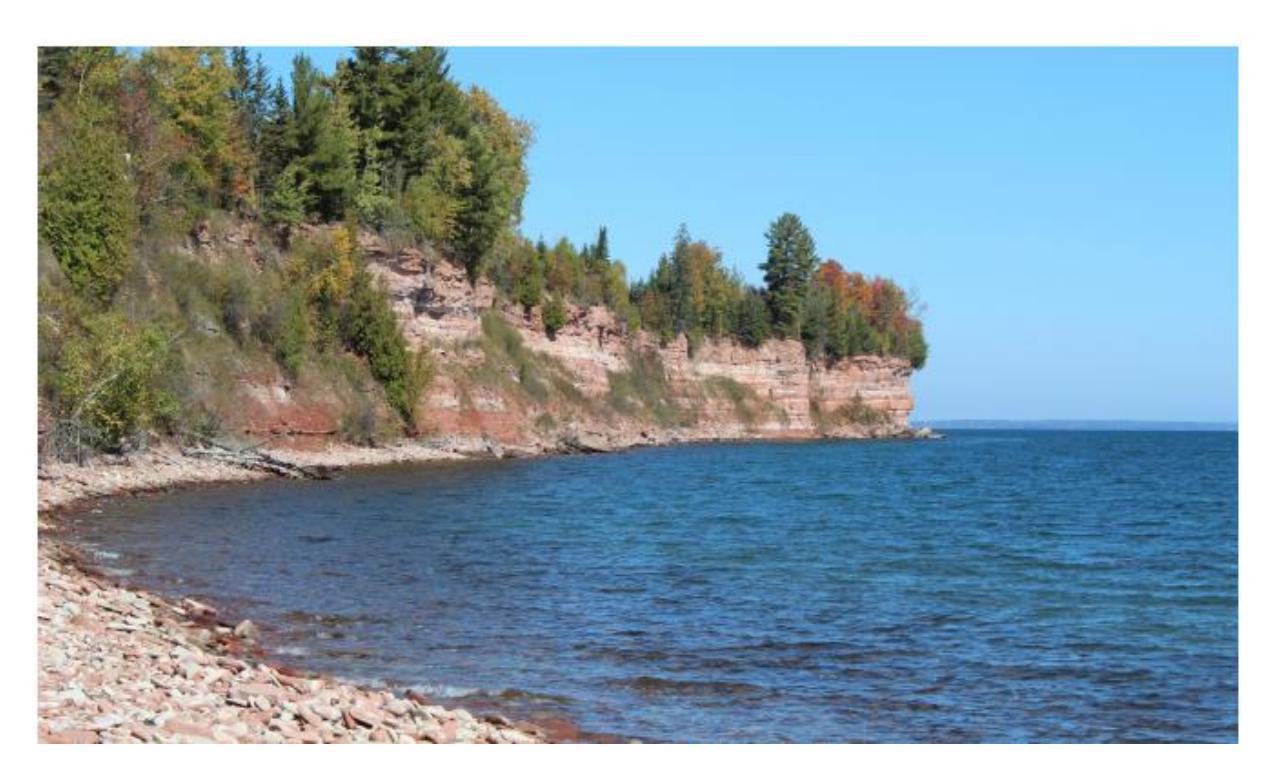
Figure 12. Jacobsville Sandstone bluff just north of the Mass Mill and Old Coal Dock site. Rock below the bluff accumulates as a talus slope. Waves break and grind the rocks into small round pink and white pebbles, distributed along the recovering shoreline.

In recovery, immediately north of the Old Coal Dock site, modern impressive Jacobsville Sandstone bluffs contribute rocks to basal talus piles (Figure 12). The sandstone talus blocks are ground up and rounded by wave action into beach cobbles, pebbles, and sands. Just north of the Coal Dock site, naturally rounded pink and white pebbles cover the shoreline in a band from the cliff outcrops to the stamp sand remnants around the base of the Coal Dock. At the Coal Dock, the shoreline band of pink and white pebbles bends outwards around the remaining slight triangular wedge of stamp sands (Figure 13a). Both the size and dark area of pie diagrams indicate the percentage of stamp sand in the sand mixtures. A large, full dark circle signifies 100% stamp sand percentage (%SS), whereas a half circle indicates 50% SS. The first cluster of large circles is located at the base of the Coal Dock, where residual hillside stamp sand patches contain as much as 74–80% stamp sand (Figure 13a).

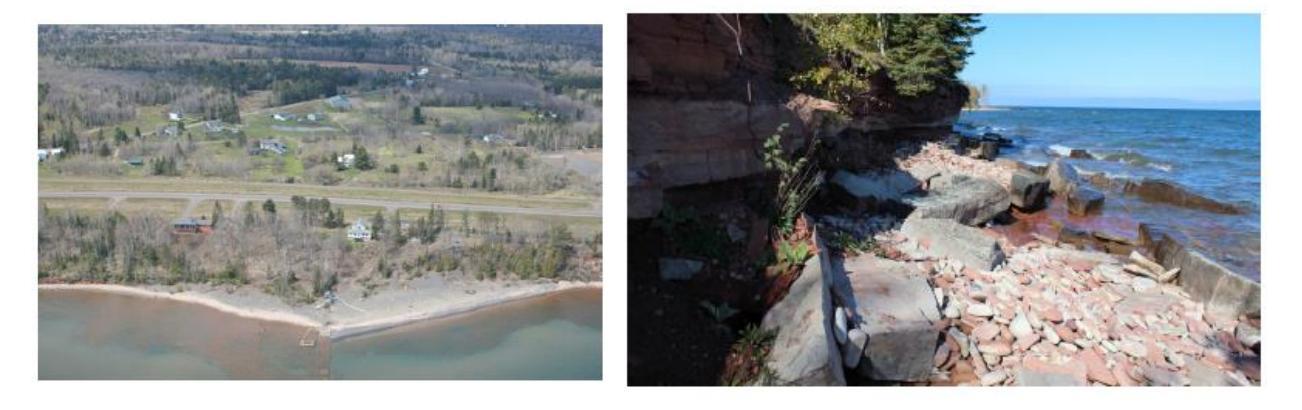
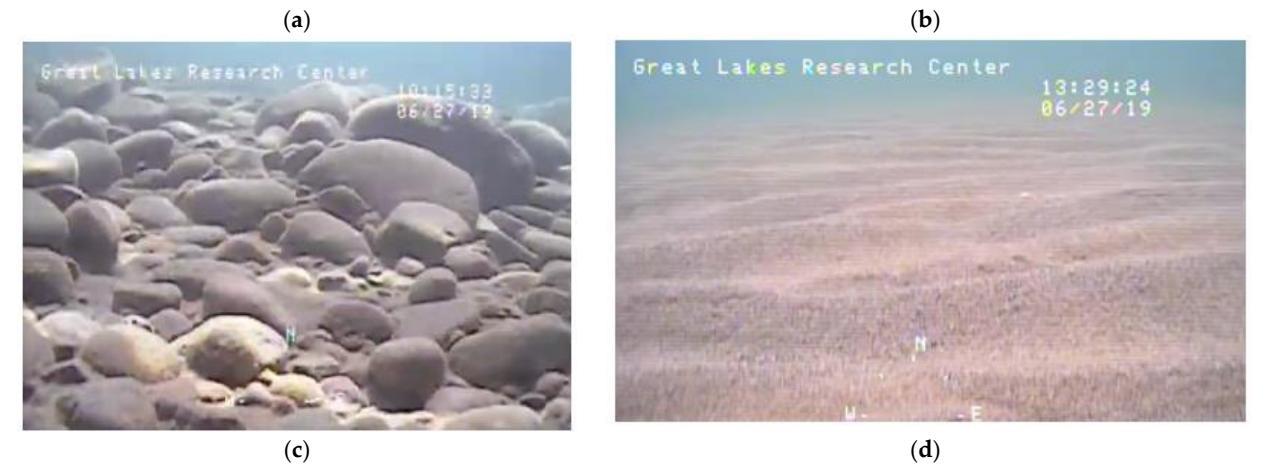
Figure 13. Recent views of the former Mass Mill and northern coastline sites. (**a**) A sandstone cobble beach is developing along the shoreline and around the remaining triangular wedge of residual stamp

sands at the base of the Coal Dock. Cribwork for the Coal Dock still protrudes out into Keweenaw Bay. The original mill, town, train station, and railroad complex are absent, only a remodeled Assay (Laboratory) House and a few scattered new homes remain. Highway #41 runs over ground once occupied by the extensive railroad tracks and trestles. (b) Sandstone block and cobble shoreline south of Mass Mill. The site includes a mixture of natural sandstone pebbles, cobbles, and capstone boulders eroding from the 5' Jacobsville Sandstone shoreline edge. The beach width was once covered by hundreds of feet of stamp sand during mill discharge, but is now in recovery. (c) ROV photo of extensive underwater large cobble and boulder fields on the shelf region off the Mass Mill site. The rounded cobble and boulder beds are sites where fish drop eggs. (d) Off Assinins, ROV photos of massive migrating sand bars show pronounced ripples. Offshore there is little stamp sand in the moving bars, often less than 20–10% of particles. The sand surface appears a grainy, mottled light pink.

Today, the particle size distribution from what looks to be a remnant of the original stamp sands discharge stuck on the slope behind the Coal Dock (Figure 13a) ranges from above 5 mm to clay-sized particles. The percentage of stamp sands left at this hillside pile below the site of the original Assay (Laboratory) Office is the highest along the beach shoreline, above 70–80% (Figure 10; see Supplementary Materials Tables S1 and S2). When sieved (n = 3 subsamples), the particles fall into the following mean size classes: 5.3 mm mesh or above (4.3%), 3.0 mm (19.0%), 1.25 mm (41.5%), 0.38 mm (13.3%), 0.19 mm (13.5%), 0.09 mm (6.1%), and 0.05 mm (2.4%). Because the high levels of copper in stamp sands at the discharge site (70% SS \times 0.3% Cu = 2100 ppm Cu) can adversely affect benthic organisms and aquatic food webs, there is a legitimate concern about contamination around remnant patches. Remains of the Old Coal Dock cribbing still stretch out from the shoreline into Keweenaw Bay (Figures 11 and 13a), creating a nautical hazard. Because of the great fetch, severe waves batter offshore underwater surfaces near the Mass Mill site. Bottoms are dominated by bedrock and cobble/boulder fields (Figures 11 and 13c). Hence, good Ponar sampling sites are few and scattered. Sand patches that are sampled indicate low percentages of stamp sand (<10%; Figure 11; Supplementary Materials Table S2). Along beach margins down to the Little Carp River, shoreline stamp sands are scarce. Offshore, there is a north-south transition from bedrock and boulder fields to large offshore sand bars and fields (Figures 11 and 13d) that cover the Assinins shelf to the edge of the Keweenaw Trough. The migrating underwater natural sand fields and bars allow long offshore sediment surveys, and observations of substrates with ROV and side-scan sonar. Underwater observations aided the construction of a benthic substrate map (Supplementary Materials Figure S3).
