Coastal Environments: Mine Discharges and Infringements on Indigenous Peoples' Rights

Article Coastal Environments: Mine Discharges and Infringements on Indigenous Peoples' Rights

Citation: Kerfoot, W.C.; Swain, G.; Verissimo, L.M.; Johnston, E.; MacLennan, C.A.; Schneider, D.; Urban, N.R. Coastal Environments: Mine Discharges and Infringements on Indigenous Peoples' Rights. J. Mar. Sci. Eng. 2023, 11, 1447. https:// doi.org/10.3390/jmse11071447

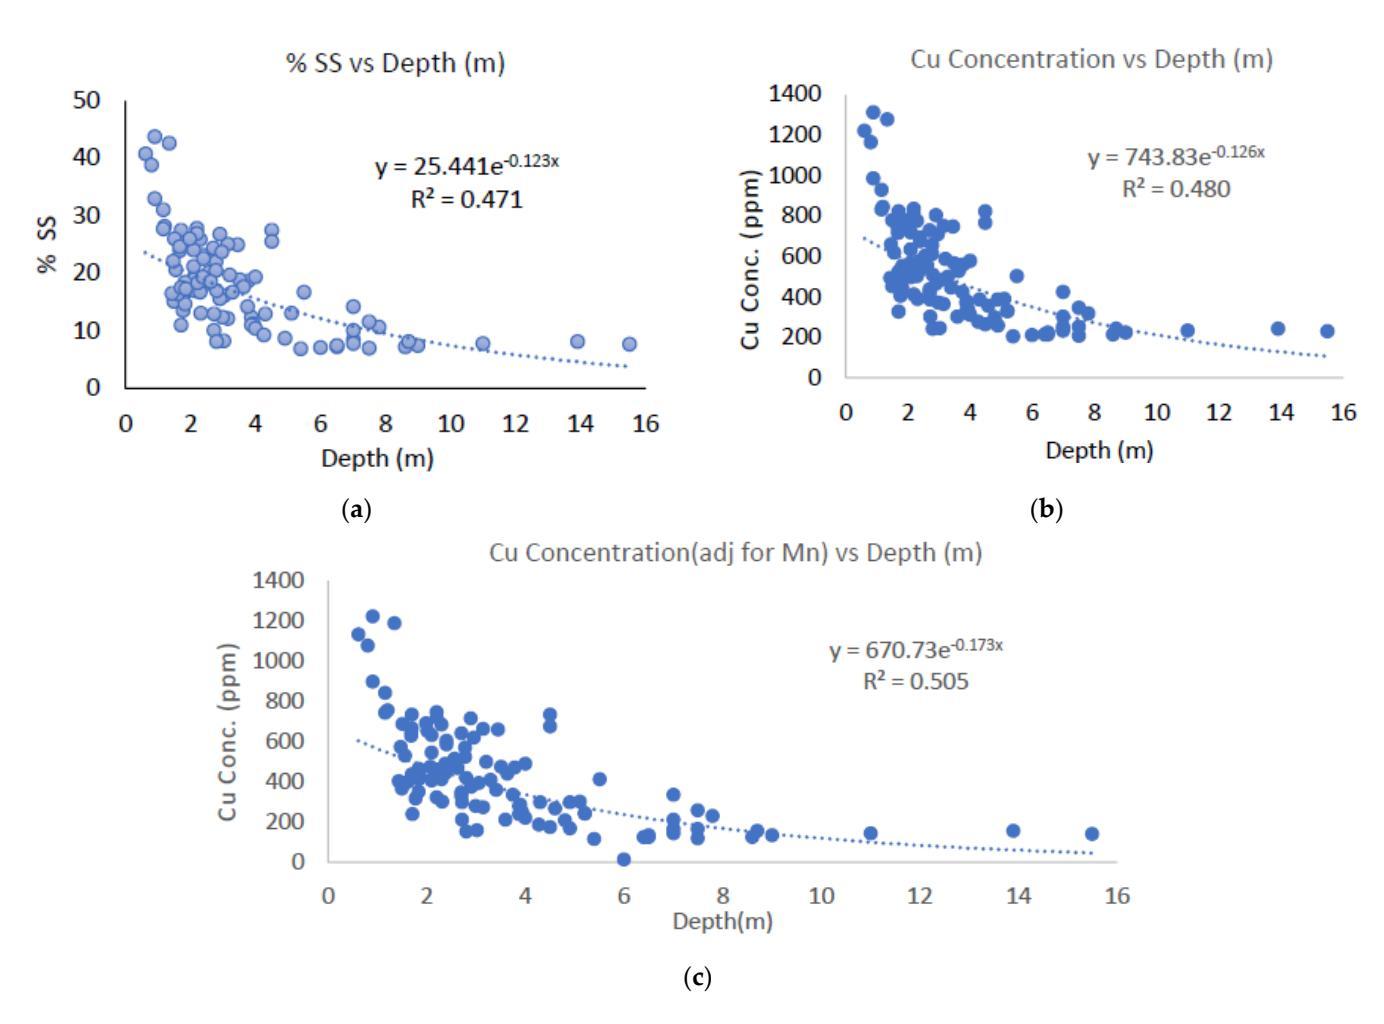
Figure 14. Stamp Sand percentages and predicted Cu concentrations plotted against water depth across the Assinins Shelf (exponential regression fits). (**a**) Stamp Sand percentages determined by microscopic counting technique; (**b**) Cu concentrations predicted assuming the mean concentration of 0.3% copper in stamp sand; (**c**) Cu concentrations corrected for Mn (see Supplementary Materials Table S4). These diagrams are underwater values and do not include shoreline stamp sand beach deposits.

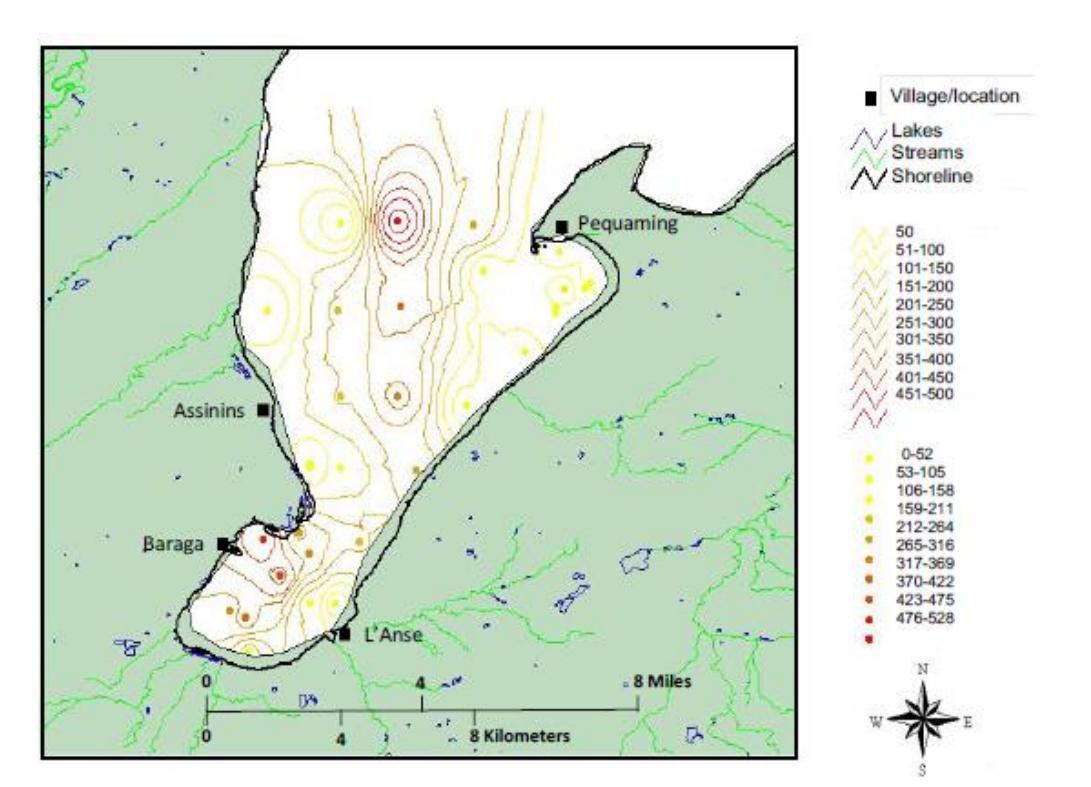
Figure 15. Ponar sediment copper concentrations in underwater sediments across southern Keweenaw Bay and in L'Anse Bay. Values for Cu contours and points are provided in the right-hand legend. Copper appears enhanced in the deep "Keweenaw Trough" region, and around the lee of Sand Point, off the Baraga Marina.

Figure 15 shows a map of modern-day surface sediment Cu concentrations across southern Keweenaw Bay and into L'Anse Bay. Copper concentrations are highest in the Keweenaw Trough off of Mass Mill (400–600 ppm) and in the lee of Sand Point in L'Anse Bay (400–500 ppm). Maximum surface values in the Keweenaw Trough reduce toward the southern end, at the L'Anse Bay sill (300–400 ppm). In L'Anse Bay, sediment cores between Sand Point and the marina possess basal laminated sediments [18], apparently marking early penetration of the stamp sand fine clay fraction into L'Anse Bay. Copper concentrations peak deeper in the sediments (600–800 ppm), then reduce to around half the peak values (400 ppm) in surface sediments. The "fines" fraction thus appears to have dispersed early and rapidly, accumulating into the "Trough" region offshore and around the lee side of Sand Point, off the Marina.

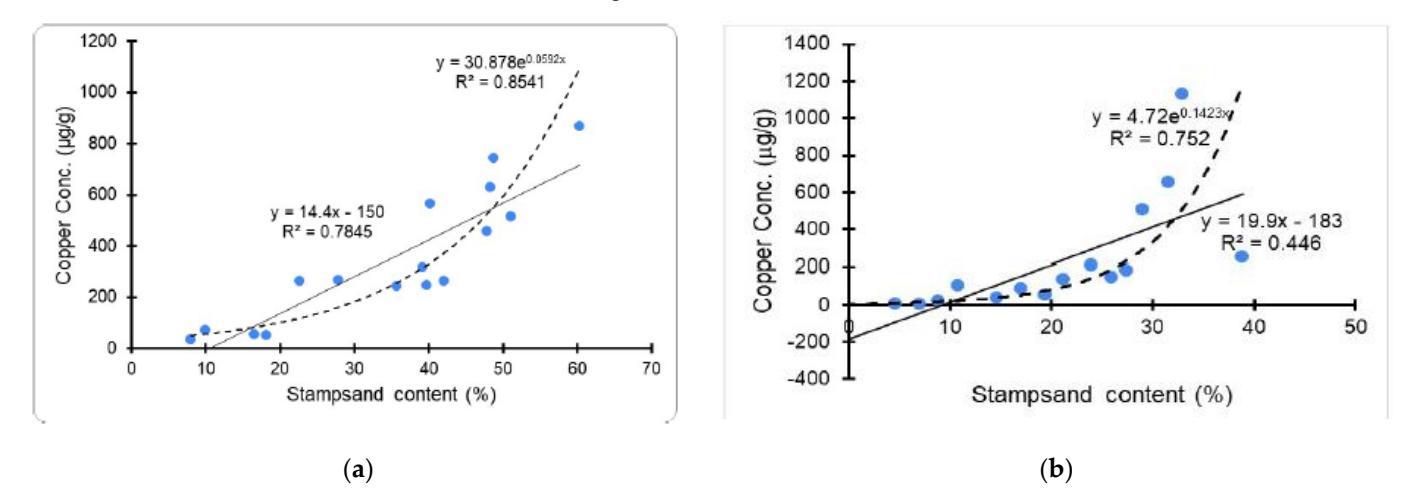
Figure 16. Relationship between directly determined copper concentrations and stamp sand content for sediment grab samples: (a) These samples were collected in 2019 from the northern Keweenaw Bay area (Gay) by Buffalo Reef; (b) These samples were collected in 2019 from lower Traverse Bay and Sand Point.

In Figure 16, direct measurements of Cu concentrations are compared with "predicted" values from two different locations in Traverse Bay. Copper concentrations in sediment grab (Ponar) samples across Grand Traverse Bay (Buffalo Reef) range from 20 to 860 μ g/g (ppm) and are regressed against "predicted" concentrations from the microscope particle counting technique (Figure 16a). The negative intercept for the linear curve (R² = 0.785) might suggest that there are some false positives (perhaps manganese grains) in the counts. An exponential curve fit has a slightly higher R² value (0.854), although both are statistically significant with a similar magnitude of prediction error (*p* < 0.05, RMSE 115 vs. 118). The intercept for the exponential curve is close to the "background" copper concentrations in Lake Superior sediments (37–77 μ g/g, ppm; [13]). In Grand Traverse Bay (Gay) sites, the nonlinear regression correlation (r = 0.924) between observed Cu and "predicted" Cu is relatively high [36].

Nearshore sediments south of the Mass Mill in southern Traverse Bay showed a similar range of concentrations (2–1130 μ g/g; Figure 16b). The linear model relating copper concentrations to stamp sand content also had a negative intercept. Unfortunately, the lack here of samples beyond 50% SS causes a problem. The nonrandom distribution of residuals suggests that the linear model is inaccurate. Again, the exponential model (Cu vs. % SS) has a higher and statistically more significant correlation, *r* = 0.867 vs. 0.668, than does the linear model (*p* = 0.00011 vs. 0.012). Copper concentrations were not measured in samples with stamp sand content greater than 40% because the sediments were too coarse

(>1 mm mass median diameter, MMD) to be completely digested. The "background copper" in this region, taken as the intercept of the exponential curve (4.7 μ g/g), is lower than that observed in the Buffalo Reef region. Although highly correlated, the observed concentrations are less than that predicted by the simple 0.3% Cu × % SS formula. At Gay, even more extensive recent cross comparisons (>168 samples, manuscript in preparation) suggest actual copper concentrations from beach and shelf samples are lower, around 65–80% of "predicted" values. This finding suggests that copper-rich particles probably had a tendency to stay near the original site of deposition and that most clay fractions were winnowed out into deep waters, or drifted around Sand Point, i.e., that there is some spatial heterogeneity in particle distribution that influences Cu concentrations. In any event, the results confirm that Cu concentrations (Trough off Mass Mill, lee of Sand Point off the Baraga Marina).

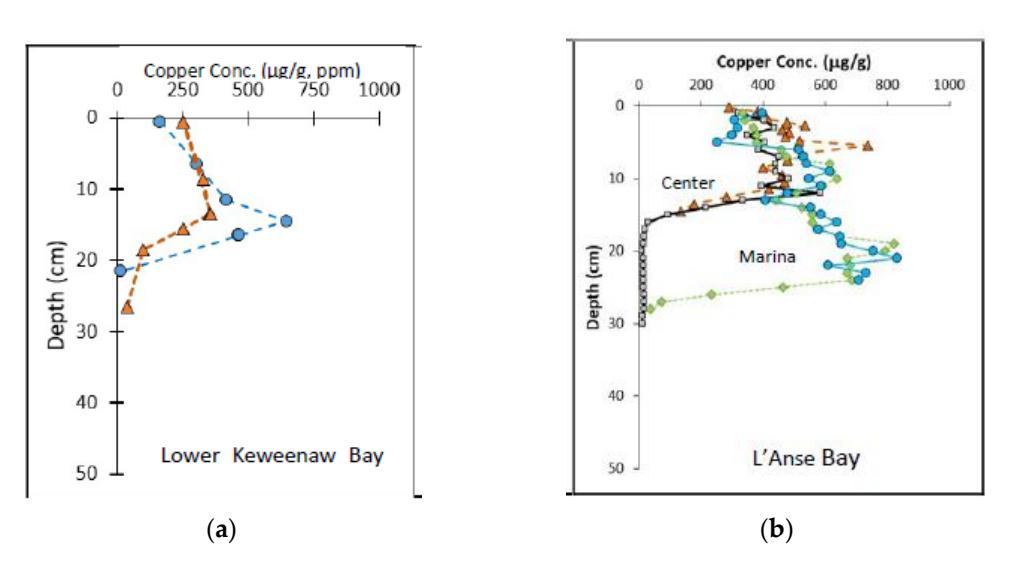
Figure 17. Directly determined copper profiles from sediment cores: (**a**) two cores from the southern region of Keweenaw Bay; (**b**) profiles from four L'Anse Bay cores, two off the Marina and two from the center of the bay. All core profiles have a buried maximum. Surface concentrations from both regions have decreased substantially since the historical maximum peak, yet remain elevated far above background (~35 mg/kg; ppm) at all locations.

Core profiles taken from the Keweenaw Trough and L'Anse Bay (Figure 17) show buried peaks and elevated surface Cu concentrations. Buried peaks range from 300 to 700 μ g/g (ppm) Cu in the southern Trough region, whereas buried peaks in L'Anse Bay cores range from 600 to 850 μ g/g Cu concentrations. The core depth differences off the Marina and center (24 cm vs. 15 cm), are likely a result of different site sediment deposition rates, as the relative Cu profiles are very similar. Laminae in the core profile in the lee of Sand Point suggest that a portion of the slime clay fraction arrived early into L'Anse Bay, possibly between 1902–1920. Core profiles show a few large stamp sand particles arriving later, around the 1950s to 1960s, similar times as indicated by aerial photographic records of the stamp sand beach arrival on Sand Point [18]. Both sets of cores indicate elevated copper concentrations in surface sediments, although concentrations have reduced about 50% or more from the buried peaks, indicating recovery is also underway in the southern part of the bay. However, in L'Anse Bay, all but one measured surface copper concentration exceeded the TEC (34–37 μ g/g), and 75% were above the Probable Effects Concentration (PEC 36–390 μ g/g; [40,41]). If copper fluxes and inventories are calculated for L'Anse Bay cores, and compared with other sites (Table 2), the mining Mass Mill discharge is placed into better perspective. A comparison of L'Anse Bay with Portage Lake (part of the Super Fund Site) shows that L'Anse Bay Cu fluxes are only 57% and inventories only 31% of one of the most disturbed sites, Portage Lake. Moreover, copper inventories are well above (13 times) the inventory characteristic of offshore Lake Superior (Figure 1), although only 31% of the Portage Lake inventory. Even after a century, large areas of southern Traverse Bay and L'Anse Bay contain copper concentrations that can affect biota.

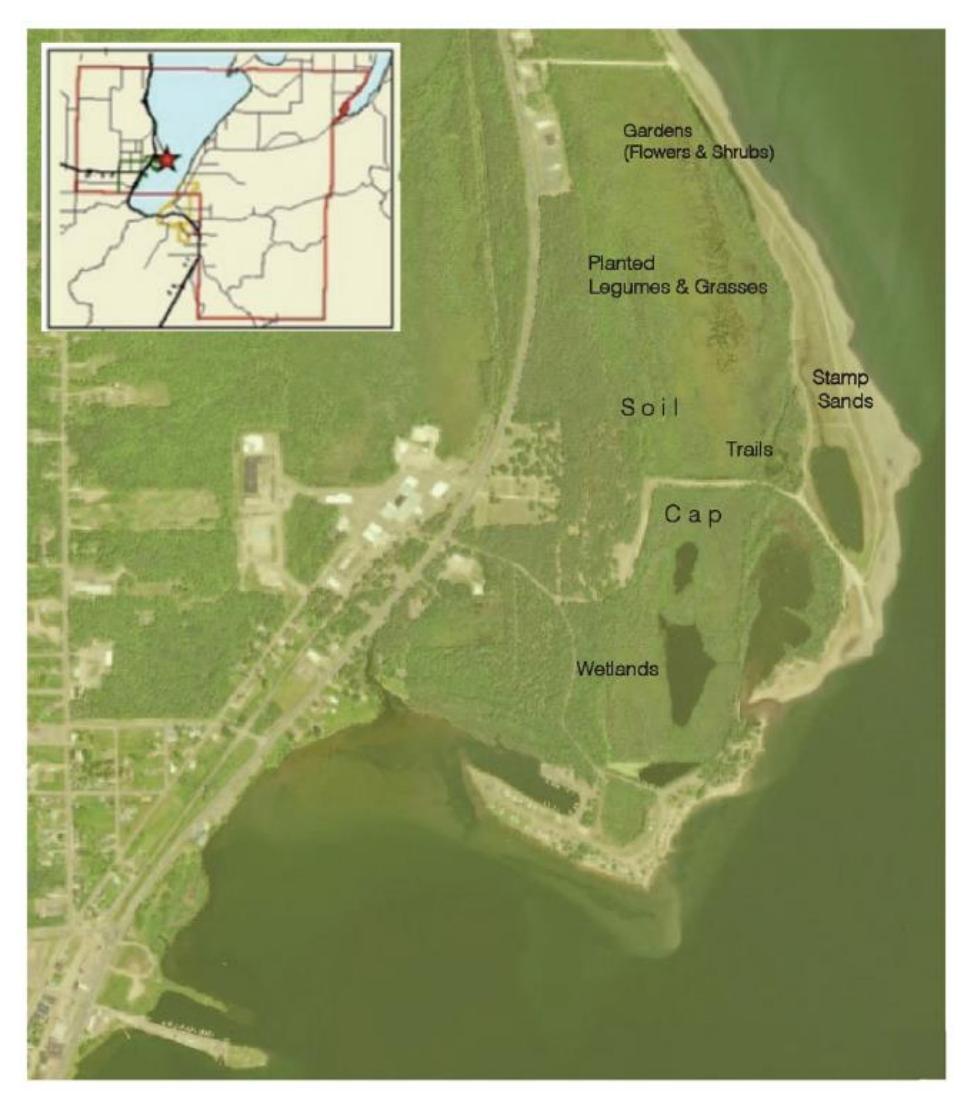
Figure 19. Sand Point Remediation Project. Upper left insert shows boundaries of Reservation lands, from Pequaming at the North to Baraga and L'Anse regions at the south. Red star marks the Sand Point Lighthouse location. The image shows wetlands, beaches, ponds, walking trails, and gardens on Sand Point. The Baraga Marina is on the bottom left, across a stretch of L'Anse Bay. Highway #41 runs across the middle of the photo. The town of Baraga is also to the left.

KBIC found additional ways to overcome potential obstacles. Although within the Reservation, in the 1990's, KBIC purchased Sand Point from the State of Michigan, helping resolve many potential jurisdictional issues. Sand Point is a sacred site for KBIC, as it includes Pow-Wow grounds, wild rice ponds, a traditional healing clinic, ancient burial grounds, and modern campgrounds. Initial studies by UP Engineers & Associates [75] during a Brownfields Pilot Project Assessment Grant indicated high levels of copper in sediments, surface water, and groundwater near stamp sands. The KBNRD (Keweenaw Bay Indian Community Natural Resources Department) was awarded a Brownfield Cleanup Grant to begin assessment of contamination at Sand Point in 2001. In 2006, the KBIC was granted funds from the U.S. Fish and Wildlife Service, the EPA Great Lakes Restoration Program, and the U.S. Department of Agriculture to begin restoration from mine tailing impacts.
