## INVESTIGATION OF A MACHINE-PLANT INTERFACE FOR EXTRACTING ROOTED INVASIVE AQUATIC PLANTS

A REPORT

In Mechanical Engineering

MICHIGAN TECHNOLOGICAL UNIVERSITY

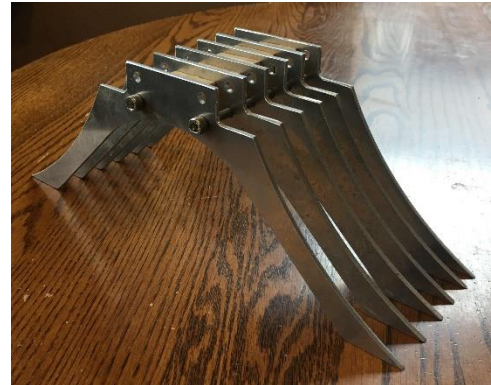
*Figure 1. More research will be performed on the configuration and geometries of an end effector similar to the Senior Capstone Design Team 11 end effector, seen here.*

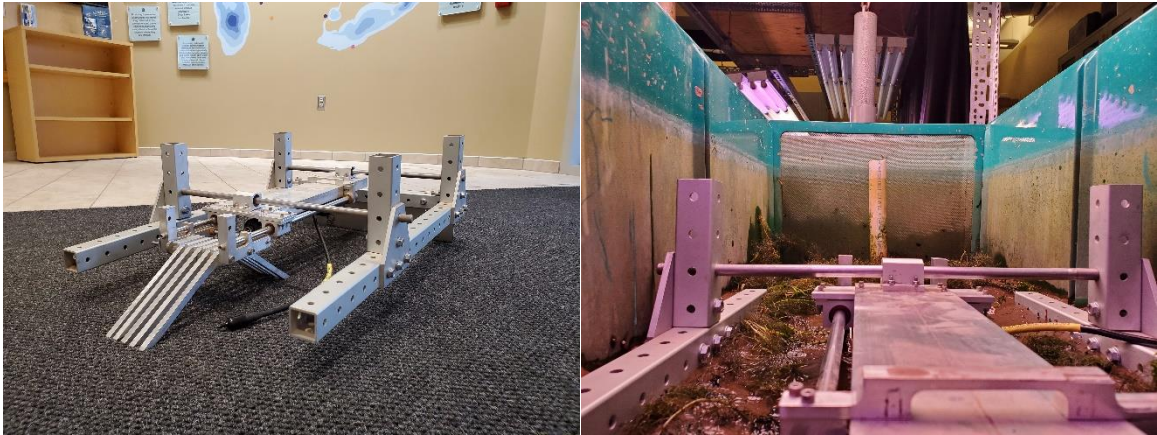
Figure 5. The tines and fin protruded below the test fixture frame (l), and the test fixture frame sat on top of the substrate (r)

As seen in Figure 5, the frame of the test fixture rested on the substrate, and the tines and fin protruded below the test fixture frame.

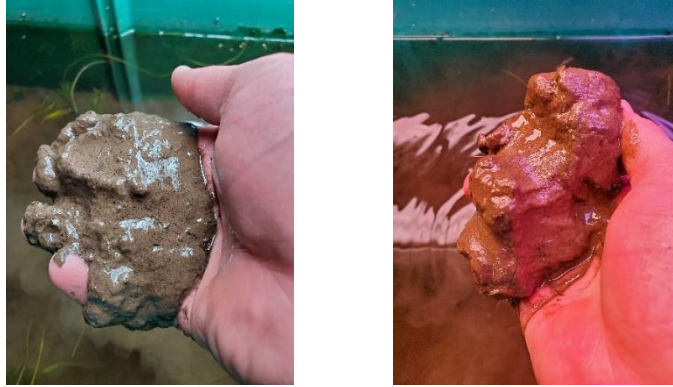
Figure 6. Muck (l) and muck/sand mix (r) substrate types were used for testing. The bulk density of muck was 36% less than the bulk density of the muck/sand mix.

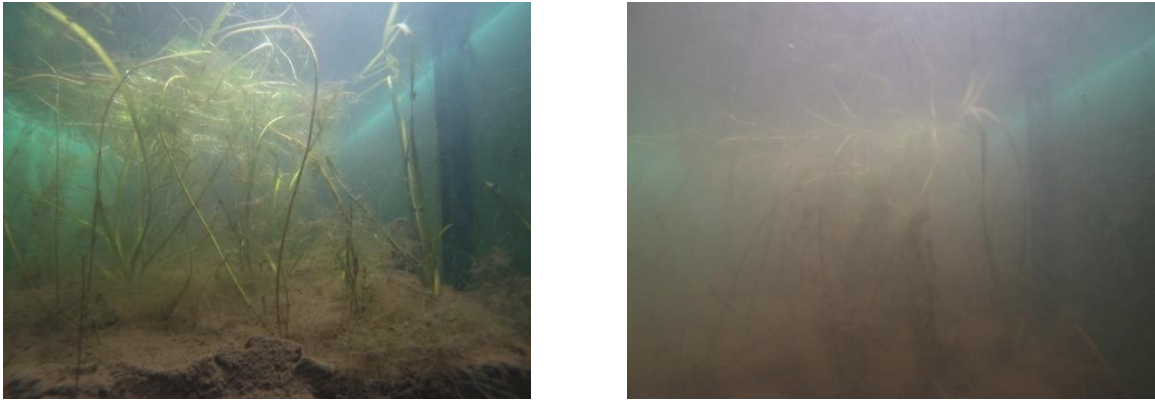
Figure 9. *M. Spicatum* in 4 NTU water (l) and 12 NTU water (r). The camera was one foot away from the plants. It is impossible to distinguish between plant species in the 12 NTU image. Clear underwater images can be taken in water up to around 8 NTU.

maximum turbidity increase outside of the tine path occurred around the end of the tine path, as shown in Figure 4. Testing showed that the upper limit for clear, underwater imaging lies around 8 NTU, as demonstrated by Figure 9.

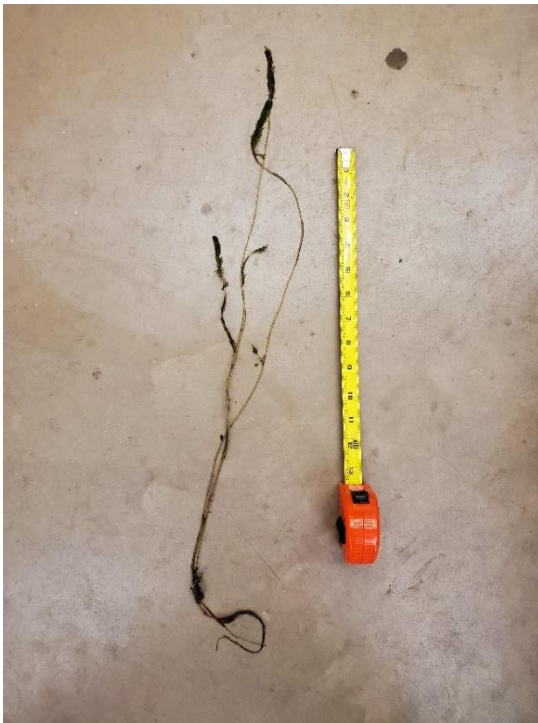
Figure 13. Complete *M. Spicatum* Plant with 30cm ruler for scale

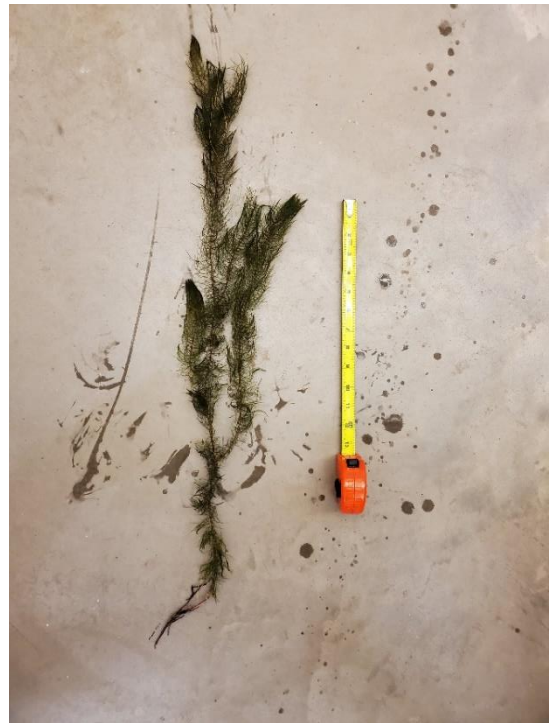
Figure 14. Complete *M. Heterophyllum* Plant with 30cm ruler for scale

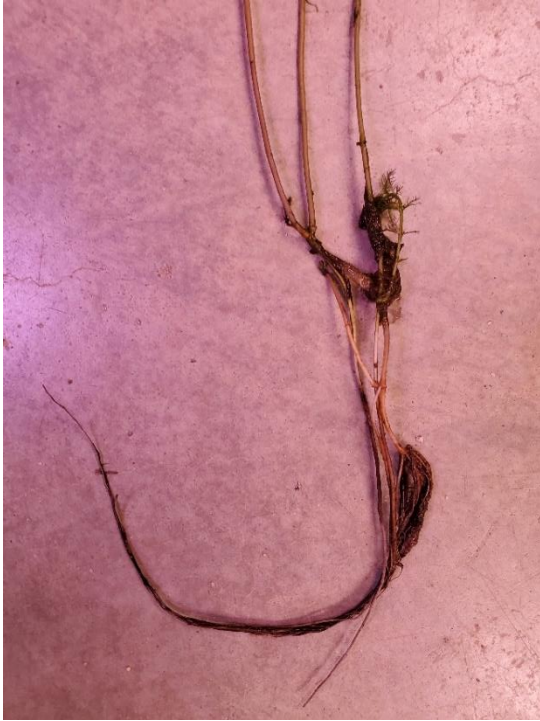
Figure 15. Complete *M. Spicatum* Root Crown

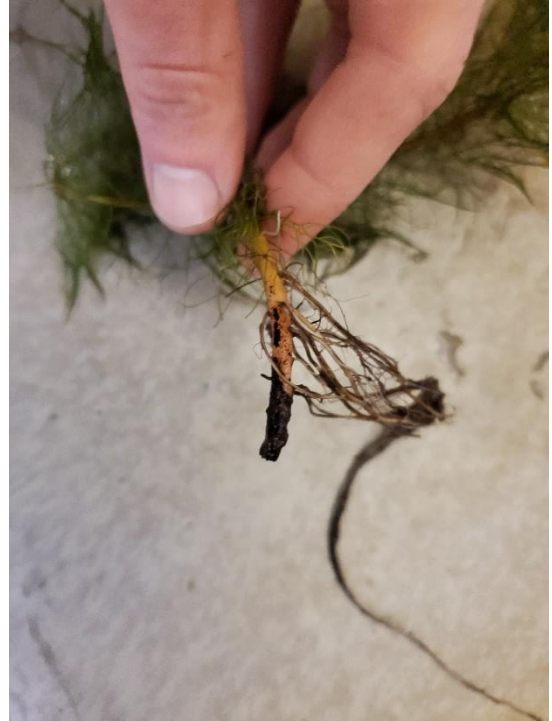
Figure 16. Complete *M. Heterophyllum* Root Crown

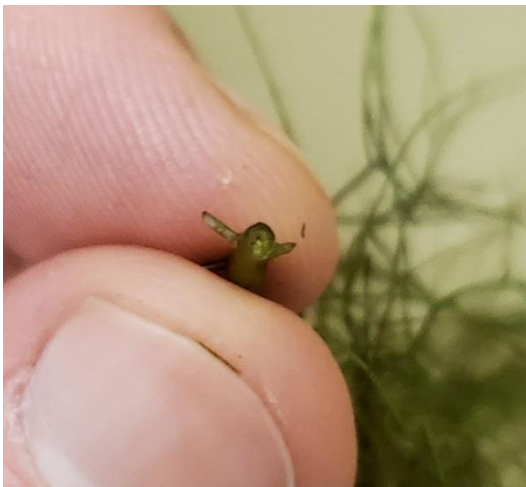
Figure 17. Fragmented *M. Spicatum* Stem. Each removed plant was inspected for fragmented zones.

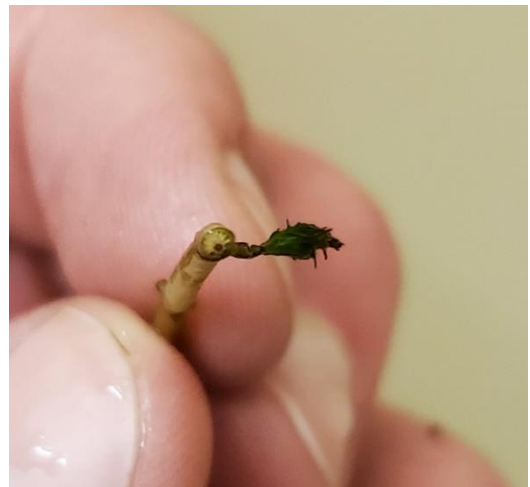
Figure 18. Fragmented *M. Heterophyllum* Stem. Each removed plant was inspected for fragmented zones.

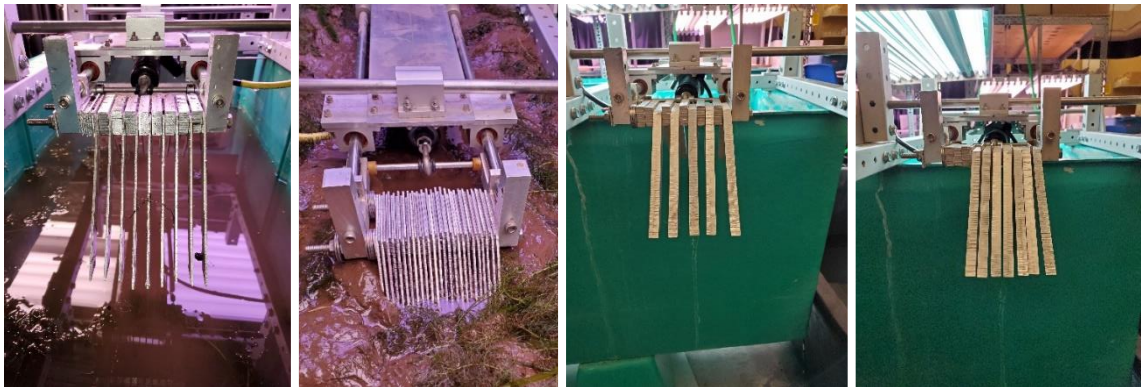
Figure 19. From left to right, nine 2.03mm tines with 9.53mm spacing, 25 2.03mm tines with 2.03mm spacing, five 9.53mm tines with 9.53mm spacing, and 9.53mm tines with 2.03mm spacing. Although the picture here contains just seven tines, the 9.53mm tines/2.03mm spacing configuration was tested with eight tines.

Tests 1-4, detailed in Table 3, tested edge width and tine spacing. The number of tines for each configuration was the maximum that could fit in the 100mm space. Figures 19 and 20 show the four tine configurations, which are made up of 2.03mm- and 9.53mm-wide tines and spacers. 9.53mm is approximately 4.5 times 2.03mm, which was assumed to be a large enough width difference for there to be differences in configuration performance.

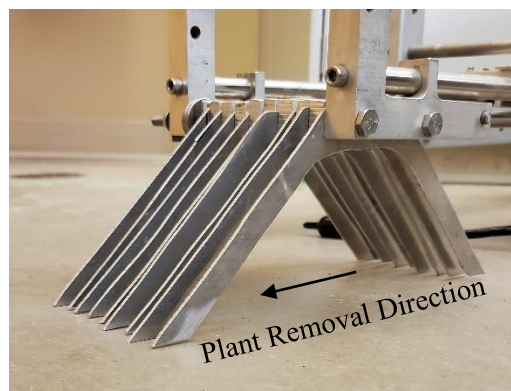
Figure 20. 9 2.03mm tines with 9.53mm isometric view.

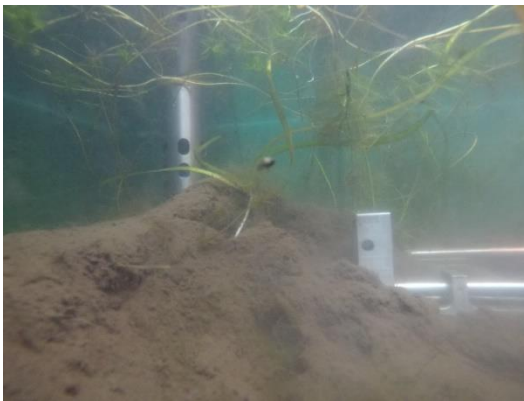
Figure 24. Substrate pile in front of tines after a trial. Trials had been performed along the width of the tank prior to the taking of this picture. The substrate mound is wider in this figure than in Figure 23.

Figures 12 and 23 – 25 illustrate the typical substrate buildup around the tines after a trial. The tines pushed the substrate forward, raising a portion of substrate in front of the tines, denoted by measurement  $x$  in Figure 12, and leaving a trough behind the tines, denoted by measurement  $z$  in Figure 12. The plants in the path would move with the tines if they were loosened and contacted by the tines. There was a space beneath the tines which was void of substrate in about 25% of trials, denoted by measurement  $y$  in Figure 12.
