## Transient nonlinear vibration characterization of building materials in sequential impact scale experiments

Bittner, J., & Popovics, J. (2022). Transient nonlinear vibration characterization of building materials in sequential impact scale experiments. *Frontiers in Built Environment*, 8. <http://doi.org/10.3389/fbuil.2022.949484>

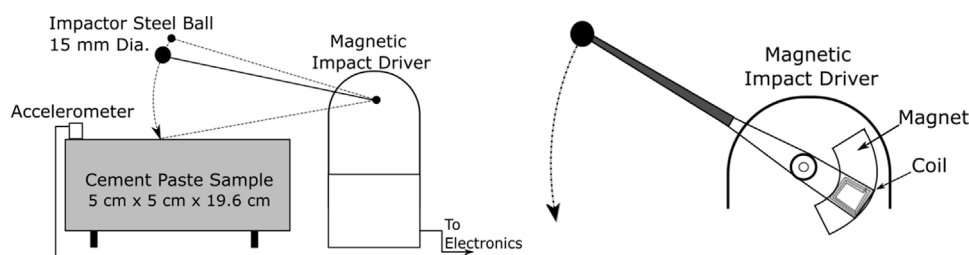
FIGURE 1

Illustration representing the sequential impact dynamic vibration test for transverse vibration on a prismatic sample (left) and the angular solenoid for repeatable impact excitation (right).

Experimental control and recording were performed by a computer running MATLAB with a digital acquisition device and two microcontrollers. The controls performed the sequential impact tests utilizing the electro mechanical device. The timing of the impact events was controlled through a programmed interrupt at a period of 4 s. The first microcontroller interfaced with the impact device. The second microcontroller interfaced with environmental monitoring sensors, for example humidity and temperature sensors. The digital acquisition device recorded the signals of the accelerometer to capture the vibrational behaviors in time.

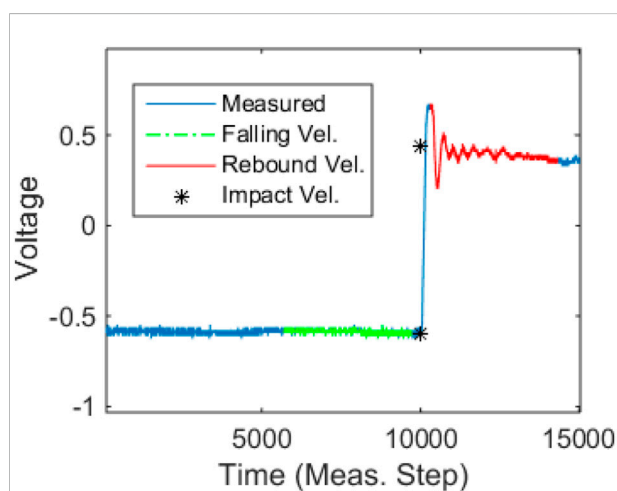
FIGURE 2

Voltage of the open circuit magnetic impact driver during an impact event occurring at approximately the 10,000th measurement time step.

Consistent device performance was critical to verify that the observed behavior was not an artifact of the new measurement system. One method to monitor the performance of the impact device was through the energy of the impacts. The energy change of each impact was measured from the impact velocity measurements as illustrated in **Figure 2**. The energy change of the impactor due to the impact was calculated by

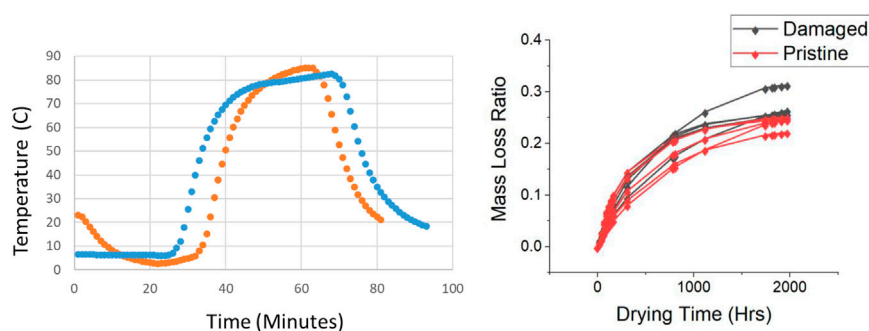
**FIGURE 3**

Temperature profiles from an embedded thermocouple within samples during two saturated thermal cycle events comprising of a ice bath and heated water bath. The first shocking cycle is colored blue and the second shocking cycle is colored orange (left). Gradual drying mass loss of damaged and pristine groups of neat cement paste prisms over time in a controlled environment. Mass loss ratio is defined as mass loss at a specific time to the initial mass of cement prism (right).

The damage procedure implemented during this investigation comprised saturated thermal shock cycles. This method of damage was selected to induce a uniform level of damage across the five prism samples while maintaining a completely saturated moisture state within the material. Two respective water baths were maintained at 4°C using ice water and at 80°C using an electric heater. Prisms in the damaged groups were cycled first to the cold bath for 20 min then to the hot bath for 20 min; this procedure was repeated for two full cycles. To monitor internal prism temperature, an extra prism was drilled, and a thermocouple was inserted into the center of it. The temperature history of the extra prism is shown in [Figure 3](#). The captured internal temperature profile shows uniform shocking behaviors for the two cycles of identical damage.

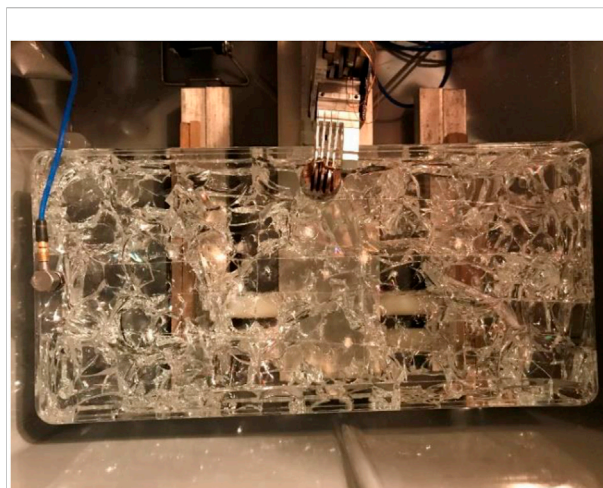
**FIGURE 4**

Solid soda-lime glass block in thermally shocked damaged state on sequential impact test device.

The damaged block and the sequential impact-testing device are shown in Figure 4. The glass block was then tested using a set of 100 sequential impacts every 2 h over a 24-h period. At the completion of 24 h of testing, the humidity in the environment was raised to 80% and the system was allowed to equilibrate for an additional 24 h. After the equilibrium period, the glass block was tested using the same sequential impact protocol.

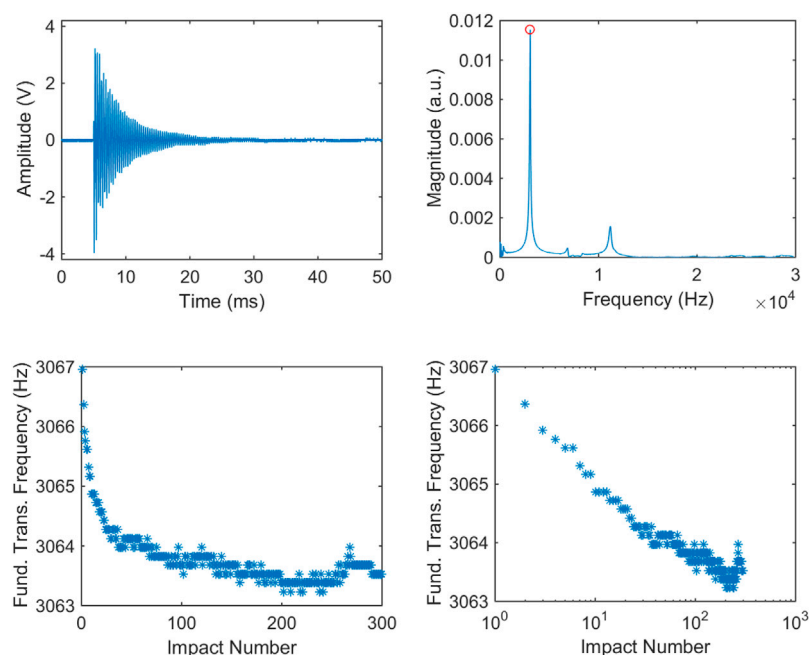
FIGURE 5

Single impact vibration time signal (top left) and discrete frequency spectrum (top right) with the frequency of the fundamental transverse mode identified by a red circle. Linear (bottom left) and semi-log (bottom right) plots of fundamental transverse frequency recorded during sequential impact testing set of dry cement paste (0.5 w/c) in uncontrolled laboratory conditions.

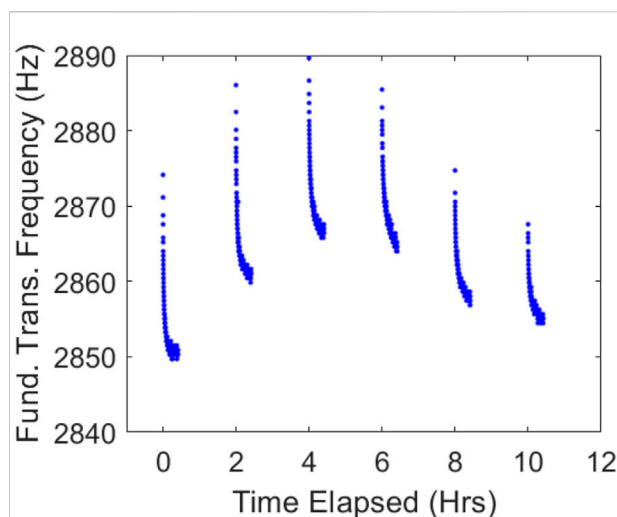
**FIGURE 6**  
Multiple repeated sequential impact tests with intermittent rest periods performed on a 2-h recovery cycle on cement paste in an uncontrolled laboratory environment.

The results of multiple sequential impact tests are shown in Figure 6. The horizontal axis shows time in hours, and the vertical axis the extracted fundamental transverse resonance frequency of each impact event. The results from individual

impacts within each sequential impact test set display a shape similar to a reversed letter “J.” Between sequential impact test sets the results display a recovery of resonance frequency (or stiffness) during the rest periods where no impact events occur.

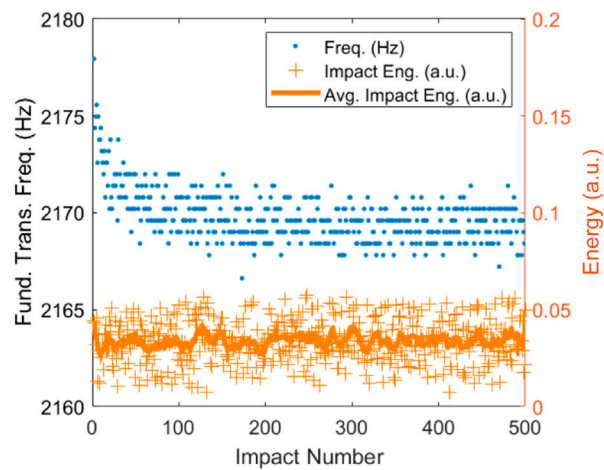
FIGURE 7

Peak fundamental transverse resonance frequency of prismatic neat cement paste sample over sequential impacts and extracted average change of energy from the dynamic electromagnetic impactor.

The recorded vibration frequency of each impact is plotted, illustrating the characteristic softening of the fundamental transverse vibration frequency shown in Figure 7. The secondary axis represents a measurement of relative impact energy from the falling steel ball owing to the impact events. The value of energy over time represents the repeatability of the sequential impact device to impart a consistent excitation impulse source to drive the vibration, thus arguing that the observed softening in the data in Figure 6 is not caused by changes in mechanical impact energy. Although the energy data do show variability (32% Coefficient of Variation), the results are effectively consistent and no consistent trend over time during the impact set is observed. This relative energy value verifies that our automated system does not display drift or systematic changes throughout the impact event set.

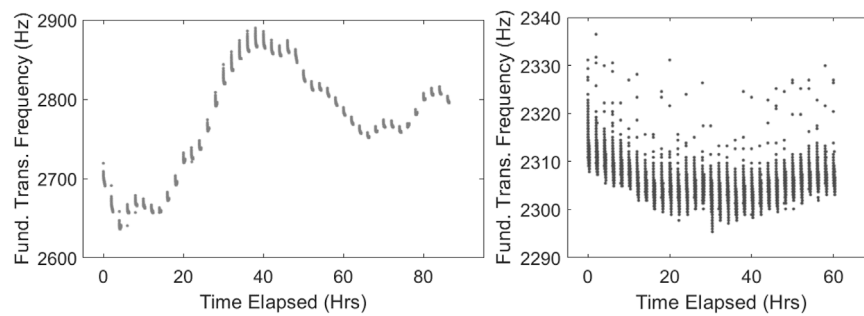
FIGURE 8

Sequential impact test sets carried out on neat cement pastes using a 2-h test cycle period in ambient laboratory conditions over the course of 5 days (left) and in a controlled temperature and relative humidity chamber (right).

A plot of the fundamental resonance frequency for multiple sequential impact test sets on a neat cement paste prism over a duration of 3 days is shown in Figure 8. Mass and geometry were unchanged during the duration of this experiment. The initial impact of each sequential impact set was observed to always be the highest frequency of each test set. In the case of uncontrolled ambient environment (Figure 8 left), the frequency varies from test set to test set. The initial impact of each sequential impact test represents the standard linear dynamic measurement captured by one single uncontrolled impact.

The results of an environmentally controlled, 32°C and 22% relative humidity, sequential impact test are shown in the right inset of Figure 8. The variability between sequential impact tests is significantly less than in the uncontrolled-environment cases shown in the left inset of Figure 8.

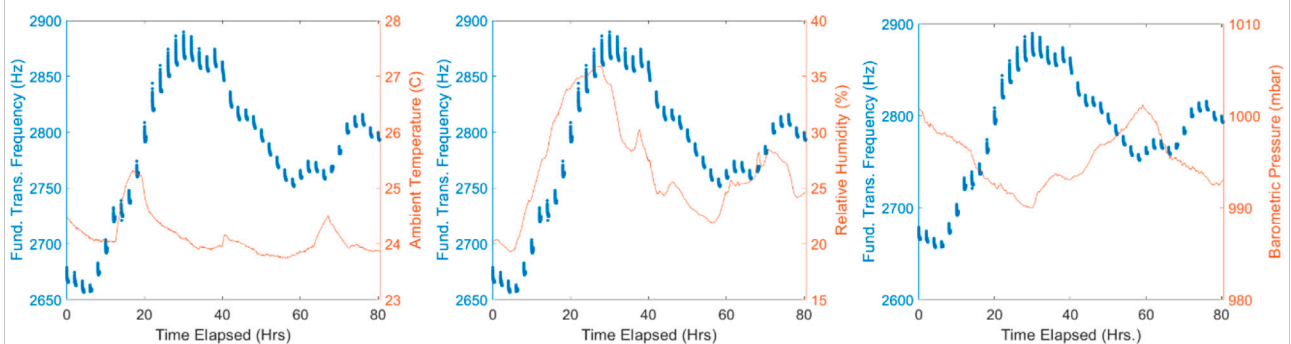
FIGURE 9

Sequential impact test results compared with recorded laboratory temperature (left), relative humidity (middle), and barometric pressure (right).

Three selected ambient environmental characteristics, temperature, relative humidity, and barometric pressure, are compared with resonance frequency results from impact set tests in Figure 9. The resonance frequency, which is proportional to Young’s modulus, does not exhibit obvious visual correlation with the small change in ambient temperature. More obvious direct correlation is observed between the resonance frequency and relative humidity and inverse correlation observed between resonance frequency and barometric pressure.

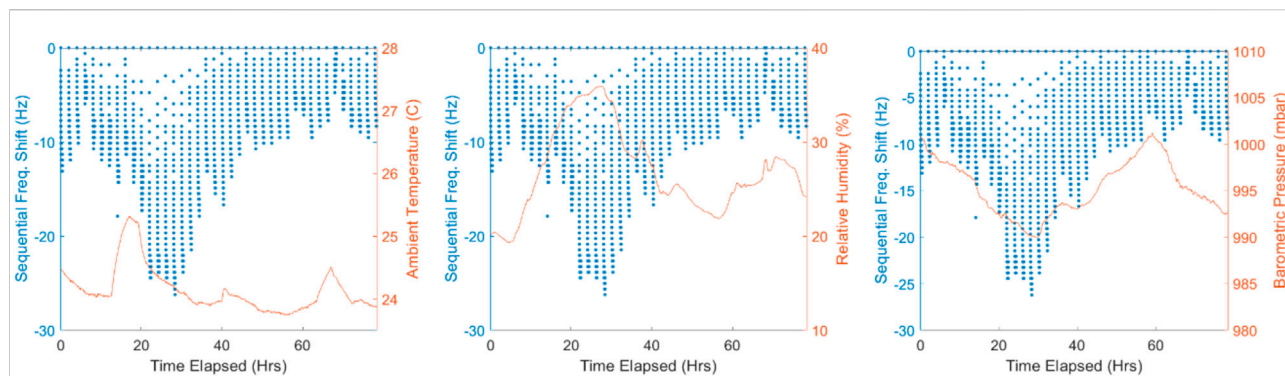
FIGURE 10

Shift in fundamental resonance frequency within sequential impact sets relative to the first impact within the set compared with recorded ambient laboratory temperature (left), relative humidity (middle), and barometric pressure conditions (right).

The shift in resonance frequency across a single sequential impact test set displays characteristic transient slow dynamic nonlinearity. The effects of ambient environmental parameters (temperature, humidity, and pressure) on the intra-test transient resonance frequency shift are explored in Figure 10. The measured transient resonant frequency shift ranged from 6 to 26 Hz per impact set, with the strongest correlation identified with the inverse of ambient relative humidity.

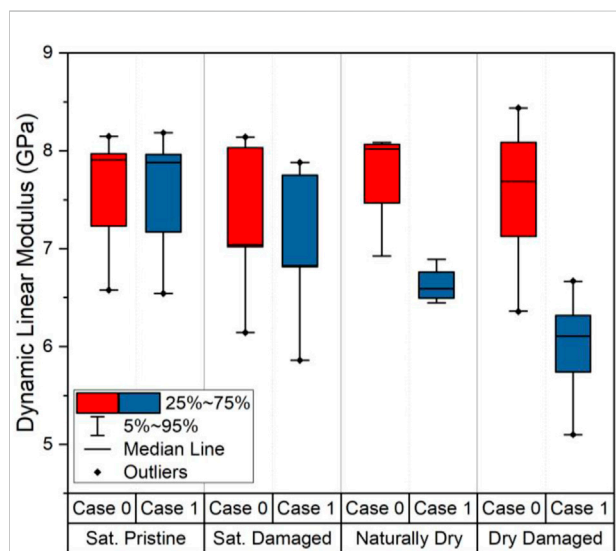
FIGURE 11

Linear transverse fundamental resonant vibration-based estimate of elastic modulus in neat cement paste prisms in the uniform saturated pristine condition, Case 0 (red bars), and the representative labeled damaged test condition, Case 1 (blue bars). The height of the bar represents the 50% confidence interval for five separate bars of each group tested four times each bar. Case 0 represents the saturated pristine material condition before exposure to the subject environment.

Figure 11. All samples were mature and started in the saturated pristine case; this condition is identified as Case 0. Some samples were then exposed to other ambient temperature and RH conditions and those samples are identified as Case 1 for each of the testing group conditions. In other words, Case 0 and Case 1 represent before and after controlled damage and environmental exposure cases, respectively. Each testing group consists of five samples tested four replicate times; that is, each bar in Figure 11 represents 20 sets of data. The control condition group, pristine and maintained in a saturated environment, displays no obvious change in dynamic linear modulus. The saturated damaged case displays a slight median decrease in modulus after being subjected to thermal shock damage but the difference in modulus does not appear to be statistically different. The naturally dry pristine case displays a notable and apparently statistically significant decrease in linear dynamic modulus. The dry damaged case presents the largest reduction in dynamic linear modulus and apparently statistically significant reduction in modulus. The magnitude of reduction in median linear dynamic modulus owing only to the pristine slow evaporation of moisture, 1.42 GPa, was larger than the magnitude of reduction measured for only thermal shocking damage, 0.21 GPa.

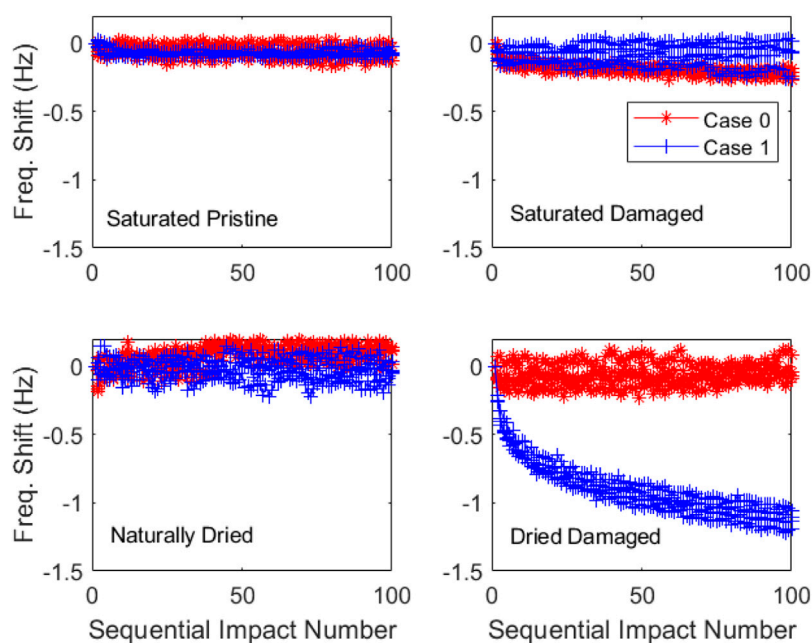
**FIGURE 12**

Sequential impact test results for four randomly selected neat cement paste samples in the saturated pristine condition before exposure, Case 0 (red), and then the same sample after damage and/or environmental exposure, Case 1 (blue). The representative test conditions are saturated pristine (top left), saturated damaged (top right), naturally dried (bottom left), and dried damaged (bottom right). Case 0 represents the saturated pristine material condition before exposure to the subject environment.

Results from the sequential impact testing set for only a single randomly selected prism from each condition group are shown in Figure 12. In the plots, the relative frequency shift from the initial point (vertical axis) is plotted against the number of impacts within an impact test set (horizontal axis) in both the Case 0 (before exposure), and Case 1 (after exposure) conditions. In all exposure conditions, Case 0, the saturated pristine condition before exposure, displays relatively consistent frequency shift value with impact number. This flat response indicates no transient conditioning behavior associated with an ideal linear elastic material behavior. For the “after exposure” case (Case 1) for the saturated group, no distinct change from linear behavior was observed, meaning that no slow dynamic conditioning observed. The same can be said for the saturated damaged

and naturally dried cases. The only visually obvious change occurred for the dried damaged condition group. The dried damage group, however, displayed a reduction of 1.33 Hz in resonant frequency during the application of 100 impact events as compared with the pre-exposure results (case 0). Clear indication of slow dynamic conditioning occurs in this case.

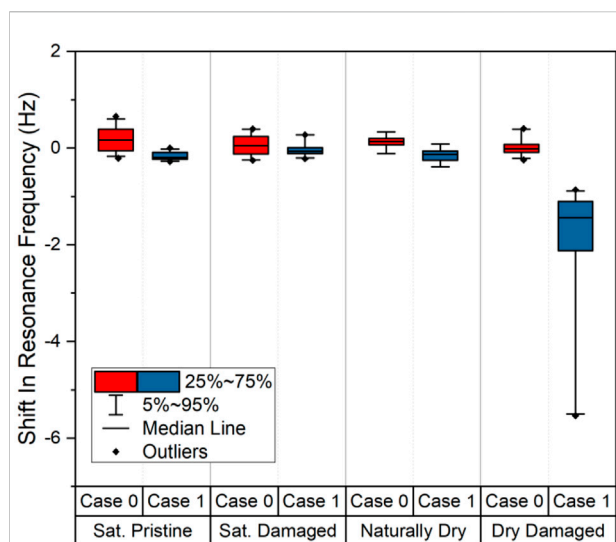
FIGURE 13

Sequential impact test results of the fundamental transverse resonant frequency shift during one series of impacts in neat cement paste samples for the uniform saturated pristine condition, Case 0 (red), and then the same sample after damage and/or environmental exposure, Case 1 (blue), for four different test conditions. The height of the solid bar represents the 50% percentile confidence interval for five separate prisms of each group tested four times each case. Case 0 represents the saturated pristine material condition before exposure to the subject environment.

The aggregation of the sequential impact testing resonant frequency shifts for the five replicates in each condition group is shown as a box plot in Figure 13. The results confirm the individual prism results presented in Figure 12. Only one conditioning group, dried damaged, shows clear and statistically significant change in slow dynamic resonance frequency shift beyond the 95% confidence intervals of the measurement. In this experiment, the repeatability of the measurement, as indicated by the relative size of the 95% confidence intervals, was observed to be constant for all conditioning groups except in the highest level of the damaged case.

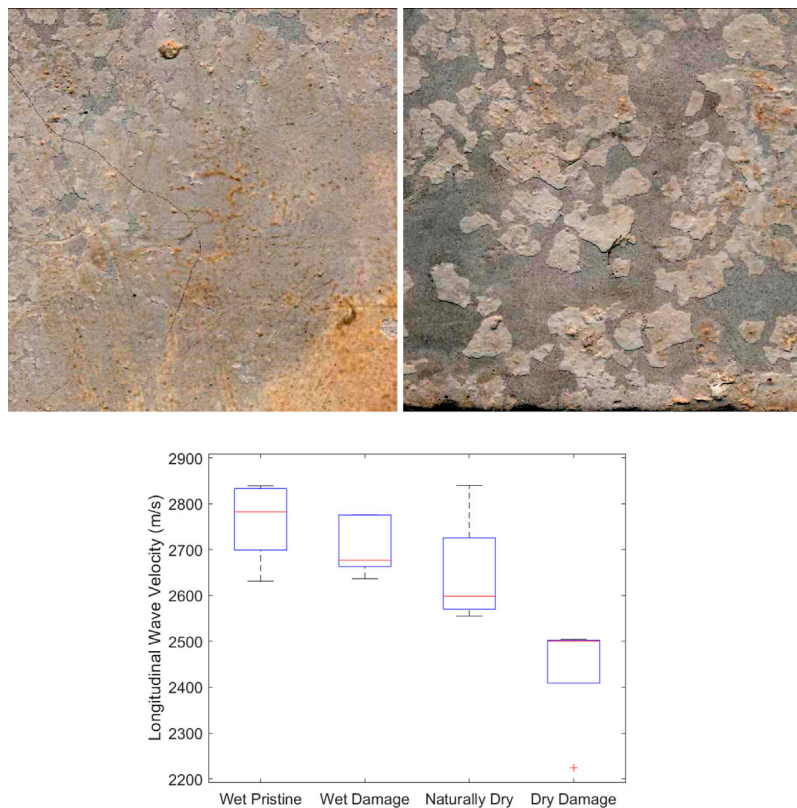
**FIGURE 14**

Surface photos, with enhanced contrast, to facilitate crack identification, of cement paste ( $w/c = 0.8$ ) prisms with two thermal-cycle induced damage (top left) and undamaged naturally dried (top right) conditions. Vertical size of images is 2.5 cm. Ultrasonic pulse velocity measurement repeated three times for five replicates of each sample condition group (Bottom). Black bars represent the 95% confidence intervals within each sample, the blue box represents the 50% confidence intervals, and the red line represents the median of the condition group.

High resolution photographic images were collected from the surface of a representative test sample for each dry condition to verify the created damaged state. The collected images for dry damaged and naturally dry are shown in Figure 14. The dry

damaged condition displays one large visible crack on the surface, while the naturally dried condition does not display any visible cracking. Owing to the high water-cement ratio, some scaling was observed on the surface of both samples.

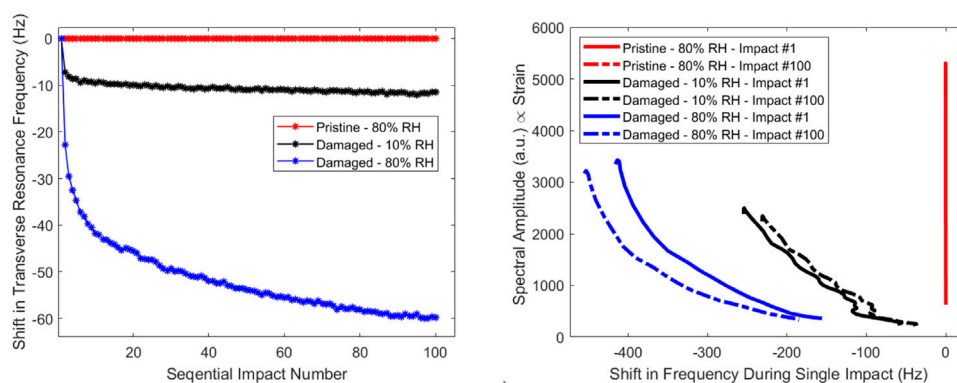
FIGURE 15

Sequential impact fundamental transverse resonant frequency shift in glass block sample for two damage states and two moisture states (left) and single-impact windowed frequency shift, NSIRAS, for the glass block sample calculated on the first (001) and last (100) signal from sequential impact test set for different damage and moisture conditions (right).

The transient slow dynamic conditioning results of a sequential impact test on a glass block in two different damaged conditions are shown in Figure 15. The pristine case displays linear behavior with no

visible slow dynamic conditioning trends seen within the series of 100 impact events. The two damaged cases do display slow dynamic conditioning occurring within the 100 impacts. The damaged case at higher humidity (80%) displays the largest conditioning behavior, reducing a total of 60 Hz over a series of 100 impacts. At the same damage state but a lower humidity (10%), a smaller resonance frequency shift of only 13 Hz is observed, which represents a 78% difference in transient nonlinear slow dynamic behavior caused only by ambient RH values.
