Polychlorinated Biphenyl Compound and Metal Contamination and Remediation in Torch Lake, Houghton County, MI

A THESIS

In Environmental Engineering

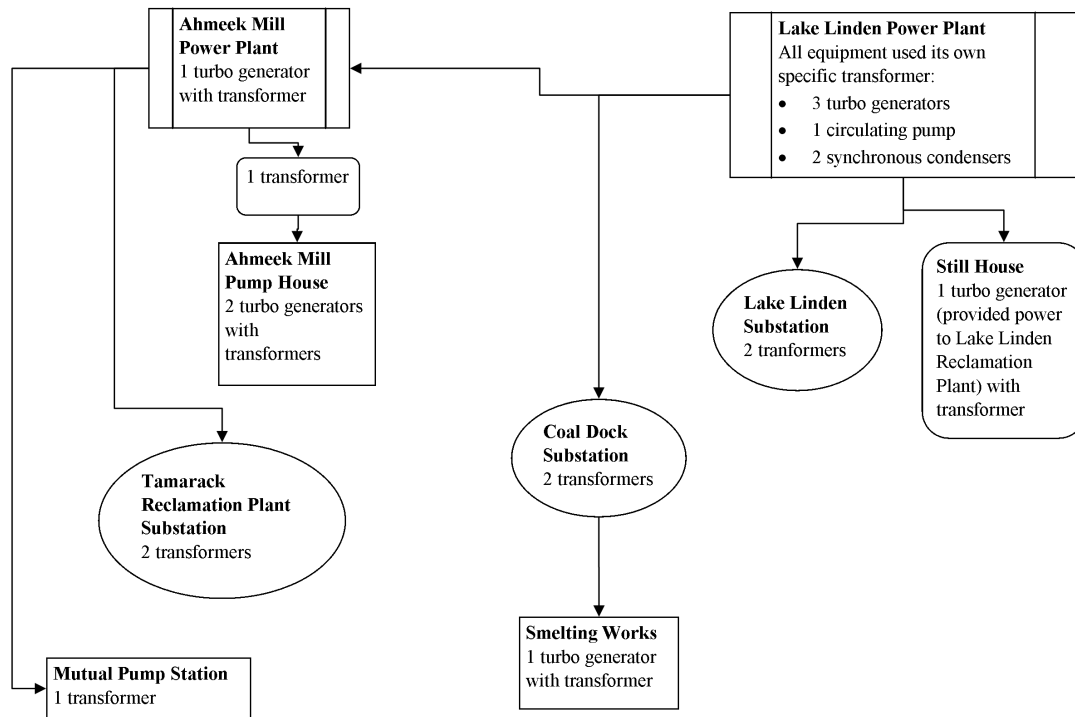
Calumet & Hecla constructed an electrical distribution system that ran from Lake Linden to Hubbell and served various mills, smelters, and the coal dock. A schematic of the electrical distribution system is shown Figure 2.1 below:

Figure 2.1: Schematic of the electrical distribution system along western shore of Torch Lake in the early 1930s identifying buildings in which electrical transformers are known to be located (Adapted from McIntosh & Burgan, 1931; Schwaiger Zawisza, 2016 (Expected)).

Equipment used in the electrical distribution system employed polychlorinated biphenyls (PCBs) as cooling liquids in transformers and dielectric liquids in capacitors (de Voogt & Brinkman, 1989). When all of the mining-associated industry operations (all of the mills, smelters and the electrical distribution system) were closed, the facilities and equipment were sold, moved locally for re-use, or abandoned. Transformer oil was spilled and as a result may have contaminated the groundwater, which flows into Torch Lake. PCB contamination causes human and wildlife health impacts, which are discussed in further detail below.

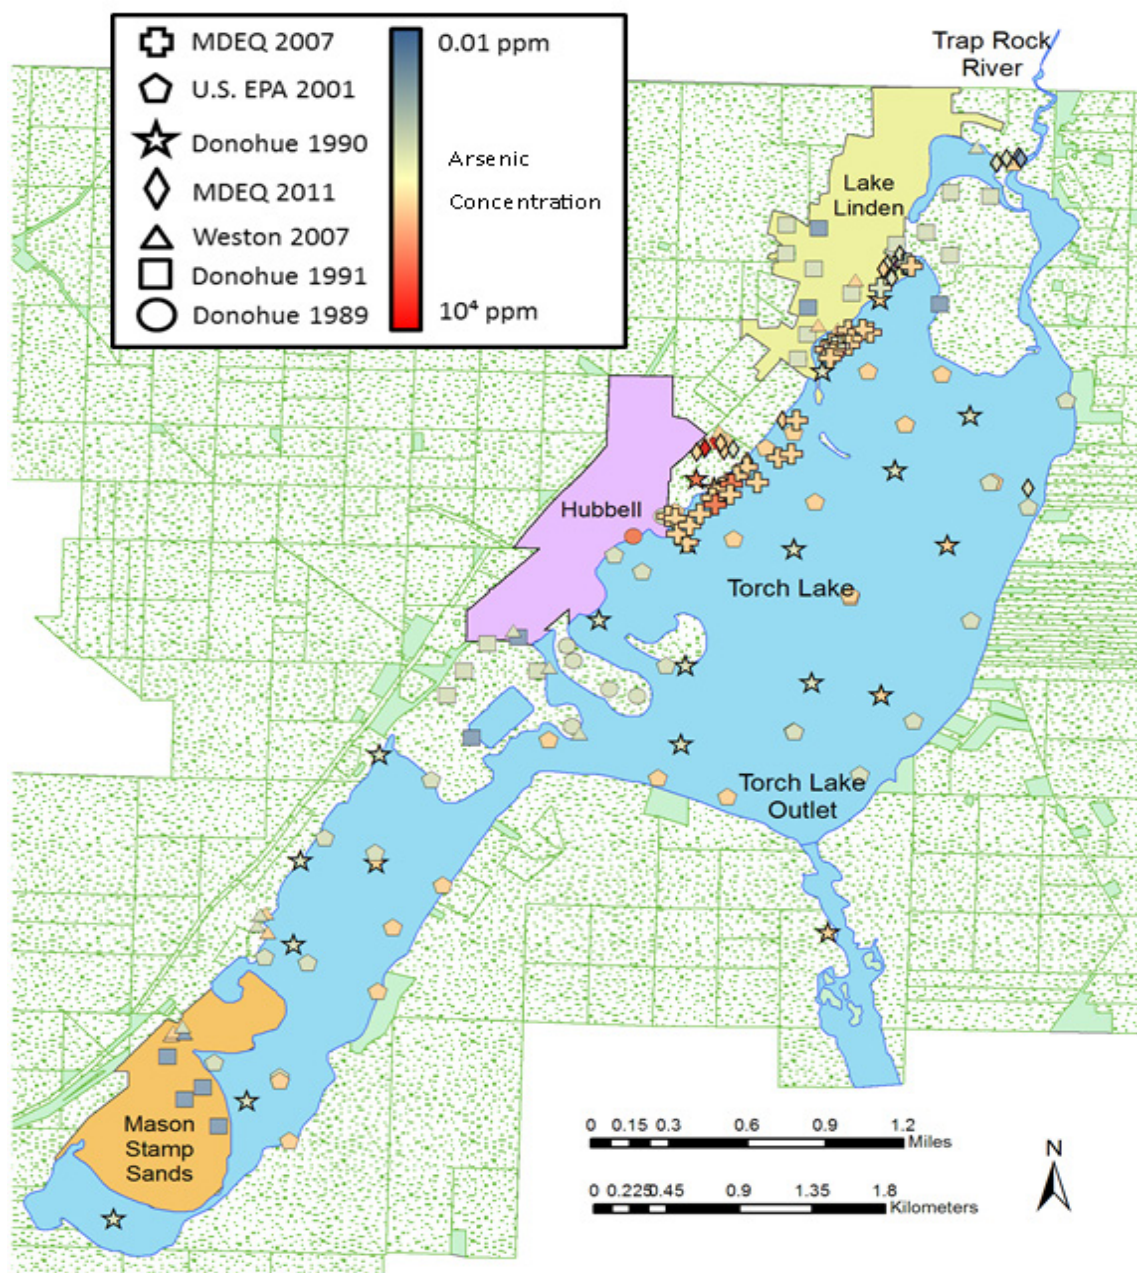
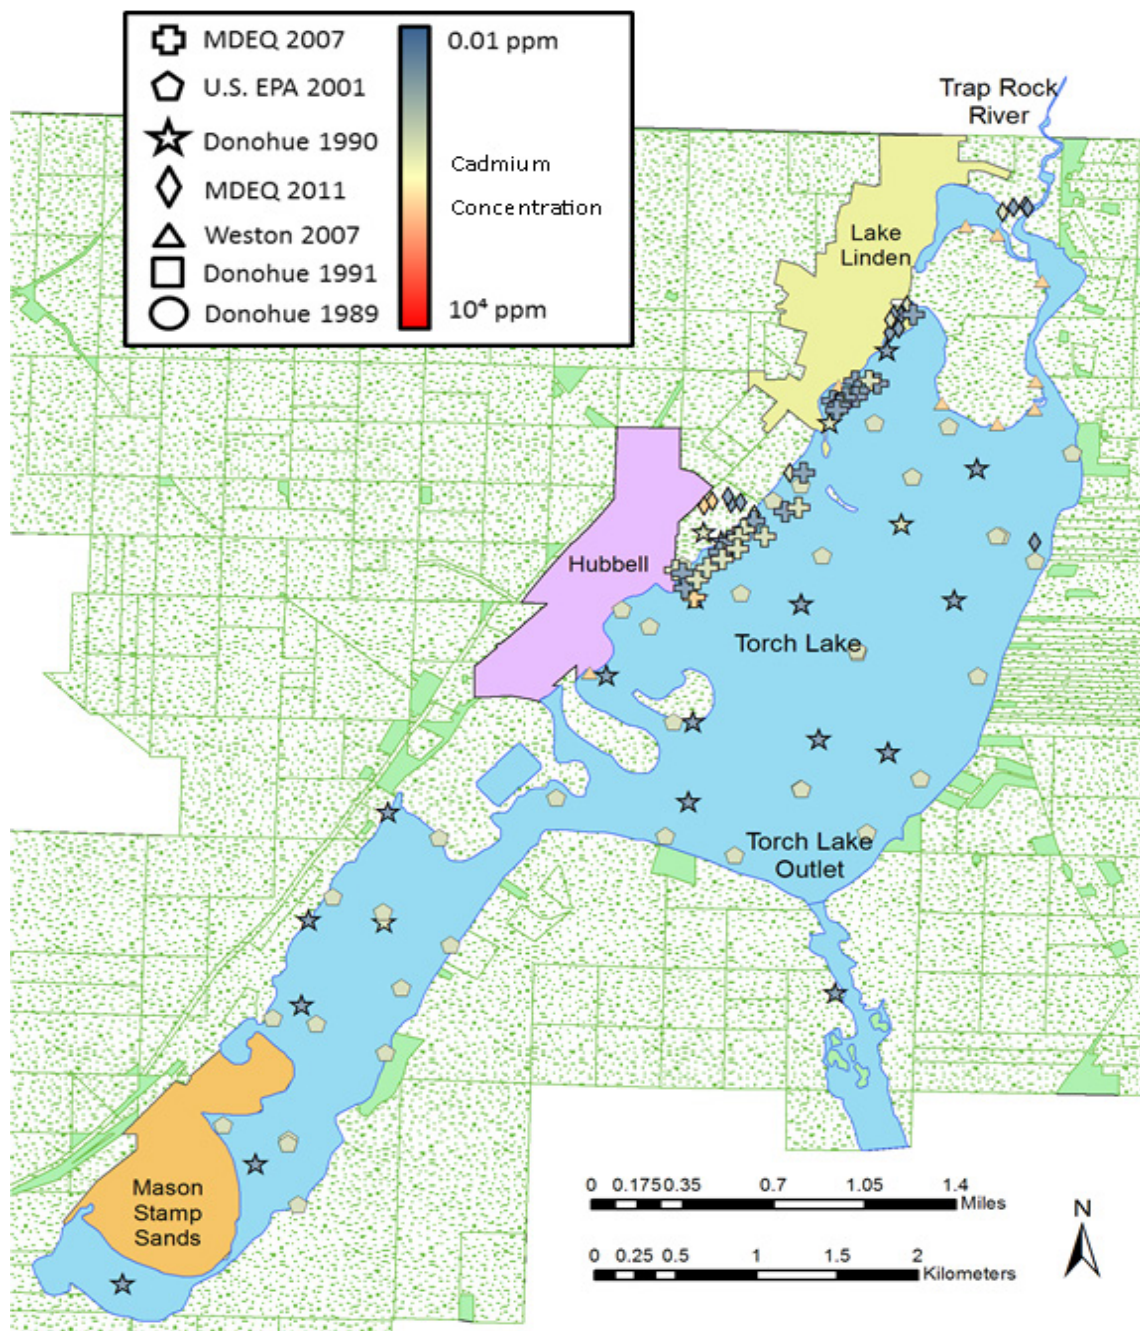
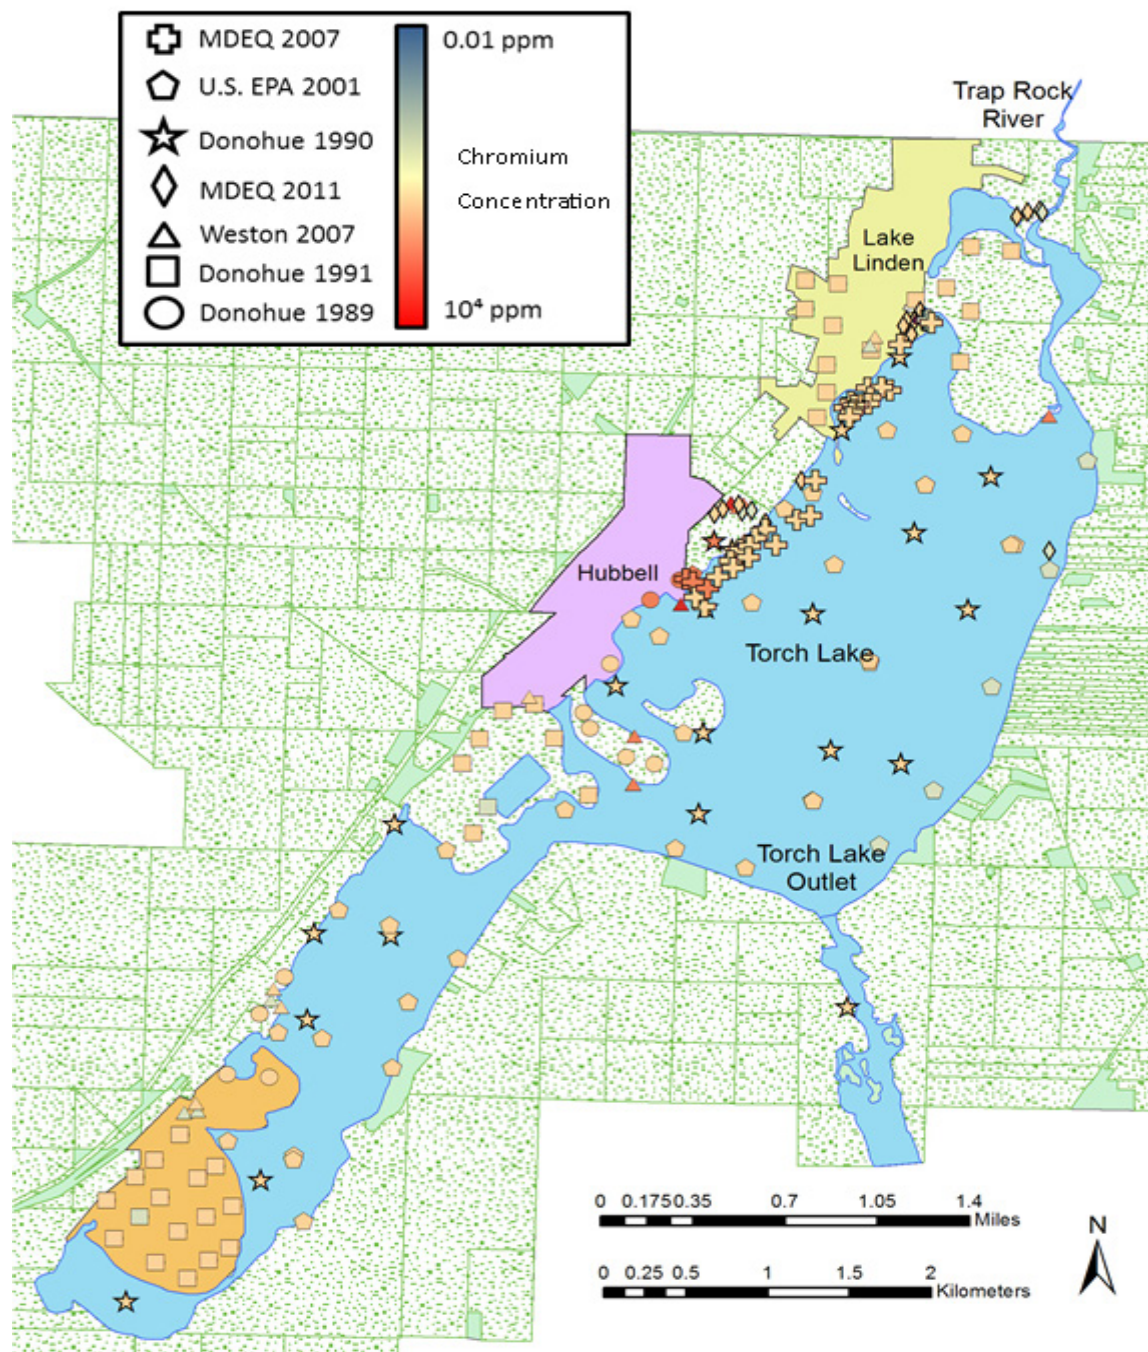
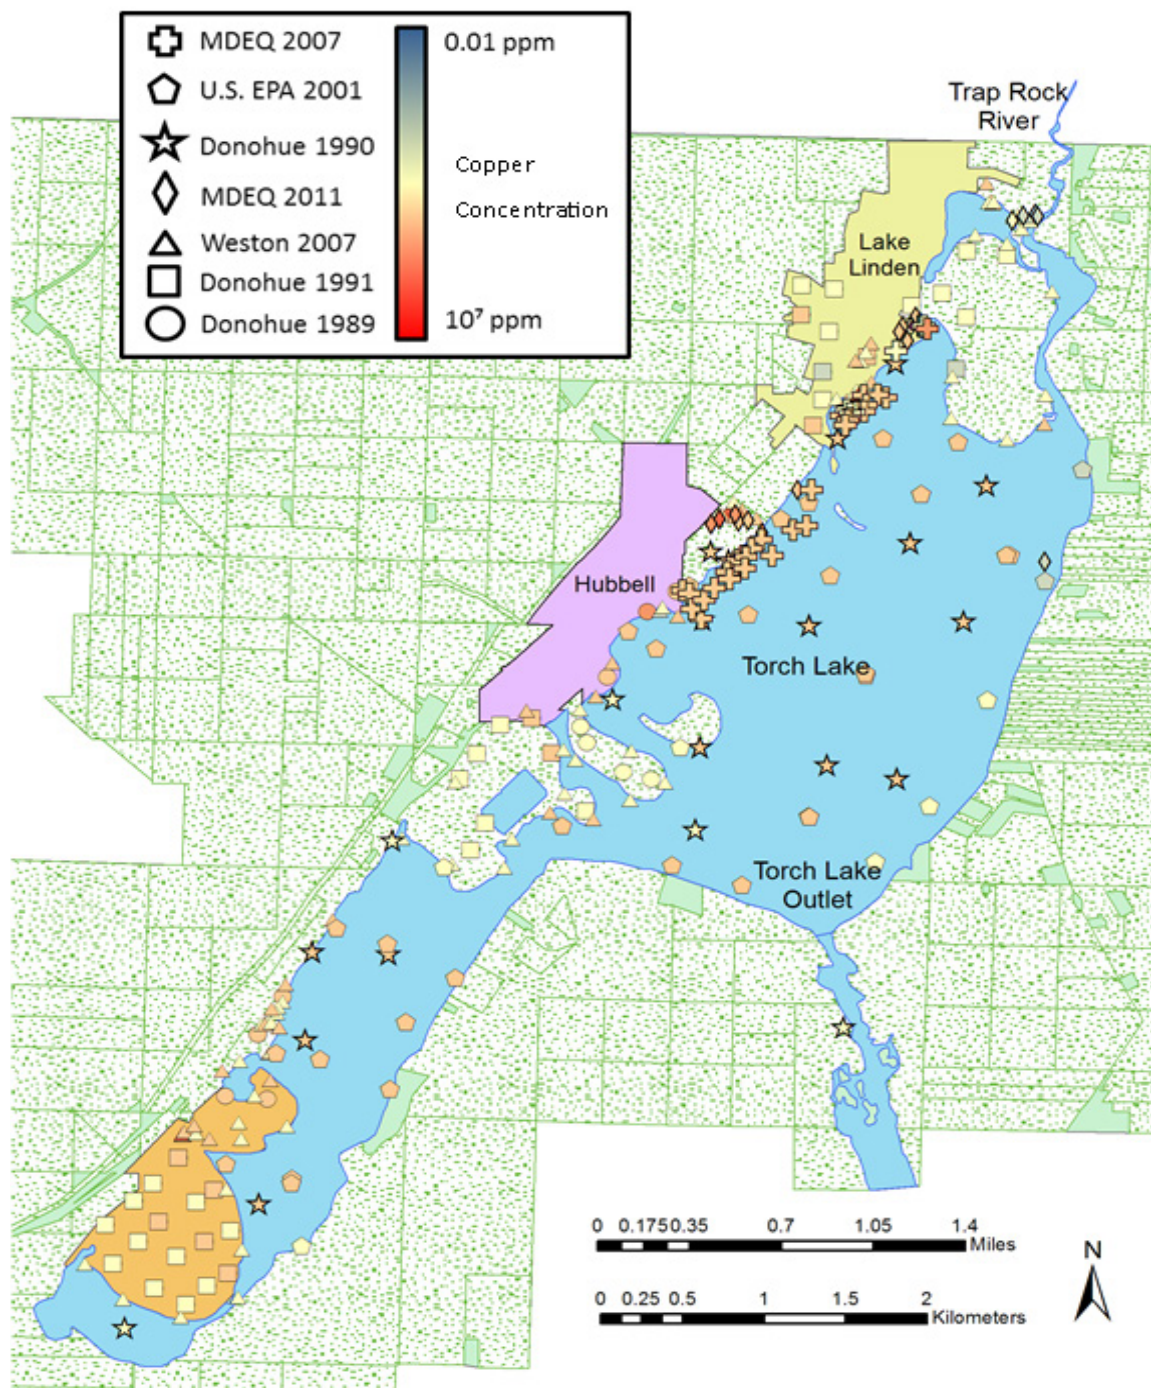
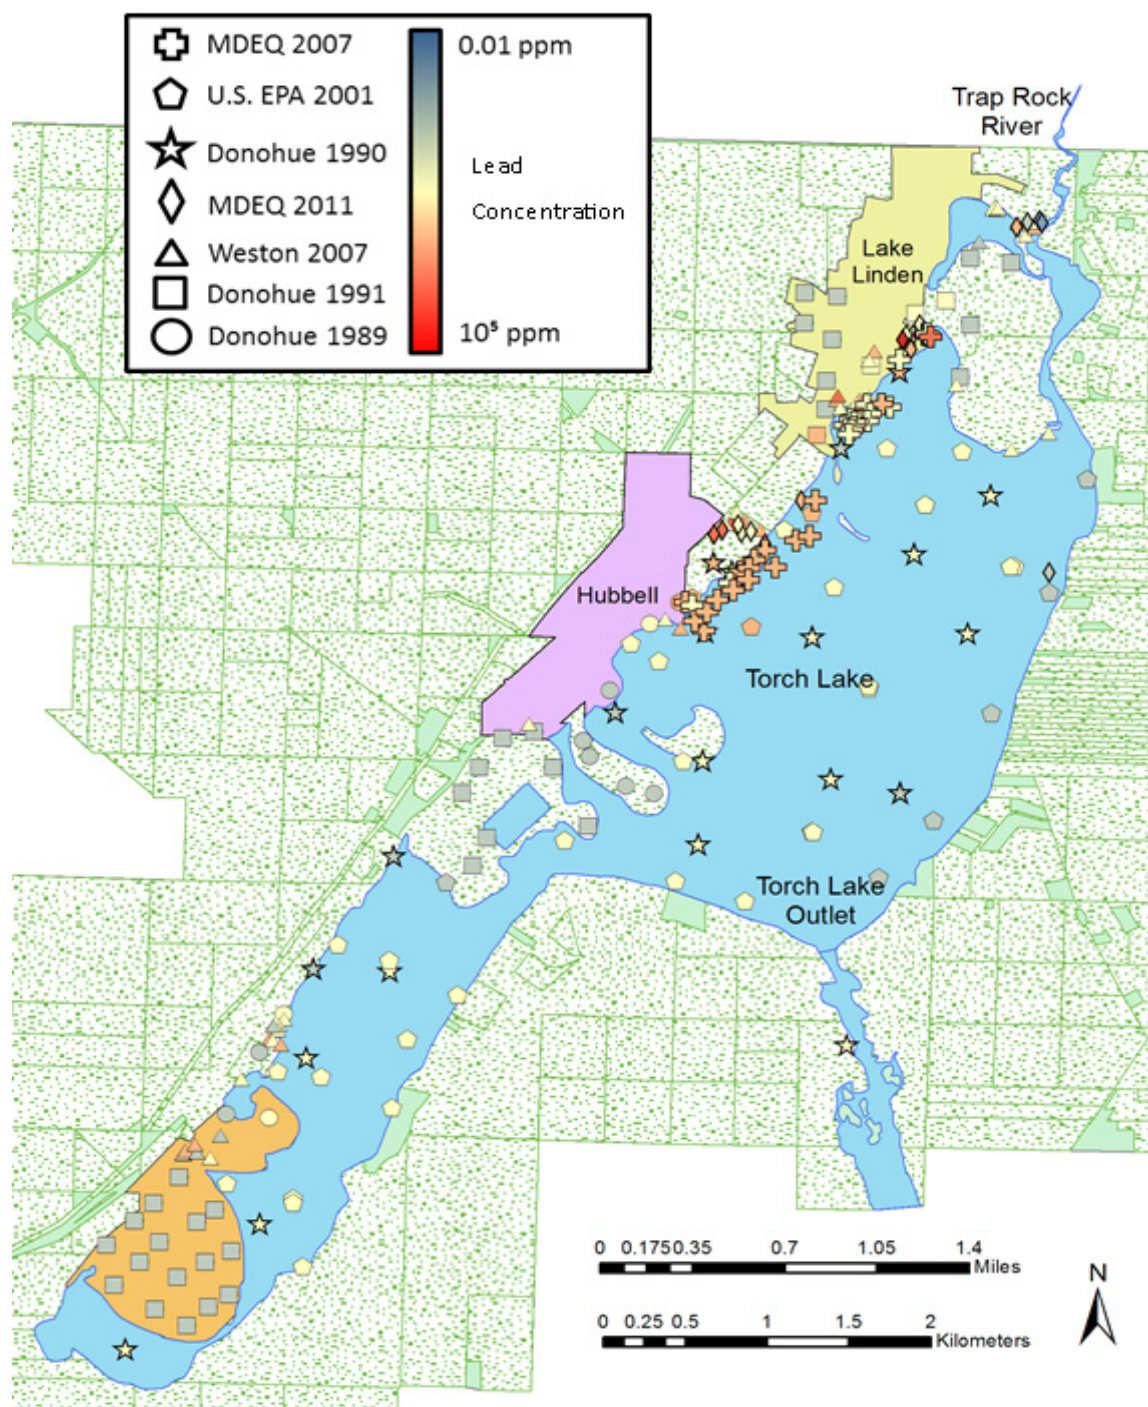
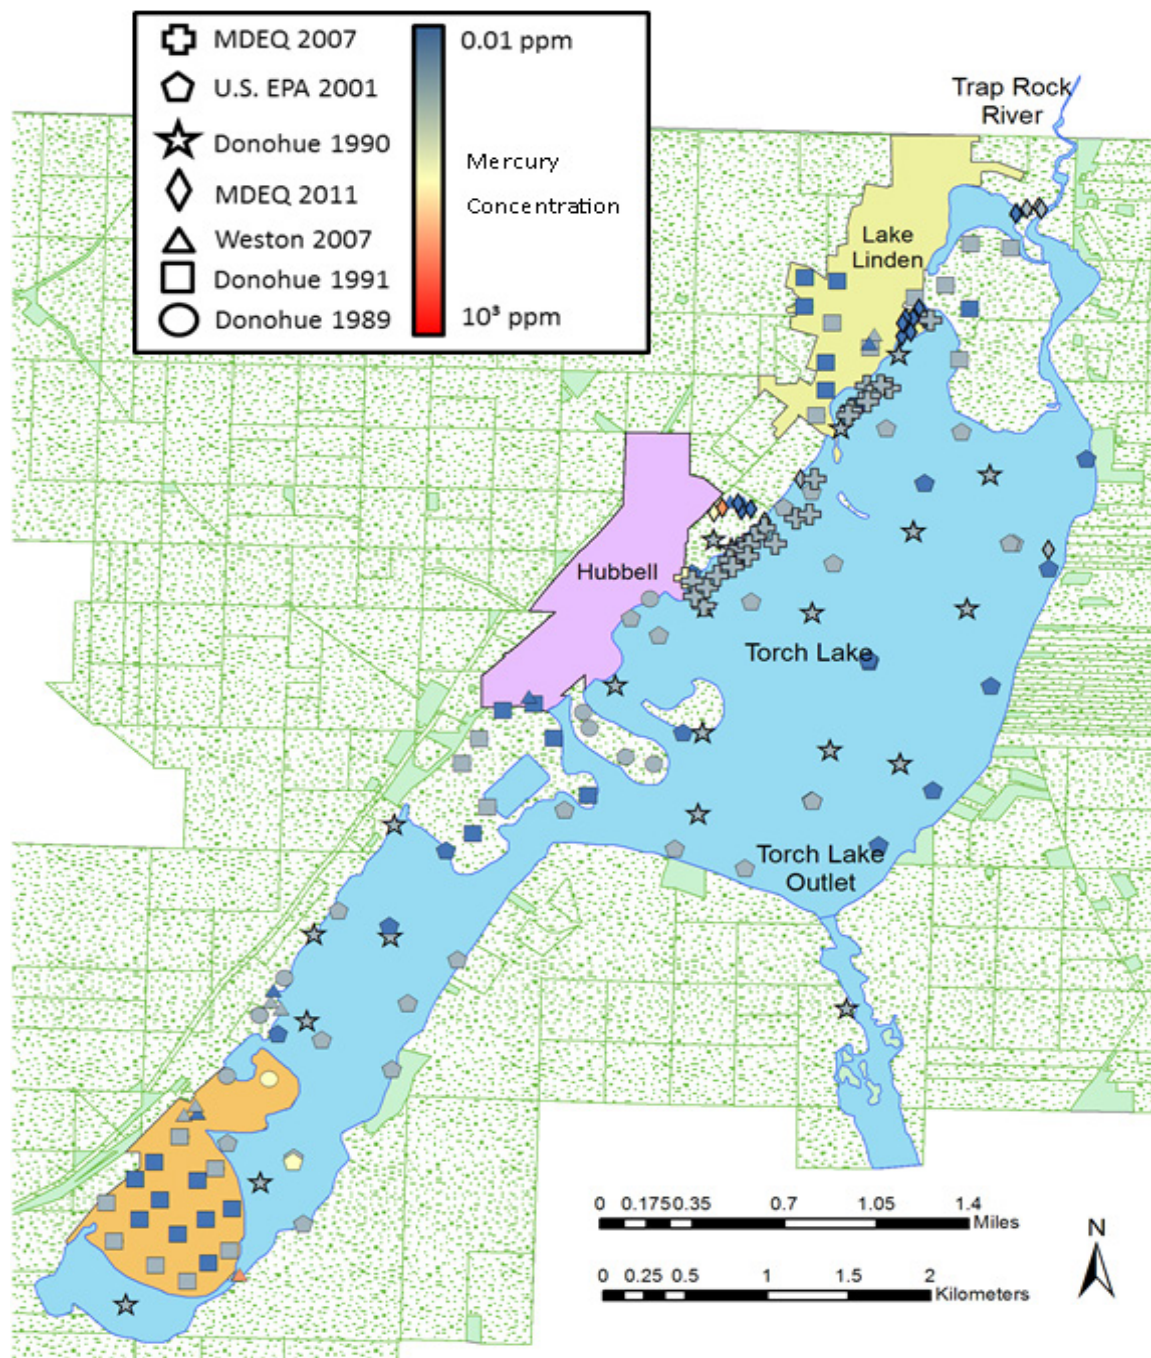
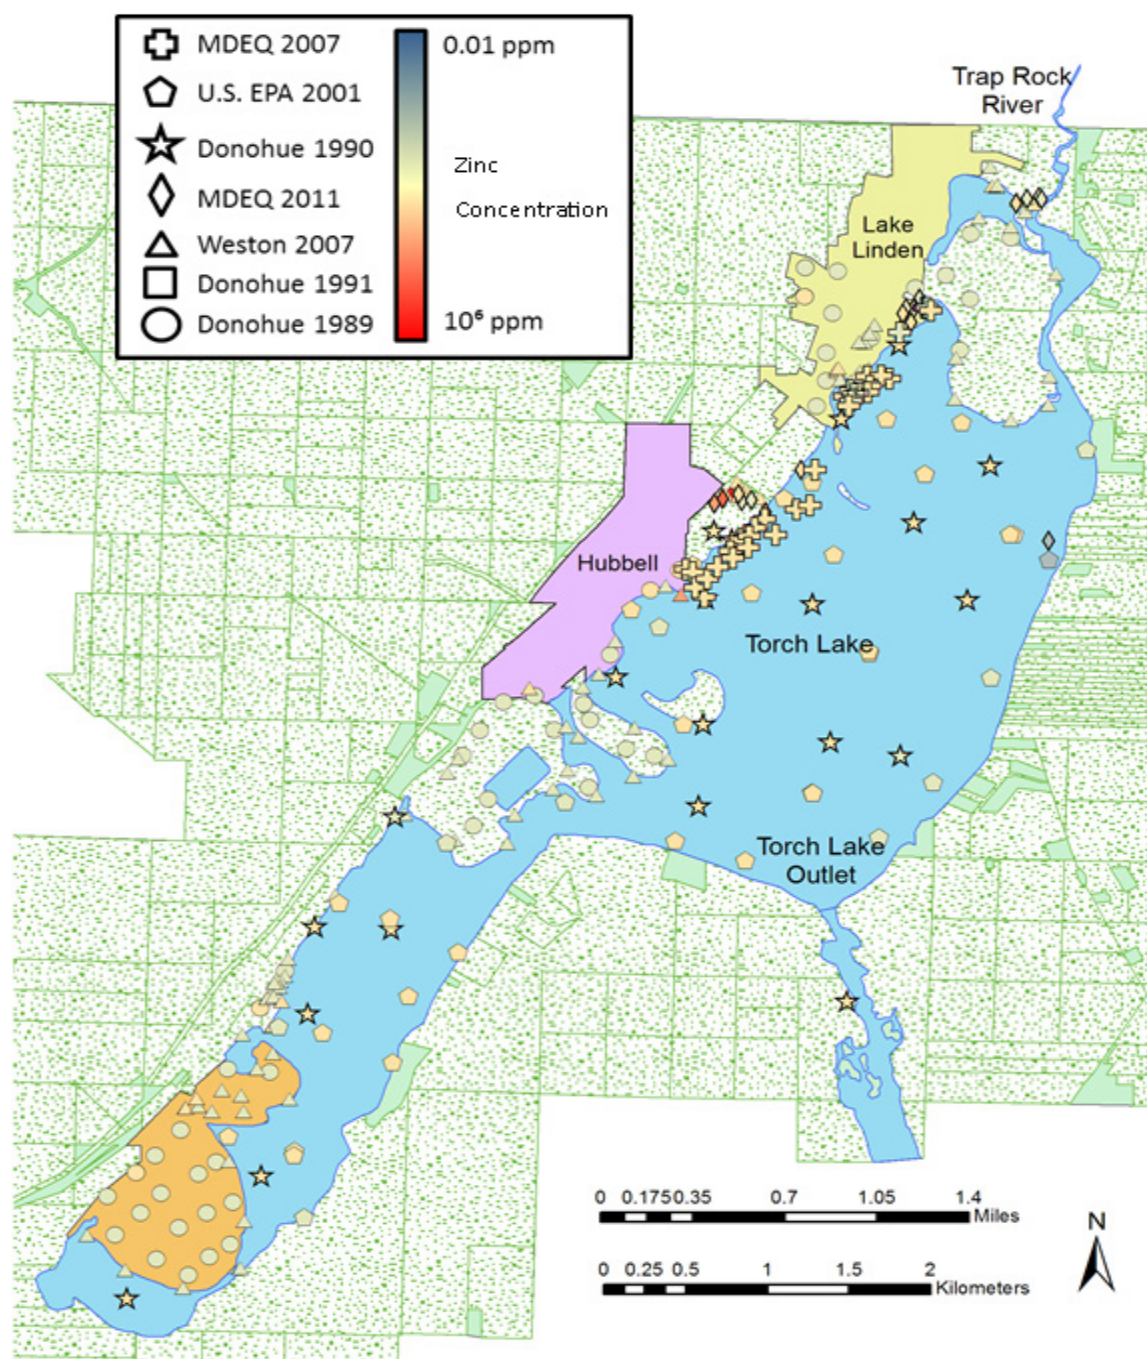
The overview analysis maps (Figure 4.1-Figure 4.7) of each metal show the distribution of concentrations in the sediment and adjacent soil. Point layers are distinguished by source so that temporal changes can be seen in addition to spatial variation. Observations for each metal are summarized in Table 4.6 (following Figure 4.7):
