Polychlorinated Biphenyl Compound and Metal Contamination and Remediation in Torch Lake, Houghton County, MI

A THESIS

In Environmental Engineering

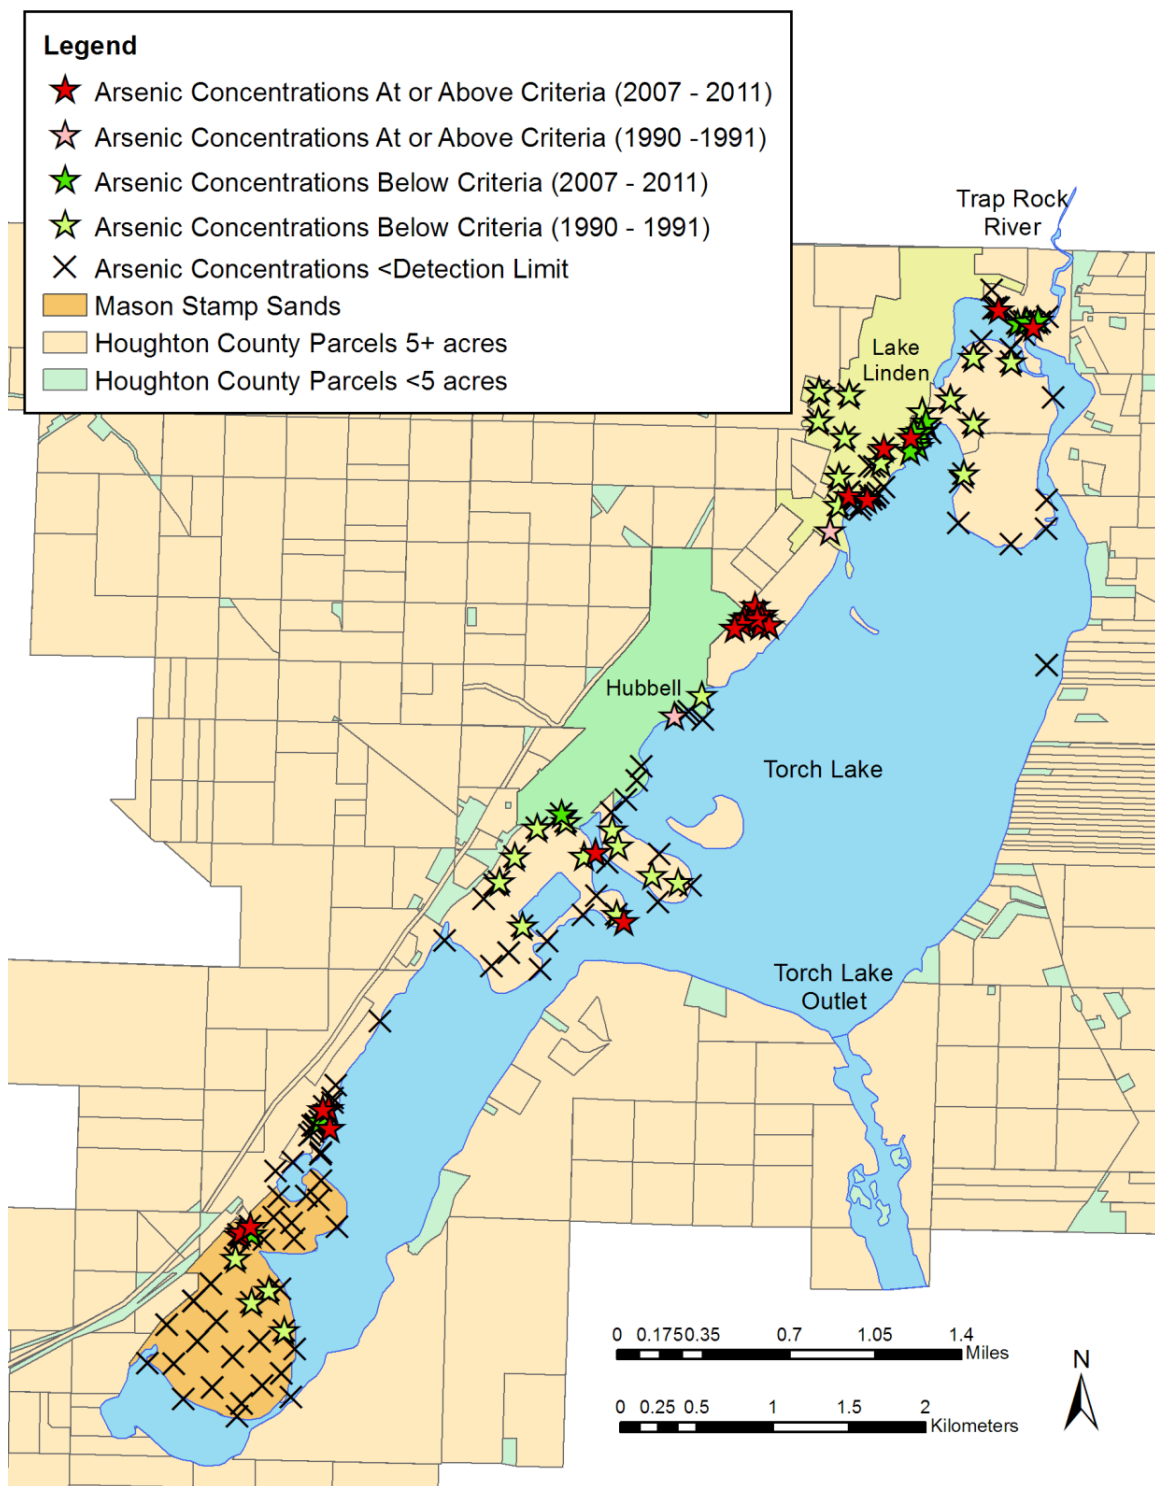
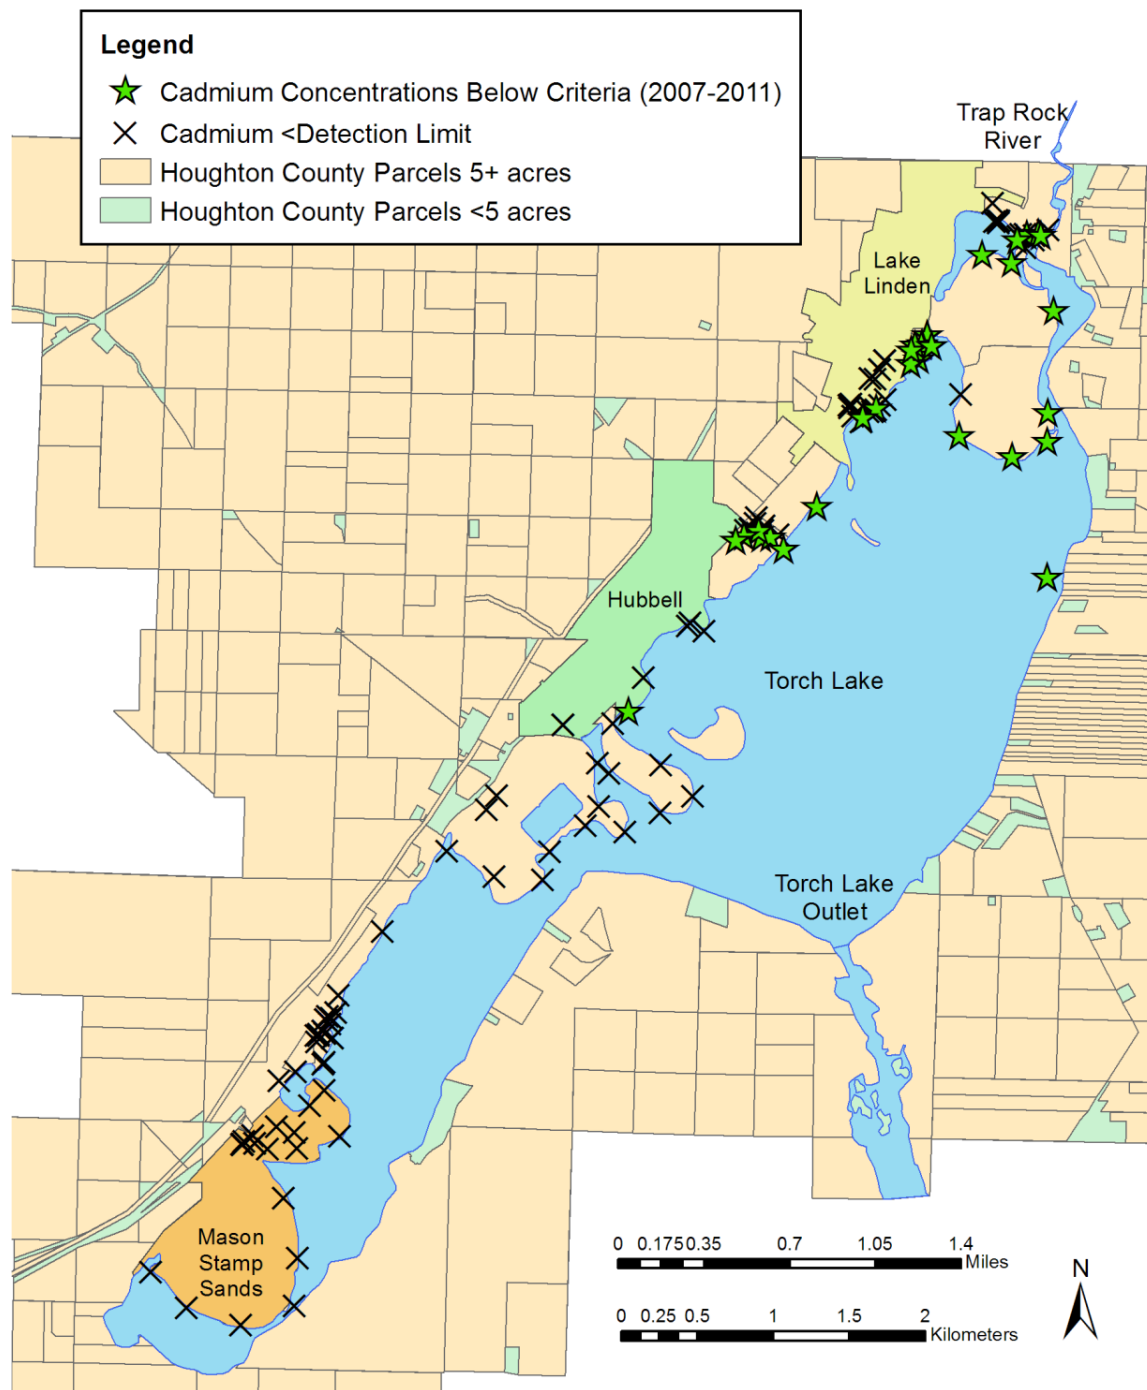
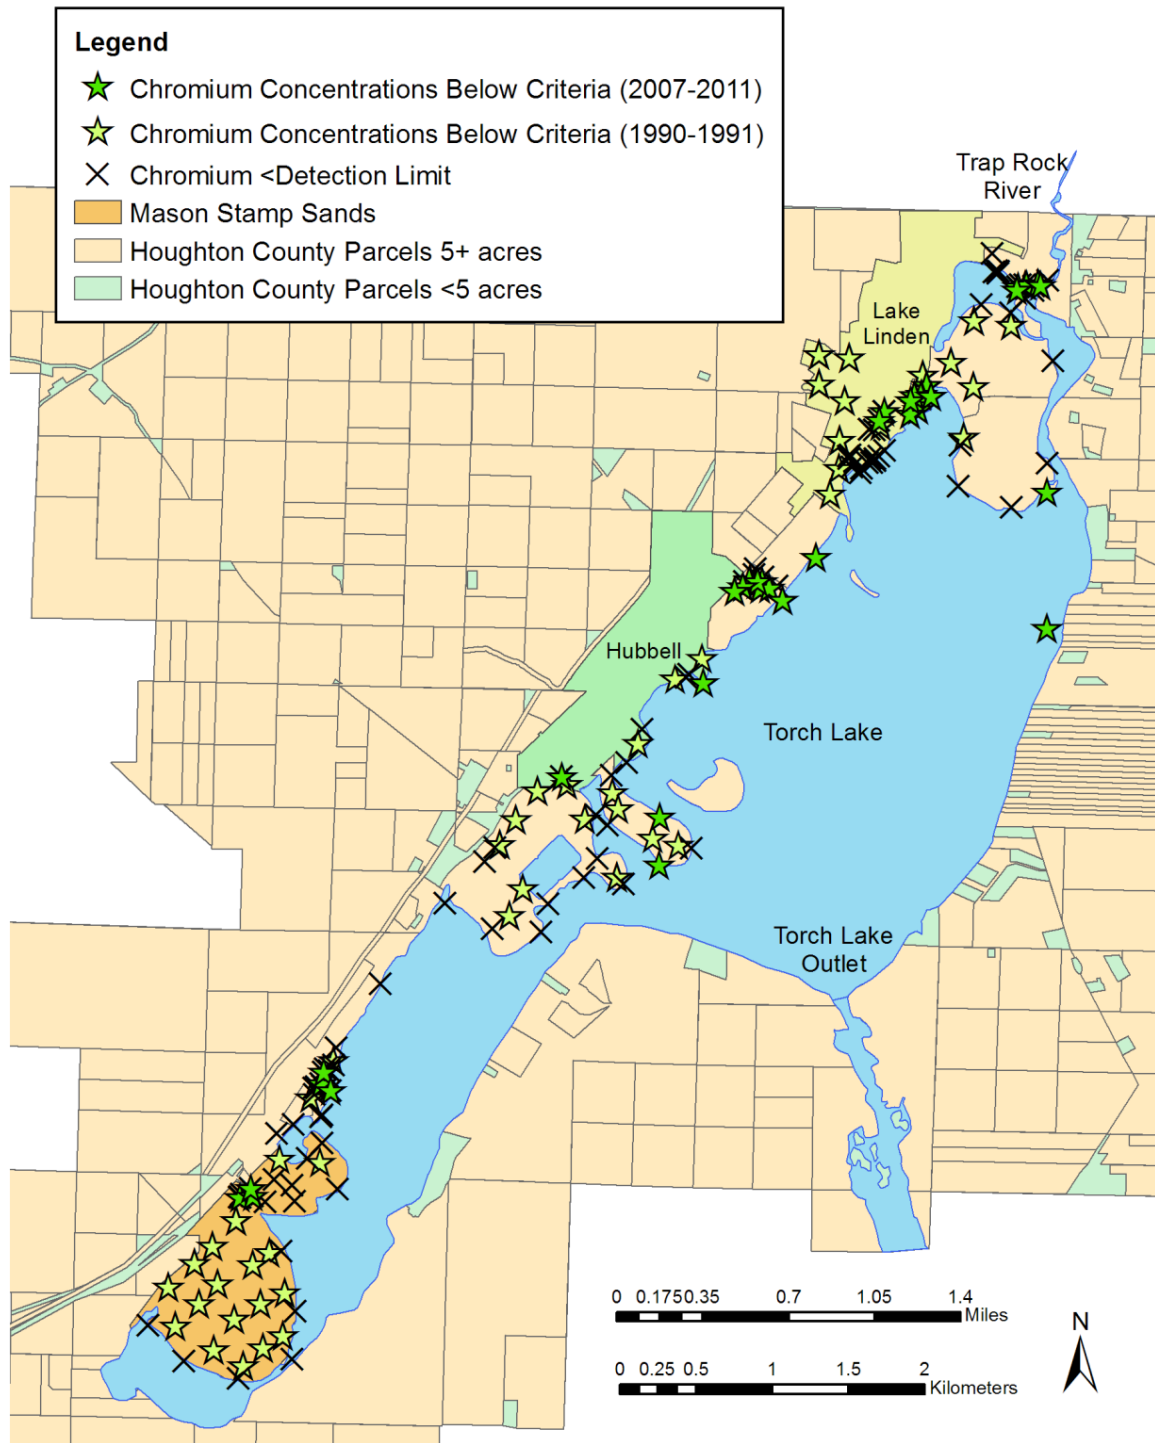
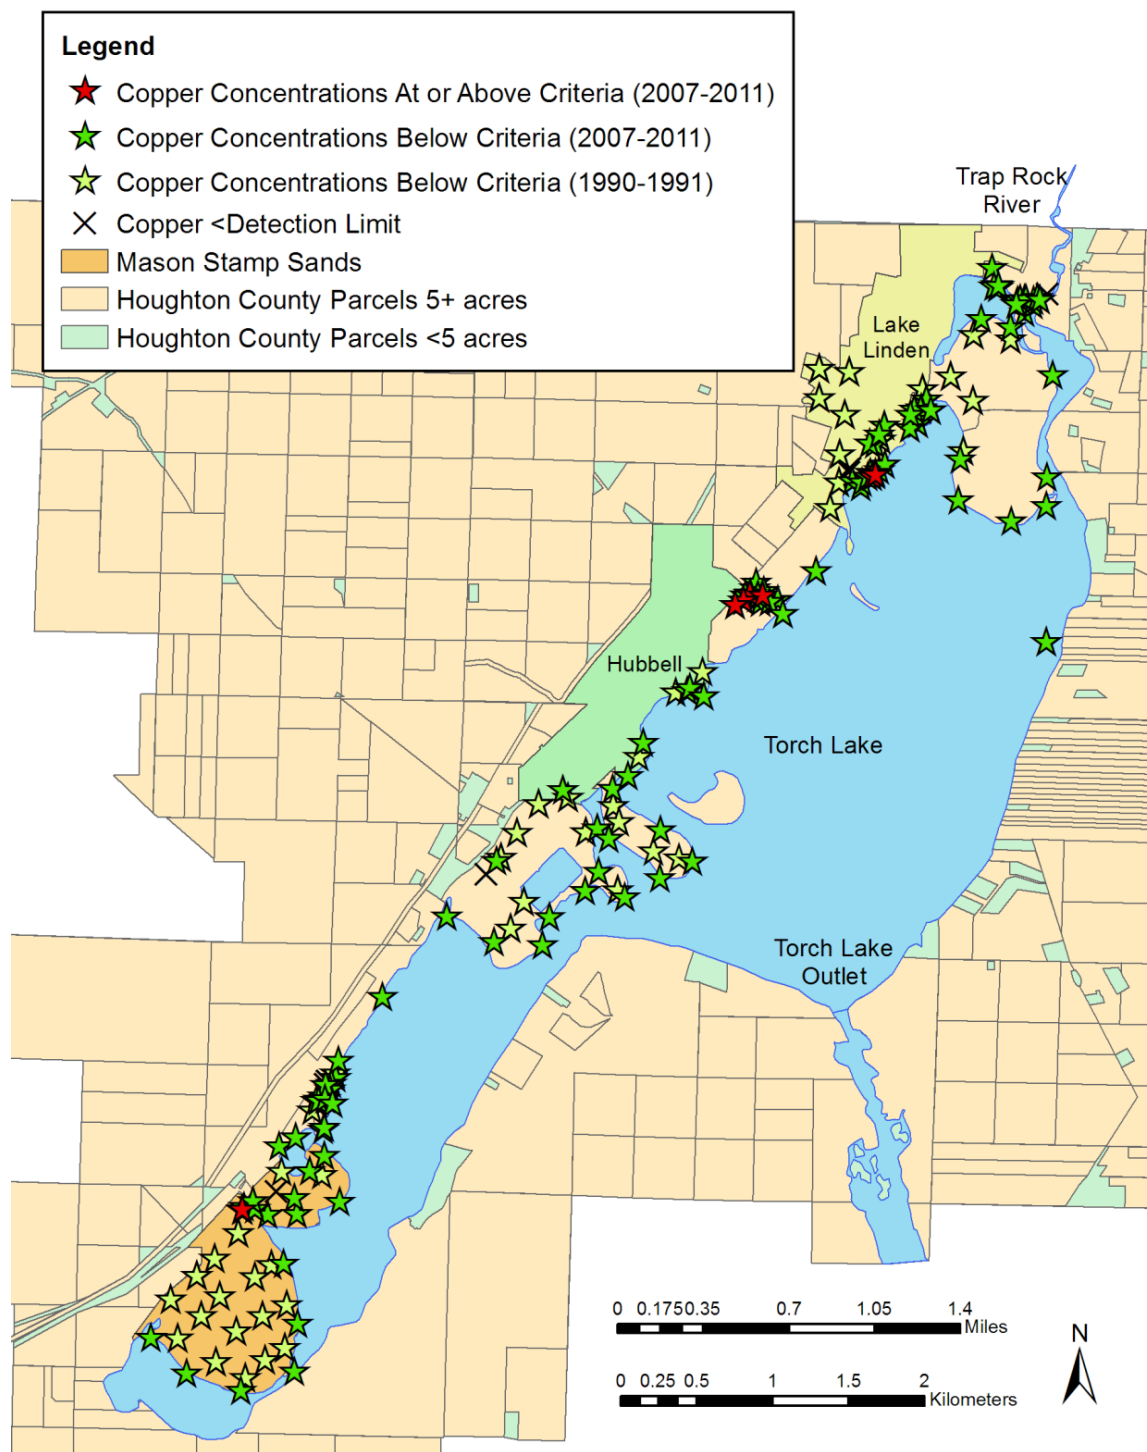
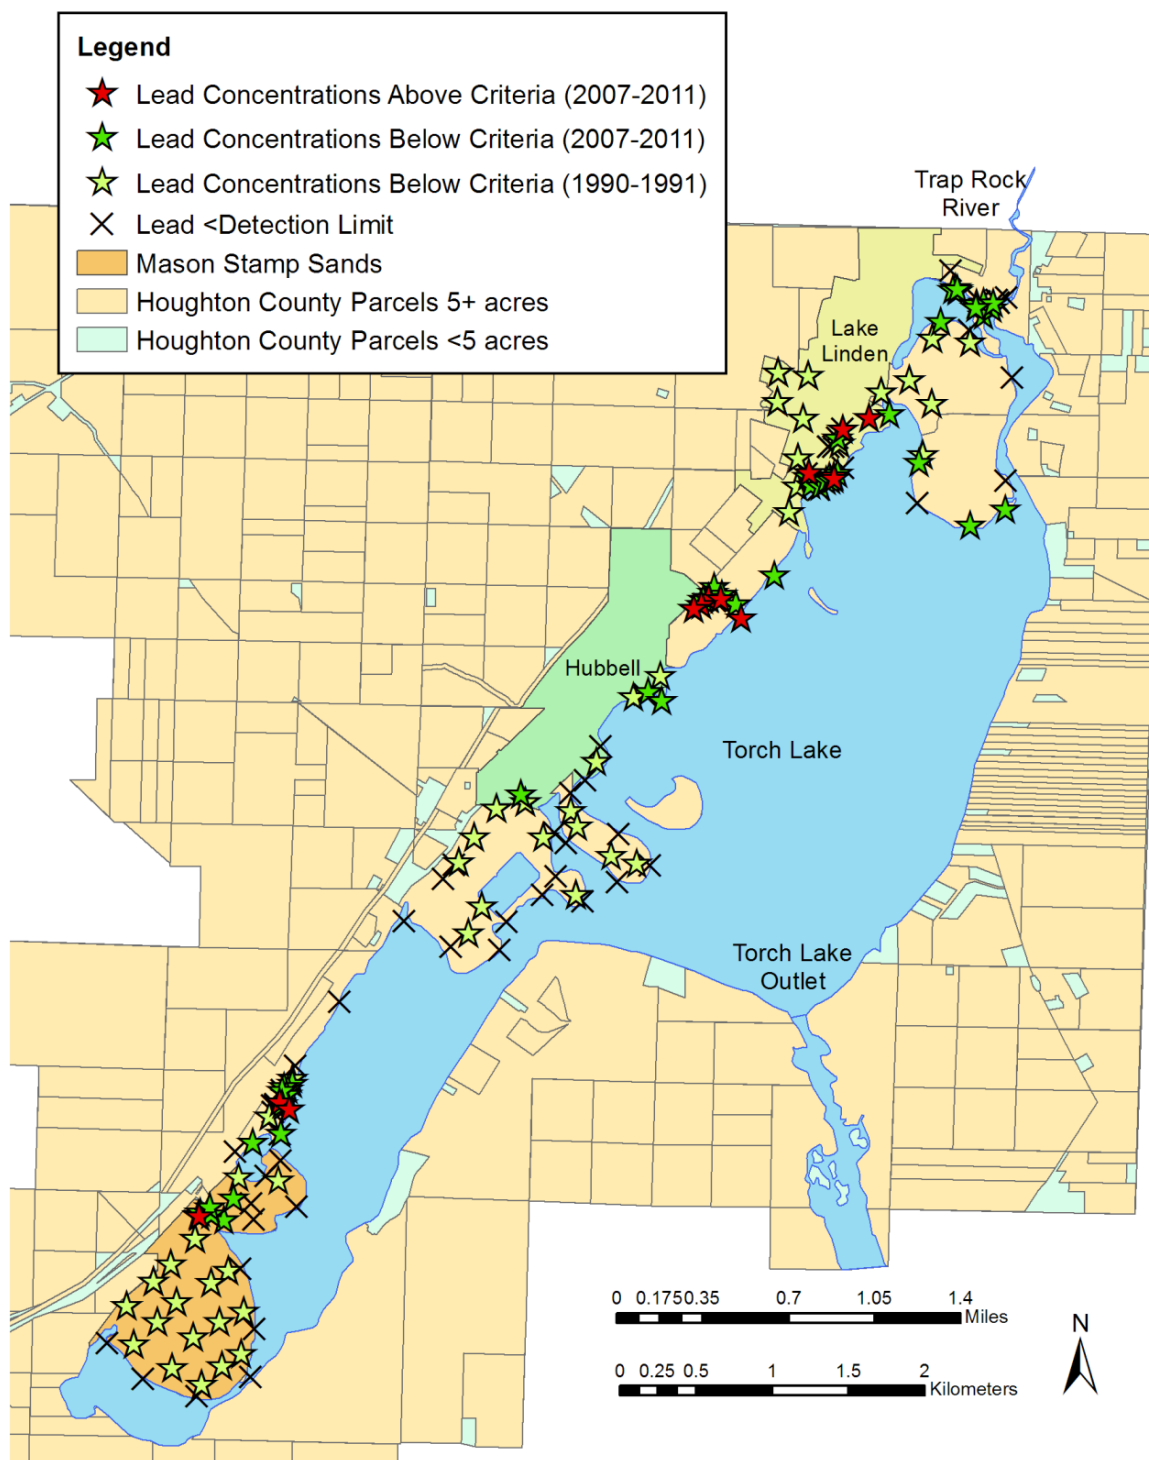
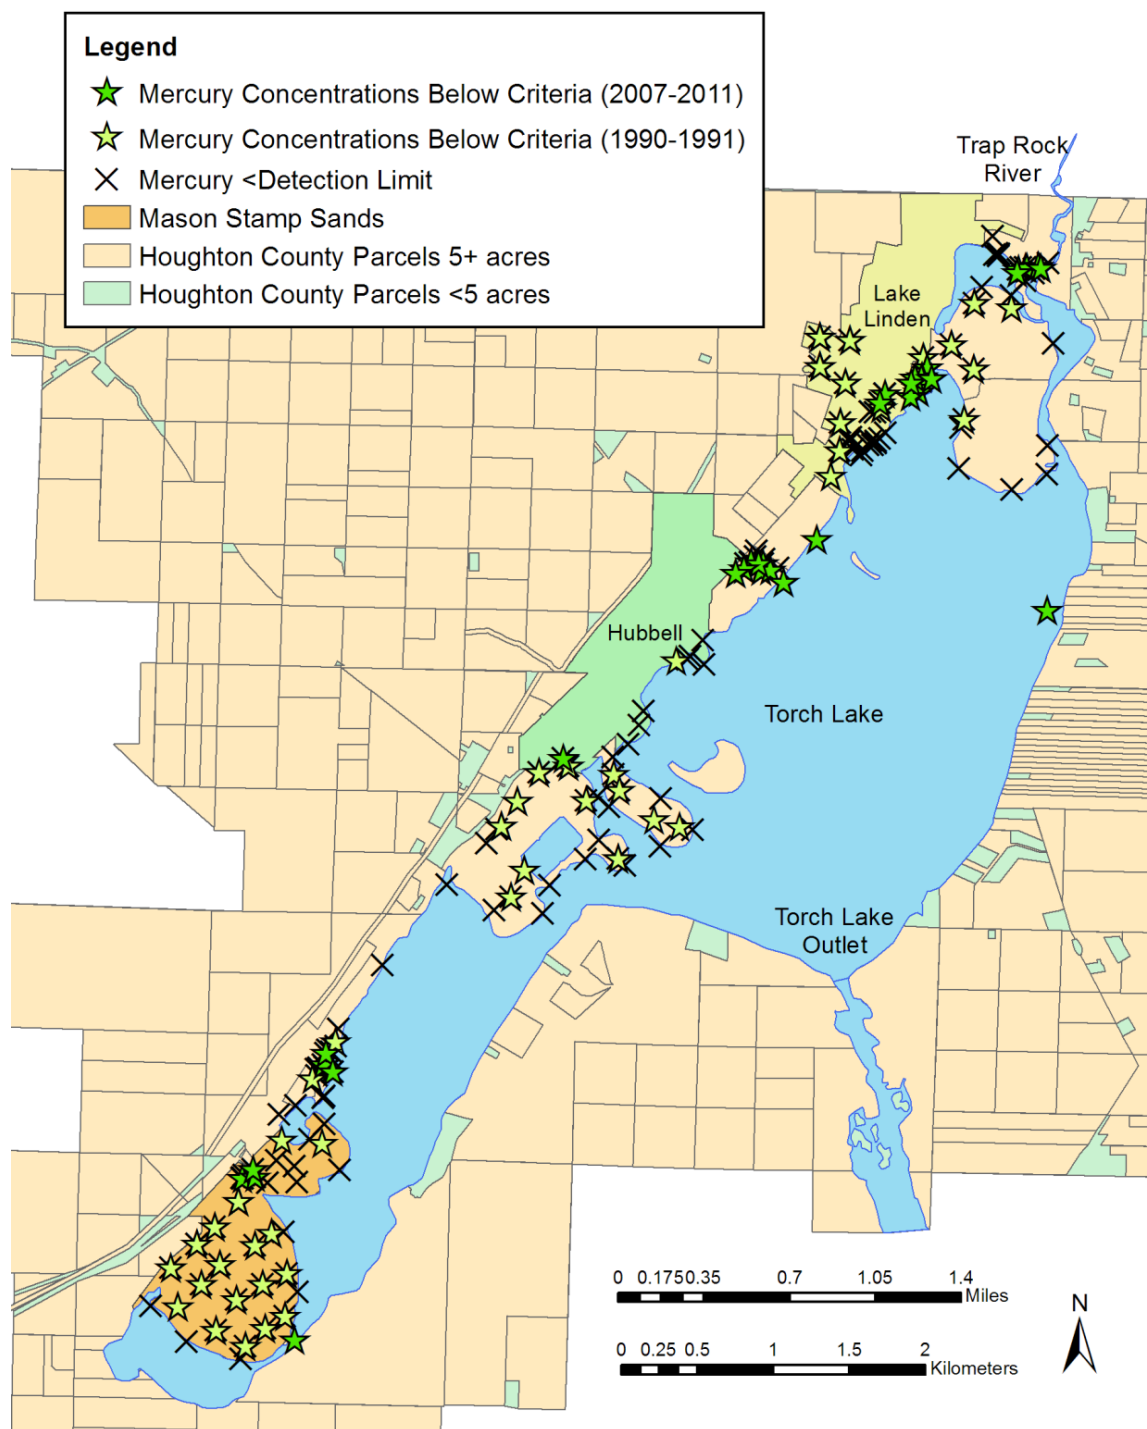
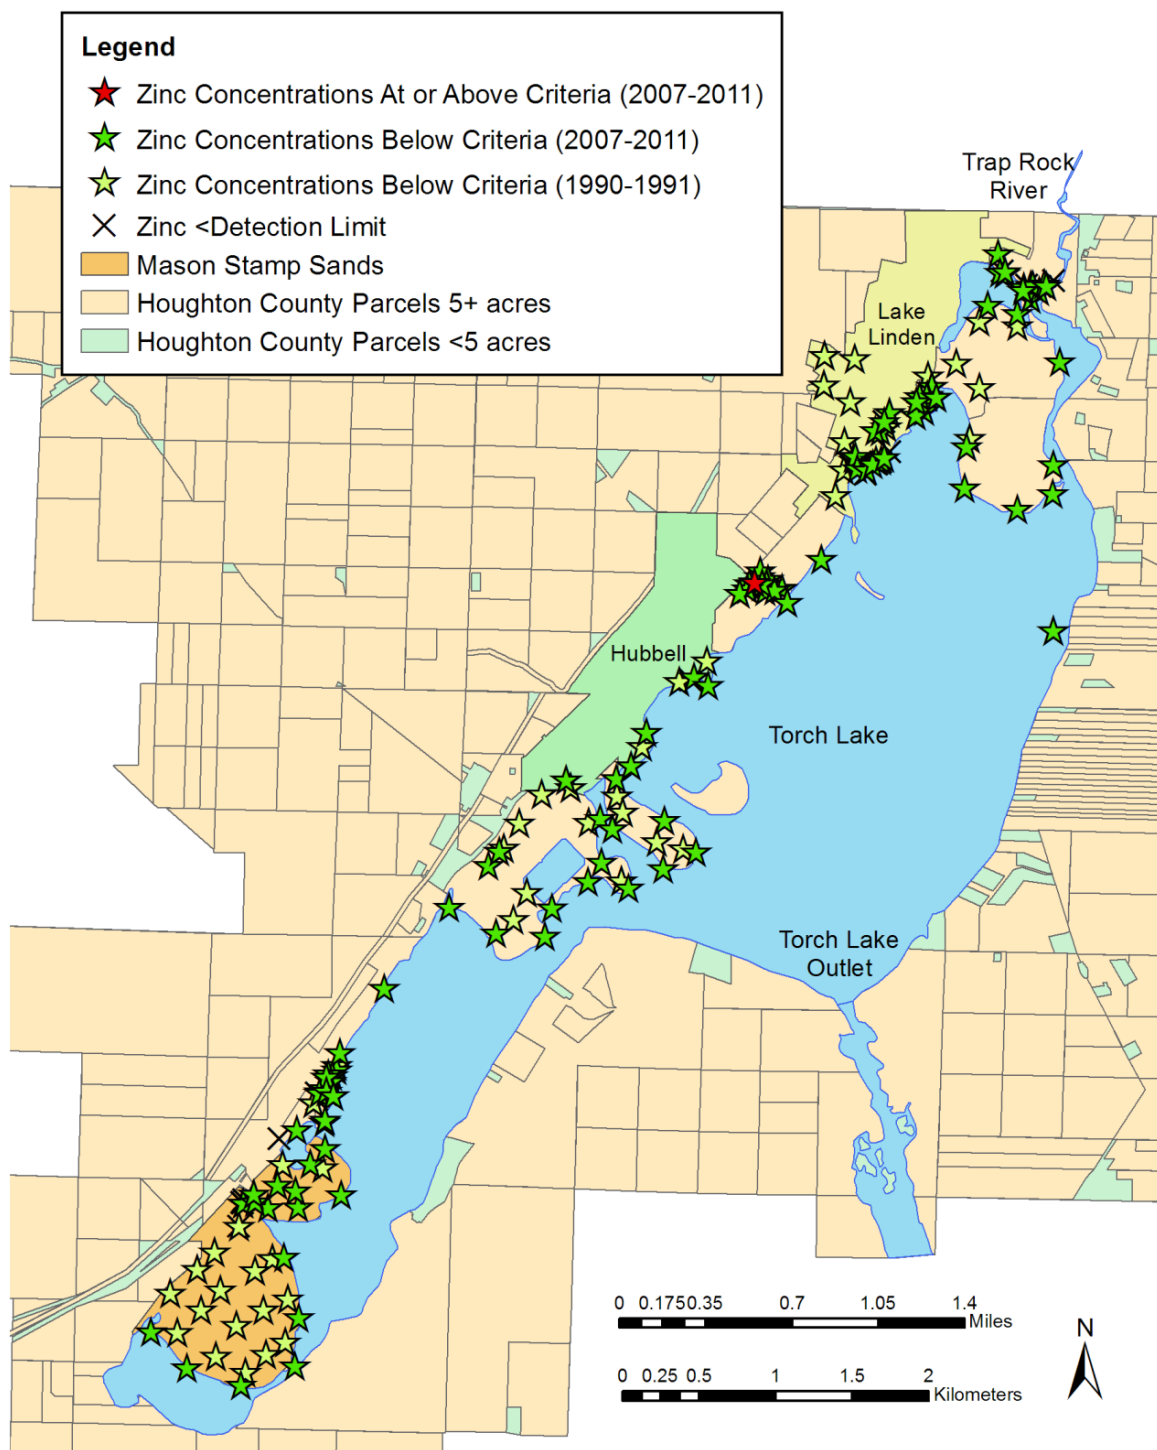
The soil maps (Figure 4.8-Figure 4.14) of each metal show the locations where concentrations met or exceeded the Michigan Part 201 Residential Soil Direct Contact Criteria (DCC), fell below the criteria, or were not detected. Point layers are distinguished by source so that temporal observations can be made in addition to spatial observations. Observations for each metal are summarized in Table 4.7 (following Figure 4.14).

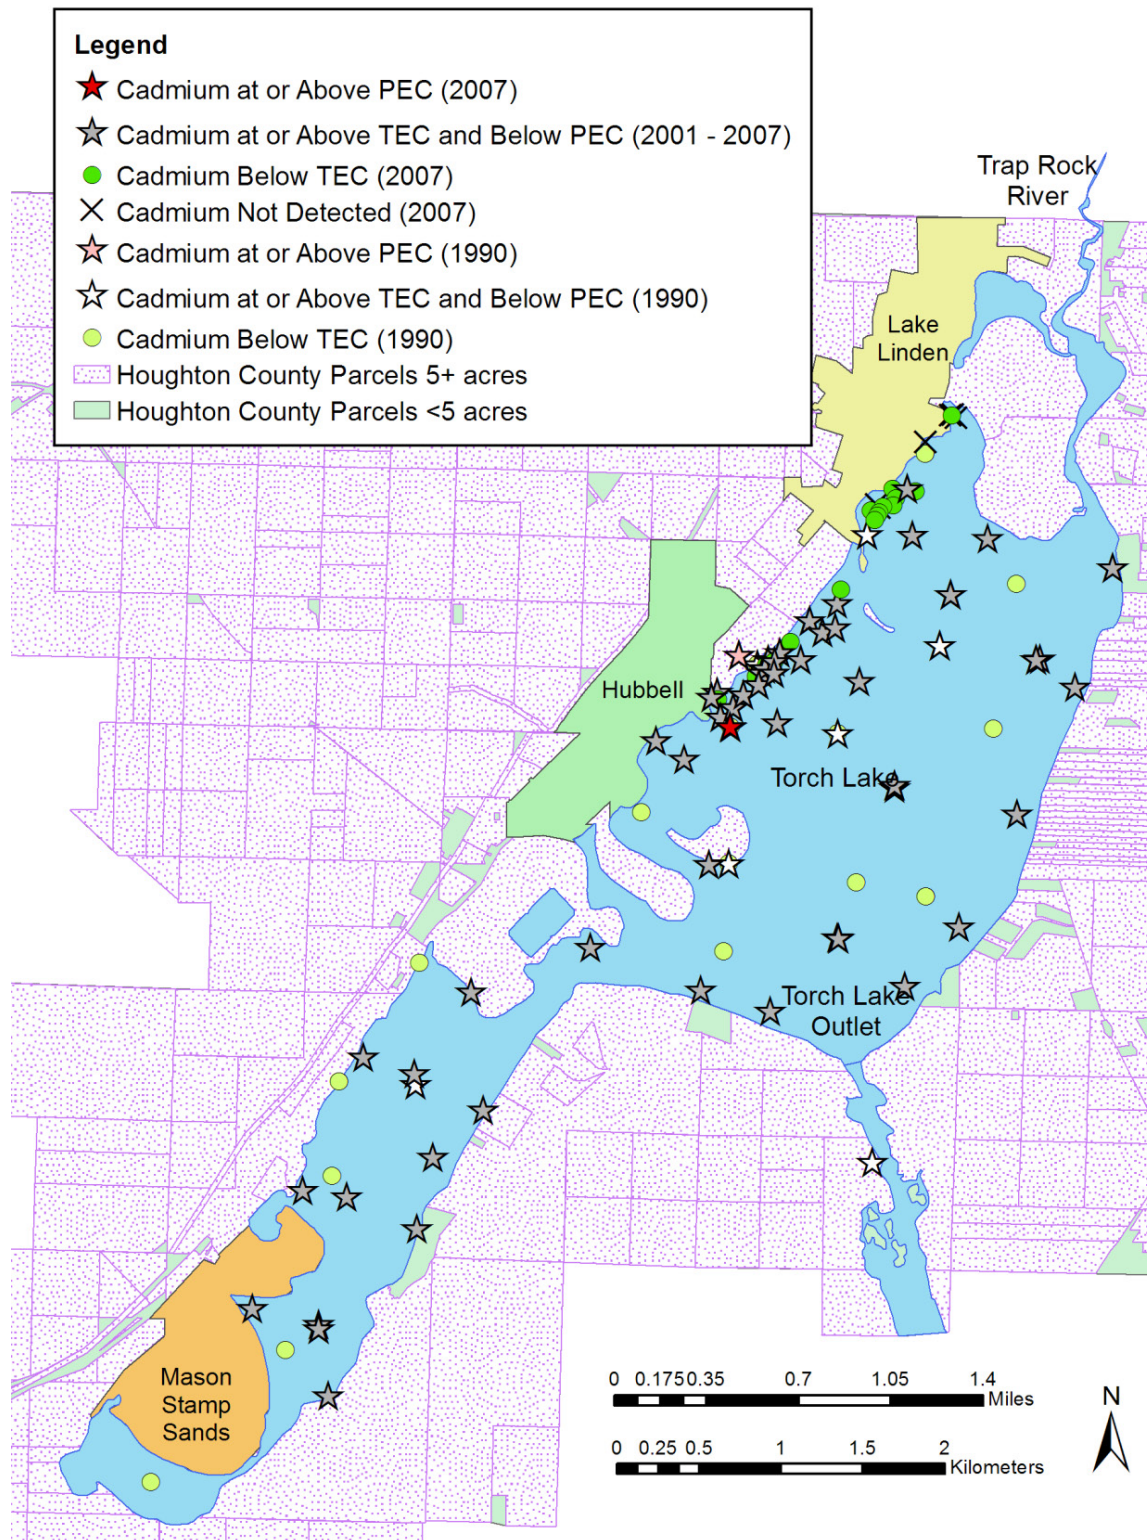
Figure 4.16: Measured cadmium concentrations compared to TEC and PEC.

The sediment maps (Figure 4.15-Figure 4.21) of each metal show the locations where concentrations met or exceeded the PEC, met or exceeded the TEC but fell below the PEC, fell below the TEC, or were not detected. Point layers are distinguished by source so that temporal observations can be made in addition to spatial observations.

Metal	Spatial Observation	Temporal Observation
Arsenic (As)	Locations where Arsenic meets or exceeds the PEC are located between Lake Linden and Hubbell. Locations where concentrations are between the TEC and PEC are located throughout the lake, and locations where As falls below the TEC are located throughout the lake.	The recent concentrations that meet or exceed the PEC are mostly found in the coal dock area between Lake Linden and Hubbell. There is no distinct pattern to the other observations.
Cadmium (Cd)	There is one location where Cadmium meets or exceeds the PEC just north of Hubbell. Most other locations detected concentrations between the TEC and the PEC. A few locations detected concentrations below the TEC. There is no distinct pattern to the locations of the detected concentrations.	There is no distinct pattern between the 2001 and the 1990 observations.
Chromium (Cr)	There are two locations where concentrations meet or exceed the PEC just north of Hubbell. Most locations where Cr falls below the TEC are found along the shoreline of the lake. Most of the locations in the middle contain concentrations between the PEC and the TEC.	There is no distinct temporal pattern.

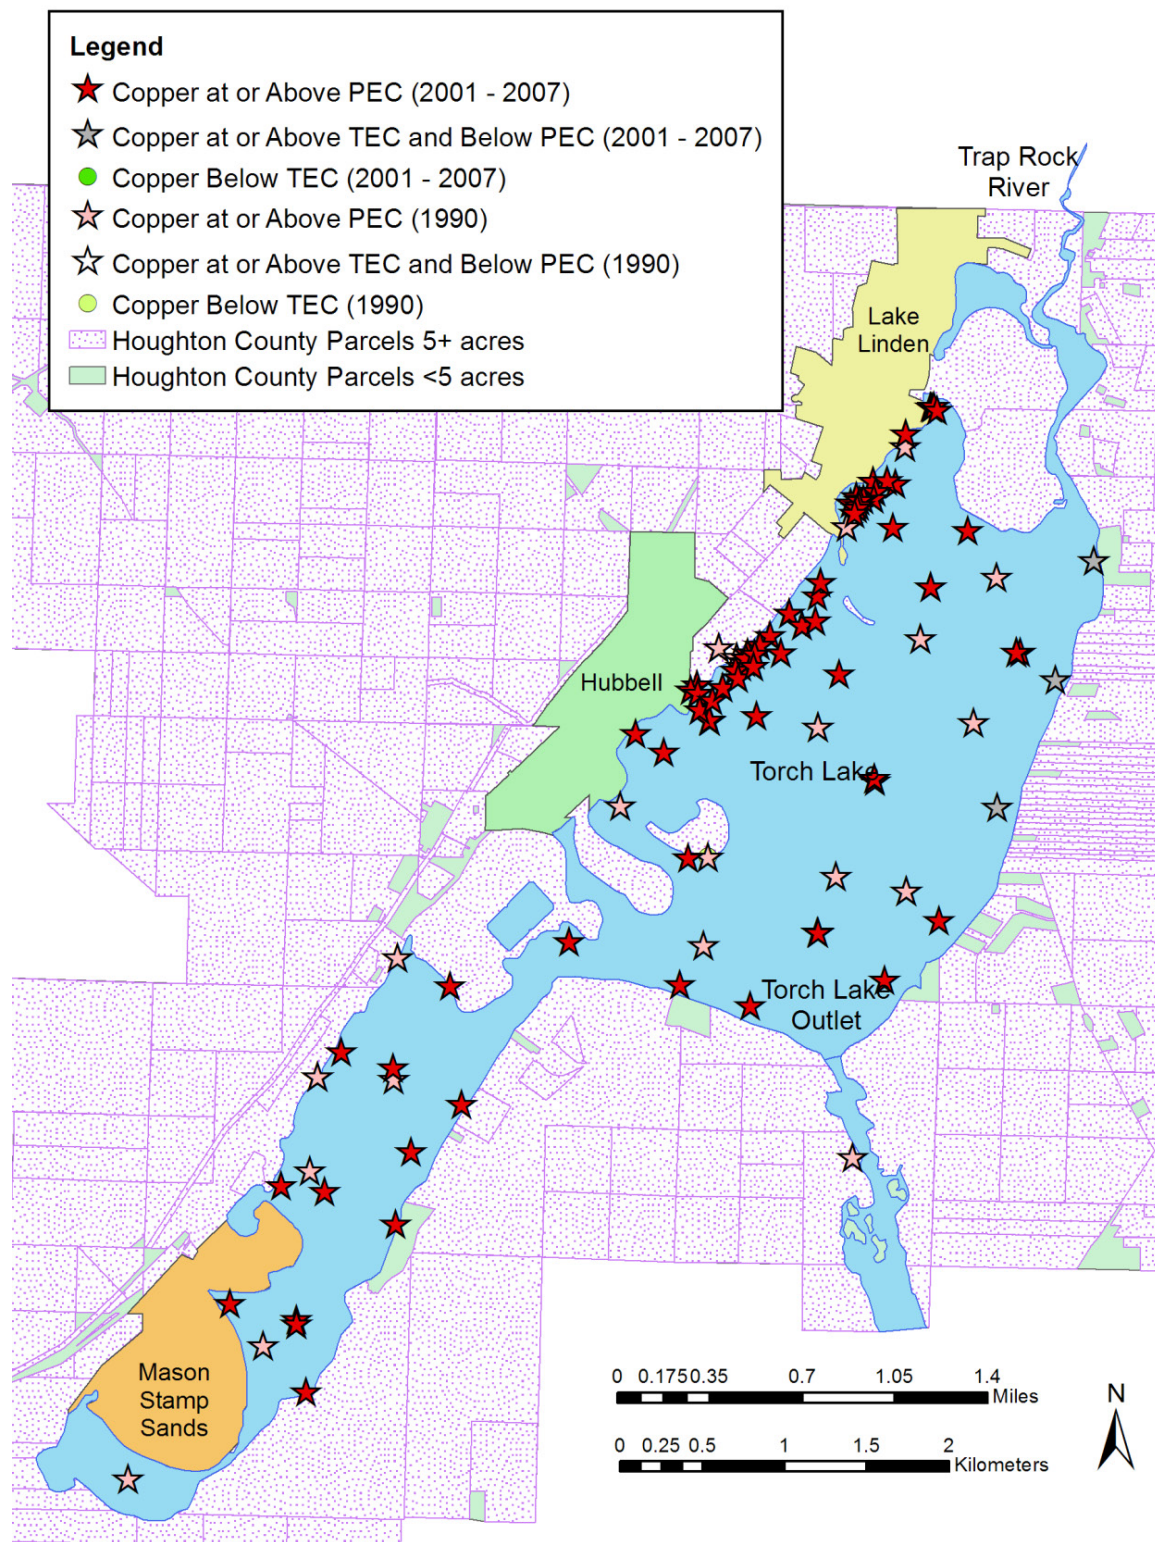
Figure 4.18: Measured copper concentrations compared to TEC and PEC.

Copper (Cu)	Most of the observed concentrations are above the PEC.	There is no distinct temporal pattern.

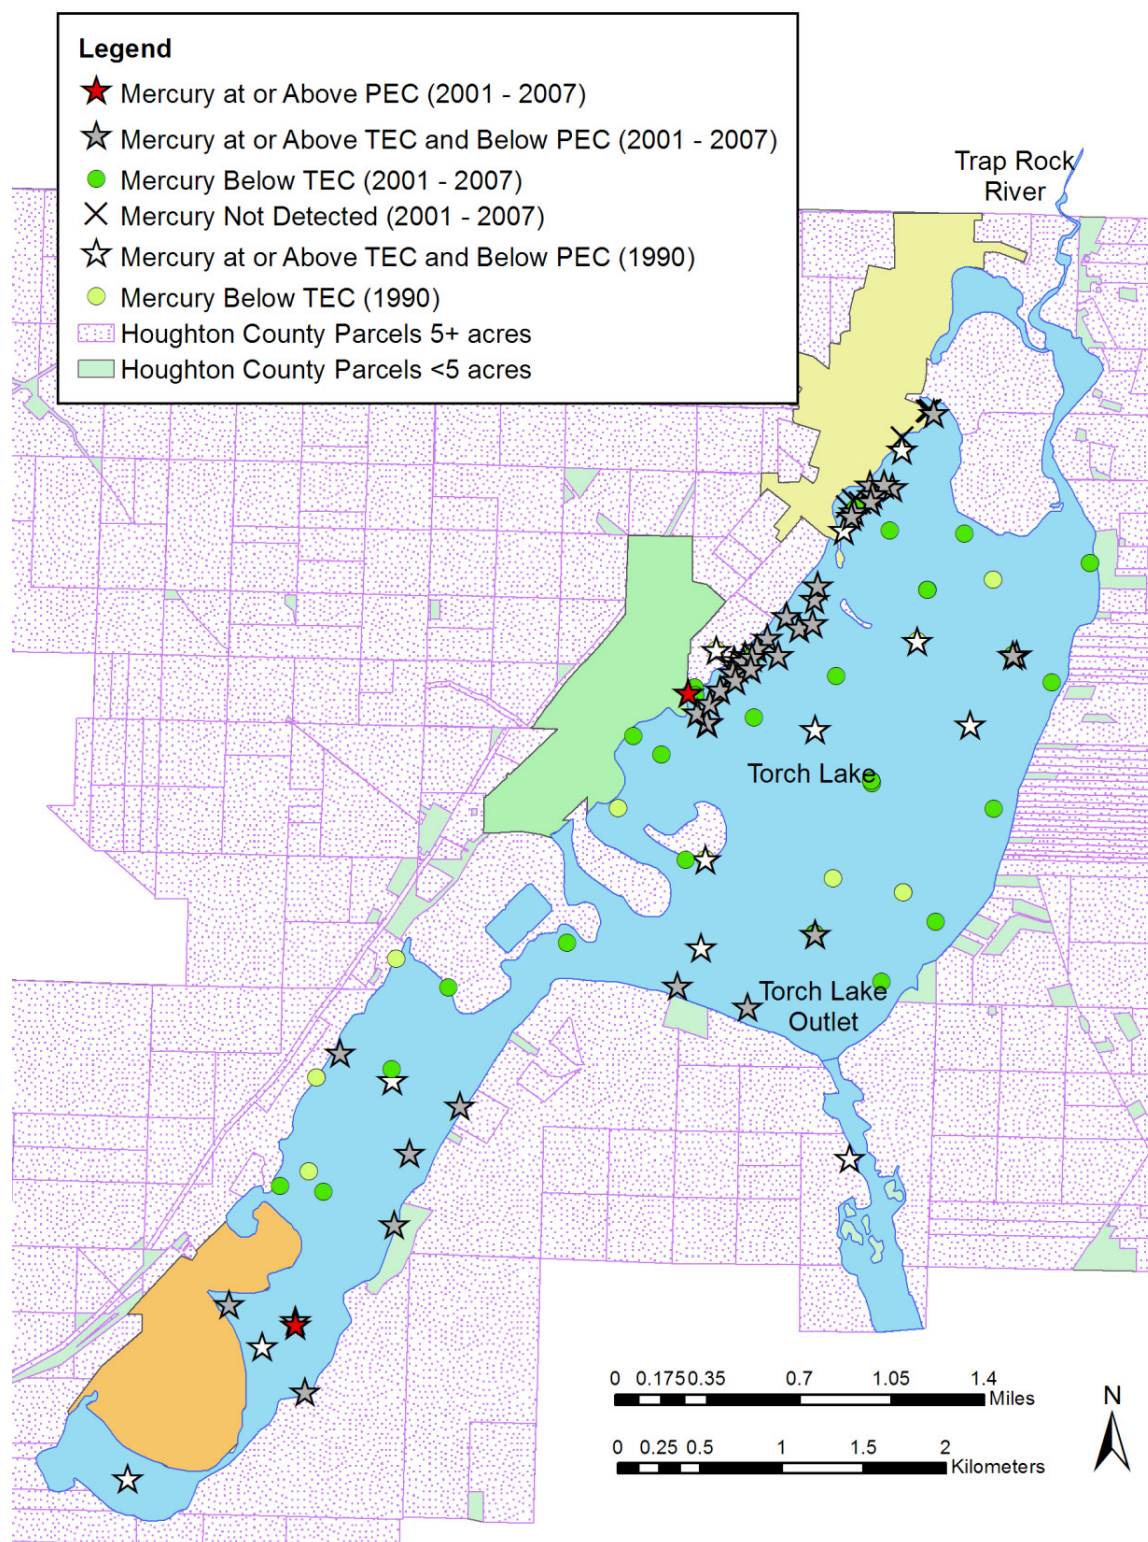
Figure 4.20: Measured mercury concentrations compared to TEC and PEC.

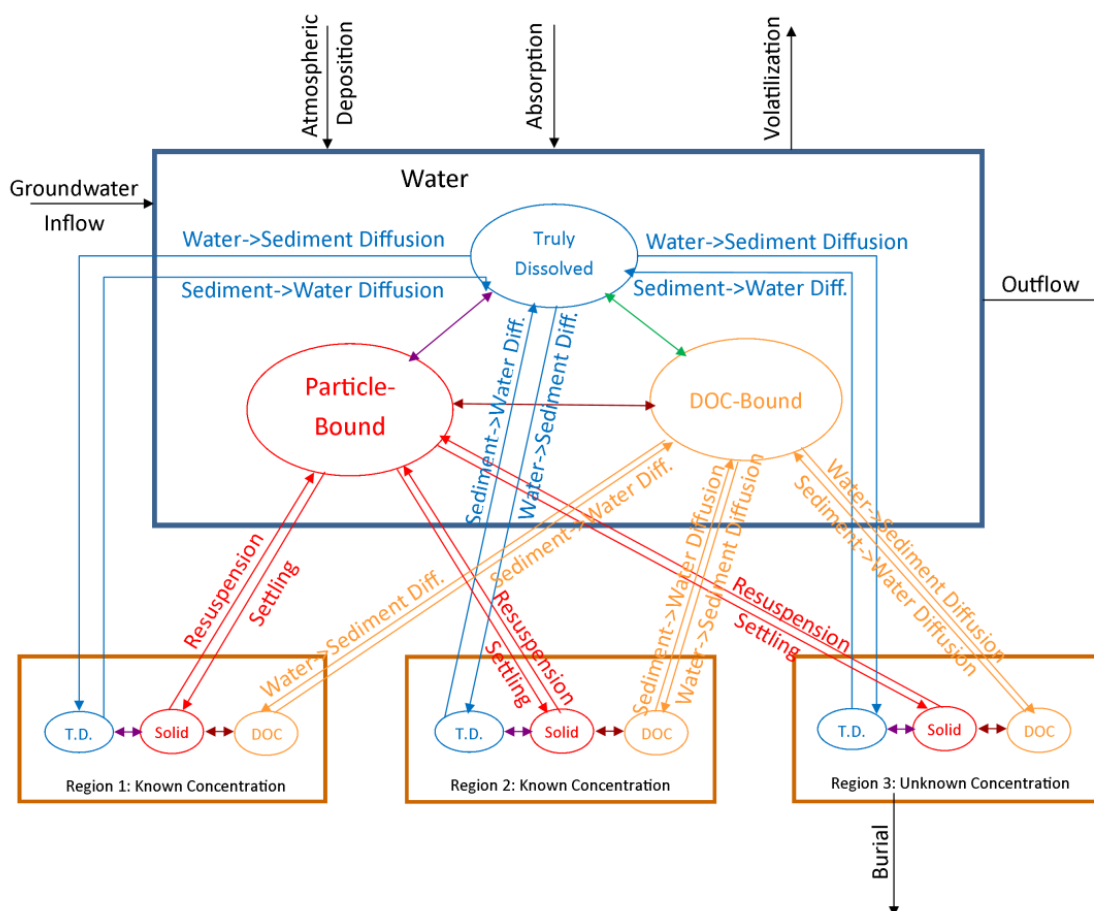
As shown in Figure 5.1, the water-column box has the following inputs: atmospheric deposition, absorption, groundwater input, sediment diffusion of both the truly dissolved and DOC-bound phases, and resuspension. Outputs include: volatilization, outflow, sediment diffusion of both the truly dissolved and DOC-bound phases, and settling. Also shown in Figure 5.1 are the inputs and outputs of the sediment box that include the following: sediment diffusion of the truly dissolved and DOC-bound phases, settling, resuspension and burial.

Figure 5.1: Torch Lake PCB mass balance model schematic.

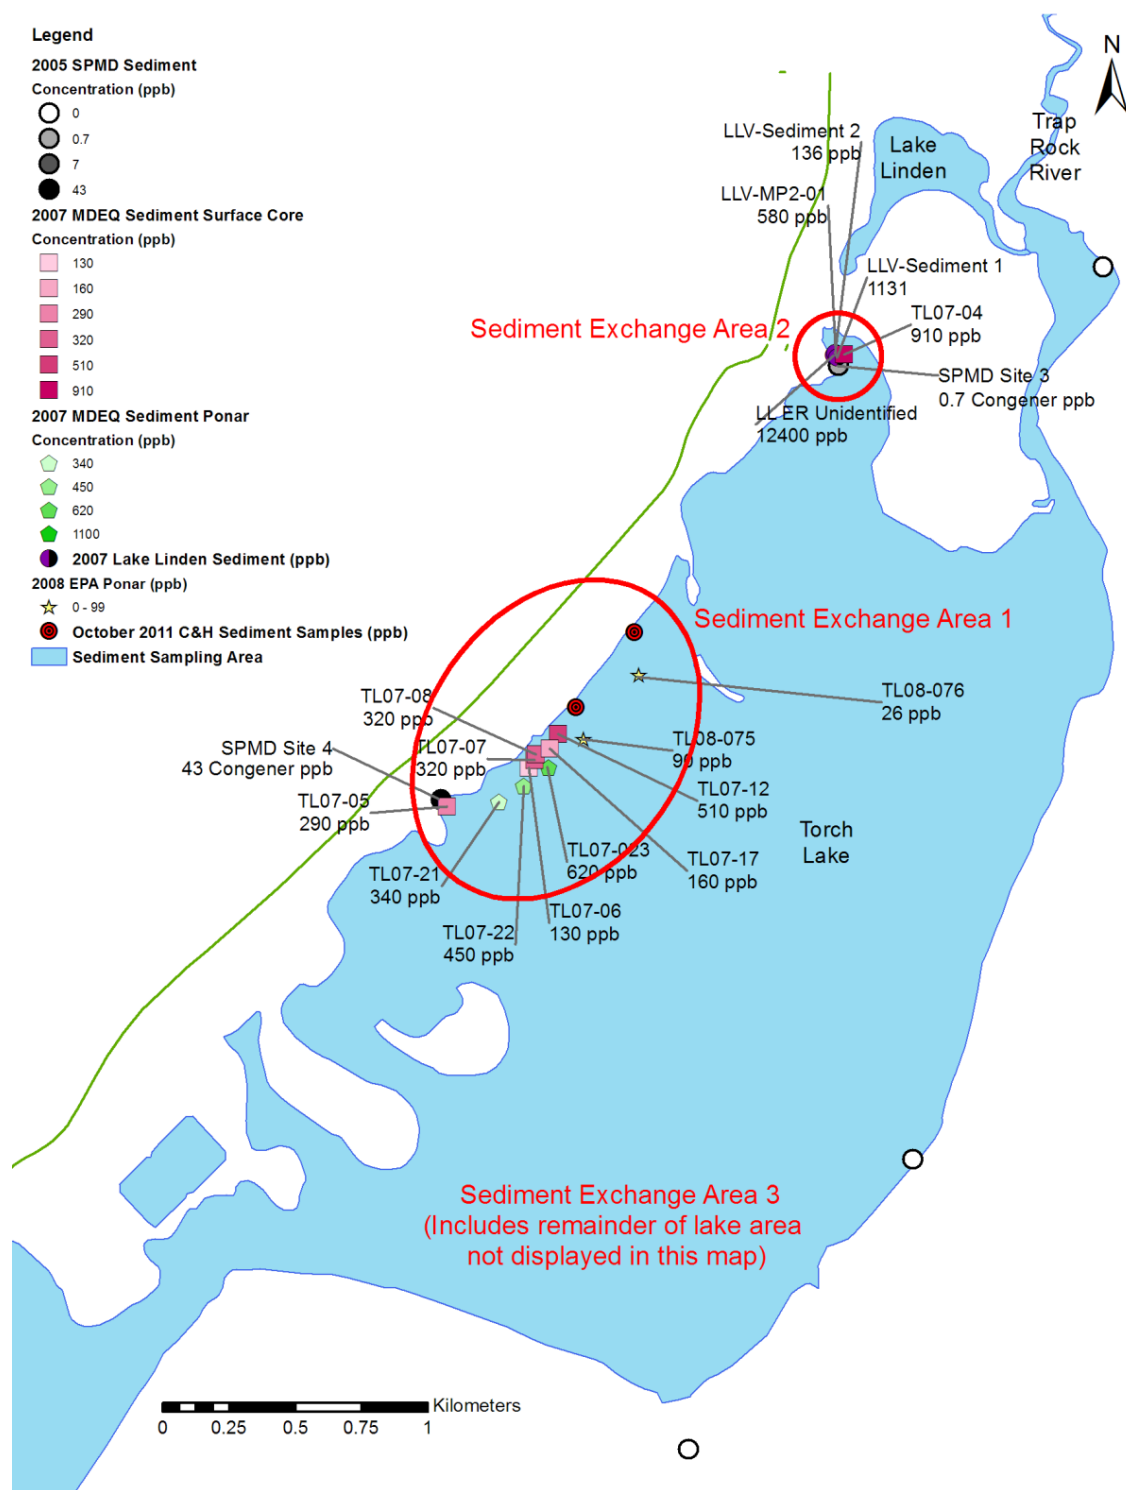
The selection of the sediment exchange regions was based on the extents of the two areas of positive PCB concentrations (where concentrations that met or exceeded detection limits were found). Circles were drawn around the points, and using the scale of the map, the areas of the circles were estimated. Because the areas of the regions included land, the area values were multiplied by estimated fractions of the water in the circles to give a more accurate estimate of the sediment exchange area. Sediment exchange region 1 is the water section of the southern circle, sediment exchange region 2 is the water section of the northern circle, and sediment exchange region 3 is the remainder of the lake area not included in either circle.

Figure 5.2: Sediment region definitions.

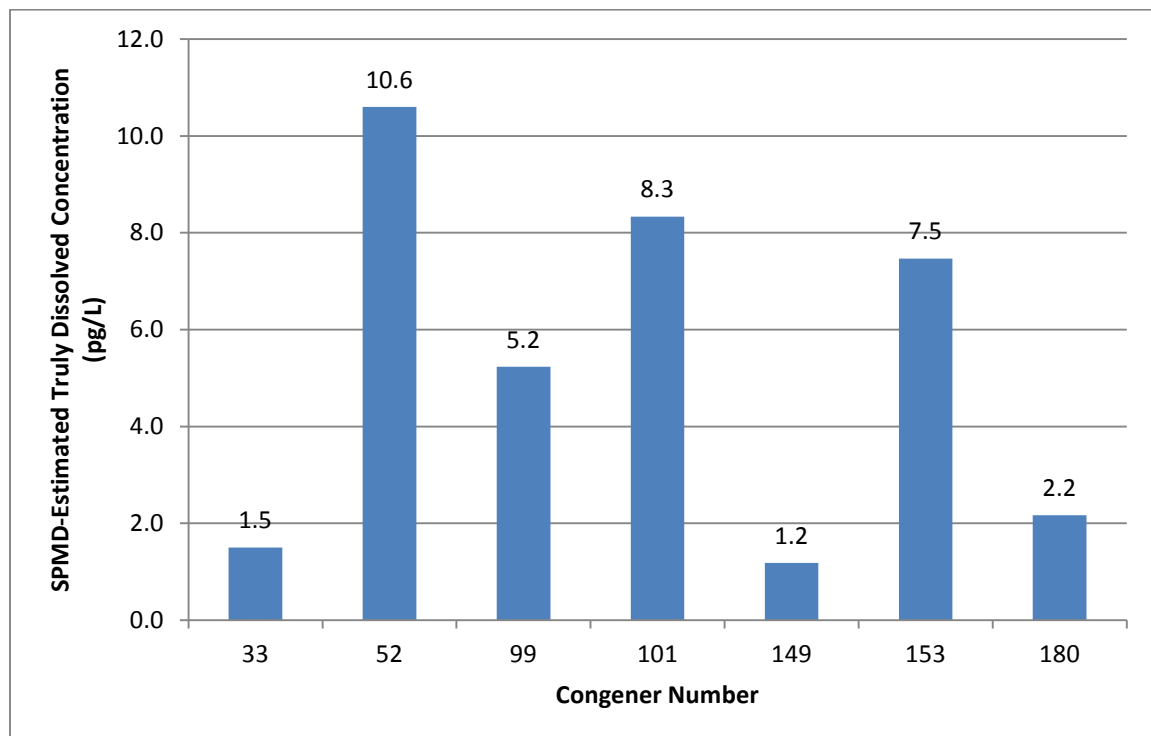
dissolved concentration could not be estimated for the congener because the concentration in the SPMD extract was reported by the MDEQ contractor that conducted the study (either GLEC or their subcontractor EST) as “0”. A reported concentration of 0 could mean one of two things: 1) that the results were below the quantitation limit or 2) the concentration could not be determined due to interference (GLEC, 2006).

Figure 5.5: SPMD-estimated truly dissolved concentrations in Torch Lake.

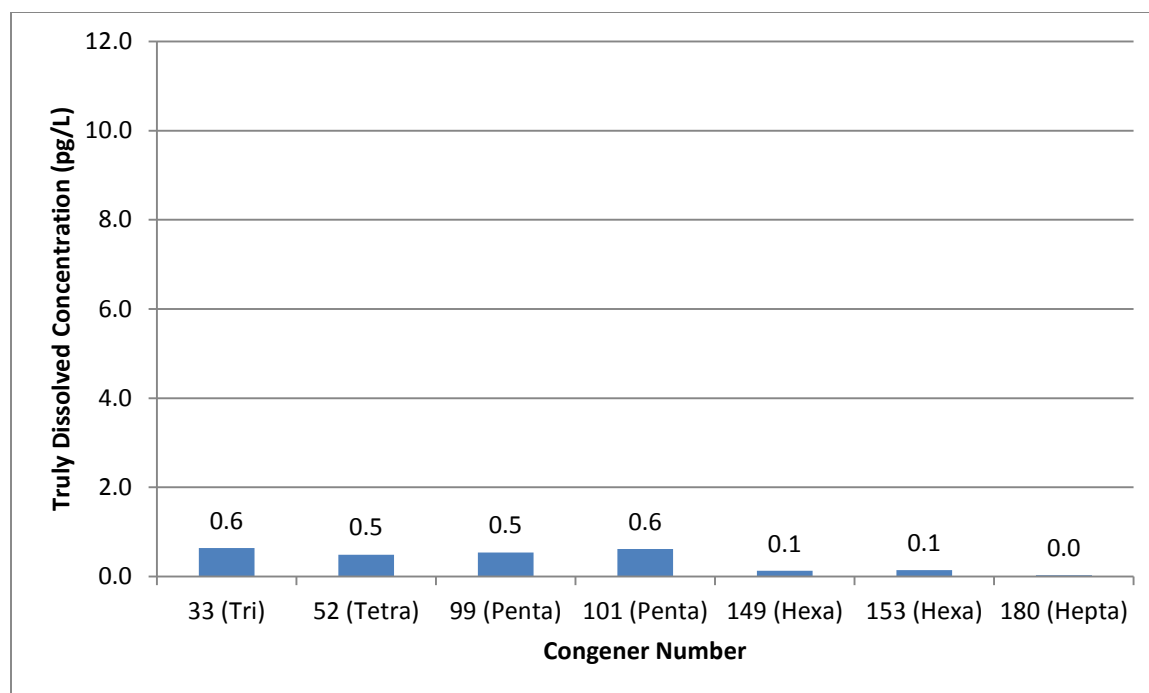
Aroclor mixture 1260, as determined by Frame et al., 1996, were used to determine the concentrations of each modeled congener in the sediment. These concentrations, along with their associated contaminated area, were substituted into the Torch Lake mass balance as the sediment exchange region 1 concentrations and area (while these values for sediment exchange region 2 were forced to equal zero) and the mass balance was calculated. The resulting truly dissolved congener concentrations are displayed in Figure 5.6.

Figure 5.6: Mass-balance modeled truly dissolved congener concentrations in Torch Lake water column due to oil spill from 1 transformer.
