Polychlorinated Biphenyl Compound and Metal Contamination and Remediation in Torch Lake, Houghton County, MI

A THESIS

In Environmental Engineering

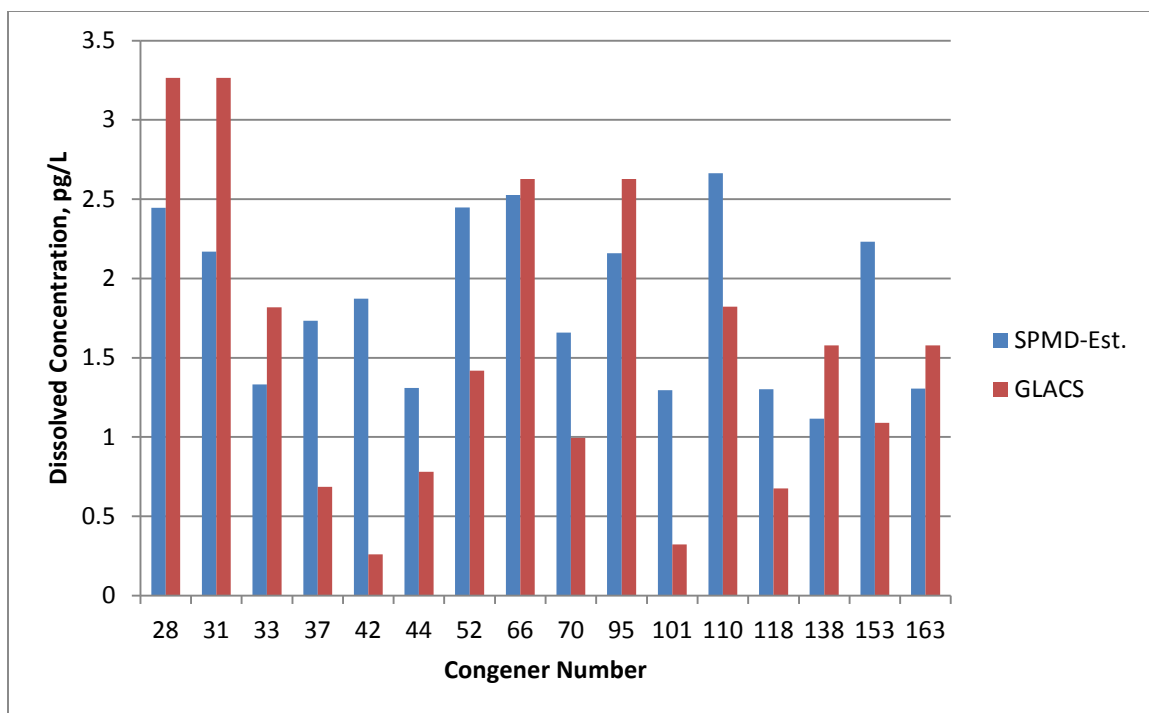
To perform the validation, first, only the congeners detected by the SPMDs in Huron Bay were considered to eliminate differences due to including zero-values for SPMD-estimated concentrations. From the GLACS data, only concentrations reported as being measured from XAD-resin were considered to be representative of the truly dissolved concentrations. Because there were concentrations reported from multiple sample sites throughout Lake Superior, the values for each congener were averaged. The averages were then compared to the concentrations estimated by SPMDs in Huron Bay.

Figure 5.9: Comparison of SPMD-estimated concentrations measured at Huron Bay in 2005 to measured concentrations in Lake Superior in 2006 from the GLACS study (Simcik, 2010).

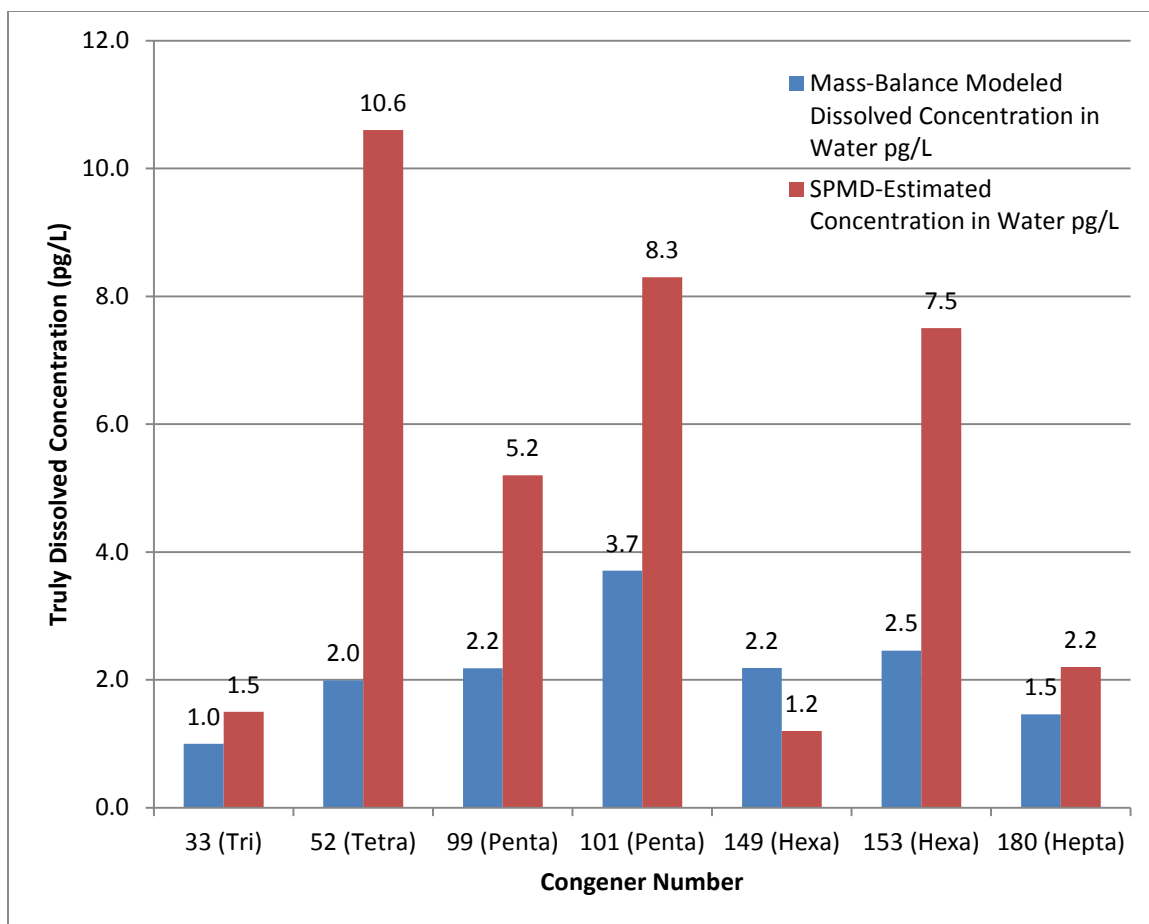
Figure 5.10: Truly dissolved PCB concentrations modeled by mass balance compared to truly dissolved concentrations estimated from SPMD measurements in Torch Lake.

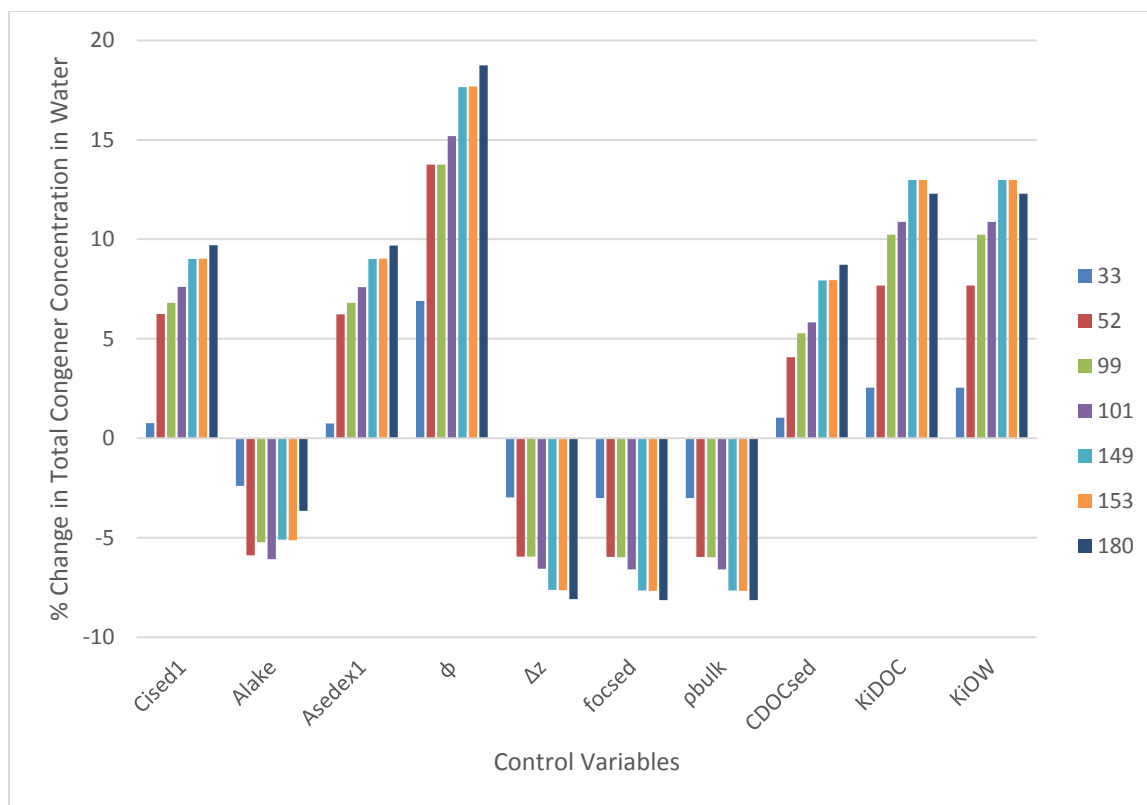
Figure 5.11: Percent change in predicted total water PCB concentration due to a 10% increase in independent parameters. Only parameters causing significant or more significant change are displayed.

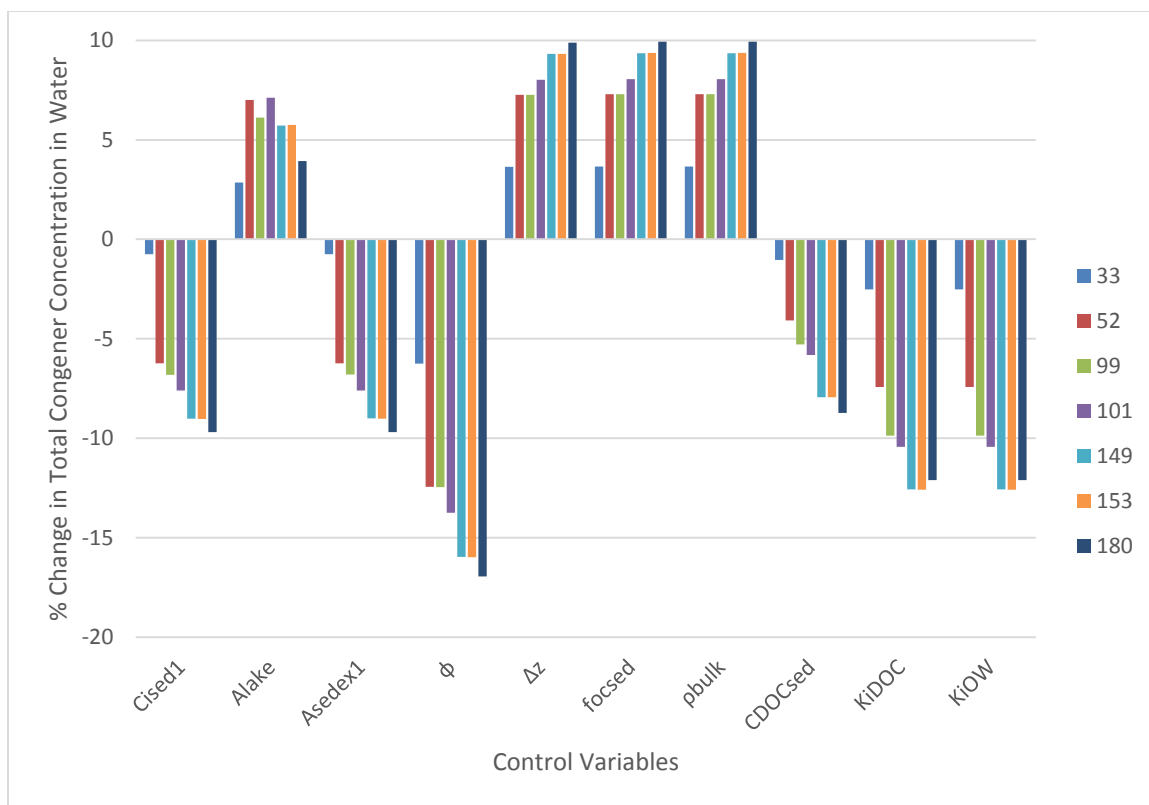
Figure 5.12: Percent change in predicted total water PCB concentration due to a 10% decrease in independent parameters. Only parameters causing significant or more significant change are displayed.

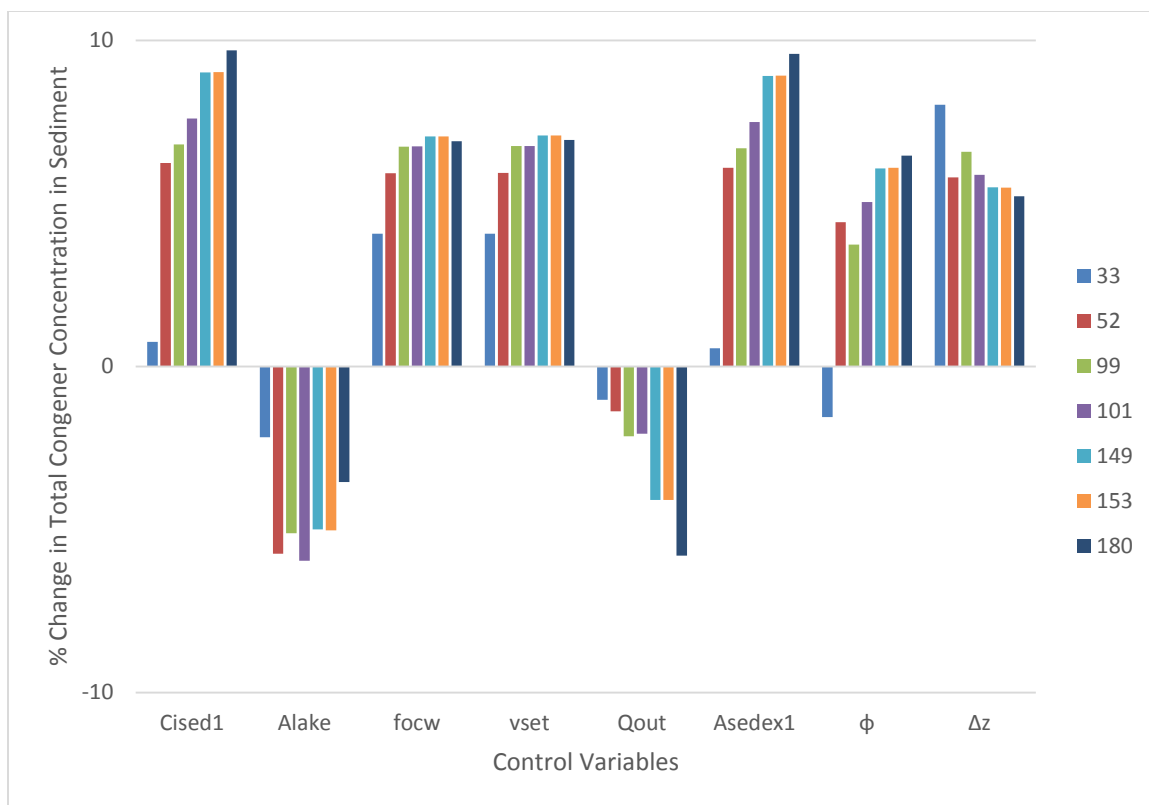
Figure 5.13: Percent change in predicted region 3 sediment PCB concentration due to a 10% increase in independent parameters. Only parameters causing significant or more significant change are displayed.

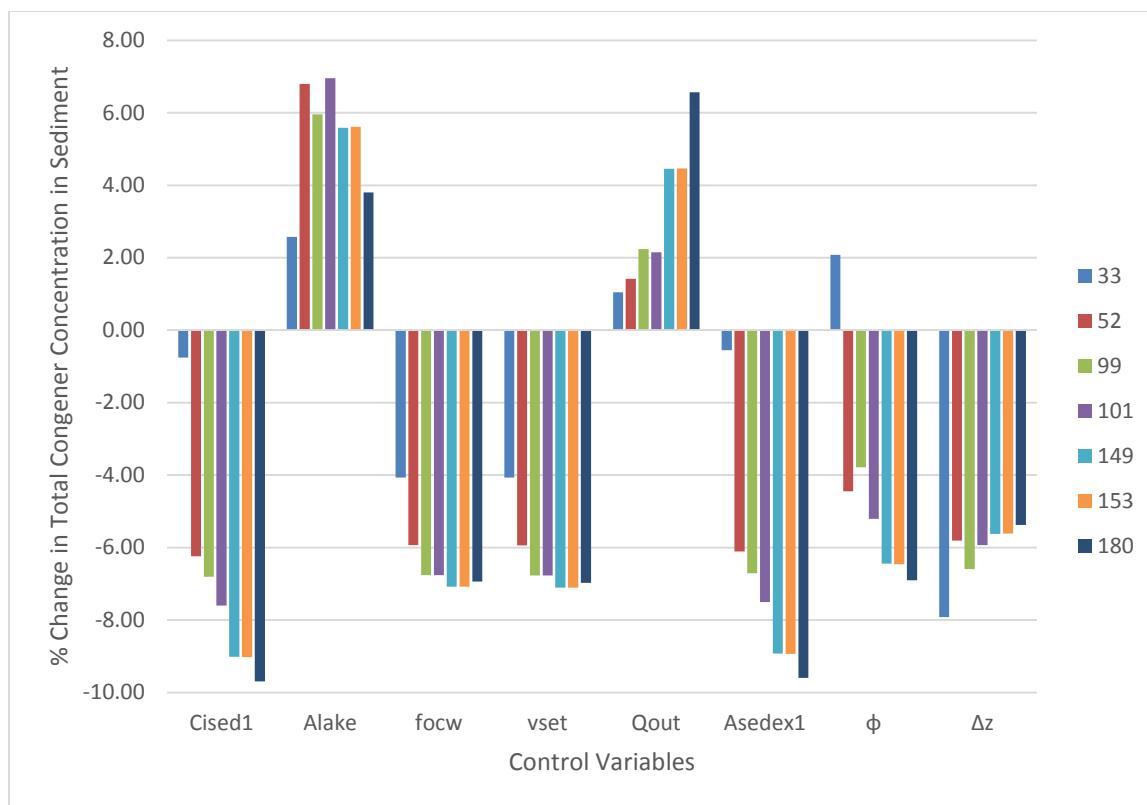
Figure 5.14: Percent change in predicted region 3 sediment concentration due to a 10% decrease in independent parameters. Only parameters causing significant or more significant change are displayed.

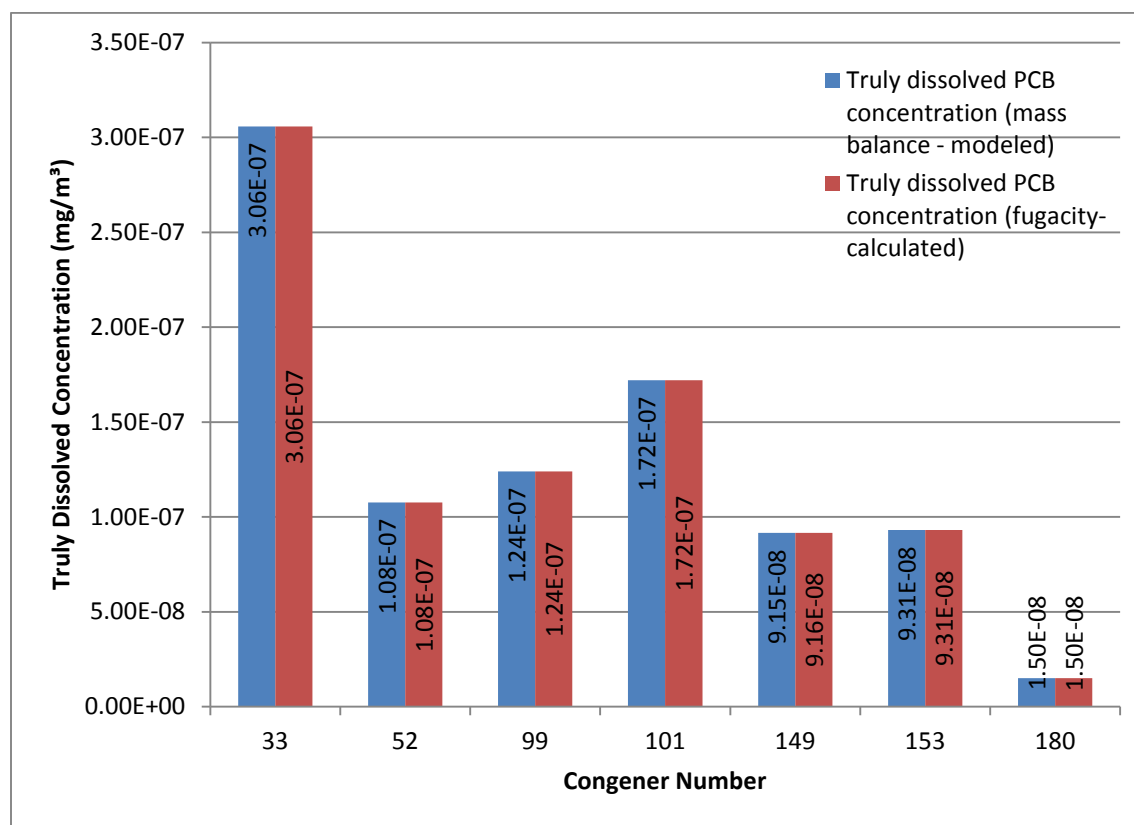
The truly dissolved concentrations of PCBs in the water modeled by the modified mass balance model (the version of the model which only took into account equilibrium processes) match those calculated using fugacity (Figure 5.15); and the calculated fugacities in sediment match those calculated using the modified mass balance model (Figure 5.16). The near-perfect matches between the truly dissolved PCB concentrations calculated with the modified mass balance model and the fugacity approach were achieved because both the modified mass balance and the fugacity models assume that PCBs in sediment, water, and air are in equilibrium with each other.

Figure 5.15: Comparison of truly dissolved PCB Concentrations calculated with a fugacity model and a modified mass balance model for Torch Lake.

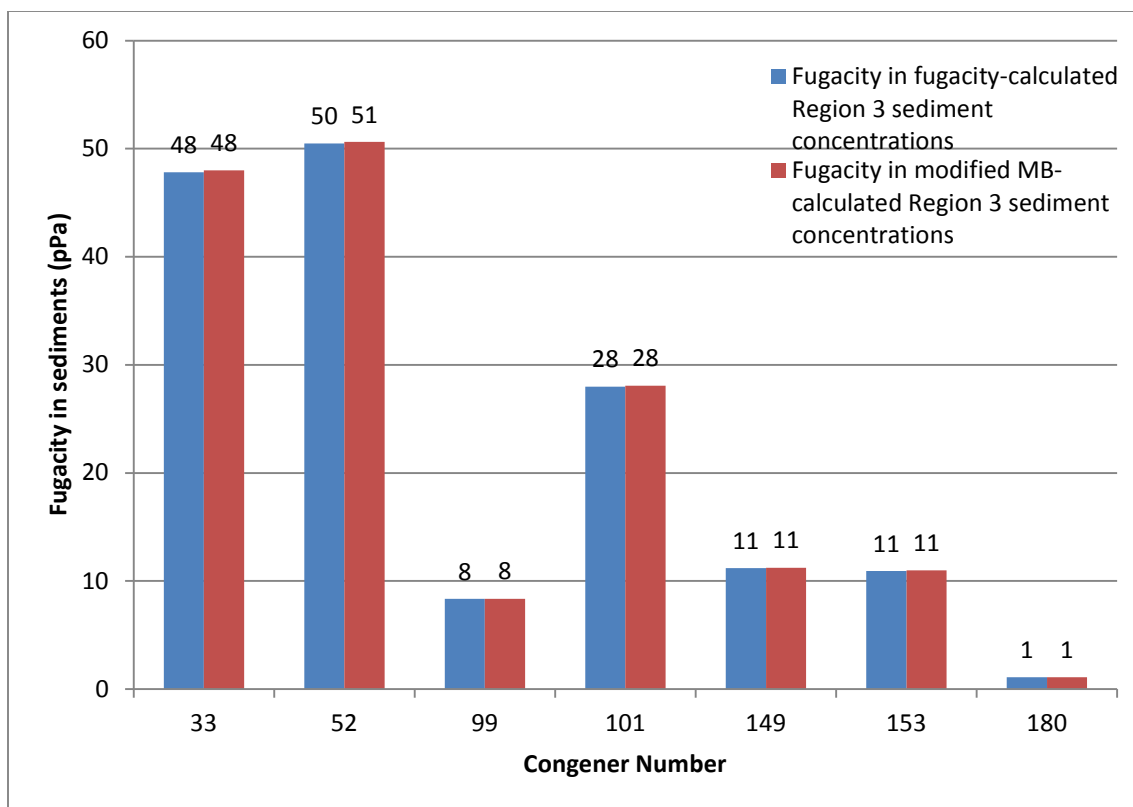
Figure 5.16: Comparison of sediment fugacities from fugacity-model and from modified mass-balance model.

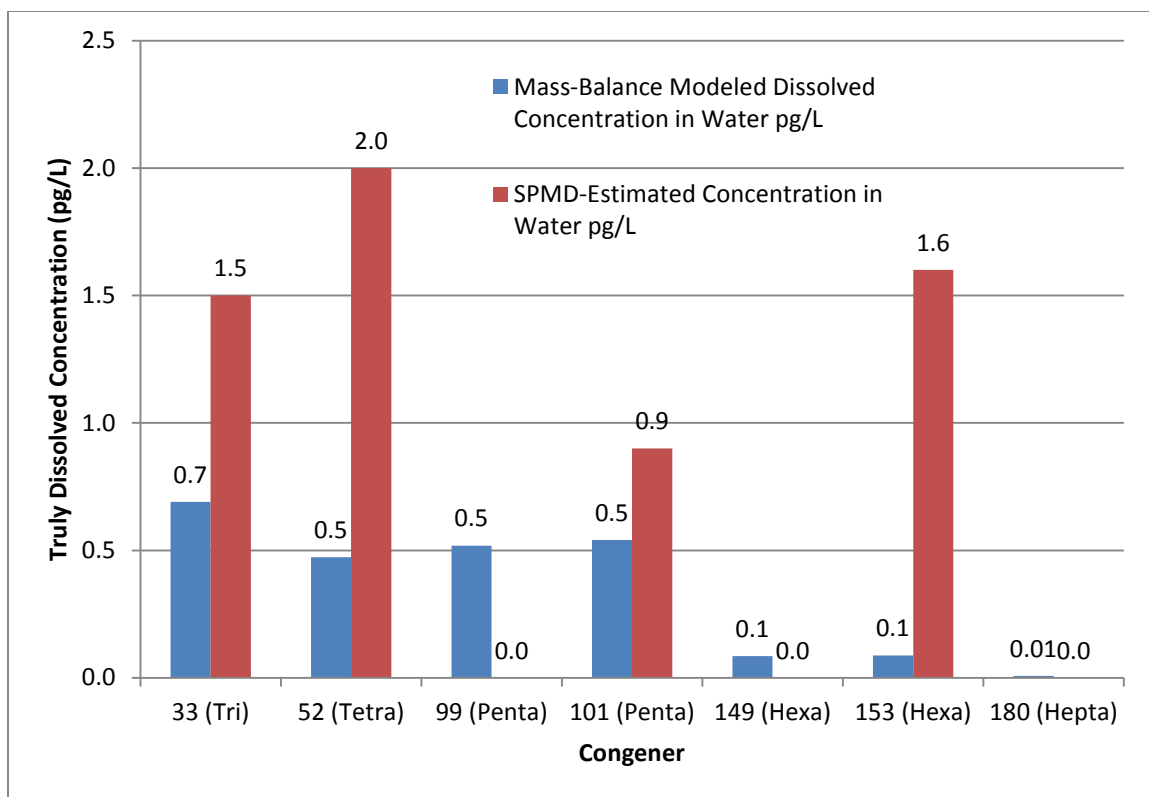
Figure 5.18: Truly dissolved PCB concentrations modeled by mass balance compared to truly dissolved concentrations estimated by SPMDs in Dollar Bay.

To test the validity of the mass balance on PCBs in Torch Lake, the mass balance model was applied to Lake Superior and Dollar Bay, for which truly dissolved concentration results were available from the MDEQ's 2005 SPMD study. In general, the modeled and SPMD-estimated truly dissolved concentrations did not agree. In both lakes, the mass balance model predicts truly dissolved concentrations less than those estimated from concentrations in the SPMDs. The results of application of the mass balance to PCBs in Lake Superior and Dollar Bay are shown in Table 5.12 and Table 5.13, respectively, and Figure 5.17 and Figure 5.18, respectively.

The SPMD concentrations are considered valid as demonstrated in the SPMD model validation section. For Lake Superior, the ratios of measured to modeled concentrations range from 2.1 to 14.4, suggesting that the model under-predicted the steady-state concentrations in Lake Superior. For Dollar Bay, the ratios of measured to modeled concentrations range from 1.4 to 18.2, suggesting that the model under-predicted the steady-state concentrations in Dollar Bay. There are several possible reasons for this disagreement. Measured rates of atmospheric deposition were only available for congeners 52 and 101; assumptions made for atmospheric deposition rates of other congeners may explain part of the error in model predictions for those congeners. The uncertainty analysis indicates that the disagreement between model predictions and measurements is small compared to the uncertainty in the predictions; alternatively, the relatively good agreement of model predictions with measurements might suggest that

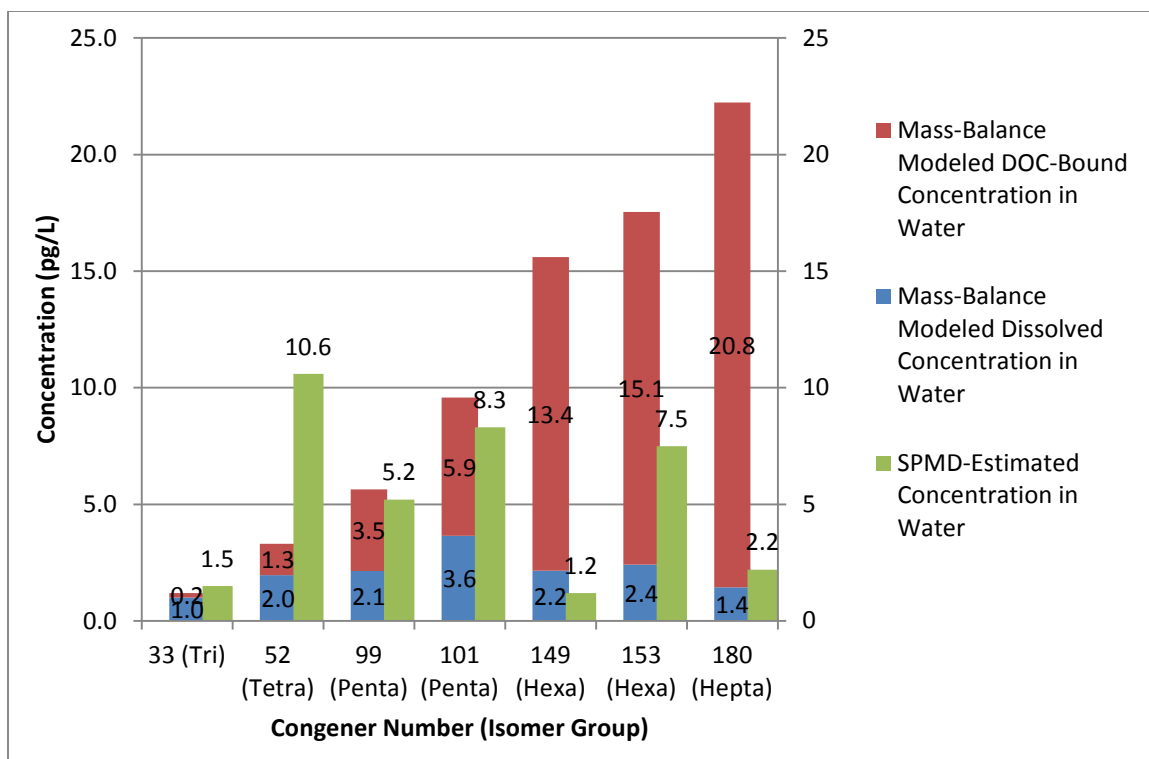
Differences between the mass balance-predicted truly dissolved concentrations and the SPMD concentrations might occur if the SPMDs took up the truly dissolved- and DOC-bound phases of PCBs. In an effort to determine if the SPMDs took up the truly dissolved-phase and DOC-bound phase concentrations of PCBs, the mass-balance modeled truly dissolved and DOC-bound phase concentrations were compared to the SPMD-estimated concentrations, as shown in Figure 5.19 to Figure 5.21 below. To be clear, SPMDs do not take up the DOC-bound phase of PCBs. As explained further in this section, if DOC partitioning was not taken into account during SPMD calibration experiments, the SPMD estimates may be greater than actual truly dissolved congener concentrations in the water column.

Figure 5.19: Comparison of (truly dissolved + DOC-bound) concentrations predicted by the mass balance model with SPMD-estimated concentrations in Torch Lake.

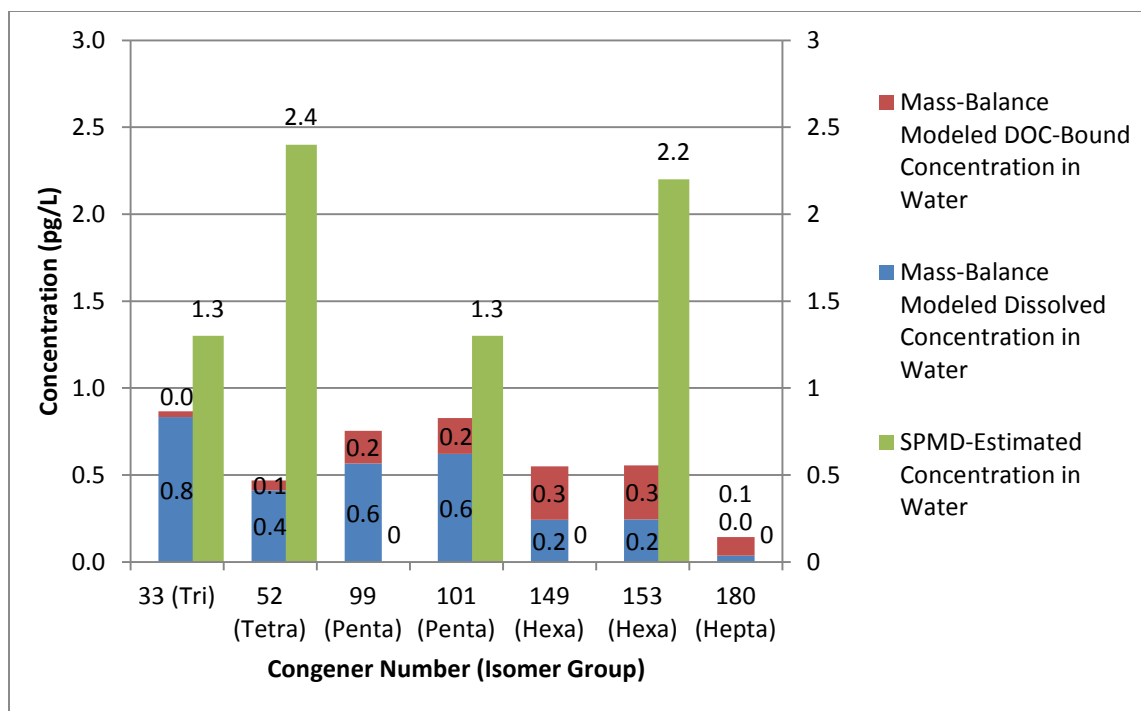
Figure 5.20: Comparison of (truly dissolved + DOC-bound) phase concentrations predicted by the mass balance model with SPMD-estimated concentrations in Lake Superior.

In Lake Superior and Dollar Bay, the SPMD-estimated concentrations are greater than the mass balance modeled concentrations as well as the sum of the mass balance modeled (truly dissolved + DOC-bound, “aqueous”) concentrations – this shows that the discrepancy between the mass balance modeled dissolved concentrations and the SPMD-estimated concentrations are not just the result of a methodological issue. As seen in Figure 5.19, the SPMD-estimated concentrations in Torch Lake are less than the sum of the mass balance modeled aqueous concentrations (except for the lightest congeners, PCB-33 and PCB-52). A couple of observations can be drawn from these results: 1) The DOC-content of Torch Lake is higher than the DOC content of Lake Superior or Dollar Bay; and 2) The conditions in Torch Lake are different than those in the control sites.

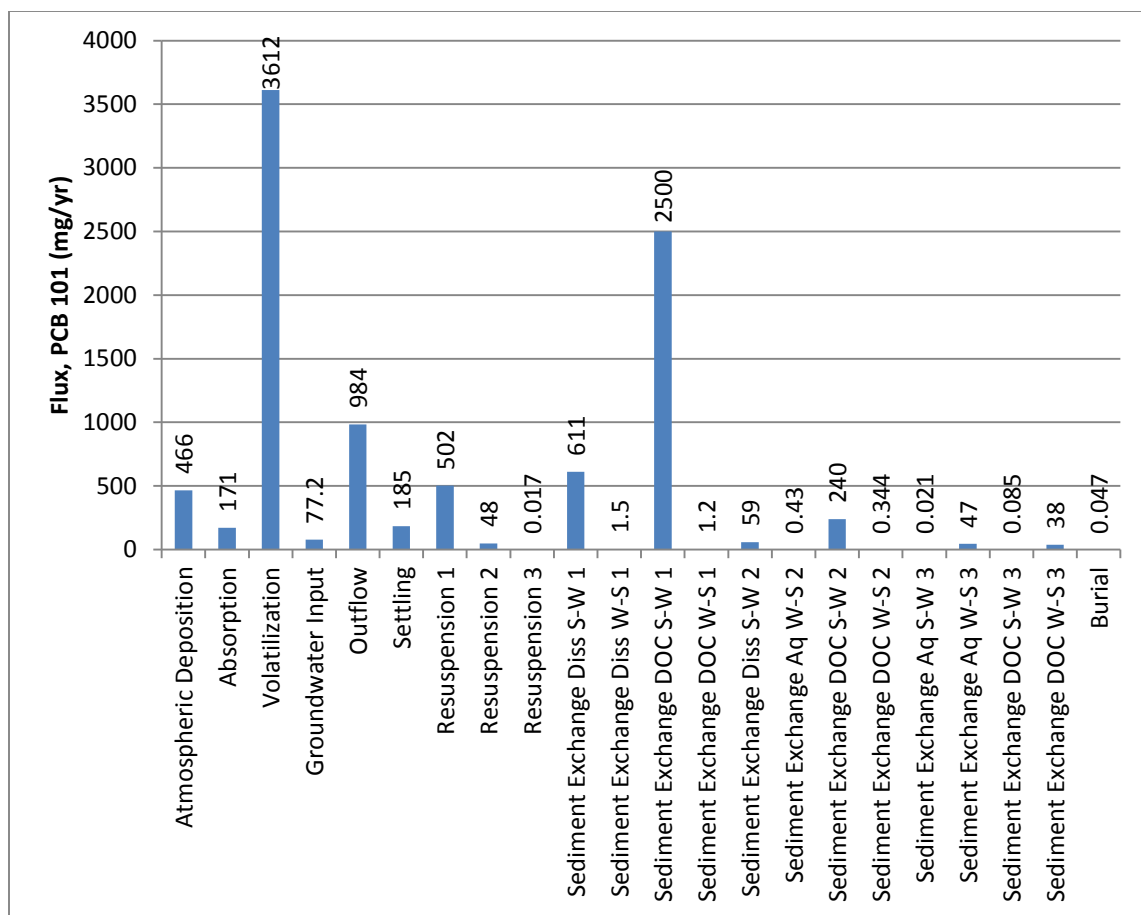
As shown in Figure 5.22 below, the diffusion of DOC –bound PCB from sediment to water in region 1 is also large compared to other fluxes in the mass balance. A comparable value for Lake Superior and Dollar Bay does not exist because these lakes do not have regions of high concentrations of PCBs in the sediments serving as potential inputs of PCBs to the lake. Future work should include an examination of this parameter to ensure that it is estimated correctly.

Figure 5.22: Magnitude of the components in the mass balance model for Torch Lake.

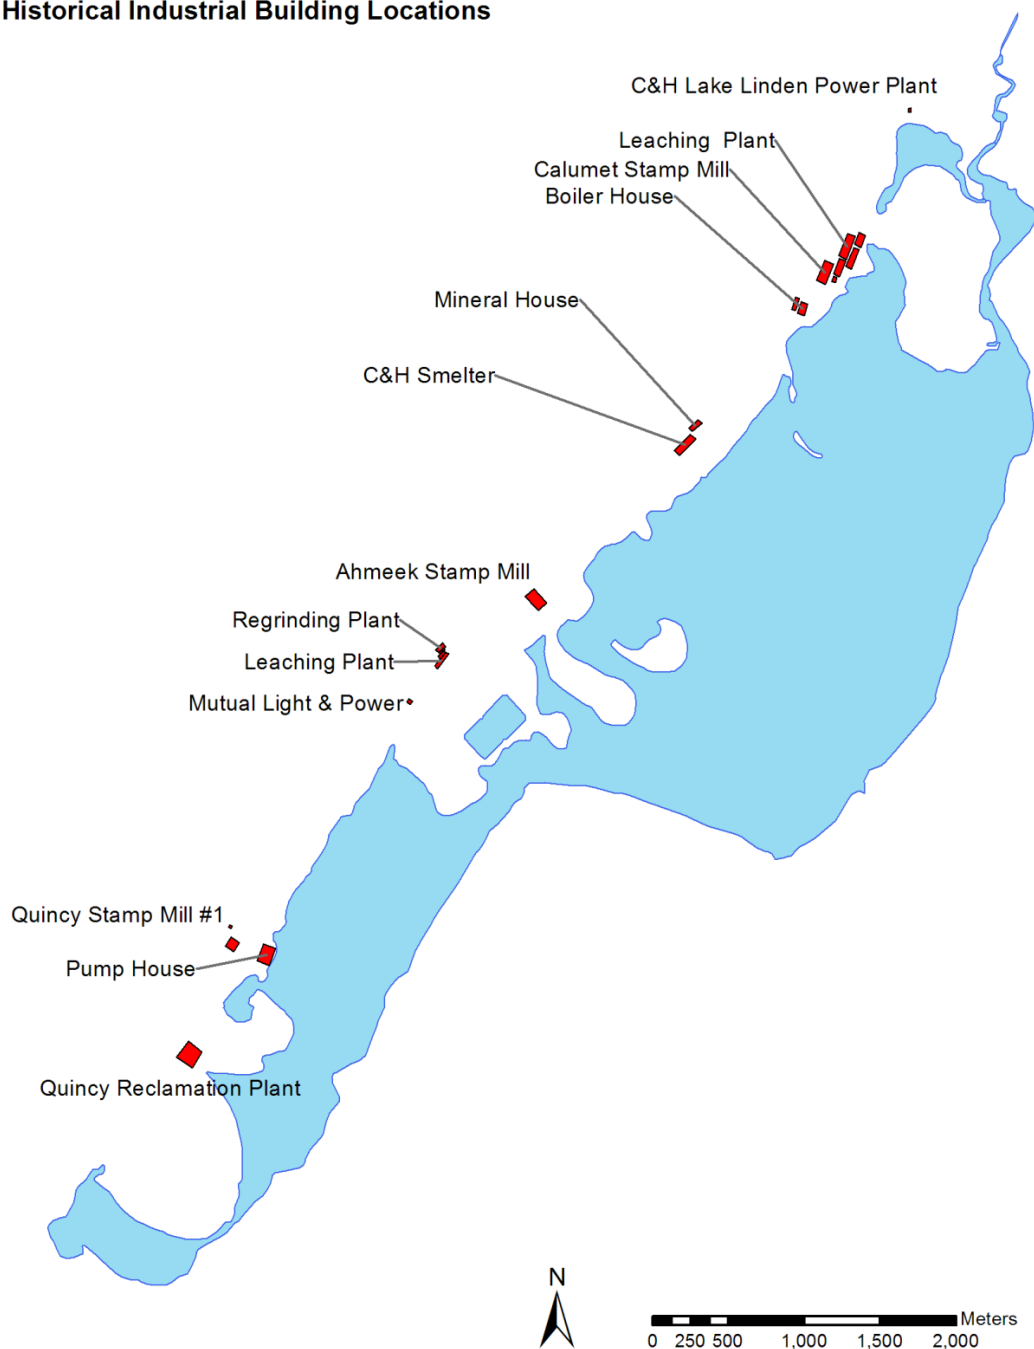
Figure 5.25: Locations of historical industrial buildings where PCBs have been found.

Because they were found in one concentrated area near what is now the Koppers site (the former site of the C&H smelter, displayed in Figure 5.25) only, the EPA concluded that the contamination found in that small area could not be causing the frequency of fish tumors occurring in Torch Lake (EPA, 1994) (MDEQ, 2007). The EPA explored the idea of placing a polyvinyl chloride cap over the contaminated location, but it was decided that this measure would be cost prohibitive (EPA, 1994).

Though PCBs were sampled in the upland material as part of the OUI Remedial Investigation and in drums of contaminated material found near Hubbell/Tamarack and Mason, they were detected in only one barrel between all sampled media (Geraghty & Miller, 1992). Two of three soil samples were collected near the Ahmeek stamp mill site (Figure 5.25) in Tamarack in the vicinity of a transformer pad and a drum. Neither of these samples yielded positive concentrations of PCBs. Recent soil sampling efforts for PCBs have not occurred near the Ahmeek stamp mill. An effort to locate the Mason soil sample site was made by the author, but it could not be located based on comparison of the schematic drawing provided in the Remedial Investigation and modern-day maps of the area. None of these sample locations had influence on the recent upland sampling for PCBs, which is discussed further below. The area of concentrated contamination in the sediment may have influenced the locations of recent U.S. EPA and MDEQ sediment sampling efforts, which were launched by the need to find a possible local source of PCB contamination that may be affecting concentrations found in fish caught from Torch Lake.

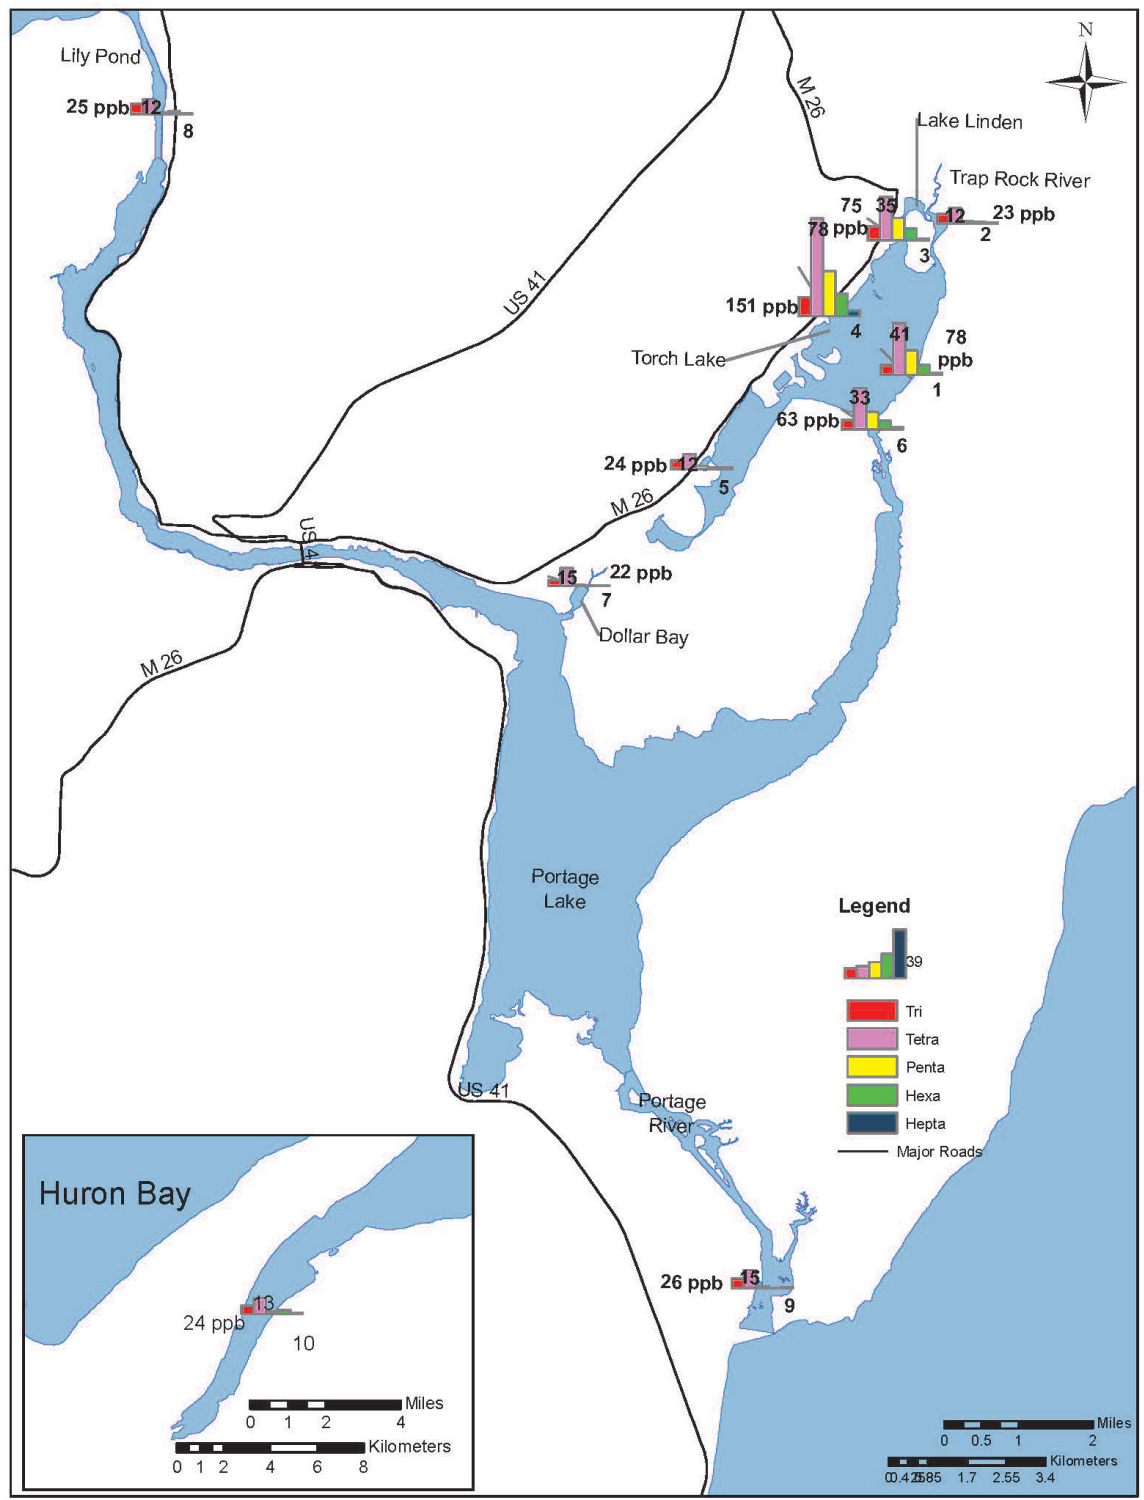
As part of the overall goal to determine if a local source or sources of PCBs to Torch Lake exists, in 2005, the MDEQ contracted Great Lakes Environmental Center (GLEC) to conduct collect samples of PCB from the lake water using SPMDs. SPMDs were deployed in 2005 in six locations in Torch Lake and four control sites located in the Keweenaw Waterway, Dollar Bay and Huron Bay, which are shown in Figure 5.26. More details about this study can be found in the methods section or in the GLEC report (GLEC, 2006). Two findings of the MDEQ 2005 SPMD study clearly show that a local source of PCBs exists in Torch Lake.

Figure 5.26: Isomer PCB concentrations in SPMDs. Numbers at the bottom right of each bar graph are the site numbers. Total PCB concentrations in the SPMDs at each site are reported in ppb. Numbers above the tallest bar in each graph give the total concentration for the most prominent isomer at that site.

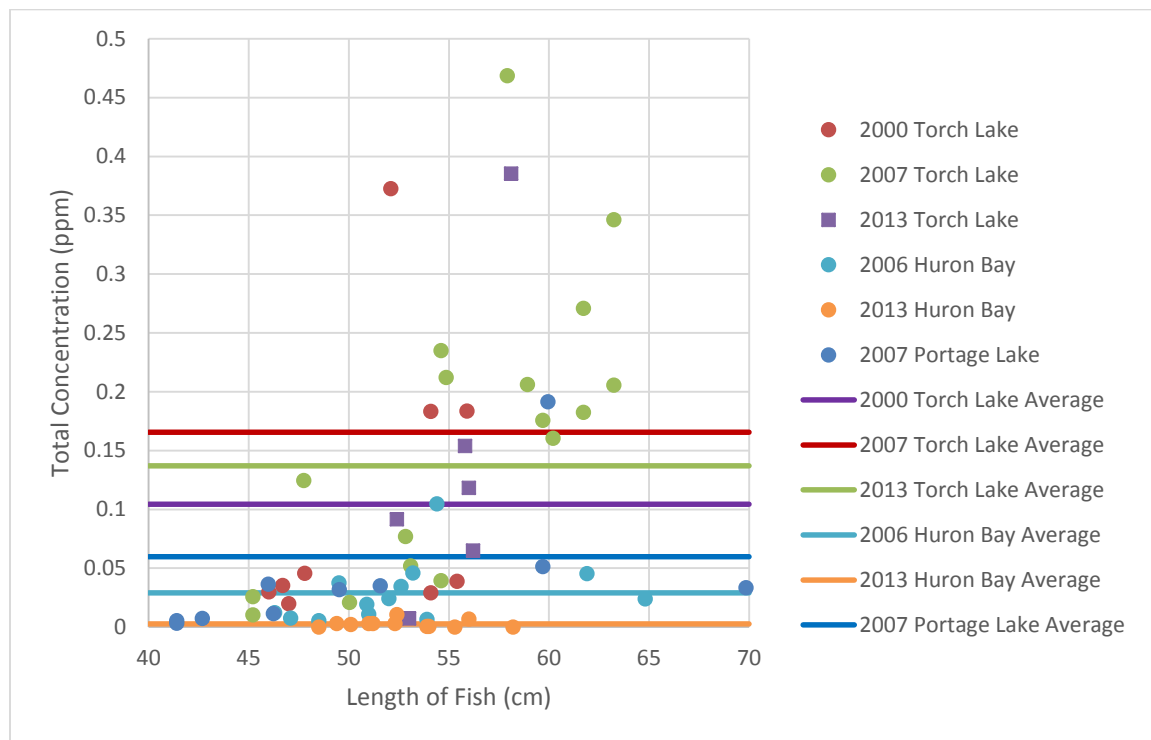
As mentioned above and as shown in Figure 5.27, concentrations in Walleye in Torch Lake are usually higher than concentrations in Walleye in Portage Lake or Huron Bay. Concentrations reported are in terms of wet weight in fillets.

Figure 5.27: Concentrations of PCBs in Walleye 45-65 cm in length of fish.

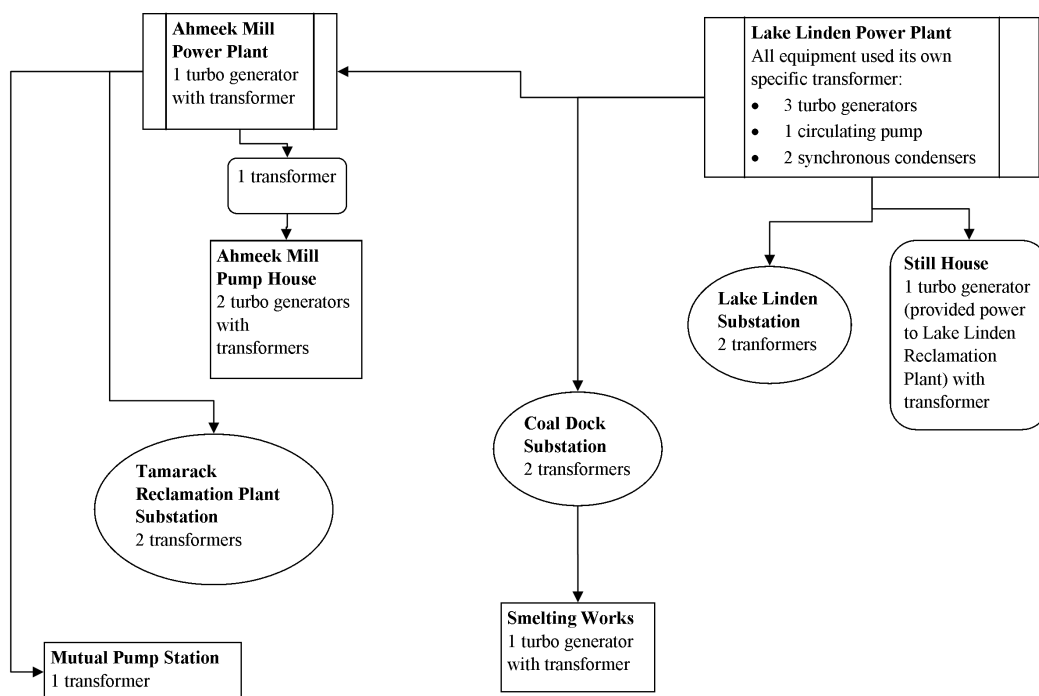
Figure 5.29: Schematic of the electrical distribution system along western shore of Torch Lake in the early 1930s identifying buildings in which electrical transformers are known to be located (Adapted from McIntosh & Burgan, 1931; Schwaiger Zawisza, 2016 (Expected)).

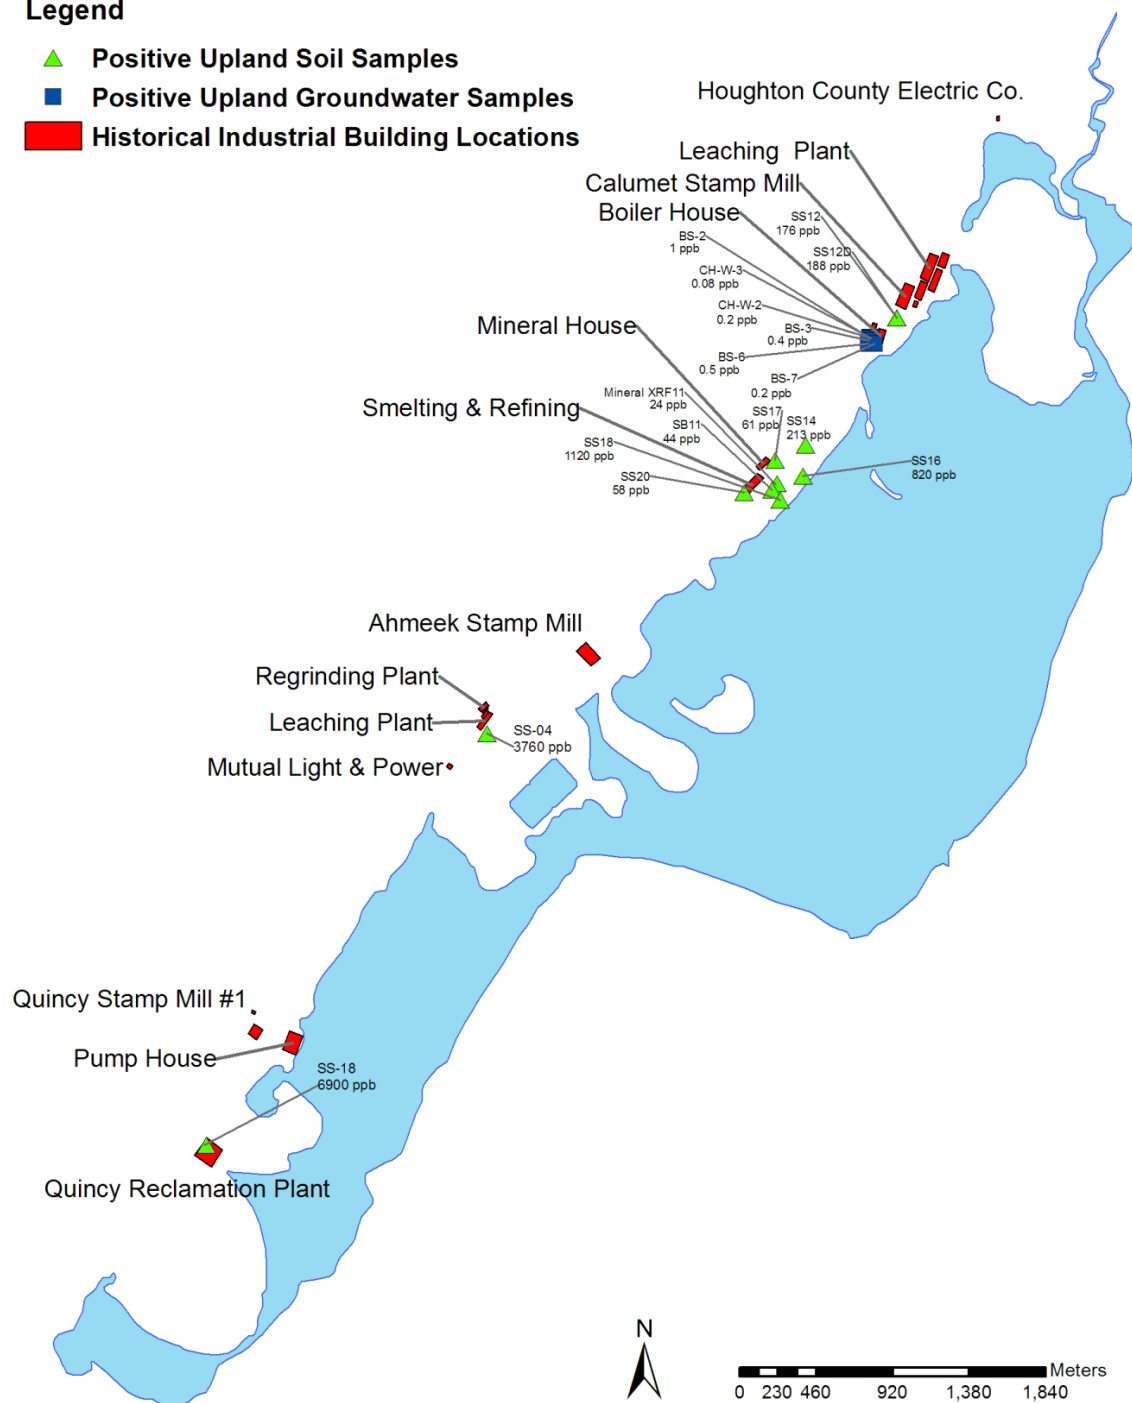
Figure 5.30: Locations of PCB concentrations above detection limits in soil and groundwater relative to historical industrial buildings.
