DOUBLE VAULT COMPOSTING LATRINES IN RURAL PARAGUAY : FEASIBLE CONSTRUCTION AND OPTIMAL USE

A THESIS

In Civil Engineering

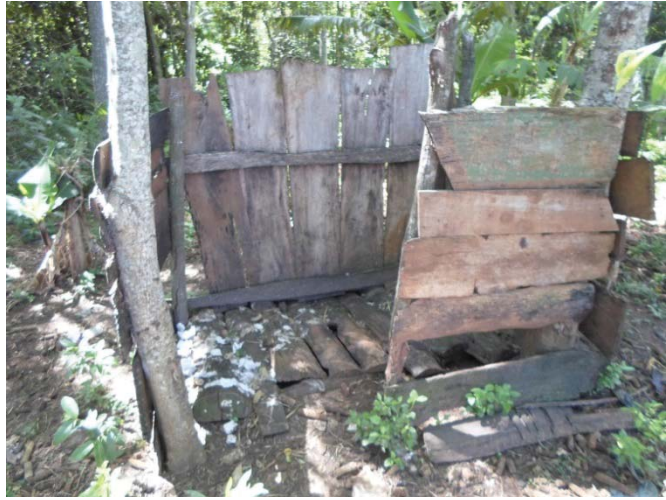
Figure 5: Typical pit latrine found in Santa Elena. Photo by author.

The majority of households use open pit latrines as their main form of human waste disposal (Figure 5). These latrines use either a concrete or wooden top and are usually uncovered and open to the elements, creating a pungent smelling haven for flies and other insects that can spread disease. Because of the smell and flies, most households place their latrines far from their homes, making them uninviting in the dark and during rain storms. It is common to use a latrine for roughly two years until it fills up, then top it with dirt and dig another pit close by.

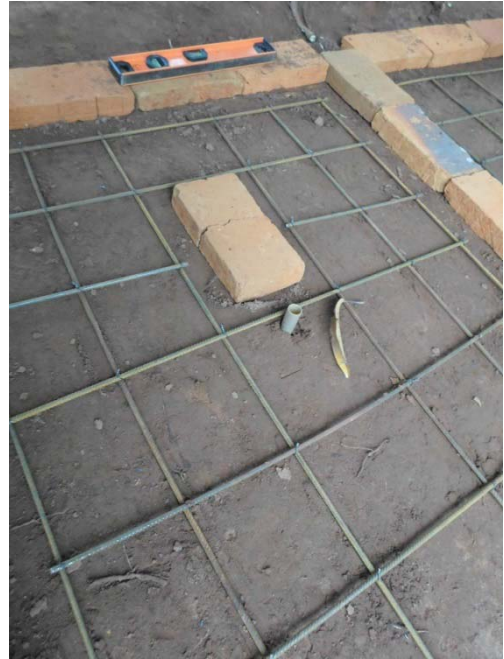
Figure 19: Placement of 20mm tubing in relation to *loza* opening. Photo by author.

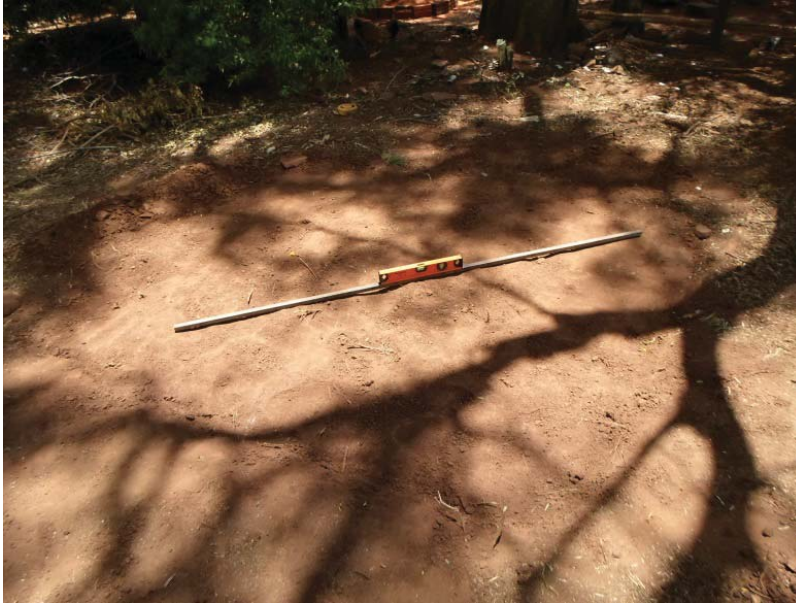
Figure 22: Level ground using shovel, hoe, rake, and long ruler. Photo by author.

2) Level ground using a shovel, hoe, metal ruler and hand level (Figure 22). Level an area of 2m X 2.5m. Dig slightly under surrounding dirt level to place common bricks slightly under ground. This will add protection from erosion caused from rainwater runoff.

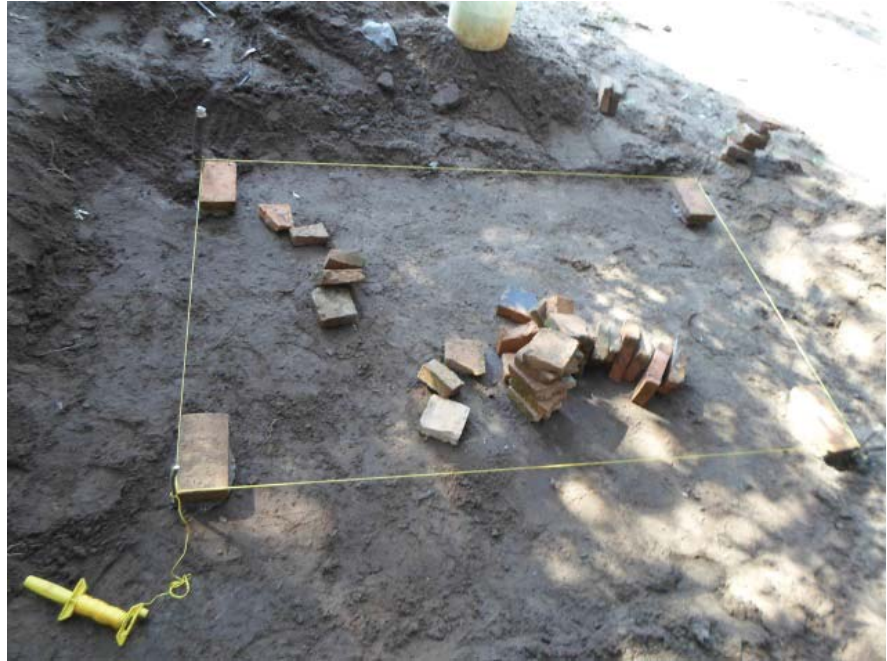
Figure 24: String strung between stakes to show placement of base level of bricks. Photo by author.

4) Pull a string line using small stakes to create a rectangle with the dimensions of 197cm X 127cm (Figure 24). The diagonal should measure 234cm. Next lay each corner brick with mortar and a trowel, and level in between each brick using the 2m long metal ruler and hand level to ensure all

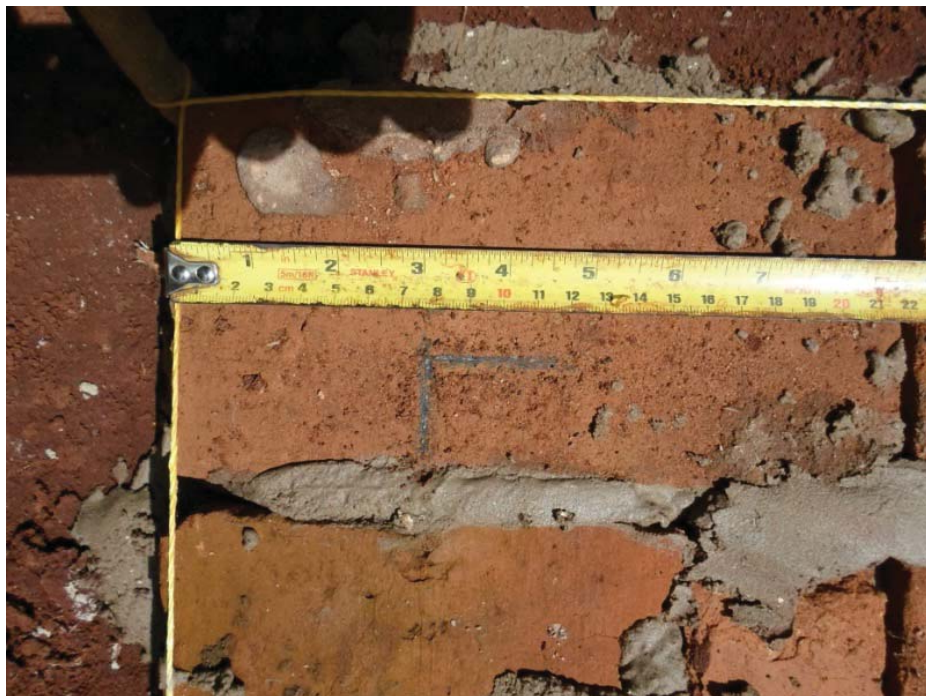
Figure 27: Corner brick placement marked 7.5cm from each side. Photo by author.

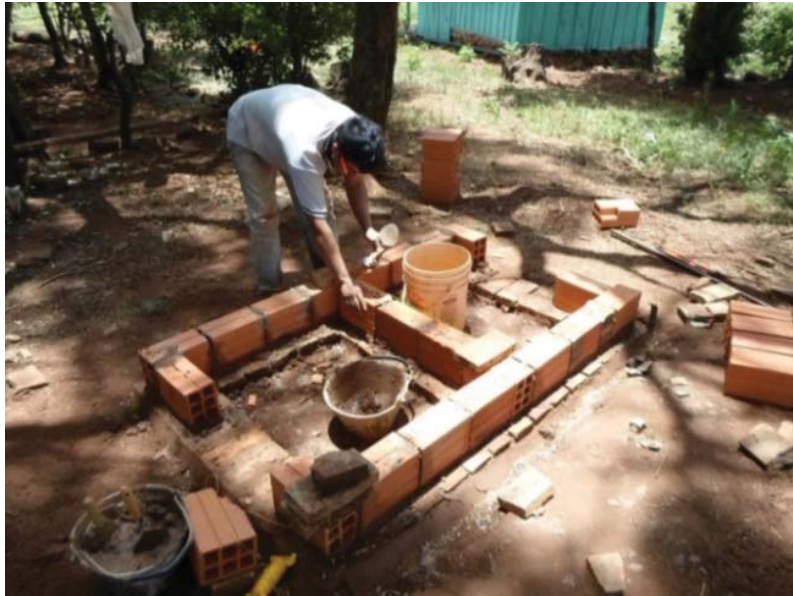
Figure 30: Center bricks of bottom layer being laid. Photo by author.

8) Once all four corner bricks are laid string lines can be pulled between each brick, and the first level of bricks can be laid (Figures 29 and 30). Remember to leave an opening in each vault to create the doors where the resulting compost will be taken out of. The doors can either be on the sides or the back of each vault.

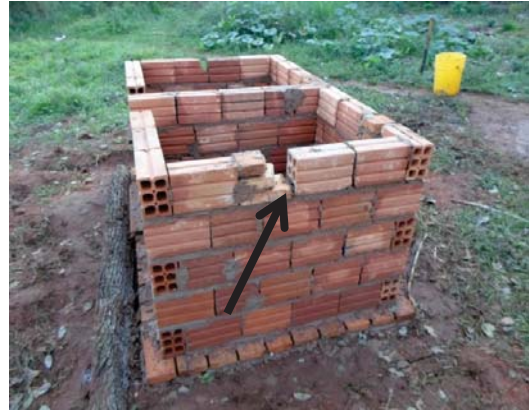
Figure 36: Opening on side of top layer of bricks for urine diversion tubing. Photo by author.

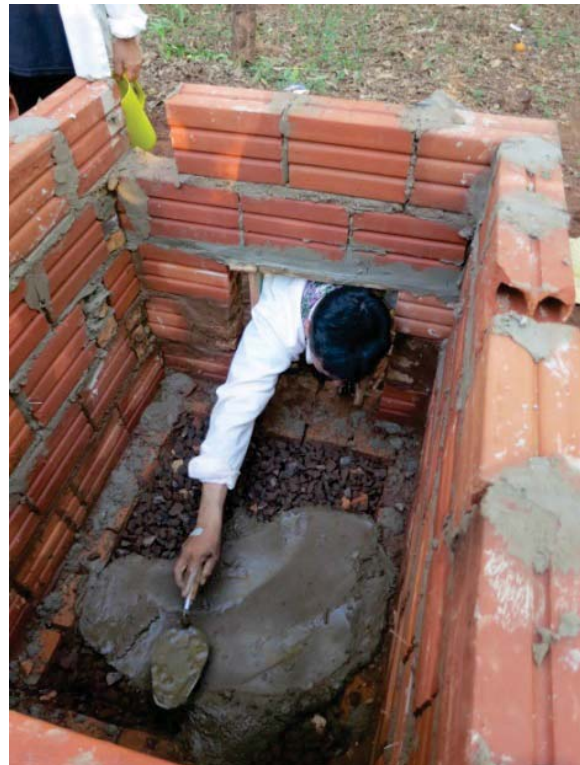
Figure 38: Vault floor being poured. Photo by author.

13) The floor of each vault can now be poured. First place rocks or broken bricks on the floor of each vault, up to the level of the common bricks used to make the base (Figure 38). Next make a mixture of five masonry buckets of sand with one masonry bucket of cement with more water than was used for the mortar. Pour each floor and smooth out with a trowel (Figure 39).

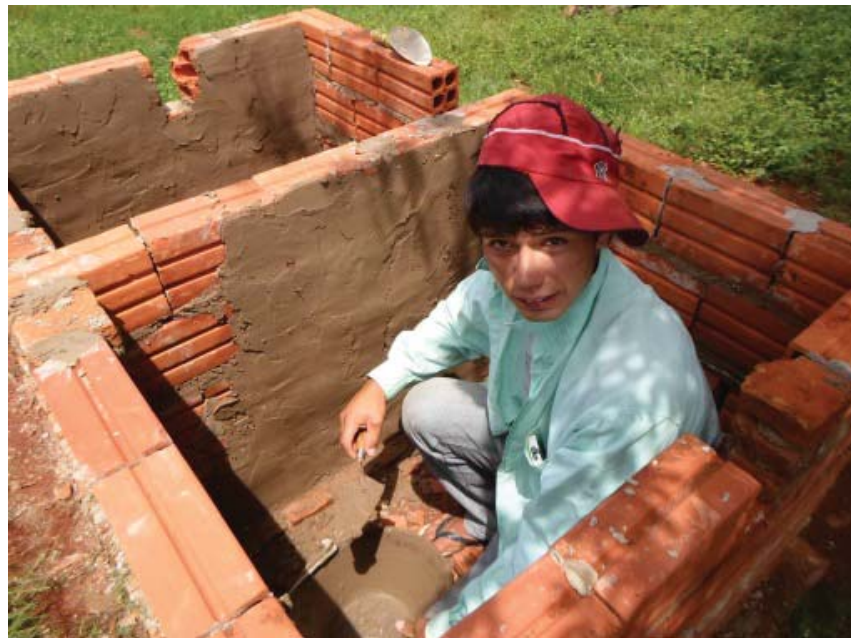
Figure 40: Ignacio putting layer of stucco on inside walls of vault. Photo by author.

14) Next a layer of stucco (*revoke*) needs to be placed on the inside of each vault (Figure 40). This needs to be done after the floors have had enough time to cure, roughly one day. Prepare a mixture of six parts sand - one part cement - one part hydrated lime to use as your stucco. Next, using a trowel, cover the inside walls of each vault with a thin layer of stucco. A technique of lightly “throwing” the mortar on the wall then smoothing it with the backside of the trowel works well to apply a uniform layer of stucco on all four walls.

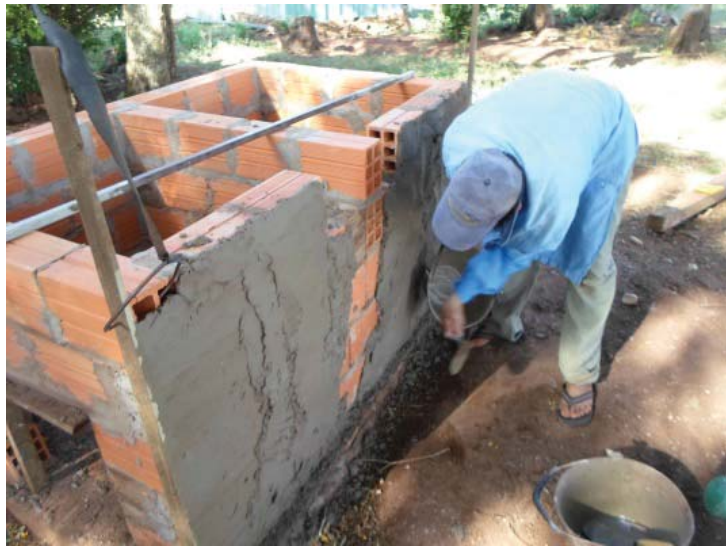
Figure 46: Author's neighbor is 'throwing' stucco on to outside walls of vaults. Photo by author.

3) Cover one wall of the latrine with the stucco, in between the thickness guides (Figure 46). The technique of coving the walls with stucco is slightly tricky at the beginning and requires much practice, but can be achieved by anyone if practiced. To place the stucco on the wall use a masonry trowel to lightly, but with a quick snap action of the wrist, “throw” the stucco onto the wall. If the mix is too wet it will fall off the wall, and if it is too dry it will crumble into pieces when “thrown” at the wall.

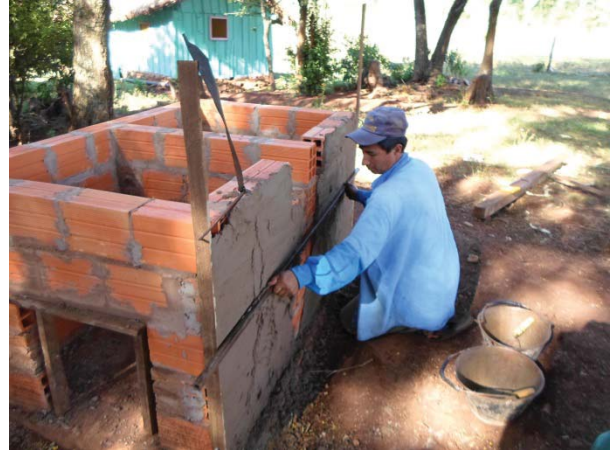
Figure 47: Author's neighbor Io smoothing stucco with long metal ruler. Photo by author.

4) Once the wall is completely covered, use the 2m long metal ruler to smooth out the stucco on the wall (Figure 47). Using the thickness guides on the corners lightly push the ruler back and forth slowly smoothing out the stucco. While planning out the surface, stucco can be added to the areas that are too thin by using the same technique of “throwing” and smoothing. Continue placing and smoothing the stucco until a relatively uniform thickness is obtained.

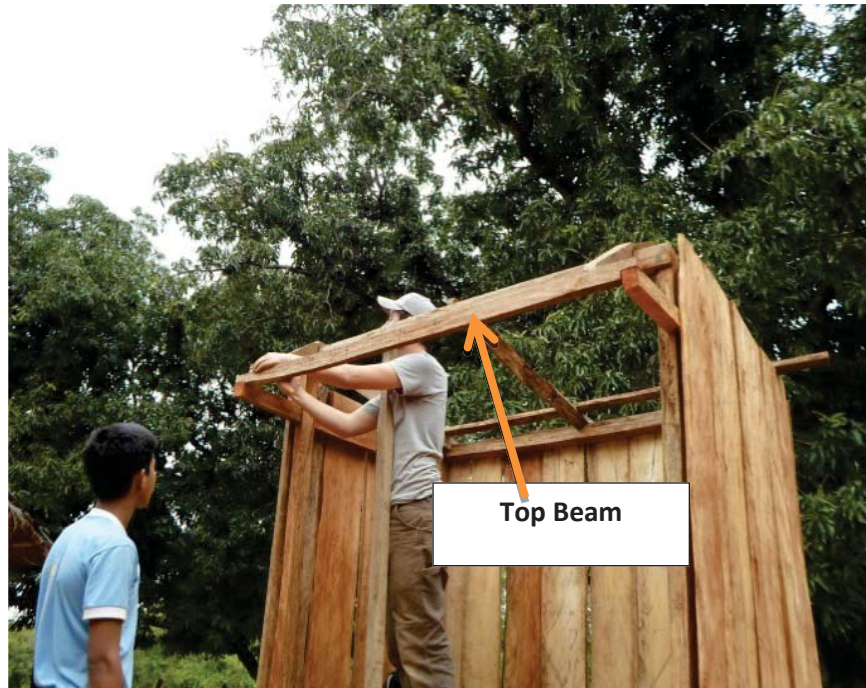
Figure 59: Top beam placement. Photo by author.

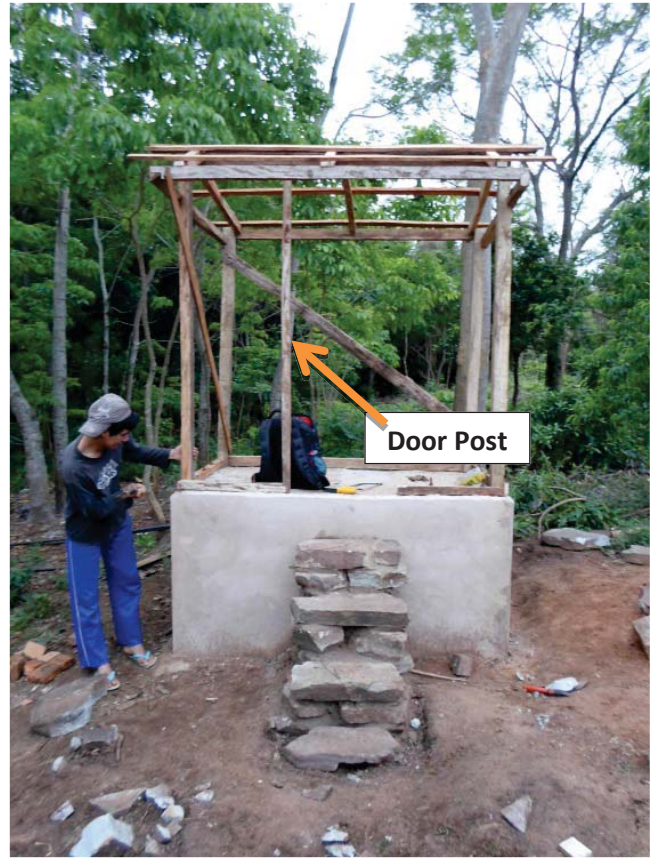
Figure 60: Door post placement. Photo by author.

8) Measure, cut, and attach door post to front side of housing structure (Figure 60).

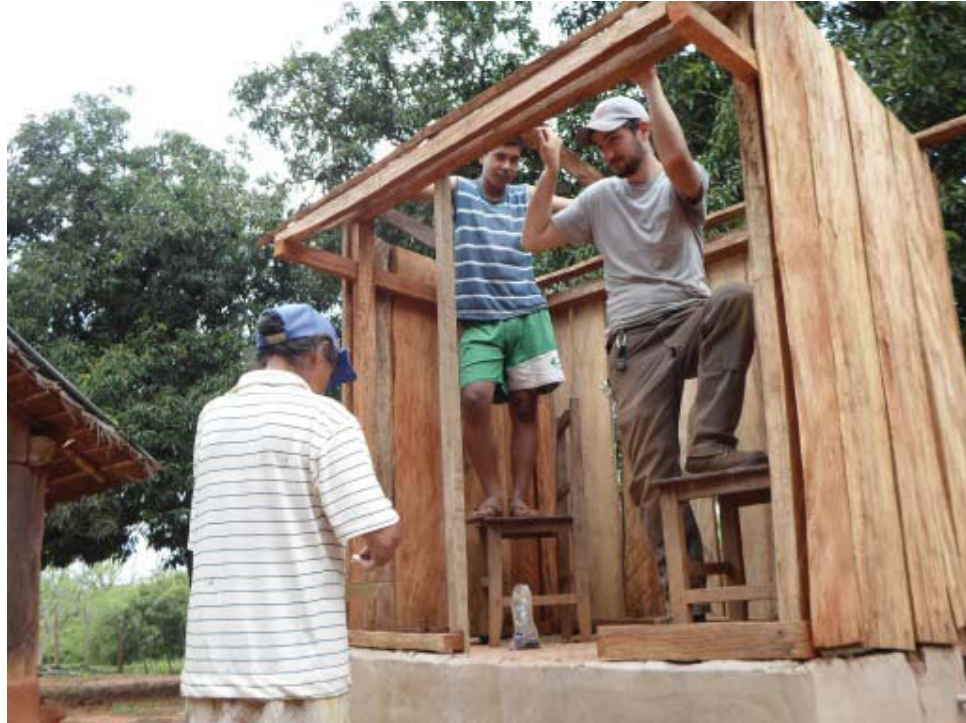
Figure 63: Attaching planks to complete walls of latrine housing structure. Photo by author.

10) Cut and attach wooden planks to form walls of the housing structure (Figure 63). The door can also be fabricated and hung at this point.

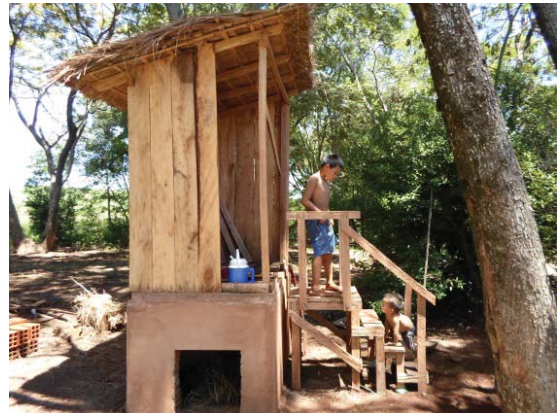
Figure 71: Side view of wooden stairs. Photo by author.

Wooden stairs are not recommended, as they are slow to make, rot over time, and are more expensive than the other options. However, if wood is the only material available or desired by the owner of the latrine, the design below can be successfully implemented and enjoyed by the owners (Figures 71-73).

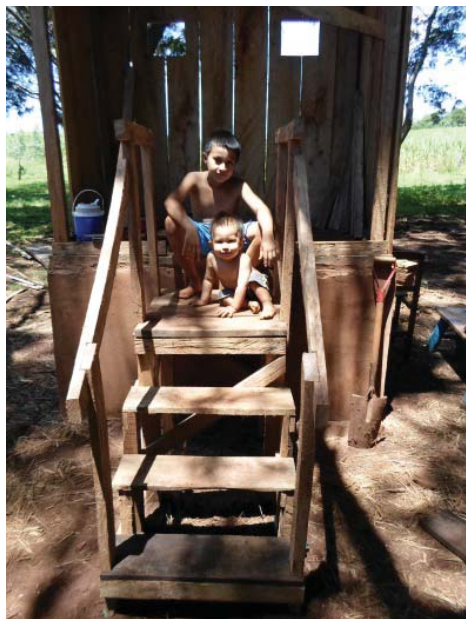
Figure 72: Front view of wooden stairs. Photo by author.

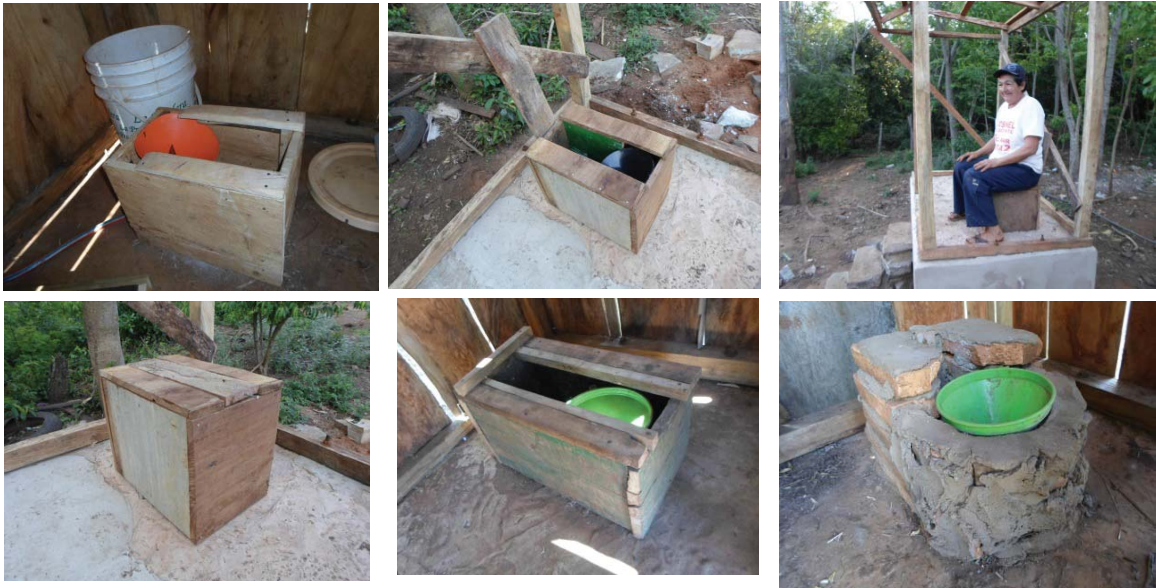
Figure 79: Six different urine diverting seats. Photos by author.

The double vault composting latrine design shown requires the use of a urine diversion system. If the contents inside the vaults become too wet it will become anaerobic and begin to produce offensive smells, and attract flies and other insects. Because of this a specialized seat is needed to divert the urine from the feces. The urine is diverted and piped into a shallow gravel filled soak pit next to the each vault using 20mm PVC tubing. The seat designs shown here (Figure 79) are only a few of many possibilities, and changes and improvements are highly recommended to fit the cultural norms and desires of the people who will be using the latrines.

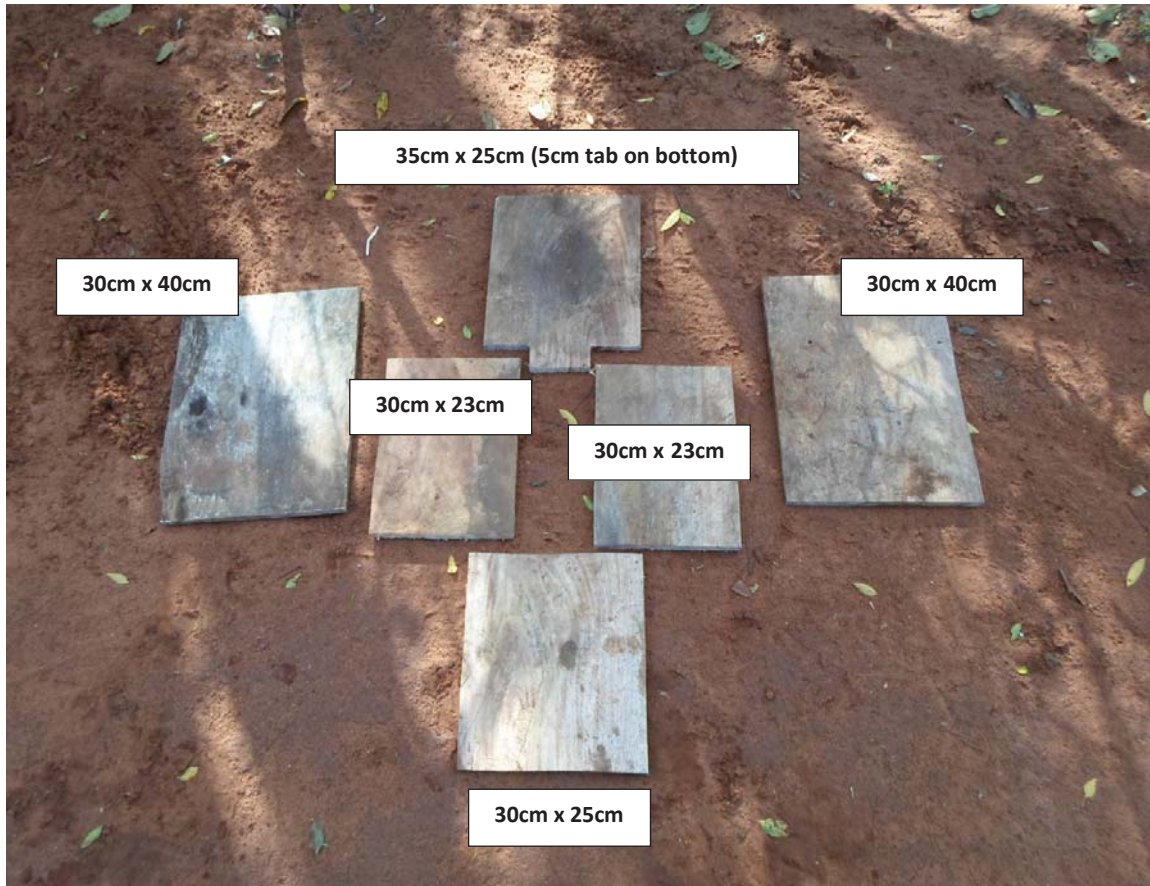
Figure 80: Board sizes and quantities needed for seat construction. Photo by author.

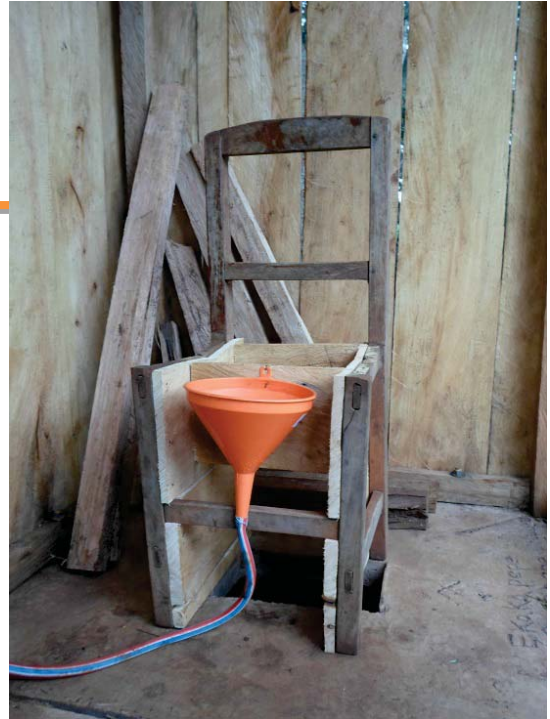
Figure 89: Placement of attached hose on funnel.
Photo by author.

8) Attach 20cm of plastic hose to the funnel using heat from a fire, wire, and pliers (Figure 89). **Note: The picture shown was from a failed prototype, but is shows how the hose needs to be attached to the funnel.*

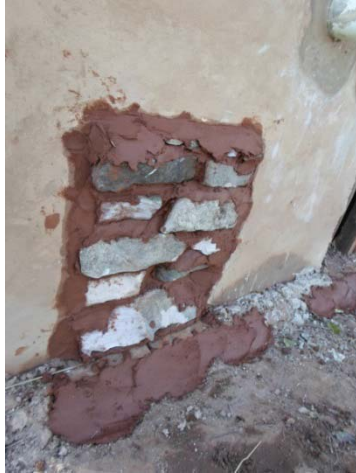
Figure 95: Vault closed with rocks and clay mortar. Photo by author.

- 3) Close vault opening using bricks, rocks (Figure 95), or wooden door (Figure 96). Rocks and bricks are obviously faster and easier to install, however a wooden door built from durable rot-resistant wood will last several cycles of use while a brick or rock covering will need to be knocked out and re-built each time the compost is taken out of the vault. If bricks or rocks are used, a mortar mix of four masonry buckets of sand and one half masonry buckets of cement is recommended. A layer of stucco (revoke) is recommended to top the closure with a mix design of one masonry bucket of sand, $\frac{1}{4}$ masonry bucket of cement and $\frac{1}{4}$ masonry bucket of hydrated lime.

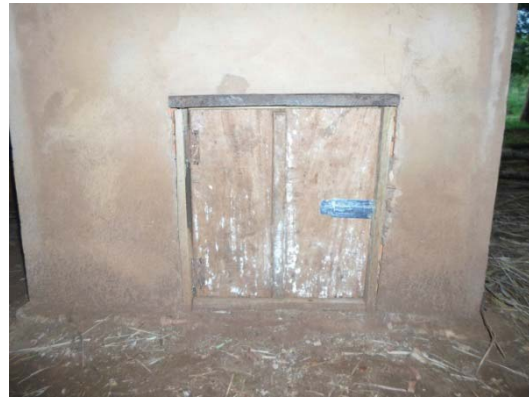
Figure 96: Vault closed with wooden door. Photo by author.
